MTC / REPORT / 01
REPORT NO. 28 / 2008

KALOL UNIT

PLANT TURNAROUND REPORT

INDIAN FARMERS FERTILISER CO - OPERATIVE LIMITED

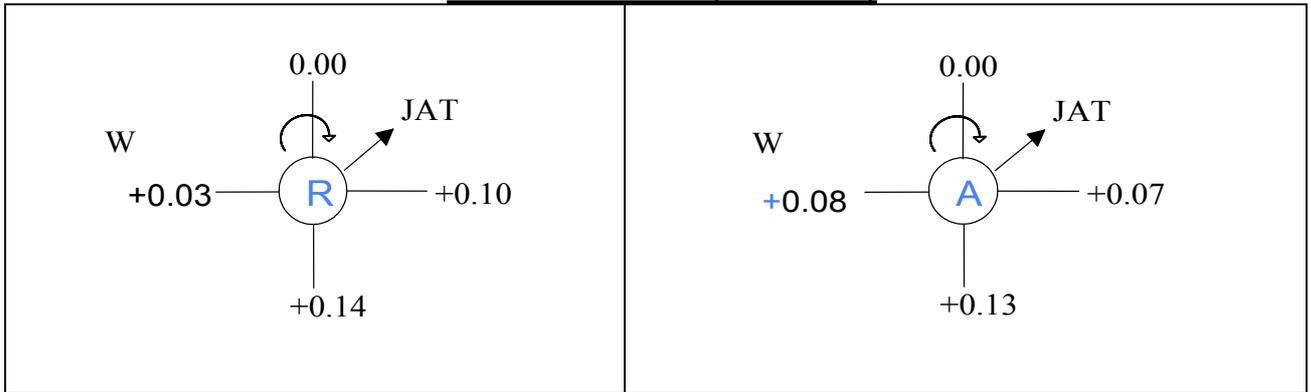
104-JAT to 104-JA (Before PM)

The coupling was inspected and the flexible element found damaged. Few shims had broken and a couple of bush for fastners had come out. Hence a new flexible element was installed and the set of fastners was replaced by new one. The DBSE and coupling hub / shaft overhang was measured and found within limit.

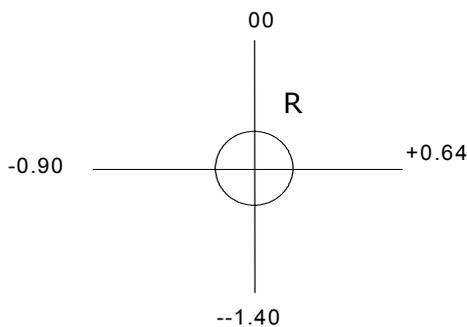
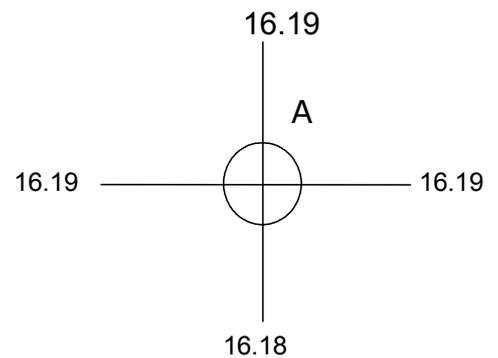
Alignment readings between Gear Box & Cooling Water Pump- Dial

Sr. No.	Description	Actual Value (MM)
1	Axial Float of the turbine	0.33 mm
2	Radial bearing Clearance coupling end	0.30 mm
3	Radial bearing Clearance Governor end	0.25 mm

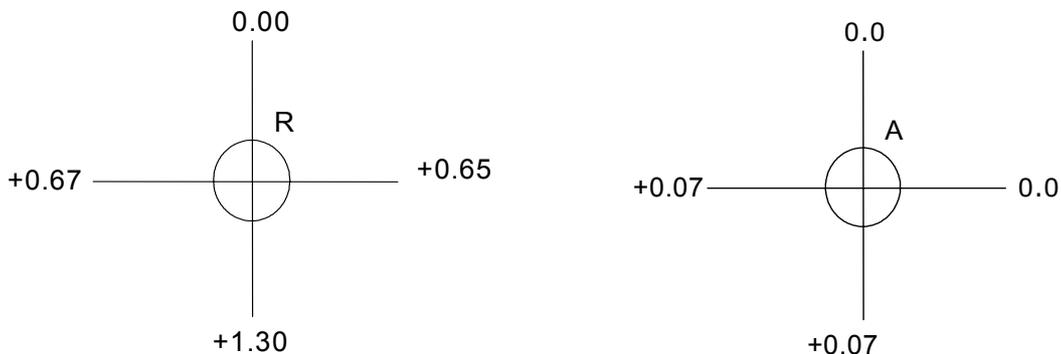
- Coupling between the pump and motor was decoupled.
- Both the journal bearings were checked & found okay.
- The clearances were checked & following are the readings.
Free end side : 0.17 to 0.21 mm , Coupling side : 0.18 to 0.24 mm
- Both the bearing housing was flushed with oil & fresh oil (SERVO-PRIME 68) charged.
- Radiator cooling water line opened and box-up after cleaning of radiator.(Only Motor driven)
- Coupling oil paper replaced and new grease filled.
- The clearances were checked & following are the readings:

- Checked the alignment between pump & motor and following are the readings:

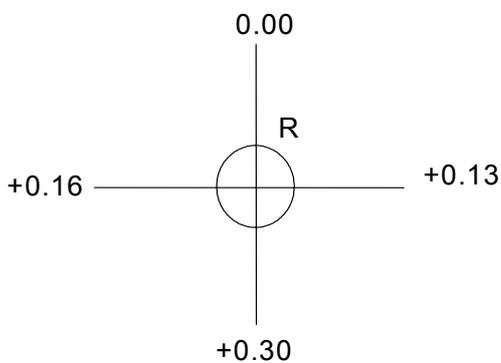
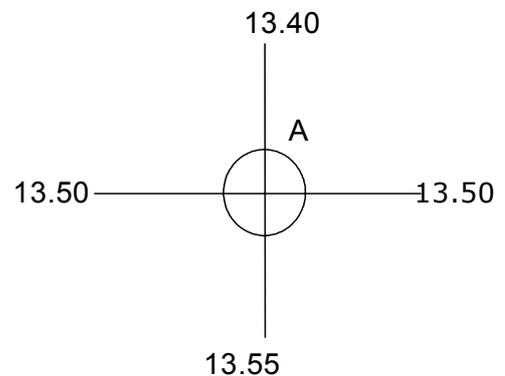
- The journal bearings were opened, cleaned and checked for clearances.
- The coupling side journal & rear bearing were found ok.
- The rotor float was measured as 0.24 mm.
- Both side glands were repacked.

- The alignment readings are as under ;-

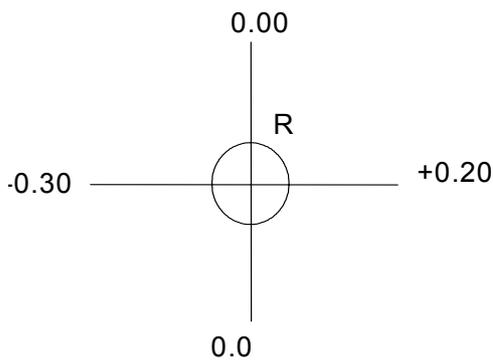
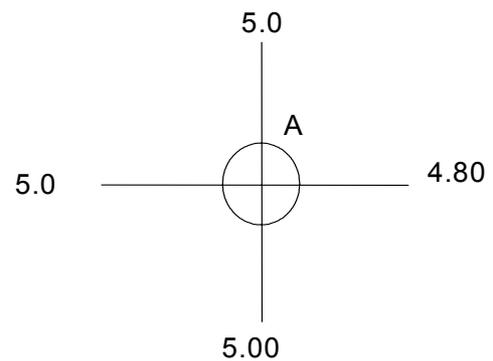
COOLING WATER PUMP (P-4401 / C):

- Checked the journal bearing Clearance at both ends.
- Coupling end 0.21 to 0.23 mm.
- The rotor float was measured as 0.35 mm.
- Cleaned & greasing done after coupling.
- Checked the alignment.

- The alignment readings are as under ;-

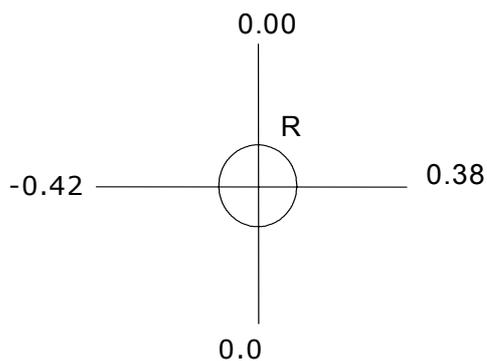
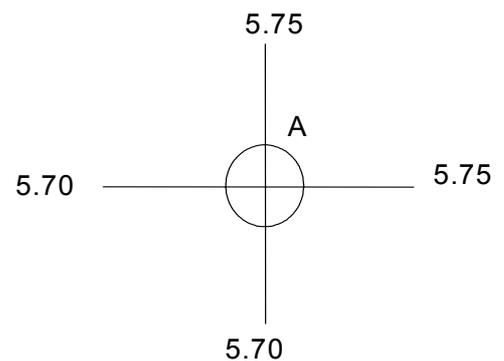
COOLING WATER PUMP (P-4401 / D):

- Checked the bearing Clearance at both end
- Coupling end 0.18 to 0.20 mm
- Free end 0.17 to 0.20 mm
- The rotor float was measured as 0.60 mm.
- Cleaned & greasing done after coupling.
- Checked the alignment & readings are as under ;-

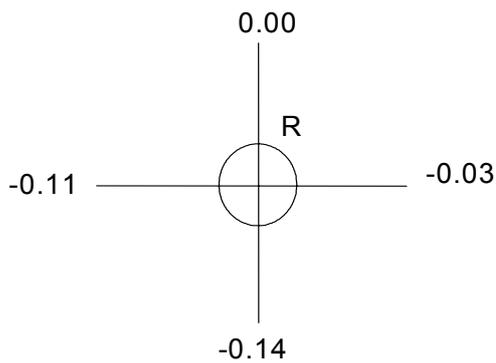
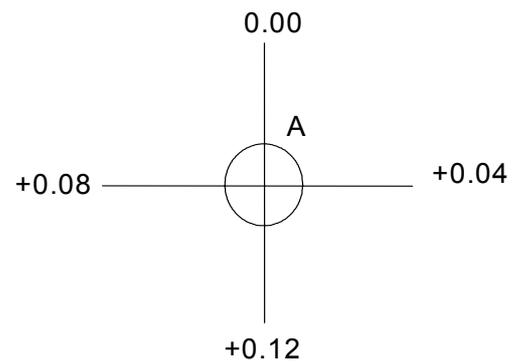
COOLING WATER PUMP (P-4404-E):

- Coupling float was checked after de-coupling and observed as 0.14 mm
- The pump to motor alignment was checked and corrected.
- Both bearing top half opened. Both side bearing checked, found in healthy condition.
- Bearing housing cleaned and fresh oil (SERVO PRIME 68) charged.

- The following are the alignment readings:

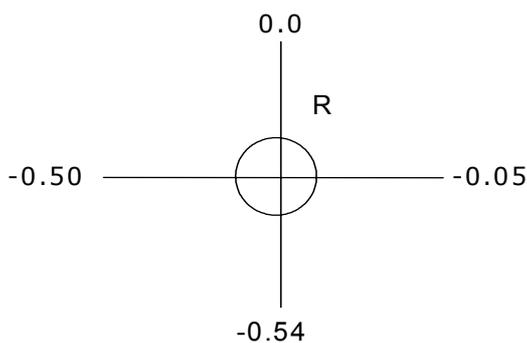
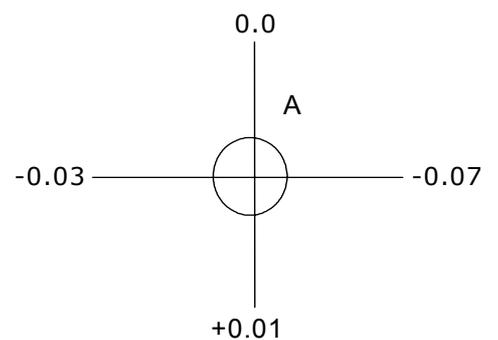
PREVENTIVE MAINTENANCE OF B. F. W TURBINE Q - 5111 :

- Cleaned the Radial & Thrust bearings.
- Checked the radial clearances of bearings using lead wire.
- Alignment readings were checked.
- The oil cooler covers were opened and hydro-jetting was carried out.
- Cleaning / replacing oil filters and oil in the oil console.
- Checked the oil lines, water line for leaks.
- Suction filter of the MOP was cleaned.
- The oil console was cleaned and fresh oil (servo-68) was charged.
- Alignment Readings: Pump to Turbine

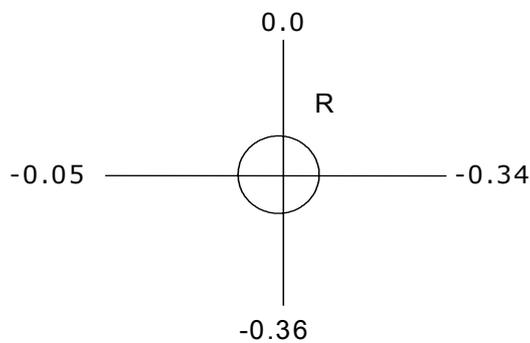
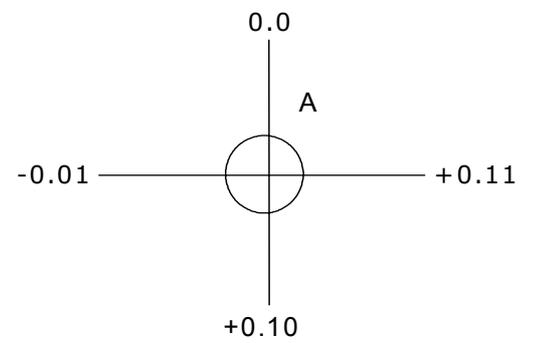
- The clearances were checked & following are the readings
- Bearing halves were cleaned and polished using green rouge.
- Gears were taken out, cleaned and inspected.
- Gears were re installed. Backlash was checked and noted.
- Bearings were assembled, clearance checked and recorded and boxed up.
- Gear Box cover O rings were replaced.
- Coupling is aligned with reference to match mark.
- Alignment reading between Gear Box to Pump.

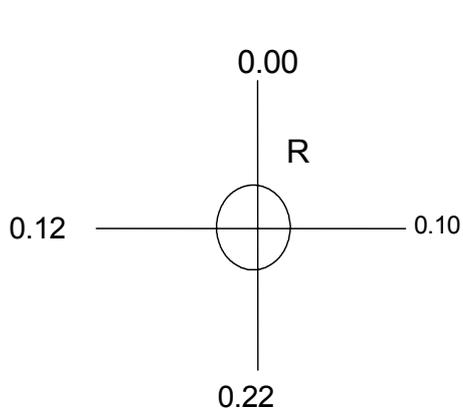
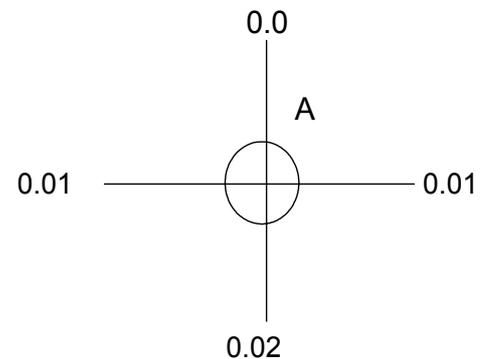
- Alignment reading between Gear Box to Motor

Sr. No.	Description	Actual value (MM)
1	Radial bearing clearance coupling end	0.12 – 0.13
2	Radial bearing clearance free end	0.13 – 0.14
3	Gear wheel front bearing clearance	0.18 – 0.19
4	Gear wheel rear bearing clearance	0.18 – 0.19
5	Pinion gear front bearing clearance	0.17 – 0.18
6	Pinion gear rear bearing clearance	0.15 – 0.16
7	Pinion Gear thrust float	0.30
8	Gear backlash	0.45
9	Axial thrust of pump (after adjustment)	0.35

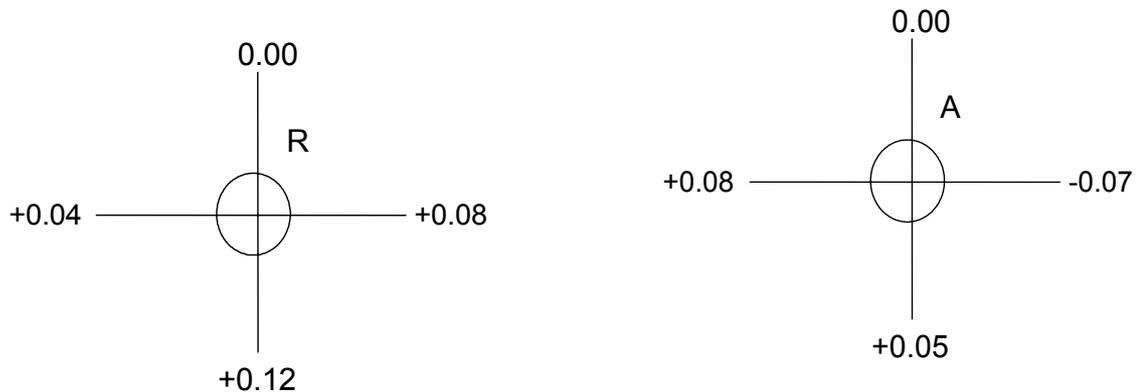
- **ALIGNMENT BETWEEN GEARBOX AND FAN:**

FD Fan to Gear box: Clamp on fan & Dial on Gear Box:

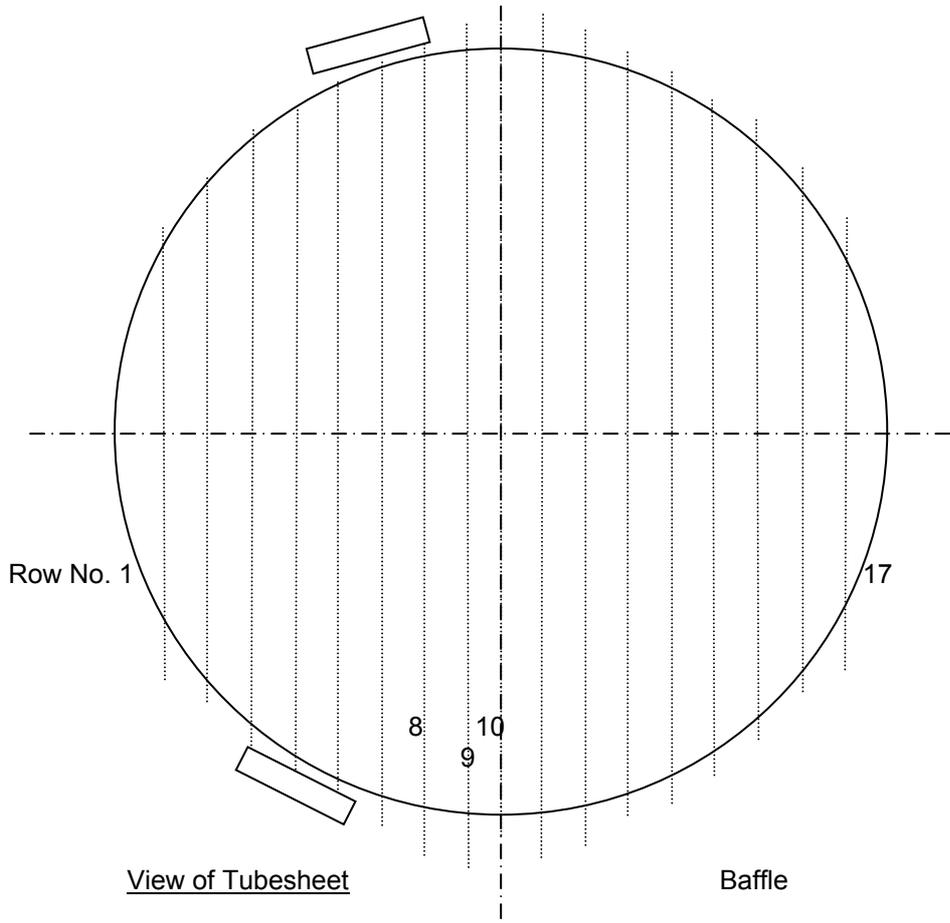
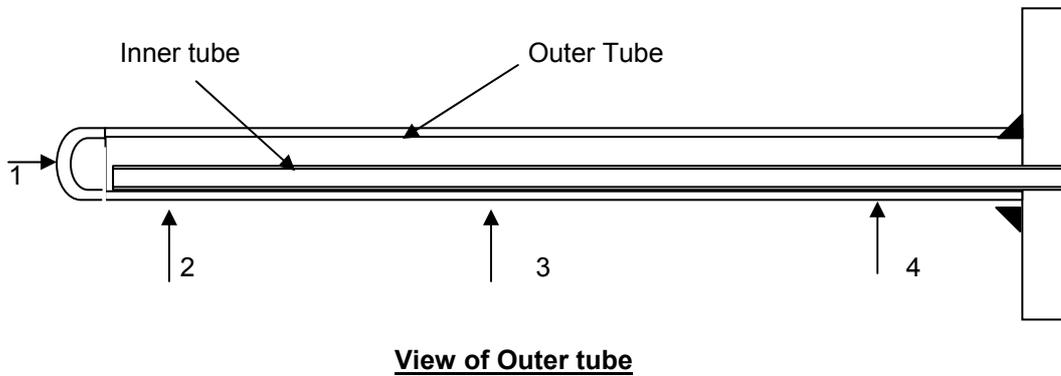
THICKNESS MEASUREMENT REPORT OF 101-CB

Plant : Ammonia
Testing Equipment : Panametrics MG 2XT **Accuracy:** 0.01mm.
Equipment : 101-CB Outer tube bundle
Date of testing : Outer tube-3.434mm., End cap-5.0mm.

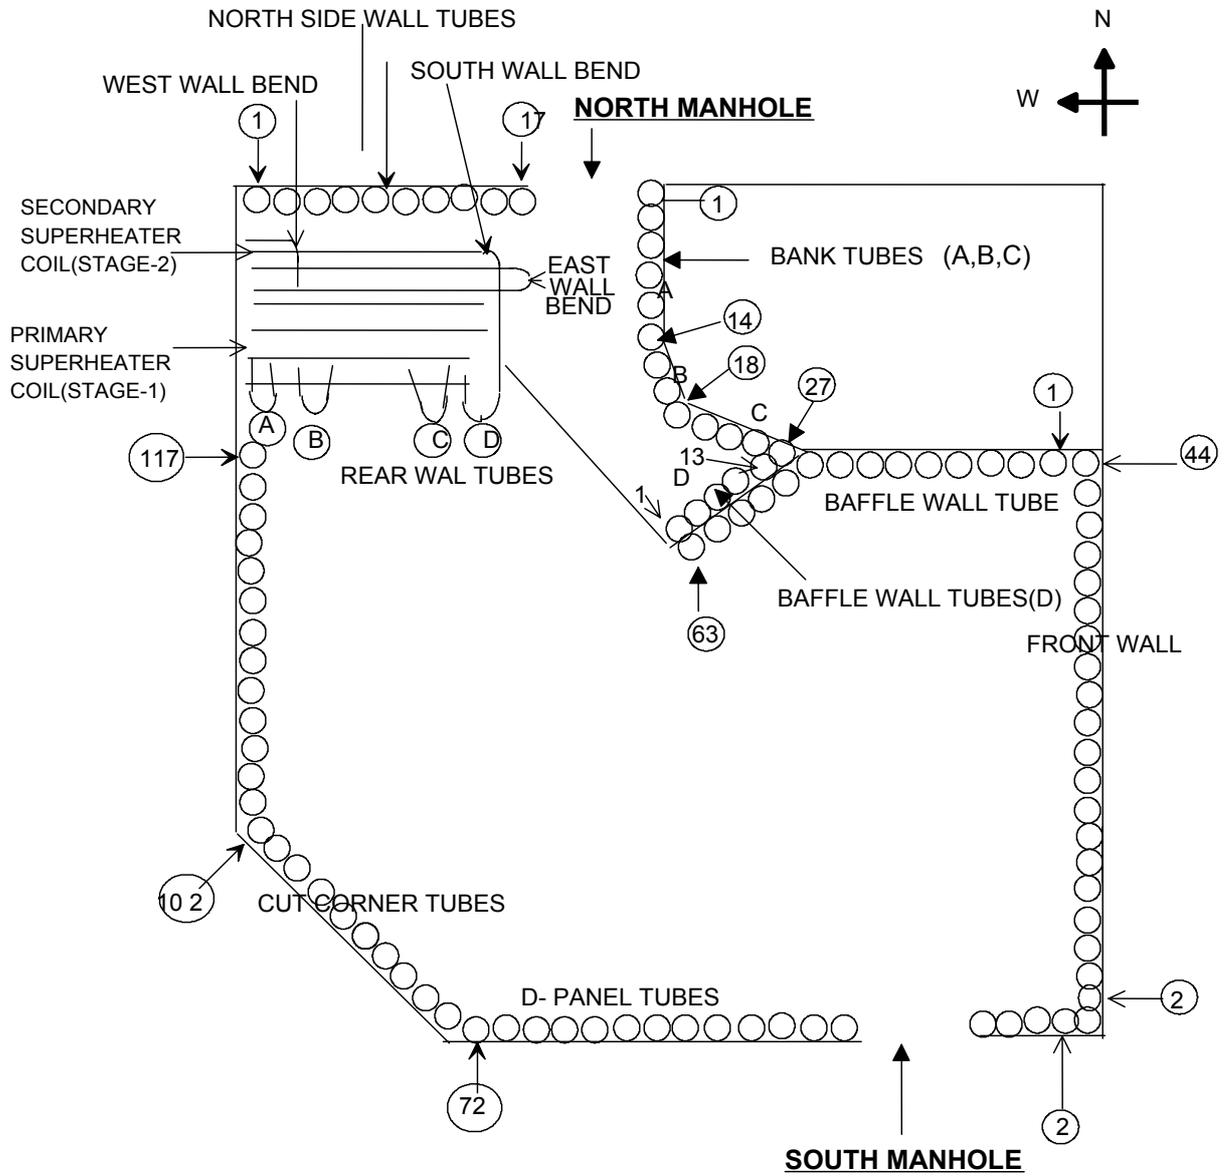
ANNEXURE-7

**BHEL BOILER FURNACE LAYOUT
(GT-2068)**
