MTC / REPORT / 01
REPORT NO. 29 / 2009

KALOL UNIT

PLANT TURNAROUND REPORT

INDIAN FARMERS FERTILISER CO - OPERATIVE LIMITED

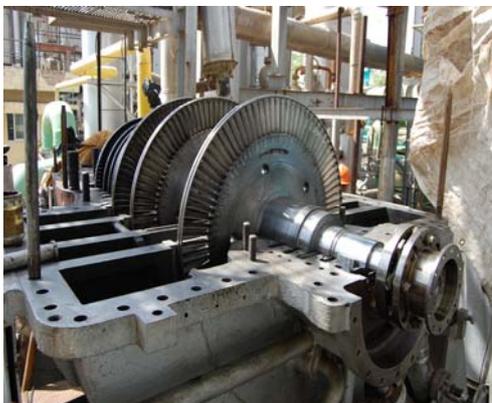
101-JT Rotor on Bottom Casing

The parting plane level readings of reconditioned diaphragms with respective casing grooves were measured. A minimum clearance 0.2 mm as required, is observed in all reconditioned diaphragms. Existing interstage labyrinth seal were found in good condition and installed the same back. Rotor was cleaned and found in condition. Small deformation was noticed in the rib of coupling hub (turbine). As Turbine was running normal before stopping the machine for overhauling, and any such rectification may change dynamic balancing of the coupling, hence it was left as it is.

During installation, the first diaphragm i.e. Stage 2 diaphragm was installed back since it's condition is good. Rests of the diaphragms were replaced with reconditioned one. All reconditioned diaphragms were fitted without any rework. These diaphragms are earlier removed from 101-JT and got reconditioned at M/s Man Turbo India Private limited, Vadodara vide Work order No 20081081 dtd 02.01.2009 @ cost of Rs 12.35 Lacs.

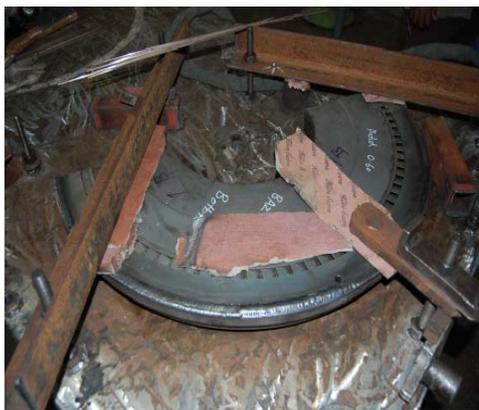
105-JT Diaphragm Welding

Diaphragm No	Clearance “J” Design : 1.39 – 1.65 mm	Addition of weld thickness on sealing face after machining
Stage-2 / KJ-52-BAZ	0.95 mm	0.60
Stage-3 / KJ-52-BBA	1.25 mm	0.40
Stage-4 /KJ-52-BBB	0.75 mm	0.80
Stage-5 /KJ-52-BBH	1.05 mm	0.50
Stage-7 / KJ-52-BBE Design : 2.8 -3.04 mm	1.45 mm	1.60

The rework was done by deposition of weld built-up on sealing face of diaphragm after positive locking of same for prevention of distortion. The welding was carried out with TIG using ER-70S filler wire. Then machining was carried out.

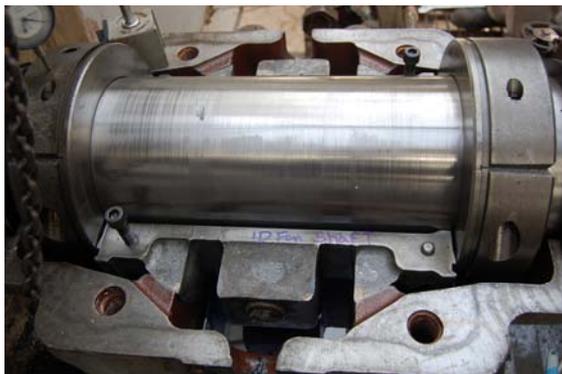
101-BJ Journal Bearing

Journal bearings and thrust bearings were inspected and found O.K. Gauss reading was taken and found below maximum allowable limit. All the bearing pads were Dye Penetration tested and no surface cracks were found. Bearing clearances were taken and found within the design range. Light scoring marks were observed at shaft journal area, which was attended by stone. The coupling end bearing dust seals were replaced by new one with shortened spring length and ends joined with adhesive. Cooling water was circulated in lines and no

leaks were observed. The final bearing clearance was measured and found within design range.

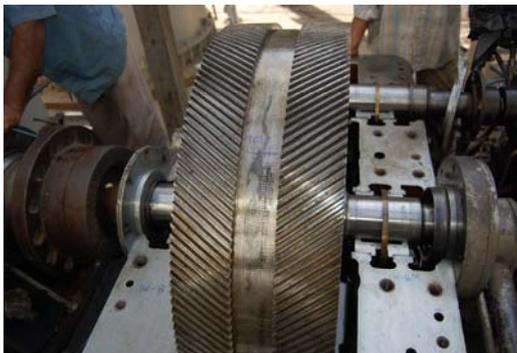
101-BJR Gears

The gear and pinion were inspected and found O.K. The condition of Bull Gear teeth is found o.k. All the bearings were inspected and one no anti-friction bearing no 6216 was replaced. The coupling key, Bush Bearings of MOP of Gear Box was found worn-out and hence the complete pump assembly alongwith new coupling was replaced. Gauss measurement of gear shaft and bearings carried out and found within limit. The oil was flushed with new oil. The final bearing clearance was measured and found within design range.

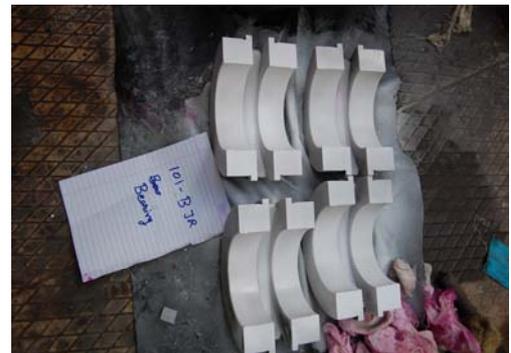
101-BJR Bearings DP Tested

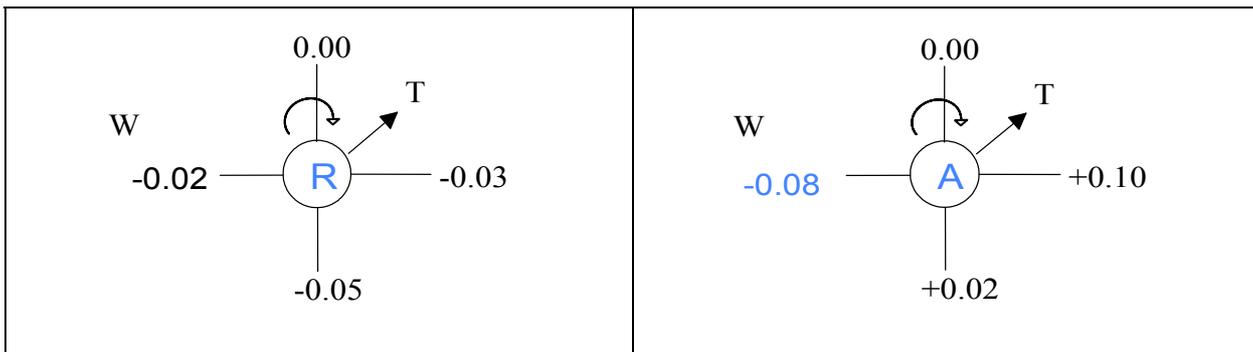
Hot alignment readings of 107-J (after stopping of turbine dus to vibrations)

High vibrations of the range 44 -46 mm/sec at Horizontal plane at thrust end was noticed. Also the speed of turbine was not under control due to malfunctioning of new control valve. Various attempts to reduce the vibration by providing support for the turbine inlet line went in vain. Finally it was decided to reorient the inlet line and replace the new control valve by the old control valve. At the same time it was observed that the main oil pump drive gear assembly was chocked and found lot of debris inside. Hence it was decided to reopen the turbine for internal inspection. Ammonia plant continued operating with stand by train, put in normal operation.

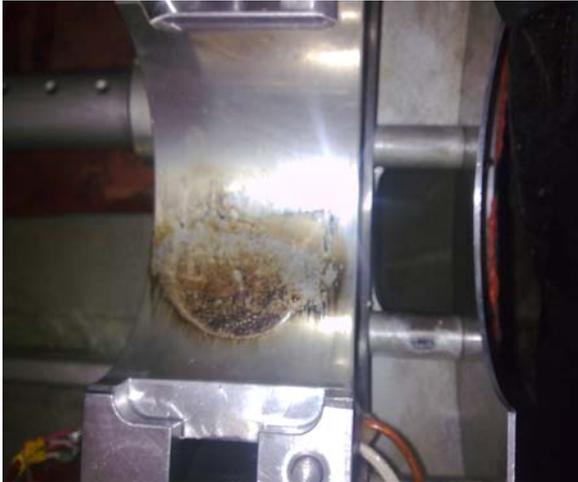
GB high speed shaft Journal bearing (Free end) with blackish layer deposits.

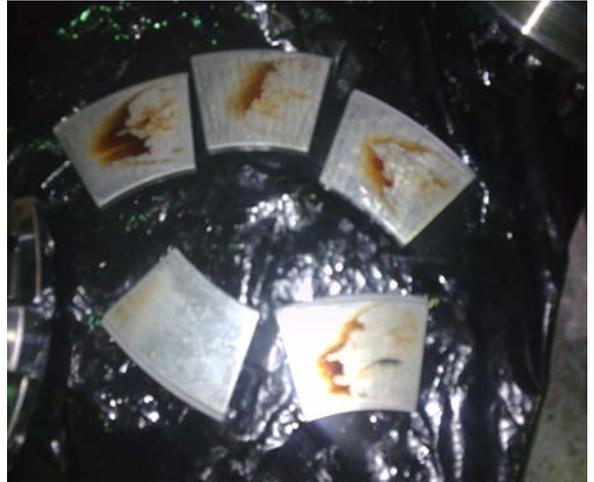
LP Compressor thrust pads with blackish layer deposits.

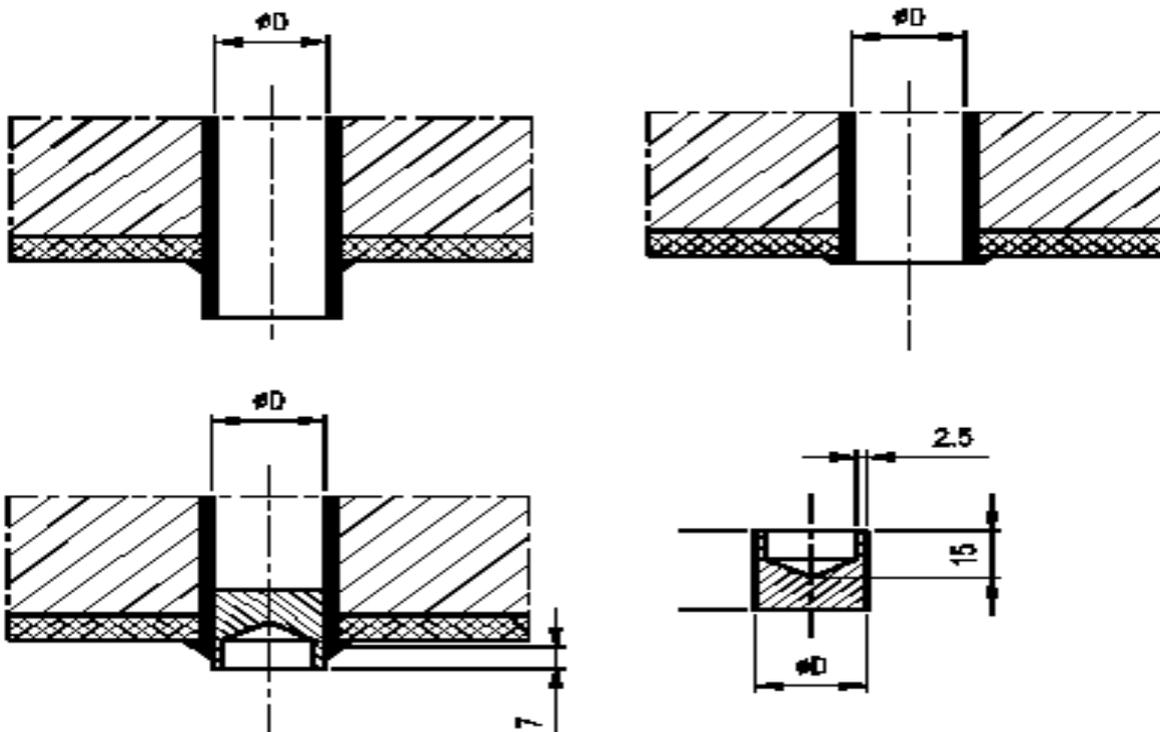
BOTTOM TUBE PLUGGING SKETCH OF HP VESSELS SUGGESTED BY S.C

- Top flange of Off gas lines was opened.
- Bottom flange (H-1202 to V-1201) was opened.
- Top cover and bottom cover was opened using bolt tensioner at 700 kg/cm².
- Eddy current testing of tubes was carried out. 5 Nos. tubes were found to be **defective. Hence it was decided to plug these tubes.(Refer Drg attached).**
Plug size: OD: 20mm, Height: 25mm, MOC: 2RE69

Following tube plugging procedure recommended by M/s Stamicarbon was followed. Procedure carried out for Plugging top tube sheet was similar to that of bottom plugging procedure, which is given below:

- Grind and remove the tube end down until 50% of the tube to tubesheet weld metal is removed.
- At top end, puncture the tube. This is required to create a positive leak in the affected tube.

- After each layer of welding perform a penetrant test and a ferrite check.
- Finally weld was cleaned and passivated by washing with 10 % HNO₃ and rinsing with DM water.

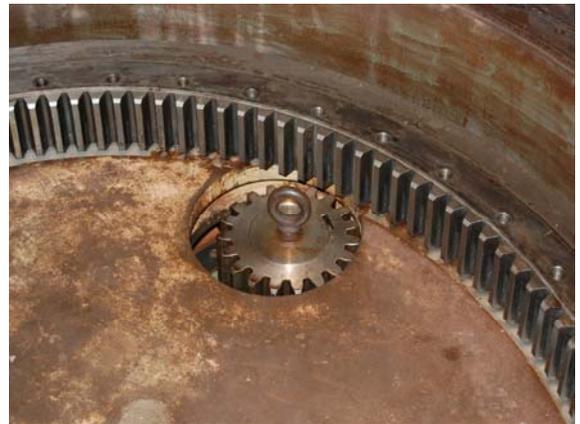
Gearbox is being removed as viewed from scraper floor

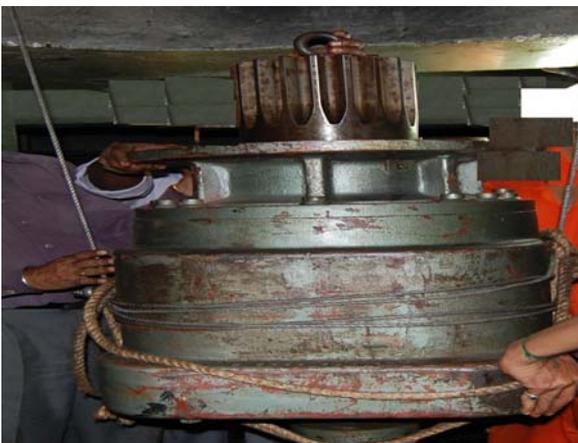
Gearbox is being removed from bottom

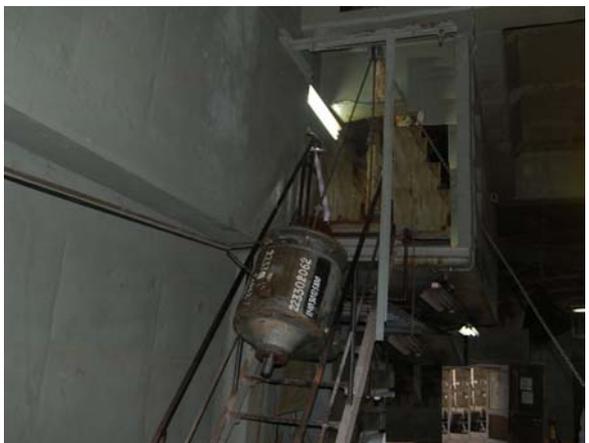
New spare GB being lifted to position

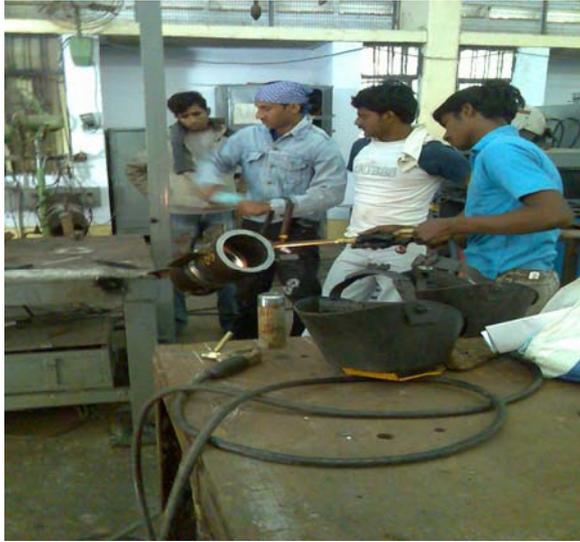
Fig. 1 Welder Test for Pipes

- Welder Qualification Test & Job Repair Test was carried out to become familiar with the job prior to actual job undertaken. See Fig. 1 & Fig. 2.
- Permission from IBR Office for carrying out replacement work was taken.

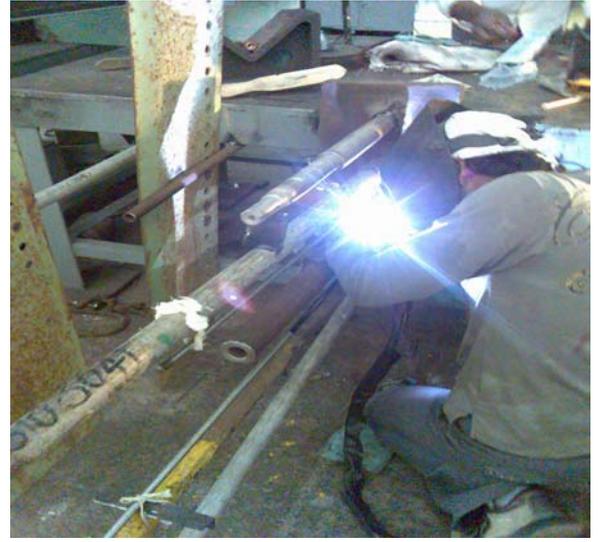
Fig. 2 Welder test for Tubes

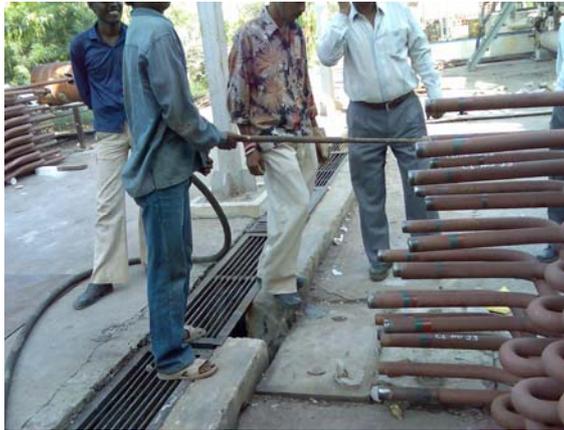
Fig. 3 Air & Sponge cleaning of Tubes

- Cleaned all Superheater Headers & Coils by air & sponge. See Fig. 3
- Prepared Clamp for Fit-up of Superheater Coils with stubs attached on headers. See Fig. 19

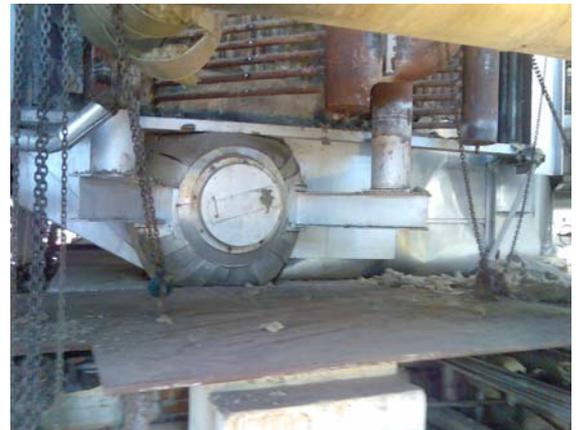
Fig. 4 Plate for marking of position of header

- Cut all the drains & vents of Superheater headers & joint of BFW line to spray nozzle of De-superheater.
- A Plate of 25mm thick was placed at the bottom & fixed for reference marking of location & orientation of headers. See Fig. 4

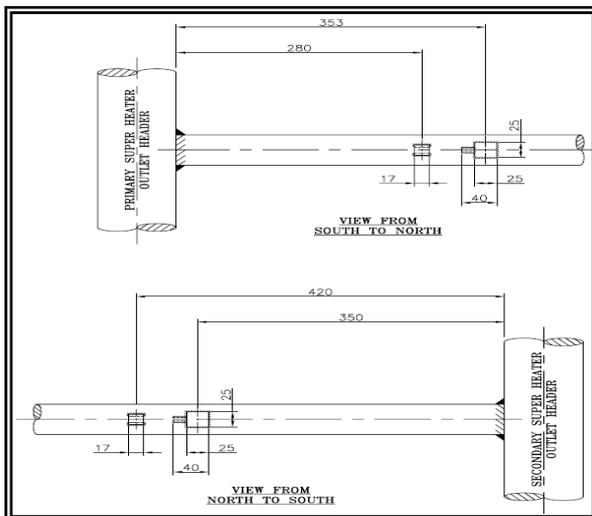
Fig. 5 Measurement of Peening Point

- Thermocouples are installed on PSH & SSH outlet header for measuring Metal Temperature. Before removal of SH coils, location of Thermocouple Pad & its clamp were measured & recorded by taking PSH & SSH outlet header as Reference point for measurement. See Fig. 5

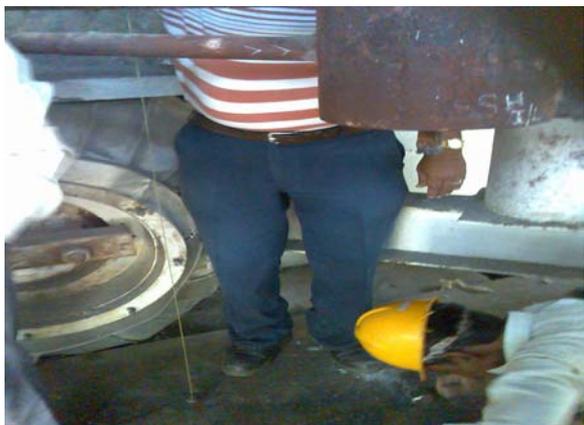
Fig. 7 Marking of Header Location by Plumb Method on Plate

- Vertical dimensions of headers were transferred to a column by Transparent PVC Water level tube. Location & orientation of all headers were marked on Horizontal Plate by Plumb method. See Fig. 7 & Fig. 8

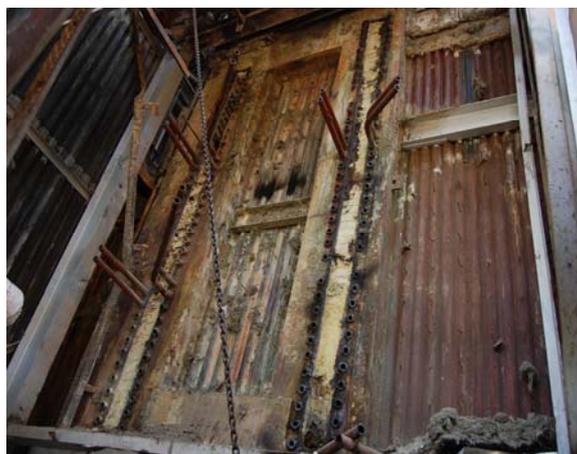
Fig. 10 View of Rear Wall after removal of Insulation

- Removed all Structures & Piping which were fouling to carry out Rigging Jobs.
- Removed Insulation from the Main steam lines, Superheater Headers, Furnace Rear Wall etc. After removal of insulation from Furnace Rear Wall, it was found that refractory was covered in two boxes of 6.0 mm thick MS Plate & provided only around the area from where PSH & SSH coils Inlet & Outlet end were coming out. See Fig. 10

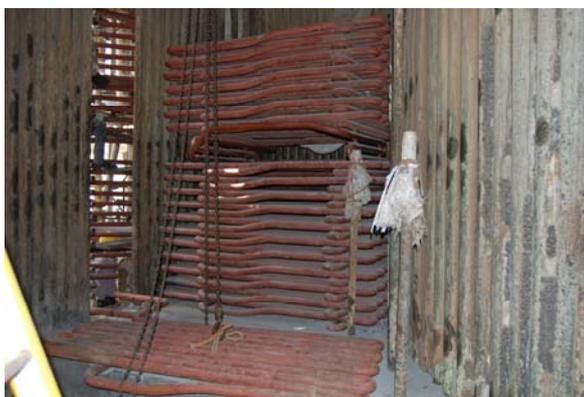
Fig. 11 Cut Spacer tubes S2 & S4 No any bank tube on PSH opening

- Since the 33" burner replacement work was in progress & burner was removed from its position for replacement, leaving an opening called burner throat opening in the furnace, therefore, we grab the opportunity, made a cut on all the PSH coils inlet & outlet arm from inside the furnace & removed all the PSH coils (38 nos.) from the opening after comparing the dimensions of PSH coils with the burner throat opening and straight spool piece of Spacer Tube S4 was cut out to facilitate removal of PSH coils as these were stacked between two spacer tubes S3 & S4. See Fig. 11

- In the meantime, we had cleared all the PSH opening area & straight spool piece of Spacer Tube S2 was cut out to facilitate removal of SSH coils from the opening of PSH Coil box as these were stacked between two spacer tubes S1 & S2. See Fig. 11

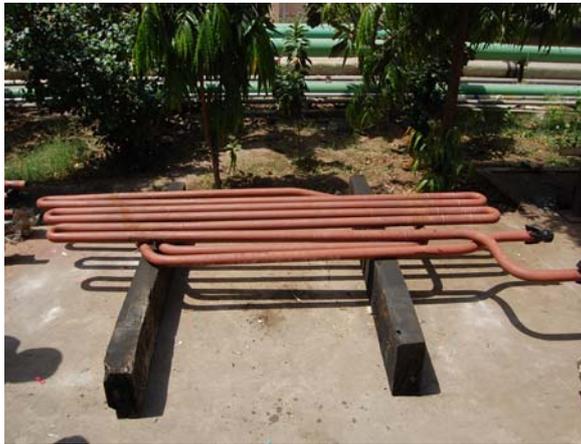
Fig.15 160 mm to be cut from PSH Coils

- After Fit-up, tacking was done & then started welding of SSH coils with header. See Table2
- Fit-up & welding of PSH coils to be done in parallel with the SSH, but as we placed the PSH coil at its position in the furnace we found that the length of the PSH coil is more than the space provided for it. So, after taking permission from IBR authorities we had reduced the length of the entire 36 nos. coil (except 2 nos. steam cooled spacer front Assy.) by 160 mm on site. 4 Nos. weld joints increased in each repaired coil during repairing (Total = 144 joints). See Fig. 15 to Fig. 20 & Table3

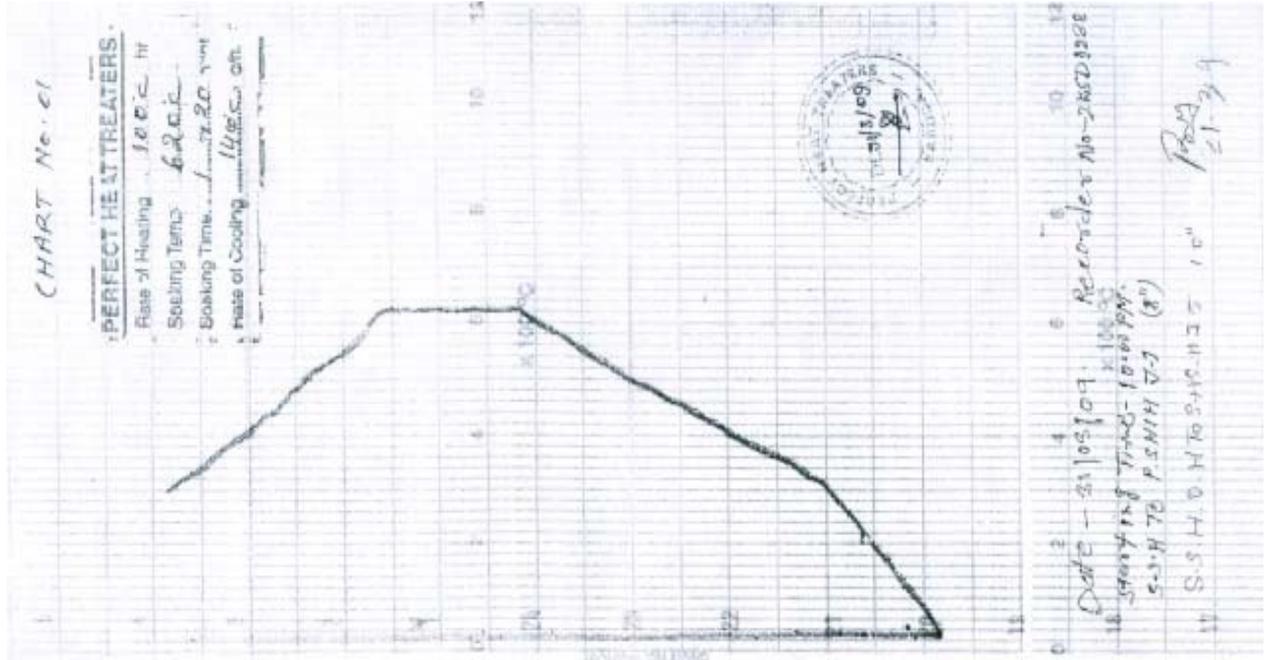
Fig. 24 PWHT Curve for CS Header Joints (J1 & J6)

- Heat treatment of all 7 header joints was done successively. See Fig. 23 & Fig. 24
- After completing header welding, welding of 4 joints of Furnace Rear Wall Panel Tubes was done. After getting DP & Radiography clearance, fins were welded with tubes. See Fig. 21

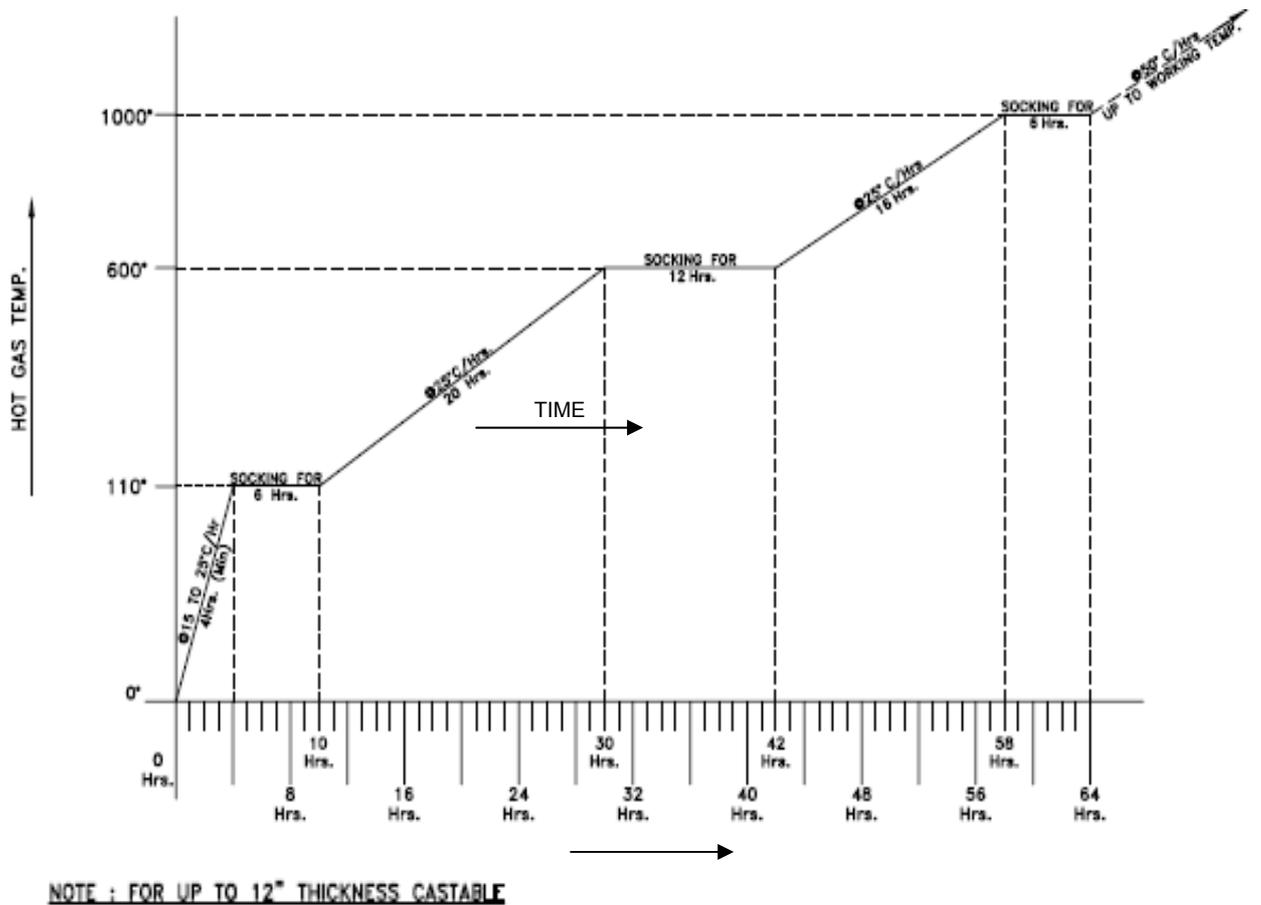
Fig. 25 Curing Cycle Curve For ACCMON CAR Refractory

- All the Superheater drain & vent joints were welded.
- Bottom reference plate was removed & all the header supports were removed.
- Refractory curing cycle was followed during heat-up of Boiler. See Fig.25 Curing Cycle Curve for ACCMON CAR Refractory
