IFFCO

KALOL UNIT

PLAN TURNAROUND REPORT

(MARCH – APRIL – 2012)

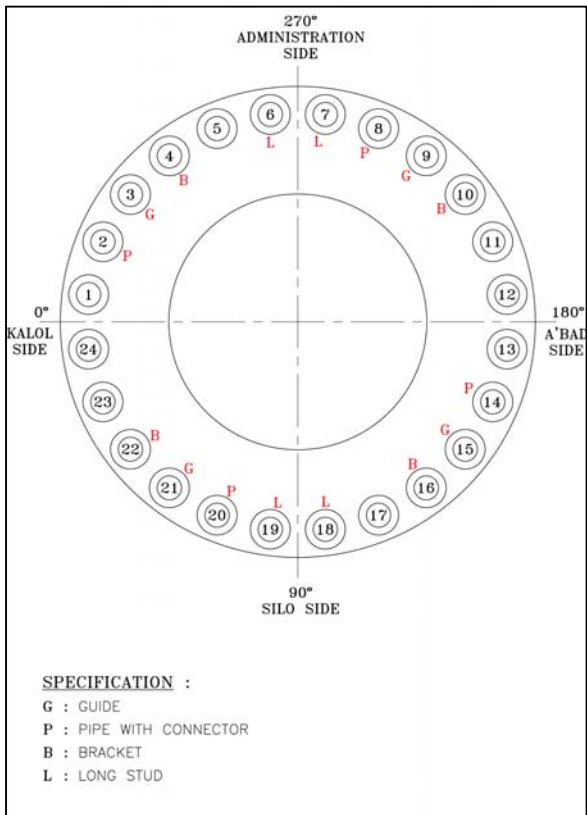
HP Scrubber – Top Dome Removal

Position of guide, pipe with connector, tube sheet holding bracket and long stud in bottom dome flange

- Shifted the top dome and kept it upto the studs to tighten the inside drain flange.
- Kept the top dome on its position.
- Tightened the nut as per procedure (In 4 steps at 300 kg/cm² g, 500 kg/cm² g, 700 kg/cm² g pressure and final check round at 700 kg/cm² g using hydraulic bolt tensioner as per sequence)
- Connected the all flange and welded the steam tracing line flange and Insulation was done .

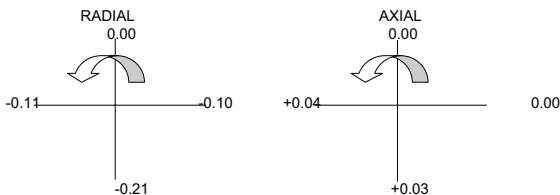
FIXTURE ON TURBINE AND DIAL ON GEARBOX

Note: fixture on turbine and dial on gear box.

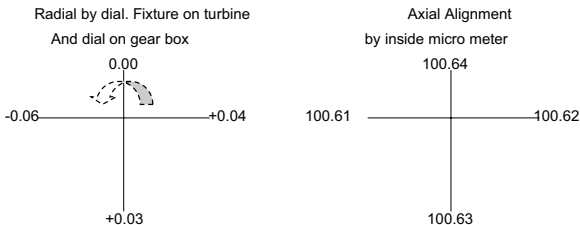
Alignment reading on turbine to gear box:

Coupling float : 20mm

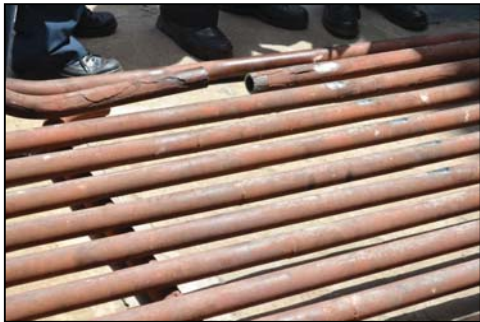
- Due to leakage of steam, refractory of boiler drum and at some other places were also found damaged.
- So, punctured SSH coil was cut from its header stub joints and removed from the position.
- New spare secondary SSH coil was inserted by cutting one cut corner wall tube and welded with its header stub joints.

- It was indicated from the failed SSH coil that, overheating may be the reason for the failure. So one thermocouple pad was also welded on the top most SSH coil for online temperature indication. Drawing of Thermocouple pad is shown below:

- Tube sample of failed coil was also given to M/s BHEL for failure analysis.

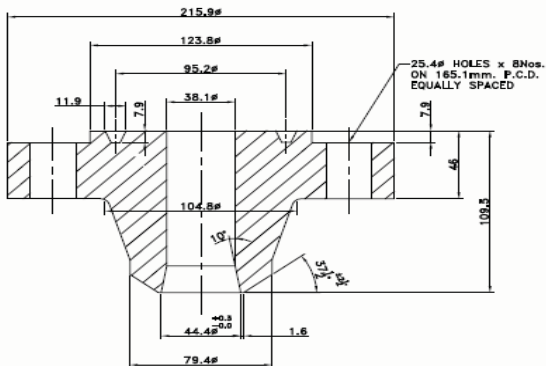
- Existing superheater safety valve was cut from its nozzle and one companion flange was welded on nozzle and one companion flange was welded on spare superheater safety valve to make it flanged end. Drawing of companion flange (P3-ES-13404, SHEET 1 OF 1, REV. 0.) is given below:

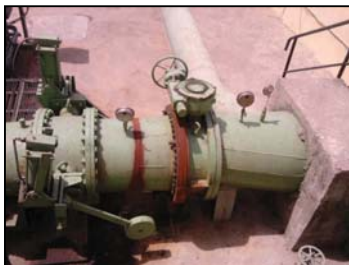
- For the installation of valve again in position, it was required to cut pump side flange along with approx 500 long spool piece, which was again rewelded after valve positioning. The same is shown in attached fig.

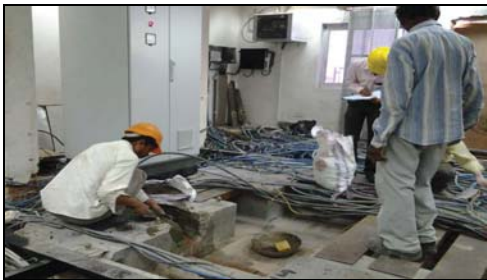
Widening and preparation of Cable trench inside DCS Marshalling Room

- Widening of Cable trench inside DCS Marshalling Room was carried out.

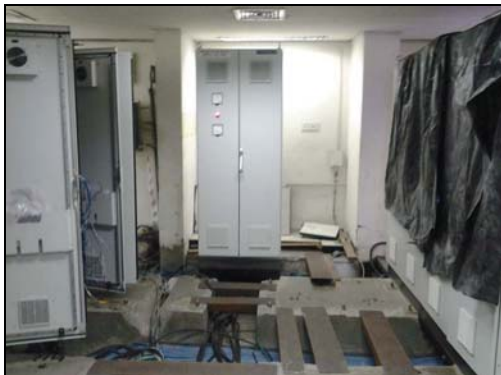
Replacement of DCS Marshalling Cabinets

- Three nos. of Old Analog Marshalling Cabinets & three nos. of Old Digital Marshalling cabinets of Yokogawa DCS were replaced with New Marshalling Cabinets. Three nos. of Analog Marshalling Cabinets, one no of Digital Marshalling Cabinet & one Analog cum Digital Marshalling Cabinet were installed inside DCS Marshalling Room.

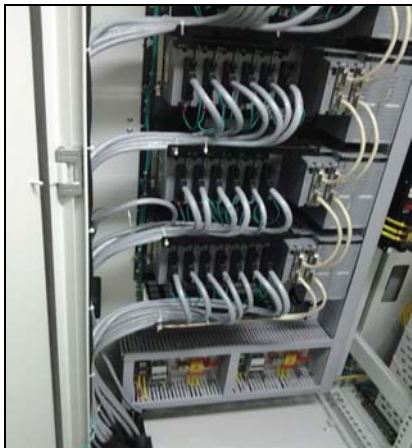
Prefab Cable connections in DCS System

- New Relay boards, YR132ADV and YRO32ADV, in digital Marshalling cabinet in C111 and C112 were provided. Digital input Card ADV159 and Digital Output card ADV559 were changed with new card ADV151 (Digital input) and ADV551 (Digital output) respectively for compatibility with the new relay boards.

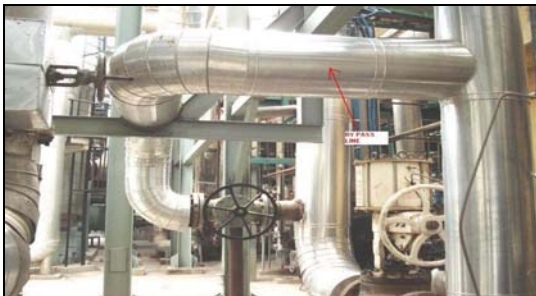
8" size bypass line to FICV – 14 with isolation valve

The above job have been carried out by M/s J&J vide W.O. No. 201004120118Dt.12/01/2012.
