IFFCO

KALOL UNIT

PLANT TURNAROUND REPORT

(MARCH – APRIL – 2014)

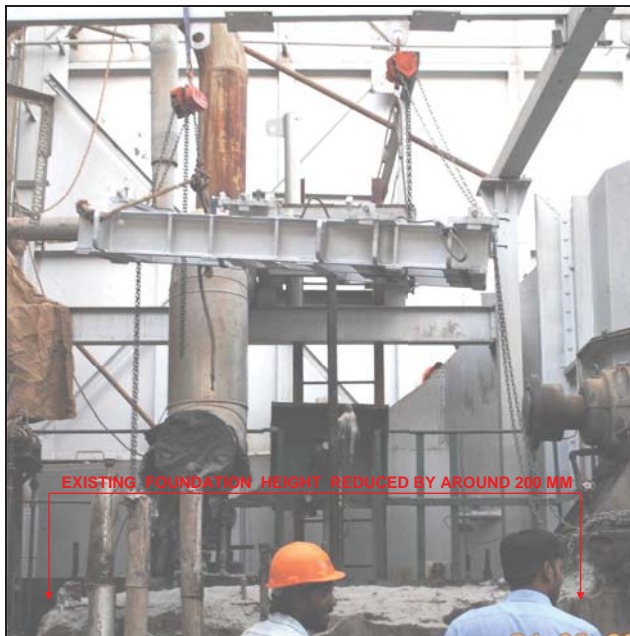
BASE FRAME BEING LOWERED TO MARK POSITION OF LEVELLING PLATE

NOTE : New turbine & gearbox was procured with base frame whose thickness/height was around 200 mm more than that of the existing base plate. Foundation bolt PCD was same as that of the existing. Hence erection of new equipments required reduction of foundation height by 200 mm, while same foundation bolt were to be used.

- Existing foundation height reduced by 200 mm as shown in photograph.
- The bend foundation bolts were straightened by heating.
- Base frame was lowered and position of leveling plates marked on foundation.
- Leveling plates were installed at marked location, leveled and cemented.
- The new base frame along with the gear box was placed on the leveling plates. Leveling of the frame was carried out using packing plates.

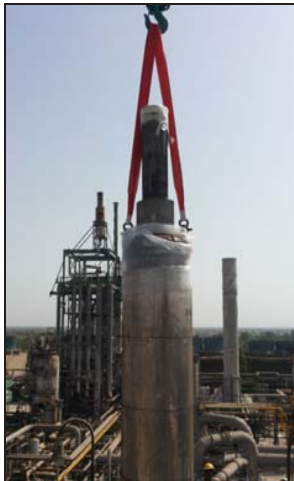
122- C shell side gas inlet portion and gas outlet pipe was covered at top

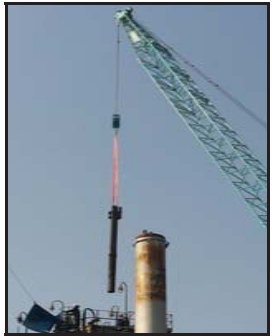
Removed Inner collector top piece

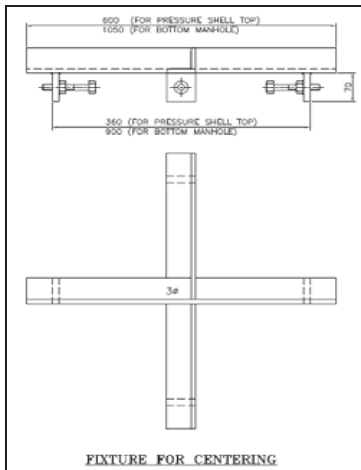
Piano wire was dropped from top Pressure shell flange

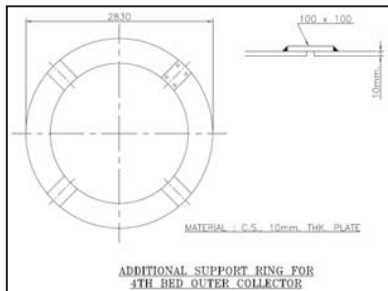
- Additional support ring was provided at centre of outer collector (Ref fig below) to prevent distortion of plate during full welding.

- Then full welding of horizontal and vertical joints was done in staggered manner.
- Cracks were observed in stitch weld between perforated plate of top outer collector bottom portion and the existing support ring. Hence the welding joint between perforated plate and support ring at the back side was inspected. Cracks were observed at that portion also. Hence it was decided to carry out full welding from the front side to strengthen the joint.

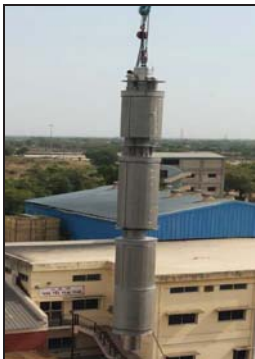
Top portion of inner collector lifted

- After centering of inner collector, tack welding with bottom support ring done on all bed at 4 points.
- Gaps of approx. 3 to 5 mm were observed between support ring and inner collector bottom in all three beds after centering and alignment. The gap was closed by inserting rings and full welding after final alignment of inner collector.

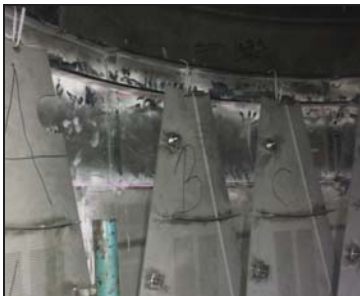
Protection screen kept at top of bed in hanging position

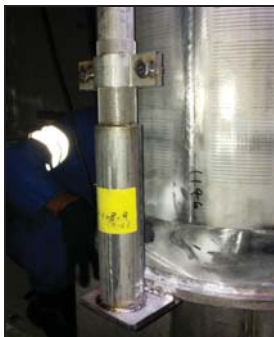
Bottom support of AT thermowell pipe

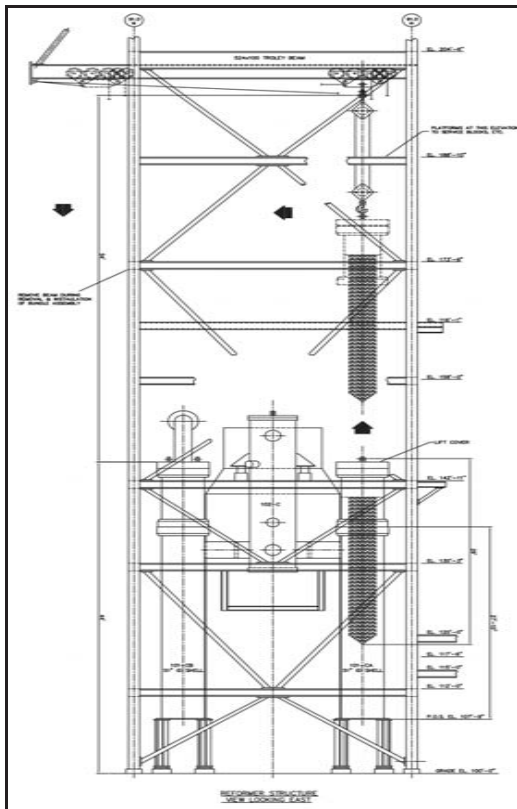
Erection of tube bundle was always carried out with the help of 30 T capacity chain pulley block as per rigging plan given below.

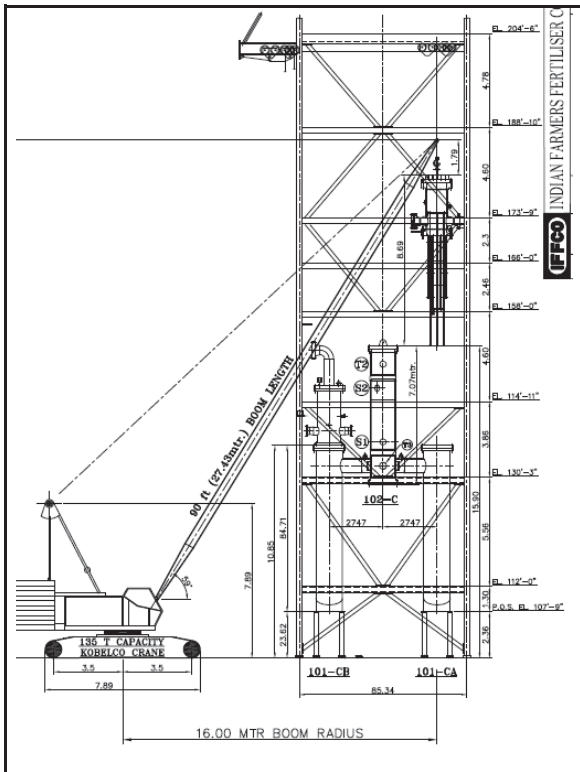
RIGGING PLAN WITH CRANE

There was limitation of head room, as there was fouling of boom due to structure above 101-CB and 101-CB top cover with down comer elbow. After detailed study, the following arrangement was made to perform the job safely.

- Fouling structural members were removed.
- 101-CB top cover with down comer elbow was opened and removed
- Ramp was made to raise the crane elevation by using sand & ½" thk MS plate (Photograph attached below.)

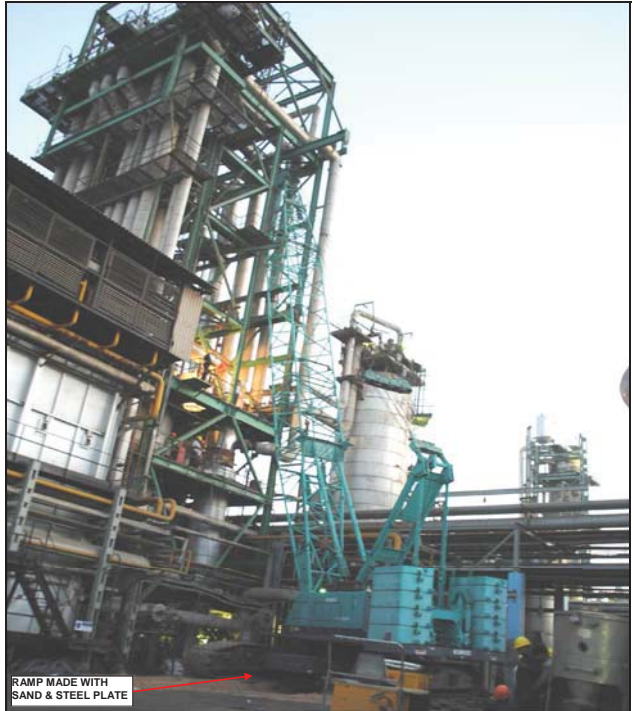
ACTUAL PHOTO OF CRANE WITH RAMP

Even after the above arrangement, still head room was not sufficient to lift the bundle and hence tube was tilted little bit to remove the same. To overcome this and use the crane in future to carry out the job safely the following actions have been taken.

- To procure a new boom section of 5' length.
- Removal of existing monorail structure.

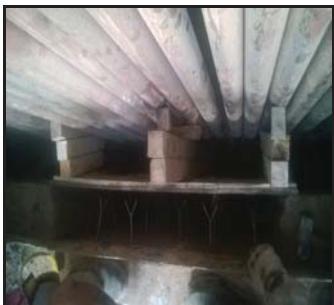
SHUTTERING ARRANGEMENT

- Pouring of the castable refractory was carried out.
- Curing time of six to eight hours was given to the castable refractory before next pouring.

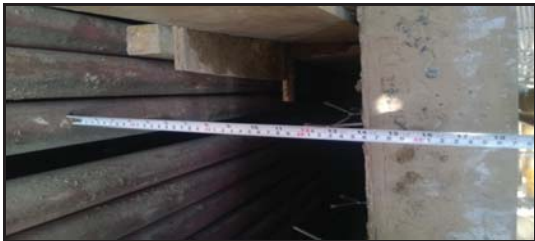
GAP SHOWN BETWEEN TUBES AND PANELS

- Panels welded, Shuttering material fixed, Castable refractory poured & cured for six to eight hours respectively & successively from 8th to 2nd panel from top. After curing, shuttering was removed and shifted.
- Pouring of refractory of 1st row of panels was carried out at Ground floor and then panels fixed bolted on its position.
- Scaffolding was removed from both sides.
- Fixing back the removed instrument panels.
- Manhole was closed by putting bricks and ceramic blanket.

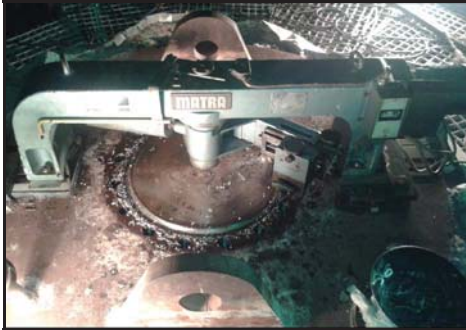
Non condensable gases & ammonia content were detected in the samples of BFW water outlet from 123-C. Hence, leakage was suspected from 123-C either by tube leakage or from tube to tube sheet seal weld joint.

DIAPHRAGM CUTTING USING MATRA MACHINE

- Removed all nuts & washers of Top Manhole cover M1. Removed cover & all studs from the tapped holes in the channel body.
- Cut the diaphragm closure plate (MOC: SB-168 Incolloy 600) using Matra machine.
- Plugged Gas inlet nozzle T1 by wooden plug.
- Unbolted Channel pass partition plate cover bolts.

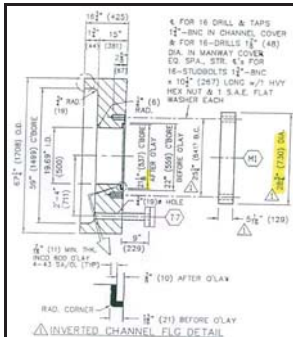
DIMENSIONAL DETAILS FOR DIAPHRAGM CUTTING

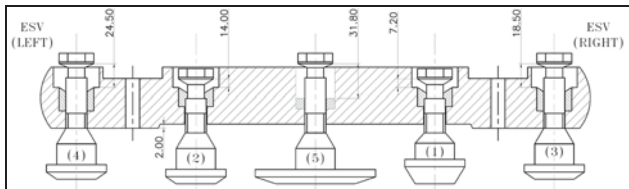
- Dismantled the 60 ATA control valve assembly (Drawing no. 0-0006-0802-04).
- Left side spindle was worn out at bottom gland bush area. Replaced the spindle with new one
- Valve cones blue matching and lapping was carried out.
- Boxed up assembly using new side gland packing rings in left and right side

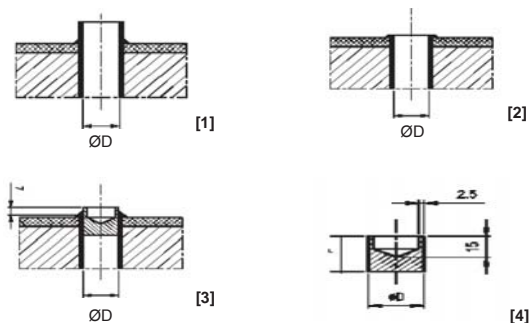
Figure – 19

Tube Plugging Sketch of HP Condenser

6	Clean and degrease the plug and the inner tube hole	Cleaned the plug and inner tube hole by acetone
7	Insert the plug	Punched at 7mm from the end of plug in four direction of plug to hold it at tube. Refer figure- 19[3].
8	Protect the surrounding tube ends very carefully with help of the old PTFE bushing.	
9	Weld the plug in two layers, GTAW (material quality filler wire equal to material of heat exchanger tube; rod diameter 1.2 mm to 2.0 mm); start / stop points staggered to each other After each layer of welding perform a penetrate test and a ferrite check	Root welding was done using TIG welding (filler wire 25 22 2 LMn, 2.0mm dia.). DP check and ferrite check of root welding done. Found satisfactory. Further 2 run of welding was done. DP and ferrite check was done, found ok. Passivation was done using 10 %HNO3 solution and rinsing with DM water After welding

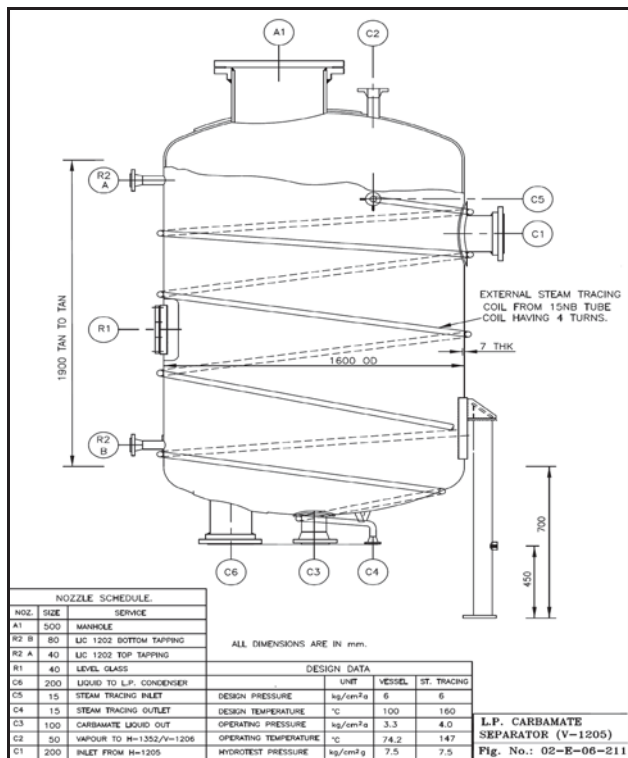
During running condition, gasket of level gauge glass was leaked. SS Jacket box was fabricated and welded it with shell of V-1205 by covering the level gauge to attend the leak. During welding of SS jacket with shell, approx 1" linear crack horizontally appeared in shell body at just below the welding. During shutdown – 2012, to prevent the leak, caulking was done on crack area and magna compound applied on the crack. Finally Hydrotest of V-1205 was done at 6.0 kg/cm² g. No leak observed.

To ensure the trouble free operation of V-1205, it is recommended to replace the existing vessel with new one. New V-1205 was fabricated in IFFCO's mechanical workshop and replacement of existing V-1205 was done departmentally.

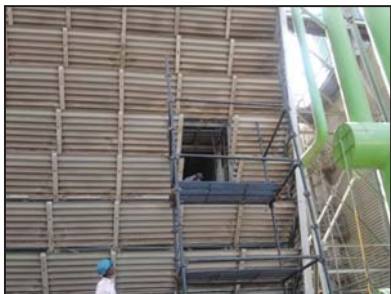
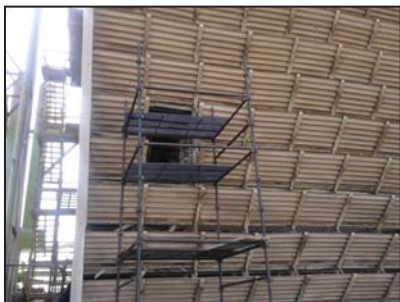
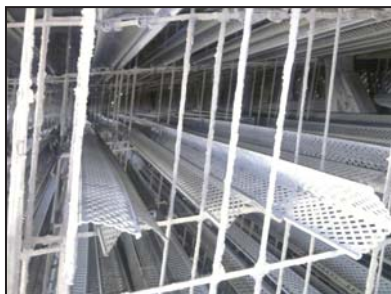
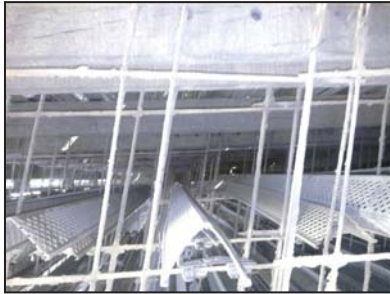
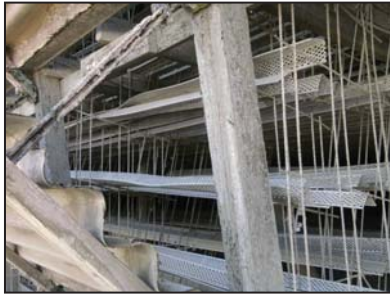
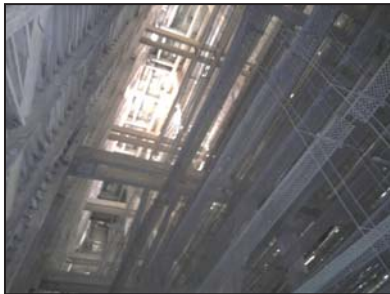
- Leakages attended from end wall & louvers.
- Repaired of stair case
- Replaced on cracked Base casting (Towards admin side) of Old Urea Cooling Tower.
- Fill area of all coolinh towers were also inspected for any damage on sampling bases by providing out side scaffolding and removing louver sheet to enter in the fill area. All fill area components and structural members found in good condition, however some PVC V-bars are found dislocated and the same was rectified. Photographs of Fill area inspection are attached below:

- Based on the committee recommendations, Structural members of the cooling towers were checked and replaced the defective members.
- Corroded fasteners were replaced with new SS304 bolts with SS 304 Square washers.

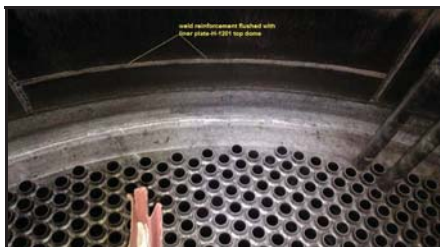
- At the central tube sheet area some of the tube ends were found having minor damage. This was observed in previous inspection also.
- In Shell south-west side insert liner "C" seam welding crowning reduced to liner level, weld deposition may be carried out. Refer attached photograph.

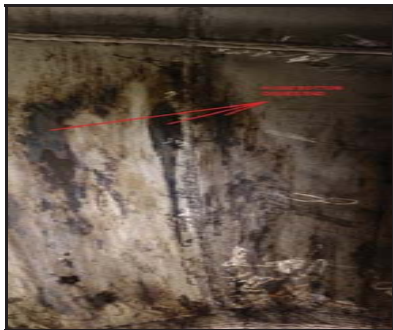
- Shell liner was silvery, shiny and dish end liner is in dark grayish in color.
Please refer attached Photograph.
- All liner welds and repairs were bright and smooth.
- The tube to tube sheet welds were bright shiny and smooth.
- Many tubes showed burn-through defects, these were also observed in earlier inspections.
- Roughening of Gas outlet nozzle long seam welding observed.

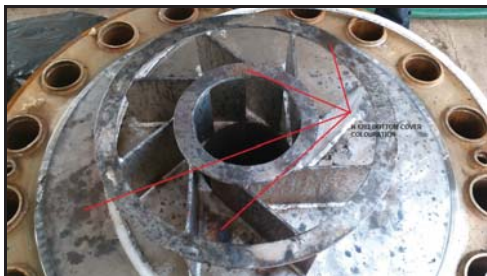
BOTTOM COVER

- The sealing face was found satisfactory.
- The liner was shiny and slightly etched.
- The vortex breaker and welds found dark grayish at several locations.
Please refer attached Photograph.

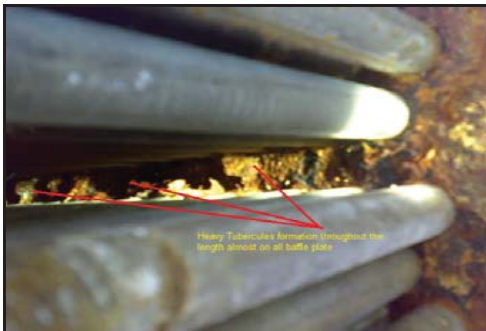
H-1811 (FIRST STAGE INTER COOLER)

- Condition of tubes and tube sheet was found satisfactory.
- Tube sheet found silver shiny in color at gas inlet side and brownish in color at outlet side.
- C.S tube baffles found rusted at several locations.
- Tube sheet found silver shiny in color at gas inlet side and brownish in color at outlet side.
- Major Tubercules formation observed in baffle plates between inlet and outlet tubes at several locations. Needs to be cleaned. Photograph is attached.
- Shell I.D found rusted and paint found peeled off at many locations.

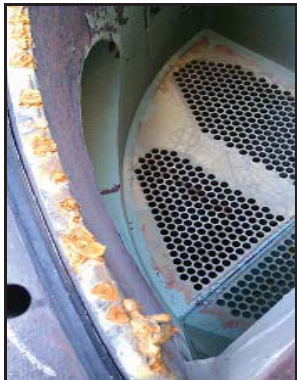
TOP HALF

- Tube sheet was found in satisfactory condition.
- Epoxy coating was found peeled off at few locations.
- Thermowell was found intact..
- Minor scaling was observed at ID of few tubes.
- Tubercules formation observed at shell ID and near gasket sealing face.

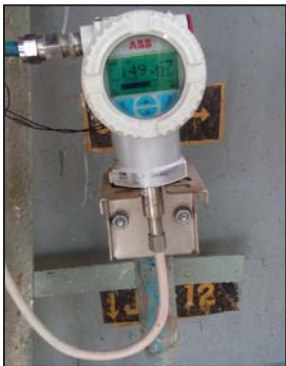
New PT of PRC-1201

- Radioactive source were removed and installed back to facilitate mechanical maintenance jobs for Autoclave & Stripper radio active level measurement instruments.
- Scintillation Counter (HP Stripper) was removed & installed back to facilitate mech. maintenance jobs.
- Calibration of "Radiac Relay" unit and its spare unit for LR-1201 (Autoclave level) was carried out.
- Normal pressure transmitter for PRC-1201 was replaced by new capillary type pressure transmitter.

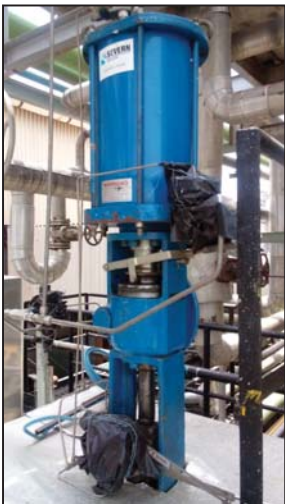
New CV PICV-1130

- Old and obsolete control valve PICV-1130 was replaced with new control valve manufactured and supplied by M/s Severn Glocon.
- Old and obsolete control valve PRCV-1504 was replaced with new control valve manufactured and supplied by M/s Dresser Masoneilan.

- Following HP Thermowells and Ring joint gasket of SS316L were replaced with new one of material 2RE69.
TR-1202, TR-1203, TR-1205 and TR-1209
- Following existing control valves were replaced with the new valves.
PICV-1130 and PRCV-1504

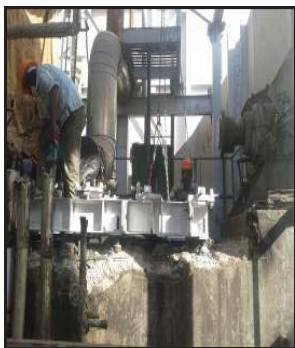
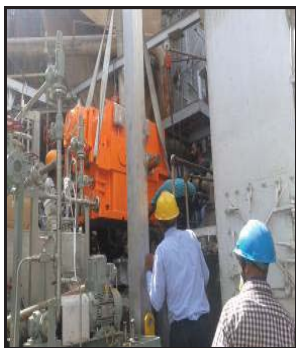
Existing foundation chipping work and pad grouting work completed by 31/03/2014. Turbine skid/ frame installed at position and level was checked. Skid was levelled 0.0mm in both the direction and gear box mounted on skid on 02/04/2014.

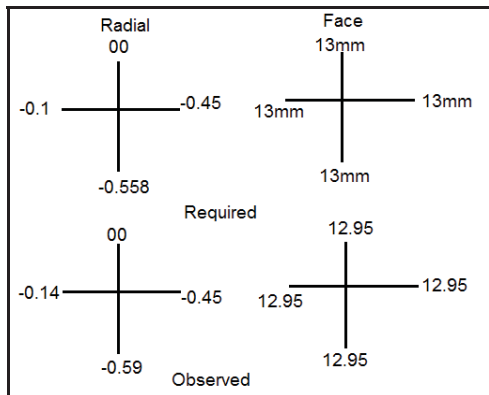
A) Gear box to fan (Dial rotated on ID fan coupling hub)

The final alignment readings (in mm) are as under :-

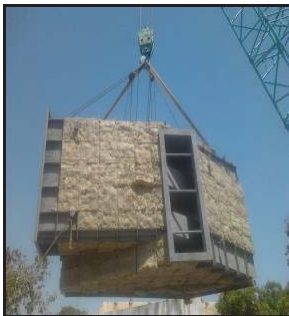
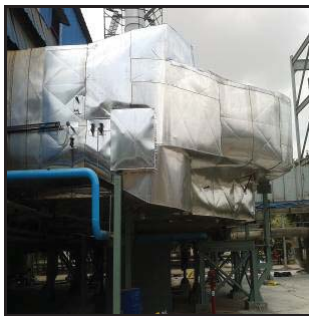
Welding of duct connections except Flue Gas Inlet and bellow was completed by 09.04.2014. BFW Coil despatched on 07.04.2014 from M/s ME energy works Pune and reached at site on 09/04/2014. The erection of BFW coil was done on the same day i.e. 09/04/2014.

The BFW piping with 100% radiography and downstream side of duct welding completed by 11.04.2014 and coil hydro testing was done on 11.04.14 at 110Kg/ Cm² in presence of boiler inspector.
