MTC / REPORT / 01
REPORT NO. 36 / 2016

PLANT TURNAROUND REPORT

(MARCH – APRIL – 2016)

INDIAN FARMERS FERTILISER CO – OPERATIVE LIMITED

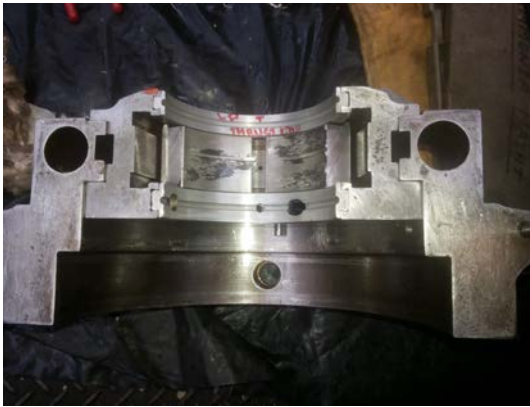
LP Compressor Thrust End Journal Brg

Hole was found offset in new 103-JLP Thrust supporting spacer ring RTD, hence, hole was enlarged in machine shop. Also, 103-JLP South Journal Brg. new Shell RTD holes found offset, holes were enlarged at machine shop.

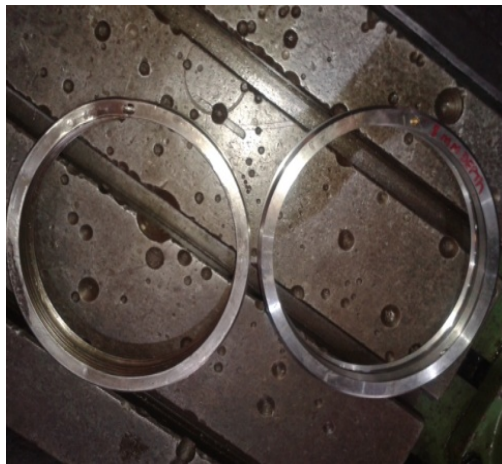
**Oil Control Ring of 103-JLP
Thrust Bearing**

Drilled 2 nos. hole on new oil control ring of 103-JLP thrust bearing at marked position (Ref fig below) & made hole depth of anti rotation pin 8 mm.

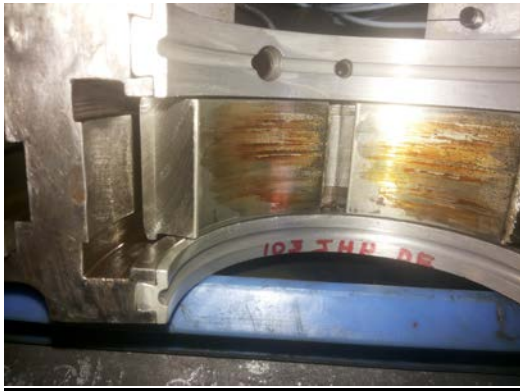
HP Compressor Coupling End Journal Bearing

The compressor was decoupled. Thrust bearing and both end Journal bearing were visually inspected and found all journal bearing pads damaged. Thrust was checked. Magnetism level of the bearings were checked and found within limit. All the removed pads were Dye Penetration tested and found to be OK.

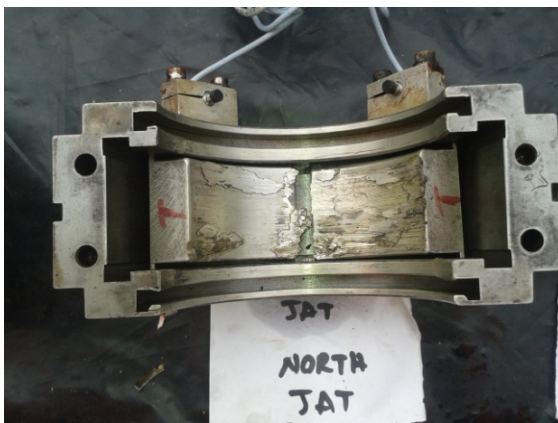
103-JAT North End Top Half Journal Brg.

103-JAT north side brg. shell anti rotation pin found at wrong side of spare journal bearing. So, holes were drilled at opposite side & inserted pin.

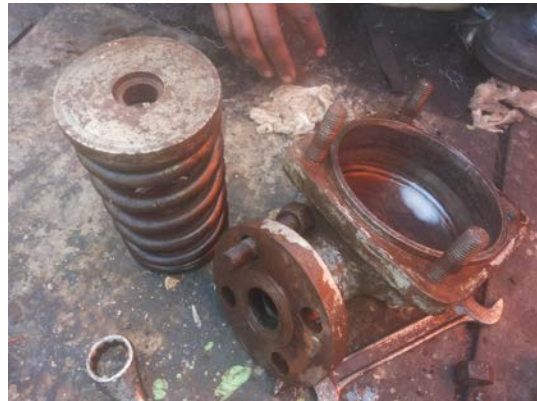
Dismantled Components of TTV

103-JAT Trip Throttle Valve oil leak attended. Following parts as per TTV D.NO: S-1028 was replaced:

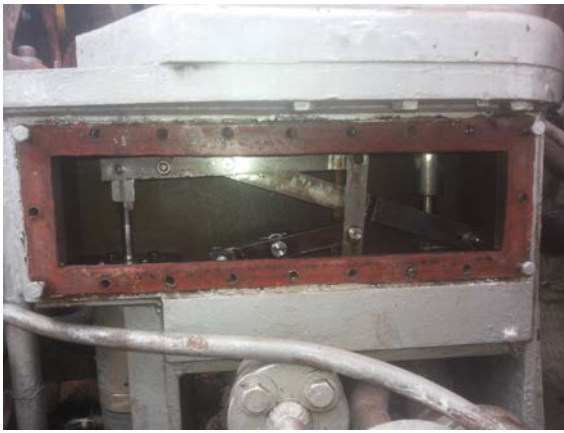
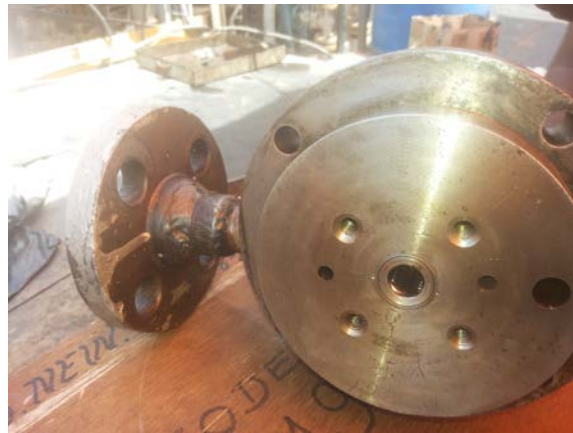
Servomotor Assembly

PRC-12 Servomotor assembly dismantled to attend the problem of stuck up & sluggish response during operation. Scoring marks were observed on piston ring. Hence it was replaced with new one. Following parts were removed (Ref -Servomotor Assy. Drg. No. F-6654-1). Controller was replaced with refurbished spare by Instrument.

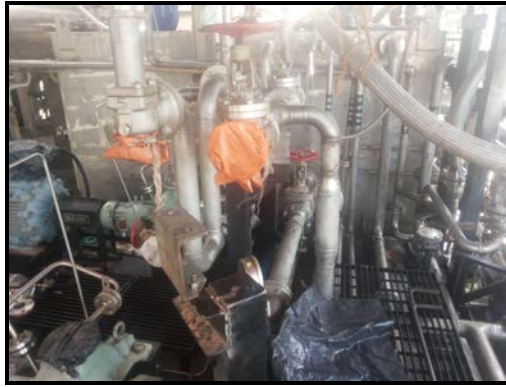
- New fabricated piece was provided at AOP discharge and AOP was run and Valve at MOP discharge closed. (Ref Photo below)

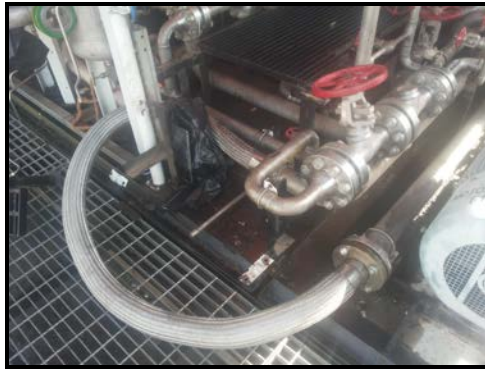
- Filter was by-passed by 3" SS Flexible hose. (Ref Photo below)

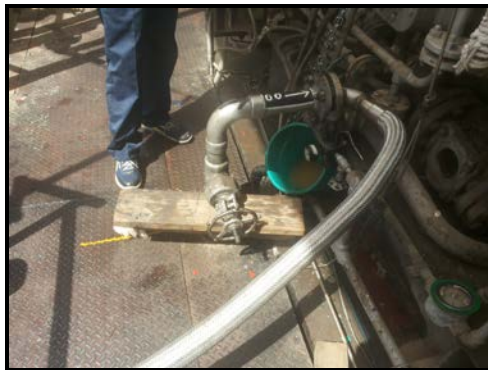
- Gate Valve to Seal oil pump suction was closed.
- Governor oil line flange at platform was connected to LO tank through 2" SS flexible hose. (Ref Photo below)

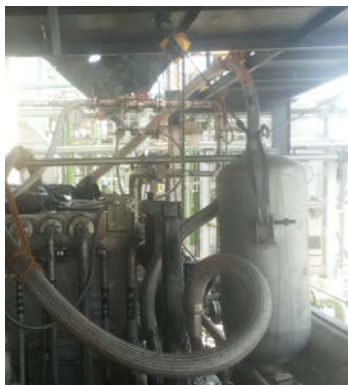
- At LO Outlet line, Old PCV 303 line, new PCV 303 spool piece, New Level Transmitter Spool Piece and New MOP NRV line were connected. (Ref Photo below)

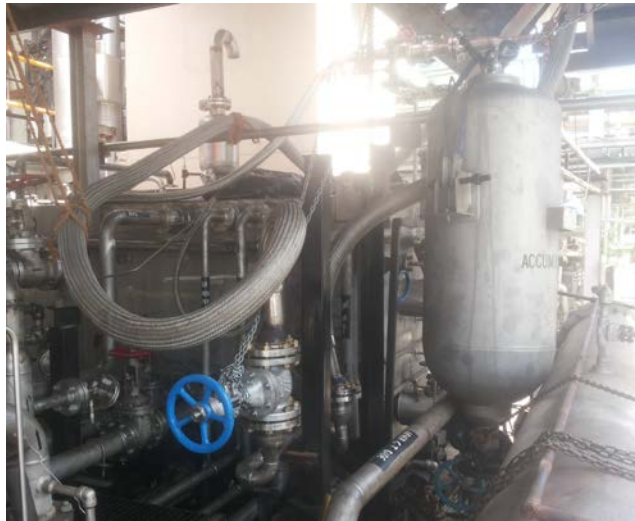
- Then SS flexible hose of 2" and two nos. 1-1/2" were provided and outlet of hose was directed to LO tank after opening cover through mesh. (Ref Photo above)
- At 4" flange for new Accumulator, 3" SS flexible hose provided with 4" flange after welding and oil was returned to LO tank then mesh. (Ref Photo below)

- Old Accumulator was removed from position and SS flex hose was connected outlet to LO tank with mesh. (Ref Photo above)
- Initially, 200 mesh size flat screen mesh was provided at all outlet lines, but it was observed that flat screen was getting torn out. Hence, conical strainer wrapped with screen of 200 mesh size was provided.

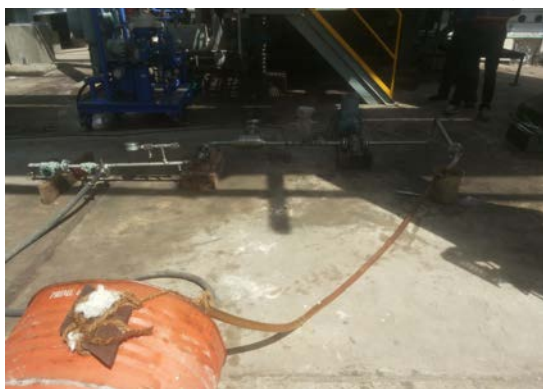
Flushing arrangement for 101-BJT LO Piping

- The additional pump installed earlier which was used as MOP was removed.
- RV's at MOP & AOP check discharge was removed and checked at test bench. Observed that the set pressure was above the required value (Reqd. set pressure 8.5 kg/cm²g). Adjusted RV Set pressure, checked at test bench & then installed.
- AOP discharge pressure was set to 6kg/cm²g by adjusting the spring of pump RV.
- Note – There was leakage through instrument fitting provided at MOP Top during start up. ID Fan was stopped and welding was done.

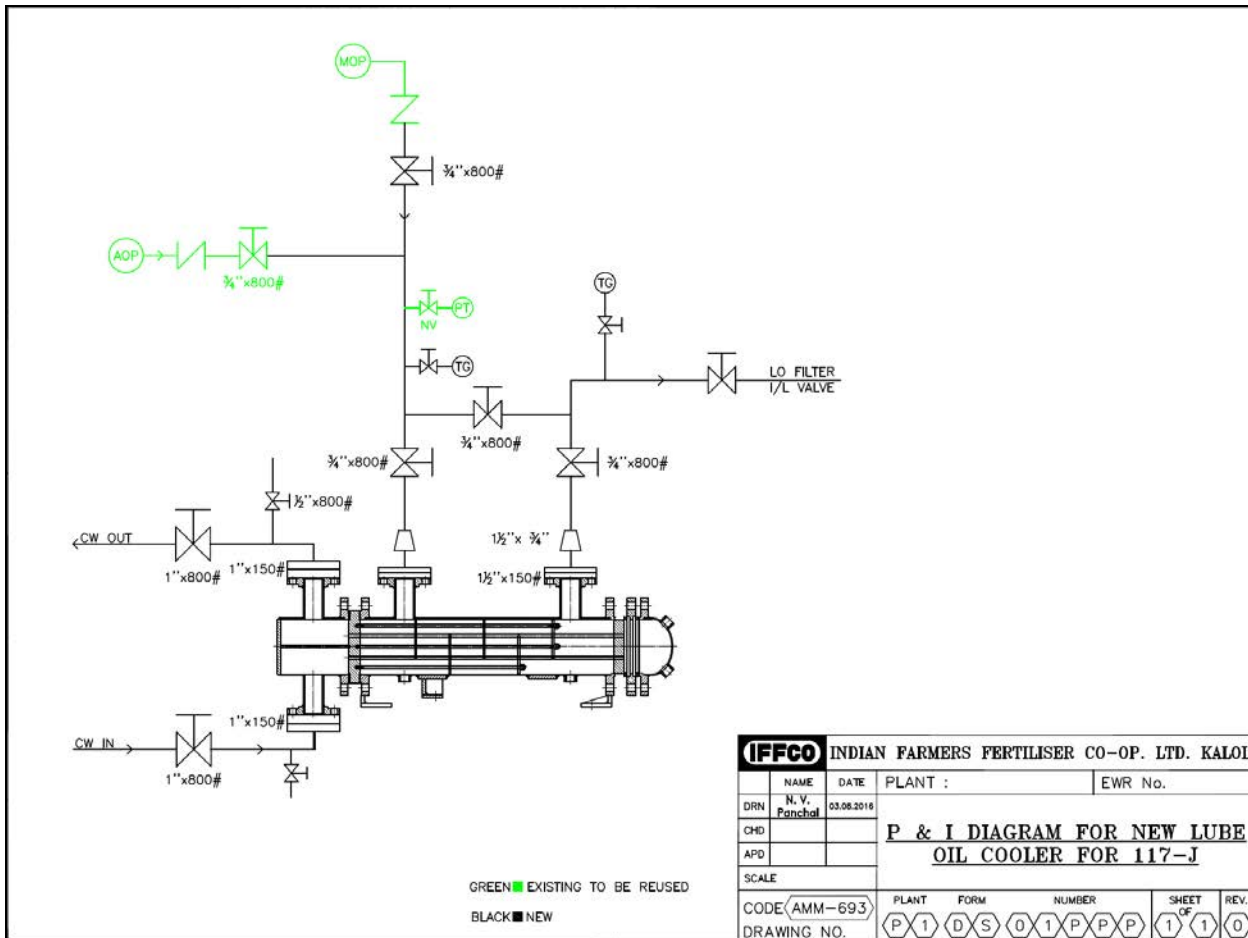
During summer LO inlet temperature was getting increased above 67 deg C and LO high temperature alarm was appearing in DCS. Hence LO was cooled by providing

water hose above filter. To resolve this new shell & tube Lube oil cooler, manufactured at workshop was installed in LO circuit.

Compressor was taken in line for checking the performance after installing LO cooler. AOP was not developing sufficient pressure initially even after adjustment from RV set screw. Cooler was also bypassed; MOP suction strainer cleaned etc. but no improvement found. After lot of efforts, a pin hole was found on the body of suction strainer from where air get ingressed in the LO circuit resulting in the poor performance of pump. Strainer was removed, repaired by welding & then reinstalled back. After that system get normalized.

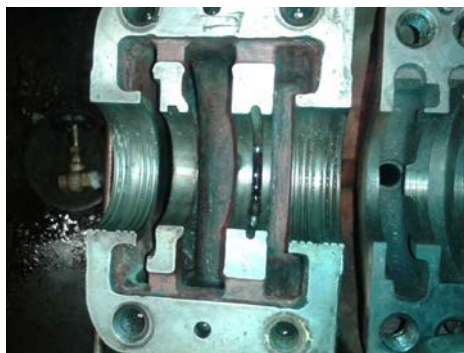
DE Side Bearing Housing Bottom

Turbine was taken for overhauling to correct the bearing & rotor shaft journal contact as the frequency of journal bearing failure increased due to axial misalignment of rotor shaft in the bearing housings. Bearing housing Alignment was checked & Misalignment was rectified by adopting the procedure laid down in Elliott Turbine Maintenance Manual Page No. 4-20 to 4-22.

To correct the misalignment, thickness of spacers located between NDE bearing housing & turbine casing were increased in top two bolts & kept same for bottom two bolts.

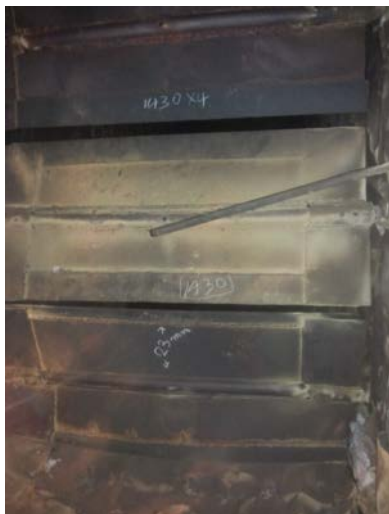
PRC-23 Dampers Before Patch Plate Welding

- Bulged liners around the PRC 23 dampers repaired.
- PRC 23 dampers were not getting closed due to gap between flappers. Hence additional plates were welded to 1st and 2nd flapper to reduce the gap to prevent ingress of excess air. Overhauled the linkage mechanism for free movement of dampers.

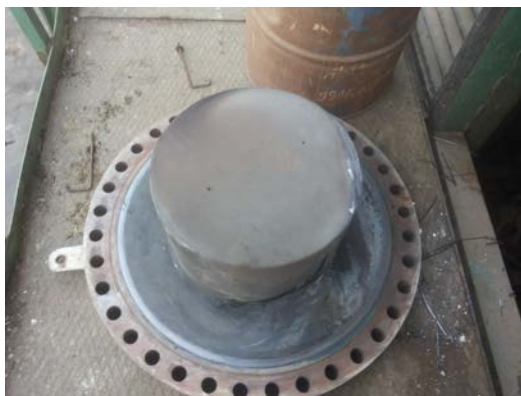
The transfer line end cover was opened for inspection, repaired the crack at the weld joint of cylindrical portion with flange & other cracks on the liners, damaged refractory on seating area of Transfer Line End Plug was repaired and then boxed up.

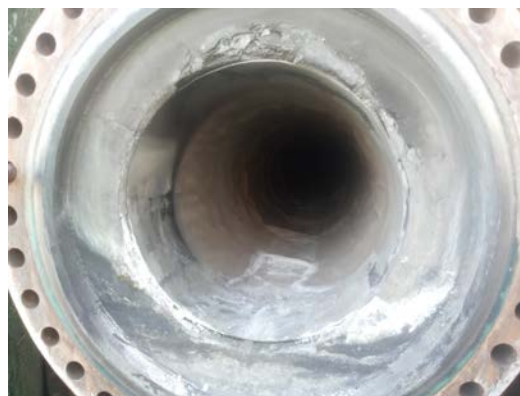
Damaged Refractory on seating area of Transfer Line End Plug

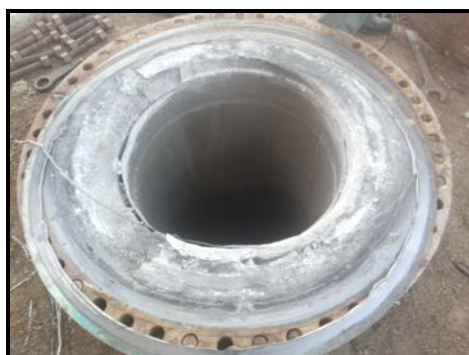
Damaged refractory at the top face

- Damaged Refractory at the face of the flange of 103-D was repaired by civil.
- Introduced the 8 sectors of grid distribution segment and rested them on the gussets of the burner. Adjusted the position of the segments in order to get 750 mm as external diameter. Tightened the nuts.

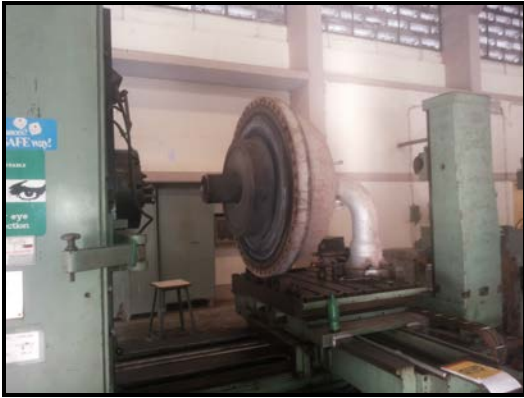
Old Burner Pipe was cut & Bevel edge made on Boring Machine

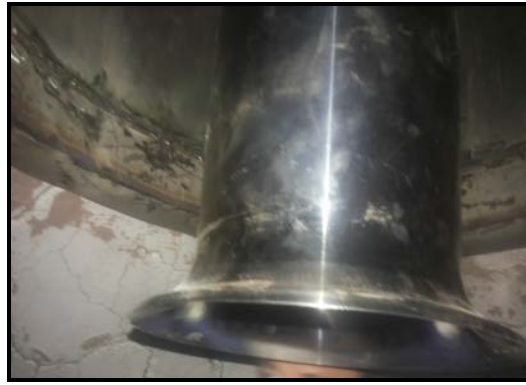
Circumferential ring in L shape welded on bottom of neck of 103-D

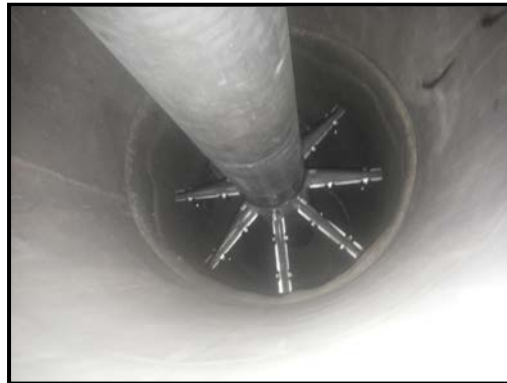
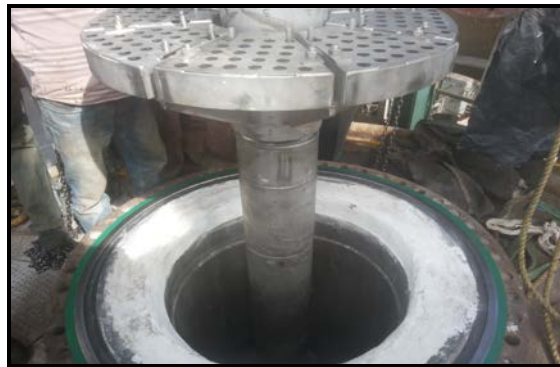
Refractory was repaired & setting of distribution grids

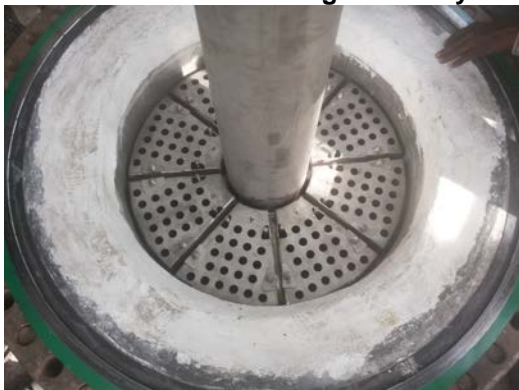
Checking restriction between distribution grids and liner

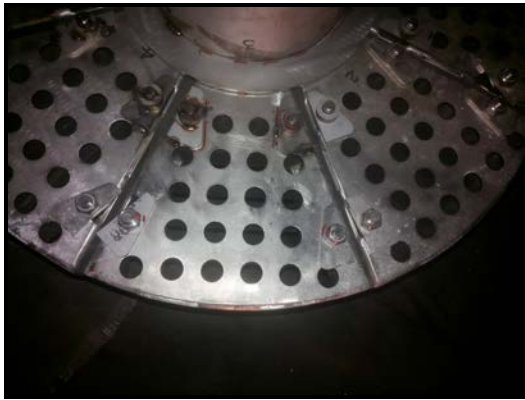
Tack Welding of Nuts to the bolts & fixing pins to the washer

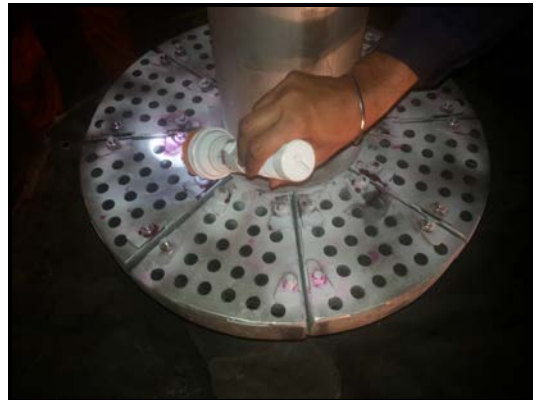
DP check of tack weld

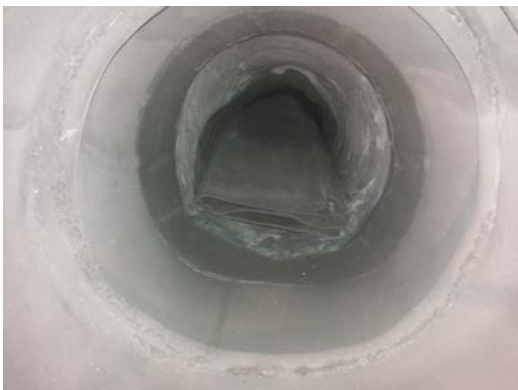
103-D to 101-CA liner Part No #15 with #16 of IFFCO drg. No 01-BS-03044 found removed & lying at bottom of pipe. (Also Ref. Drg No – 405 D2 of M W Kellog). Most of the gas passage of pipe found blocked. Damaged liner piece was cut & removed from position. Liner segment (4Nos.) issued from store (store code: 2010115189935230). It was welded in position.

Damaged 103-D to 101-CA pipe Liner

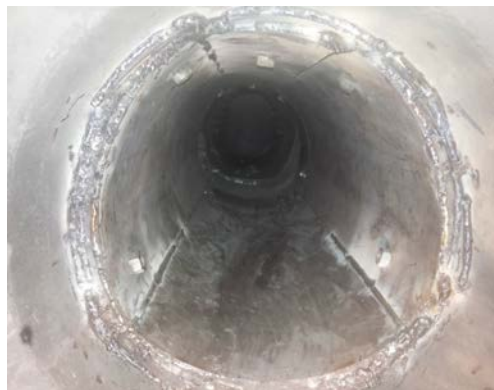
Repaired 103-D to 101-CA pipe Liner

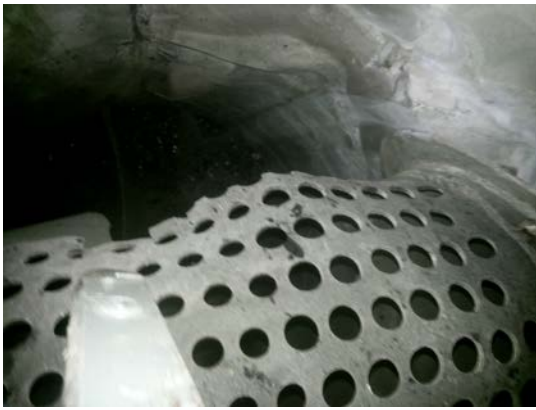
Liner and its welding surrounding the gas distributor found broken, eroded and bulged. Broken liner was replaced & repaired by welding. The Gas distributor was found broken and lying at the bottom floor. Cut & removed the damaged distributor & new distributor was fixed at the position.

Damaged Distributor of 101-CB

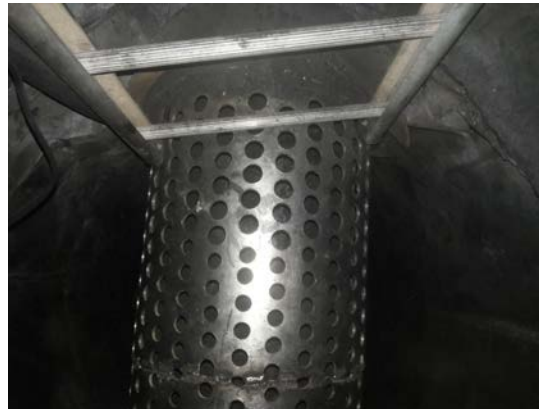
New Distributor welded on position

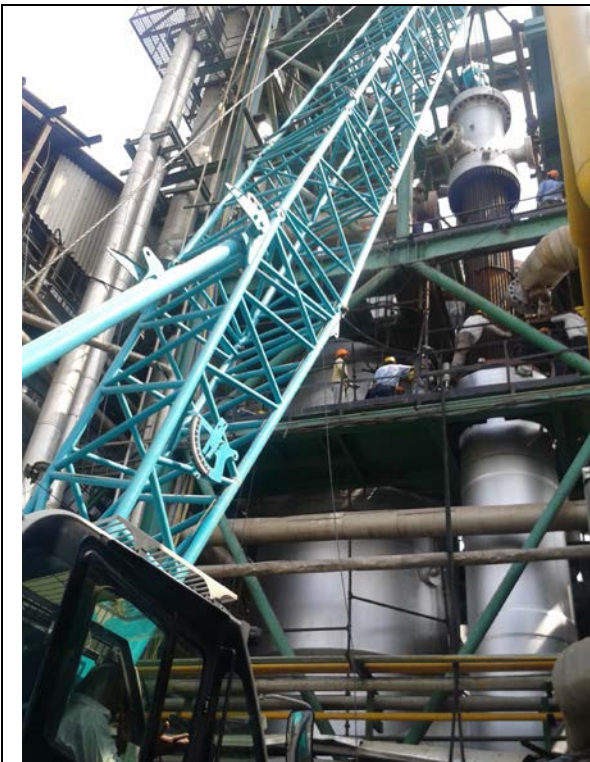
101-CB Tube Bundle Installation

After completing shell liner repair jobs, tube bundle assy. was inserted into the shell with new joint gasket by the help of Kobelco crane. Removed the lifting cover & placed the top cover with new gasket. Tightened cover to channel & channel to shell flange joint bolts. Inserted new gasket & then tightened downcomer & both riser flange joints bolts.

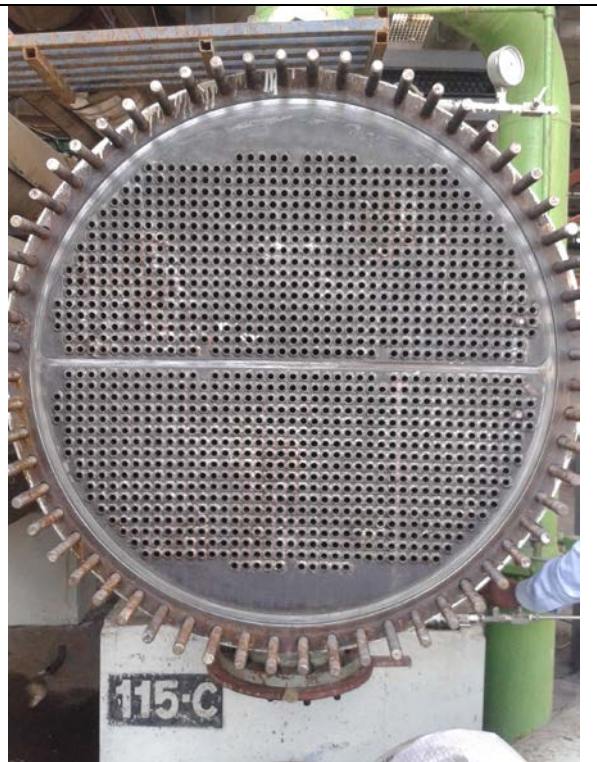
Tubesheet of 115-C after Seal Welding

Channel cover was opened. Pneumatic test was carried out from shell side at 3.5 kg/cm²g air pressure. Total 28 nos. tube to tubesheet joint leakage locations & one no. tube leak found.

Tube to tubesheet seal welding carried out & one no. leaky tube plugged. Then, Helium Leak detection test carried out and found OK. Welding was done by welder from M/S Patel Airtemp, Ahmedabad.

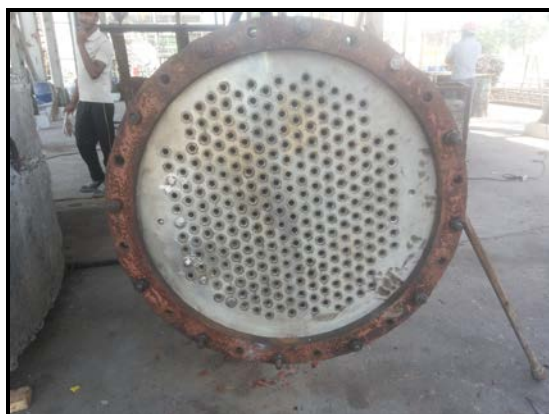
129-JC- Hydrotest of 129-JC was also carried out at 2.7 Kg/cm²g in dummy shell. 2 nos. tubes were found to have leakage. It was plugged.

2 nos. Tubes Plugged in 129-JC

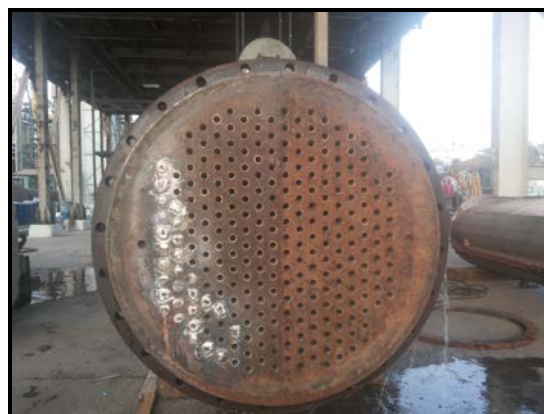
After removal of bundle holding studs were found broken. It was replaced with new one made in W/s. Hydro test of 130-JC was carried at 6 kg/cm2g. 24 nos. were found leaked. (Total plugged tubes – 28 Nos.)

Total 28 nos. Tube is plugged in 130-JC

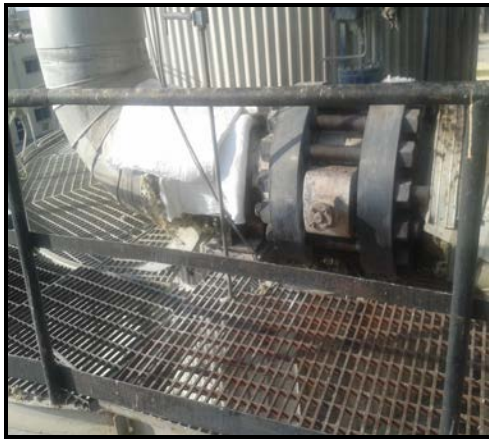
During normal operation leakage was observed at HIC-487 valve d/s flange weld joint. It was temporarily repaired by welding in running plant. Replacement of the pipe piece, 14" X Sch-120 along with the flange 14"X 1500# RTJ, MOC: P-22 carried out (marked in red colour in Drg.).

HIC-487 valve d/s flange weld joint leak location

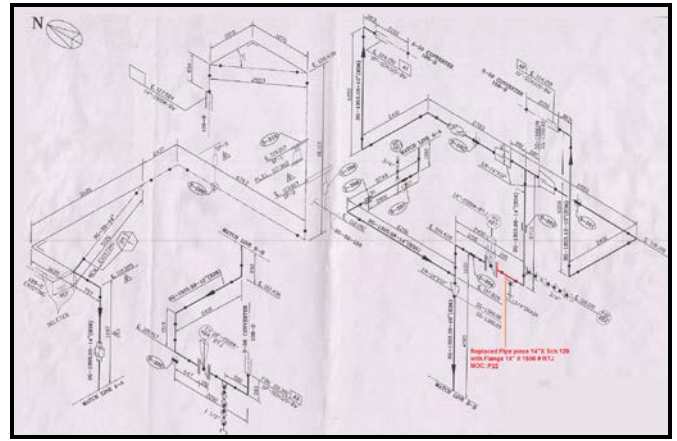
Replaced Pipe Piece & Flange marked in Red colour in Isometry Drg. No. 6332

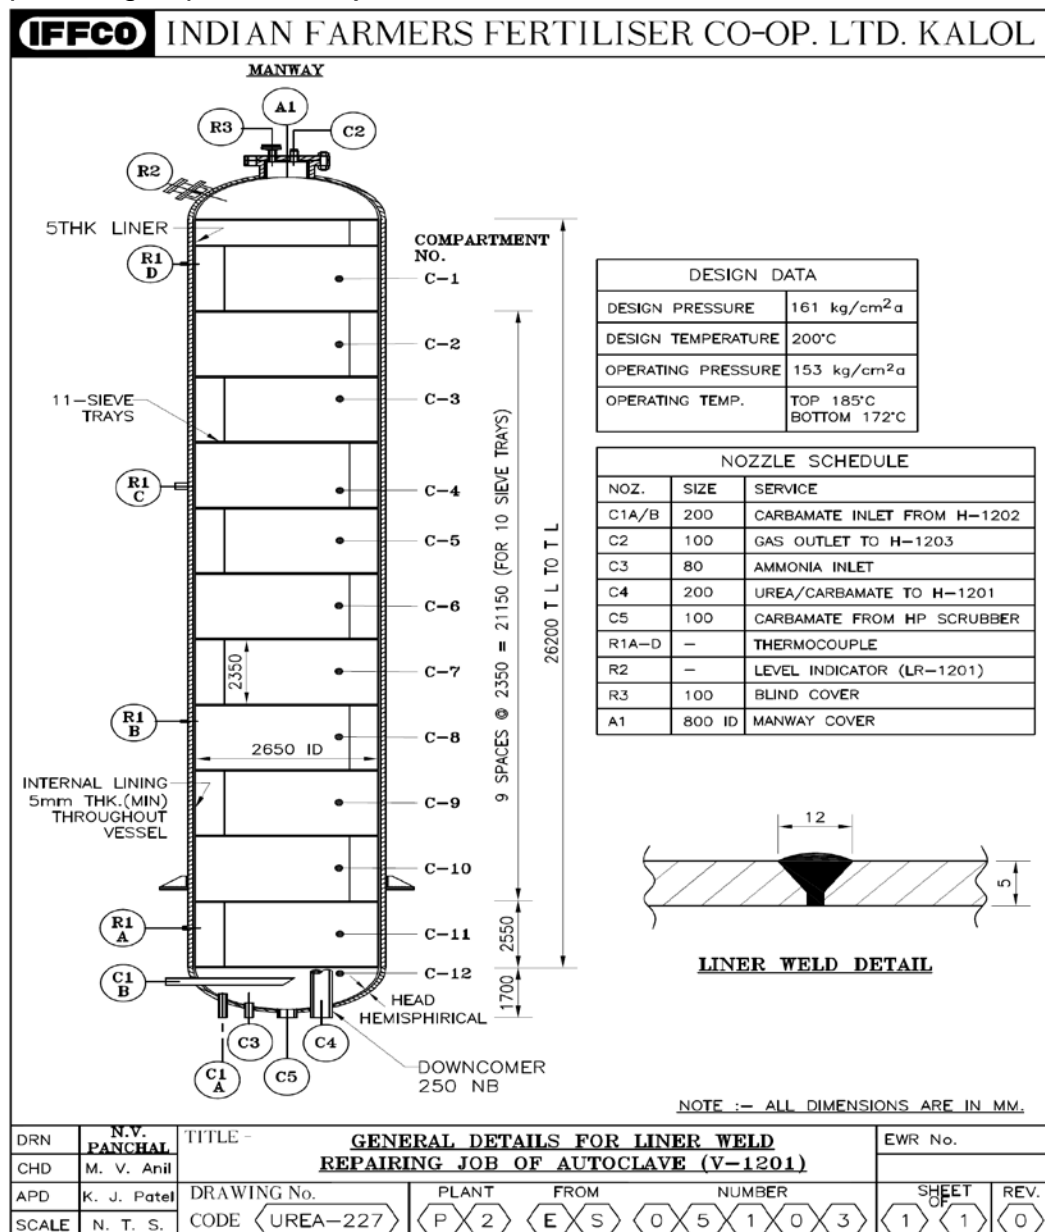
Repair of Liner weld joints of Autoclave

Liner welds of each compartment of V-1201 were most affected by corrosion. It was decided to repair liner weld one by one during shutdown.

During shutdown 2016, repairing of liner weld of 11th compartment was carried out. M/s Shree Ganesh Engineering, Ahmedabad was engaged along with our own fabrication and inspection group for above job.

- Weld area was cleaned by SS wire brush.
- Welding joint was ground and flushed. Visible pitting / pores were removed with Grinder and surface was made smooth. It was ensured that grinding was not done deeper than 2 mm below the surface of liner.

- Corroded area of Heat Affected Zone of joints was also grinded and removed.
- DP of grinded portion was carried out. Porosity observed was removed. However if the porosity extends deeper than 2 mm below the surface of liner, it was fused while performing welding.

- Welding was done by TIG using 25-22-2LMn filler wire size -2.4 mm dia with low heat input.
- Inter pass temperature kept below 150 deg. C.
- Minimum three layer of weld was required. At some portions where the width was increased due to removal of corroded portion, an additional layer of welding was applied.

- It was ensured that no area was left ground without welding
- Final DP was carried out.
- Ferrite content was checked. It was found within acceptable limit (Max 0.6 %)

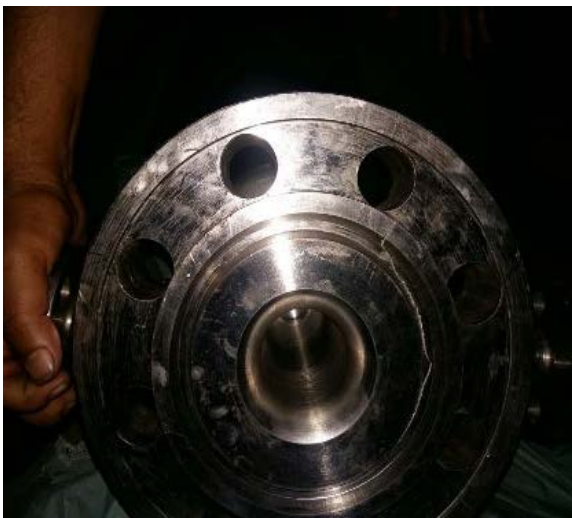
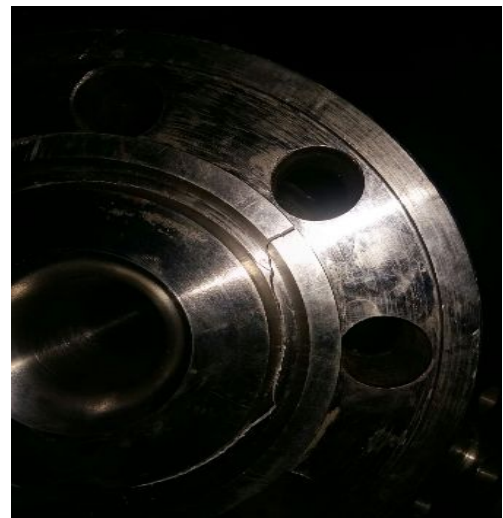
Crack HVD1 Nozzle

Out of 5 Relief Valve, 1 Relief Valve was taken at RV station, PT Top and installed at position. During installation, HVD1 nozzle was cracked from gasket seating area.

In presence and consultation with Tyco Sanmar representative, other relief valve with HVD1 nozzle was installed again, nozzle was cracked.

Later on, It was decided to installed Relief Valve with SS 316L nozzle with new high capacity spring. So, same were reconditioned by M/s Flotec. Also, 03 nos. Relief Valve were repaired and keep it as spare in store.

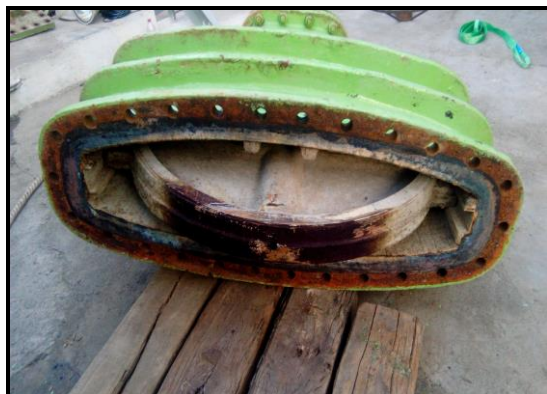
Removal of bonnet with gate (disc)

Actuator of gate valve was removed in presence of electrical section. Bonnet bolts of valve were loosened and removed the bonnet with gate (disc) of valve with help of Kobelco crane. Gate (disc) was dismantled from the bonnet. Both side seating area of gate (disc) were checked and found ok. Cleaning & polishing on both sides

seating area were done. Both side body seating area were checked & found ok. Cleaning & polishing on both sides seating area were done. Bonnet with gate was placed on its position with new gasket. All bonnet bolts were tightened. Gate valve was kept in fully closed position. Contact between the body seta & gate seat was checked from inside the line (opening through the check valve) and found satisfactory. Actuator was placed on it position, checked with valve open / close operation.

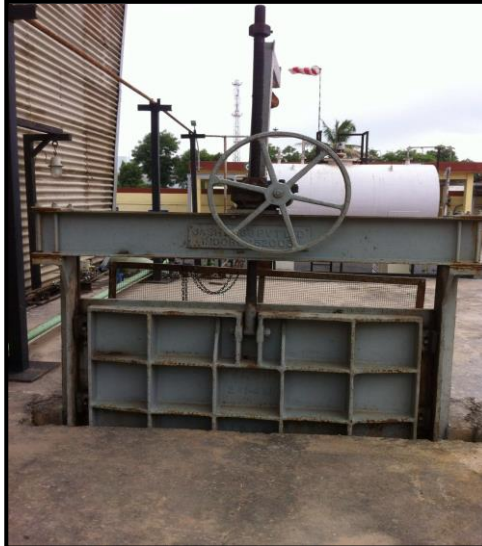
Gear box of gate no. 1 opened, found bearings are in good condition, gear teeth having minor scoring. In gate no. 3 & 4, bottom wedge blocks (4nos.) were found in damaged condition.

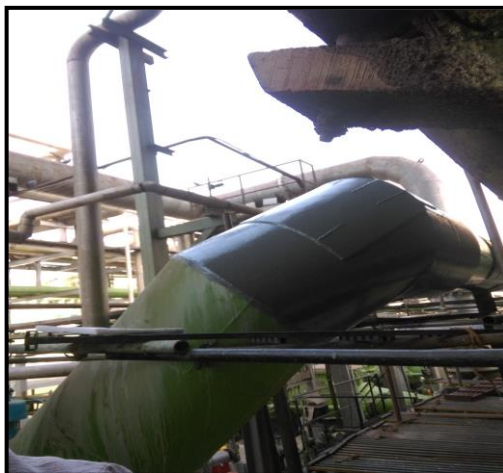
- Hot water distribution valve (butterfly valve, size: 14" x 150#) of NCT cell no 1 (silo side) was replaced with new one. Reconditioning of remaining valves of all 14 nos. of cell was done.
- Heavy pitting observed on 36" cooling water return header (near Q-4411). Welding of 8mm thick patch plate was done on it. A **Stanvac** make corrosion resistance compound was applied on patch plate.

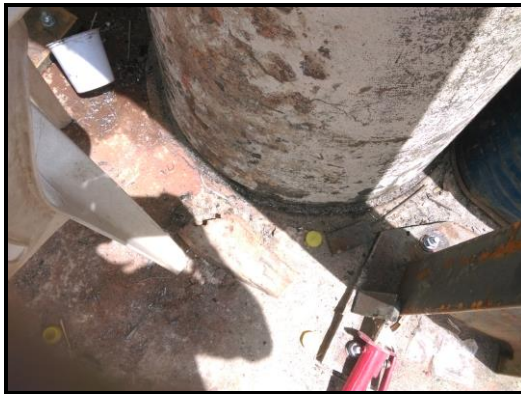
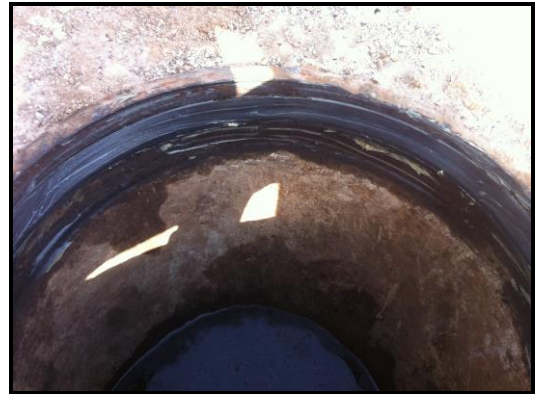
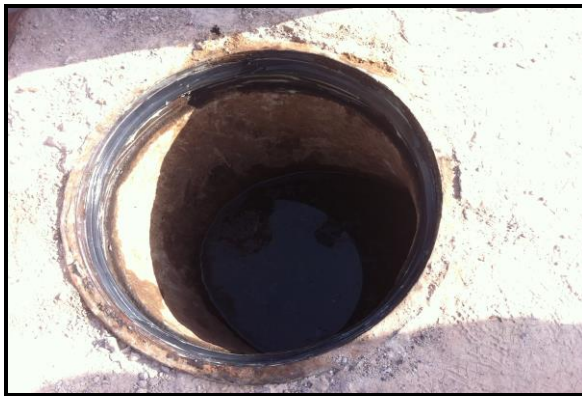
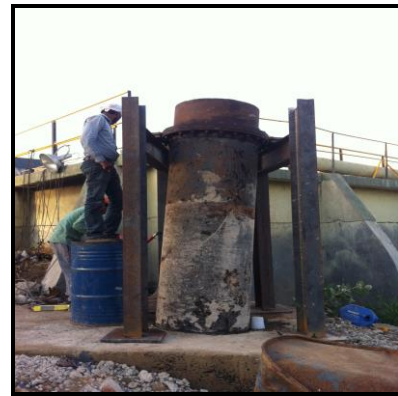
Narmada Plant

Near Narmada main reservoir, a heavy leakage was observed from the push-on joint of 36" DI pipe line (cement mortar lining). Leakage was visual from the middle of two thrust block. Top thrust block around the leaky pipe joint was broken by civil section.

Vertical DI pipe line was flanged joined with MS pipe line. 300mm above the CS pipe line (36" NB) was cut & removed it along with DI pipe line from the push-on joint using hydra. Not gasket found at joint & lead wool was used for sealing. Now joint area was cleaned & new 700mm rubber O-ring was provided on inside groove of joint. Cut DI pipe with flange & CS pipe piece was placed the on it position using hydra. MS structure was fabricated to support the vertical line. 4 nos. of each base plate of MS structure was grouted with HILTI fasteners M16 (total 16 nos.). In pipe joint, lead wool was inserted and araldite compound was applied on it. Further assembly & fabrication was done. After successful testing, handover it to production department.

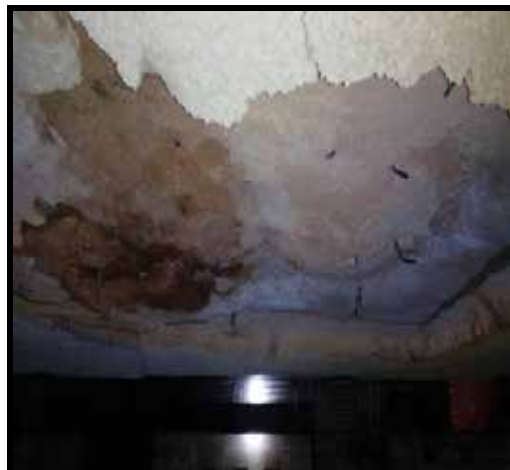
- Scaling was observed on all the tubes of Mixed Feed Coil.
- Bottom most part of Insulation covering plate was found burnt off at most of the locations. This was observed in previous inspection also.
- Refractory at the ceiling in front of 1st & 2nd row tunnel was found fallen hence exposing the holding anchors. Also some patches of refractory found fallen in front of 3rd & 4th row at few locations.

Ceiling Location from where the refractory dropped

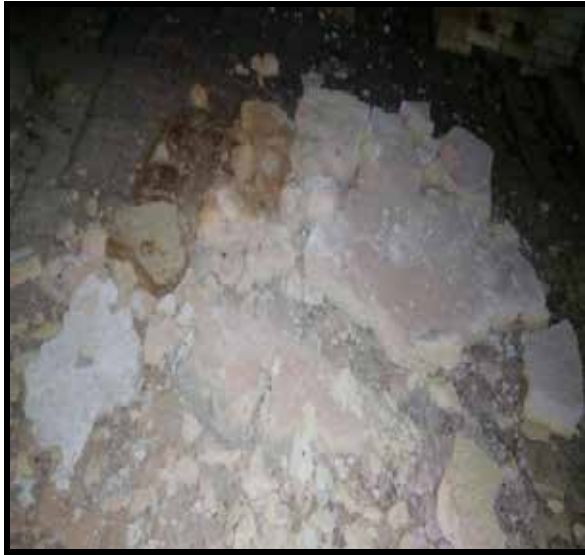
Refractory fallen on the floor.

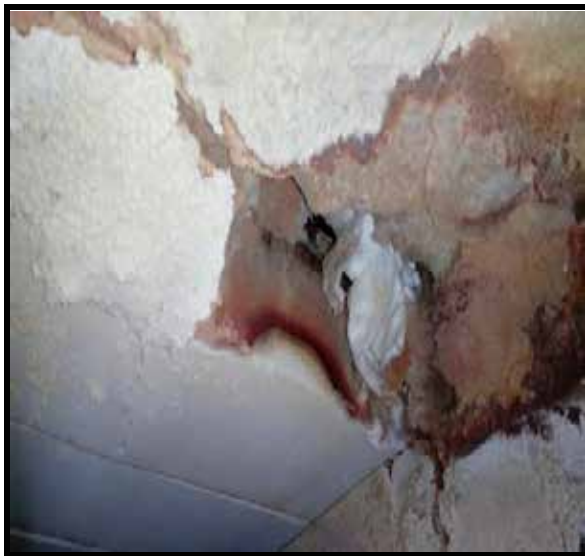
- Half portion of tunnel block was found lying on the floor in 4th row tunnel.

Location at which the tunnel block fallen in 4th row

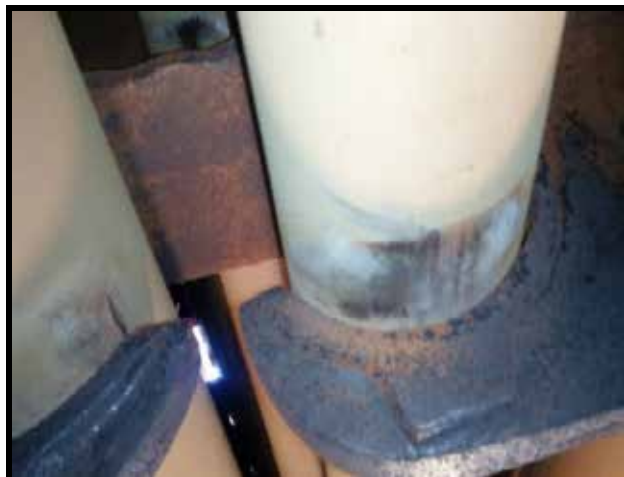
- Rubbing on the coils observed near anchor supports, however no reduction in thickness was noticed.

Rubbing marks on Coil bottom

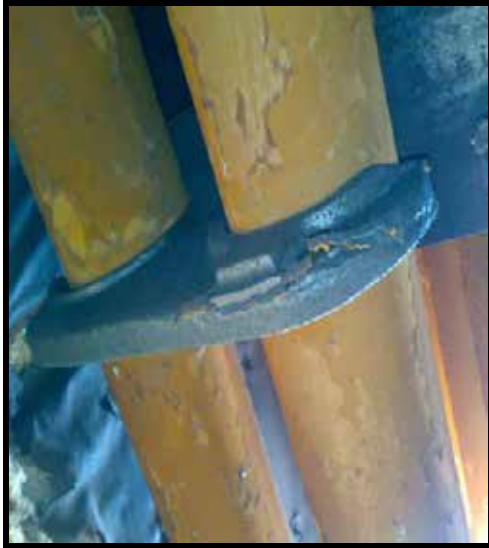
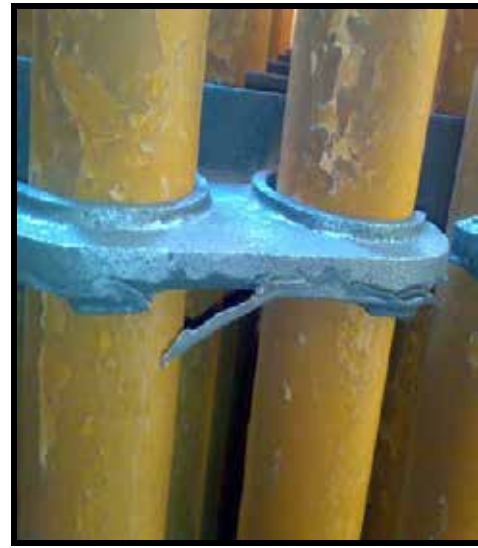
- Peeling-off of top layer of casting was observed on first two rows of east side anchor supports of mixed feed coils. This was observed during previous inspections also.

Metal peeled off in anchor supports

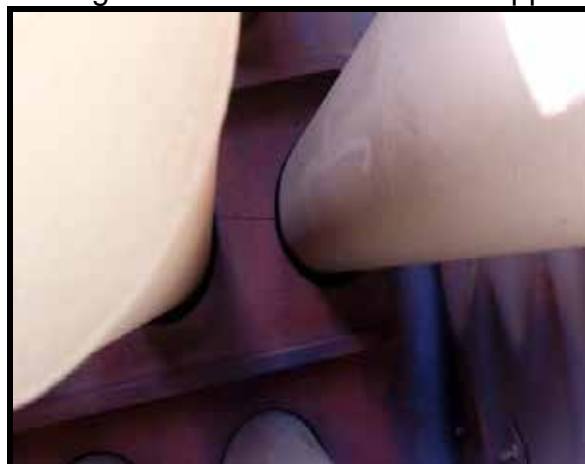
- HT and LT super heater coils were found in satisfactory condition.
- Supports of LT/HT steam super heater coils were found in satisfactory condition.
- Gap observed between Liners in East wall just above the partition wall.
- HT steam super heater top coil tube fins found damaged in 02 nos. tubes. (5th & 9th tube counting from North)
- Crack was observed on Ligament of Mixed Feed coil support at North side.

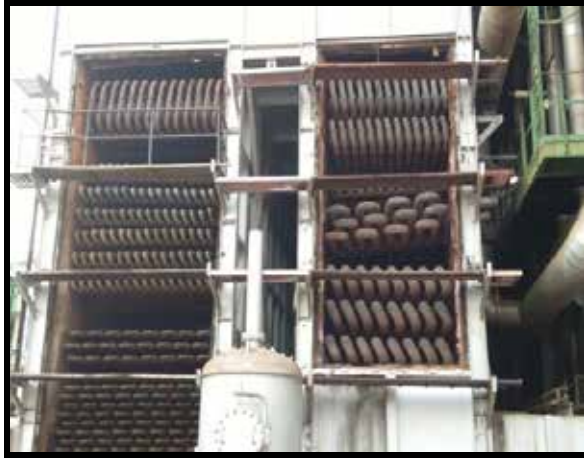
- Damper condition was satisfactory however liner was found bent and distorted near the damper. Loose Liner Piece was found lying on floor.
- Thermo well near damper was found slightly bent.
- Air pre heater coil was found sagged up to 300 mm downward direction at south side. Same was observed during previous inspection also.

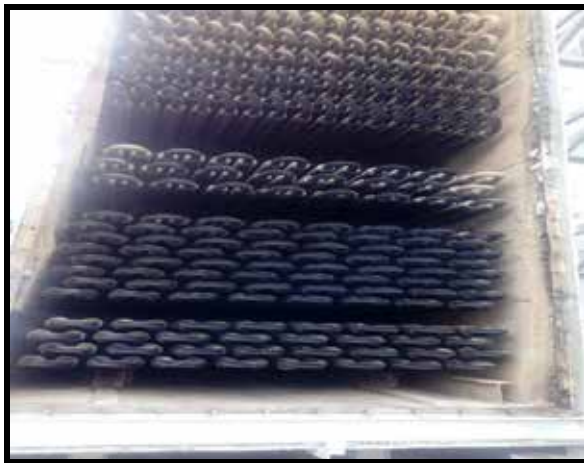
- Loose blackish deposition was observed on bottom most 03 nos. coils of LT convection zone.

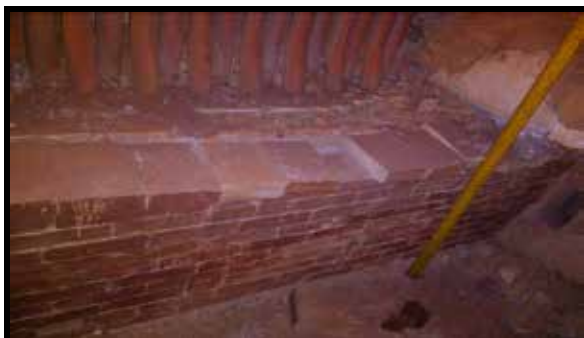
- Condition of the tubes was found satisfactory.
- Burner holes found satisfactory.
- Top header refractory was found having cracks at few locations.
- Bottom wall refractory found loose in East-West side.

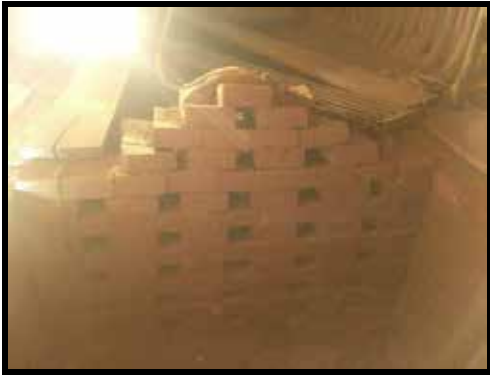
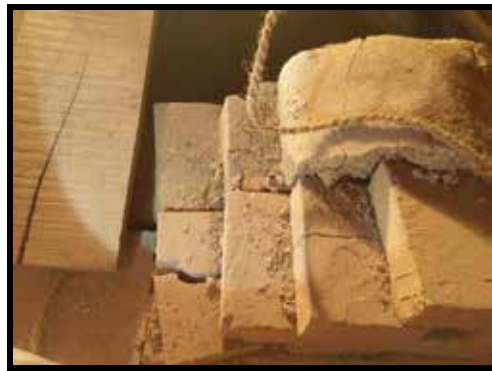
- Centre partition wall refractory found sagged and some refractory found cracked/damaged.

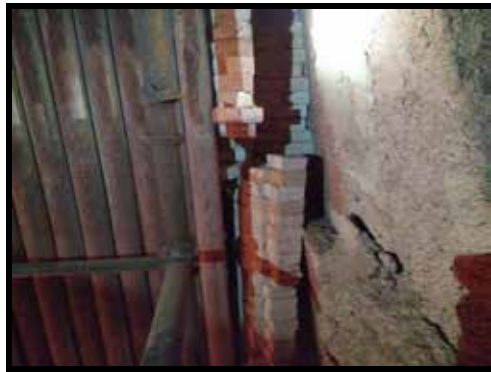
- Tube supported refractory found loose and damaged adjacent to burner no. 4 from bottom.

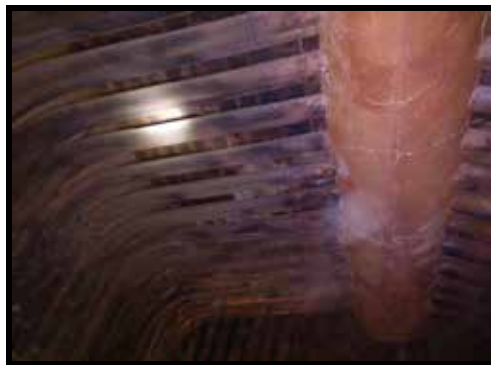
- Top roof refractory found damaged and lying on the top tubes.

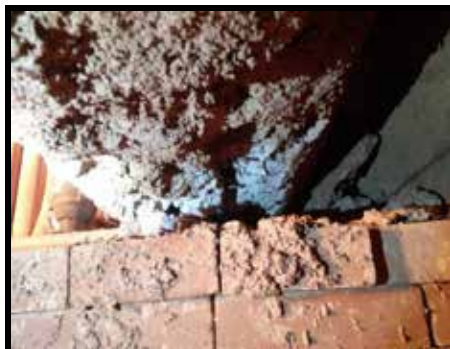
- Thermo well condition found satisfactory at north side behind tubes.
- North side bottom down comer header refractory found damaged in bottom most area towards west direction.

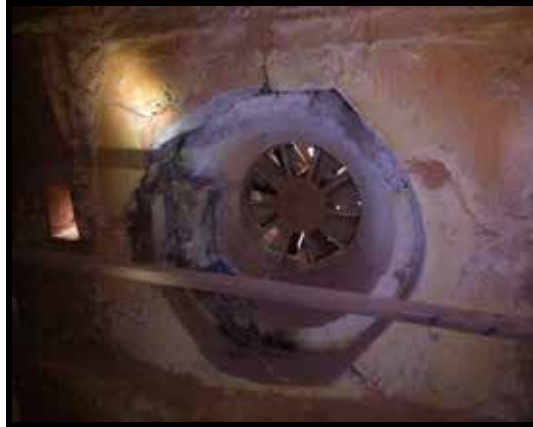
- Burner side wall refractory found damage in burner no. 5 from bottom.

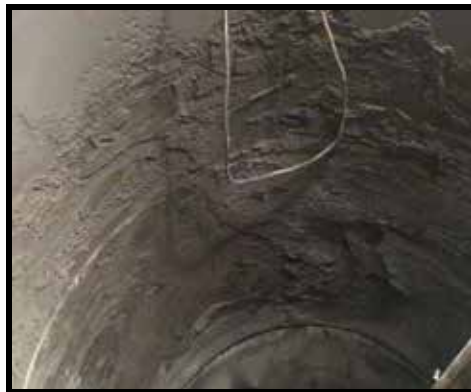
Thick deposition of dust layer observed on liner surface and hence it could not be thoroughly inspected. However scattered pitting of 1-1.5 mm depth was observed at few locations.

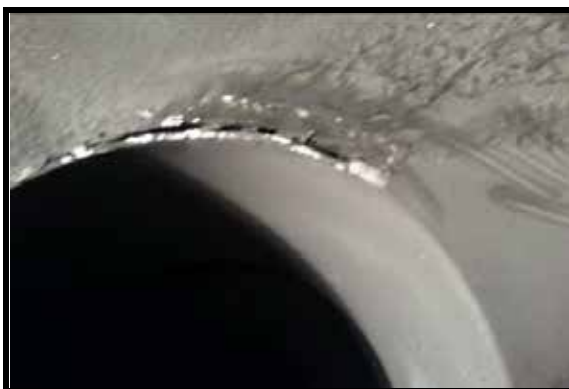
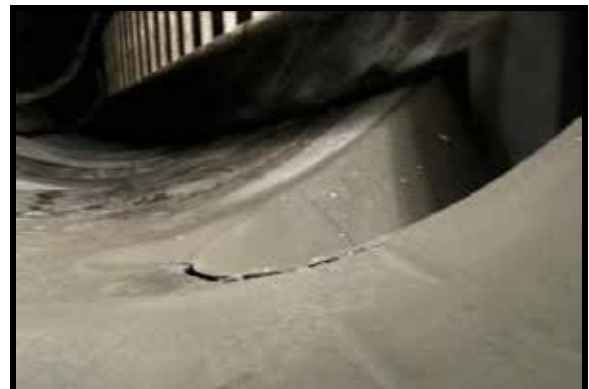
- Welding of gas outlet nozzle liner with shell liner was found broken at few locations, causing gap of approx. 2 to 5mm on periphery of nozzle.

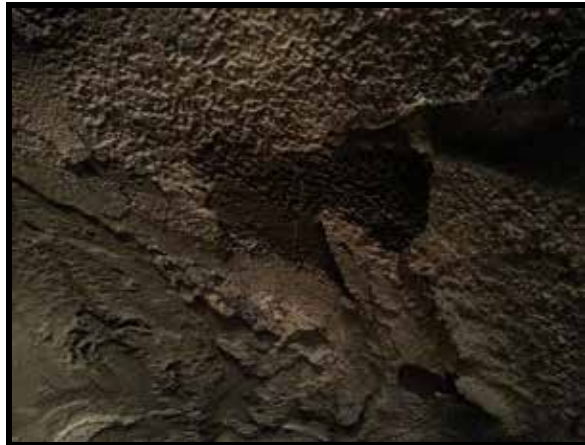
- Thick deposition of dust layer observed at surface of 2nd course, hence surface could not be thoroughly inspected. However Approx. 1-2 mm deep pitting were observed at scattered locations.

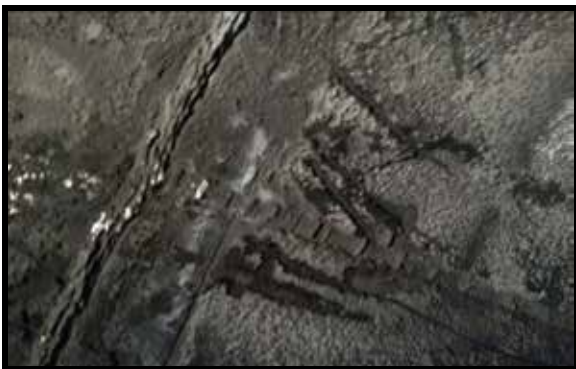
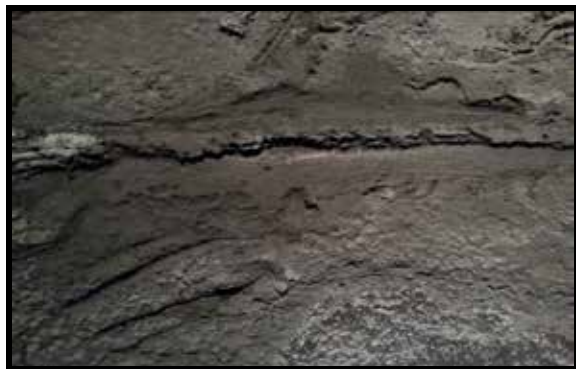
- Its longitudinal weld seam was found eroded in its full length below the liner surface. Its circumferential weld was also found eroded at scattered locations

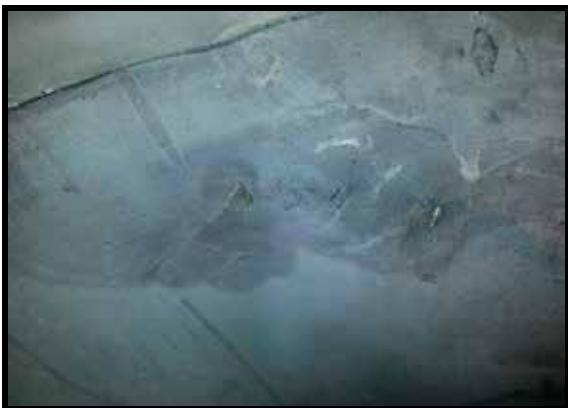
- Bulging of approx. 5-7 mm was observed just above the gas distributor.

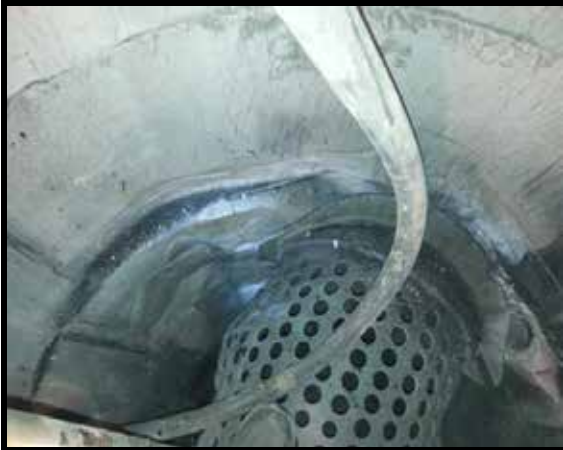
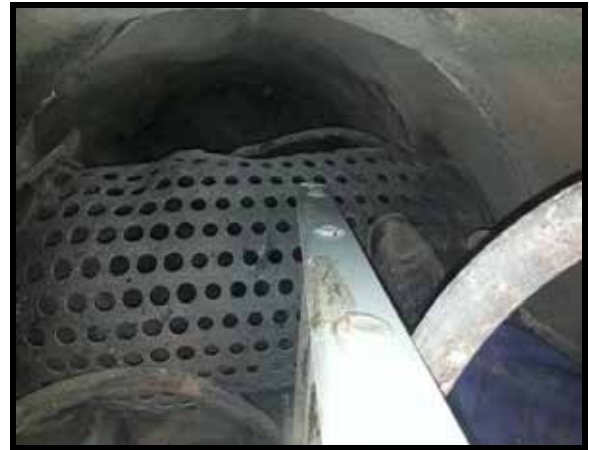
- Liner and its welding surrounding the gas distributor found broken , eroded and bulged.
