MTC / REPORT / 01
REPORT NO. 36 / 2016

PLANT TURNAROUND REPORT

(MARCH – APRIL – 2016)

INDIAN FARMERS FERTILISER CO – OPERATIVE LIMITED

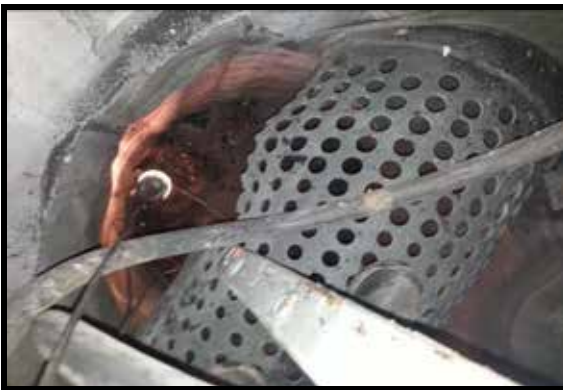
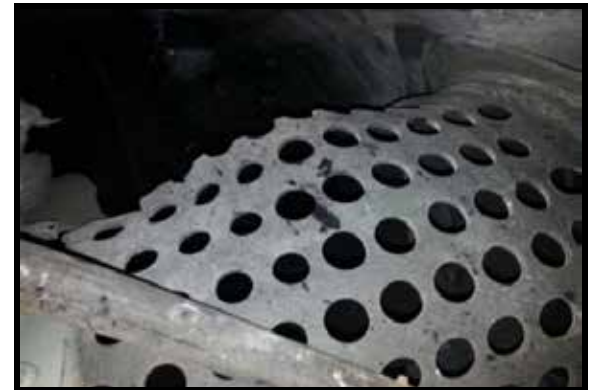
- Gas distributor bottom half portion was found broken and lying at the bottom floor.

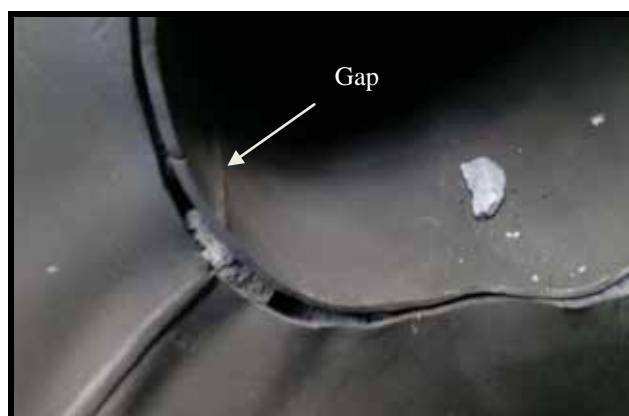
- Thermo wells were found intact.
- Approx 1" Gap was observed between shift liners of top shell to transfer line.

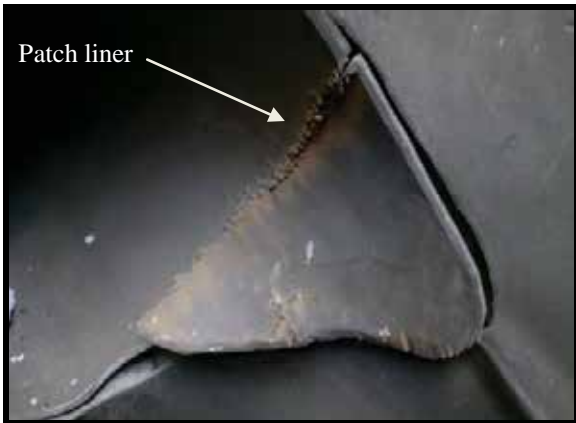
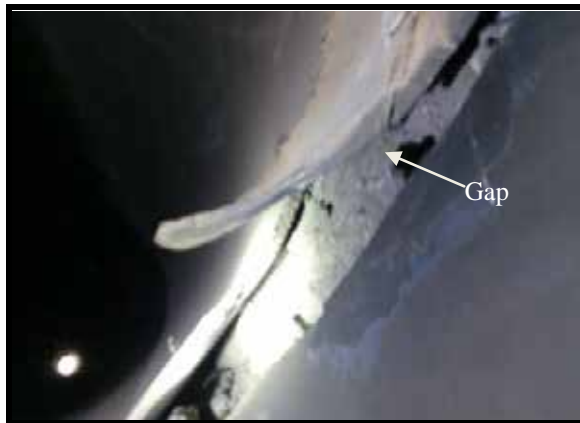
- The Patch liner on the junction of transfer line found almost detached creating gap and exposing the refractory.

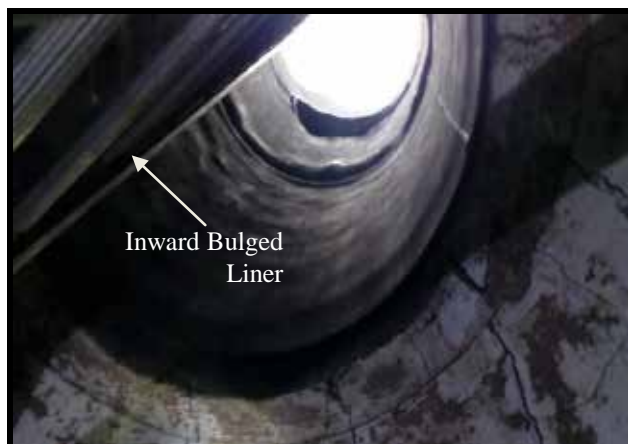
- Inward bulging of approx 1" observed in top shell liner all around the circumference. The ID measured at this location & was found to be approx. 700mm. The location of this bulged location is approx 1990mm from vessel top flange face.

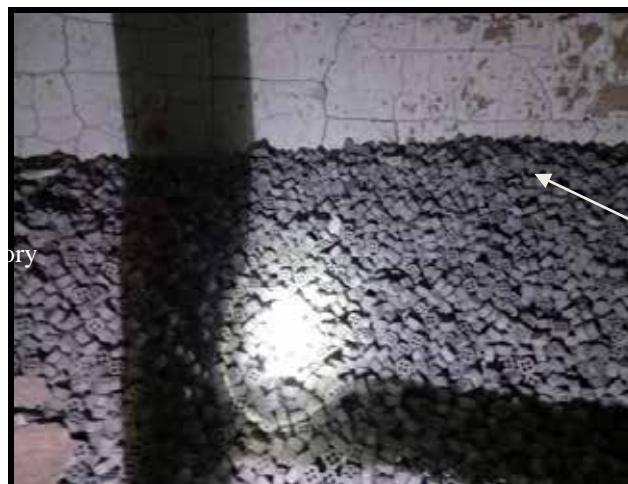
- The catalyst was found uniformly converged throughout the shell. Loose refractory material was found lying on the refractory bed.

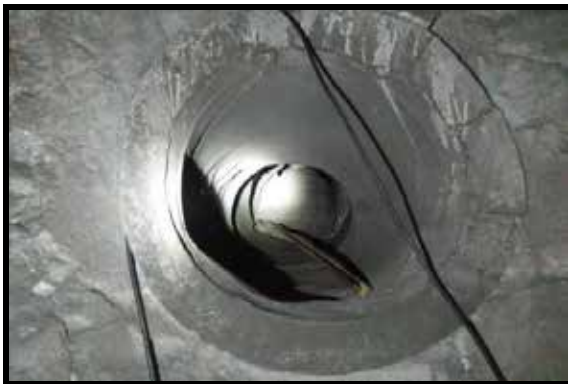
101 CA Nozzle View

- The refractory around the 101-CA/CB gas inlet nozzles (approx half of the top circumference) was found eroded and loosened.

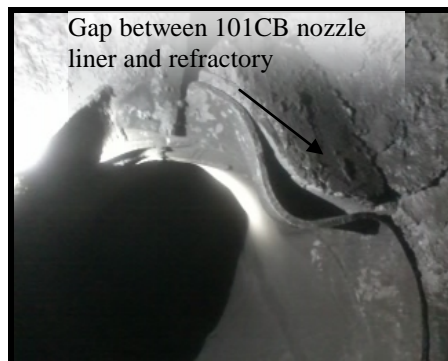
- Gap was observed between the 101-CA/CB gas inlet nozzle liner and the shell refractory joint. Gap of approx 2" was observed towards the 101-CB nozzle.

The same was observed in previous inspection also.

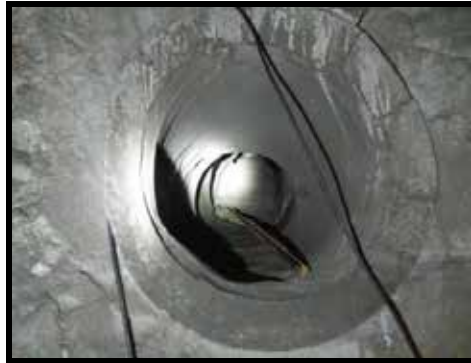
- The liners inside the 101-CB gas inlet nozzle were slightly buckled /distorted. Condition of the thermo-wells was satisfactory. The same was observed in previous inspection also.

- The liner inside the 101-CA gas inlet nozzle was found damaged/detached from its position in approx. 4 ft length creating obstruction in gas flow path. Also the exposed refractory found loosened and damaged at several locations.

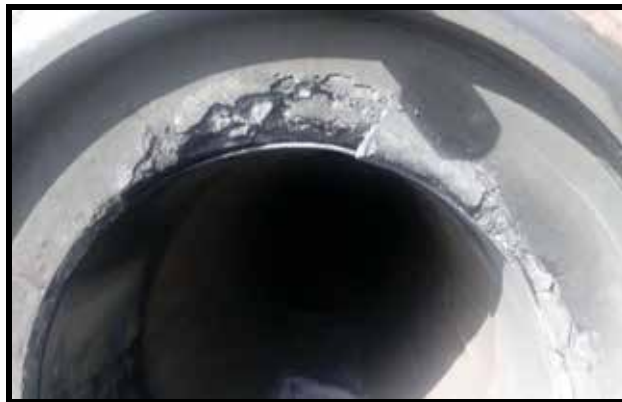
107 - D ,TRANSFER LINE (FROM OUTSIDE)

- Minor buckling/distortion of the liner was observed throughout the length of the transfer line.
- Minor damage of the refractory was observed at flange (end plug side) of the transfer line.

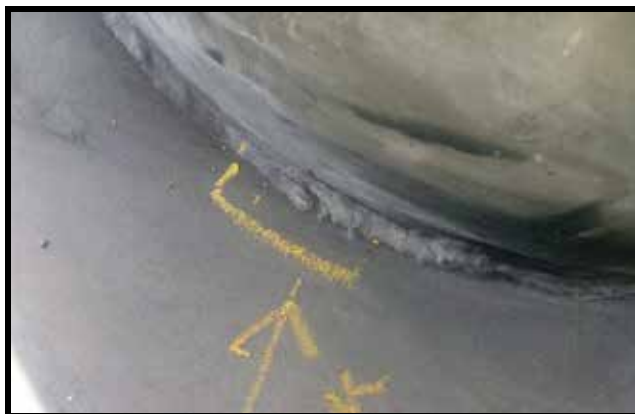
- Thermowell was found intact in its position.
- Crack approx of 1" length was observed on End plug weld with its flange.

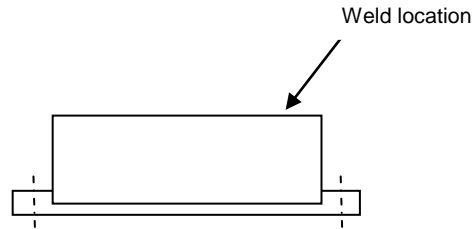
- Several cracks were observed on top plate of end plug weld with cylindrical portion.

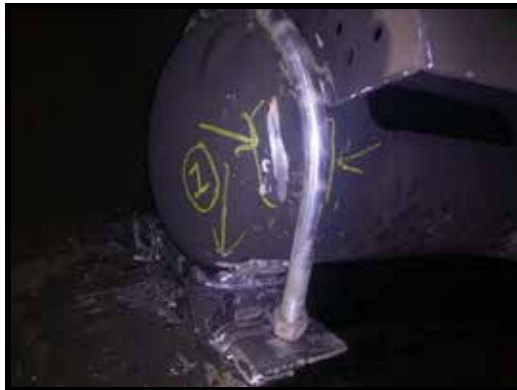
102-EB, CO₂ STRIPPER

- Demister pads were found slightly shifted in middle portion.
- Demister pad supporting strips and rods were found satisfactory.
- All the bolts of liquid inlet nozzle flange were found in position & intact.
- West side distributor header was found rubbing with the shell plate in S-W direction causing dent in the shell plate. Same was also observed in previous inspections.
- East-North side distributor header found rubbing with U-clamp support plate causing dent/slot of 100 mmX20 mm and 40 mmX10 mm area in cap of header at bottom and west side respectively. (marked with yellow chalk as 1)

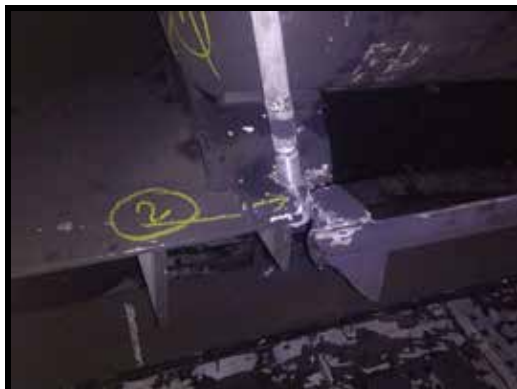
- South-West side distribution header U-clamp support found cracked/detached towards east side. (marked with yellow chalk as 2)

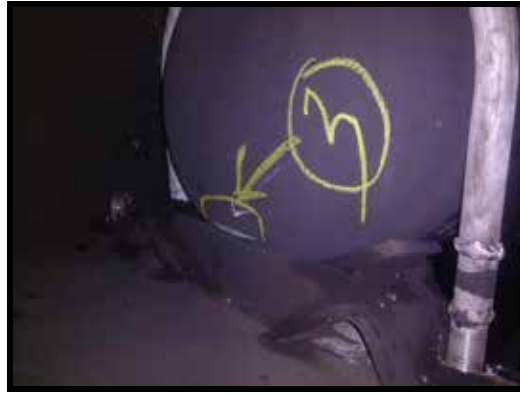
- West-South side distributor header found rubbing with U-clamp support causing dent in cap of header. (marked with yellow chalk as 3)

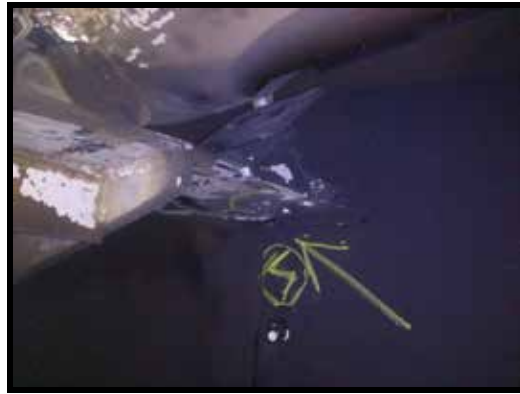
- U-Clamps of East-North and West-South side distribution header were found loose. Need to be tightened. Further with East-North side U-clamp hole found enlarged. Need to be repaired. (marked with yellow chalk as 4)

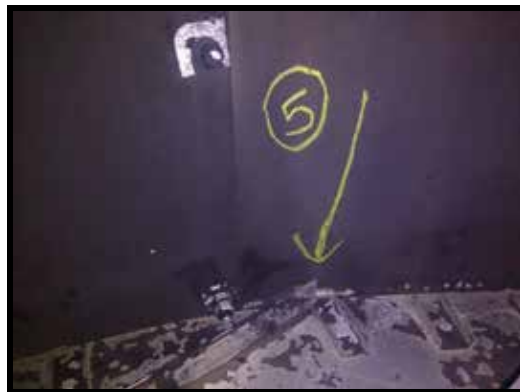
- 01 no. Stud found stuck up between shell liner and trays below distribution header towards west-south corner. (marked with yellow chalk as 5)

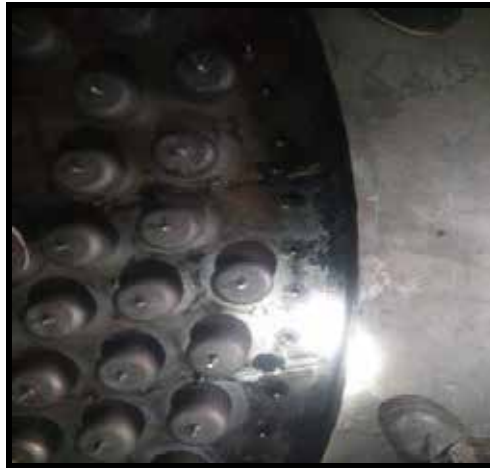
- Demister pad was found intact in its position in satisfactory condition.
- Condition of bubble caps found satisfactory.
- Distributor collectors / drain pipes in West direction one was found satisfactory.
- Debris found lying on the surface of bubble cap resting plate.

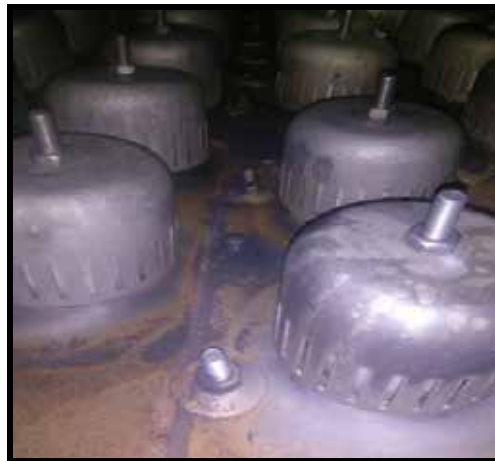
- Debris found adhered on the bubble cap resting plate stud.

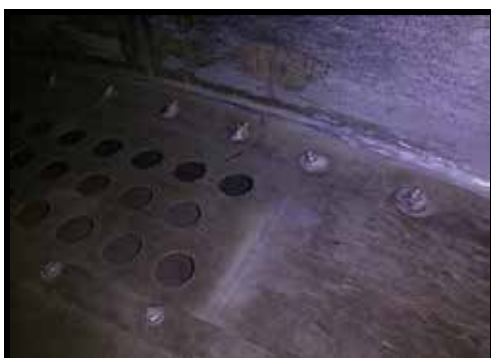
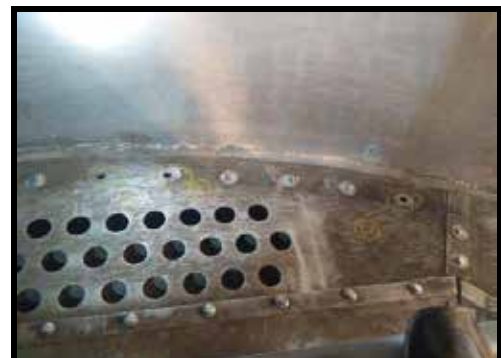
- Rectangular riser box and other fittings found intact in position.
- Holding bolts of bottom tray found loose and bent at many locations. 03 nos. bolts are missing from at north side. (Marked with yellow chalk)

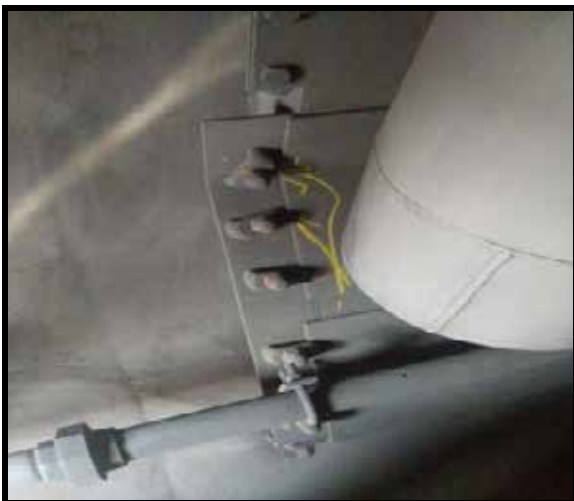
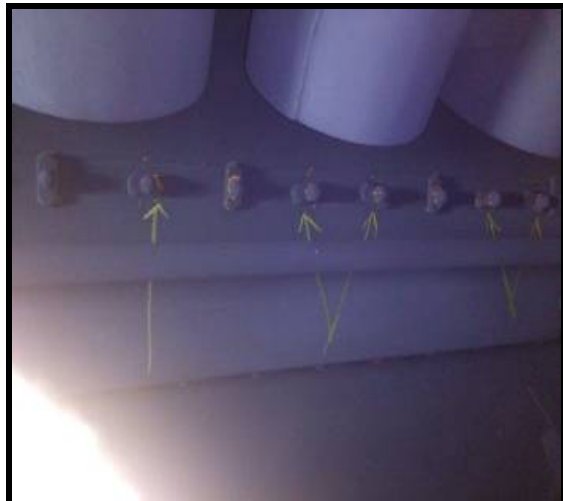
101-F, STEAM DRUM

- Grayish black coloration was observed inside the drum.
- All Cyclone Separators were found intact in position.
- Demister pads were found intact in position.
- Minor pitting of approx. 0.5 to 1.0 mm depth was observed at scattered locations.
- One of the holes at south end of phosphate dozing line (1" NB) was found enlarged.
- Few bolts and clamps of Demister Pad holding cover plate were found loose. (marked with yellow chalk.)

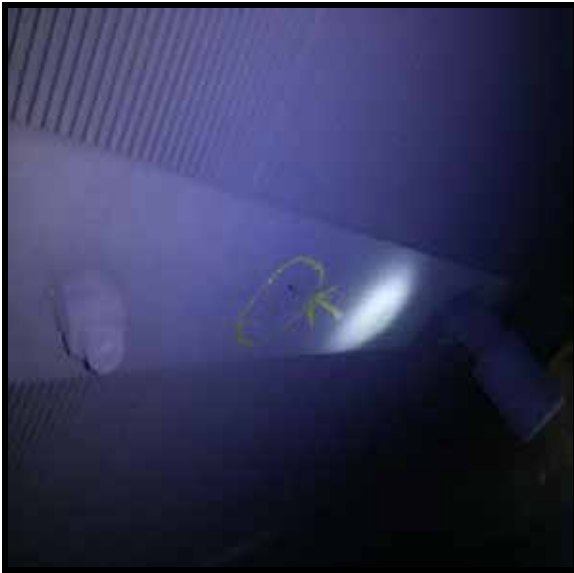
- 02 nos. Demister Pad holding plate found sheared at the top. (Same were marked with yellow chalk)

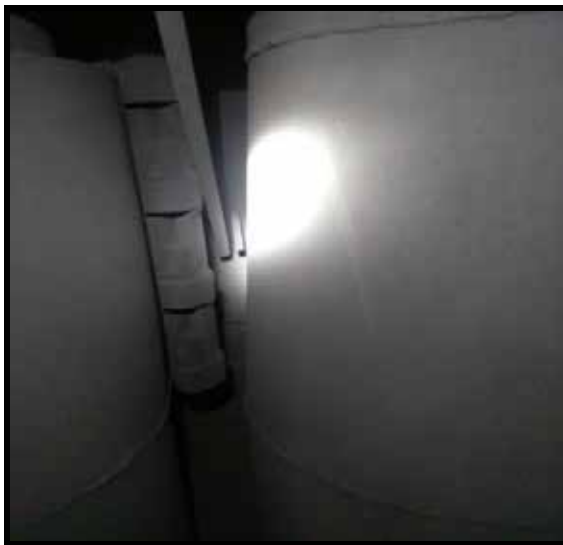
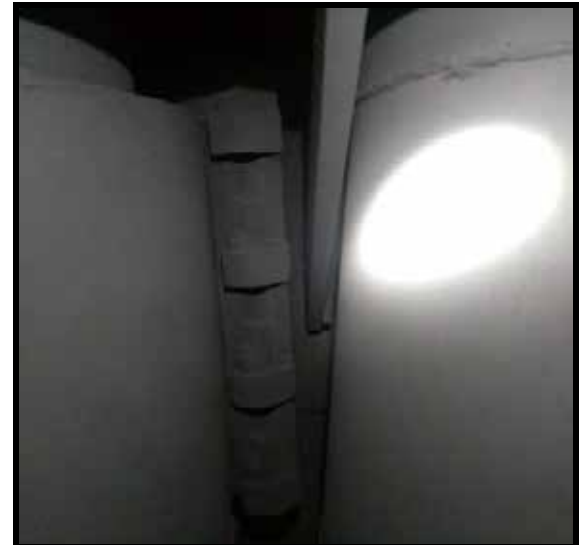
- On East side demister pad stiffener plate fastener was found missing at 04 locations at bottom side of plate.

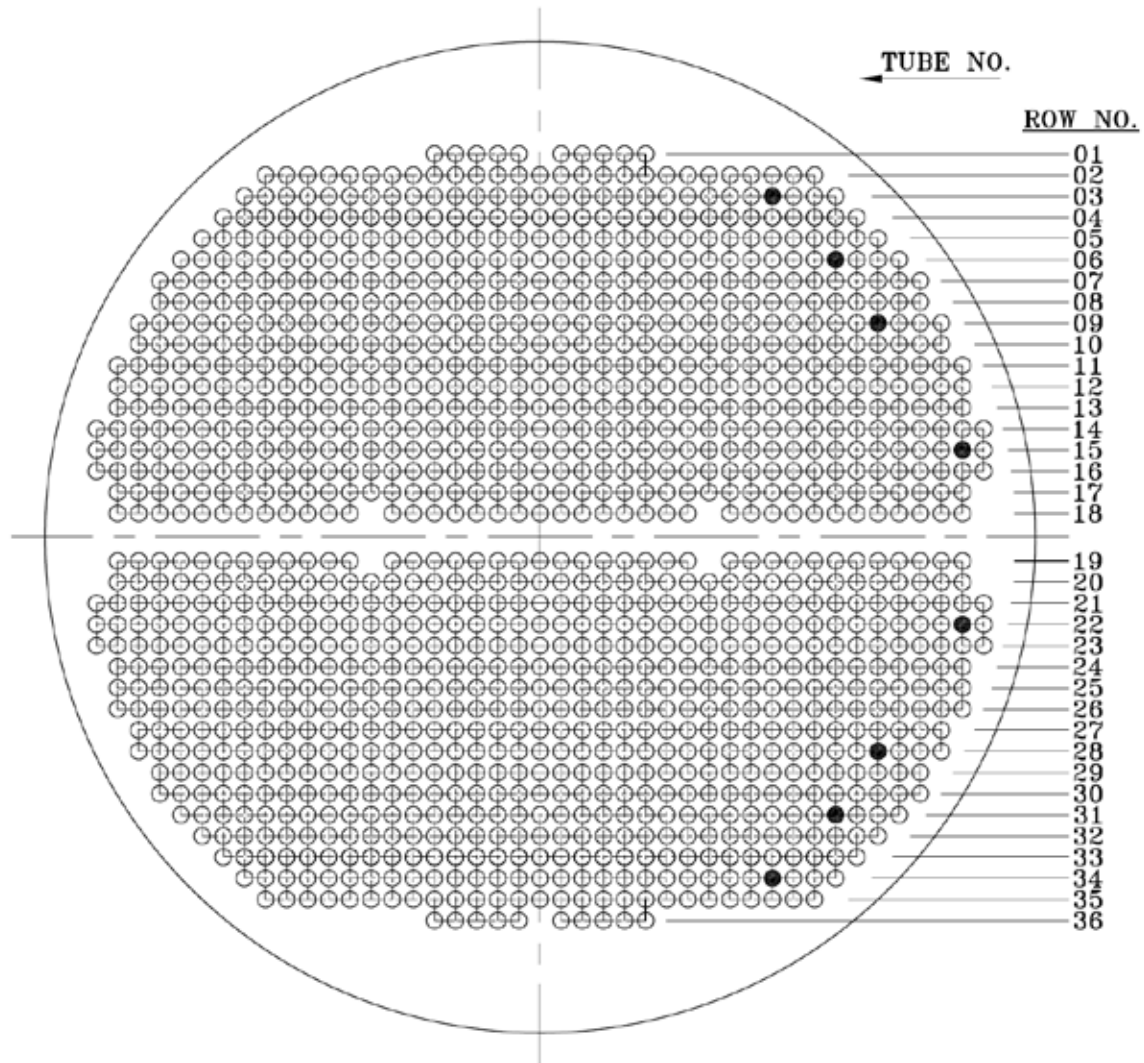
TUBE SHEET LAY OUT OF 115-C, METHANATOR EFFLUENT COOLER

TUBE PLUGGING DETAIL S/D-2016			
ROW NO.	TUBE NO.	DESCRIPTION	REMARKS
15	2	LEAK IN AIR TEST @ 3.5 Kg/cm ²	S/D-2016
3	4		
6	4	LEAK IN HELIUM TEST	
9	4

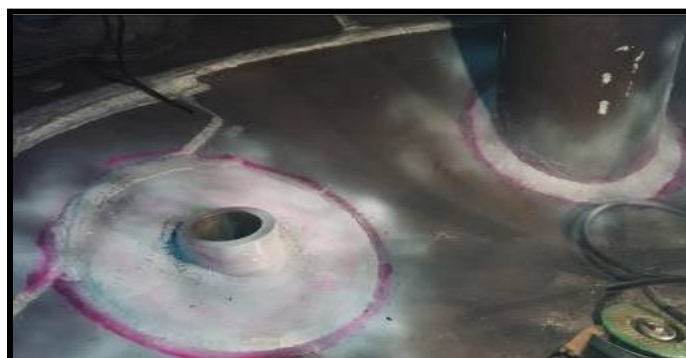
Compartment No.12 (Bottom Compartment.)

- Down comer nozzle with dish end liner weld joint edges were observed exposed. The same was observed during last inspection also.
- Dark brown coloration on dish end observed.
- Concave depression of approx. 2-3 mm depth and approx. 5mm depth were observed at approx. 200mm above the C seam in 4"dia in east and west direction of the shell respectively. The same was observed during last inspection also.
- All tray holding clits of old Trays were found blackish in color and having corrosion attack including its welding.

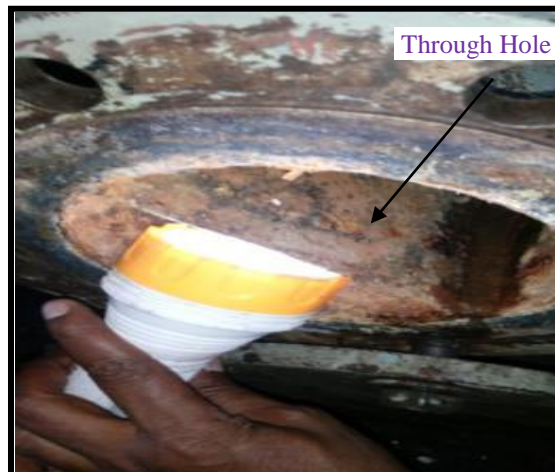
H-1131-A (LO COOLER OF P-1102-A)

- Condition of tube to tube sheet weld was found satisfactory.
- Thick brownish scales & pitting were observed on the channel area & baffle plate.
 - Through Hole was observed on Baffle plate.

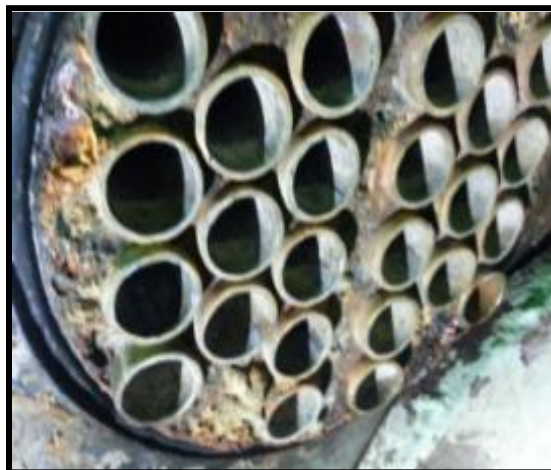
H-1131-B (LO COOLER OF P-1102-B)

- Thin creamy scales were observed inside the tubes.
- Thick brownish scales were observed on the tube sheet, channel area & baffle plate.
- Deep cavities and scales were observed on the tube-sheet area (West Side).

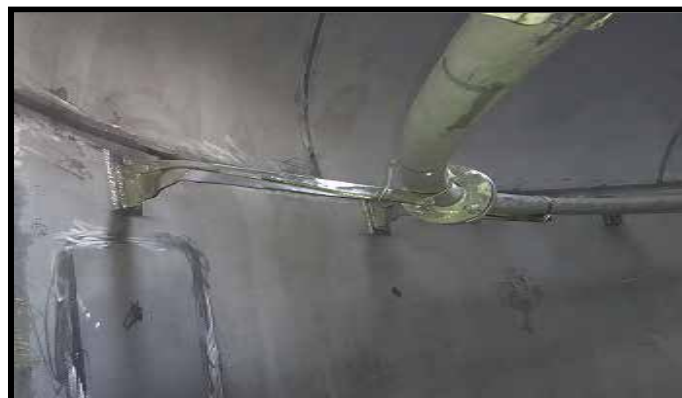
H-1424 (2ND STAGE EVAPORATOR):

- Shiny silver surface observed inside the vessel.
- Impingement cone corner was found bent in downward directions at few locations this was also observed in earlier inspection.
- Tube to tube sheet welding found satisfactory and tubes found clear from I.D.
- C sparger and its supports found bent in downward direction at many locations.

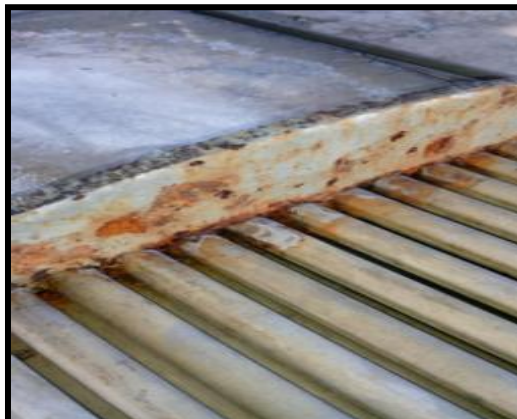
H-1811, 1st INTER STAGE COOLER OF HITACHI COMPRESSOR

- Condition of tubes and tube sheet was found satisfactory.
- Thin scattered scaling observed on tubes.
- Scaling and rust observed on baffle plates.
- Near the baffle location scales/rust observed on OD of the tubes.

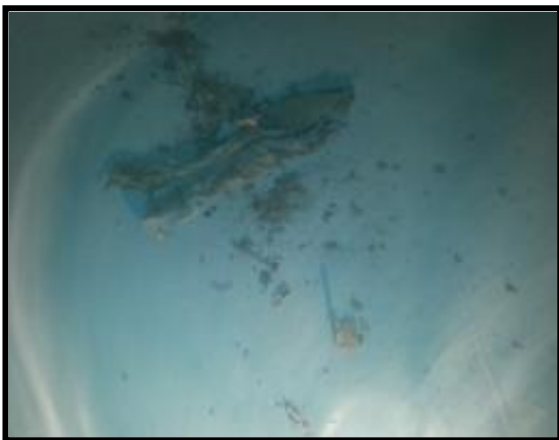
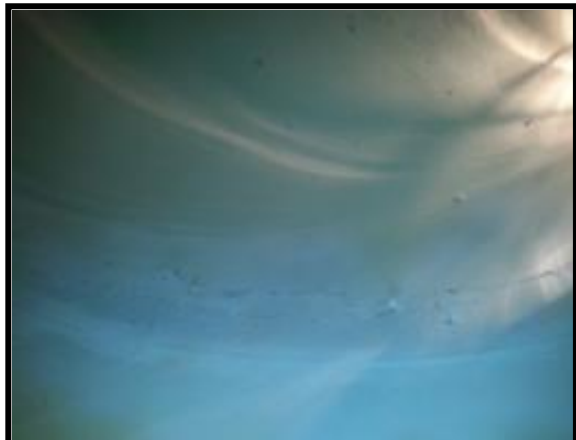
NEW AIR RECEIVER

- Metal pieces, Pieces of welding rods and Debris found lying at the bottom which were removed and cleaned.

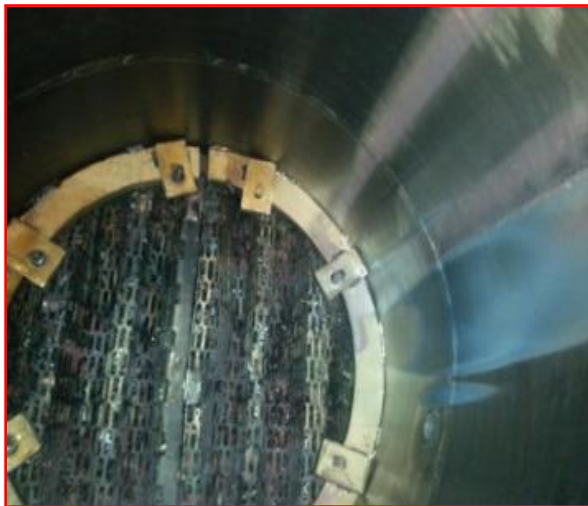
- Shell observed silver shiny in colour.
- One no of rasching ring holding tray bolt found shifted from its position and nut of few bolts were found missing.

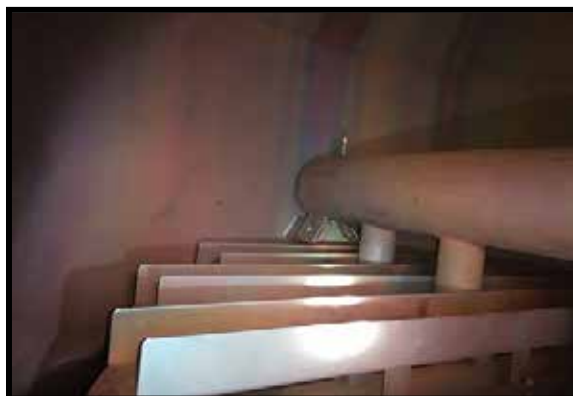
V-1206 (ATMOSPHERIC VENT SCRUBBER):

- Demister pads were found intact and satisfactory in position.
- Shell observed brownish red in color from inside.
- All bolts of liquid inlet flange found satisfactory, However header clamping bolts found loose / nut missing at west end.

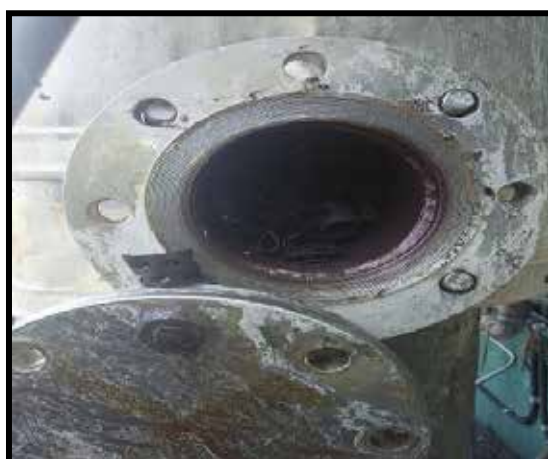
Bottom Hand hole

- Nozzle found filled with Paul rings.

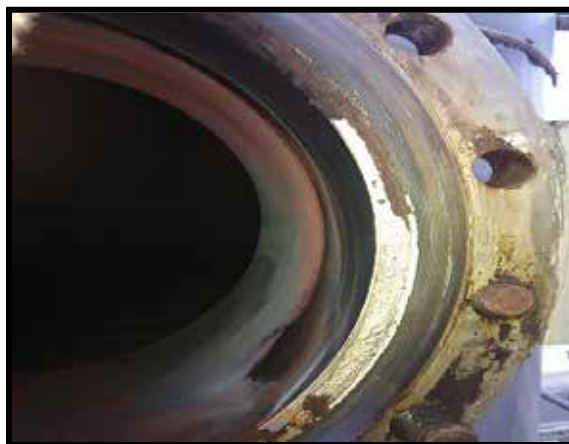
- Brownish coloration was observed inside the vessel.
- All fasteners were found intact
- Weld joint condition was found satisfactory.
- Manhole gasket seating face observed eroded / corroded at several locations.

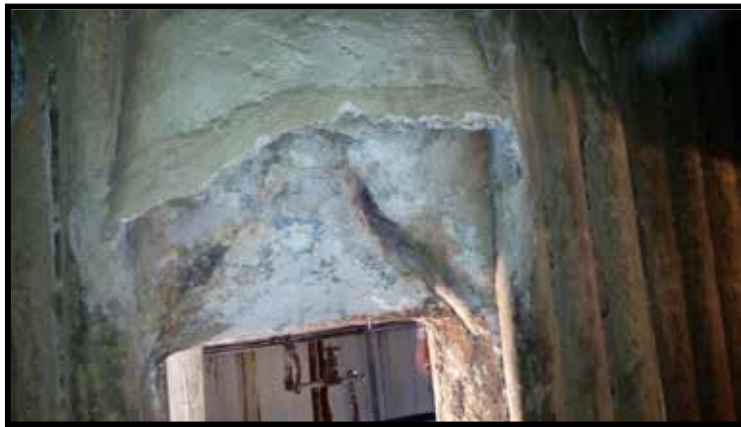
From South Wall Access Door

- Refractory found damaged just above the access door.

- Minor rust and scaling was observed on South wall, Front panel, Rear panel, Cut corner tubes and baffle wall tubes.
- Floor refractory was found damaged & loosened at some locations.
- Condition of thermo-wells found satisfactory.
- Condition of refractory around the burners was found satisfactory.
- Minor scaling was observed on Primary Super heater tubes.
- Insulation fiber modules placed on top of the Secondary superheater coil was found displaced from its location.

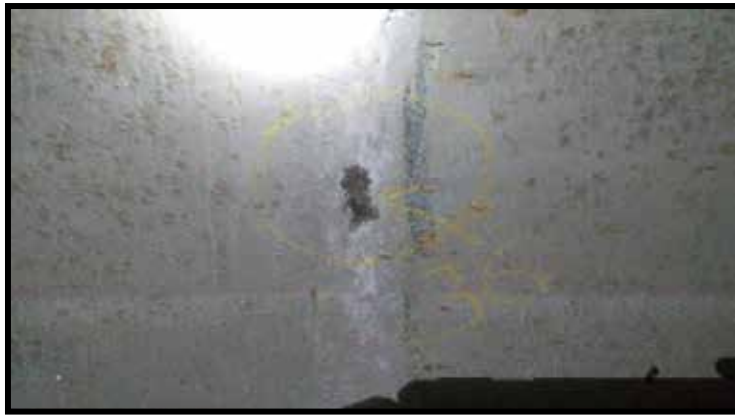
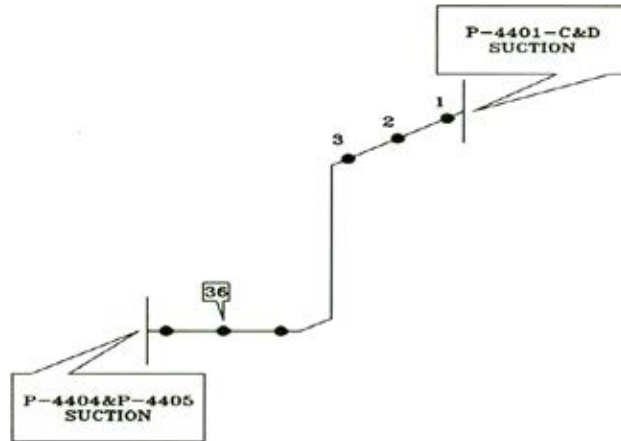
52"NB COOLING WATER INTER CONNECTION LINE OF P-4405 TO P4401C/D:

- Epoxy paint was found peeled off at many locations however primer was found intact on these locations.
- Blisters on Epoxy paint also observed at many locations.
- All circumferential and long seam welds found satisfactory.
- Crack was found on the previously applied putty at the location no.36 (counting from P-4401 C/D Suction) which was repaired.

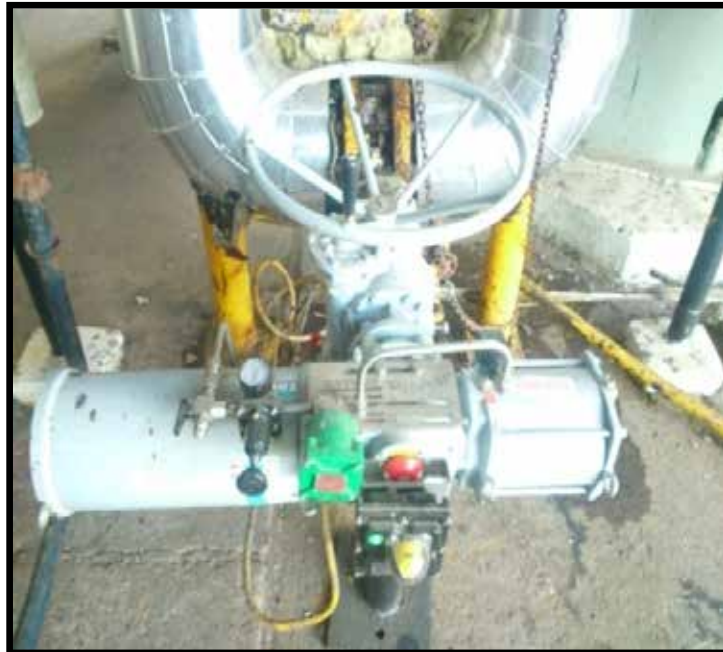
VS-203: Old control valve was replaced with new one. SOV power cable wiring connection & air supply tubing work were carried out. Finally control valve action was checked and found ok.

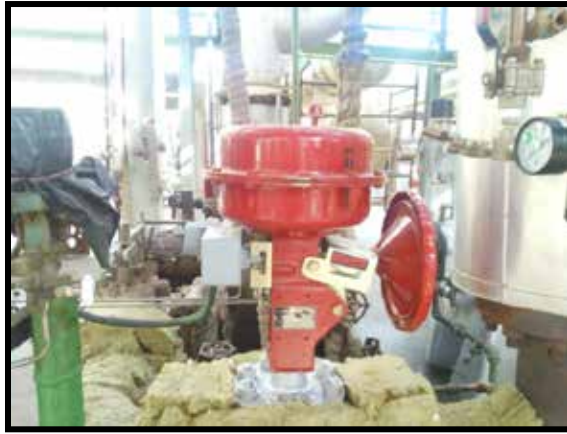
V-7: Old control valve was replaced with new control valve. Signal cable, SOV Power cable connection & air supply tubing work were carried out. Finally control valve stroke was checked and found ok.

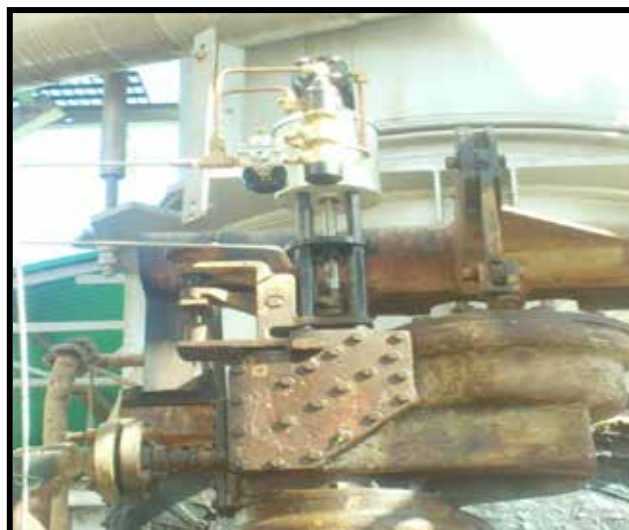
HIC-101J: Old pneumatic governor actuator was replaced with ITT Conoflow make new one. Calibration of I/P Converter was carried out. New pressure gauge was provided for I/P converter & air supply regulator. Finally governor actuator stroke was checked & found ok.

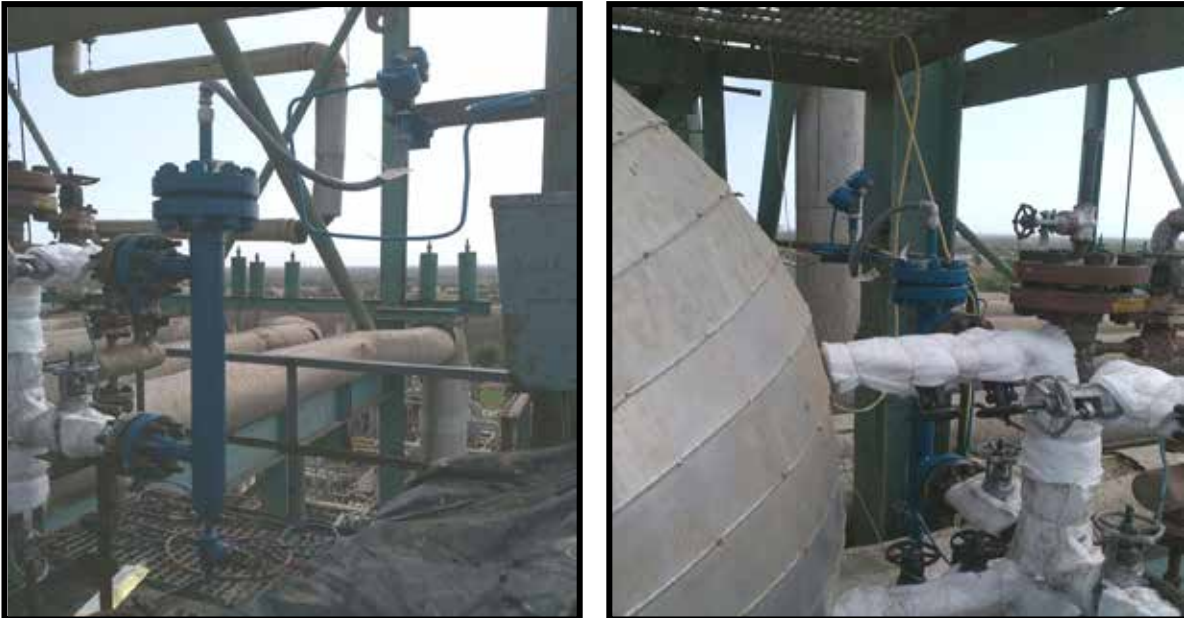
Steam Drum Low Level trip 2oo3 Logic: As per EWR A-304 two Radar type level measurement transmitters were installed at steam drum for providing 2oo3 logic for steam drum low level trip system. Stand pipe was made by mechanical maintenance. Radars were installed on stand pipe; cable laying, dressing, ferruling & termination work were done at junction box & PLC cabinet end. One trip amplifier was installed in PLC cabinet for Digital tag LSSL1B & programming of trip amplifier was done. Other tag LSSL1A was taken as analog tag & directly terminated at analog isolator in PLC cabinet. Logic was made by YIL Person in I-47 Block. Finally logic was tested & found ok.

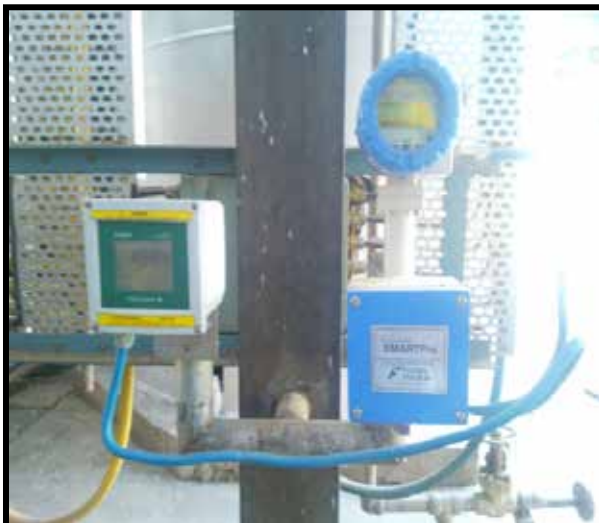
Conductivity & pH Meter in Steam Drum CBD Line: As per EWR A-322 conductivity & pH meters were installed in steam drum CBD line. Mounting support was welded at relevant position & both conductivity & pH meters were installed on it. Single pair cable had been laid between junction box & meter. Cable dressing, ferruling & termination work was done at both junction box & cabinet end. Tubing work was done from sample point to both meters. Tags AR-101FC & AR-101FP were made in DCS & defined in relevant graphic page. Finally both meters were taken in line & found ok.

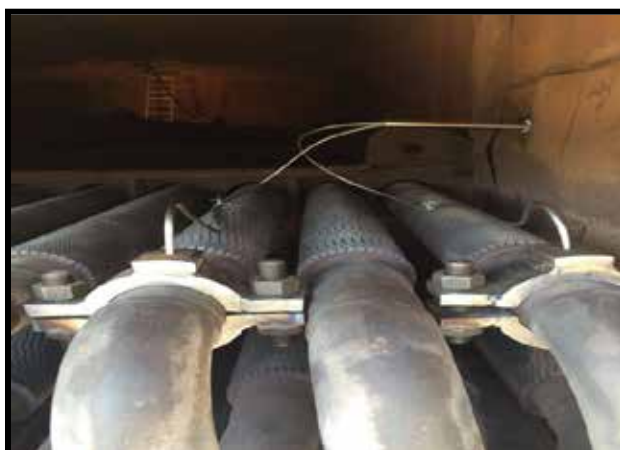
Metal Skin Temperature Indication of Super Heater Coil of Reformer: As per EWR A-321 metal skin temperature indication of super heater coil of reformer was provided. K type duplex thermocouple was installed inside the reformer tube. Related thermocouple single pair cable was laid between junction box & thermocouple head, cable dressing, ferruling & termination work was done between temperature cabinet C-101F & junction box. Tag TI-103-E was defined in IOM & related graphic page of DCS. Finally tag was taken in line & found ok.

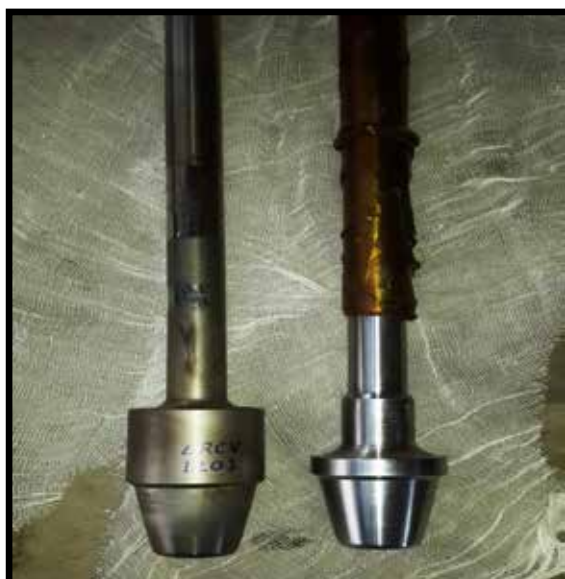
**LRCV-1201 Plugs Old and New
Modified to reduce side thrust**

LRCV-1201: Valve was opened from the bonnet then cleaned and checked its body and trim part, seat was found ok but plug was found with erosion over stem length. Replaced its plug of MOC: HVD1 with modified plug of MOC: Safurex. Also modified its bonnet for continuous flushing in stuffing box of valve. Boxed up the valve with new bottom guide bush, gland packing set and seal rings set for bonnet. Installed the actuator on valve body with Valve Positioner and Positioner transmitter. Replaced the volume booster with new one then carried out control valve stroke checking and calibration of position transmitter. Also connected tubing related to continuous flushing arrangement provided in valve.

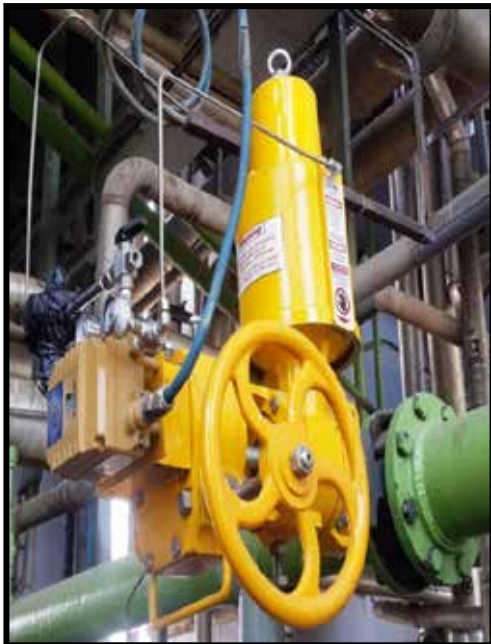
Control valve TICV-1226

TICV-1226: Old Existing control valve TICV-1226 was replaced with the new valve.

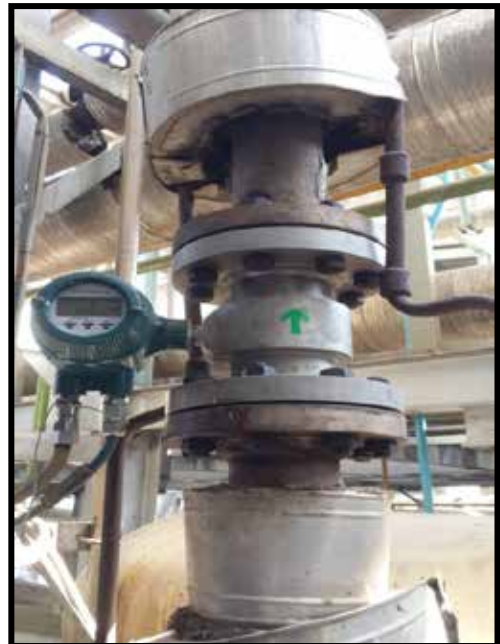
Magnetic flow meter FRCT-1421

Existing magnetic flow-meter FRCT-1421 was replaced with the new magnetic flow-meter with HART Compatibility.

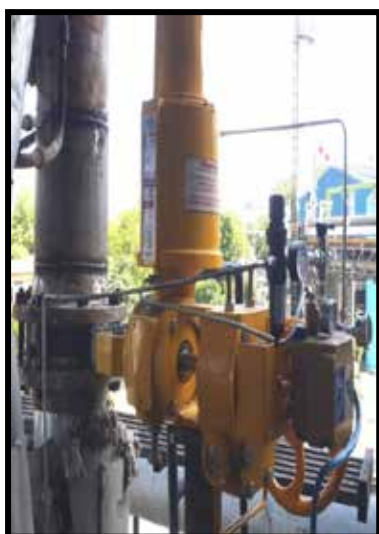
Control valve HICV-1406

EWR-U275: To provide control valve (HICV-1406) in place of existing manual isolation valve to bypass Pre-evaporator (H/V-1418):

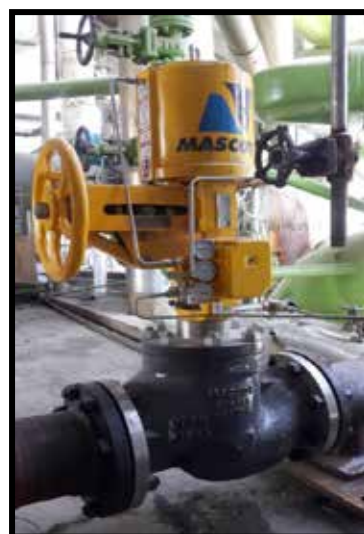
Control valve HICV-1204

New control valve HICV-1204 of higher capacity was installed after line modifications on cooling water bypass line of CCS-II cooler (H-1207) and its operation and stroke was checked.

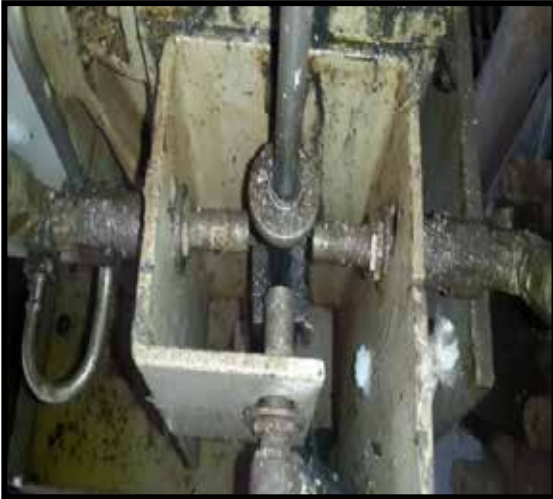
Proximity switches installed with Square shaped Target block

- It is to overcome damage of 2 out 3 logic three proximity sensor on each above mentioned valve. The square shaped target block having different dimension for side face and for diagonal and rotary movement of it may damage the proximity sensors mounted in close proximity, where as there is no any chance of damage of proximity sensor mounted with round shaped target block having only single dimension and it is the radius of block. The installations with square and round shaped blocks are shown below:

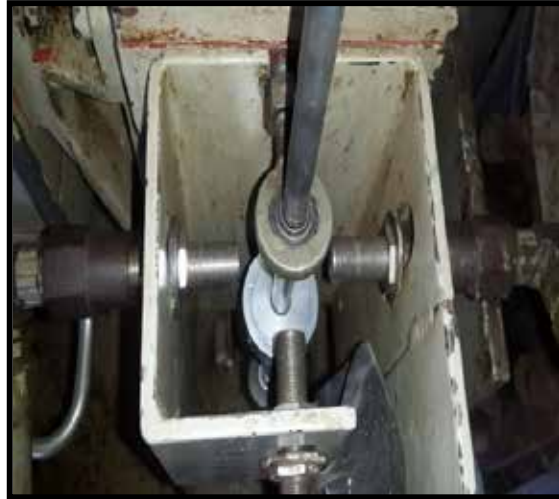
Proximity switches installed with Round shaped Target block

- This square shaped to round shaped target block modification were done for following tags of HP, LP and Admission steam Proximity switches.
- HP Steam control valve Hi position: ZSH-1849, ZSH-1850, ZSH-1851
- LP Steam control valve Hi position: ZSH-1854, ZSH-1855, ZSH-1856
- Admission Steam control valve Hi position: ZSH-1857, ZSH-1858, ZSH-1859

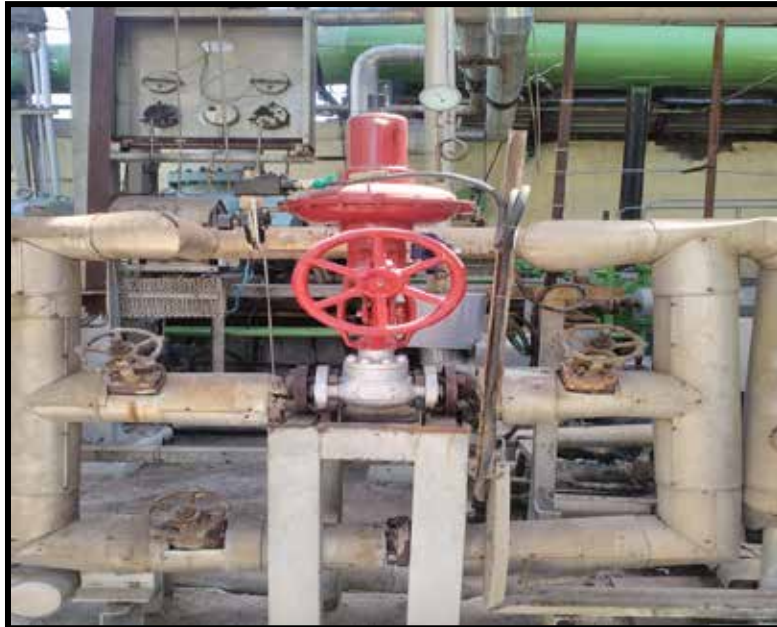
FCV-1: Cooling Tower (40-ata steam to Q-4412 Turbine) old control valve replaced with new Control valve along with related accessories i.e. SOV, limit switches etc. Air supply tubing was also replaced. Control valve stroke was checked and found ok.

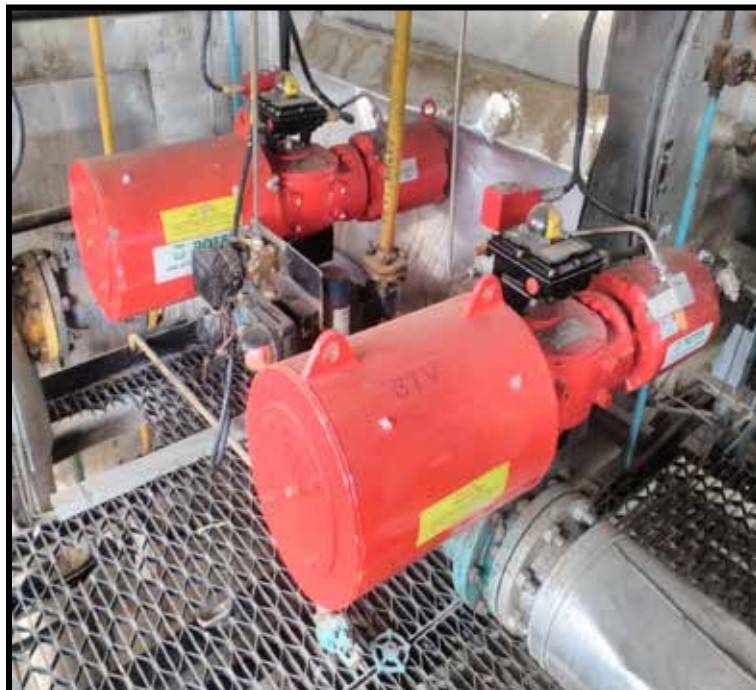
BTV-2-4A & BTV-2-4B: Actuators of both the BTV valves were replaced with new Scotch type actuator. Reconnected limit switch & SOV cables with new actuator. Checked operation of both the valves from control room.

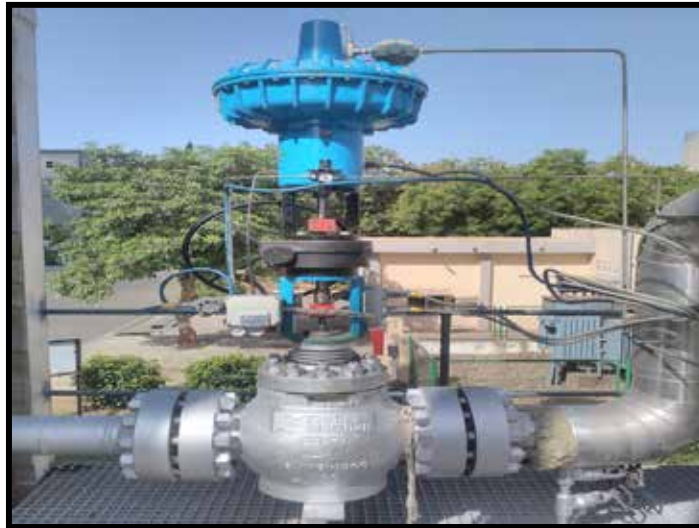
PICV-6: New 60-ata steam vent valve installed by GE was taken in line. Power & signal cables were connected to SOV, Positioner and limit switches. SS tubing for air supply to Positioner & volume booster was done. Valve's operational logic related wiring inside Marshalling cabinet was done. Control valve stroke was checked and found ok. New Graphics page was prepared in DCS for operation of valve.

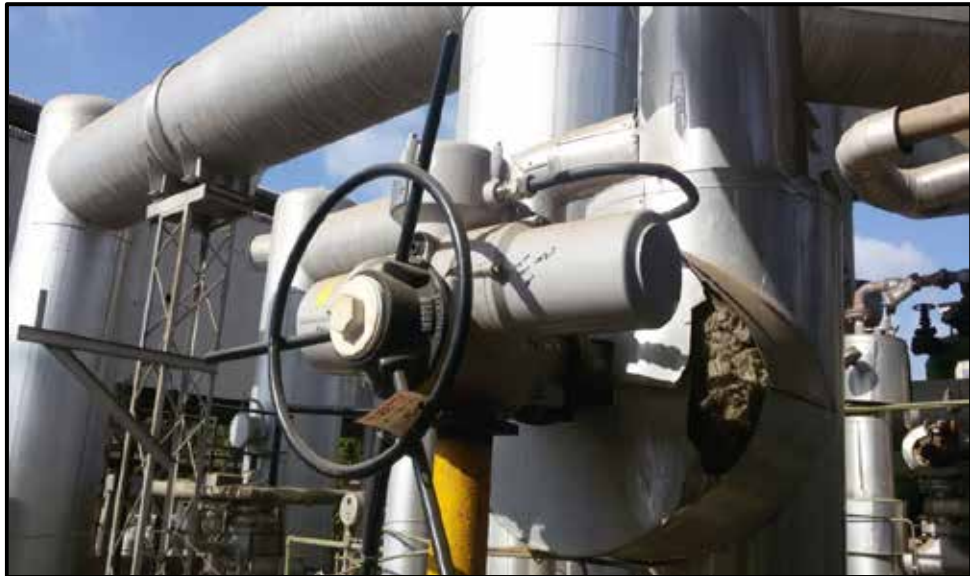
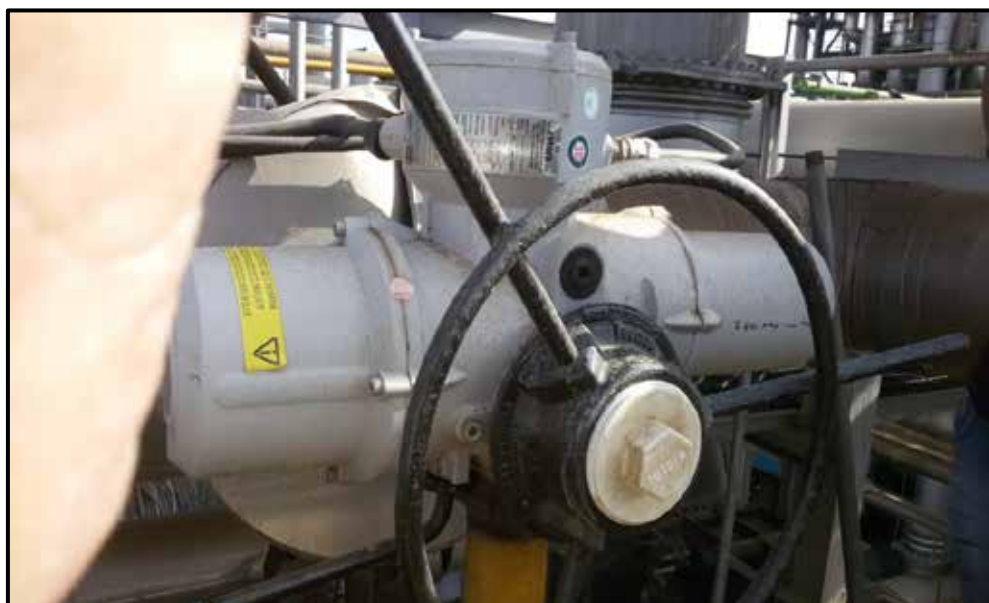
The existing manual operated valves are replaced with Rotork make IQ2 series latest motor operated actuators in 101J & 105J train in ammonia plant . The MOVs are installed & commissioned successfully during ATA-15. The same is also tested for operation & indications from Local as well as DCS as per process requirement.
