MTC / REPORT / 01
REPORT NO. 36 / 2016

PLANT TURNAROUND REPORT

(MARCH – APRIL – 2016)

INDIAN FARMERS FERTILISER CO – OPERATIVE LIMITED

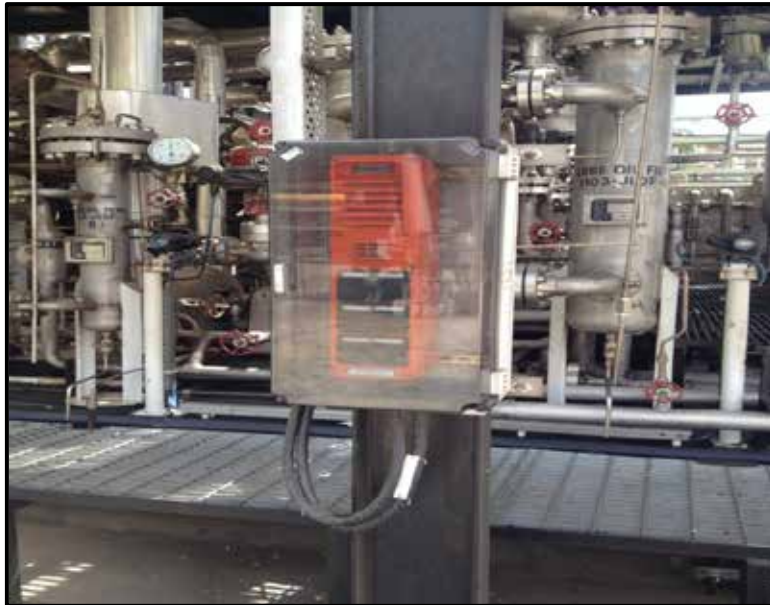
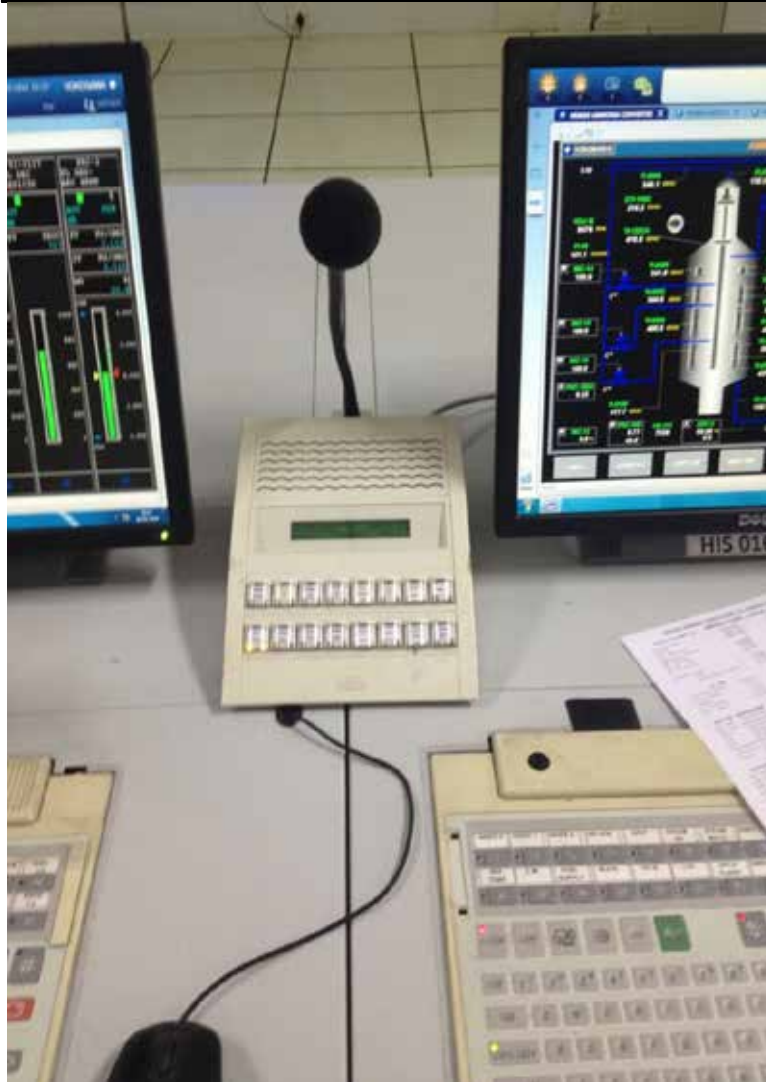
Installation, testing & commissioning of new PA system at various locations

The old , non-operative Philips make public address system is replaced with the new updated latest Neumann make public address system at various locations & control room.

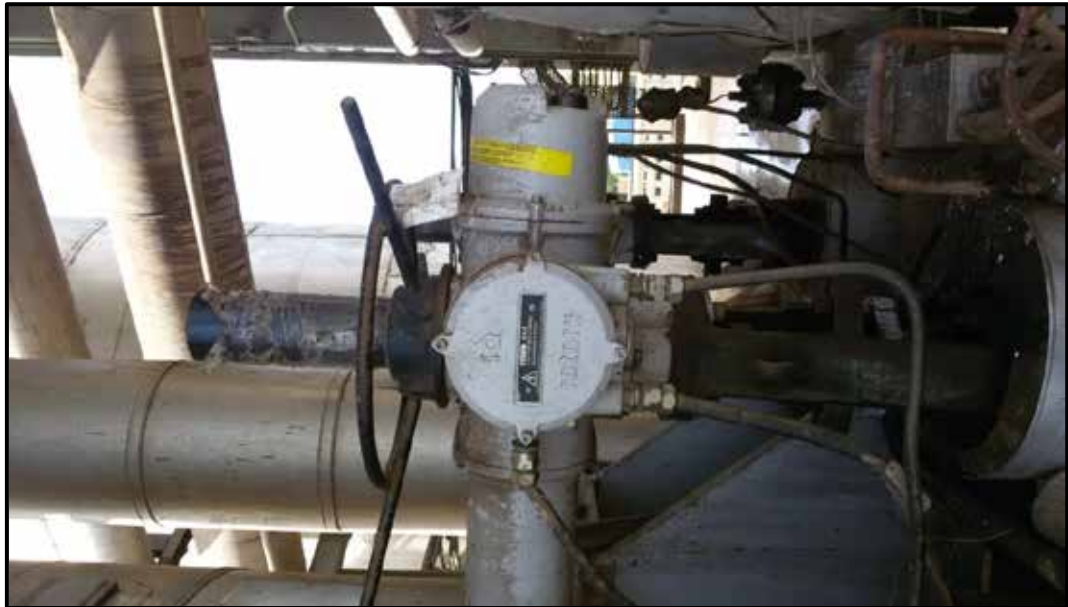
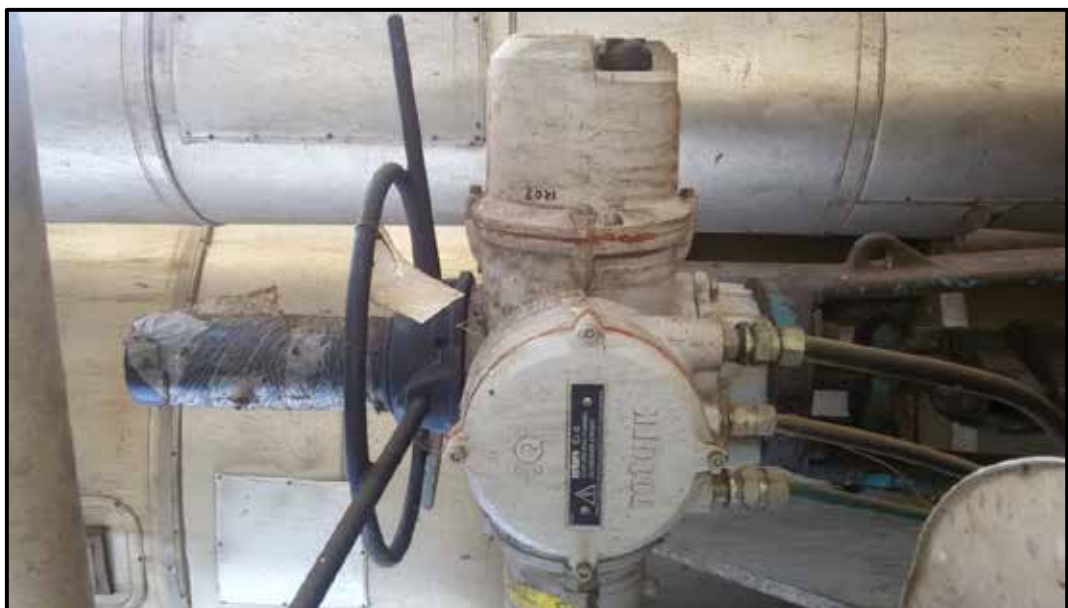
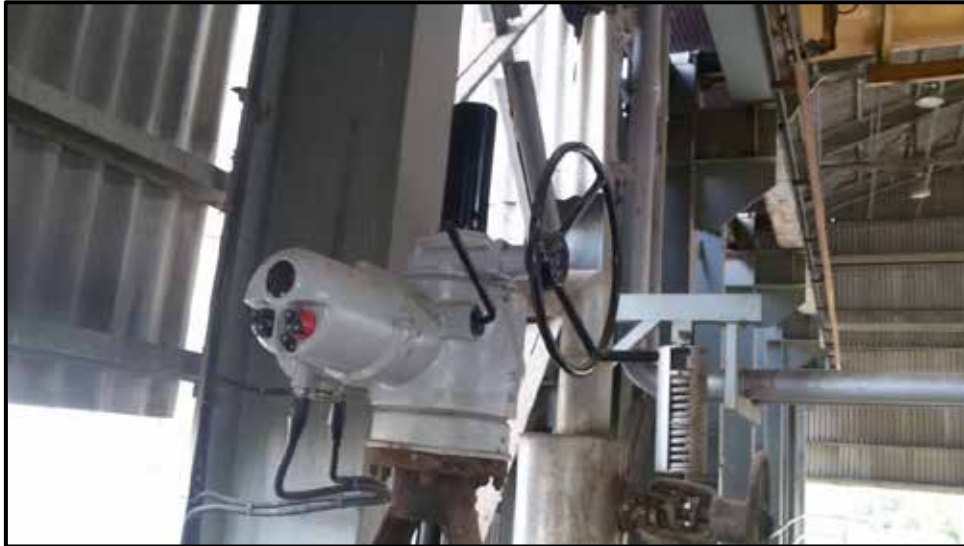
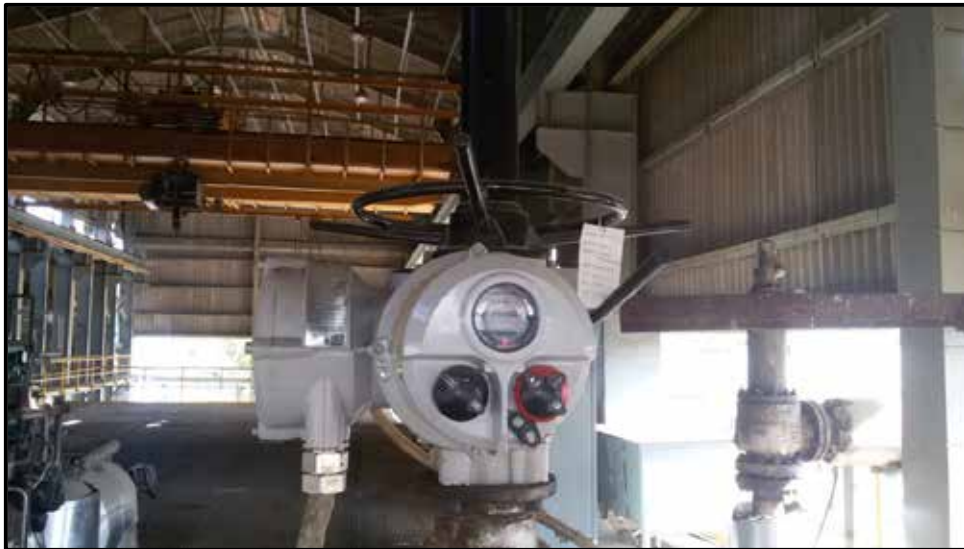
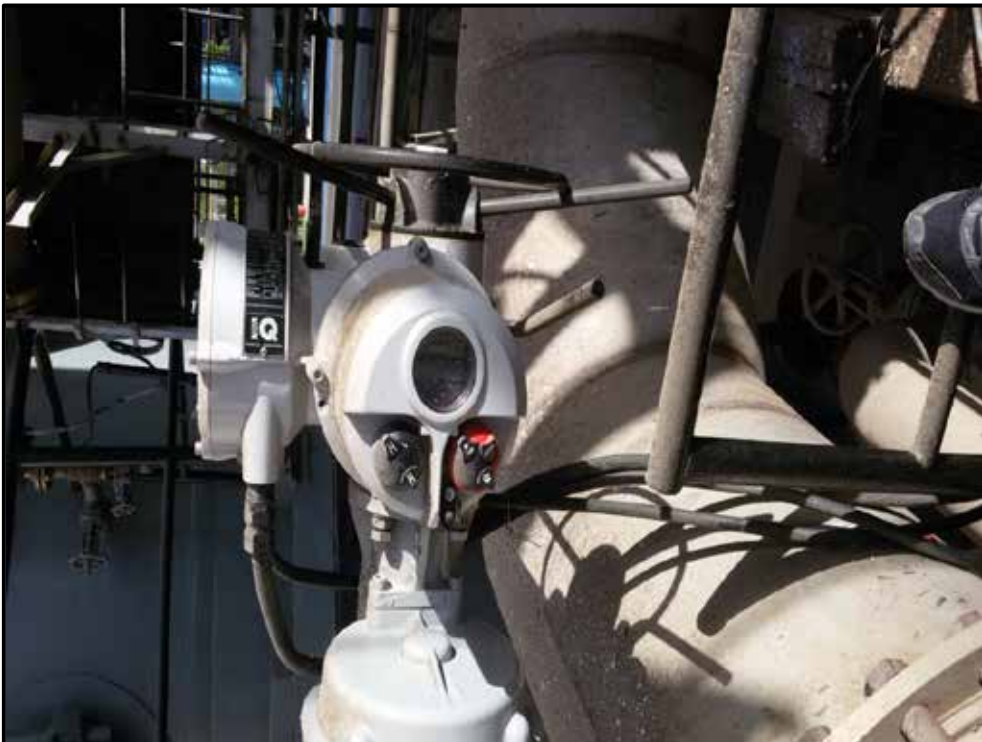
The existing manual operated valves are replaced with Rotork make IQ2 series latest motor operated actuators in MOV1811&MOV1110 train in Urea plant. The MOVs are installed & commissioned successfully during ATA-15. The same is also tested for operation & indications from Local as well as DCS as per process requirement.

Similarly MOV 1202, MOV1203 & MOV1842 are replaced with Rotork make IQ2 series latest motor operated actuators successfully. The same is also tested for operation & indications from Local as well as DCS as per process requirement.

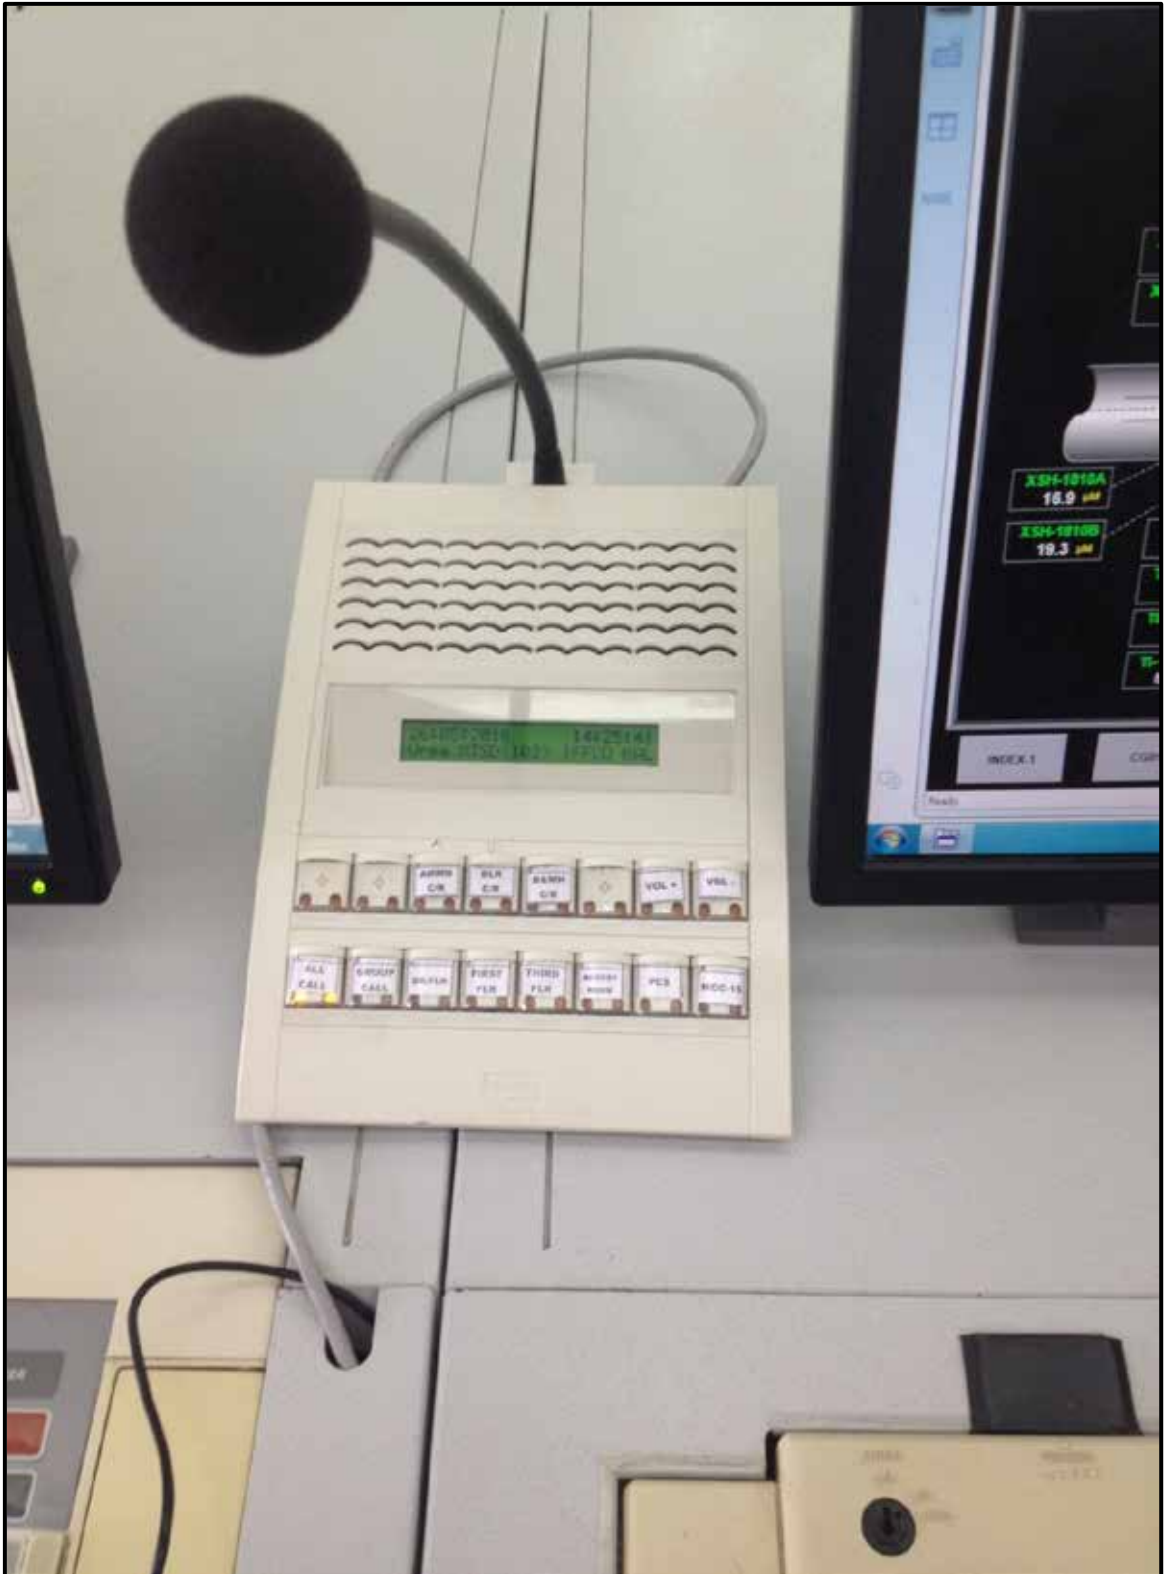
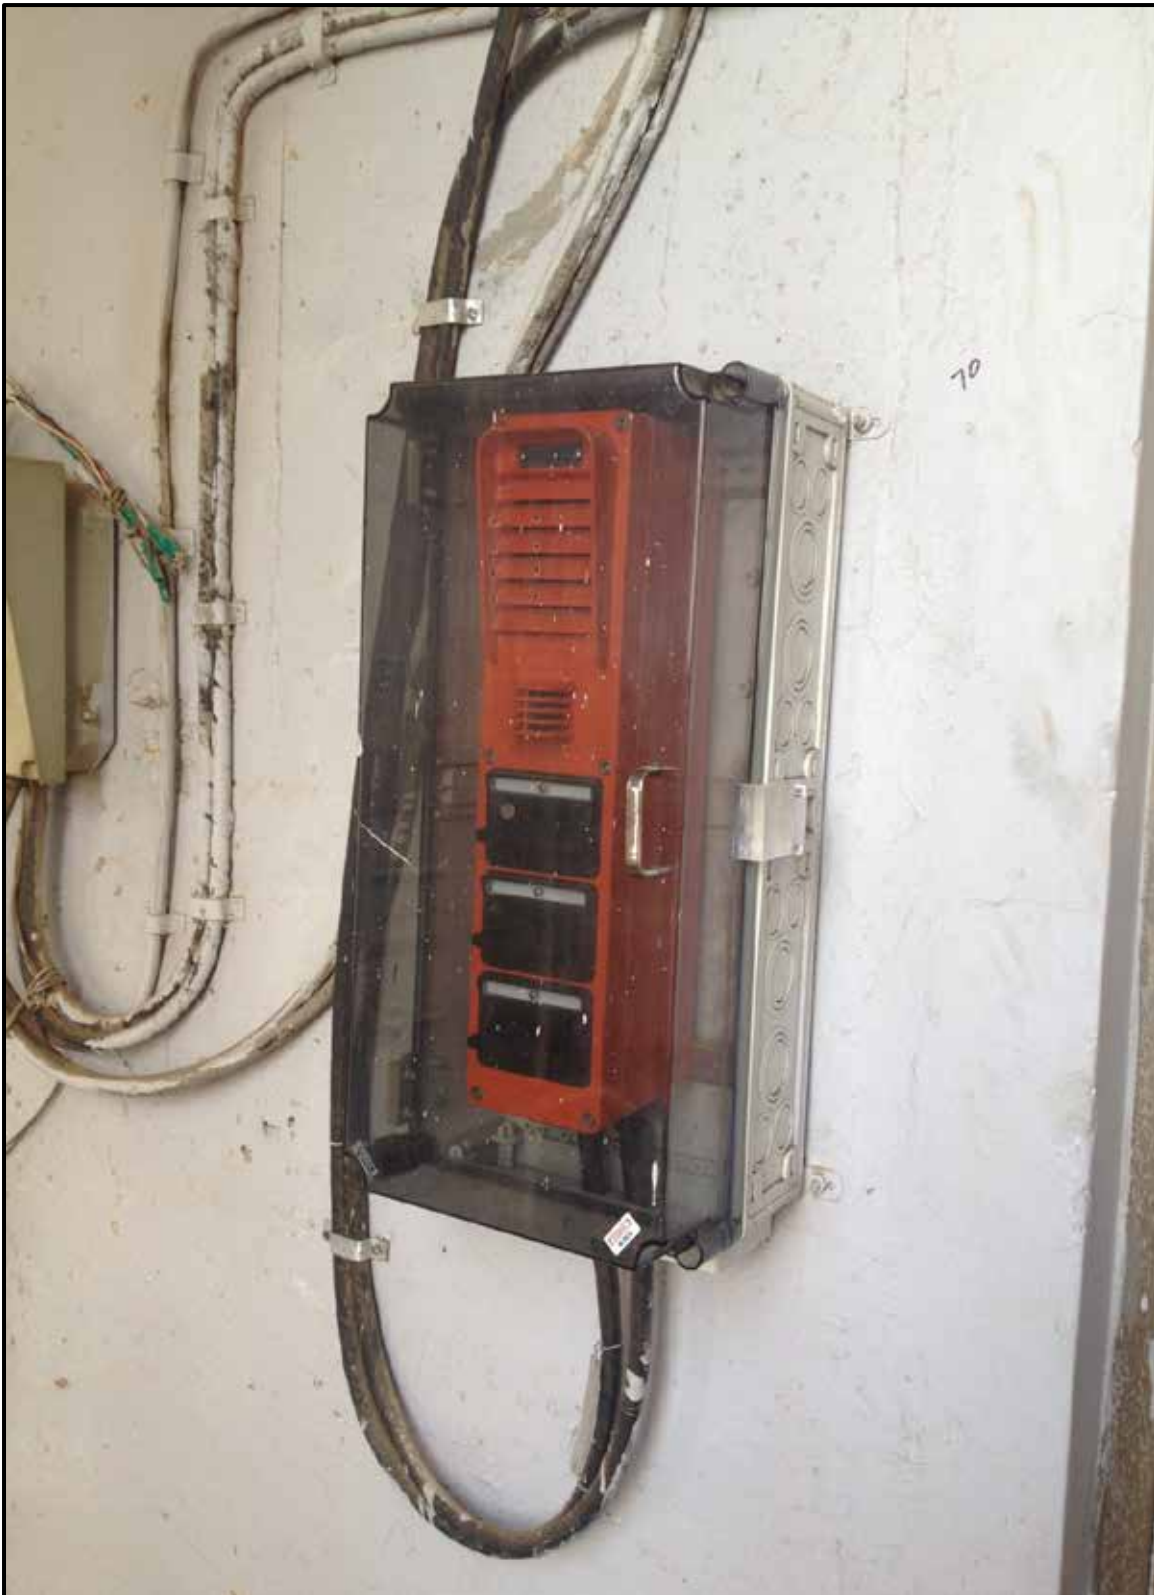
· **Installation, testing & commissioning of new PA system at various locations.**

The old, non-operative Philips make public address system is replaced with the new updated latest Neumann make public address system at various locations & control room for better communication.

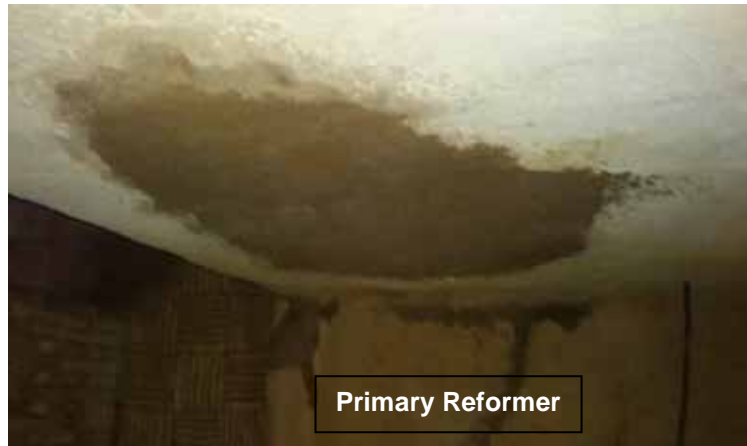
Primary Reformer

The refractory repairing in primary reformer & auxillary boiler was carried out. The 15 no. of hollow blocks in primary reformer were replaced. The casting of auxillary boiler side panels was carried out by civil section using the refractory material "Insulyte-11".

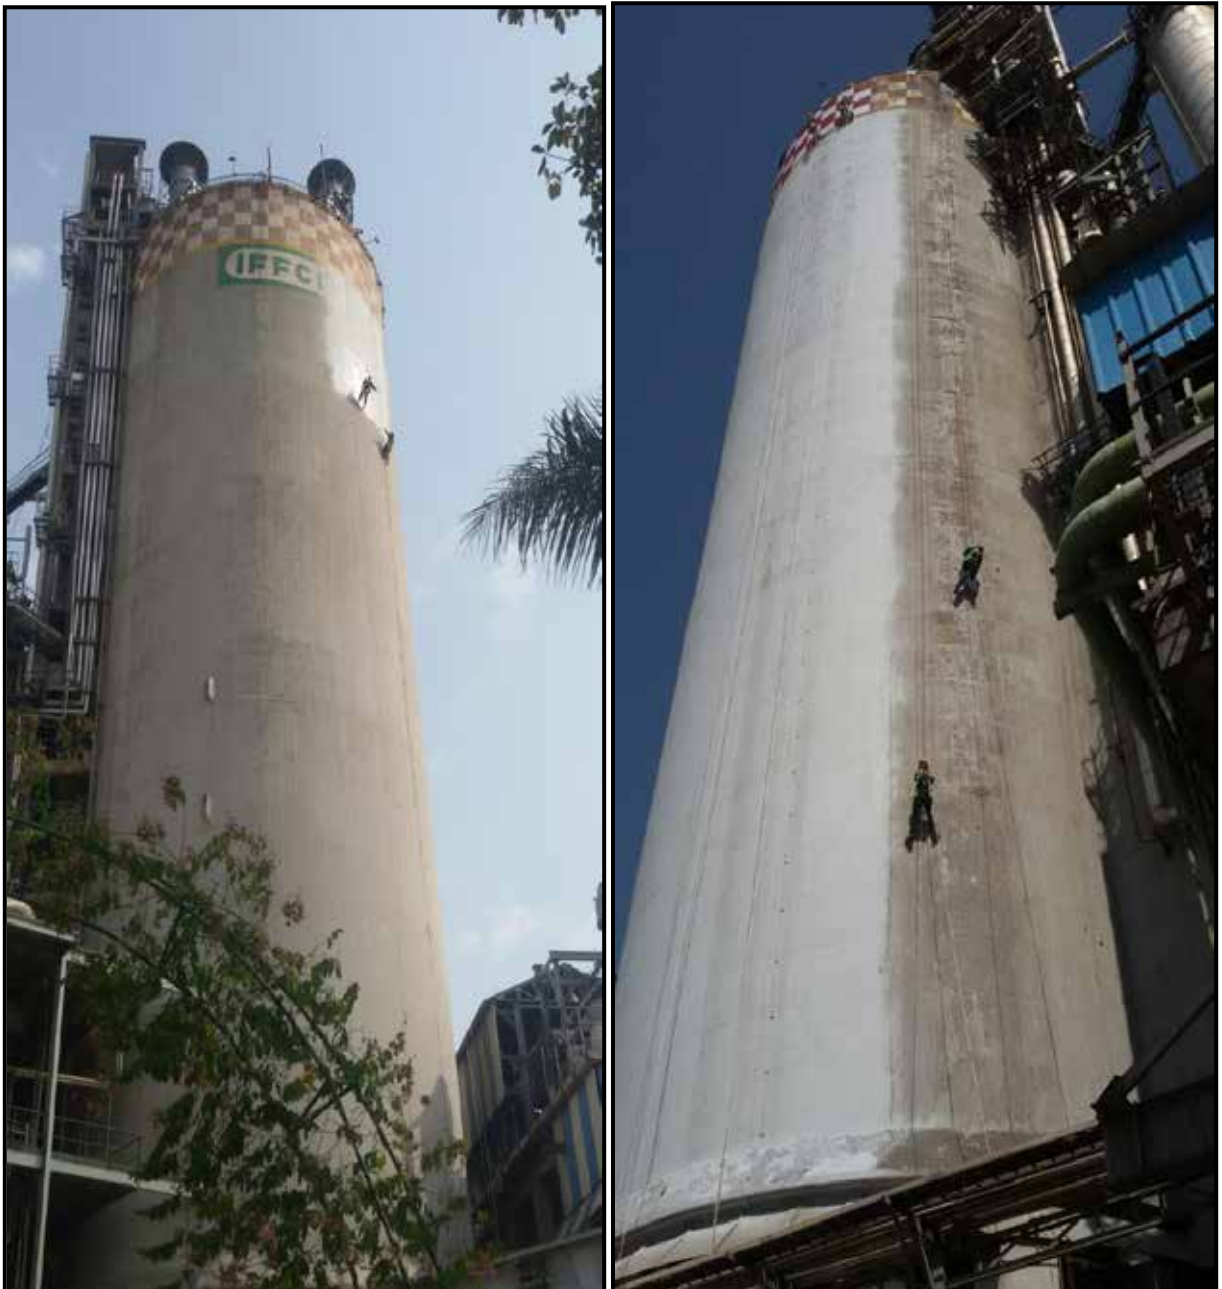
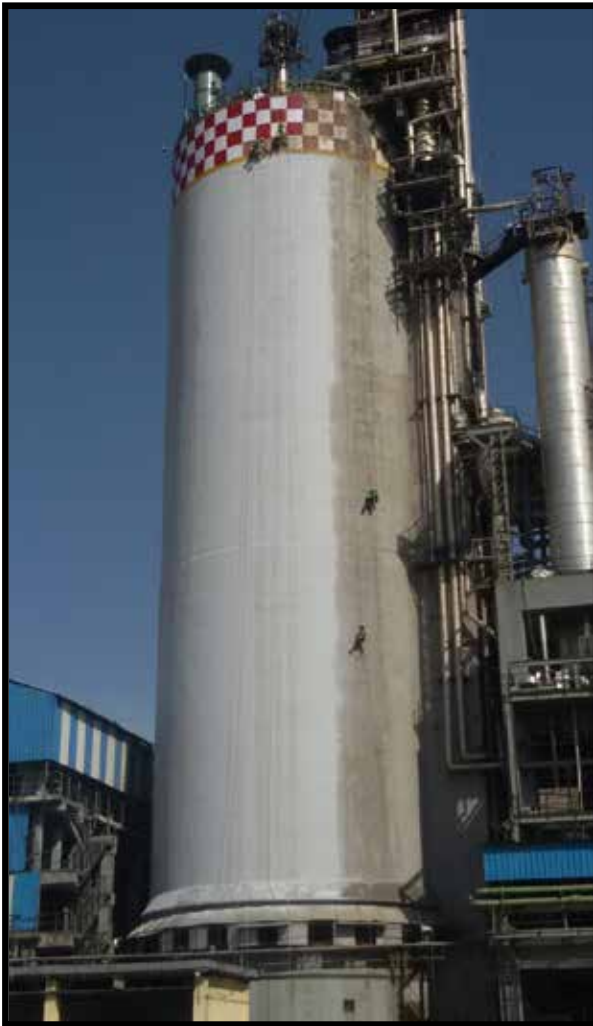
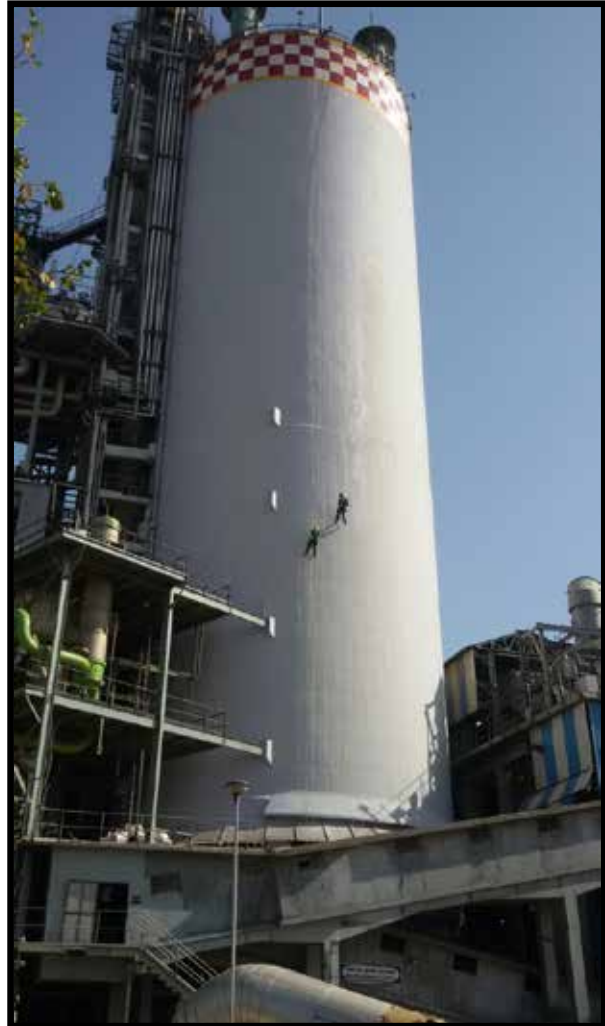
Anti corrosive treatment of prill tower:

Anti corrosive treatment of prill tower was done by M/S Deewan Enterprises, Bareilly. The total height of the prill tower is 72 meters and diameter of the prill tower is 18 meter.

Top 8 meter chequered block & bottom 8 meter was painted using Epoxy painting and remaining portion was painted using apex paint. The lift walls, columns, beams and conveyor gallery M-2117 & M-2121 were also painted using epoxy paint and apex paint.

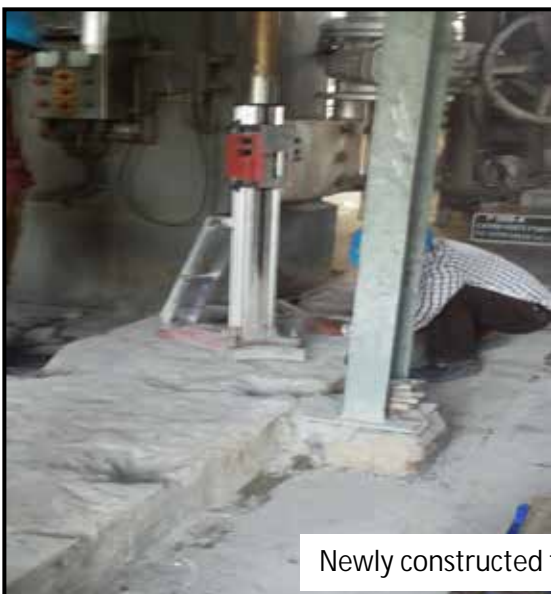
Newly constructed foundations P1202 A/B

The new pump P-1202A/B is to be installed in urea plant. The foundation of old foundation was retrofit and new pockets were made by using the Hilti core cutter. The size of the old foundation was modified using dowel bars and new steel reinforcement was also provided to accomodate new modified pump.

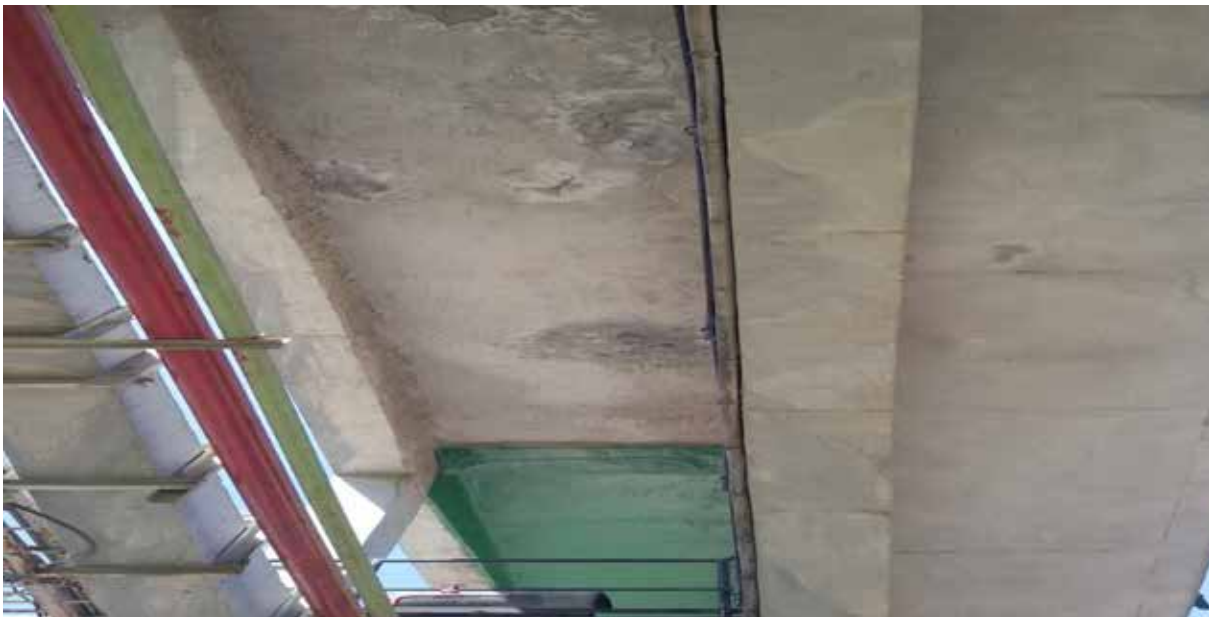
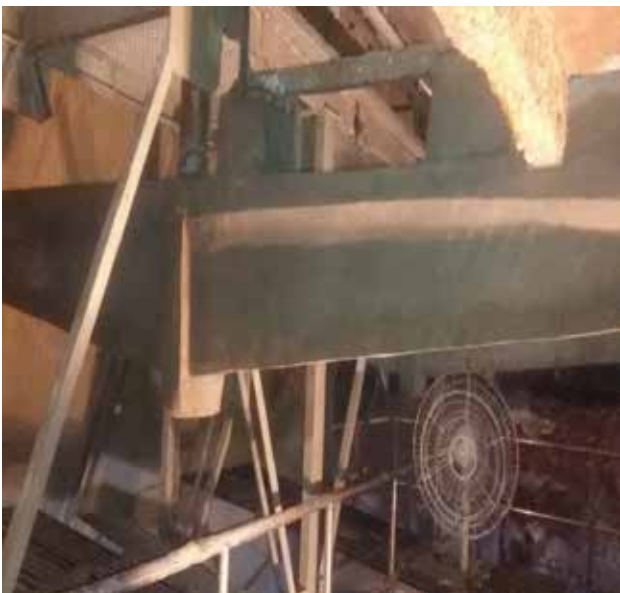
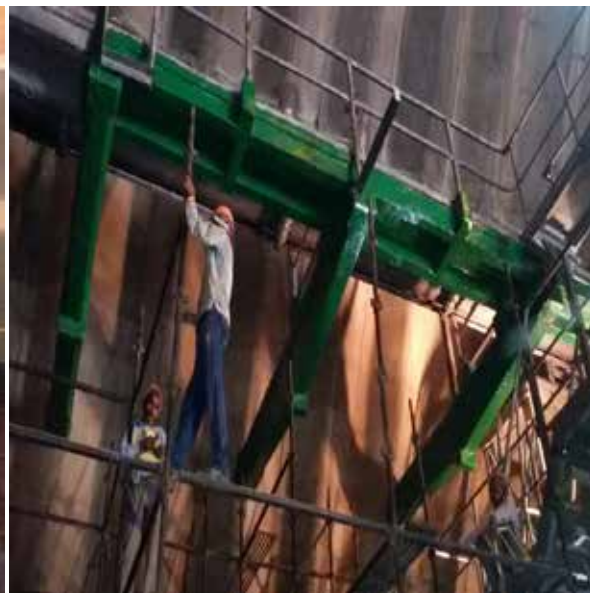
Rehabilitation of conveyor gallery M-2117 (beams, columns & soffit) area of B & MH plant by providing elastomeric lining

The condition of the concrete structure in silo & conveyor gallery area is deteriorated. To rehabilitate the concrete condition, It was decided to provide the chemical treatment offered by M/S Greensboro polychem Pvt. Ltd. Accordingly the job was carried out which included removal of existing plaster, cleaning of the surface, application of Polydee-RC (Rust convertor), application of bond coat, providing polymer modified mortar (PMM), proper curing of the PMM & application of 1 mm thick elastomeric layer. The supply of material and job execution was carried out by m/s Greensboro Polychem Pvt. Ltd.

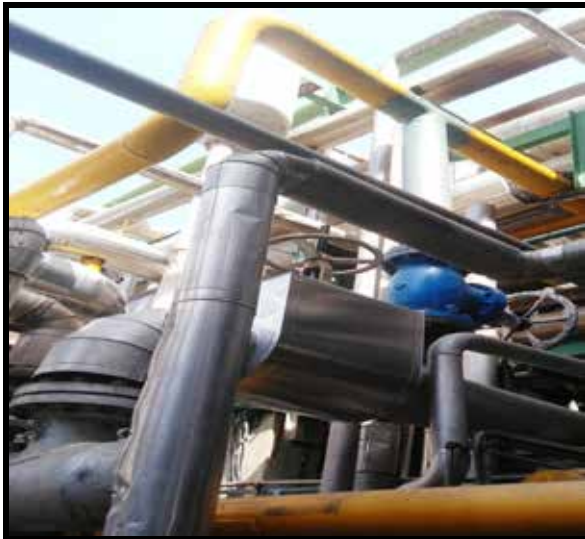
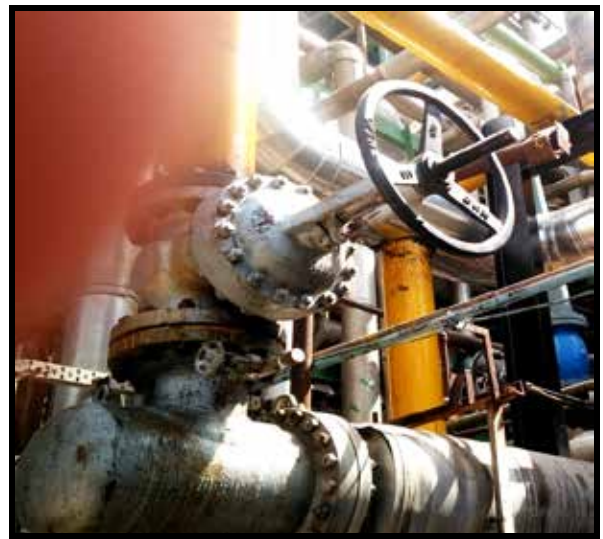
8" NB By pass of Feed pre-heater (150-C)

8" isolation valve provided on inlet / outlet nozzles of 150-C and 8" bypass line provided with 8" NB globe valve.

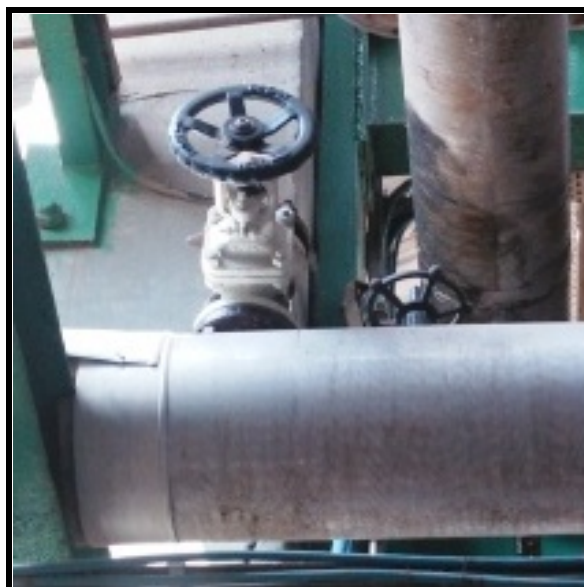
2" NB tapping for LP purge gas of Synthesis Loop.

2" tapping with isolation valve for LP purge gas to Flash Gas tower taken from Line NH-120-2"

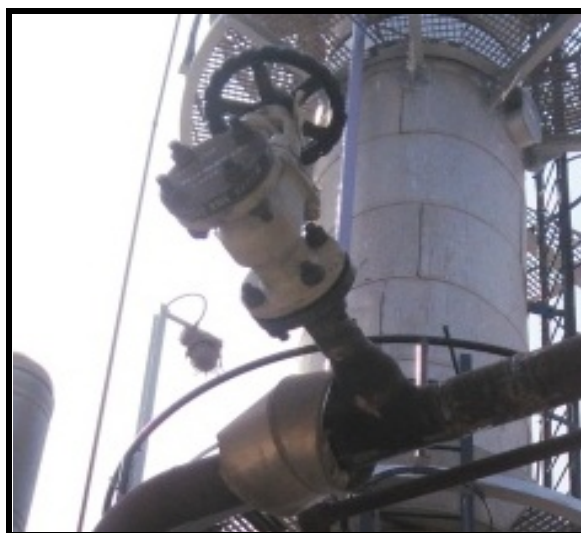
2"NB Tapping for water supply to flash gas tower from ARU

2" NB tapping with isolation valve taken from treated water supply line 3"-EL-102.01-D24 in ARU Unit.

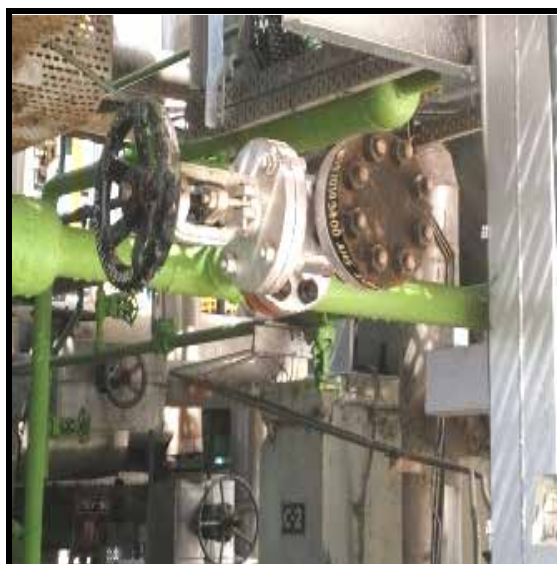
2" NB Tapping for Ammonia water from Flash gas tower to ARU Unit

2"NB tapping taken with isolation valve from ammonia water inlet line 3"-AW-113.01-D24 to feed pre-heaters (HE 1A/B/C/D)

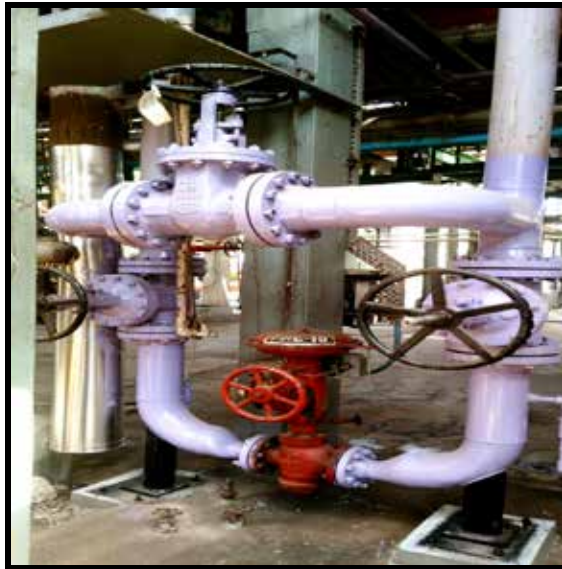
Bypass arrangement of FRCV-18 (Hot ammonia control valve) and Battery limit isolation valve. (Ref. EWR No. A325Dated 03/07/2015)

6" NB Bypass of MOC A106Gr. B has been provided for FRCV-18 with upstream & downstream isolation valve. Also, Battery limit isolation valve provided near DM water tank on the same line going to Urea plant.

This will provide operation flexibility and isolation at Ammonia battery limit. The job was carried out by M/s J&J

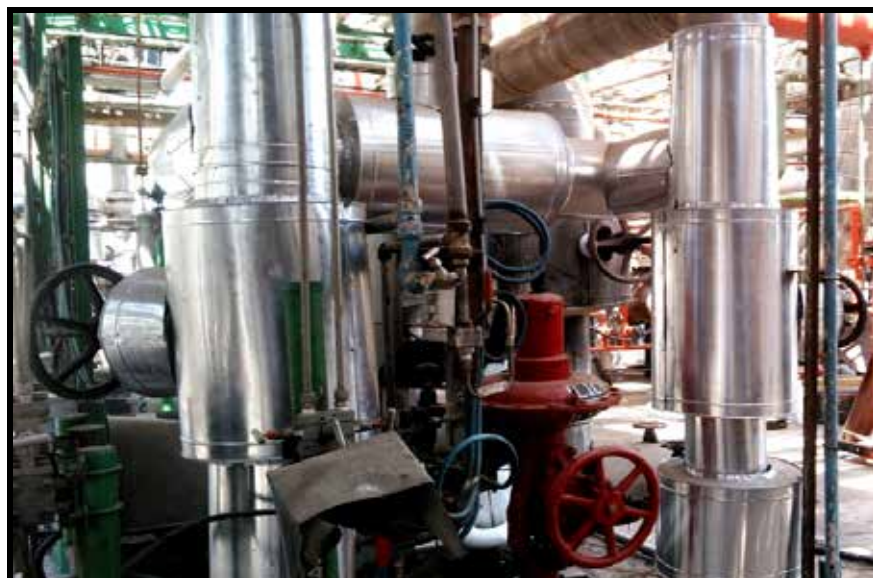
Bypass arrangement of LICV-19 (Cold Ammonia Flow control valve) and Battery limit isolation valve. (Ref. EWR No. A-326 Dated 03/07/2015)

3" NB Bypass of MOC A106Gr. B has been provided for LICV-19 with upstream & downstream isolation valves. Also, Battery limit isolation valve provided near DM water tank on the same line going to Ammonia storage tank.

This will provide operation flexibility and isolation at Ammonia battery limit. The job was carried out by M/s J&J

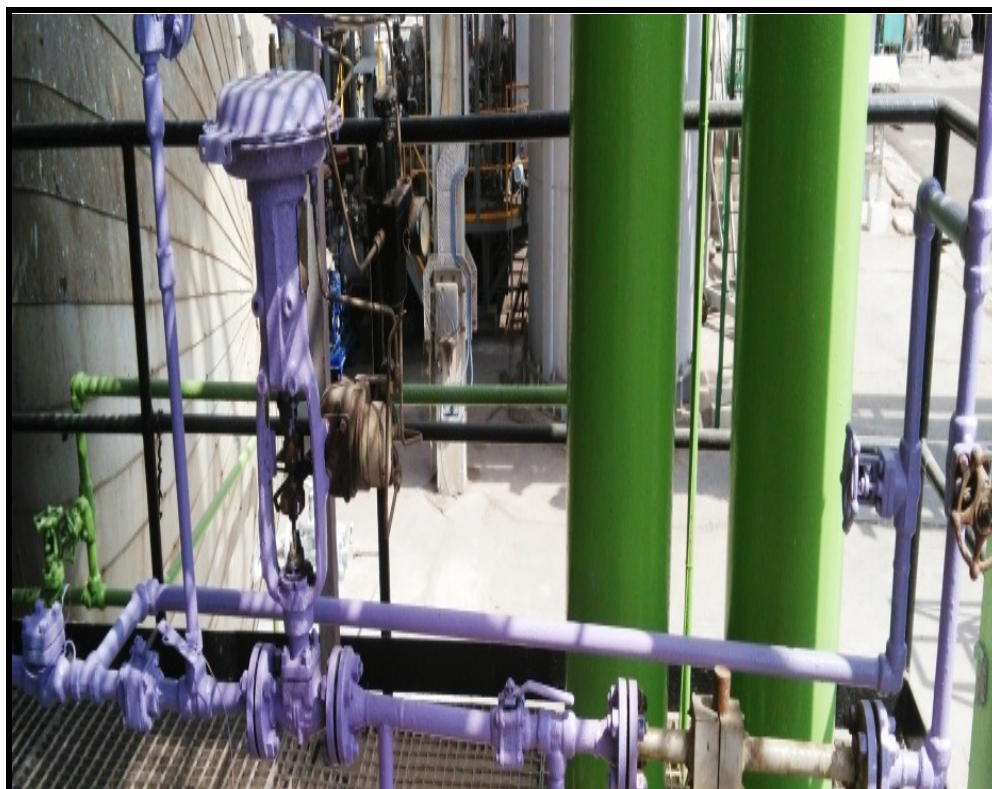
In existing system bypass line was there which exclude LCV-502.

Accordingly 1" by-pass line to LCV-502 with isolation valve has been provide. This will increase operation flexibility of the system.

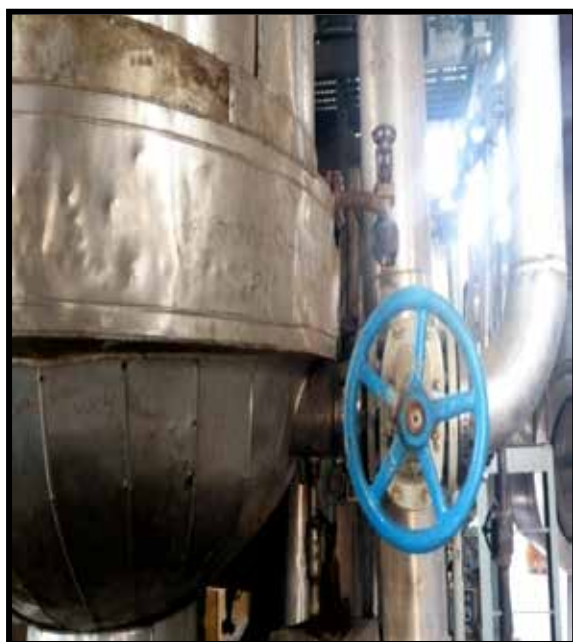
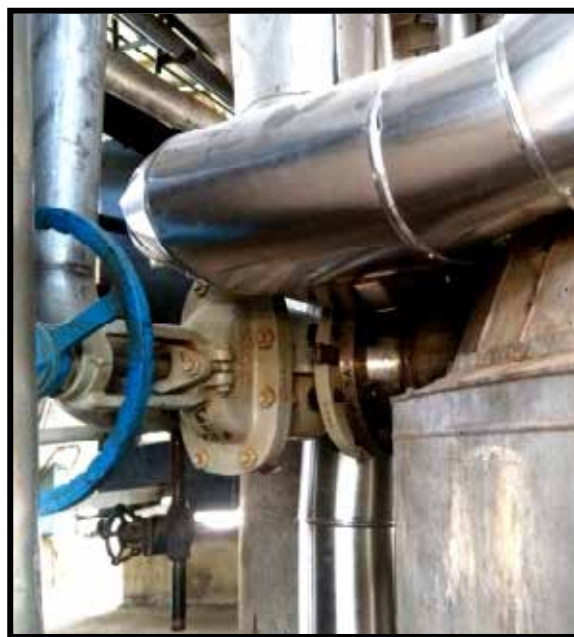
- 6" SS304L inlet/ outlet nozzles on recirculation heater top/ bottom channel cover provided with 1" SS vent/ drain isolation valve.
- 6" CS/ SS Pipings for supply and return connection provided from existing chemical cleaning system of plate heat exchangers.
- Isolation valve with blinds and 1" NB drain and vents have been provided.
- With implementation of above, the performance of Recirculation heater (H-1204) will be improved and thereby reduced the load on LP system and Hydrolyser section.

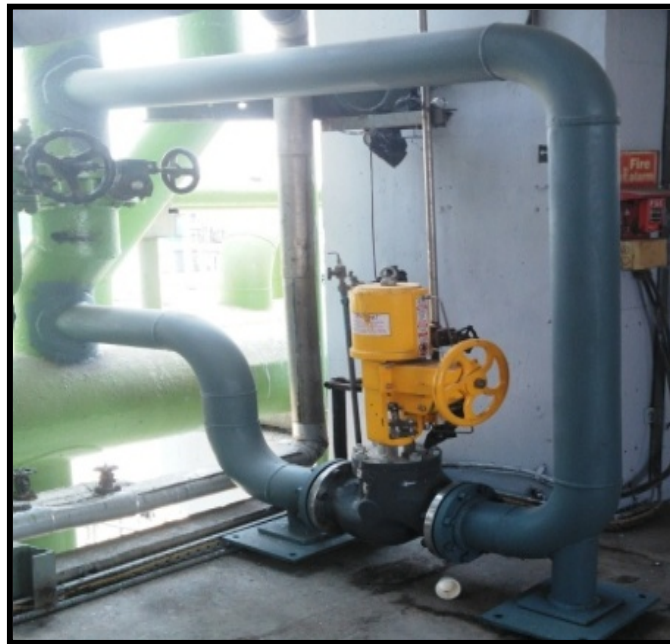
Higher capacity control valve (HICV-1204) on cooling water bypass line of CCS-II cooler (H-1207) to control CCS-II temperature. (Ref. EWR No. U-265 dated 22/11/2014 and T/02/1331 dated 27/02/2015)

- In existing system H-1207 cooling water outlet bypass control valve size is not sufficient to maintain CCS-II temp during start up and shutdown. 2" Globe type control valve (Redundant LCV-1123B) having Cv-50, Class 300# RF was installed in April, 2009 in place of isolation valve on 3" bypass line of cooling water outlet from H-1207 to avoid hammering .
- During plant turn around, 2"NB Globe type control valve (HICV-1204) on 3" cooling water bypass line (H-1207 CW outlet) has been replaced by 6" NB line

with 6" Globe type control valve procured vide P.O. No. 201004160544dated 28/07/2015.

- It will be helped for maintaining the CCS-II temperature from DCS timely during plant start-ups & shutdowns and hammering in cooling water lines will be avoided by monitoring and controlling the CW outlet temperature.

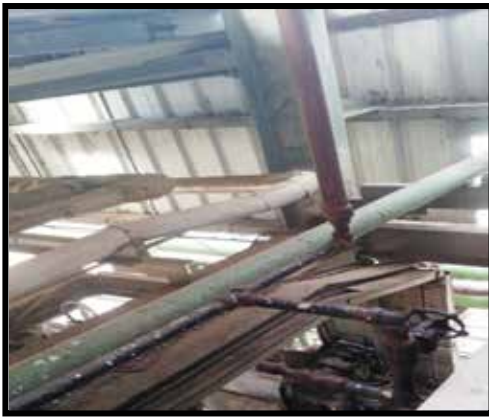
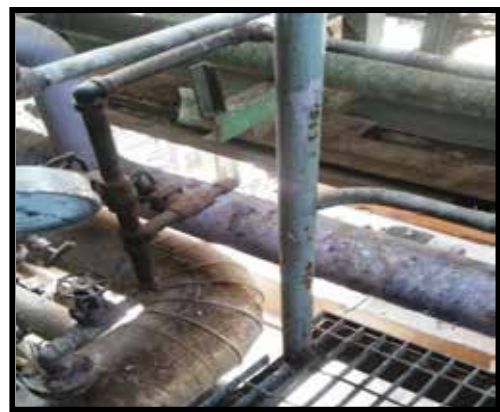
- In existing system both hot and cold ammonia supply line in Urea plant battery limit were open to atmosphere, hence it was very difficult and unsafe to depressurize the system.
- Therefore 1" hot ammonia vent and 1" cold ammonia vent connected to 1-1/2" common line and this 1-1/2" common line has been connected to 20" vent

header at 3.25 Floor. Also, 1" vent with isolation valve for each vent provided at existing location

- With implementation of above modification, operational safety, working environment and operational flexibility will be increased in Urea plant.

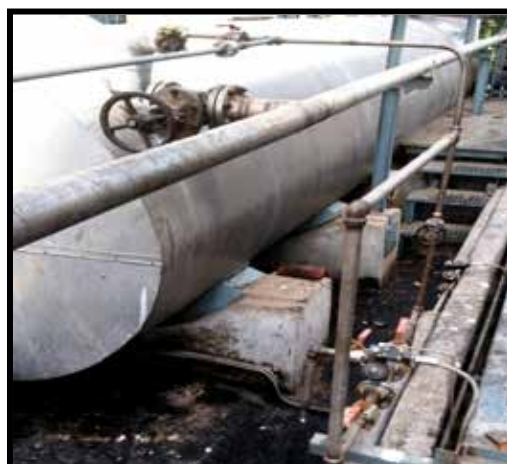
Installation of control valve HICV -1901A & HICV-1901B on Neem oil pump Bypass & Discharge line.(Ref. EWR No. U-263dated 28/06/2014 and TM/02/1331 dated 27/02/2015)

- A solenoid operated control valve (HICV-1901A) provided with by-pass line on 25mm NB oil recycle line.
- A solenoid operated control valve (HICV-1901B) provided on Neem oil pump (P-1901 A/B) discharge line.
- Trip logic provided to open HICV-1901A and to close HICV-1901B on auto with delay timer, when urea solution is diverted to urea solution tank.
- Additional isolation valve provided on Neem oil recycle line (25mm NB) to transfer neem oil from pump discharge to either of the neem oil tank.
- With implementation of above EWR, optimization of neem oil consumption and improve the operational flexibility of neem coating system will increased.

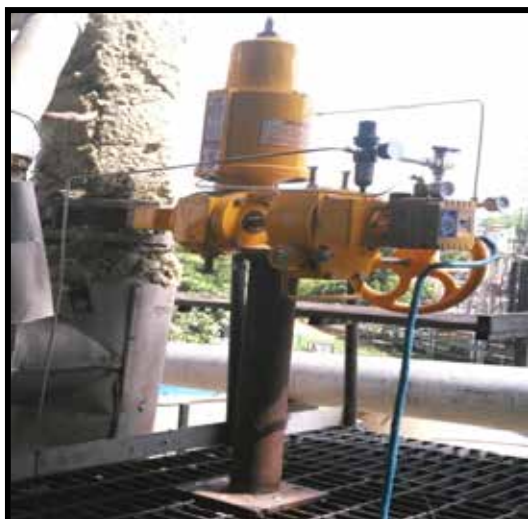
Installation of DCS operated control valve (HICV-1406) to bypass H/V-1418. (Ref. EWR No. U-275 dated 07/05/2015 and TM/02/1331 dated 26/08/2015)

- The butterfly type control valve (HICV-1406) provided in place of existing isolation valve on line PR-1401-8"-X10, to bypass pre-evaporator during plant start up/ process upset/ any emergency.
- With implementation of above, it will improve the operational flexibility and reliability of system

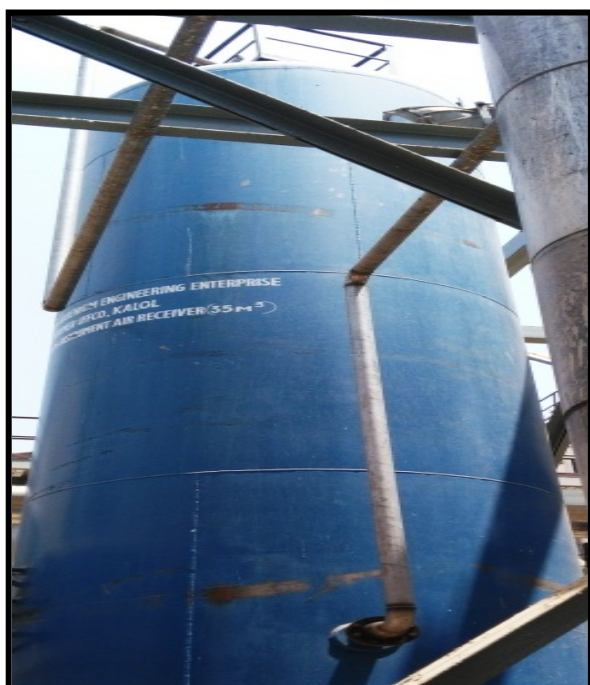
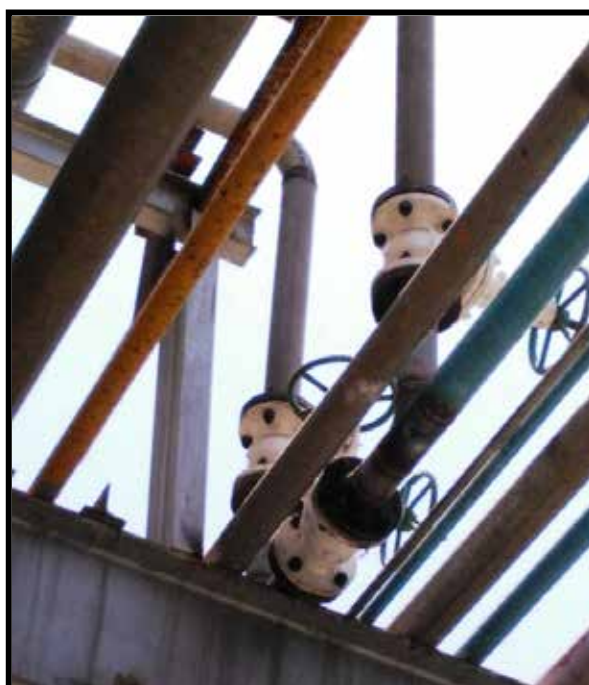
New instrument air receiver for Urea Plant :

- New Instrument receiver taken in service with instrument header. Necessary piping modification has been carried out by M/s J&J . Instrument air receiver has been checked from inside for cleanness before taken in line.

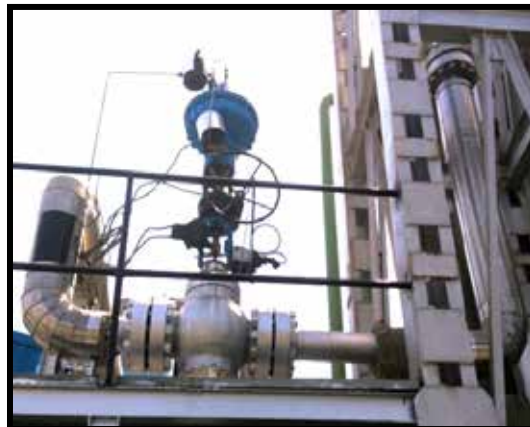
Details of PICV-6 are as under :-

Size	: 150 NB
End Connection	: Flanged , RTJ ,Octagonal groove
MOC	: SA217Gr. WC6
MAKE	: Forbes Marshall
Type	: Globe, single seated
Leakage class	: Class V
Calculated Cv	: 164

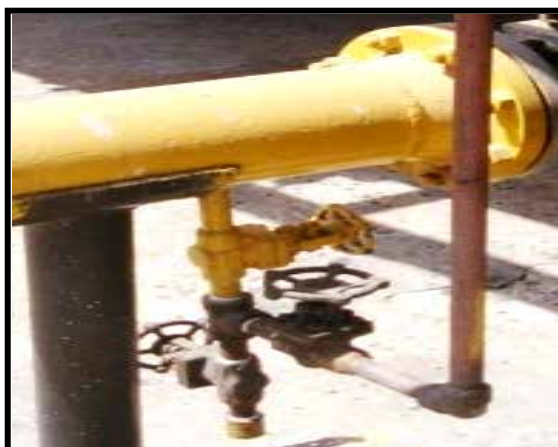
Vent line from drain from fuel gas header in BHEL boiler area. (Ref. EWR NO. SG 64dated 16.09.2015)

The existing ¾” drain line on fuel gas line extended and connected to vent header in BHEL boiler area with isolation valve.

This will help in removing inerts from gas to safe height and avoid unsafe working conditions.
