KALOL UNIT

PLANT TURNAROUND REPORT
(MARCH – APRIL – 2017)

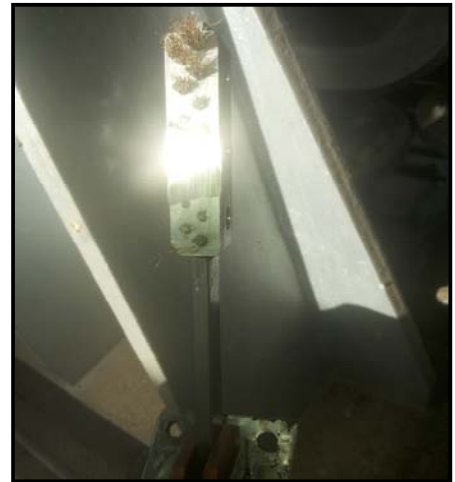
Replaced the Oil Guard (Governor end) as edges found damaged and worn out. Earthing brush was damaged and the holder of brush was touching the spacer, due to which marks were found on spacer.

Earthing brush found completely worn out

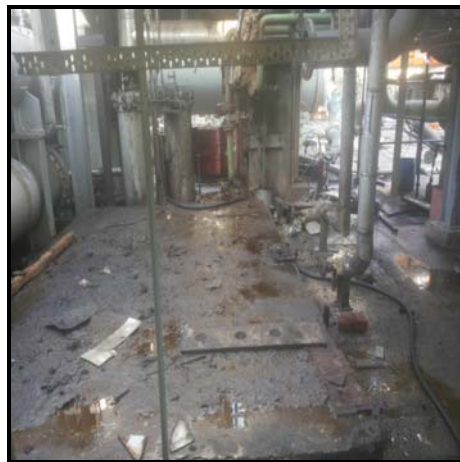
Foundation after removal of LO console

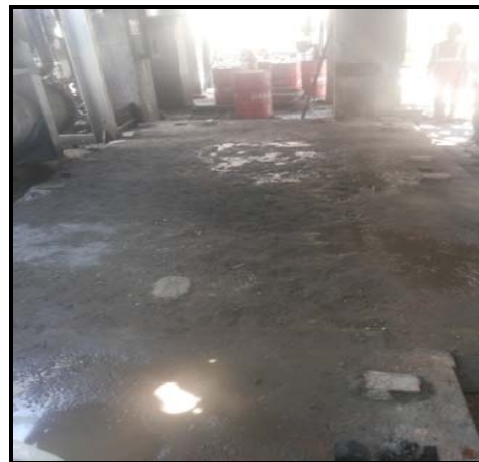
- The crane was placed at 127-CA/CB side during removal.
- Bottom level of new LO Console was to be kept at a lower level than the old one. Hence Top of old foundation was broken and removed by Civil. Top of LO Console foundation was made parallel to the top of the foundation for pump and drive.

Foundation of LO console after breaking of top portion

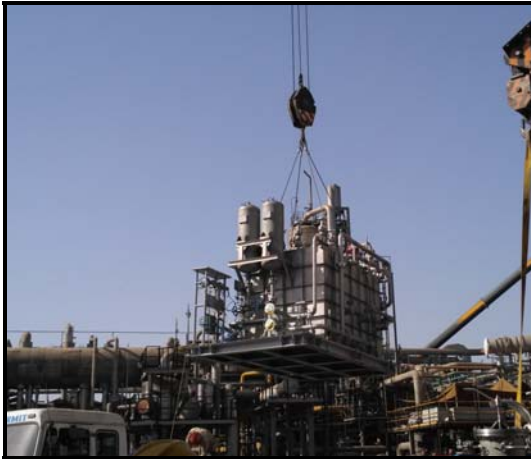
- The dimension of LO console was checked with the available space and it was observed that the Instrument Panel mounted on the new Console will foul with the steam inlet line of 101-JT. Hence the top portion of panel was cut and removed and instrument position was changed before erection.

Lifting of new 101-J/105-J LO Console for Erection

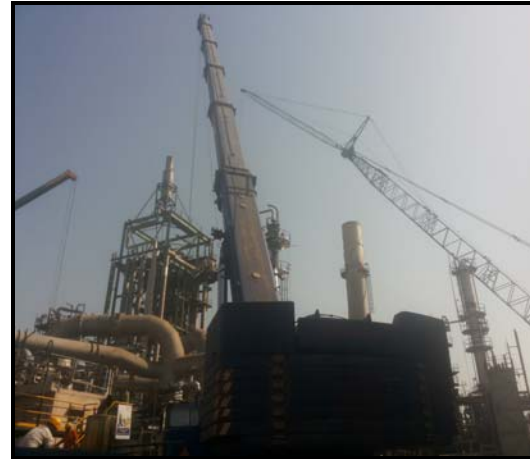
Erection of LO Console

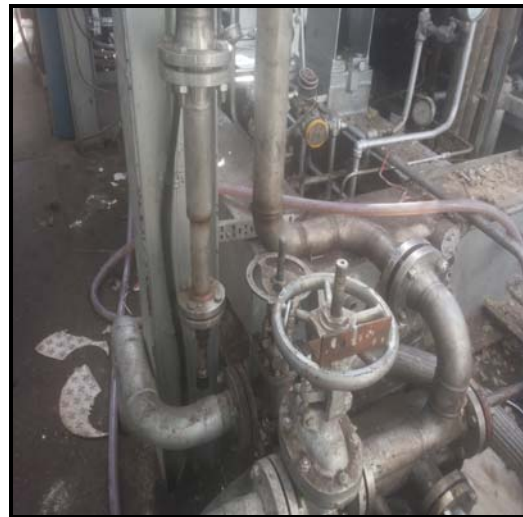
For flushing LO inlet header 101-J GO and LO lines bypassed

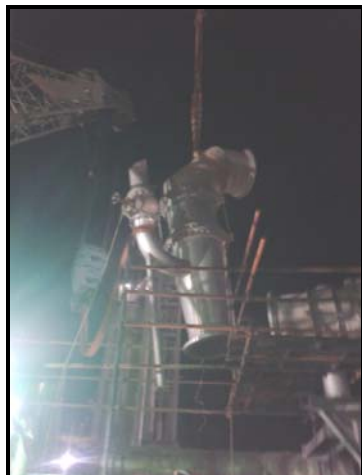
Removal of Exhaust Piping

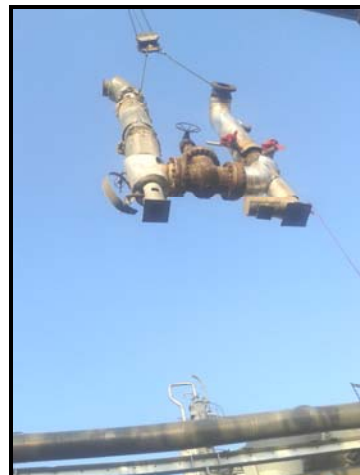
Removal of Extraction I/V

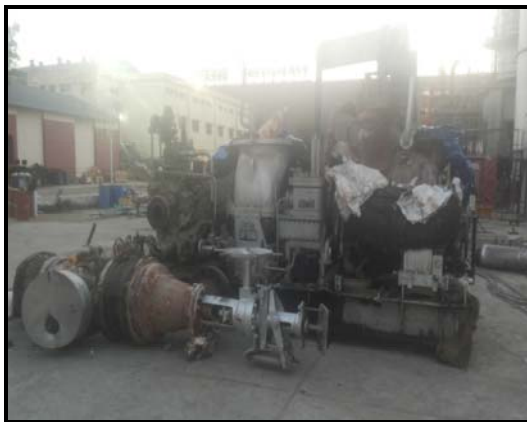
103-JAT and 103-JBT removed and kept on Ground floor

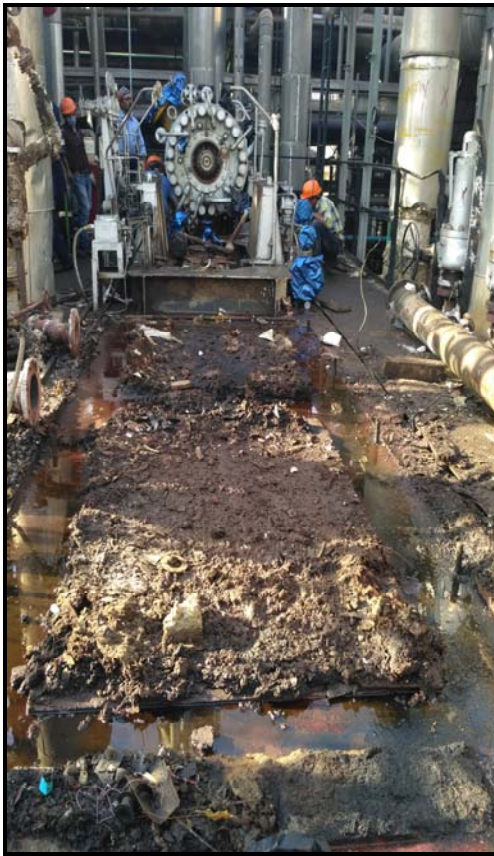
Turbine Floor Before cleaning

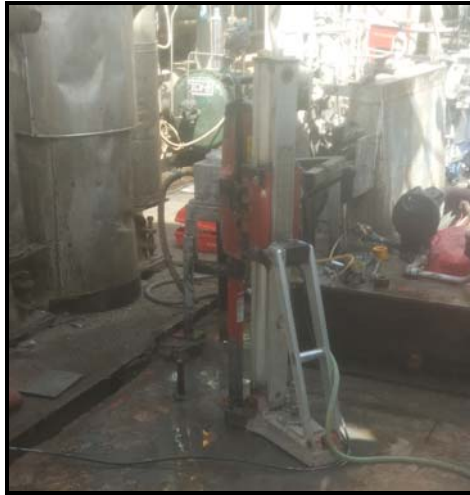
Core cutting for M 36 bolts

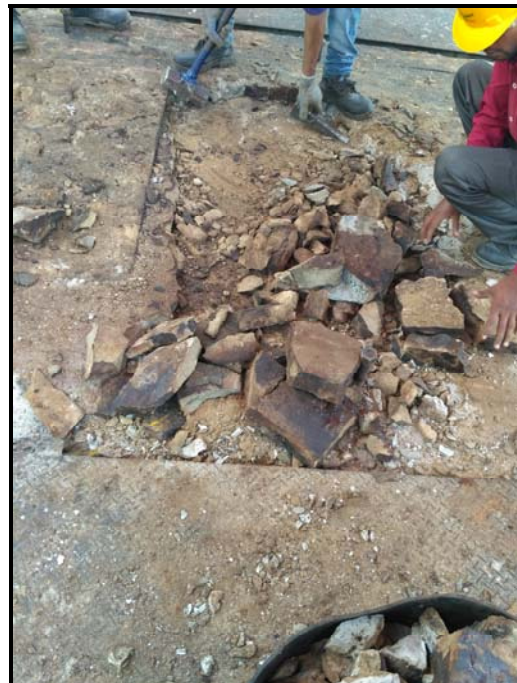
Breaking & removal of Old grouting matl.

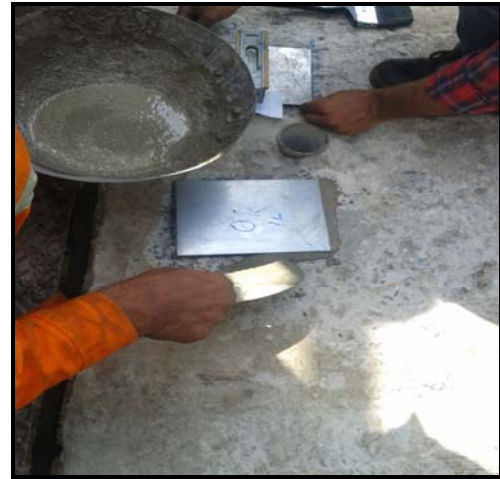
Fixing of Packer Plates using Shrinkomp

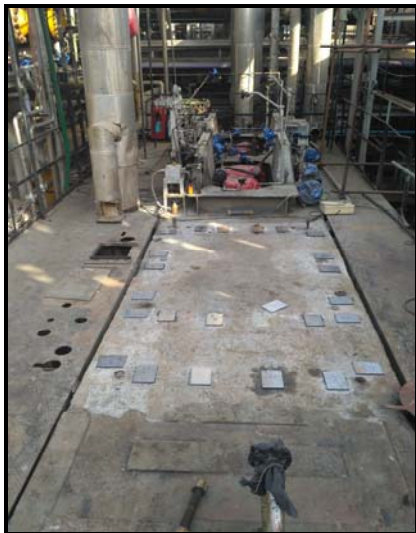
Surface Cleaned after Micro chipping & Blue checking

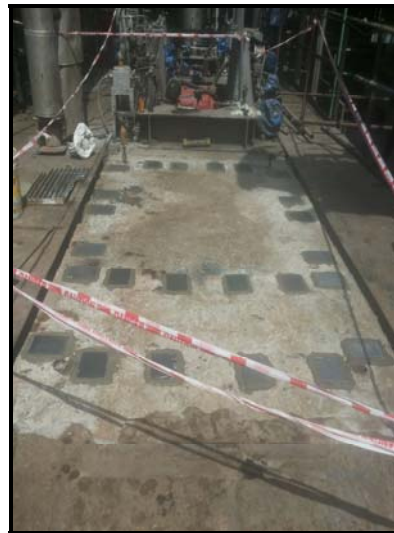
Packer plates fixed in their position using Shrinkomp

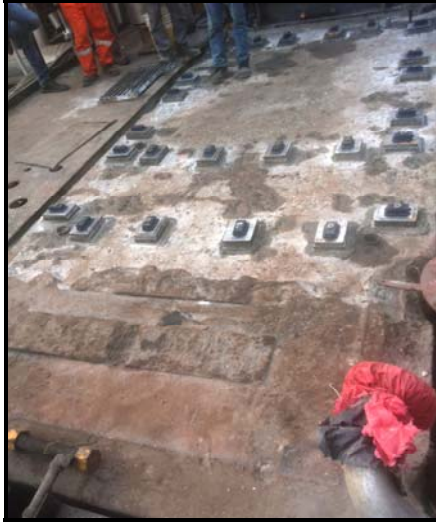
Foundation after positioning of shim plates and fixator

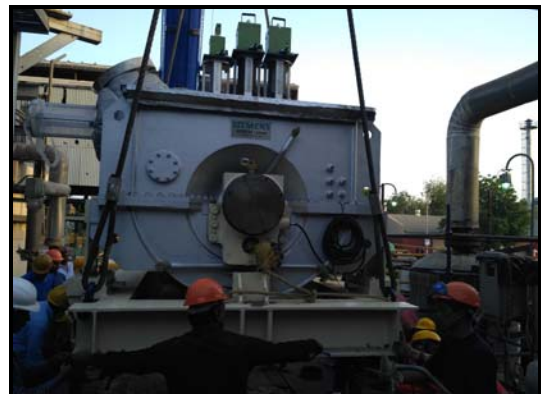
Turbine being positioned on foundation

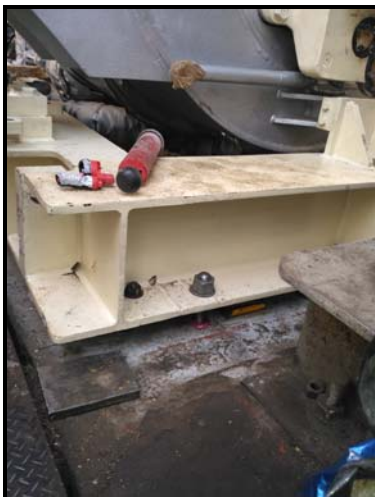
Grouting of front 2 bolts using Hilti Chemical

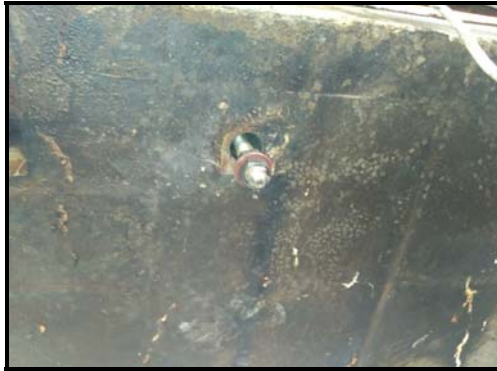
Foundation bolt exposed from bottom

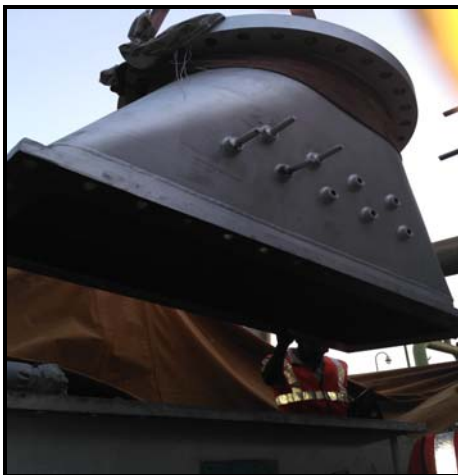
Installation of Transition Piece

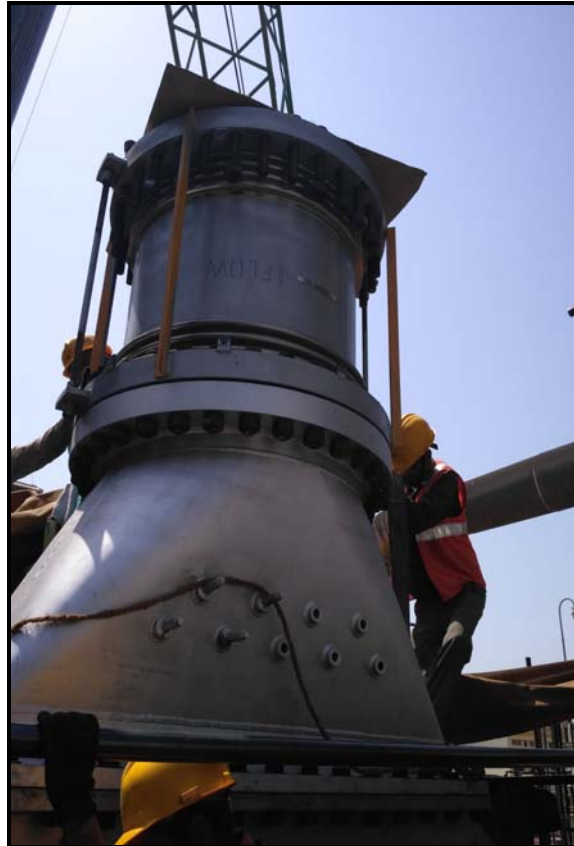
Installation of Expansion Bellow

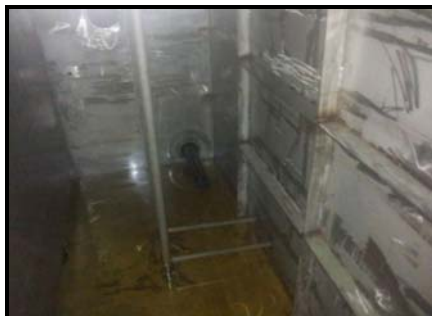
Inside view of LO Console

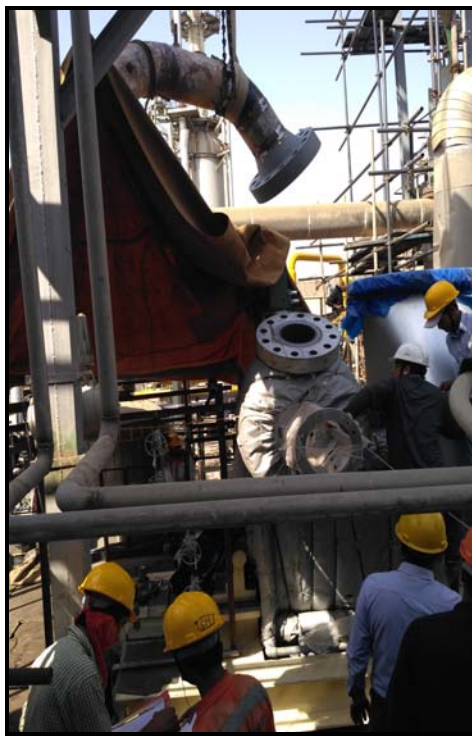
Inlet Line Fabrication u/p

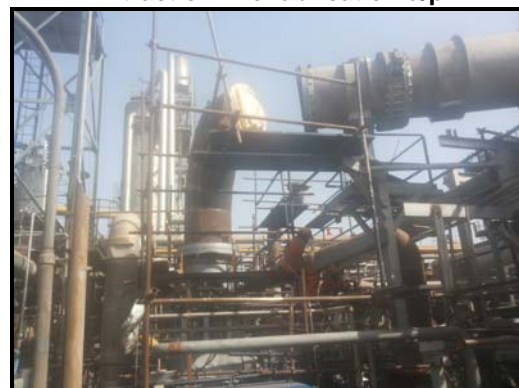
Exhaust line fabrication u/p

- New Startup Vent Valve of 2" was also provided at steam inlet line as per recommendation of Siemens.
- In Exhaust line ring was welded at top to align the line with turbine Nozzle.

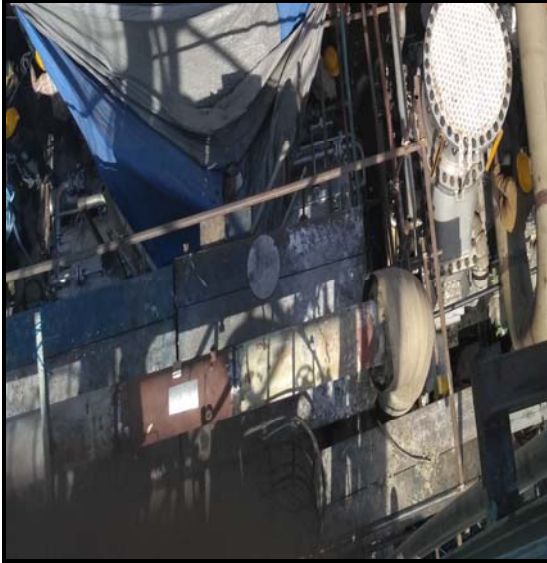
Flow nozzle in Steam inlet Line

- The flow nozzle of inlet line FN-8101 was having a upstream length of 1094 (Recommended- 984 mm with addl. 0.5% uncertainty) and d/s length of 6720 (Recommended- 3935 mm with addl. 0.5% uncertainty)

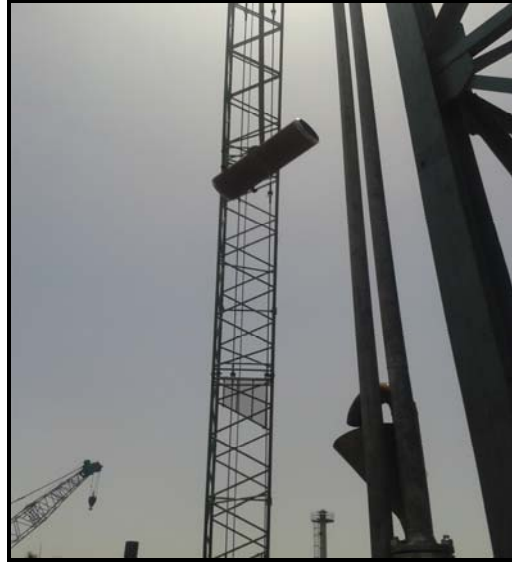
Flow nozzle of Extraction Line lifted

- The flow nozzle of extraction line FN-8102 was having an upstream length of 4370 mm (Recommended- 5453 mm with addl. 0.5% uncertainty) and d/s length of 1650 mm (Recommended- 1309 mm with addl. 0.5% uncertainty). The required length for upstream side was unable to achieve due to restriction of position of steam lines.

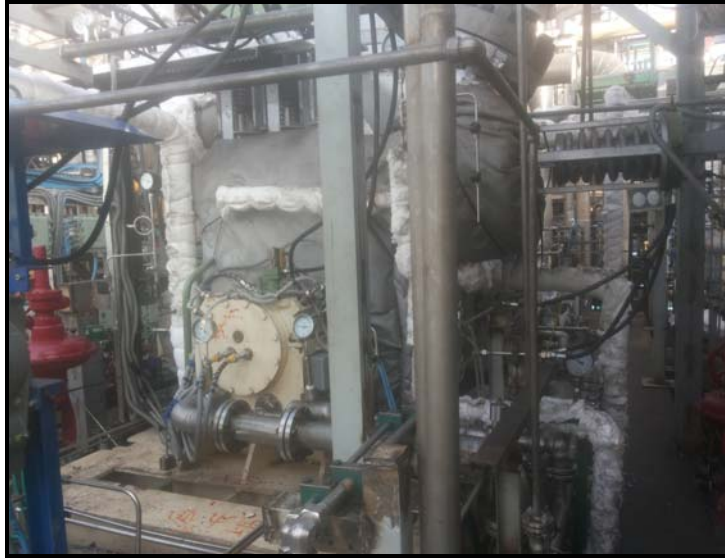
View of Turbine after completion of work

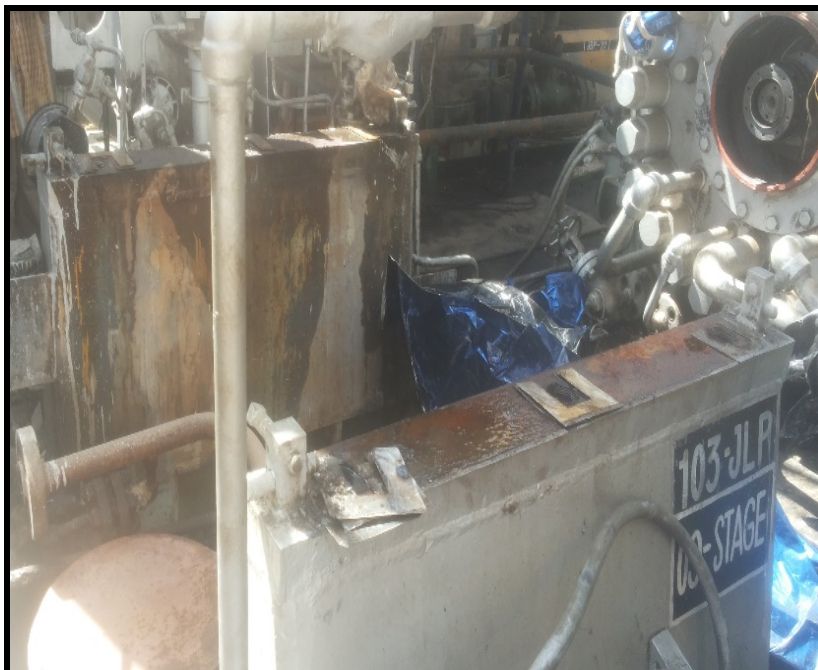
LP Compressor base after removal of compressor

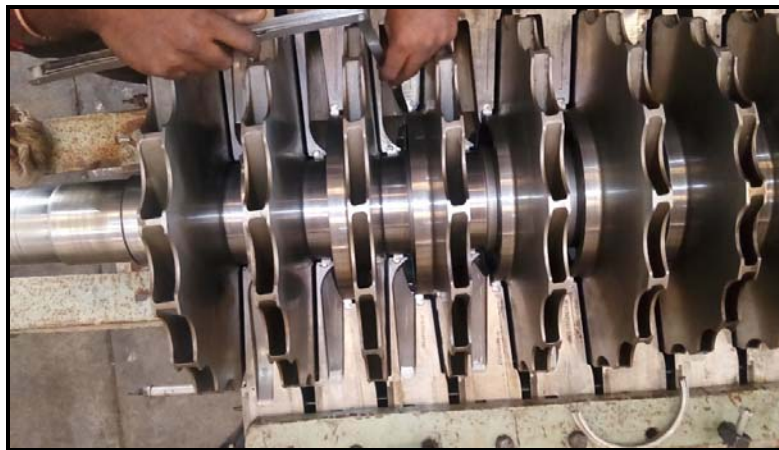
Measuring Clearance of bottom half

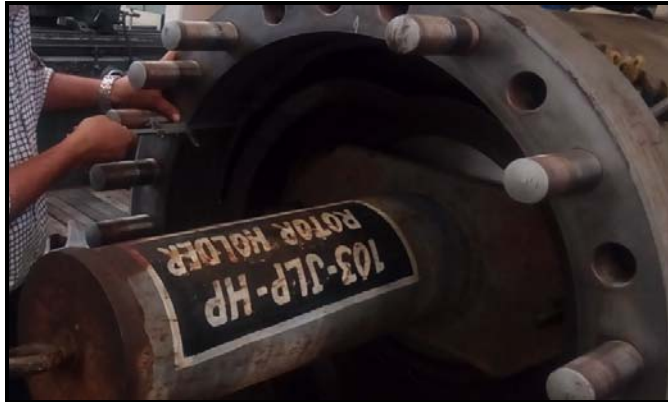
Insertion of bundle in casing

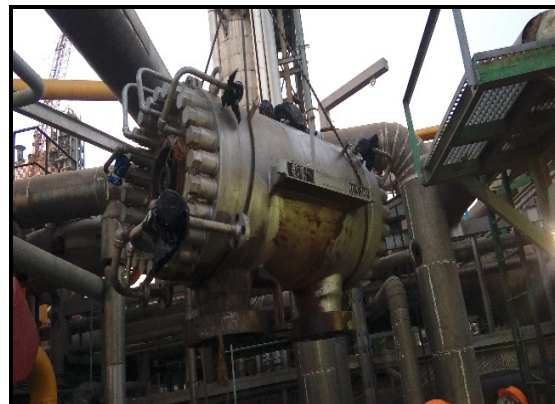
HP Case removed from foundation

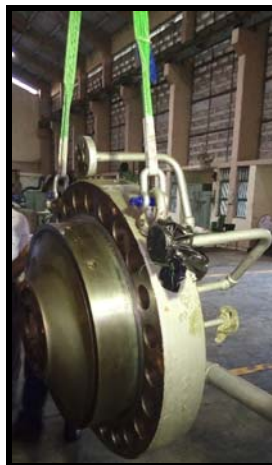
Discharge head cover removed from barrel

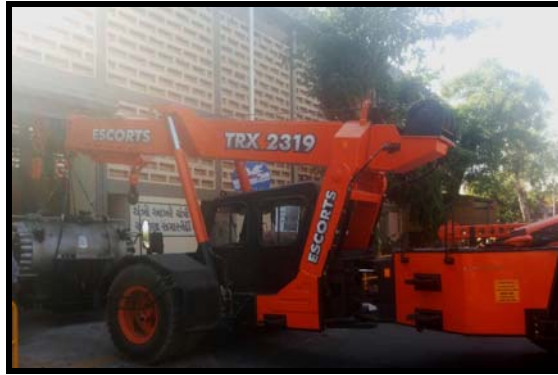
JHP Barrel being taken outside from Workshop

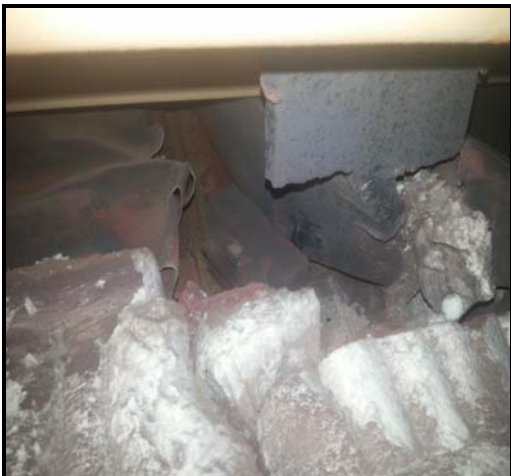
- It was observed that all 4 nos ITS supports of MFC at south ends were damaged badly and coil is slightly downward at this side.
- Hence new supports were provided and coil was supported
- Supports were made from the old supports (Inconel 600) of Air preheat coil which was removed

Damaged 2nd ITS support

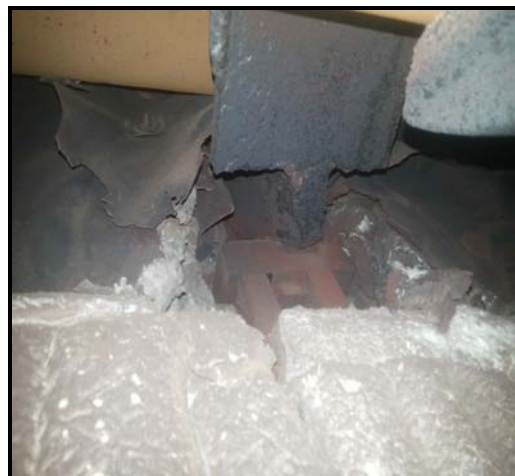
Damaged 3rd ITS support

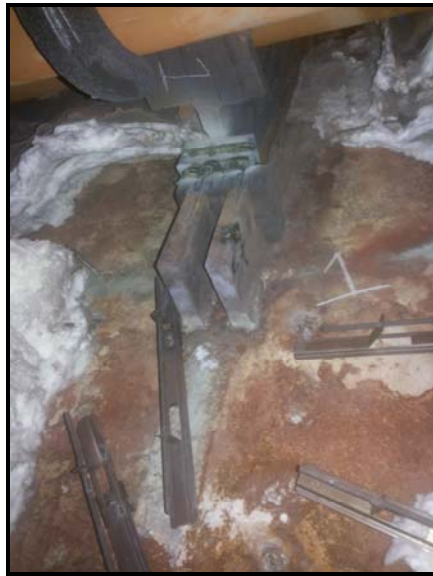
1st ITS support after repair

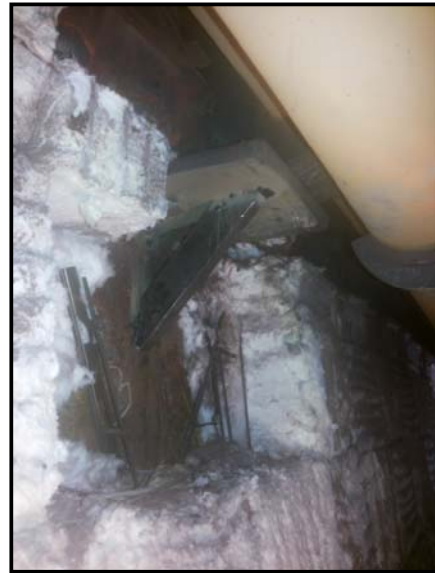
3rd ITS support after repair

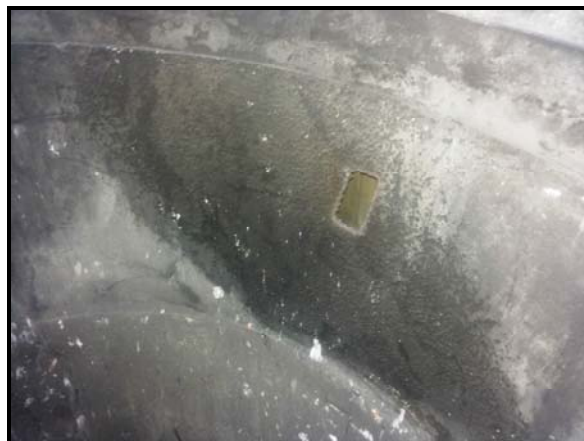
Shell liner removed from 101-C

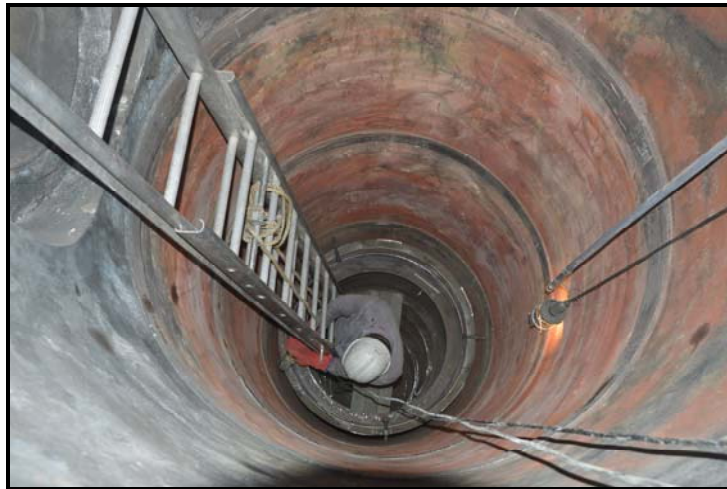
101-CA after complete removal of liner and refractory

- Inlet gas distributors were cut & removed from the shell.
- Segment wise cutting and removal of liner including cone plate & cone cover was carried out by grinding and plasma cutting.
- The removal was carried out from top to bottom one by one alongwith removal of refractory.
- Removed drain pipe of nozzle S3.
- Cleaning of shell surface was carried out by wire brush/grinding
- After removal of refractory, it was found that strip of width 75 mm is welded on the shell on which cone cover and spokes are welded. This is not shown the original drawing of 101-C. As there was no direct welding with shell, pre heating was not required to be done as planned earlier.

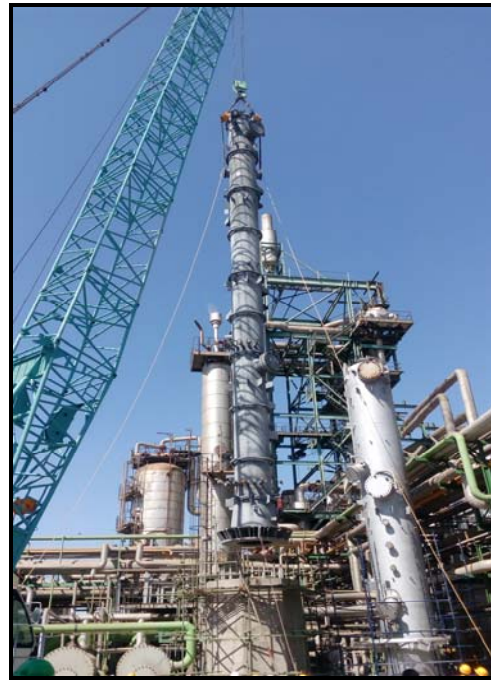
Erection of 1104-E

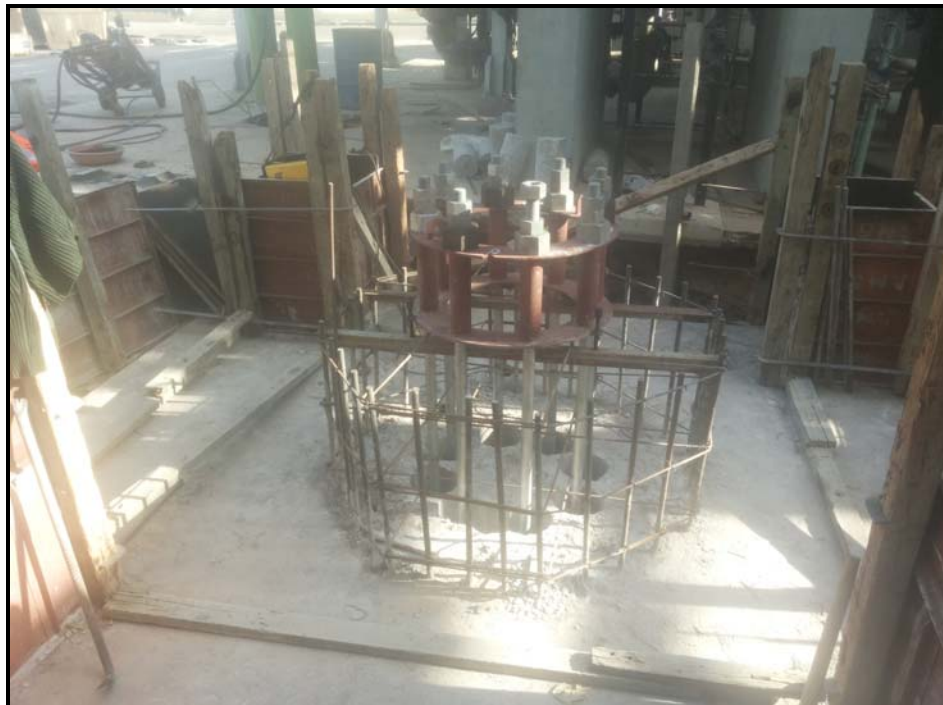
Template of 106-E provided in foundation

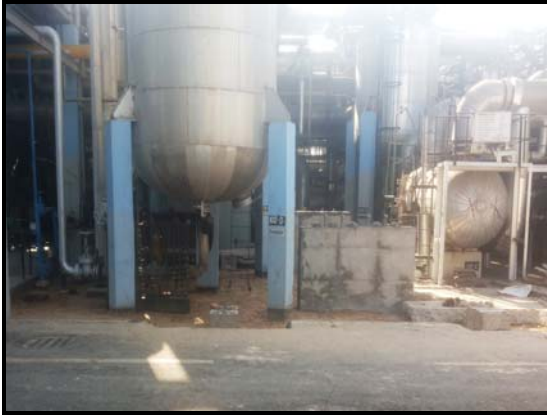
Foundation of 1114-CA/B ready and 1104-CA/B/C u/p

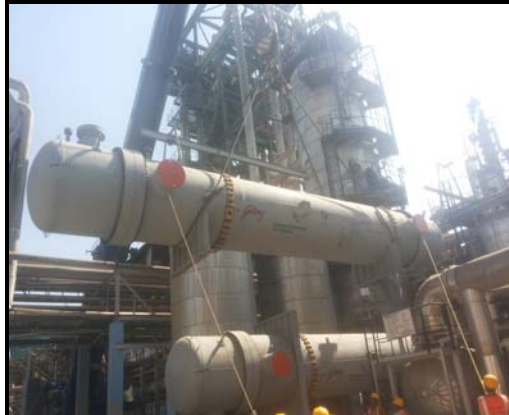
Erection of 1114-CA/B

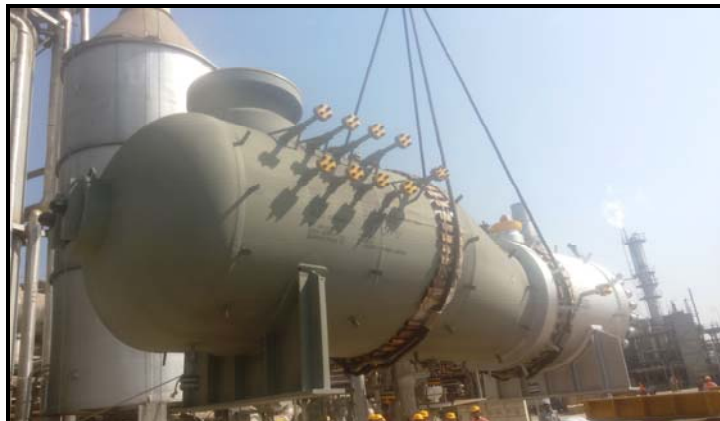
Erection of MP Boiler

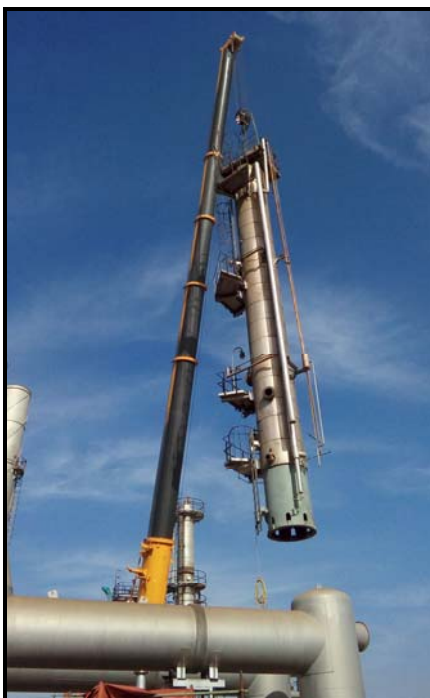
Removal of 104-E

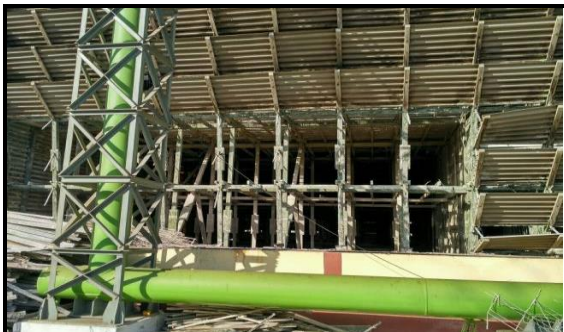
Dismantling of old wooden cooling tower structure-1

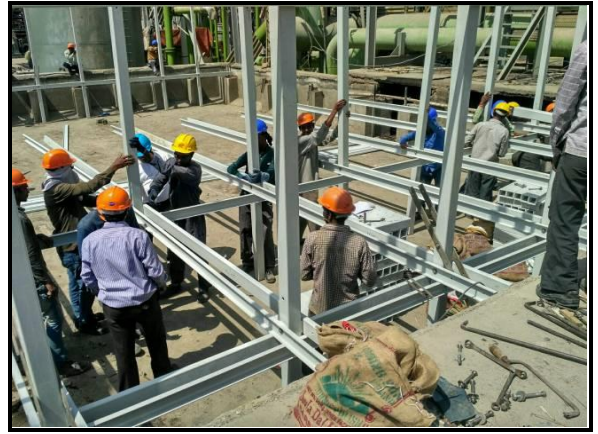
Erection of new FRP cooling tower structure - 1

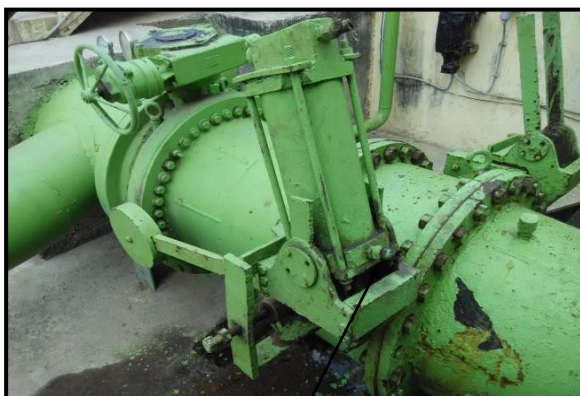
Old Check Valve

- Refurbishing of all Jash make sluice gate (1/2/3/4/5/6) of cooling water pump sumps was carried out. Gear box of all gates were opened, visually inspected and found satisfactory condition. Stem cleaning/ greasing and shutler seat / frame seat facing cleaning & greasing were done. One no. of damaged bottom wedge block of Gate no. 4 was replaced with new one.
- Check valve of cooling water pump P-4401E was replaced with new one (Dual Plate Check Valve, 28" x 150#, Flanged ends, Raised Face) due to passing.

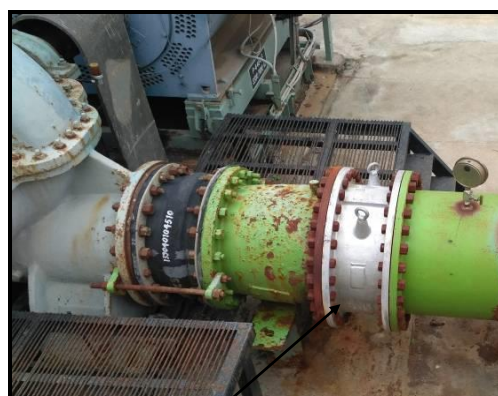
New Check Valve

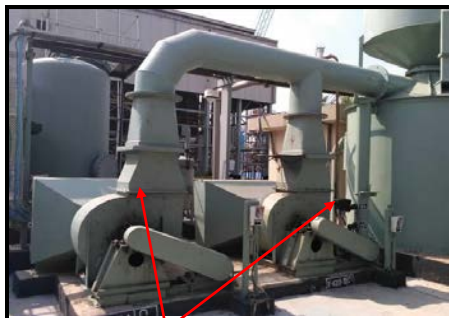
Old sliding gate valves

- Rerubber lining of SPC unit vessel & HCL unloading tank of was done. The job was carried out by party M/s Unicon Industrial rubber lining, Vadodara at their works.
- Sliding gates in discharge duct of degasser blowers K-4201A/B were replaced by butterfly valves (size: 14" x 150#).

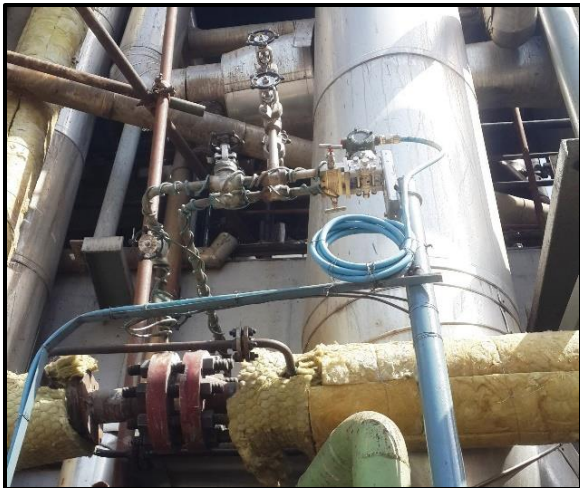
Flow element & DPT for FI-1206
