KALOL UNIT

PLANT TURNAROUND REPORT
(SEPTEMBER - OCTOBER – 2018)

Plant Turnaround for the year 2018 was taken from **17th Sep 2018** to **15th October 2018** for carrying out ESP Phase III (Energy Saving Project), Preventive maintenance jobs of Static & Rotary equipment.

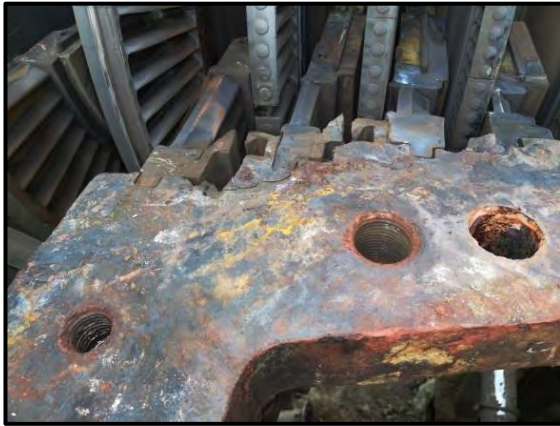
- Moisture rings fixed with the 4th, 5th & 6th diaphragms were found badly eroded.

Eroded Moisture Rings

- 5th & 6th no. diaphragms with moisture rings were replaced by spare refurbished diaphragm set. Diaphragm no. 4 couldn't be replaced as it was not seating properly in the groove.

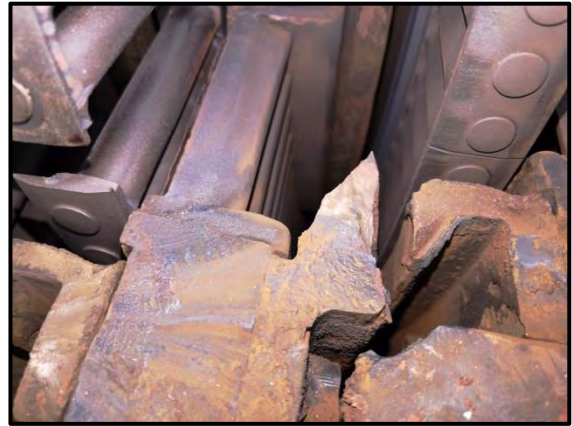
101-JT Moisture Ring

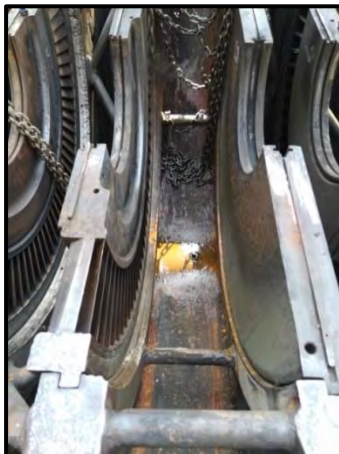
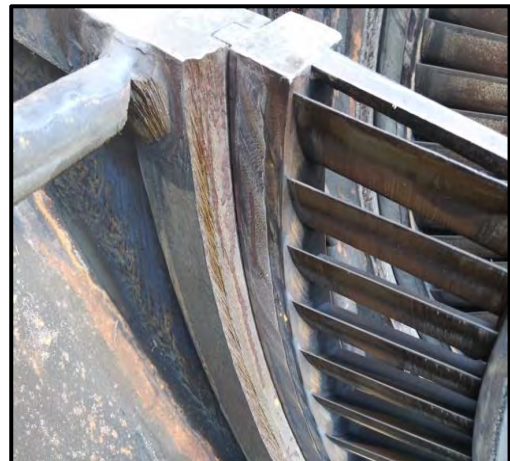
- Heavy erosion was found at the welding joint of reinforcement rods for the diaphragm holders in the top & bottom half of casing.

Eroded Reinforcement Rod

- Eroded welding joint of reinforcement rods for the diaphragm holders in the top & bottom half of casing was repaired by welding using SS410 welding electrode (E 410).
- Loose diaphragm pin tack welded by SS410 welding electrode

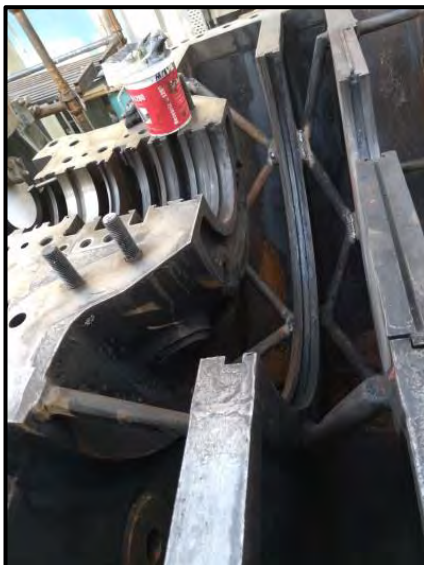
Weld Repaired Eroded Reinforcement Rods

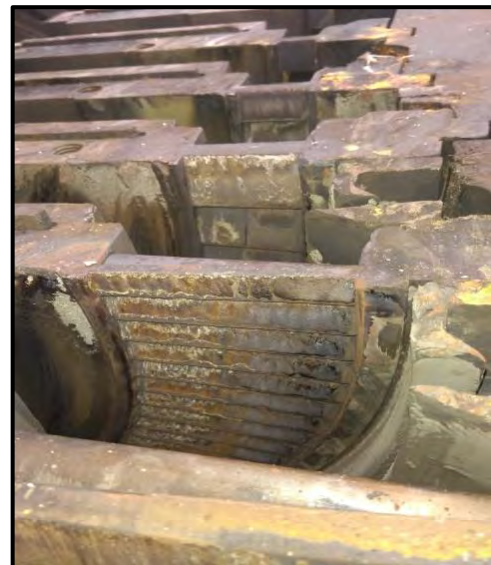
Deposits observed in blades

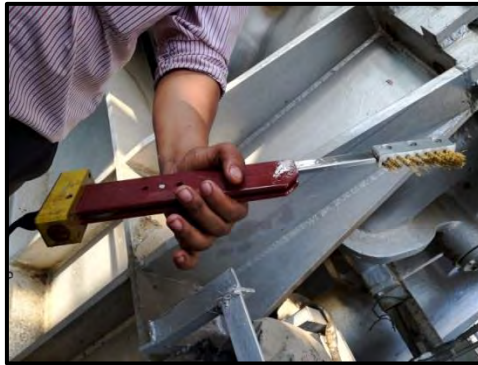
- Earthing brush was damaged and the holder of brush was touching the spacer, due to which marks were found on spacer.

101-JT Earthing Brush

- Additional Earthing brush was installed over coupling between 101-JR & 101-JHP. Provision was made on Coupling guard top half.

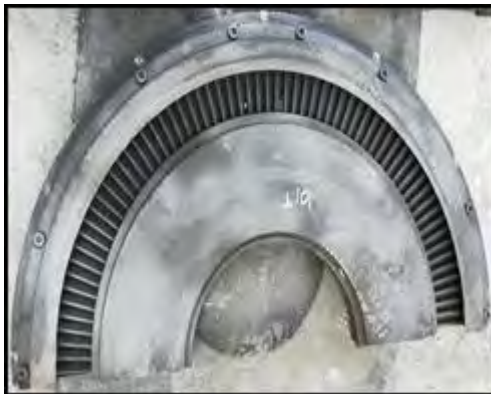
5th stage Diaphragm with eroded moisture ring

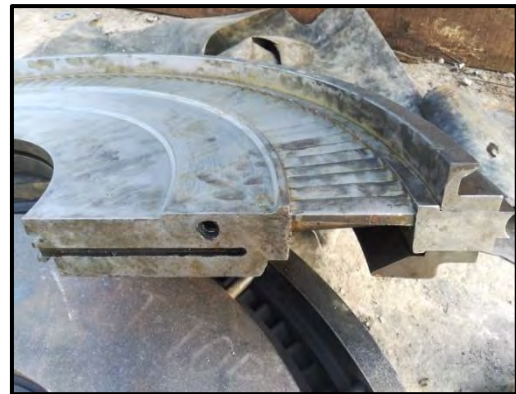
Spare 5th stage Diaphragm with moisture ring installed

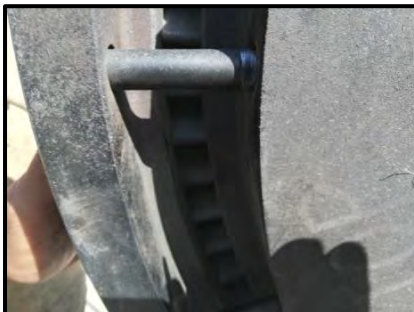
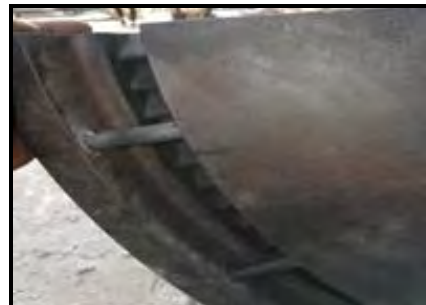
Loose diaphragm pin tack welded by SS410 welding electrode

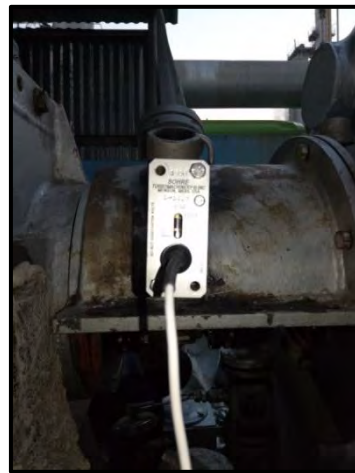
Additional Earthing brush between 101-JR & 101-JHP

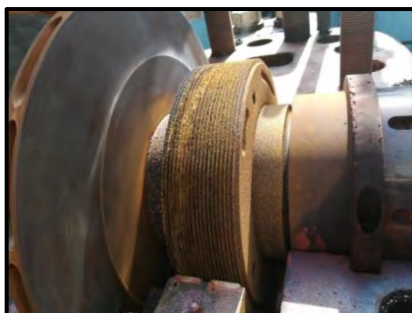
Balancing drum found corroded & eroded

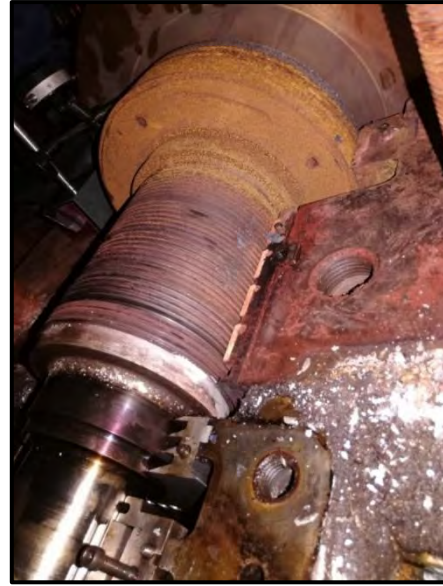
Balancing drum & seal found corroded & eroded

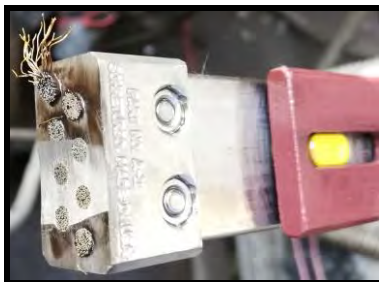
Bristles of Earthing brush installed at Coupling End bearing housing was found worn out completely. Hence, earthing brush was replaced by new one. New additional Carbon Earthing brush was supplied by M/s. Siemens India Ltd. It was installed on inboard oil seal of 103-JT Front end bearing housing.

103-JT Earthing Brush Coupling Side

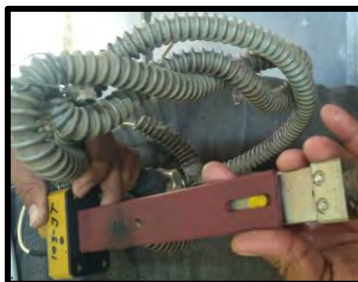
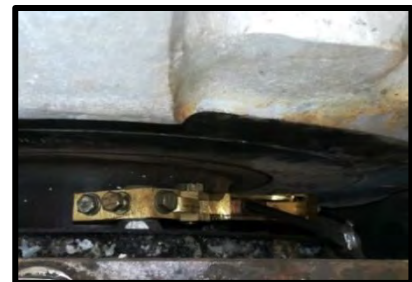
New additional Carbon Earthing brush

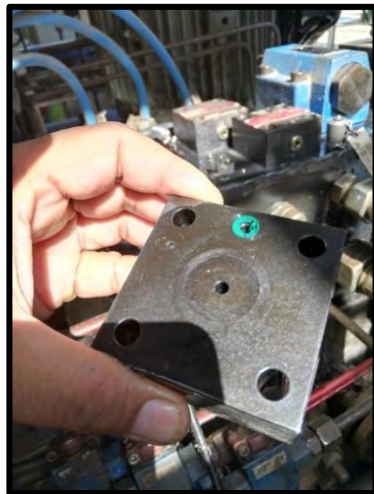
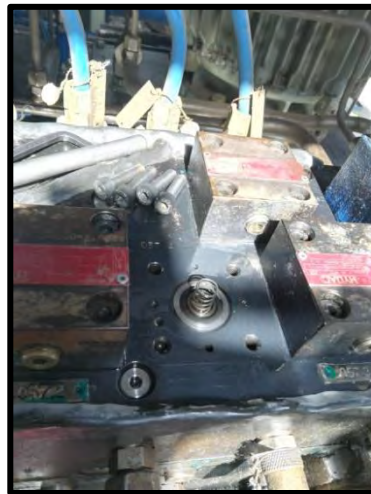
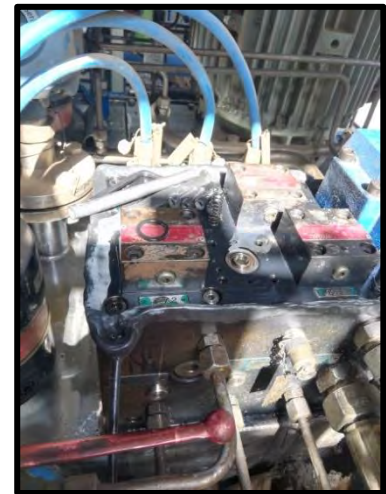
Middle Logic Cover damaged seal

- 103-JT Extraction Control Valve (CV-8104) Supply line & Drain line hose was having leakage. O-ring of hoses was replaced by new O-ring supplied by Hydac.
- 1 no. Logic cover leakage (South side) was attended by replacing complete seal kit. However after trial run, leakage was observed from middle cover. As the seal kit was not available, one O-ring (green color) was replaced with new one supplied by M/s Bhavna Rubber, Ahmedabad. O-Ring Size: 9.66mm OD X 1.85mm Cross section Dia., MOC: Viton.

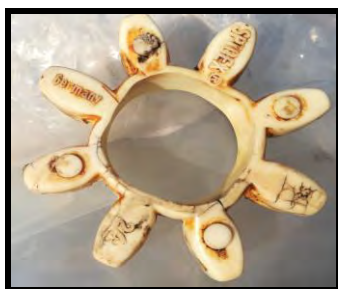
- COP-8503 Pump 3 micron filter element replaced as DP was high.
- COP-8503 Pump Relief Valve DB4E-01X-200S was replaced as pump was not developing pressure above 100 Kg/cm²g
- Coupling Flexible Element of all pumps i.e. COP-8501, COP-8502, COP-8503 & COP-8504 found badly damaged. Replaced all elements

Old Flexible Element of COP-8503

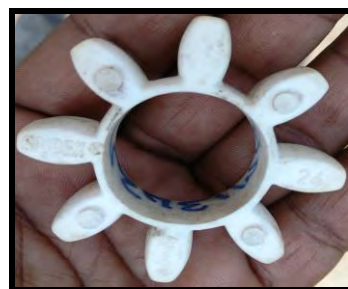
New Flexible Element for COP-8503 & COP-8504

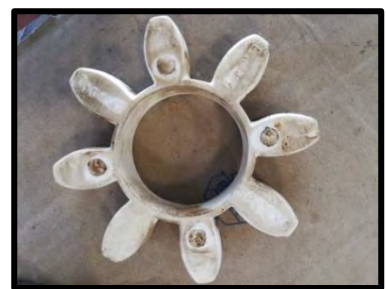
New Flexible Element for COP-8501 & COP-8502

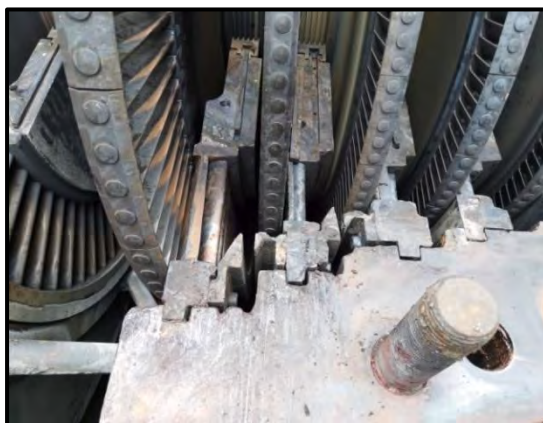
- Moisture rings fixed with the 4th, 5th & 6th diaphragms were found badly eroded. 5th & 6th no. diaphragms were replaced by spare refurbished diaphragm set. Diaphragm no. 4 couldn't be replaced as it was not seating properly in the groove. Also, Heavy erosion was found at the welding joint of reinforcement rods for the diaphragm holders in the top & bottom half of casing. This was repaired by welding.

105-JT Moisture Ring

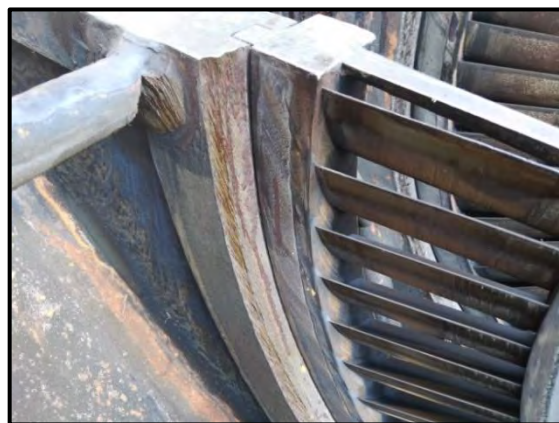
Eroded Reinforcement Rod

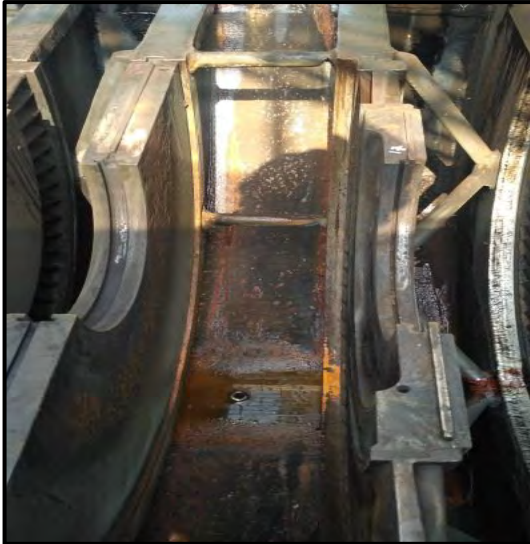
Eroded Reinforcement Rod

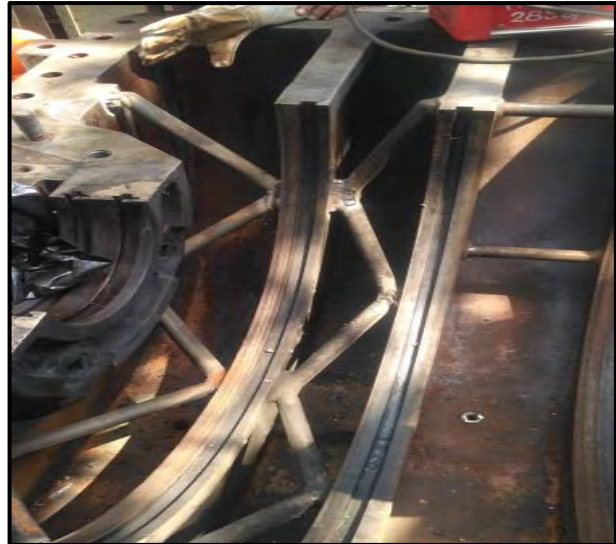
Weld repaired Reinforcement Rod

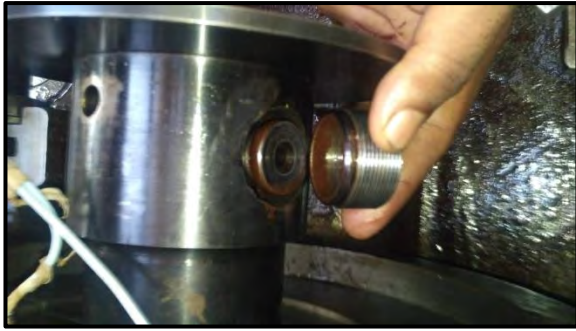
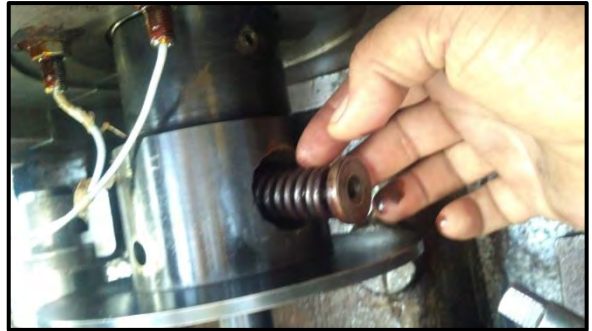
Removal of 105-JT OST assy. for cleaning & inspection

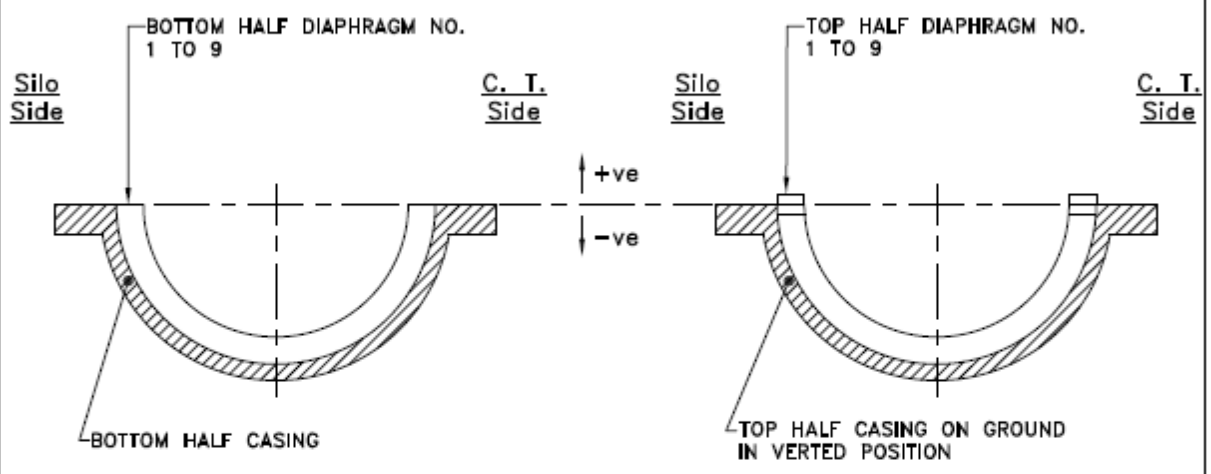
WHEEL TO DIAPHRAGM CLEARANCE (105-JT)

DIAPHRAGM NO. FROM GOVERNOR END		NO.:1	NO.:2	NO.:3	NO.:4	NO.:5	NO.:6	NO.:7	NO.:8	NO.:9
BOTTOM CASING WITH BOTTOM HALF DIAPHRAGM										
SILO SIDE (X1) L	BEFORE	+1.00	+0.40	+1.04	+1.92	+2.10	+1.60	-0.20	+2.60	+0.90
	AFTER	+0.01	+0.05	-0.01	-0.00	-0.02	-0.05	-0.01	+0.00	-0.02
C.T. SIDE (X2) R	BEFORE	-2.08	-1.68	-1.64	-2.20	-2.80	-1.60	+0.10	-2.90	-2.60
	AFTER	+0.01	+0.01	+0.01	-0.00	+0.02	+0.02	+0.01	+0.00	+0.02
TOP CASING WITH TOP HALF DIAPHRAGM										
SILO SIDE (X3) L	BEFORE	-0.65	-0.35	+0.15	-0.68	-1.20	-0.40	-1.00	-1.50	-0.40
	AFTER	-0.45	-0.20	-	-0.04	-0.72	-0.64	-0.50	-0.60	-0.35
C.T. SIDE (X4) R	BEFORE	-0.85	-0.50	-0.05	-1.00	-1.35	-0.95	-1.80	-2.00	-0.40
	AFTER	-0.55	-0.18	-0.25	-1.70	-1.80	-1.00	+0.70	-1.80	-0.45
NET CLEARANCE (SUM OF ALL FOUR i.e. (X1+X2)+(X3+X4) with reference to parting plane)

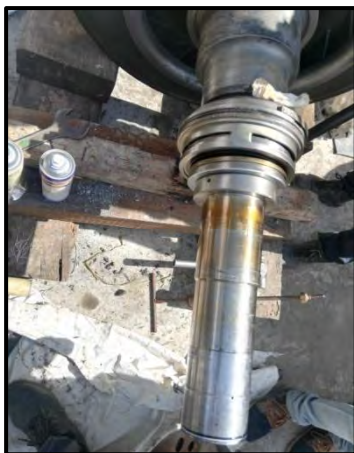
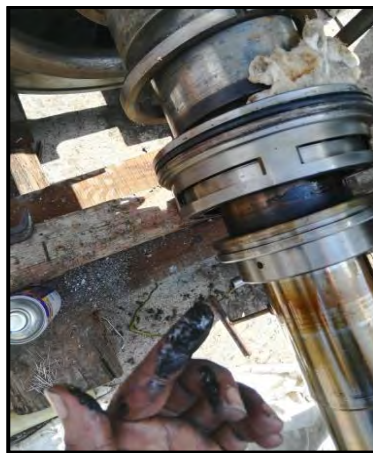
- Blackish deposits were observed in Mech. seal area.
- Bearing assembly & Seal assembly at both ends of Rotor was dismantled.

Thrust End Mechanical Seal

- Worn out Seal faces at both ends were replaced by new seal assembly (Part No.36 & 41), one no. seal collar locknut (Part No.39) was cut to remove as it was not opening, hence, it was replaced by new one.

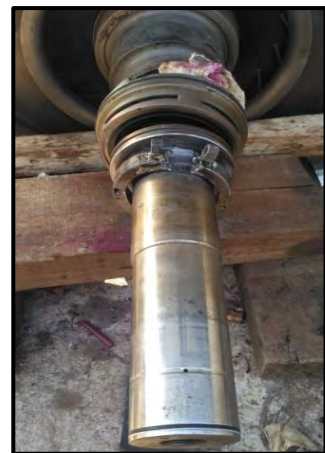
Lock nut cut for Seal Collar removal as it was stuck

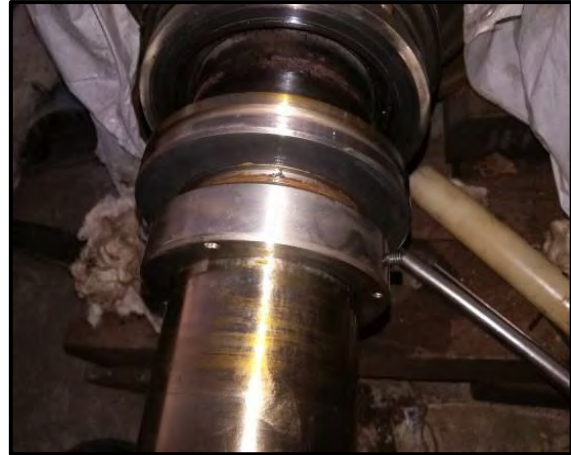
Opposite Thrust End Seal Collar Lock Nut Removal

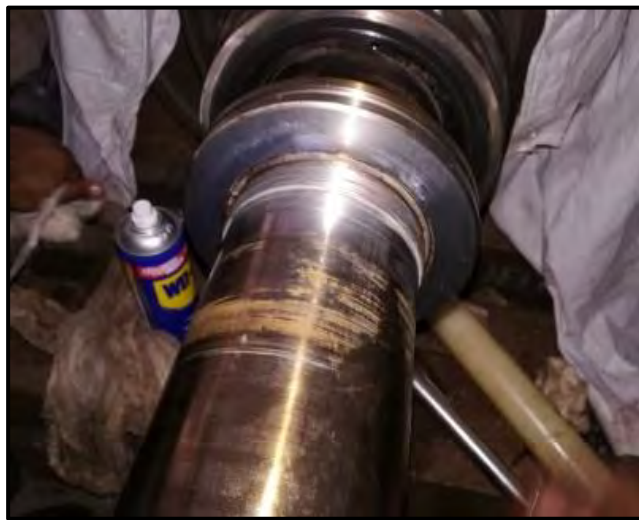
Opposite Thrust End Seal Collar Removal

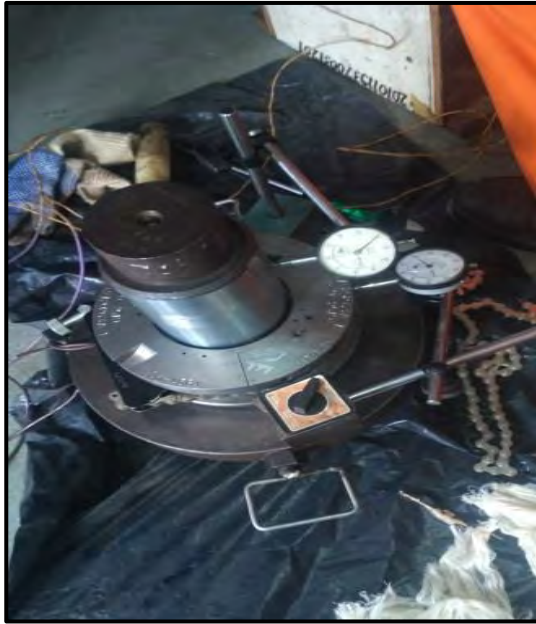
- Journal bearings and Thrust bearing were visually inspected and Dye penetration test carried out. Found OK.
- Gauss reading of the bearing pads and base rings were measured and found within limits.
- Bearing clearances were taken and found within the design range.

Journal Bearing Clearance measured at Mandrel

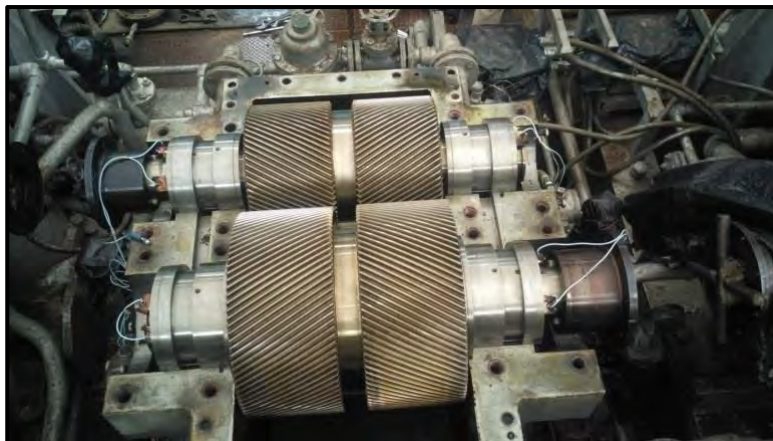
Description	Position	Before (Gauss)	After (Gauss)
Gear Journal Bearing	North	0.4	0.4
	South	0.4	0.4
Pinion Journal Bearing	North	0.3	0.3
	South	0.4	0.4
Thrust bearing	Active	0.5	0.5
	Inactive	0.5	0.5
Oil Guard for Above	South		
	North		
Shaft Journal	Thrust End	0.5	0.5
	Non thrust end	0.4	0.4

105-JR after removal of Top Cover

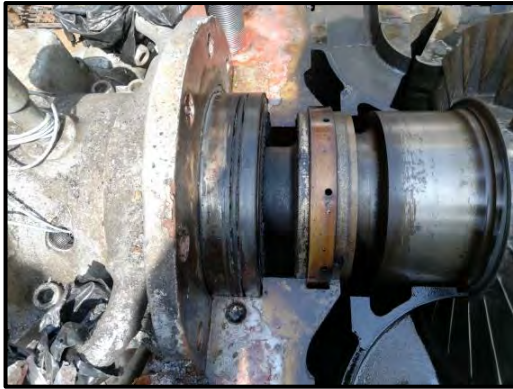
- Blackish deposits were observed in Mech. seal area.

Bearing Housing and Mech. Seal Assy. at NDE

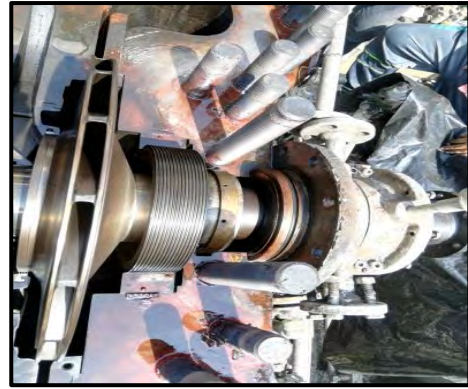
Bearing Housing and Mech. Seal Assy. at DE

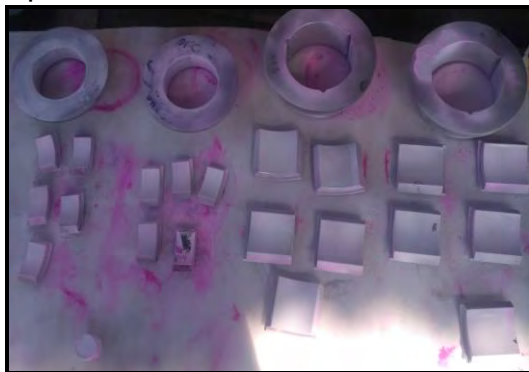
- Journal bearings and Thrust bearing were visually inspected and Dye penetration test carried out.

Journal Bearing Pads DP Check

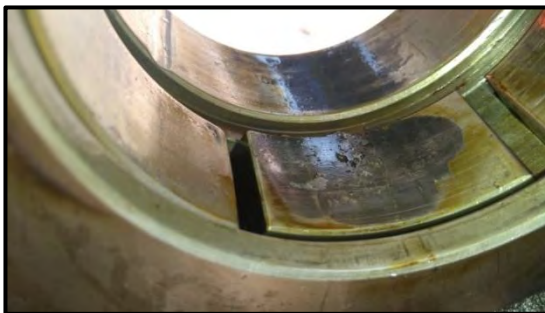
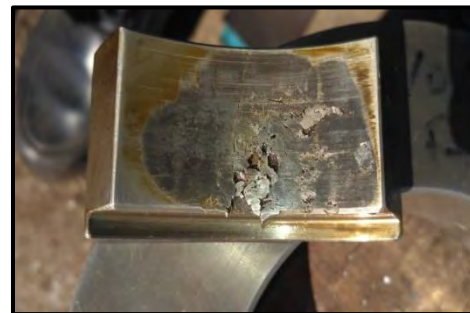
- One no. bottom journal bearing pad of DE side bearing found damaged and hence replaced this pad.

Damaged Journal Brg. Pad

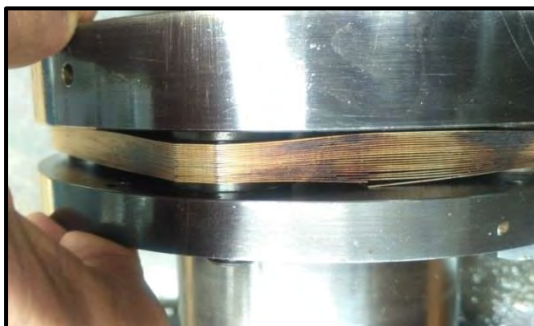
- Axial Thrust measured, found 0.46 mm which is more than recommended one. Hence, thrust bearing spacer shim thickness adjustment done & the Axial Thrust reduced to 0.34mm. Final shim thickness maintained, Inner spacer shim thickness=9.76mm, Outer spacer shim thickness = 9.48mm.
- HP Compressor to GB Coupling Transmission Unit shims found broken. Hence, Transmission Unit was replaced by spare one.

Broken shims of 105-JHP to GB Coupling transmission unit

- To accommodate spare Transmission Unit & provide 1mm pre-stretch as recommended in coupling drawing by manufacturer, pinion wheel coupling hub need to be pushed inside towards Gear box.

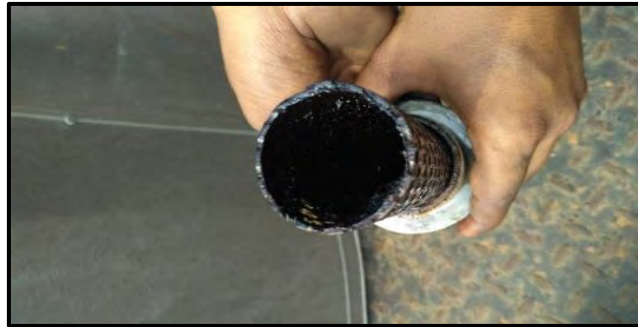
- Sour oil Piping, Level Transmitter housing, Y strainers, Seal pot opened for inspection, found sludge, hence cleaned properly and boxed-up.

Choked strainer of 105-J seal oil line

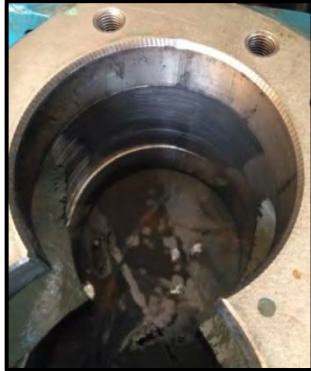
MOP mounted on GB shaft was dismantled and replaced by the spare one as the internals of pump worn out during running plant. After opening the removed MOP, it was observed that cage of ball bearings were found broken and the balls were free. The housing was worn out in some portion. Some areas of Gears were also worn out.

Pump Housing found worn out

All the Lube oil lines were flushed thoroughly to remove the worn out metallic particles. Additional AOP along with associated piping (which were removed during SD-2017) was installed back for emergency purpose (After proper flushing)

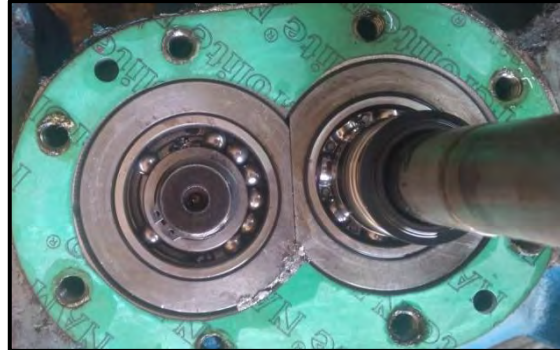
Damaged Ball Bearing

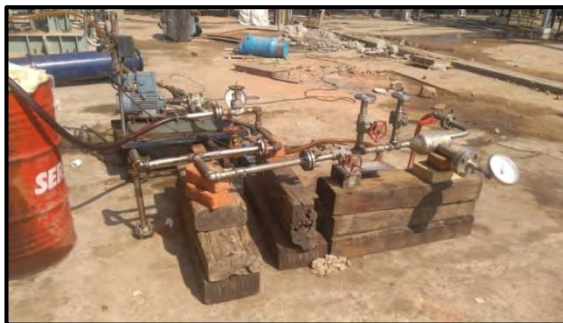
LO lines of Additional AOP was flushed

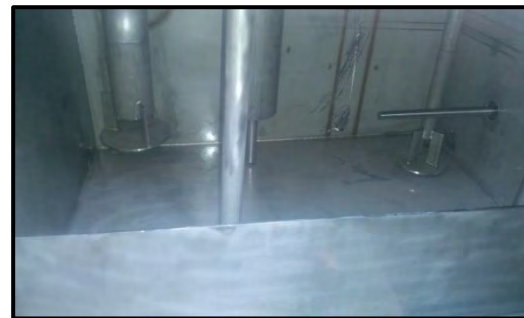
101-BJT LO console after cleaning

Provision for transmitter was made by drilling of Console wall towards Silo side. Lube Oil console was cleaned, new oil charged & filter elements replaced.

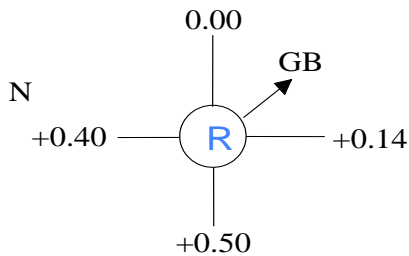
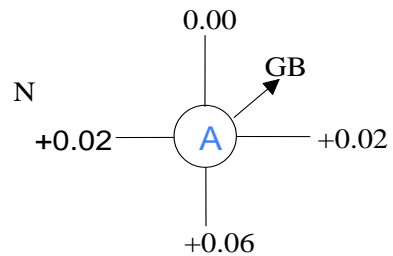
Before Preventive Maintenance

ALIGNMENT READING RECORDS: 101-BJT to 101-BJR

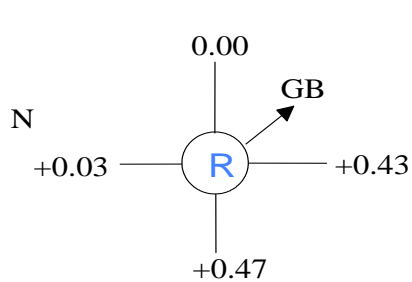
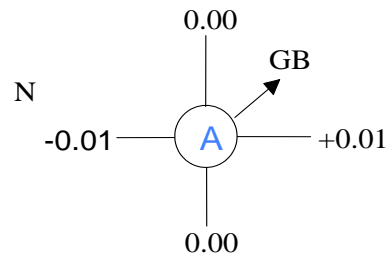
Before Preventive Maintenance

ALIGNMENT READING RECORDS: 101-BJR to 101-BJ

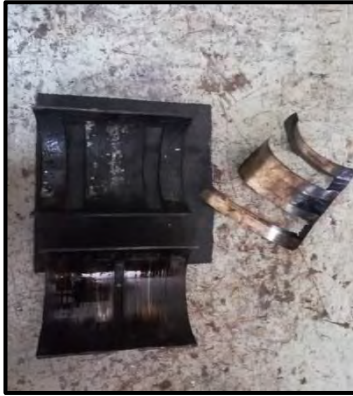
Preventive Maintenance of 104-JT Train was carried out from 11/09/2018 to 12/09/2018 before Annual Turnaround during which drive end side journal bearing of 104-JT found damaged i.e. white metal lining found worn out completely & also heavy scoring was found on shaft journal portion. At that time journal bearing was replaced & shaft was cleaned & polished. Rotor replacement was planned during Annual Turnaround.

DE Journal Brg Sleeve (Before SD)

- Rotor was lifted out of the casing. OST assembly was removed.
- Casing top & bottom halves were cleaned properly.
- Rotor was replaced by the spare one. New journal bearing sleeve provided on DE side.

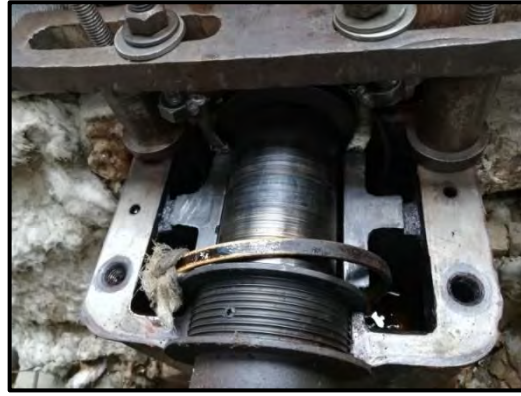
DE side Shaft Journal area (Before SD)

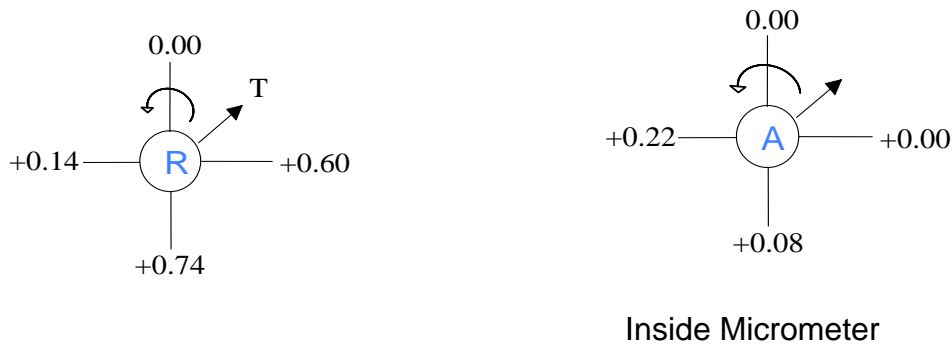
ALIGNMENT READING RECORDS : 104-JT to 104-J

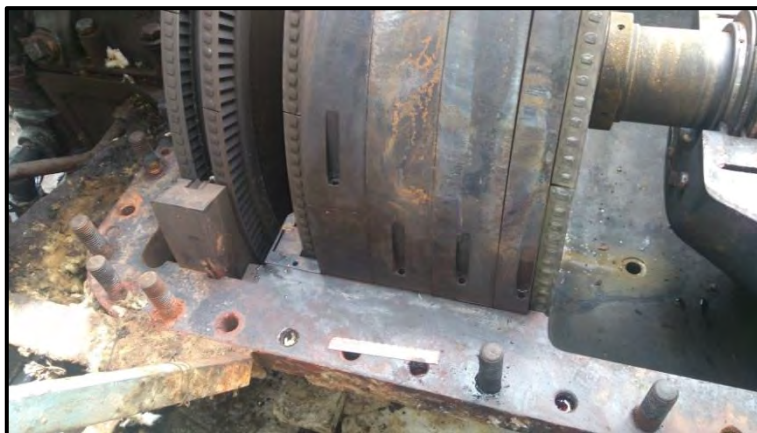
- Turbine was decoupled after removing Coupling Guard.
- All instruments & probes mounted over the turbine were disconnected & removed. The exhaust piping was locked, exhaust bellow & RV was removed.
- Axial thrust & total float was measured and recorded.
- Both end bearing housing and Casing bolts were opened.
- Bearing housing top halves at both ends & casing top half was removed.
- It was observed that #2 diaphragm was found rotated slightly from position.

#1 Diaphragm was found rotated slightly from position

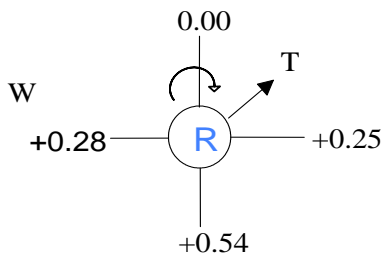
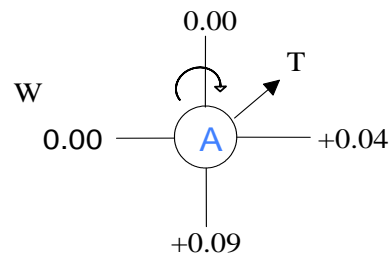
ALIGNMENT READING RECORDS : 104-JAT to 104-JA (Before PM)

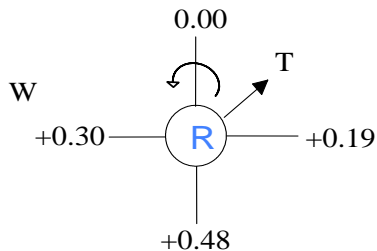
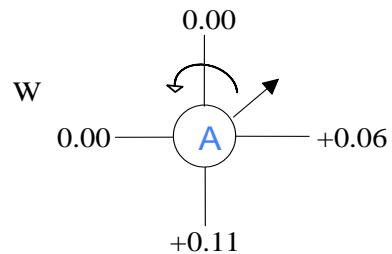
ALIGNMENT READINGS : 104-JAT to 104-JA (After PM)

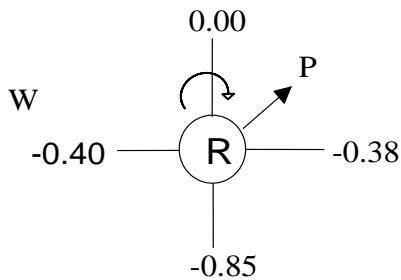
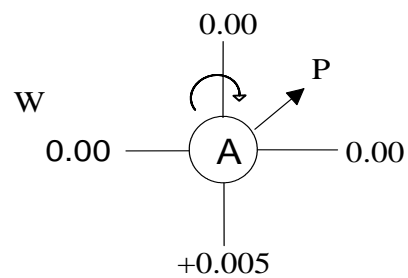
107-JT to 107-J (Before PM)

ALIGNMENT READING RECORDS: 107-J TRAIN

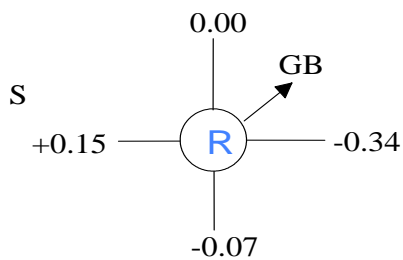
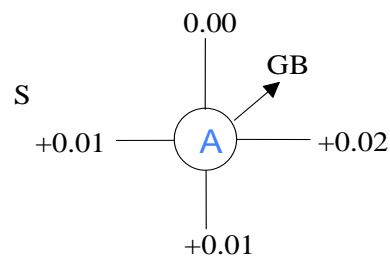
BEFORE

ALIGNMENT READINGS: 115-JAT to 115-GB

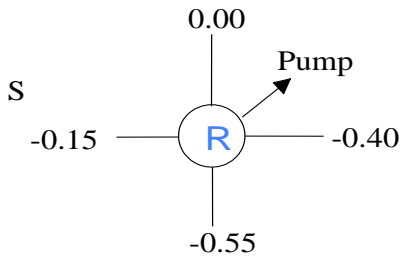
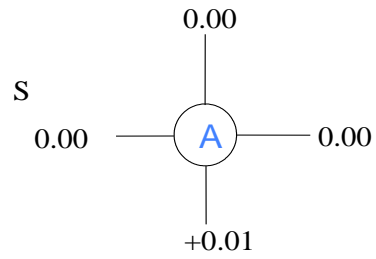
BEFORE

ALIGNMENT READINGS: 115-GB to 115-JA

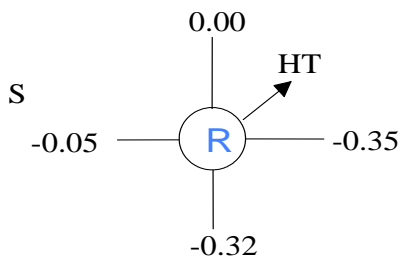
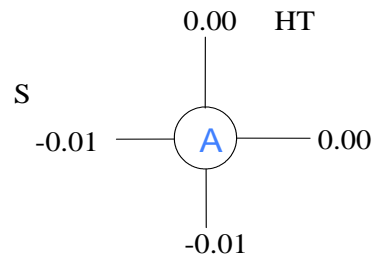
BEFORE

ALIGNMENT READINGS: 115-HT to 115-CLUTCH

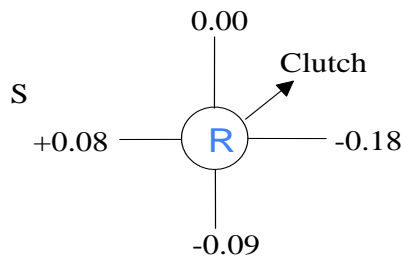
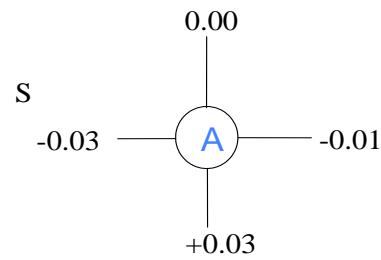
BEFORE

ALIGNMENT READINGS: 115-JA to 115-CLUTCH

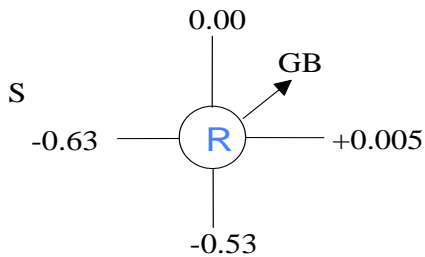
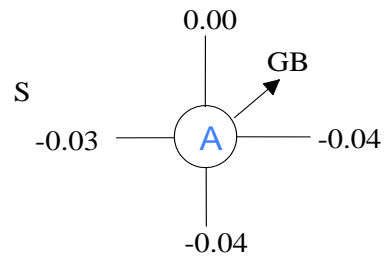
BEFORE

ALIGNMENT READINGS: 115-JBT to 115-JBR

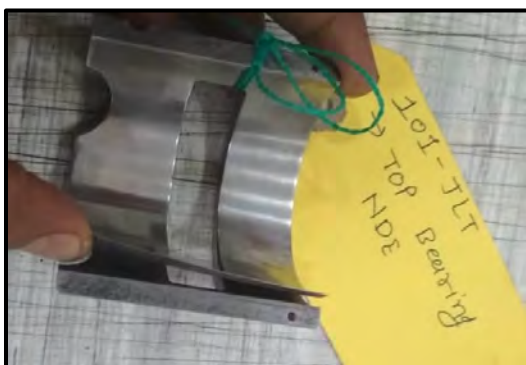
- Preventive Maintenance of Turbine was carried out first time after installation.
- DE & NDE Bearing Housing's top cover was opened for bearing inspection.
- NDE side top half of journal bearing's white metal lining found in detached condition. This bearing was replaced.

Detached White Metal Liner of NDE Bearing Top

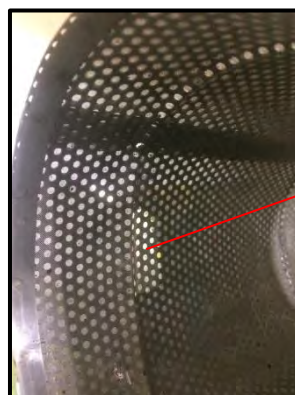
Damaged Mesh of LO pump Strainer

- Mesh of Strainer of LO pump was damaged and the same was repaired.

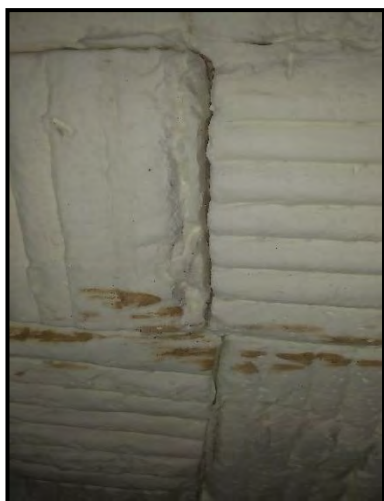
During normal operation, thermography of Reformer wall was done and it was observed that the temperature was high in some areas of side walls. This was due to gaps between the modules at various locations. Hence it was decided to fill the gaps by inserting Ceramic Fibre of suitable thickness (6mm / 12mm / 25mm) and fix with Veneer Mortar during Shutdown. Accordingly, WO No. 201004190871 dated 12/09/2018 was placed on M/s. Unifrax India Pvt. Ltd., to carry out the job.

Gap observed between blocks

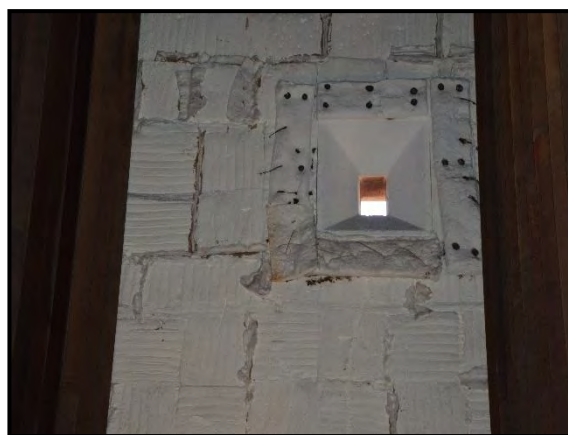
The Z-section module of side wall near peep hole (Control room side) was fall down during normal operation and sparger was provided in this area. New modules were provided in this area.

Peep hole repairing done

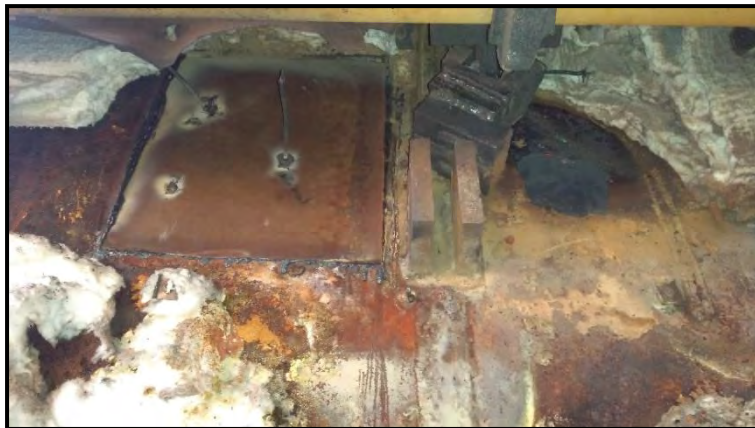
- There was hotspot at South side wall and sparger was provided in this area. It was observed that the insulation of south side wall of MFC was damaged and plate was having hole. The support guide of MFC was removed from position.
- The damaged portion of the plate in this area was replaced and new Ceramic Fibre insulation and incoloy plate was provided. The support guides were also repaired. The castable insulation damaged near Tunnel area was also repaired.

Plate welded on side wall and guide removed from position

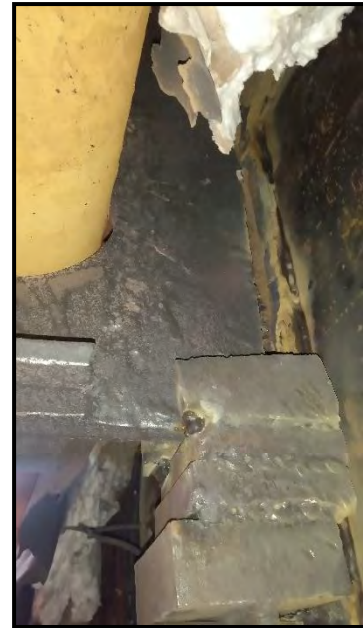
Supports after repair

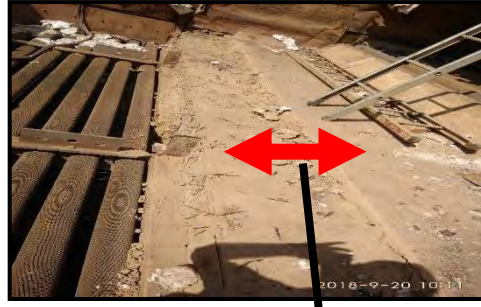
Broken the refractory upto 600mm on bridge plate

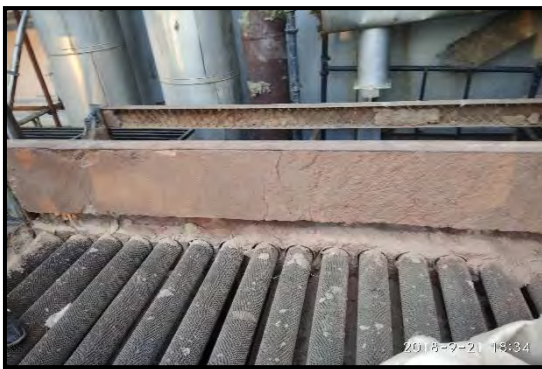
- Cutting of North & south side walls of LT coil carried out at an elevation of 6804 mm. Then it was shifted to ground.
- ETS of new LT Coil was fouling the with the ETS of BFW coil. Hence the height of ETS of BFW Coil was cut by 500 mm from top and ETS of New LT Coil was cut by 75 mm from bottom.

Refractory broken at 500 mm of BFW ETS

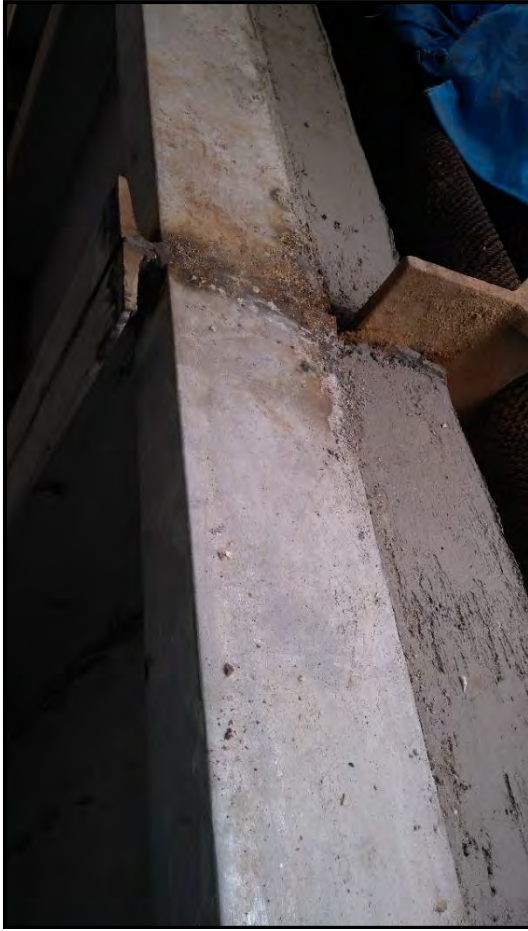
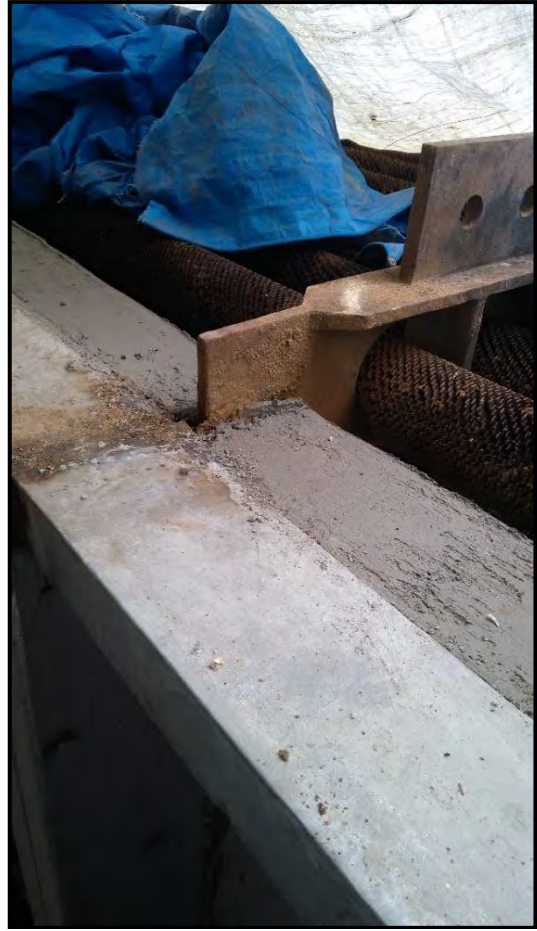
New Refractory on side wall of BFW coil

- Damaged refractory of North and South side walls above BFW coil was removed and new refractory was provided.

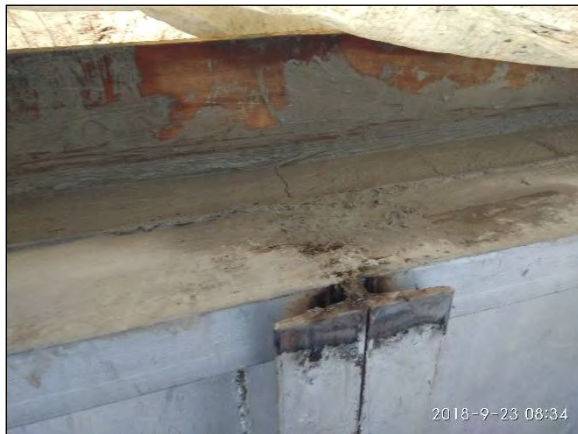
North side refractory

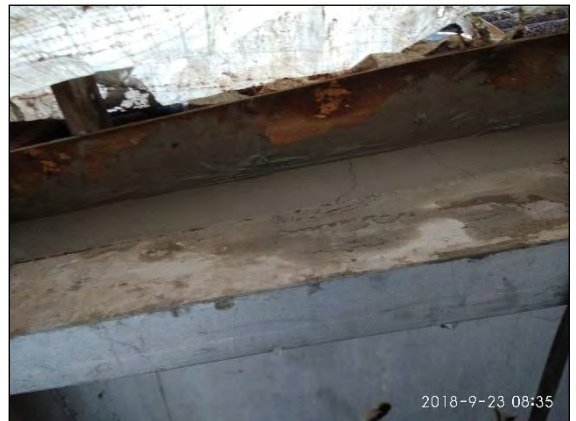
South side refractory

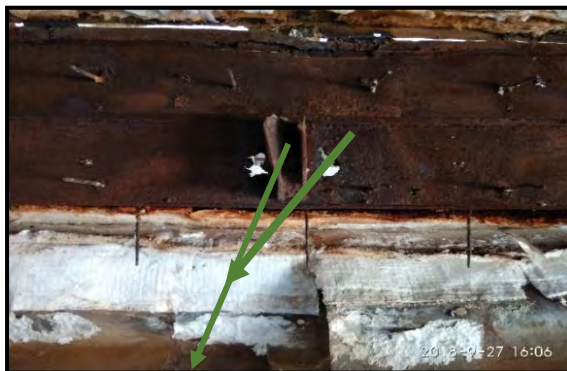
- Casing plate of Transition zone towards HT section was badly corroded and was having holes. So provided patch plate of size 150X 113 X 6mm of 12 qty along the length.

Damaged portion

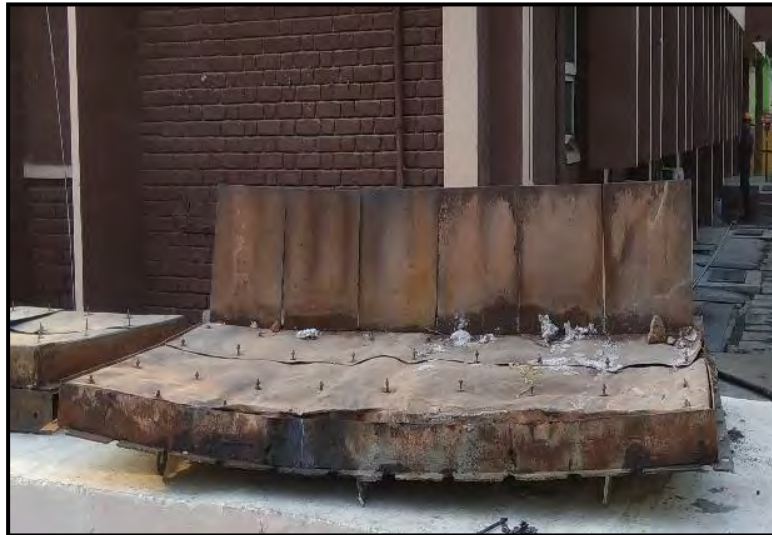
- It was planned to replace the complete insulation of Transition zone and area above LT Coil. However M/s JNK had not supplied sufficient quantity of Incoloy studs and washers. Hence only repairing was carried out wherever insulation was damaged. (M/s JNK later supplied the Incoloy studs with washer).
- The damaged insulation of side wall was repaired by providing new Inconel studs and ceramic fiber blankets of required thickness and Inconel sheets of 0.5mm.
- LT coil top Panels towards silo and C.T side fixed in position and welding was carried out on both sides.
- I-beam supports under bridge plates which were removed were welded in position. (Size- I-Beam-175mm, 7 nos and 200 mm I-beam , 2 nos on each corner)
- End Panel of Mixed Feed coils was replaced as it was bent.

Old panel cover of Mixed feed coil

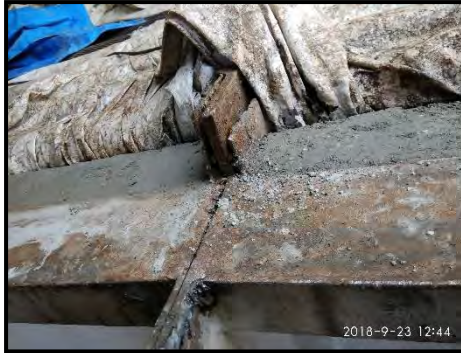
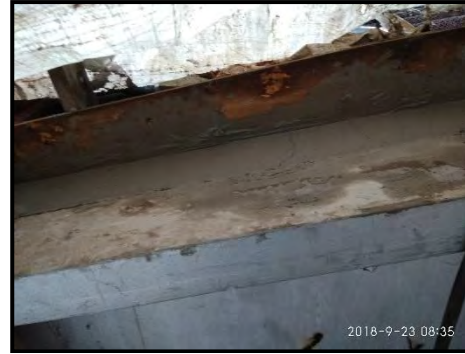
- Welding of header box of LT Coil and BFW coil was done
- Damaged refractory of BFW header box was replaced.

Repair of damaged refractory

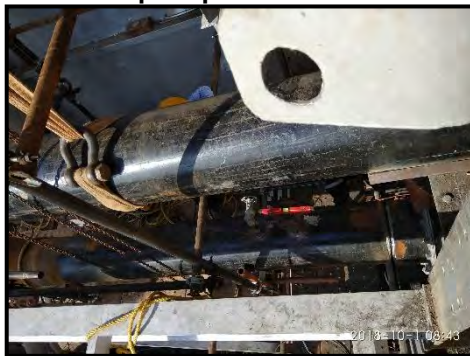
Fit up of spool piece

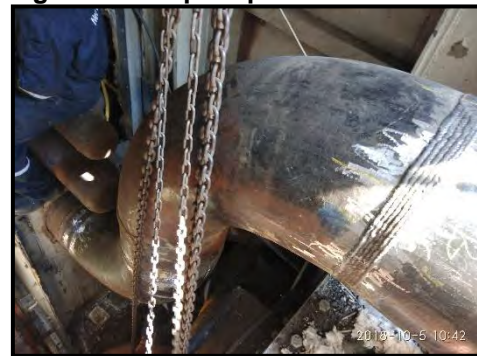
Outlet elbow

- After alignment, started bevel preparation and fit-up of joint J1. It was completed by 01/10/2019, 16.00 hr.
- Started pre-heating the spool piece by coil warping up to 150°C and started root run @ 17.00 hrs. root, first & second hot passes completed by 19.50 hrs.
- Pre-Heated the joints @ 150°C
- Root radiography was done.
- Then final welding was done. Final DP, Radiography and hardness measurement was done.
- Then fit up of elbow (supplied by JNK) at LT Coil Outlet spool piece was done. Then fit up of elbow with spool piece (supplied by JNK) was done. (Layout

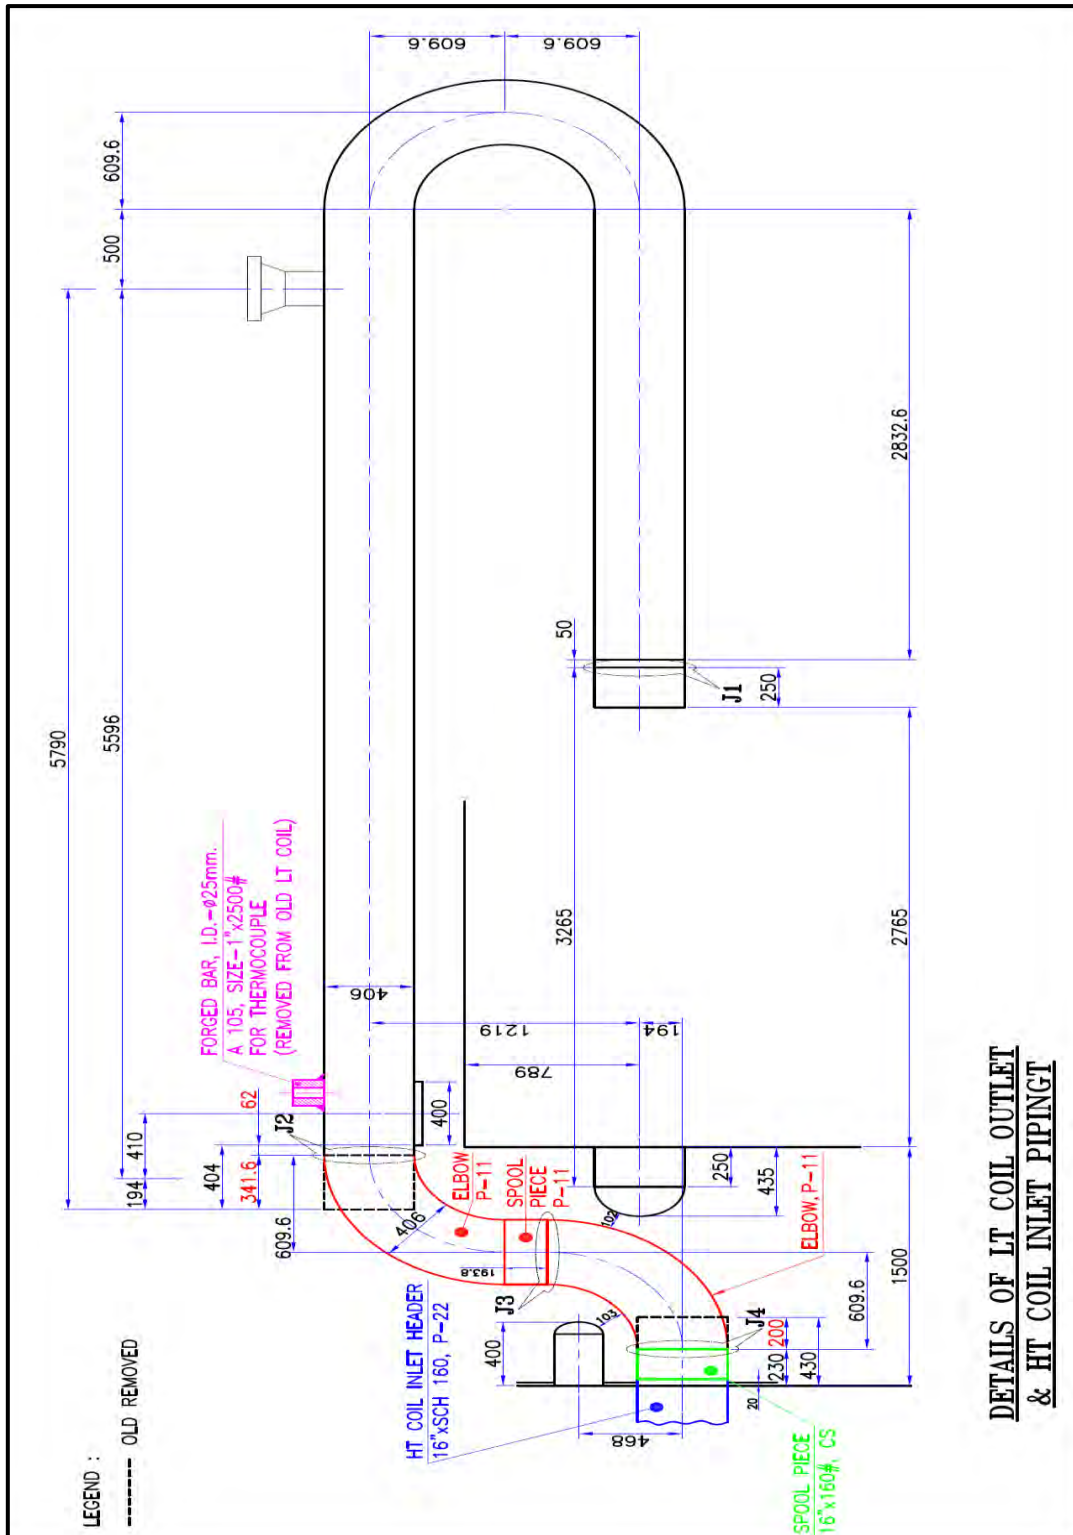
**DETAILS OF LT COIL OUTLET
 & HT COIL INLET PIPING**

drawing was made for LT-Coil To HT coil inlet Spool piece as site condition on 03/10/2018 which is attached below)

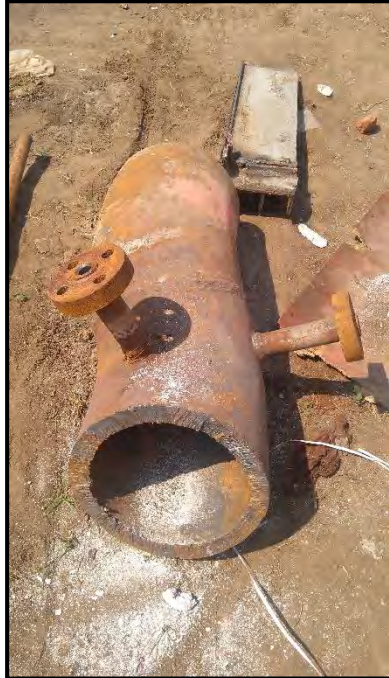
Removed outlet spool piece
