KALOL UNIT

PLANT TURNAROUND REPORT
(SEPTEMBER - OCTOBER – 2018)

Plant Turnaround for the year 2018 was taken from **17th Sep 2018** to **15th October 2018** for carrying out ESP Phase III (Energy Saving Project), Preventive maintenance jobs of Static & Rotary equipment.

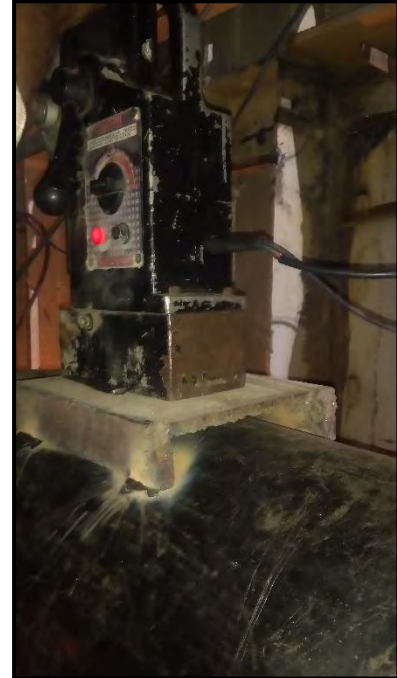
Online drilling for thermowell

- There was no provision for thermocouple for measurement of temperature at LT Coil outlet after Desuperheater. Hence Pipe with Flange (Forged bar Size – 1" #1500, ID – 25 mm) which was removed from the old LT Coil outlet piece and was welded at Outlet spool piece. 25 mm dia hole was drilled in pipe by Magnetic drilling machine by W/s and welding was done.

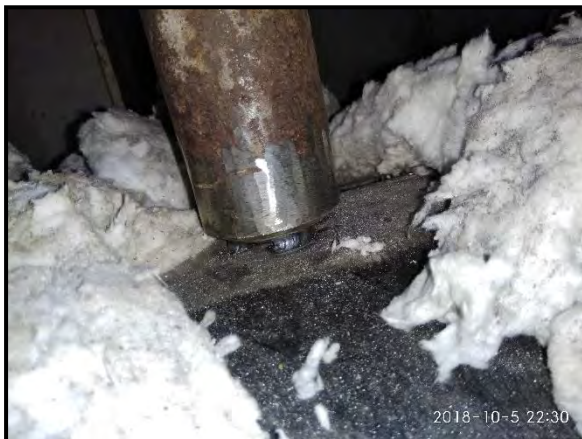
Thermowell pipe was welded on 16" Outlet spool piece after making 25 mm hole

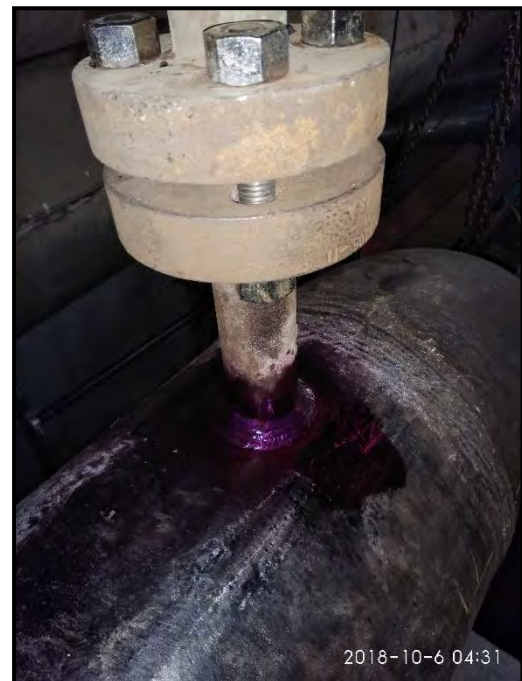
DP after welding

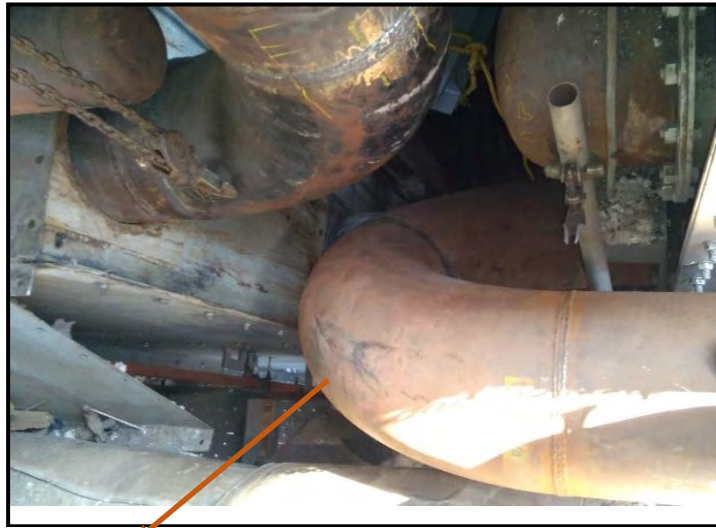
16" elbow welded to inlet header of coil for Blow stack

- LT inlet header was not welded with inlet line. Provision for steam blowing was made by welding 16" elbow at inlet header of coil. The elbow was then welded to 16" pipe and stack was provided in the area between convection

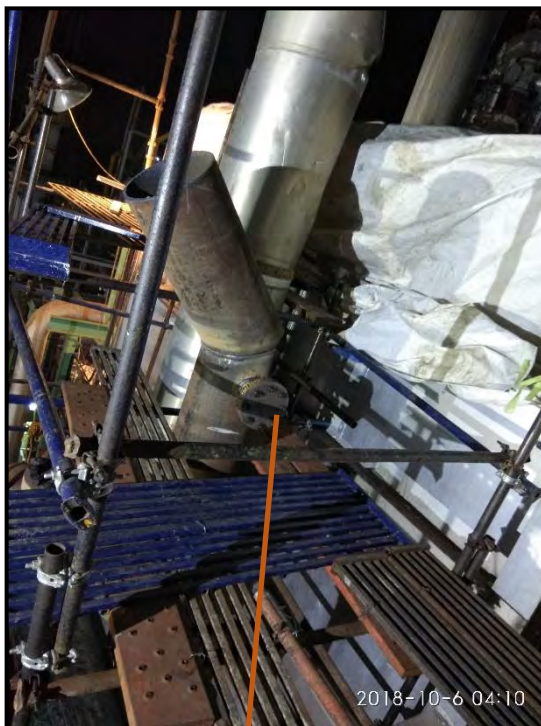
Target plate flange for blow stack

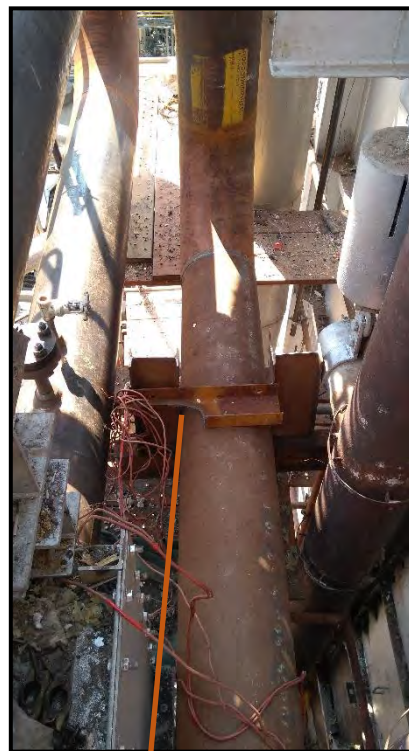
Support for blow stack

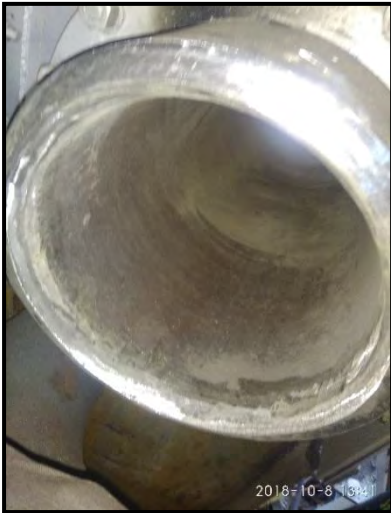
ID reduced up to 15mm of LT coil inlet header

- Blowing of LT & HT Steam super heater coil loop was started at 05.00 hrs of 06/10/2018 and completed by 20.00 hrs of 07/10/2018 with no impression on the target plate. Then got the clearance for blowing arrangements removal.
- Blowing arrangement was cut and removed by 05.00 hrs of 08/10/2018.
- Size of LT coil Inlet header was 16" SCH 160, 40.46 mm thk. and the elbow was of size 16" X Sch 100, 26.19 mm thk. Hence to match ID, LT coil Inlet header ID was reduced by 15 mm.

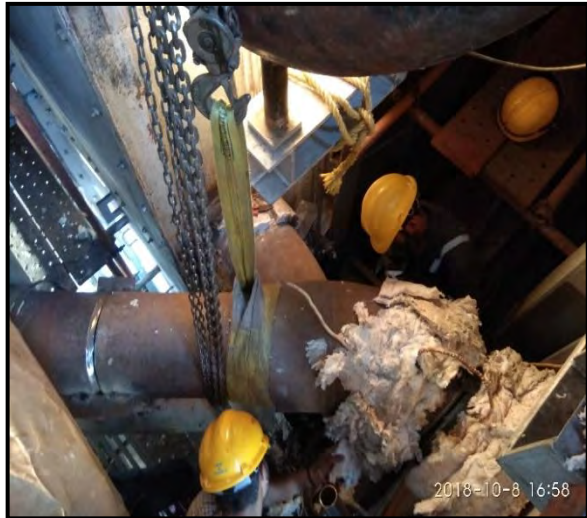
Inlet header spool pieces fit-up

- Fit-up was completed by 18.00 hrs on 08/10/2018, welding completed by 08.00 hrs on 09/10/2018 (J5 & J6)

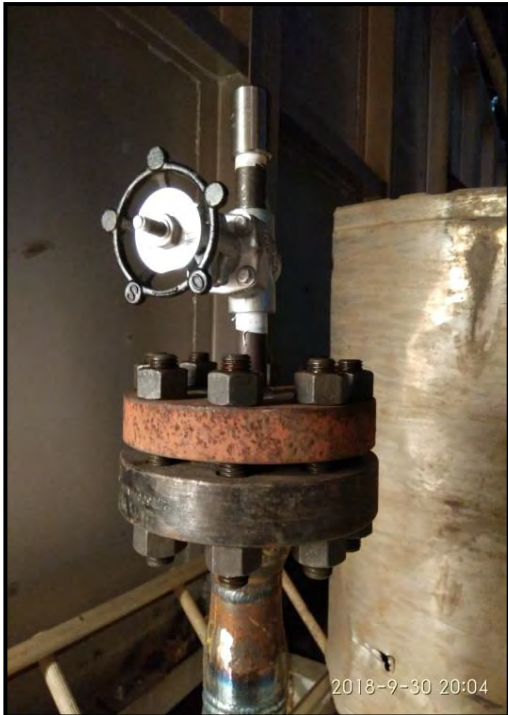
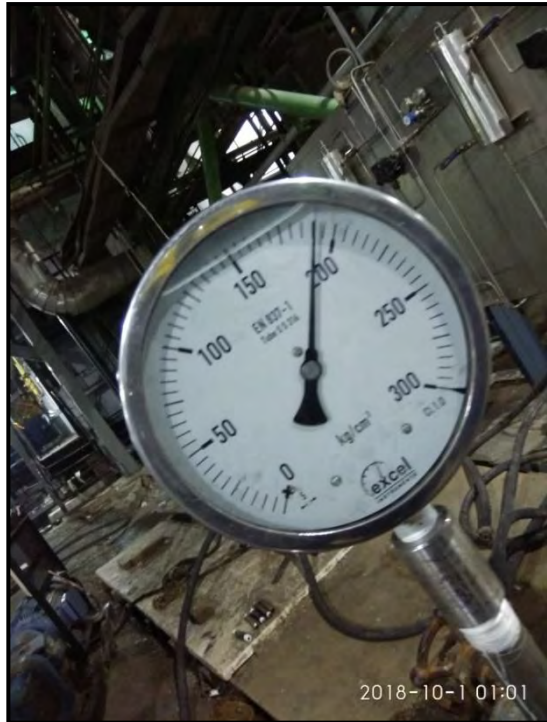
Hydro test @180 Kg/cm²g

- Hydro test was conducted two types internally on 30/09/2018 and in presence of IBR Inspector on 01/10/2018, at 180 kg/cm²g and kept on hold for 20 mins but no leakage was found.
- On 09/10/18 after completion of LT coil Blowing job. Fabrication of remaining joints BFW line was rerouted for de-super heater as per site.
- Joints fit up and welding completed by evening 19.30 hrs.

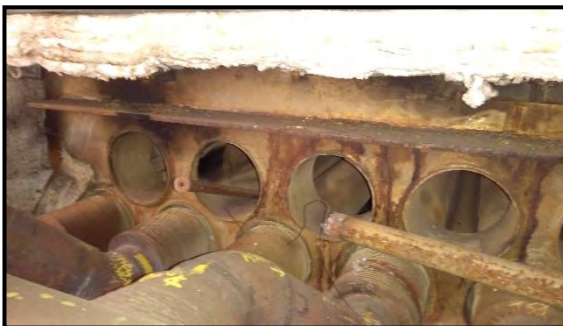
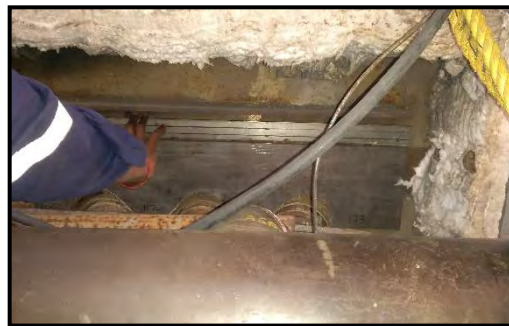
SS 304 Plates were provided on ETS to cover the hole after removal of first coil.

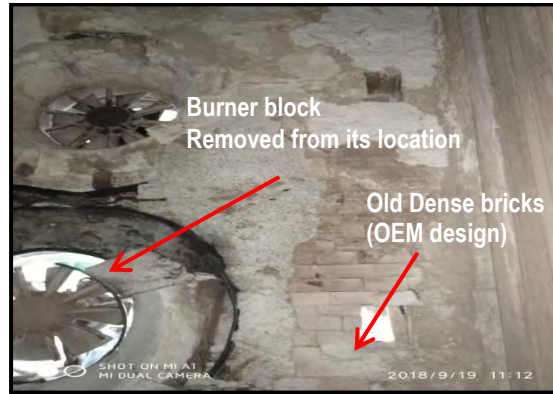
- Refractory of Burner wall was damaged badly.
- Front wall bricks had fallen from its positions i.e. area (east side) between the 4th and 5th burner.
- Top half of 2nd burner block areas were found exposed with casing and without burner blocks.
- Below the 5th burner, major area of front wall was found repaired / patch worked, which were done in previous shutdown.
- Front wall bricks (original design) were exposed in area nearby in-between the area of 2nd & 3rd burner.

Damaged burner block

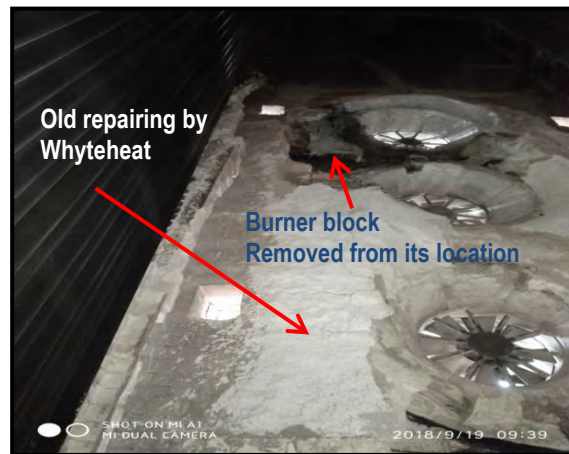
Damaged burner block

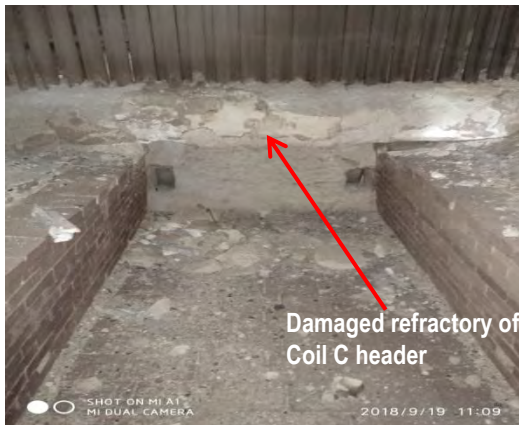
Damaged refractory of coil C header

- Castable refractory of Coil-C header found in damaged condition which was removed by breaker machine. Old Y-type Anchors welded with header were found in satisfactory condition. Additionally two layers of new MS chain links were welded with existing anchors. Wooden forming was done for bottom half of header for approx. 1 meter and casting was done with Insulyte-11. Similarly casting of full length of bottom half of header was done in approx. 1 meter

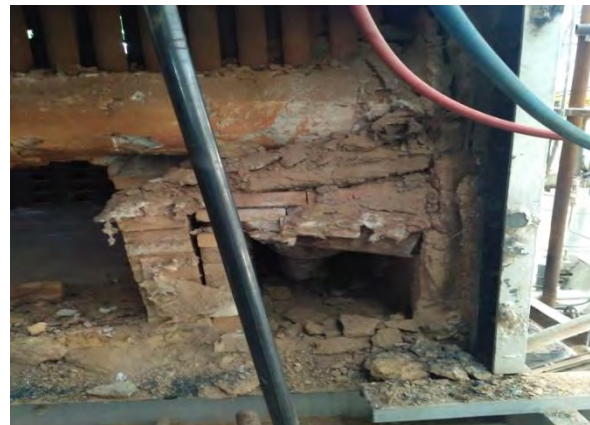
Damaged tunnel brick (birdge wall) with back wall

- **Inner most brick bridge wall** of both side (along the header of Coil A&B) and **partition brick wall** were found in damaged condition. Damaged bricks of bridge wall were replaced and the bricks of partition wall were replaced and height was made as per the MW Kellogg drawing 215-C1. Tunnel bricks & castable refractory toward north end of coil B header were also found in damaged condition. The new bridge wall in both side and partition wall were made by dense bricks. Brick tunnel with retainer plate at north end of Coil B header were observed in damaged condition. New retainer plates (6mm thick, MOC: **Inconel**) at north end of coil B header (both side) were provided to extend the tunnel of coil B header. 12mm expansion gap was kept between refractory tunnel of coil header and back wall. Retainer plate was supported on 3” square box (fabricated by 6mm thick Inconel plate), which was welded with bottom casing by using electrode (E Ni Cr Fe2). 3” square box was covered with 12mm thick ceramic fibre blanket & tightened by Inconel wire. Casting on retainer plates were done with Insulyte-11.

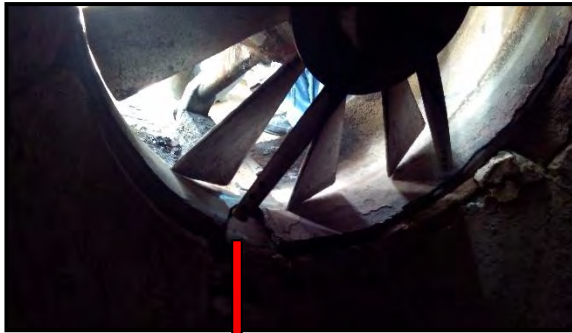
- The arms of Burner # 1, DGN 26 was broken, the lugs was having cracks and burner housing plate was broken at bottom portion.

Burner housing plate was broken

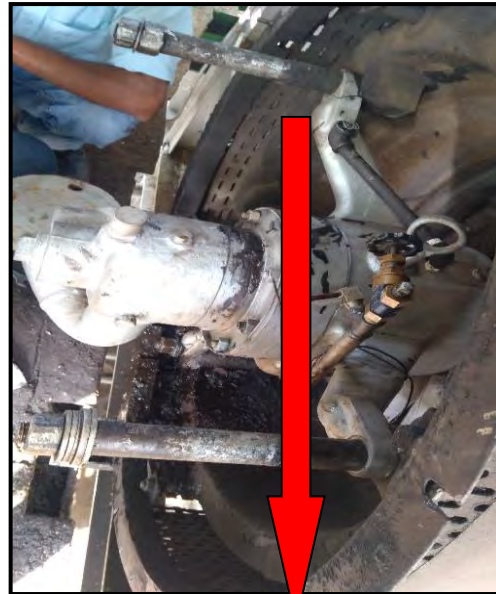
Crack observed

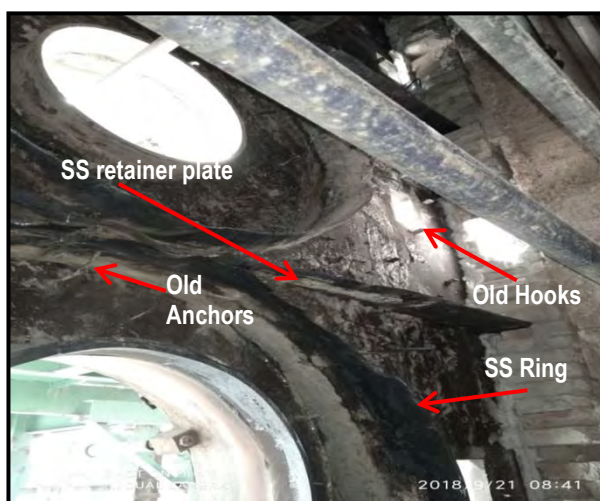
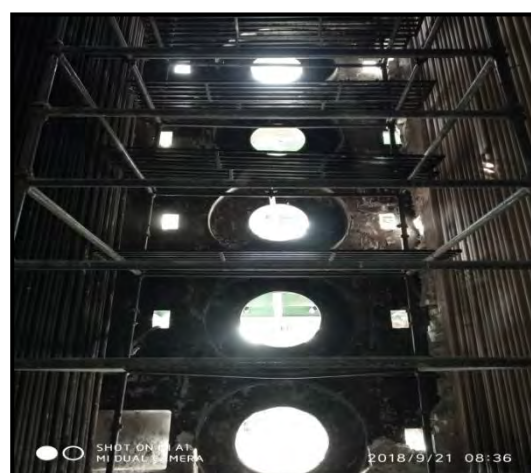
Old refractory removal

- Scaffolding were made inside the boiler for removal of complete front wall refractory
- Old bricks, casted refractory & burner blocks of complete front wall were removed from its position using breaker machine.
- 5 nos. of 14mm thick SS310 ring around the respective burners were cut using plasma cutting tool. Surface flushing was done by grinding
- 4 nos. of 5mm thick SS retainer plates welded with front wall casing were cut with help of plasma cutting tool. Surface flushing was done with help of grinding.

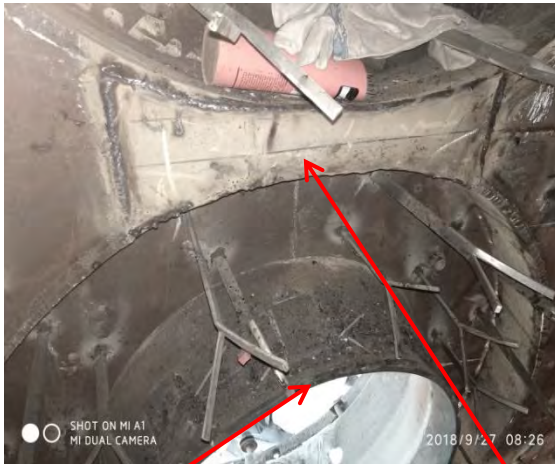
New anchor welded in burner block area & Patch plate

- Complete cleaning of front wall was done with help of buffing tool.
- Welding of UV anchors (height 250mm, MOC : Inconel 601) with front wall CS casing were done by using 3.15mm dia electrode (E Ni Cr Fe2)
- Welding of anchors (height: 360mm, MOC: Inconel 601) with CS casing of burner port were done by using 3.15mm electrode.
- Welding of hooks (MOC : Inconel 601) for brick holder pins with front wall CS casing were done by using 3.15mm dia electrode (E Ni Cr Fe2).
- Bituminous painting was applied on complete front wall.
- Castable lining was done in each part (90mm depth) of all burner blocks by Insulyte-11 as shown in figure below.

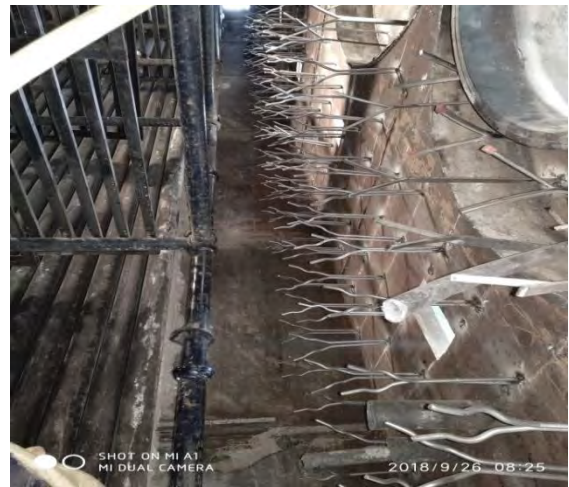
Anchor welding in burner block area

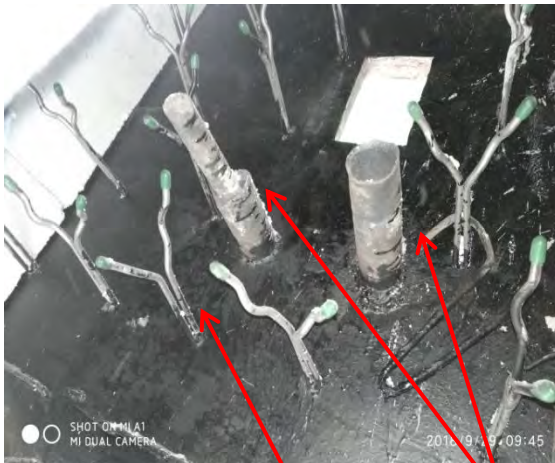
Bitiminius painting, new anchor & old piping (for draft measurement)

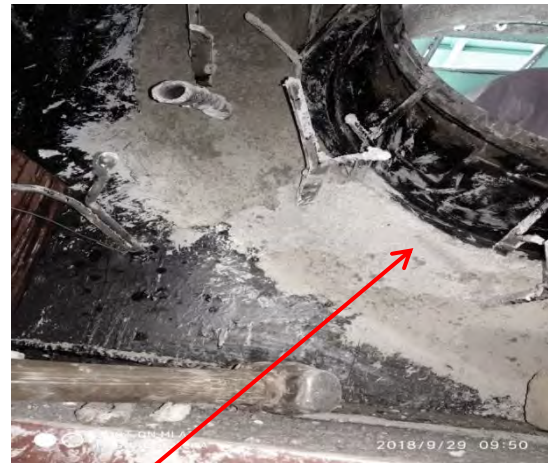
Insulyte-11 in port of burner block to match the level

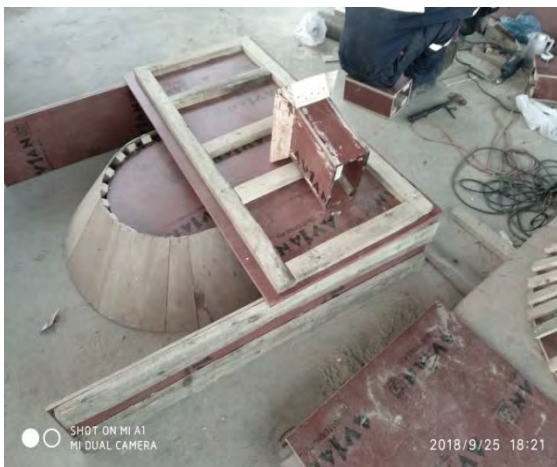
Wooden formwork preparation for castable burner block

- Wooden formwork was prepared for bottom half of 1st burner and casting was done by Refractory Accmon70M. Wooden formwork removed after 8 hrs of curing.
- Wooden formwork was prepared for top half of 1st burner and casting was done by Refractory Accmon70M. 3 mm thick ceramic paper was placed in between the top & bottom half of burner block before casting of top half to keep 3.0 mm expansion gap. Wooden formwork removed after 8 hrs of curing.
- After casting of 1st burner block, wooden formwork was prepared for remaining portion at east side, west side & bottom side of 1st burner. Casting was done by refractory Insulyte-HT. 12mm thick fibre blanket was placed in-between the castable lining of Accmon70M and Insulyte-HT to keep 6mm expansion gap. Wooden formwork removed after 8hrs of curing.

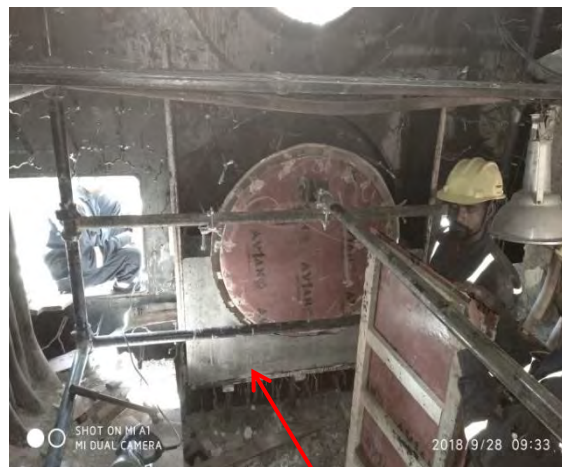
Castable lining of bottom half of 1st burner (bottom most)

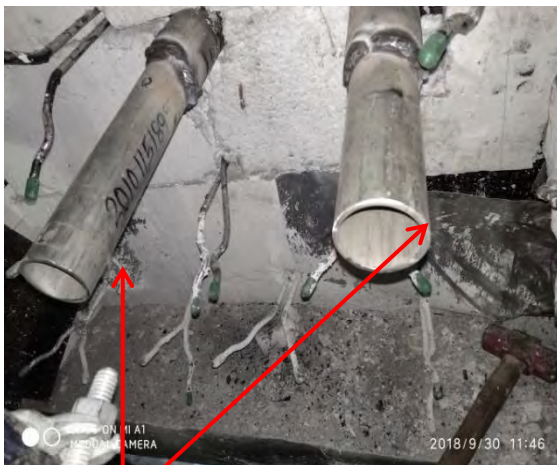
New Pipe (Inconel 800 , 1-1/2" x sch 40) for draft measurement

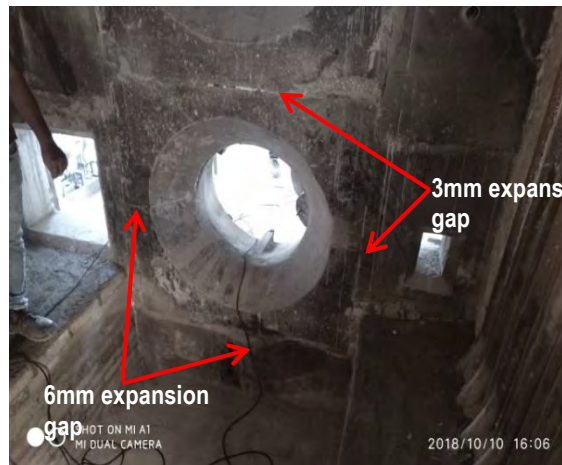
Expansion gap

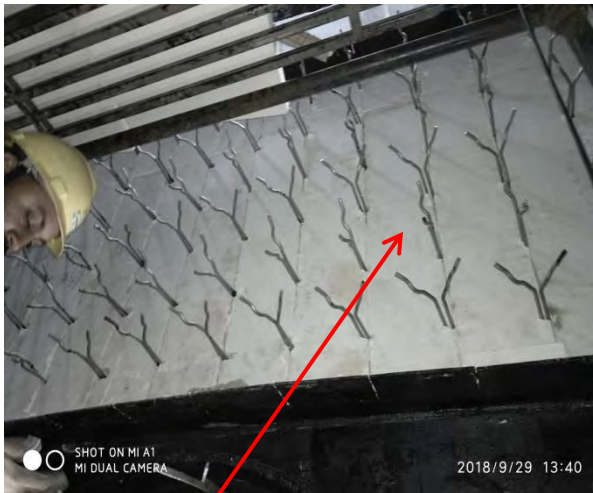
From top of 5th burner – New anchor with ceramic board

- 50mm thick ceramic board was placed on casing before starting of porosint 750 bricks work.
- 75mm wide SS304 plate was welded with existing SS retainer plate and enhanced the height from 165mm to 240mm. Bottom most row of porosint bricks (230mm x 115mm x 75mm) were kept on SS retainer plate by keeping height 115mm. after that all bricks were kept keeping 75mm height as shown in figure. After each fourth row (vertically), brick holder pins were inserted on bricks & hooks. Up to 11.2 meter from bottom of burner wall, porosint 750 bricks were used as shown in figure.

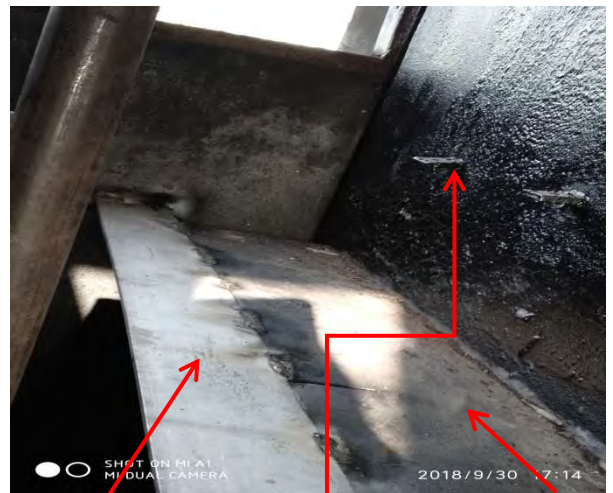
New SS304 plate welded with old retainer plate & hooks for brick holder pin

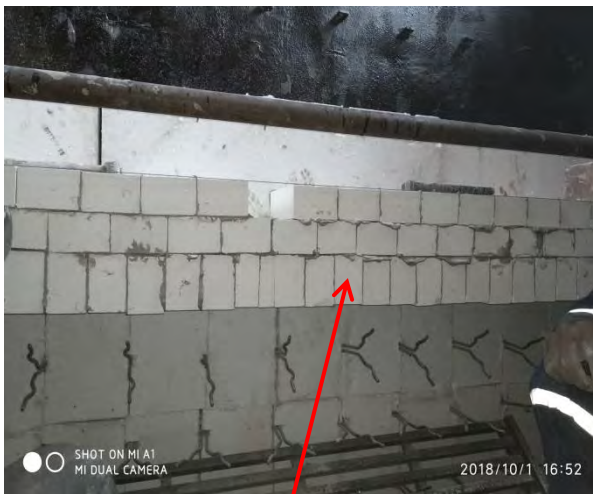
Porosint 750 bricks (bottom most)

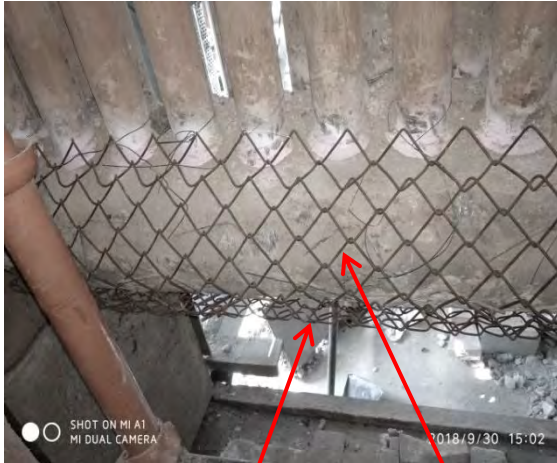
Coil C Header – new MS Mesh & Old welded anchors

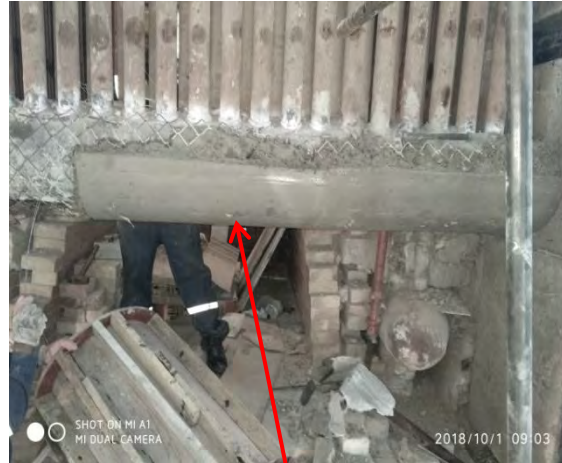
Castable lining of Coil C header (Under progress)

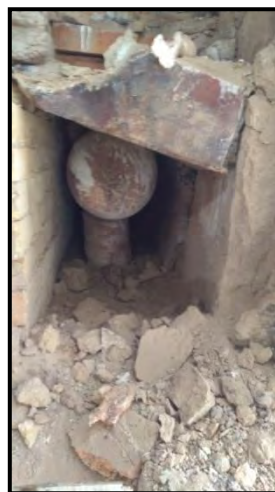
Retainer plate and refractory at north end of Coil B header was in damaged condition

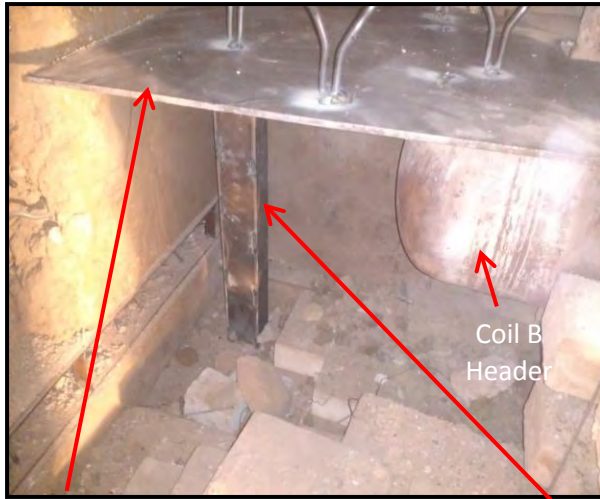
Retainer plate for tunnel brick & castable and support

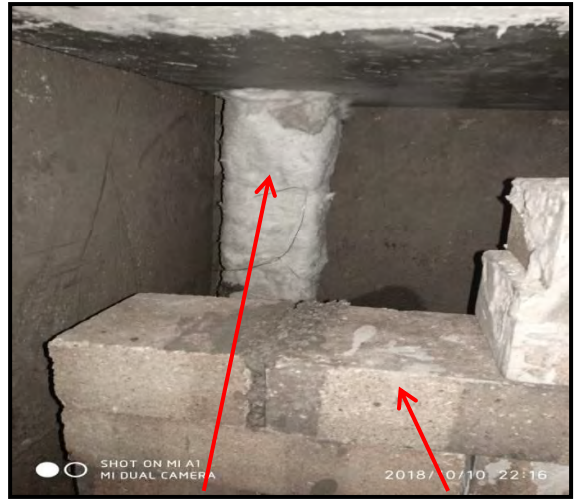
Ceramic fibre blanket and tunnel dense brick

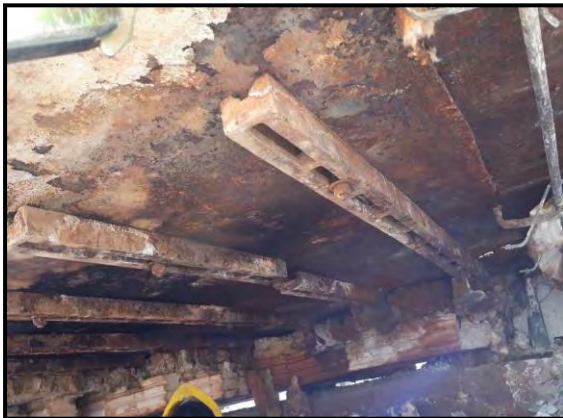
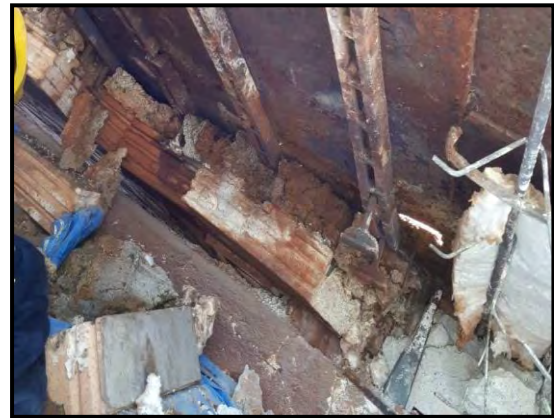
Top roof Hanging bricks after removal

- Around 25% of total top roof area towards north side was found casted and most of the area of castable refractory was found in damaged condition. SS rods with anchors were exposed which were welded with top roof to support the old refractory casting. At some locations, hanging dense bricks were found missing from its position. Castable refractory of top outlet header of Coil A & B found in satisfactory condition.

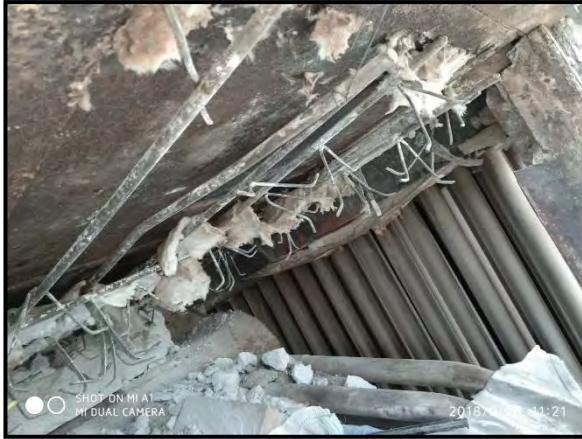
Top roof – 25% of top roof area was provided with castable supported with welded SS rods and hangers

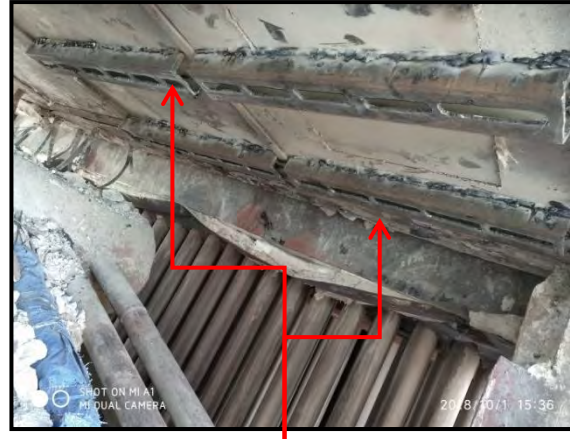
New channel welded with top roof

- 12 nos. of new slotted channel (600mm long) were fabricated from 75mm CS channel.
- The fabricated slotted channels were welded with top roof by keeping the distance 330mm between two channels (at previous locations).

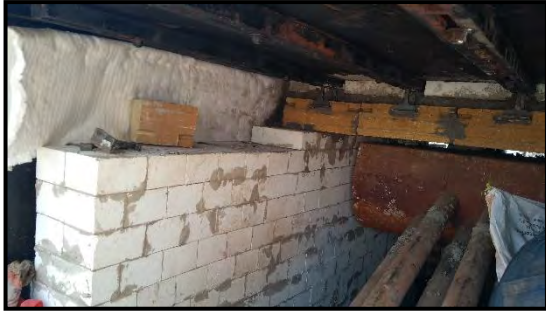
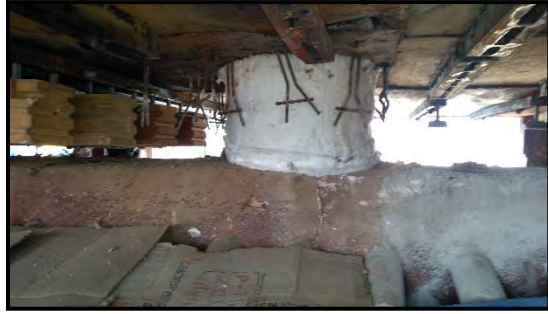
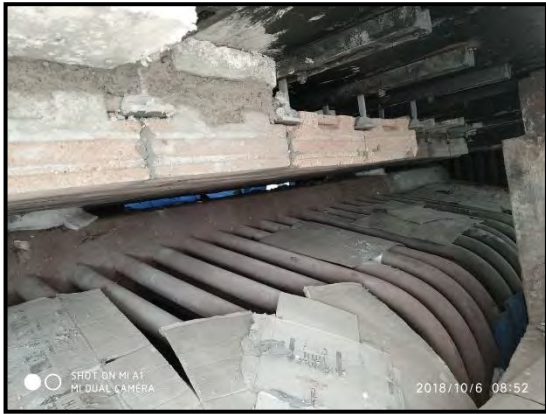
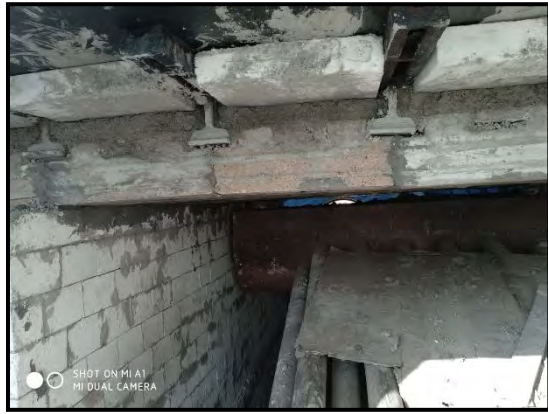
Roof Brick installation under progress

- Similarly the top roof brick linings (three lining of bricks) were done from south side to north side one by one brick lining. L-type hangers were used at ends of slotted channels.
- Total 493 nos. of hanging bricks i.e. 17 nos. of brick lining row from south side to north side and total 29 nos. of brick lining row from east side to west, were used in complete brick lining of top roof.
- Around the riser header of coil A & coil B, UV type anchors (H=140mm d=8mm SS310) were welded, fiber blanket (thickness 25mm) was wrapped around the header, wooden formwork was prepared and casting was done by Accmon70M.
- Near Coil C, castable lining was done by using Accmon70M after welding of UV anchors at some portion where space for brick lining was not available.

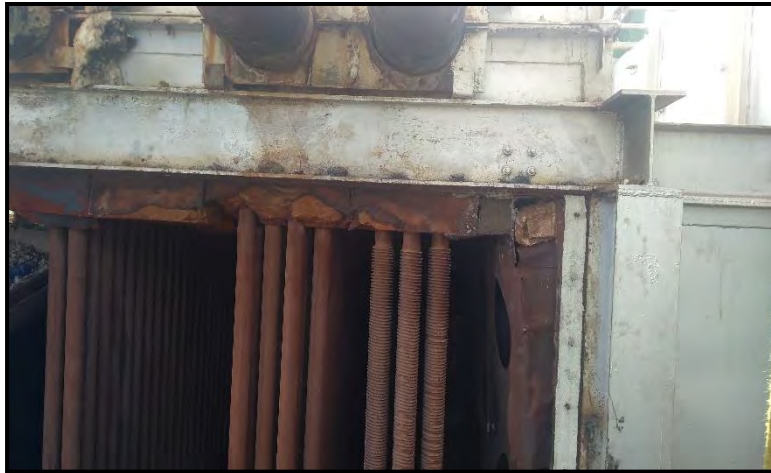
View of Coil C,D & E after removal of Wall #10

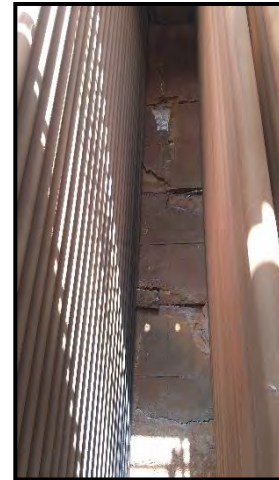
- Total 10 nos. of bolted panels i.e. 5nos. in each east and west wall (near Coil D & E) were removed & lowered to the ground with the help of kobelco crane one by one. Side plates of all removed bolted panels of east wall were observed in damaged and deformed condition. Old anchors of existing panels were cut by grinding. Damaged side plates of panels were completely removed by gas cutting. New side plates (5mm thick, MS plate) were welded with old panels. All deformed panels were straightened. UV-type anchors (MOC: SS310) were welded on panels by keeping 200mmx 200mm square pitch. Bituminous painting was applied on panel surface. Castings of all panels were done with Insulyte-11. All bolted panels were boxed up from bottom to top one by one with help of kobelco crane.

Damaged wall #10

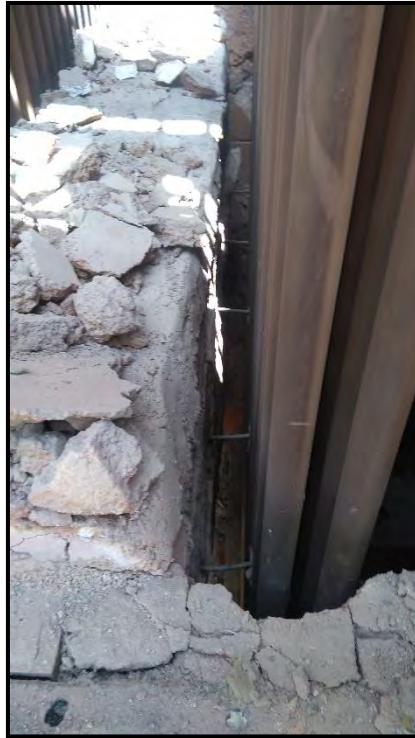
- From north wall of boiler, total 7 nos. of panels were removed. Out of 7, 3 panels were bolted & remaining 4 panels were welded. Welded panels were damaged during removal by using gas cutting and bolted panels were in bulged conditions. All 7 new panels were fabricated by using 5mm thick MS plate and new C channels were fabricated with size of 150mm x 165mm for frame. Out of total 7 nos. of north wall panels, 2 panels were fabricated with provision of bolting and peep holes. UV-type anchors were welded in all

Damaged refractory of Wall #9

panels and C-channels. Bituminous painting was applied on panels and C channels surface and casting was done by Insulyte-11. Except bottom two panels, remaining five panels were welded at framing, fabricated by 150mm C-channel. Bolting provision were done for both bottom panels.

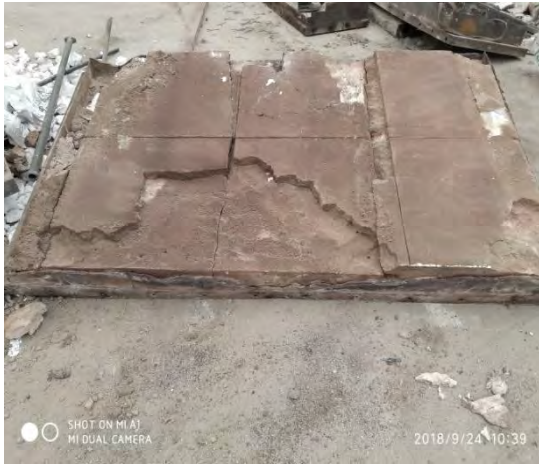
Damaged refractory of removed panel

- 3 nos. of panels of west wall (near coil C header) were removed by gas cutting. One bottom side panel of east wall (near coil C header) was removed by loosening the bolts and remaining 2 welded panels were removed by gas cutting. All 5 welded panels were damaged during removal by using gas cutting. New 5 nos. of panels were fabricated except bolted panel. Castings of all panels were done with Insulyte-11 after welding of UV-type anchors (MOC: SS310) and bituminous painting. All welded panels newly fabricated and boxed up at position by welding.

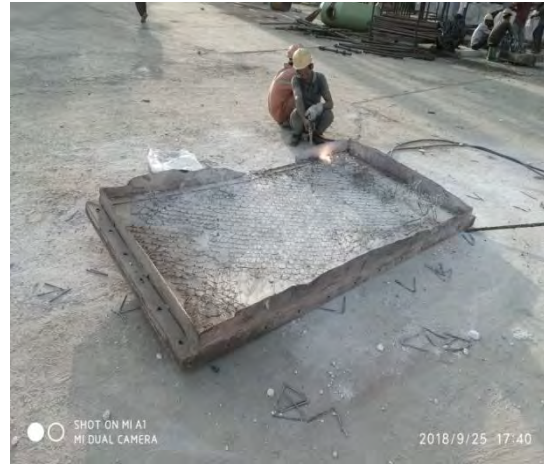
Damaged side plate cutting from panel

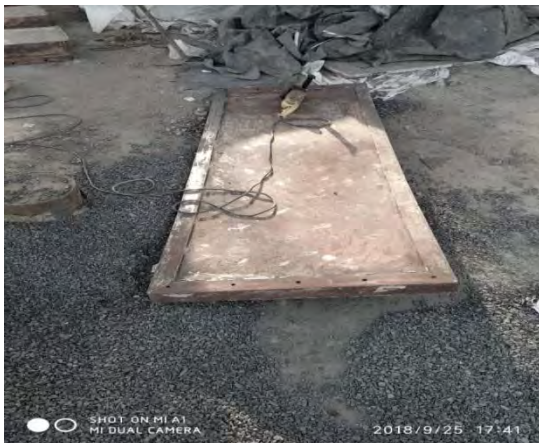
Panel after cutting of side plates

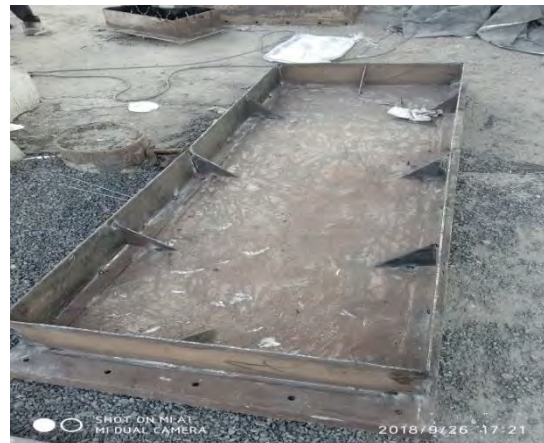
Welding of side plate and retainer with old removed panel

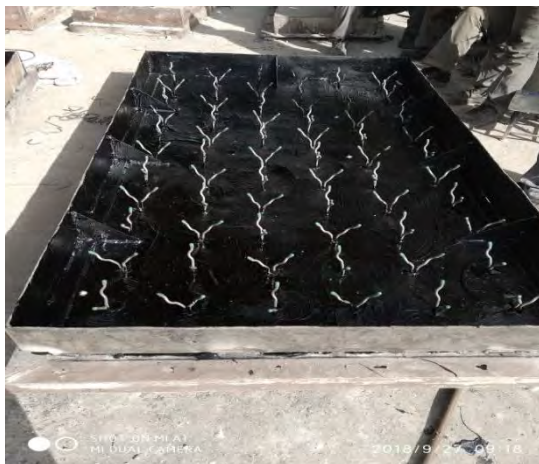
Panel after welding of Anchors and bituminous painting

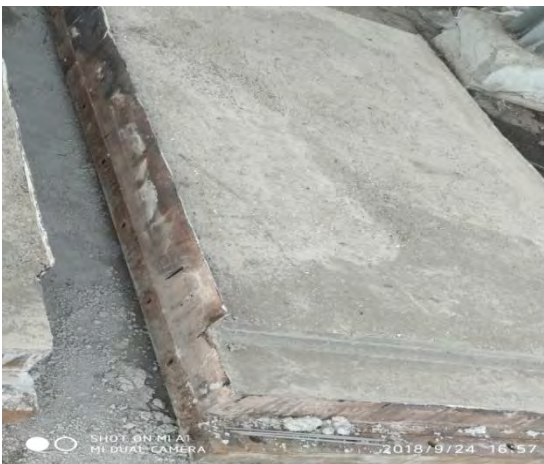
New castable Insulyte -11 in Panel

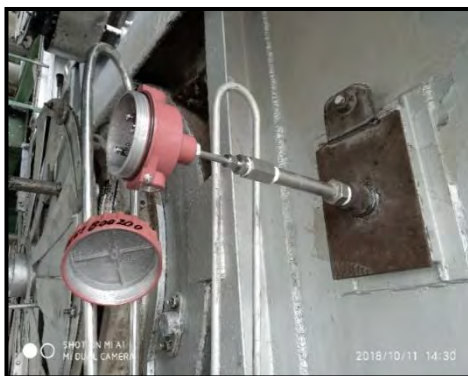
Temporary Thermocouple fixed in peep hole

To perform the initial heating of castable lining, Primary reformer tunnel burner portable burner was installed by providing a plate in the place of 1st burner (bottom most) of auxiliary burner. A temporary pipe line of ¾” size was fabricated from PG tapping of Separator, 178-F to this Burner. PG was provided in this line. For monitoring & controlling the heating, 4 nos. of temporary thermocouples (F1, F2, F3 & F4) were installed in peepholes of front wall (burner wall) i.e. both sides of 1st & 5th burner and 2 nos. of temporary thermocouples (R1 & R2) were installed in peep holes of north wall.

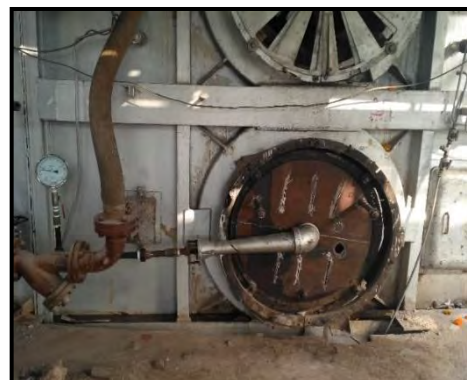
Temporary portable burner (primary reformer tunnel burner)

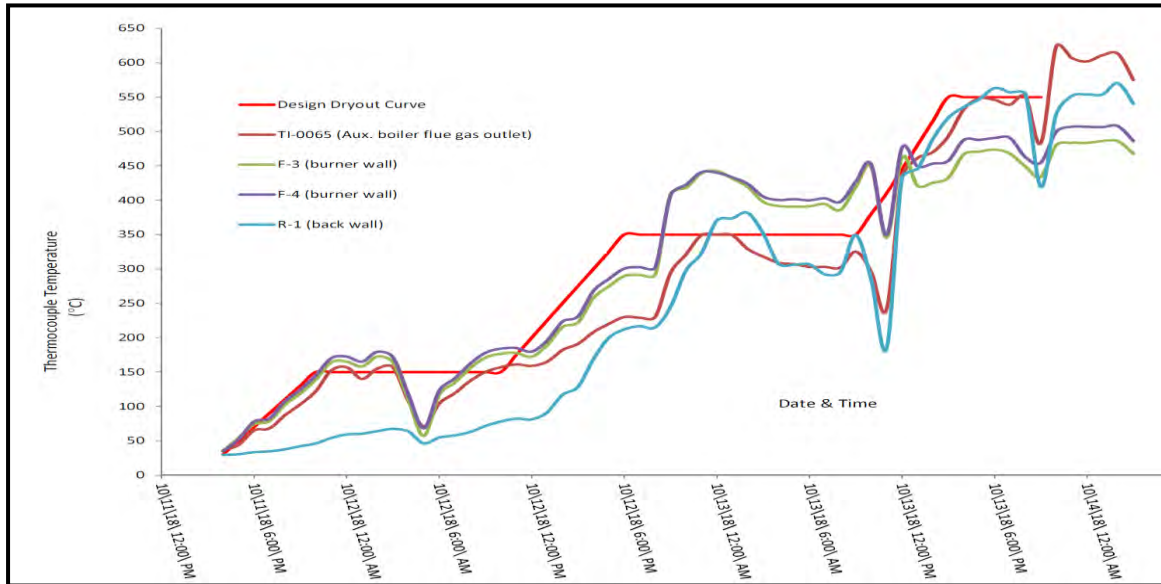
Actual Dryout schedule

Heating of castable lining was started on 11 October 2018, 4.00 PM and finished on 13 October 2018 9.00PM after 53 hours of Dryout schedule. Actual heating curve comparative with design dryout curve is shown as below in figure. Readings of thermocouple F1 & F2 were not taken into consideration for monitoring & controlling the heating of castable lining. After 53 hours of dryout schedule, auxiliary boiler was taken in line.

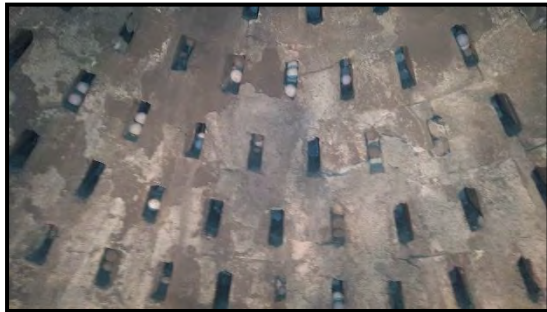
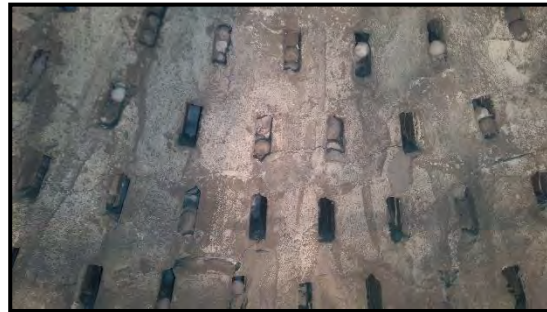
- 103-D, Secondary Reformer only Bottom Dome was opened for inspection.
- It was observed that the opening of bottom brick layer was choked by Alumina Balls. These Alumina balls were removed
- Lining of 103-D to 101-CA and CB were found OK
- Damaged refractory repair was done by Civil.

103-D bottom opening was choked by Alumina Balls

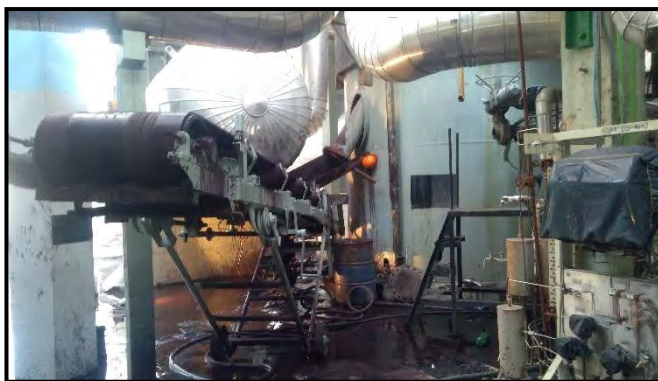
Unloading of Catalyst

- 104-D2, LT Shift Converter: Manholes were opened. Screens were removed for catalyst replacement. After removing all catalyst from the vessel, internal inspection of the vessel was carried out.
- Stiffening rod of the inlet distributor (09 out of 12) found detached at North, South & East side, repaired by welding.
- Thermowell pipe found bent and its assembly found loose at end. It was repaired.
- After filling bottom Alumina balls, Bottom floating screen was provided.
- Then Catalyst loading was done.
- Then Rasching ring was provided above catalyst.
- Then top Floating screen and grating was provided
- The bottom Floating ring mesh (Mesh size 3 X 3) and Top floating ring mesh (Mesh size 2 X 2 X 0.063" Ø & Mesh size 6 X 6 X 0.054" Ø) were replaced.
- Manhole boxed up.
- LTS Catalyst was replaced after 6 years (earlier replaced on 2012)

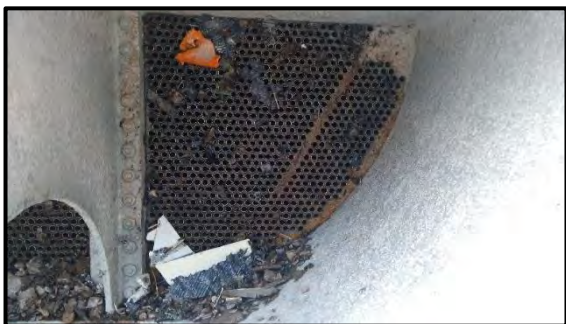
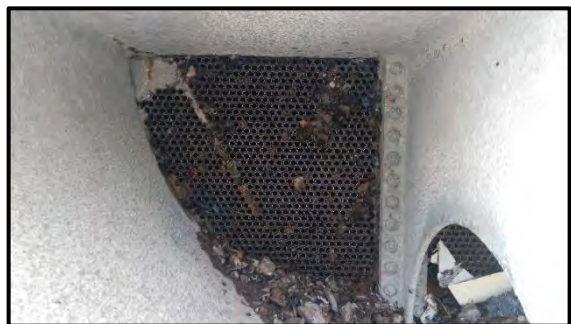
101-JCA/B

Deposits found after opening 101-JCA

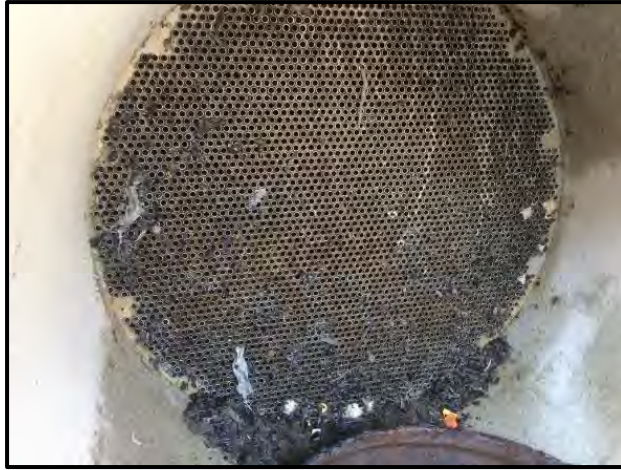
- After opening, Deposits found after opening 127-CA & B
- Basket strainer was removed after removal of the Flushing line.
- The Flushing Valve provided on 127-CA & CB during SD-2017 by Technical was replaced as it was unable to operate during normal operation.
- Basket Strainer and Flushing line was assembled and cover was boxed up.

Deposits found after opening 127-CA & B

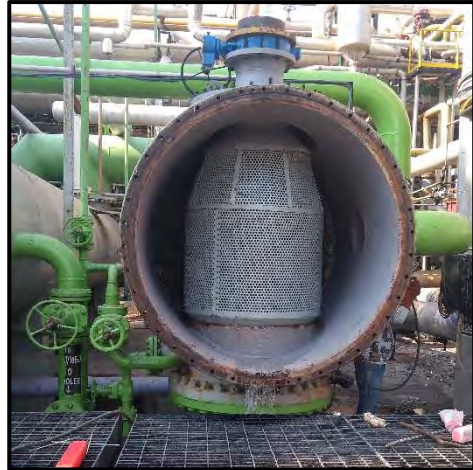
Strainer assembled after cleaning

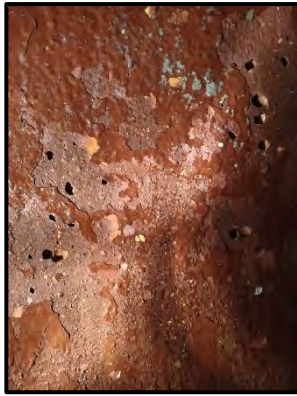
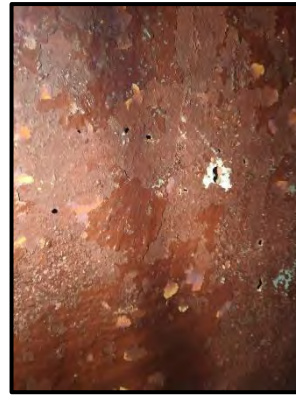
103-F, Reflux Drum: Manhole opened for inspection and then boxed up. No repairing points observed. Cavities observed in Epoxy at scattered locations in lower half of the vessel. Epoxy coating was done inside .

Cavities observed in Epoxy at scattered locations

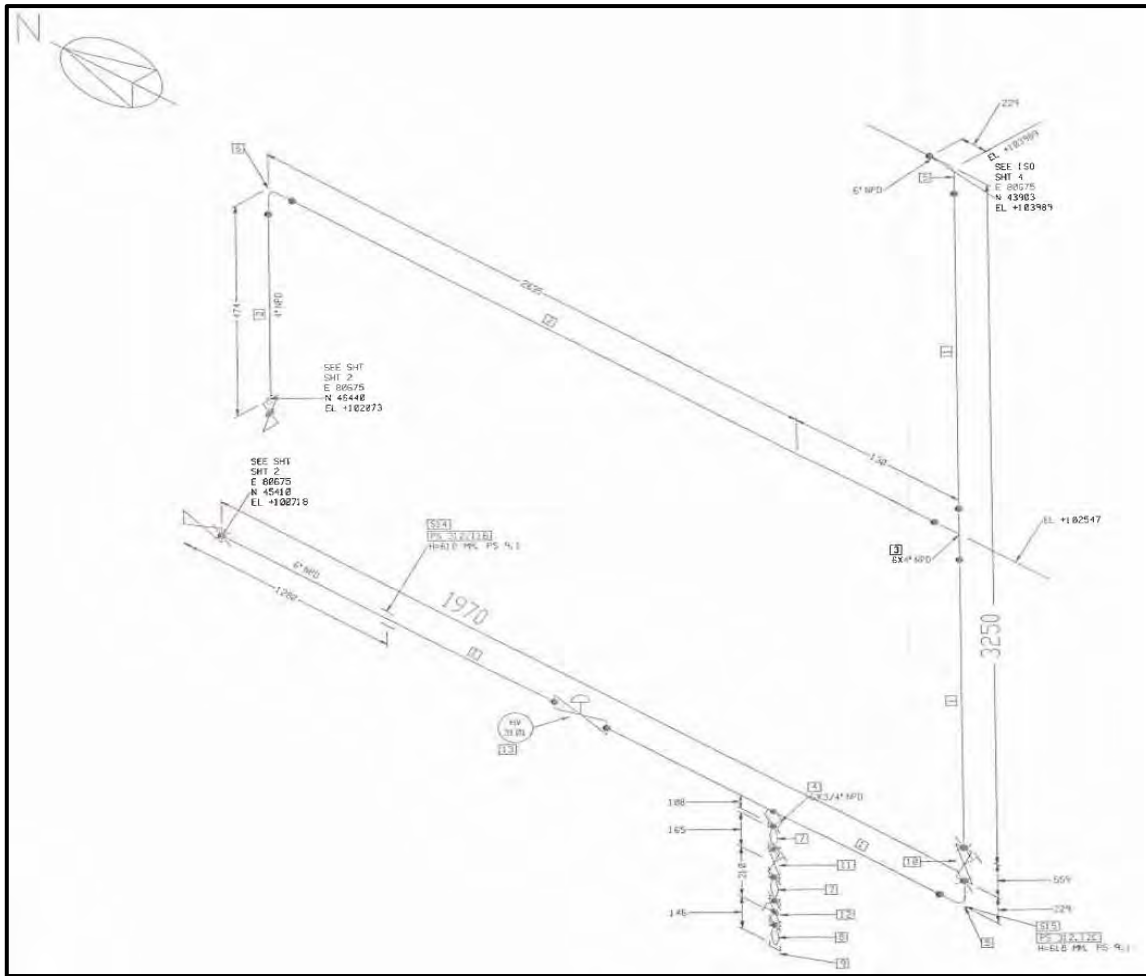
Control Valve HICV-3101 was provided

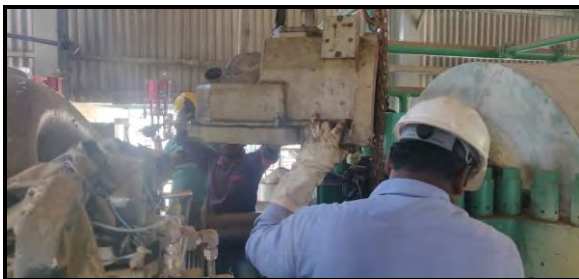
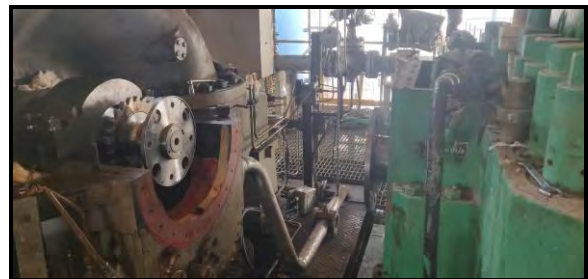
- Dismantled the coupling guard.
- Decoupled the Turbine from LP case.
- Alignment of Turbine and LP case was checked and found ok.
- Journal bearing assembly on free end side was opened for inspection. Found clearance values outside the acceptable limit. (Ref Table-1) and hence it was decided to replace the same with new tilting pads for maintaining the clearance values.

DRIVE END BEARING REMOVAL UNDER PROGRESS
