KALOL UNIT

PLANT TURNAROUND REPORT
(SEPTEMBER - OCTOBER – 2018)

Plant Turnaround for the year 2018 was taken from **17th Sep 2018** to **15th October 2018** for carrying out ESP Phase III (Energy Saving Project), Preventive maintenance jobs of Static & Rotary equipment.

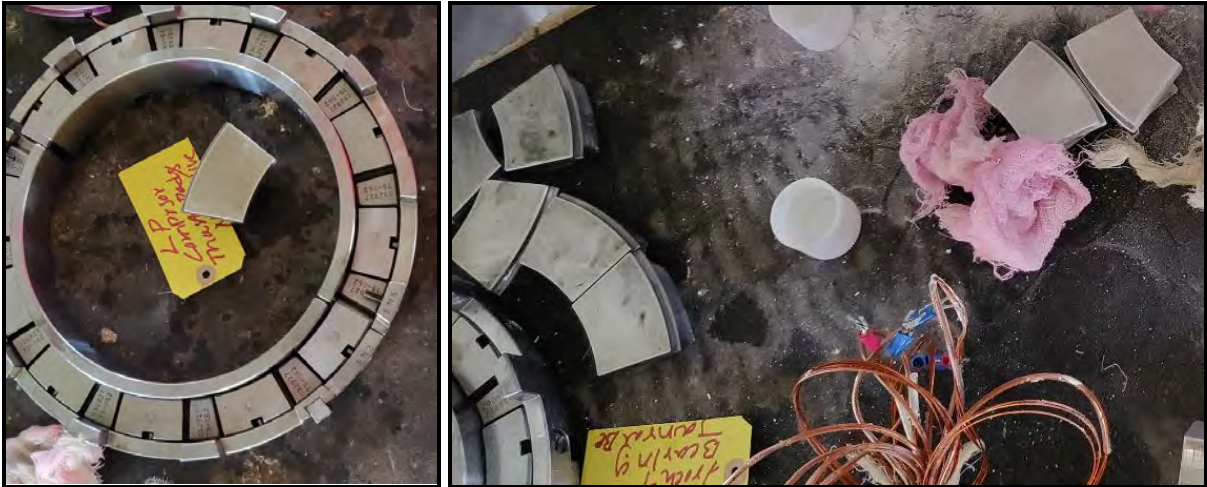
DP OF BEARINGS PADS BEING CARRIED OUT

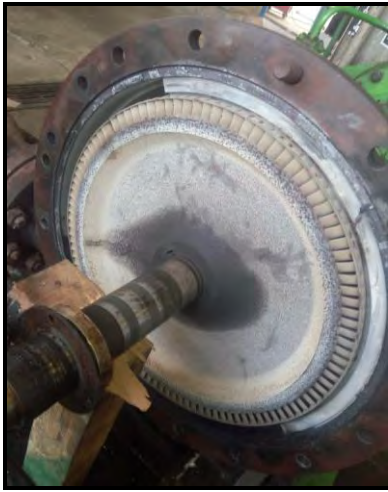
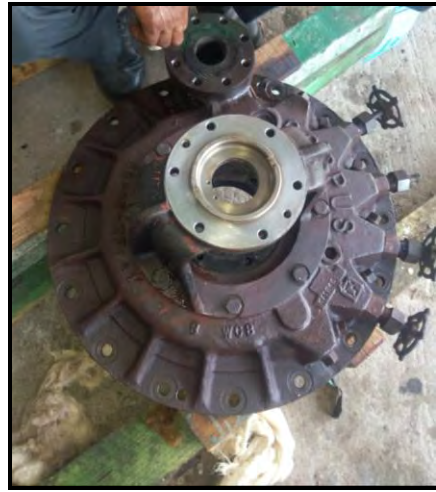
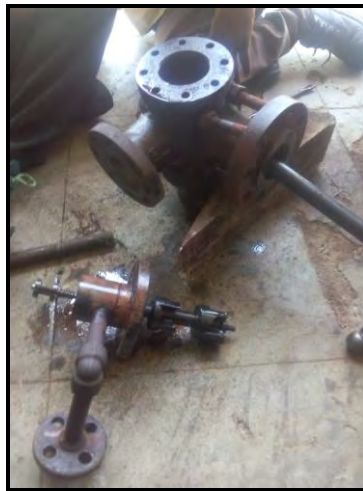
Q-1814 DISMANTLING UNDER PROGRESS & GOV VALVE SPINDLE STUCK IN BONNET

- Visual inspection & DP check of all major components was carried out.
- The governing valve spindle was found struck in open position. On dismantling the valve, the spindle was found bend.
- Non drive end gland housing was found cracked.
- The diameter of the shaft at NDE bearing area was found reduced. Clearance was observed in-between bearing & shaft.
- Governing valve had no margin to travel with governor shaft still having margin to travel.

New rotor was issued from stores. History showed the rotor was refurbished after last shutdown with new shaft. Dimension measurement, balancing check & gauss measurement was done. The rotor was found ready for use.

- Rotor total float & nozzle clearance was measured by providing dummy aluminum bearings. Nozzle clearance found to be 1.15 mm against design value of 1.17-1.88 mm. Hence this was increased to 1.25 mm by providing 0.1 mm shim before bearing of drive end.

- Reassembled the gland housing new carbon rings. The NDE gland housing was taken from Ammonia Mechanical w/s 112-JT rack. It was used after dimensional measurement. Leak off line tapping direction was changed in the new housing and hence the leak off lines were modified. Birkosit was provided between all joints.

- Connected governing valve linkage & trip valve linkages. The length of connecting rod linkage in-between governor & governing valve was adjusted to keep the slight margin for governing valve opening as well as closing, with governor shaft full travel. This will prevent any compressive or tensile stress on governing valve, thus avoiding its damage.

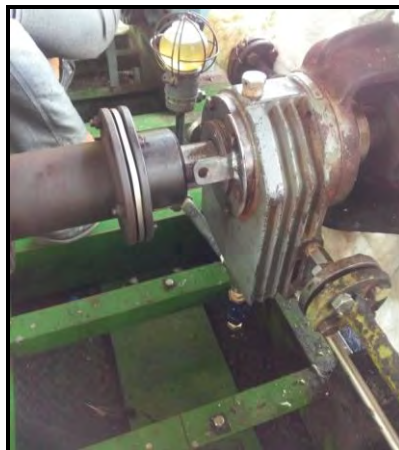
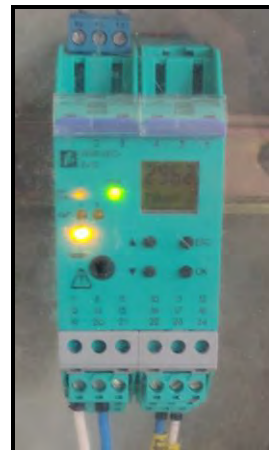
BRACKET PROVIDED ON BEARING HOUSING FOR KEYPHASOR FOR SPEED MEASUREMENT

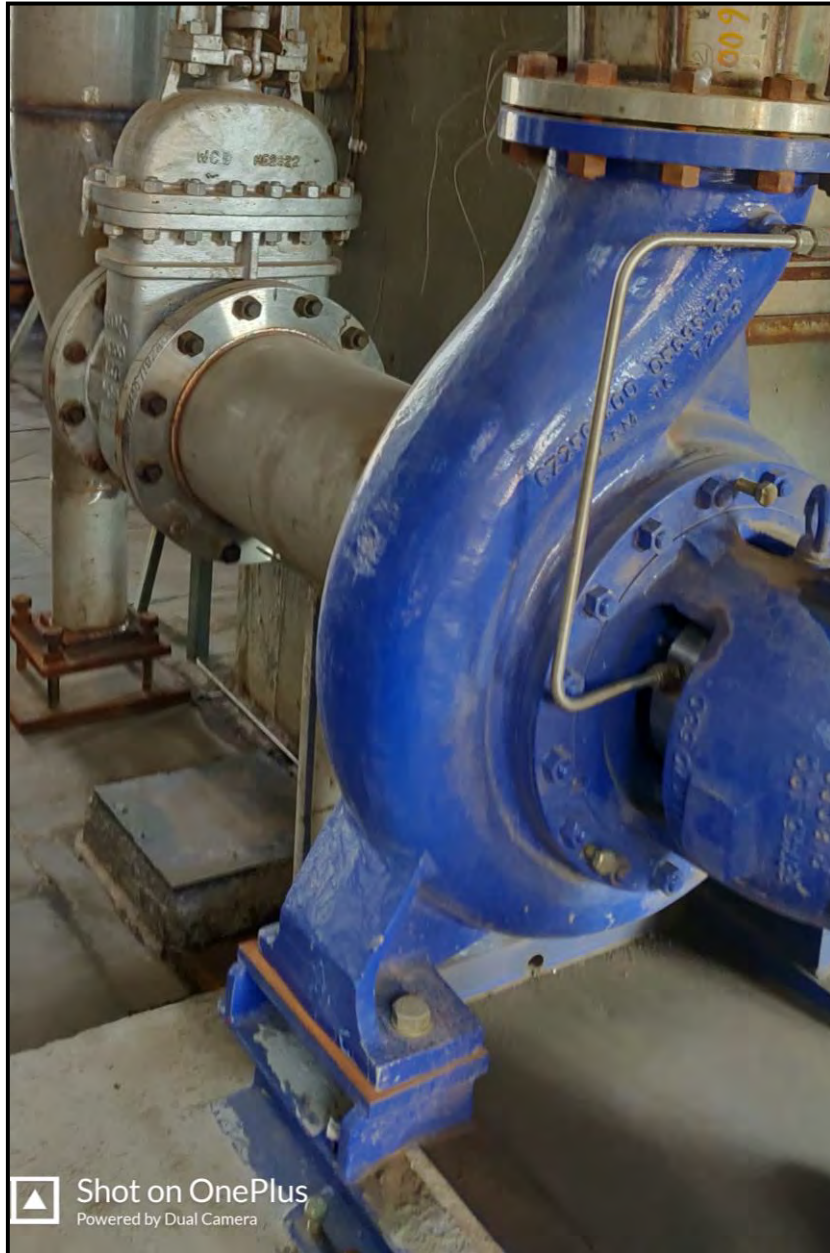
The old pump was of carbon steel construction. As part of upgradation, the pump P-1202-A was replaced in the year 2016. This year the pump –P-2012-B was replaced by new one. The complete base frame was replaced by new one. The suction and discharge line was modified to match the respective flanges of the pump. The suction valve was repositioned to make it safe for movement. The old motor was installed after overhauling. Alignment was done keeping the maximum misalignment values under 0.01. The suction and discharge flanges were opened & blind plates provided in-between them keeping little gap. The newly fabricated lines were flushed. DOR of the motor was checked and coupling done. The oil of the pump was flushed. Trial run of the pump was taken. The pump was found to be running normal with vibration within acceptable values.

NEW PUMP P-1202-B, SUCTION LINE, DISCHARGE LINE & BASE FRAME

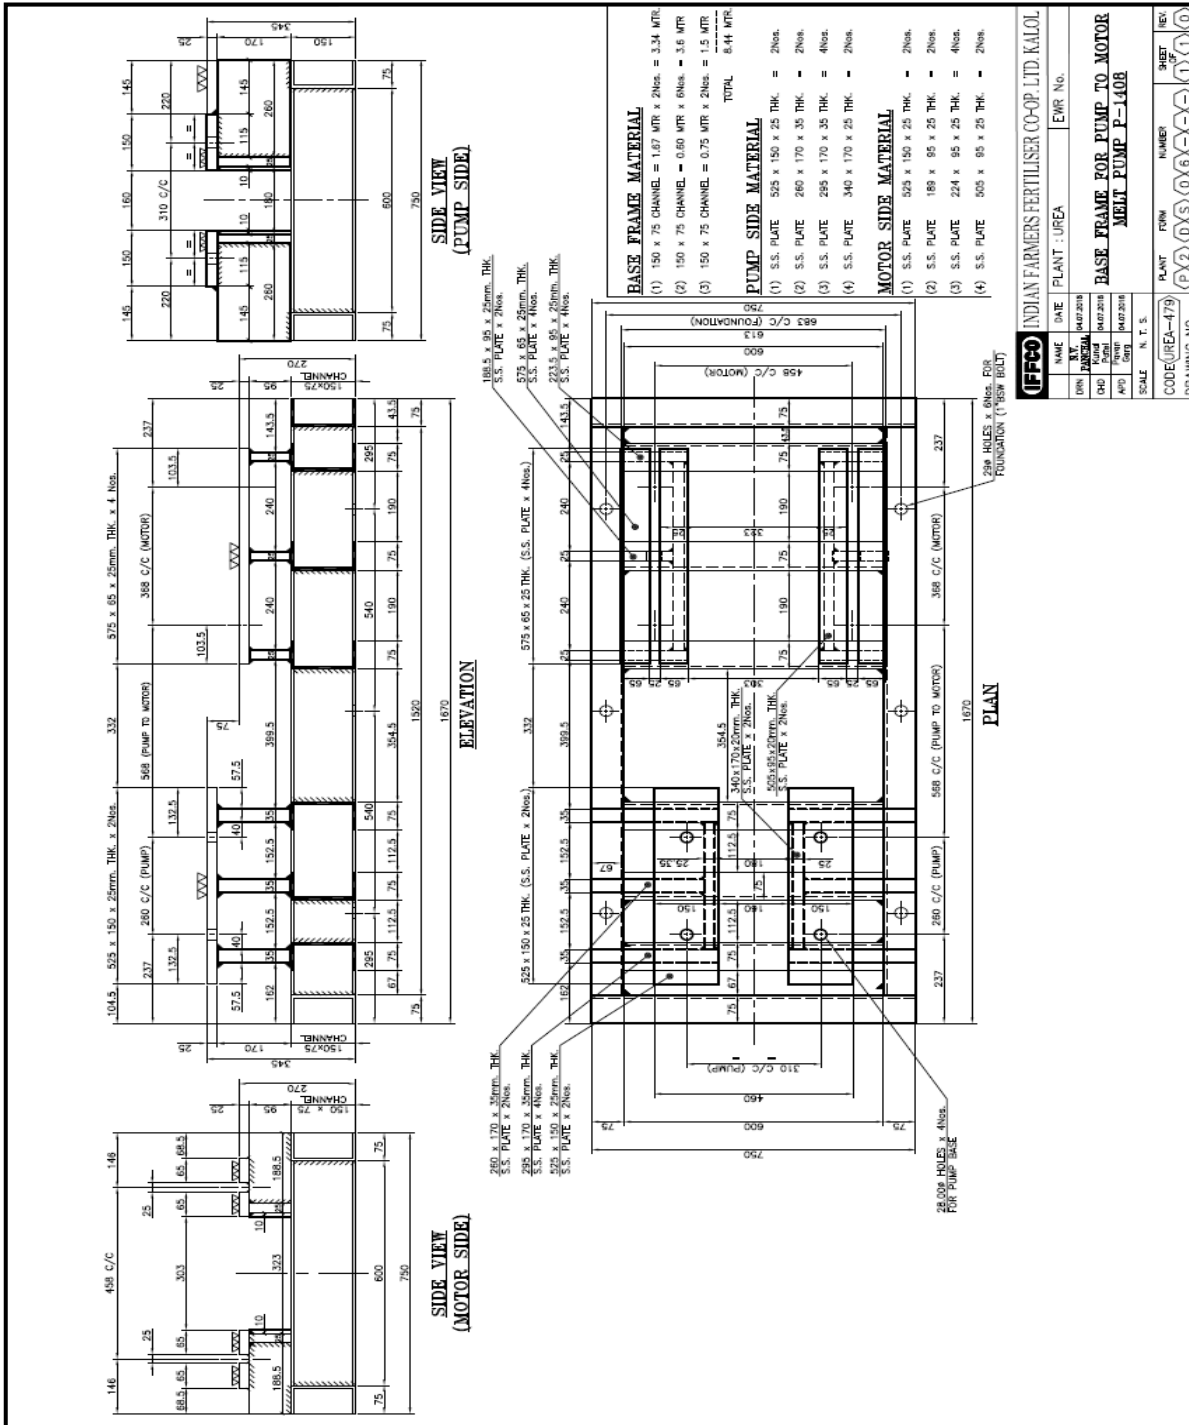
The melt solution pump had been running with higher vibration since long time. The high vibration was mostly due to the old foundation frame. This frame was of multi-level construction i.e. C-Channel on plate, plate on frame, Frame on another plate & then this plate on grouted frame. Further thread taping for the pump & motor foundation bolts was on the bottom most plate. This threads were damaged resulting in loose foundation bolts.

P-1408 ON NEW BASE FRAME

Hence new foundation frame was fabricated at workshop. The grouted portion was made of carbon steel channels & coated with stanvac epoxy paint. The portion above the grout was made of SS plates. The base plates were machined to desired height on

boring machine followed by lapping for 36 hours. Excess J-bolts received with new P-1202-A & B were used here for foundation grouting.

Spare refurbished pump was installed with new frame. Refurbished motor was installed Alignment was done. Utility steam/condensate lines were rerouted to create space for easy maintenance. Coupling was done with new pads. The pump was trial run & found to be running normal with vibration well below the acceptable limit.

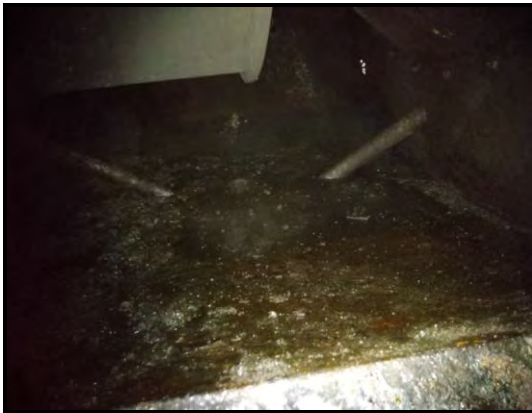
- Visual inspection of both bearing was done. Oil flushing of both bearing was done.
- Belts were replaced by new belts.
- Alignment of both pulleys was done and belt tension was checked and guard was provided.
- The casing was damaged at various location in the bottom half. Hence reinforcement of new 5 mm CS plates was provided as shown in the photograph.

K-1701 CASING BEFORE

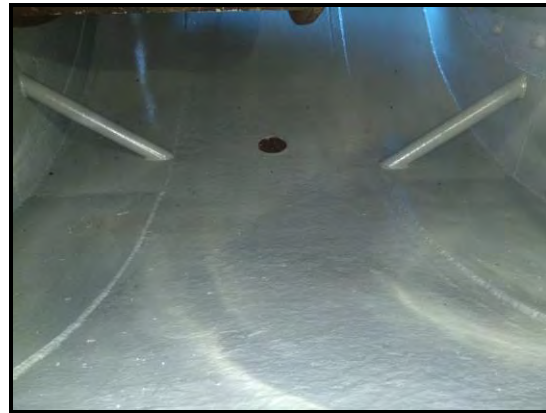
K-1701 CASING AFTER REPAIR

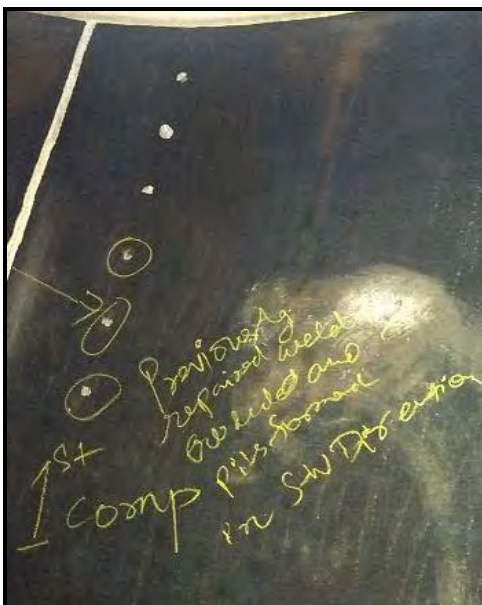
COMPARTMENT -1 South-West

In south-west direction above” C” seam previously repaired defects having pitting of 0.5 mm deep & 10.0 mm dia, marked D5-2 and minor pinhole observed in “C” seam, marked as defect D5-3 were repaired and found satisfactory in DP test.

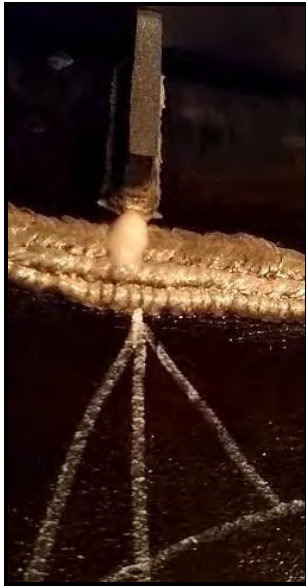
Helium leak detection carried out on 25.09.2018 with 0.26 kg/cm² (g) pressure in shell side liner annular space (Weep hole no 4 to 15) and leakage observed in south direction at bottom of cleat welding and just above the “C” seam welding top edge which were re confirmed by liquid soap solution test. marked as D5-1. This was repaired and found satisfactory in DP test.

COMPARTMENT - 5 South (Before)

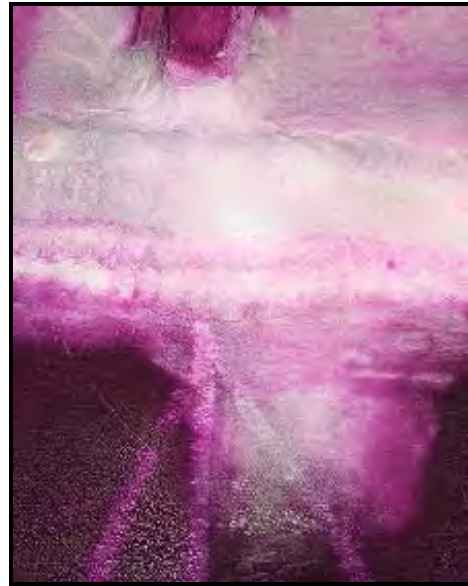
COMPARTMENT - 5 South (After)

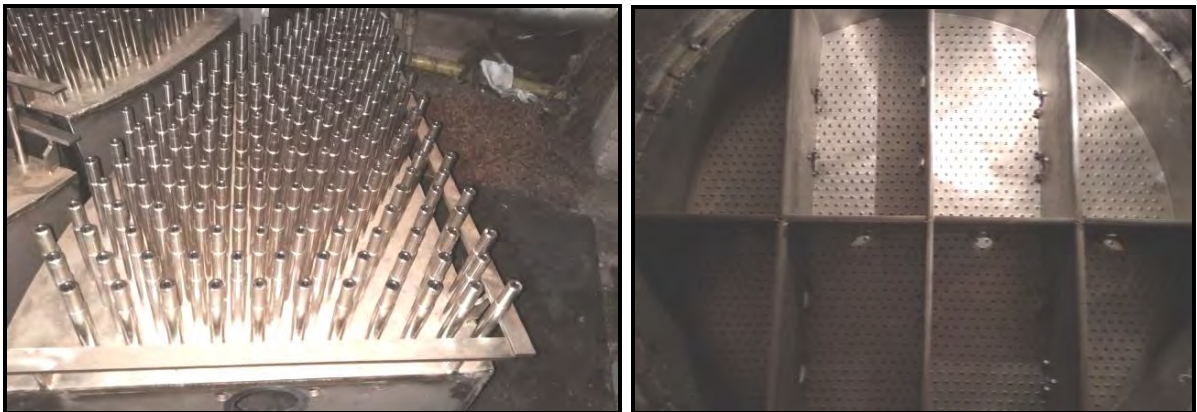
BOTTOM GAS DISTRIBUTOR AFTER & BEFORE REMOVAL

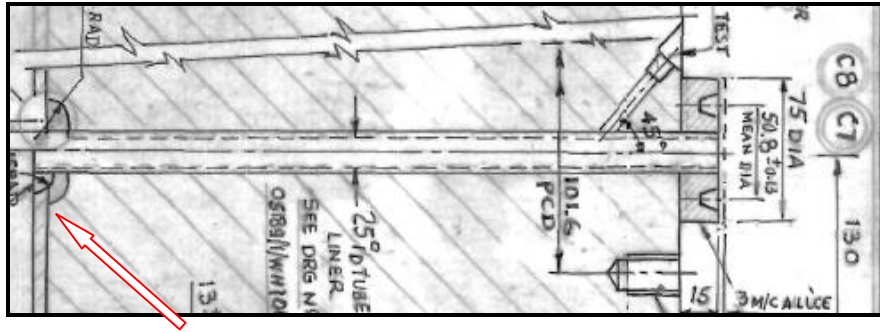
- Shifted the top dome towards K-1403-3 , placed on wooden sleeper
- Removed the diaphragm
- Departmental inspection was carried out. Repair work was done as per report. Pneumatic test of liner weld was carried out, leak observed at blind flange weld joint with liner. The same was repaired.

REPAIRED JOINT

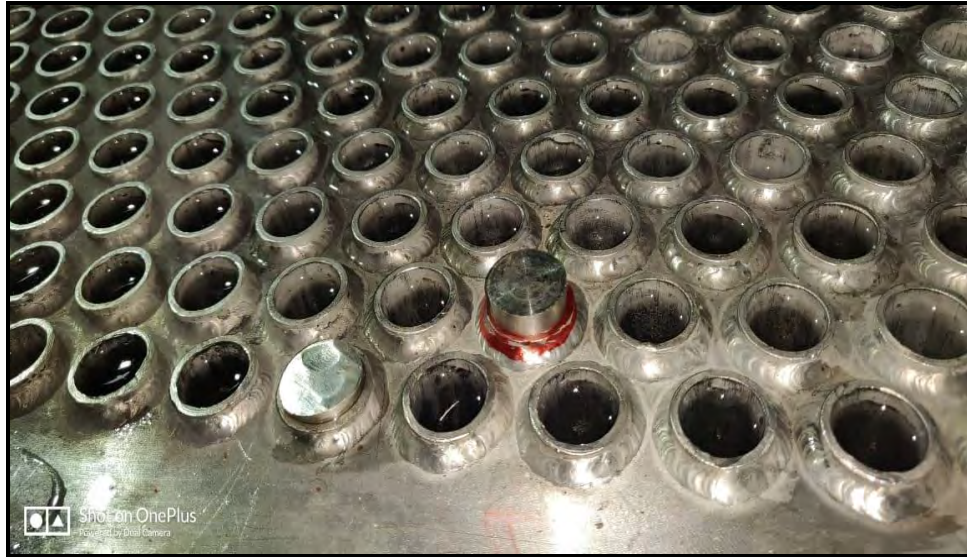
One tube was plugged as per IRIS inspection report

H-1205 TUBE PLUGGED HIGHLIGHTED IN RED

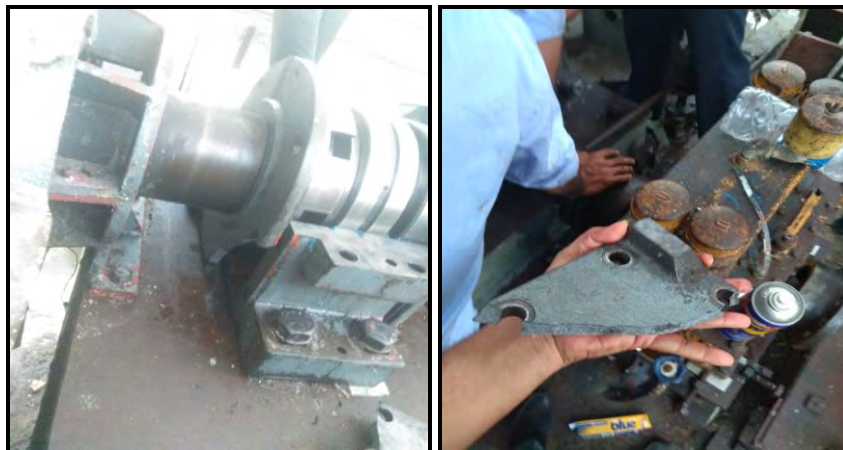
- Turbine rotor carbon seals were replaced by new one.
- Motor side Plummer block (SOFN 230 BL) of the fan was cracked.
- We replaced the Plummer block by MASTA make Plummer block (SOFN 230 BL).

Motor side Plumber Block damaged during Assembly

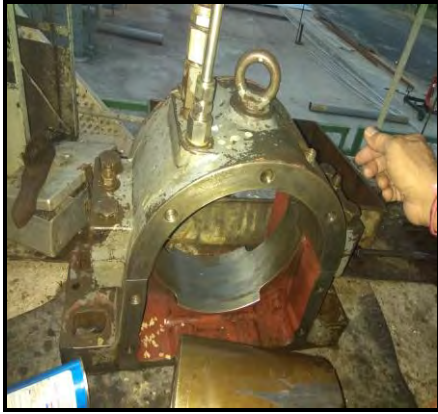
Old Plumber Block

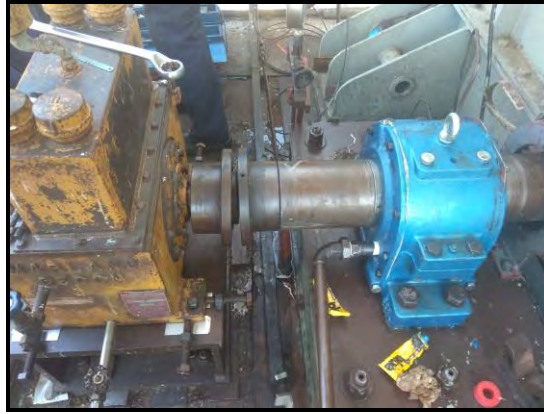
New Plumber Block

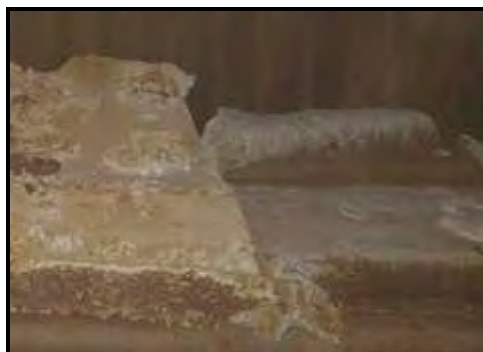
- East side refractory near to manhole refractory was found in damaged condition. So, repaired by civil department.
- Floor refractory was found damaged. So, repaired.
- Refractory around the bottom burner was found damaged. So, refractory was repaired. All nozzles of bottom burners were cleaned.
- Insulation fiber blankets placed on top of the Secondary superheater coil was found in damaged condition due to refractory fall down on it. So, it was replaced.

- Refractory found damaged and loosened above secondary super heater coil. Anchors were found missing from drum surface. So, anchors were welded with drum and refractory was repaired.
- Baffle wall refractory was repaired.

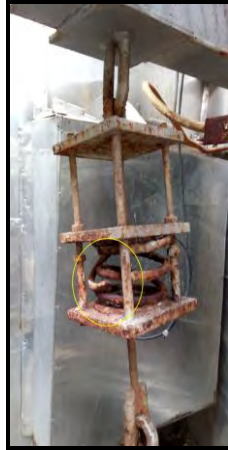
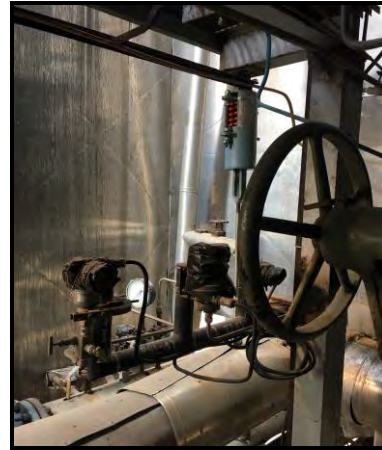
We have done detailed inspection of boiler area spring support with M/s Procyon Techno Industry. They had recommended to replace 05 Nos of spring supports. Based on their recommendations, we had procured spring supports against PO No. 201004181359. Details are as

- It was replaced by Model no. : VS2-B-10 (Variable Spring hanger)

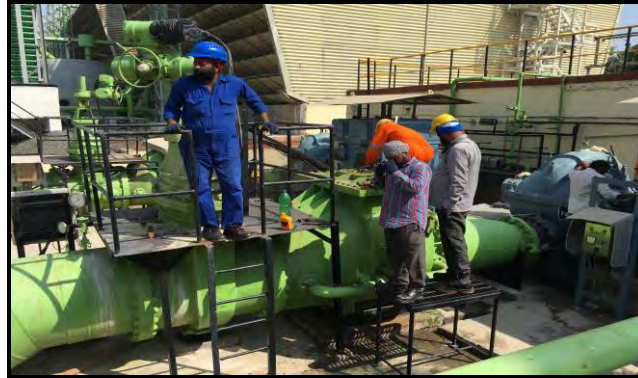
- Recycle line of size 10" was installed in discharge line of P-4404-E.
- Main isolation valves of Pillar No. 21, 10 & 8 of steam line were replaced.
- Replacement of BFW line BFW line from Utility to Ammonia. Size: 6" X Sch 80.
- Cooling tower distribution valve overhauling job.

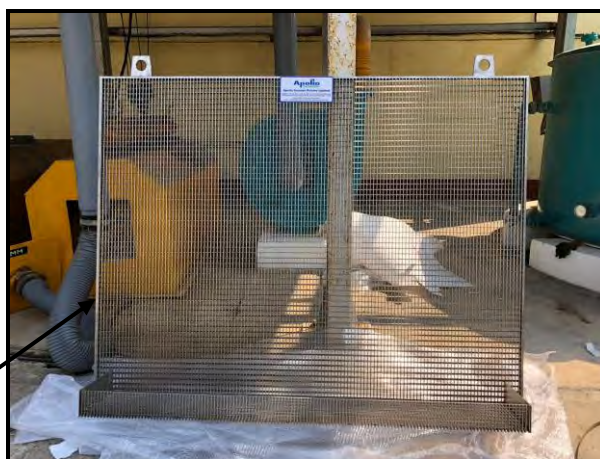
New SS-304
Screen

- Gap between V-wedge Wire: 12MM
- Effective Opening of Screen: 77-82%
- MOC of the Screen: SS-304
- Overall dimensions of Screen with Frame: 2000MM Width X 1600 MM Height

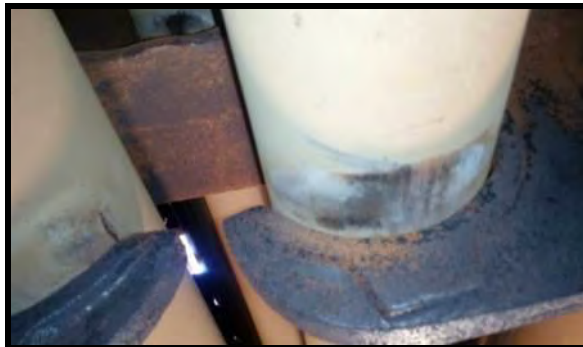
- Scaling was observed on all the tubes of Mixed Feed Coil.
- Bottom most part of Insulation covering plate was found burnt off at most of the locations. This was observed in previous inspection also.
- Rubbing on the coils observed near anchor supports, however no reduction in thickness was noticed. (Also observed in previous inspection)

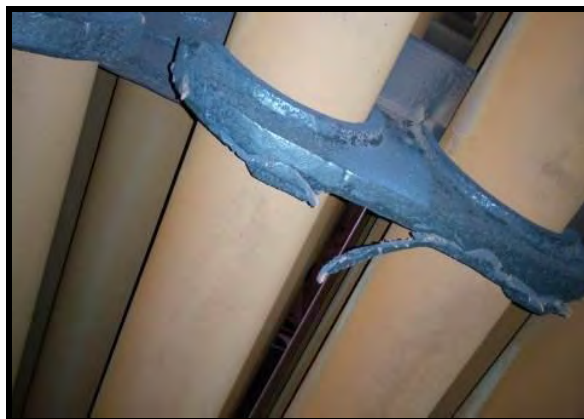
- Peeling off of top layer of casting was observed on first two rows of east side anchor supports of mixed feed coils. (Also observed in previous inspection)

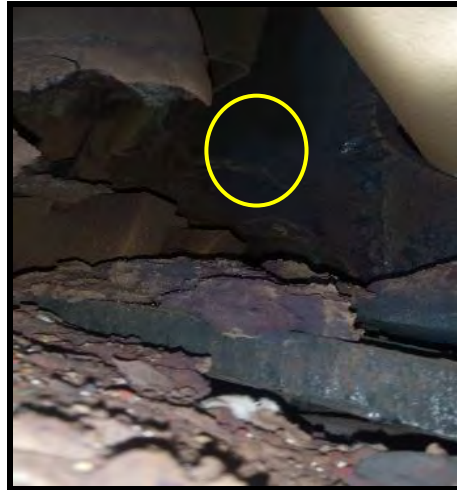
- 1st Mixed feed coil support (counting from West) found cracked / damaged at south end. (Also observed in previous inspection)

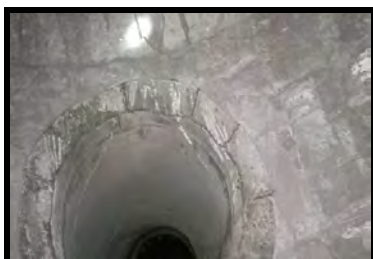
101 CA Nozzle View

- The refractory around the 101-CA/CB gas inlet nozzles (approx. half of the top circumference) was found eroded and loosened. Same was observed during previous inspection also.

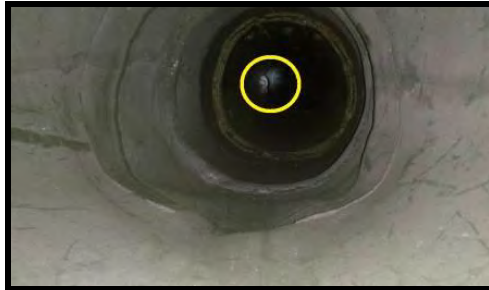
- The liner inside the 101-CB gas inlet nozzle was slightly buckled /distorted. Condition of the thermo well was found satisfactory. Same was observed during previous inspection also.
- The liners inside the 101-CA gas inlet nozzle were found slightly buckled /distorted. Insert liner condition was found satisfactory. Condition of the thermo well was found satisfactory.

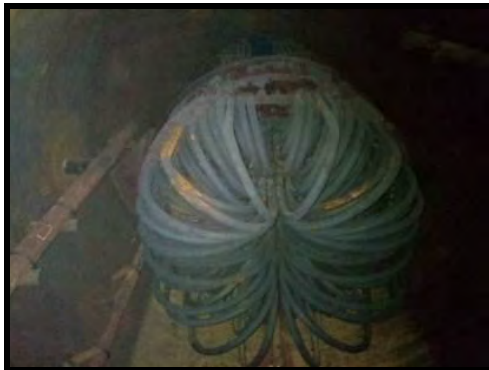
- Condition of the weld joints were found satisfactory.
- Rust/ scaling observed on the weld & Dished End.
- Rust / scaling observed on the tube baffles and some of the tubes.

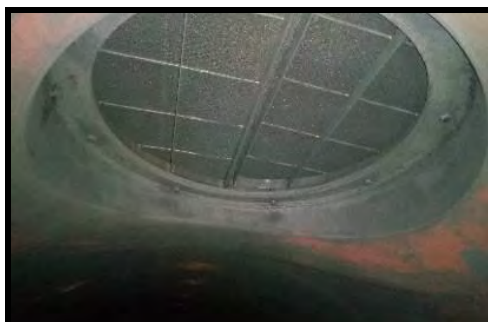
- Rust / scales observed lying on the shell bottom.
- South side top demister half was found upward lifted.

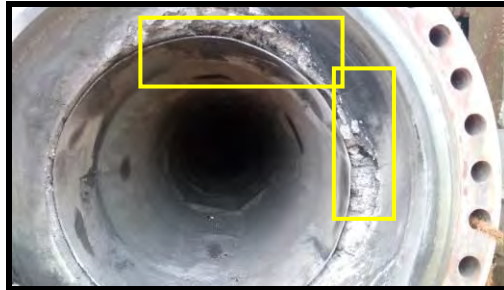
- Minor buckling/distortion of the liner was observed throughout the length of the transfer line.
- Minor damage of the refractory was observed at flange (end plug side) of the transfer line. Also End plug seating area found eroded/damaged at Top and North side. (Same was observed in previous inspection)

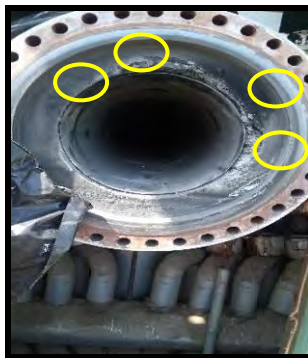
- Scattered cracks were observed on the end plug seat.

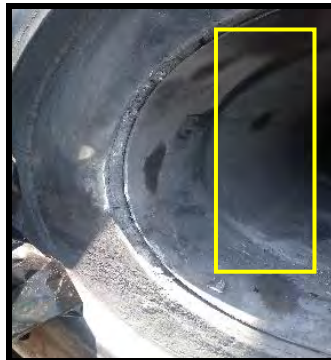
- Gap was observed between transfer line and End plug seat in entire periphery.

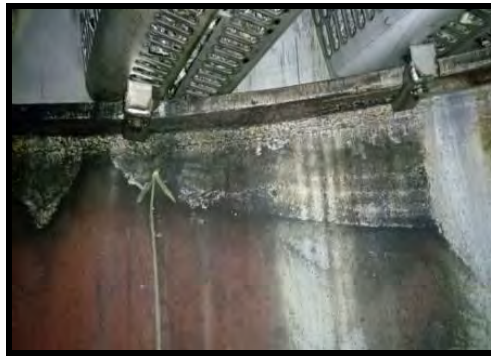
- 01 no. Rasching ring holding clamp was found loose at south side.
(Same was observed in previous inspection & Marked with yellow chalk)

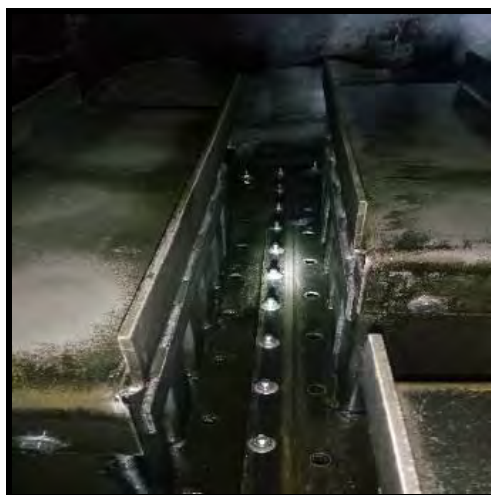
- Brownish grey coloration was observed on the shell as well as on all the gas risers.
- Sample collectors were found intact in its position.
- Condition of the gas risers was found satisfactory.
- Loose piece of debris found between gas rising holding plate towards North.

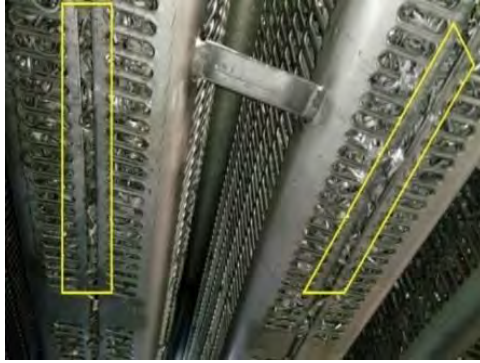
- Excessive gap as compared to others was observed in several rasching ring holder.(between two half of holder, Same was observed in previous inspection)

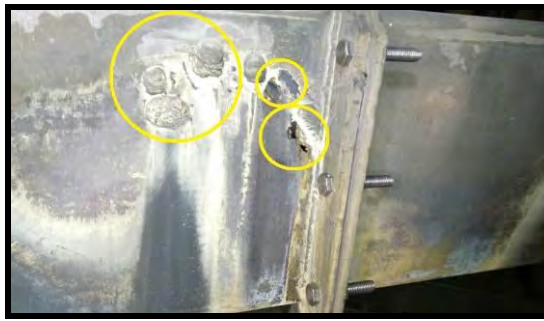
- Condition of liquid distributor was found satisfactory.
- Brownish grey coloration was observed on the shell as well as on all the fittings.
- Corrosion cavities and holes were observed on South most liquid distributor collector plate, located just below the liquid distributor. (Visible just from M/H, (Same was observed in previous inspection))

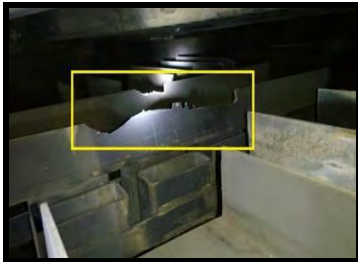
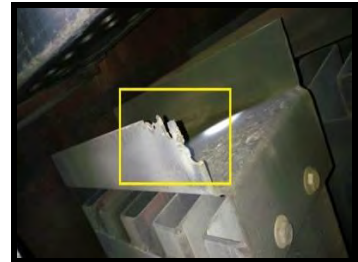
- Gas riser holding plate was found eroded/damaged from top edge at West-East side & Centre area. (Same was observed in previous inspection)

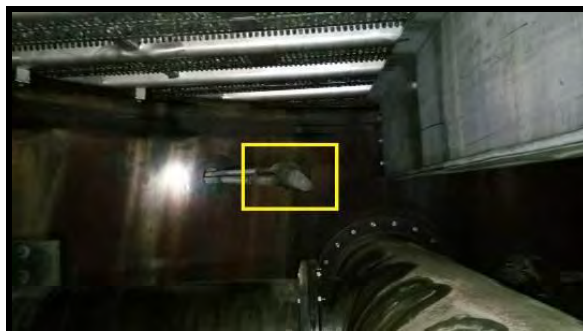
- Sample collector was found twisted. (Same was observed in previous inspection)

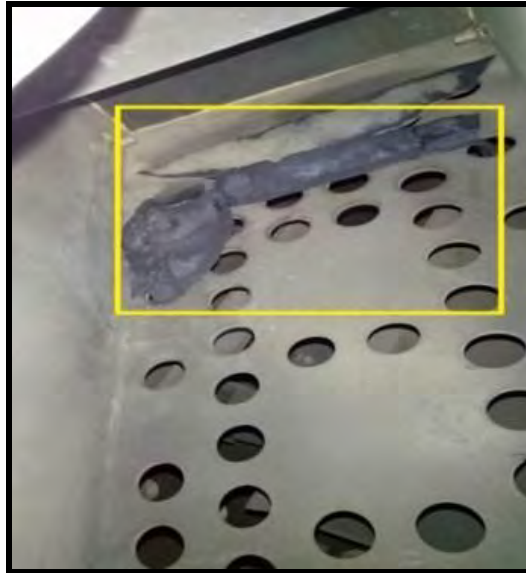
- Rubber piece was found lying on the gas riser holding plate at west side. (Same was observed in previous inspection)

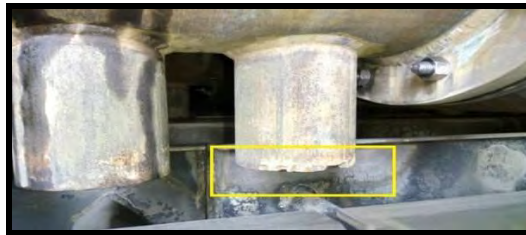
- Liquid distributor bottom nozzle found eroded at bottom edge. (Visible just from M/H, Same was observed in previous inspection)

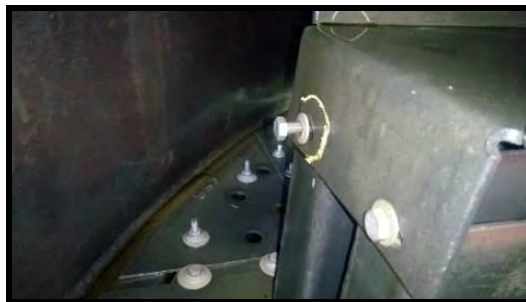
- 01 no. bolt of gas riser holding plate found loose at South side. (Marked with yellow chalk)

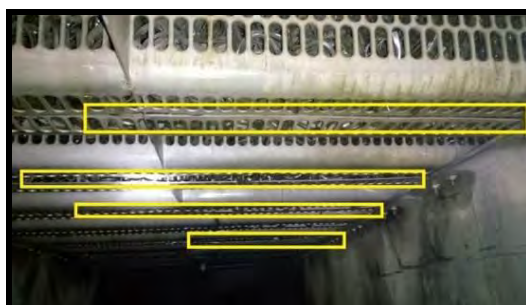
- Excessive gap as compared to others was observed in several rasching ring holder. (Between two half of holder, (Same was observed in previous inspection).

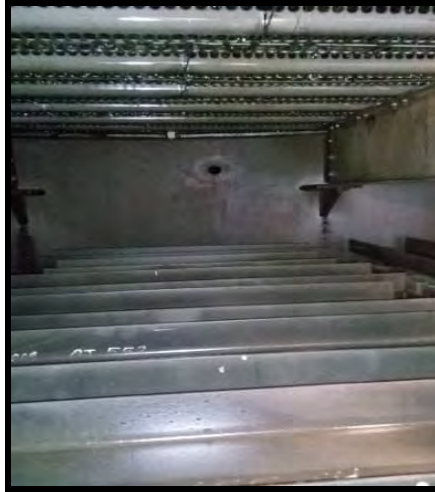
- Grey coloration was observed on the shell.
- Sample collector was found missing from its location.

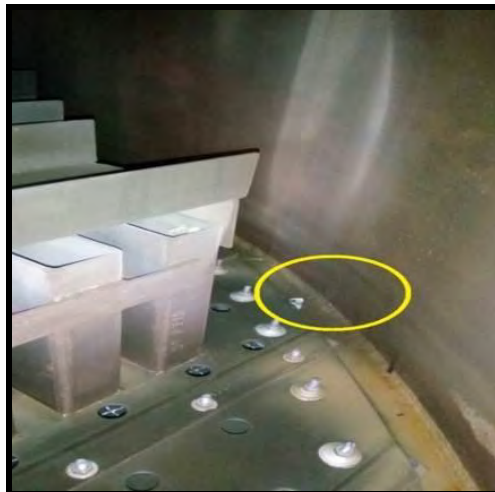
- Piece of rasching ring was found stuck up between shell and riser plate. (Same was observed in previous inspection)

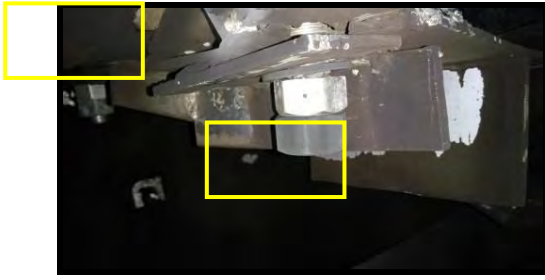
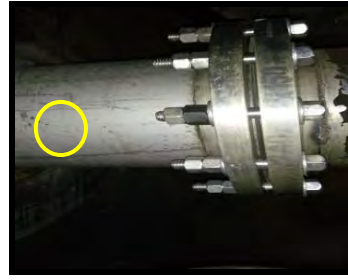
- Demister pad supporting strips were observed slightly downward bent (mostly in center portion) and supporting rods were found satisfactory.
- All the bolts of liquid inlet nozzle flange were found in position & intact.
- 01 no. nut of inlet header flange & 01 no. check nut of South-East side U-clamp observed with CS material.

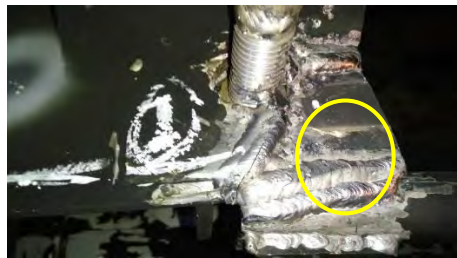
- West side distributor header was found rubbing with the shell plate in S-W direction causing dent in the shell plate. Same was also observed in previous inspections.
- Crack was observed in South-West side U-clamp support plate welding. (Image no. 01)

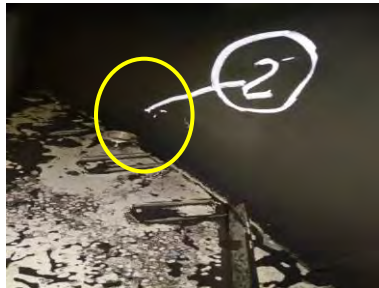
- South-West side U-clamp check nut found missing and same was laying below the header at S-W corner. (Image no. 02)

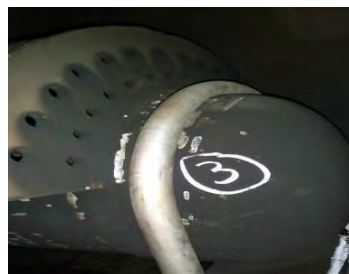
- U-Clamps of North-West side distribution header were found loose. (Need to be tightened, Image no.03)

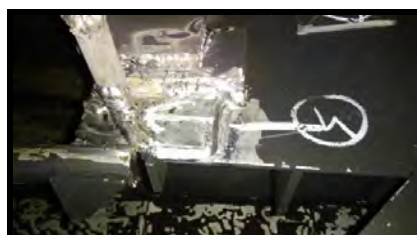
- Crack was observed in U-clamp tack weld with plate. (Image no. 04)

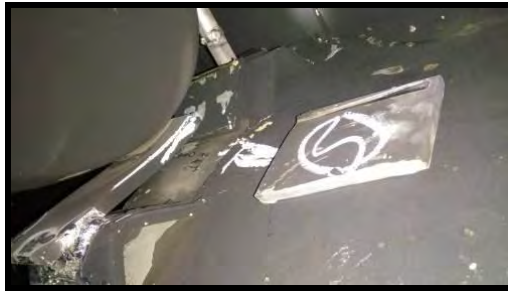
- North-West side, header bottom support plate found cracked/detached and same plate piece found laying near it. (Need to be repaired, Image no. 05)

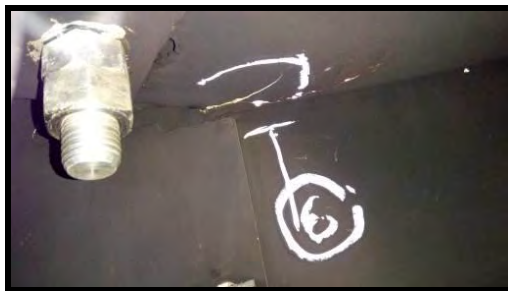
- A crack was observed having approx length of 75 mm in the bottom of the U-clamp support plate at North-West side. (Image no.06) (Same was observed in previous inspection, Need to be repaired)

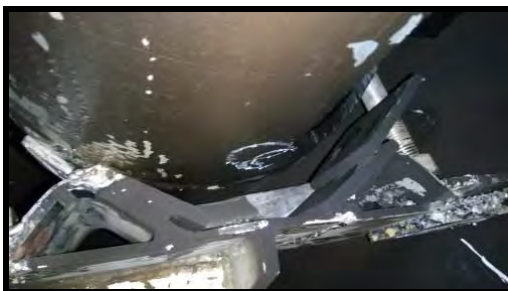
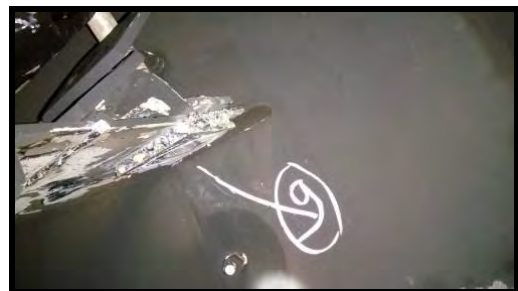
- Weld erosion observed in bottom stiffening plate of header support plate.
- North-East side distributor header U-clamp found loose & its nut found missing resulted in distributor header observed upward lifted. (Need to be attend Image no. 8 & 9)

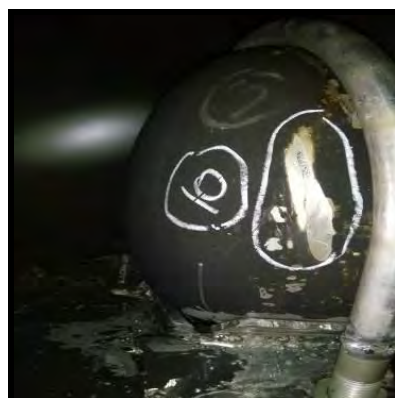
- North-East side distributor header found rubbing with U-clamp support plate causing dent/slot of 50 mmX10 mm area in cap of header at west side. (same were marked with yellow chalk) (Image no.10)

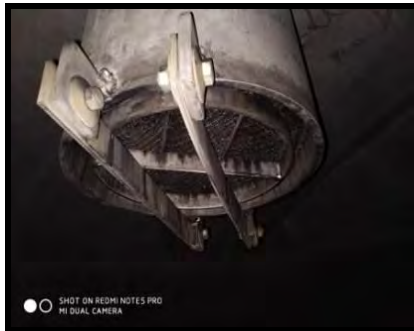
- Silverish coloration was observed at top dish end and shell coarse.
- Demister pipe found intact in position.

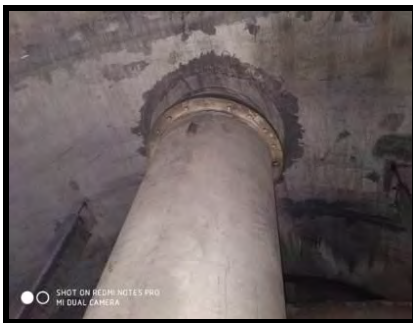
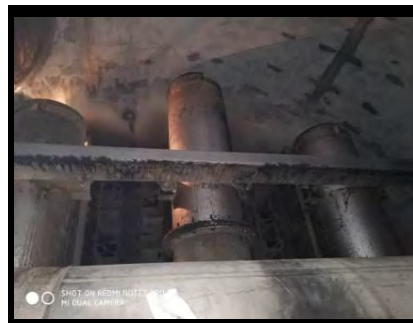
- Liquid distributor Main header and its distributor pipes found intact in position, color of the same was observed silver/ Gray. Supports of the main header and distribution pipes were found intact in position.

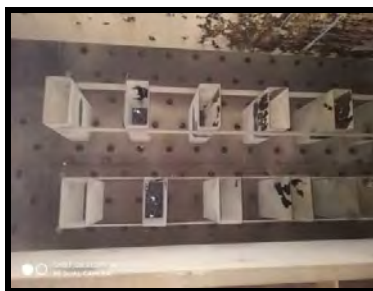
- Thin brownish scaling observed on the Liquid collectors and distributor trays segment. Gas vent rectangular risers were found intact in its position and have assumed thin brownish scales.

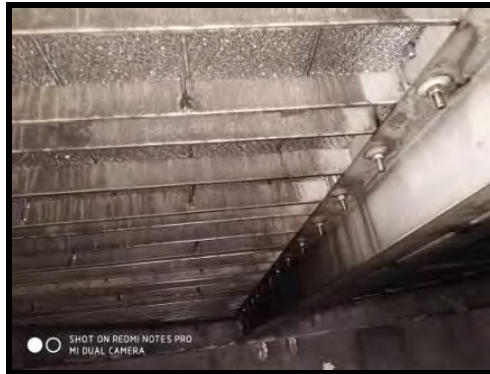
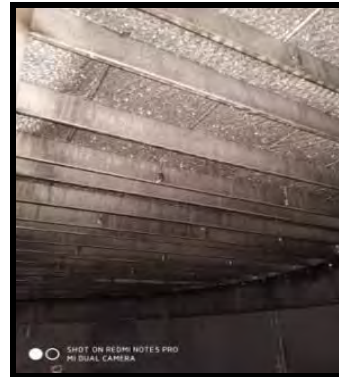
- Demister pad was found intact in its position.

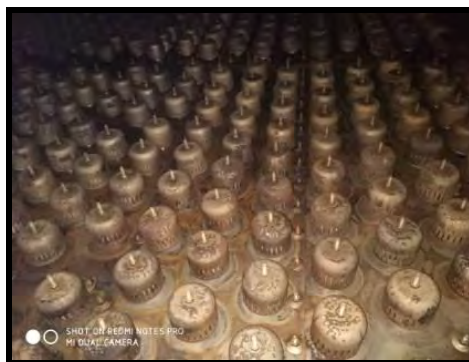
- Condition of bubble caps found satisfactory.

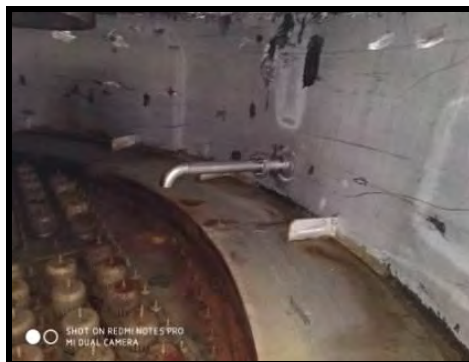
- Distributor collectors / drain pipes in West direction was found satisfactory.

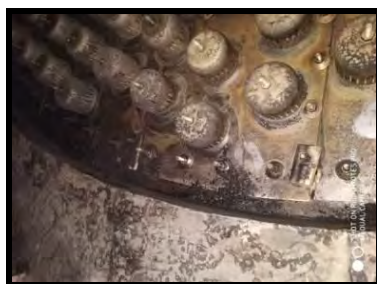
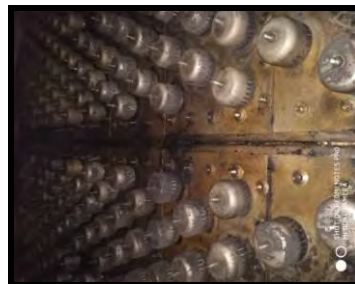
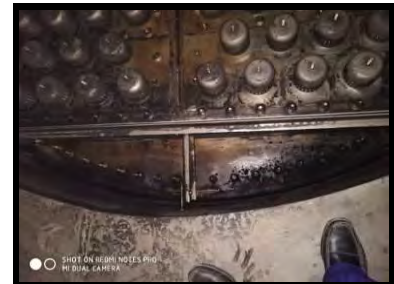
- Debris/ black muck was found accumulated at many locations on the bubble cap holding plate.

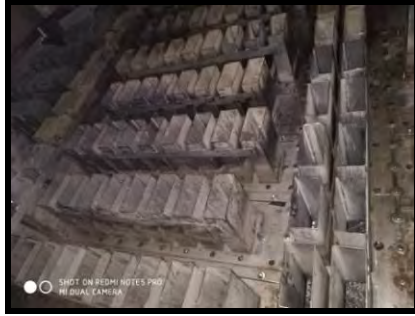
- Rectangular riser box and other fittings found intact in position.

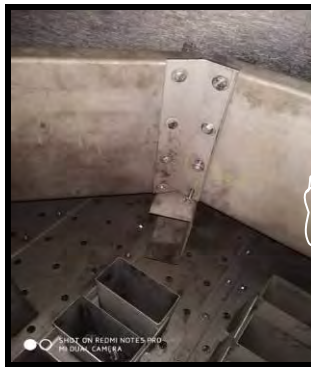
- 02 nos. of fasteners of vertical plate segment in the East direction were observed loose need to be fixed. Marked with Yellow chalk.

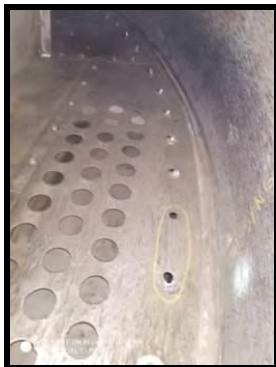
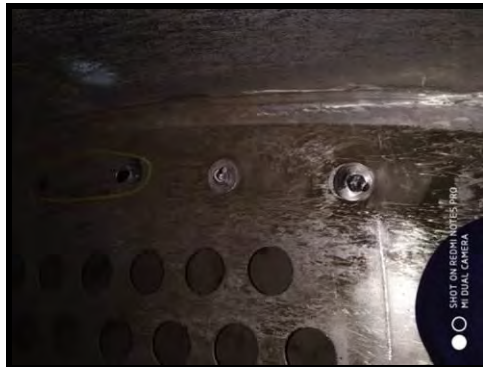
- Holding bolts of bottom Annular tray found bent at many locations. 02 nos. bolts are missing in North-West side. (Marked with yellow chalk)

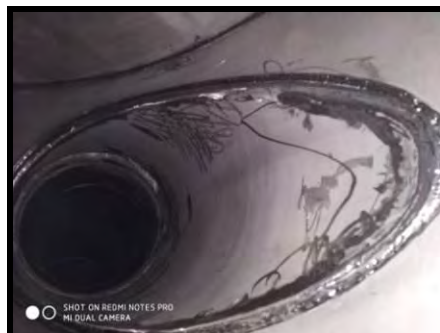
- Silver coloration was observed on shell with scattered etching marks at several locations. Condition of both the tangential Nozzles & their welds were observed satisfactory.

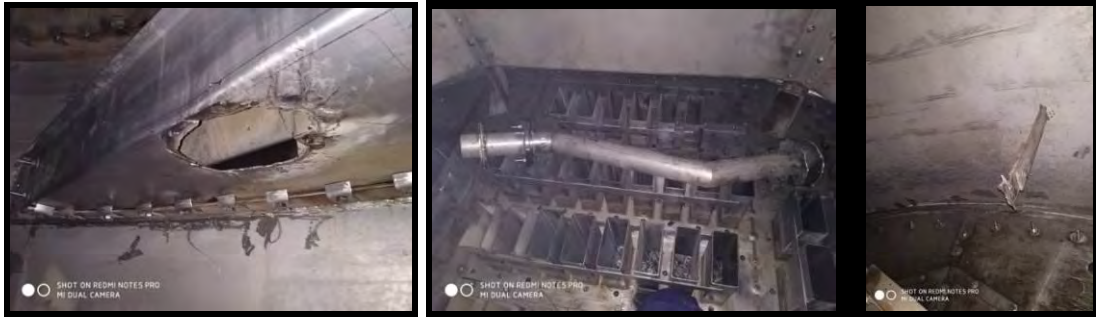
- One of the Bubble cap tray drain line was found detached from top plate and support strip. It has been fallen on the riser boxes.

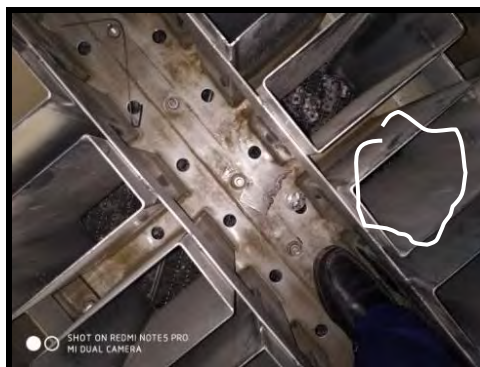
- 01 nos. plate segment having approx. size of 1.5"x3" found lying on the riser box holding plate. All the damaged parts of the drain pipe support, strips etc. need to be removed from the compartment.

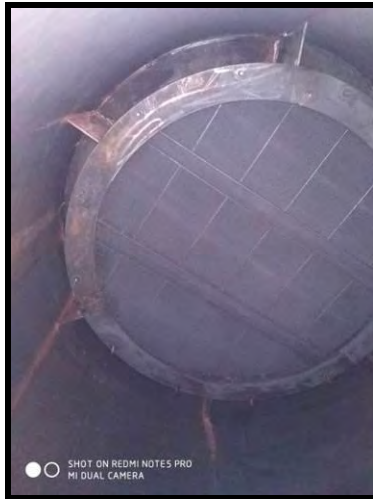
- Grayish Coloration was observed on the shell & Man-way.
- Mist eliminator was found intact in its position.
- Brownish flow marks were observed coming from the supports of the Mist eliminator.

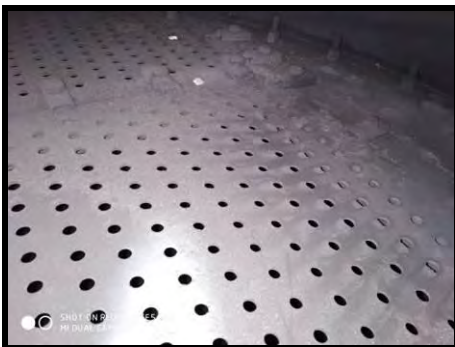
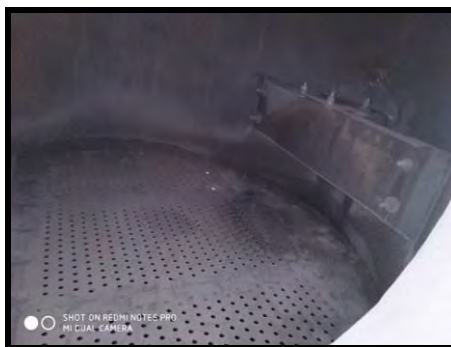
- Grayish dust was found adhered on the top plate and internals.

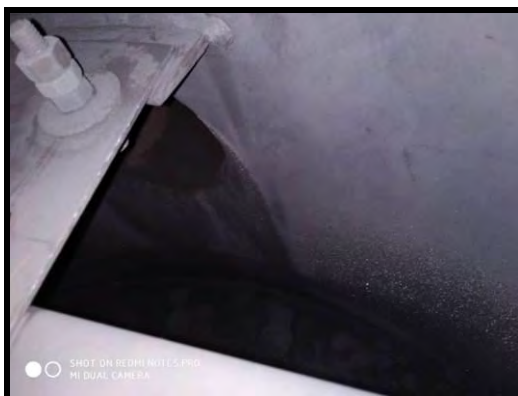
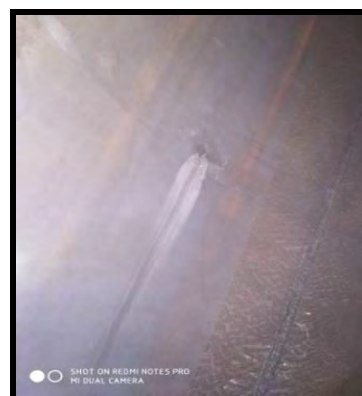
- Metallic foreign particles were observed adhered to the shell near the liquid inlet nozzle & the 2" Differential pressure connection nozzle.

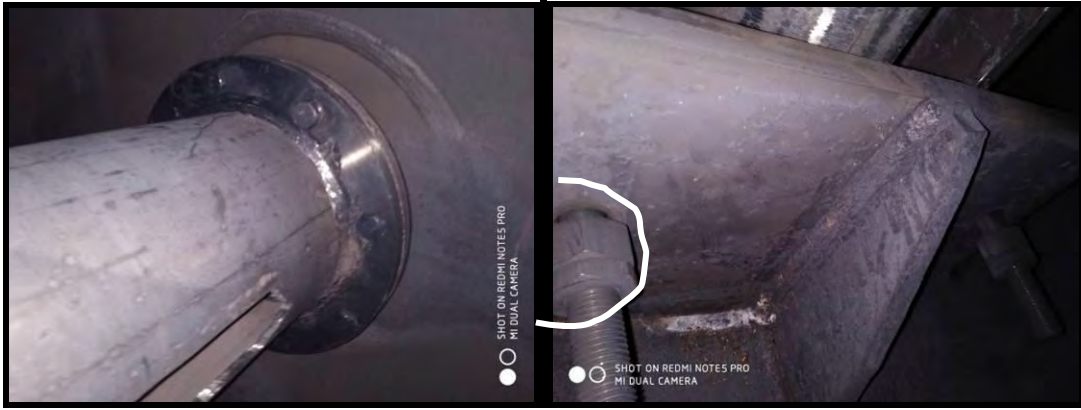
- Grayish Colouration was observed on the shell & Man-way.
- Bottom most tray was found intact in its position.
- 'U' Clamp of 10" SS Internal Pipe (Steam Inlet) was found loose. Also, the Internal pipe flange fasteners were found loosened. Need to be tightened.

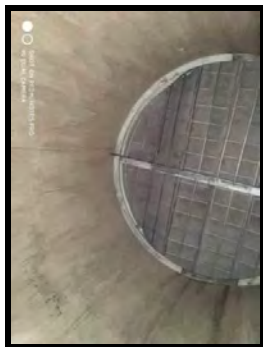
- Epoxy paint condition was found satisfactory.
- 02 segments of Demister pads were found lifted from its position at East Side.

Need to be fixed.

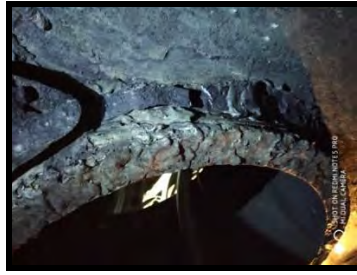
- Putty applied on the circumferential weld joint of manhole nozzle with shell from inside was found detached approx in top half of the circumference.

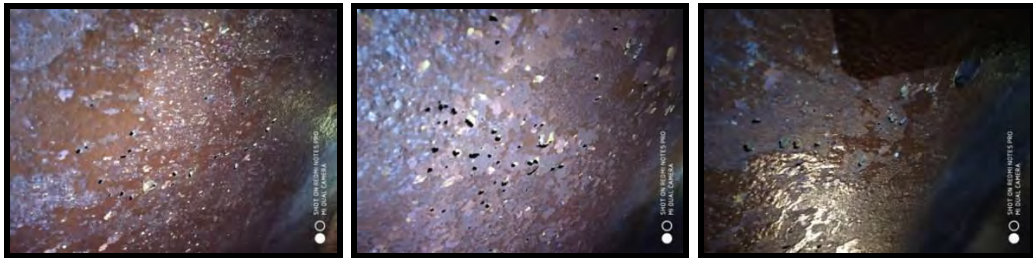
- Demister pads were found intact in its position.
- Cavities observed in Epoxy at scattered locations in lower half of the vessel, more prominent up-to approx. 1.5m height from bottom dish-end.
