KALOL UNIT

PLANT TURNAROUND REPORT
(SEPTEMBER - OCTOBER – 2018)

Plant Turnaround for the year 2018 was taken from **17th Sep 2018** to **15th October 2018** for carrying out ESP Phase III (Energy Saving Project), Preventive maintenance jobs of Static & Rotary equipment.

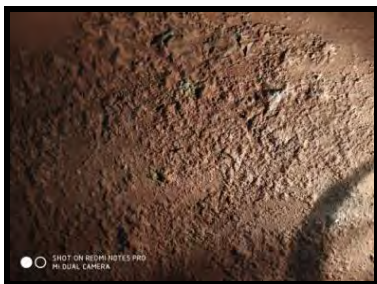
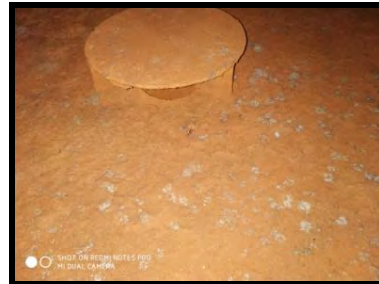
- Nozzle condition was found satisfactory.
- Soft dry Blisters were observed in complete dish end. Manway epoxy blisters were observed filled with liquid matter.

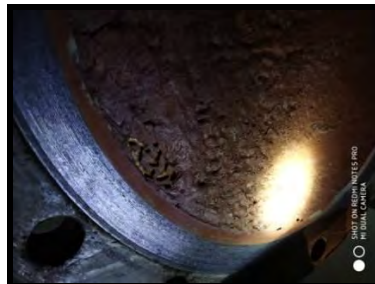
- Epoxy layer was observed damaged on the Manway Inside Stub-end, causing corrosion. Same was observed on the manway cover.

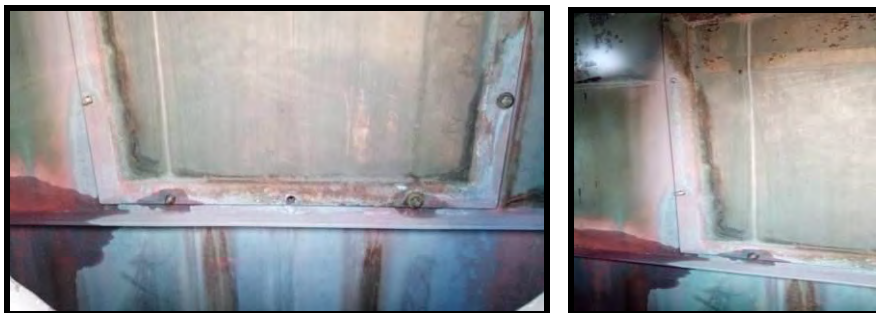
- Redish coloration was observed inside the shell.
- Water found accumulated at bottom of the dish end.
- Water condensation particles observed adhered on shell.
- Welding condition found satisfactory.
- 01 no. stud found sheared, 01 no. stud & 01 no. nut found missing of the tray enclosure plate just in front of manhole.

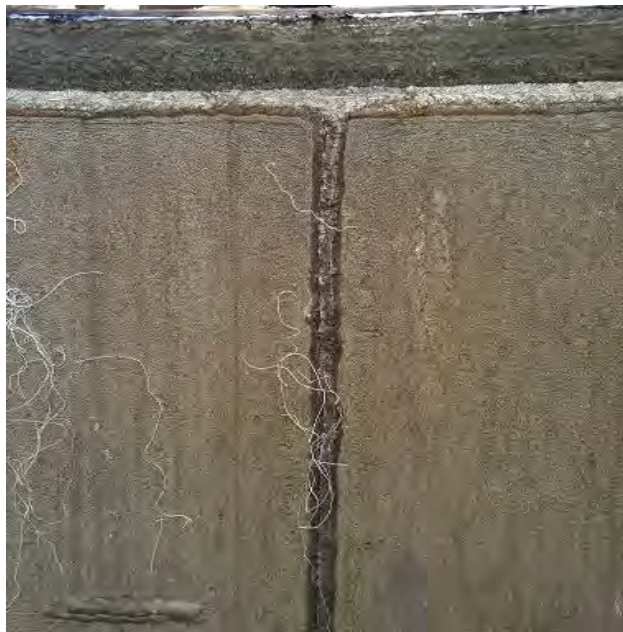
- Heavy roughening /corrosion of man way liner including its weld was observed. Man way liner “L” seam weld observed more rough/ porous in comparision to its “C” Seam weld.

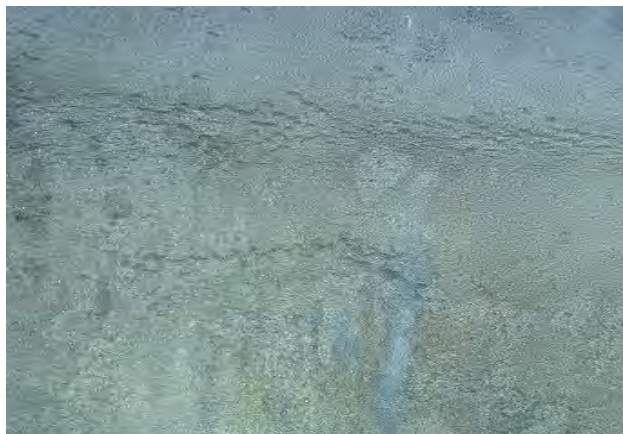
- Parent metal of man way liner observed rough / corroded / eroded at several scattered locations.

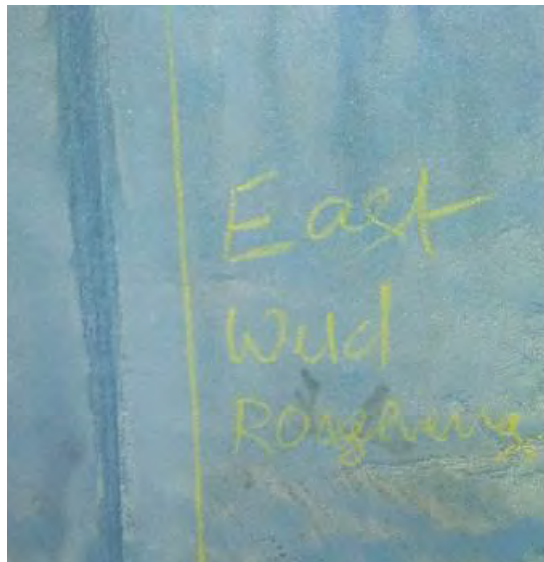
- Grayish oxide layer was observed on dome liner.
- Petal welding observed rough / porous, more prominent in East side of dome.

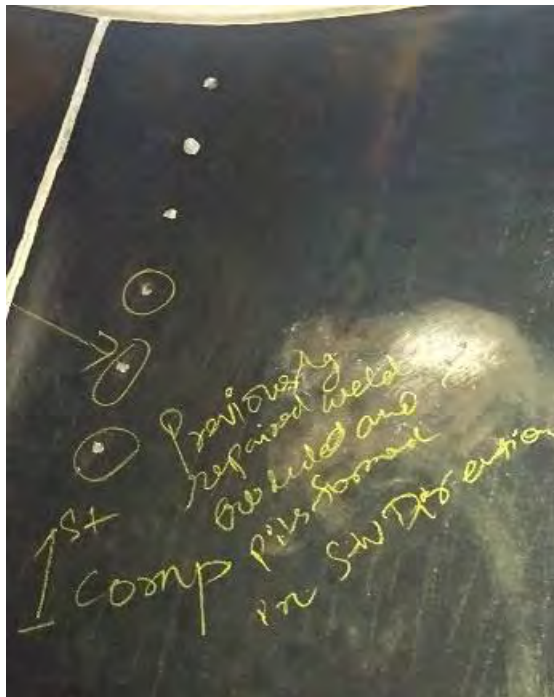
- Cylindrical Liner plate just below dome liner was found silver bright in colour throughout in circumference.
- Bulging of 5 to 8 mm height and 75mm width observed approx. 600 mm above tray level in South – West corner.
- Previously repaired defects on liner at S-W direction besides long seam observed eroded and pits of 0.5 to 1 mm depth and 10-15mm dia approx. were observed which were marked as D1-1 for repair. Repair was carried out by welding and found satisfactory in DP test.

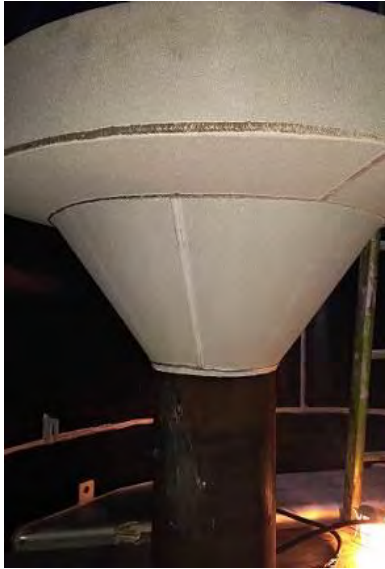
- “C” Seam and “L” seam welding found satisfactory.
- 01 no. of old tray holding cleat (total – 14 nos.) was found black and severely corrosion attacked including its welding, same was observed in last inspection.
- Down-comer cone (Funnel) observed silver shiny in colour and rough in surface. Downcomer pipe observed brown in colour. Its welding was highly corroded / etched as razor sharp edges of welding observed.

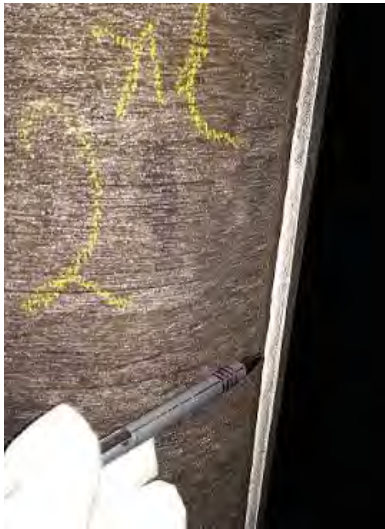
- All new cleats (Total-14 No's) and its welding observed satisfactory.
- Down comer found dark brown in colour and rough in surface.
- Welding edges observed sharp due to down comer erosion.

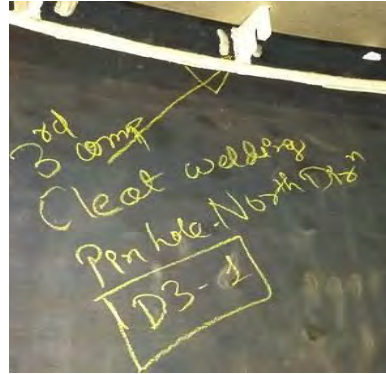
- “C” Seam and “L” seam welding found satisfactory.
- Half of the down comer observed brownish and half observed silver shiny in colour, sharp edges of welding observed due to erosion of down comer.
- Above “C” seam in North direction near cleat Pinhole of approx. 0.3 to 0.5mm and 3 to 4 mm depth observed, Marked as D3-1 for repair. Repair was carried out by welding and found satisfactory in DP test.

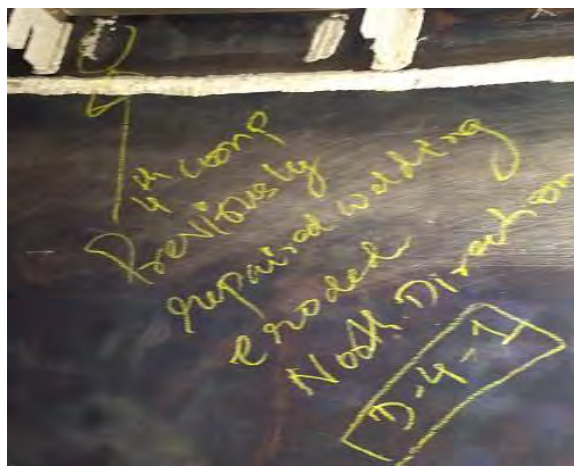
- Circumferentially provided Insert liner (Approx. 3.0 Ft long x 4 Inch width) observed silver shiny in color.
- Previously repaired defect on liner found eroded and pits of 0.3-0.5 mm depth in 50mm length approx. were formed in North side direction just above the “C” seam, marked as D4-1 for repair.

- Pin hole of 1.5 -2.0 mm depth was observed in West side “L” seam, marked as D4-2 for repair.
- Repair was carried out by welding on both defects and found satisfactory in DP test.

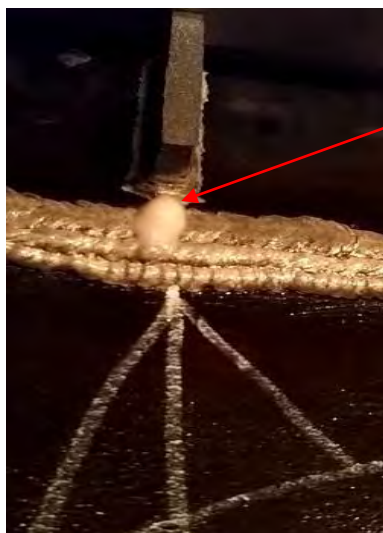
- Convex bulging of liner plate of approx. 3 to 9 mm height was observed just above the circumferential weld joint in almost complete periphery. The same was observed during last inspection.
- Concave depression of approx. 2-6 mm was observed at approx. 500 mm below the C-weld seam in full periphery. The same was observed during last inspection.
- **Helium leak** detection carried out on 25.09.2018 with 0.26 Kg/cm₂ (g) pressure in shell side liner annular space (Weep hole no 4 to 15) and leakage observed in South direction at bottom of cleat welding and just above the “C” seam welding top edge which was re confirmed by liquid soap solution test. Marked as D5-1 for repair.

Bubbles Coming out from crack.

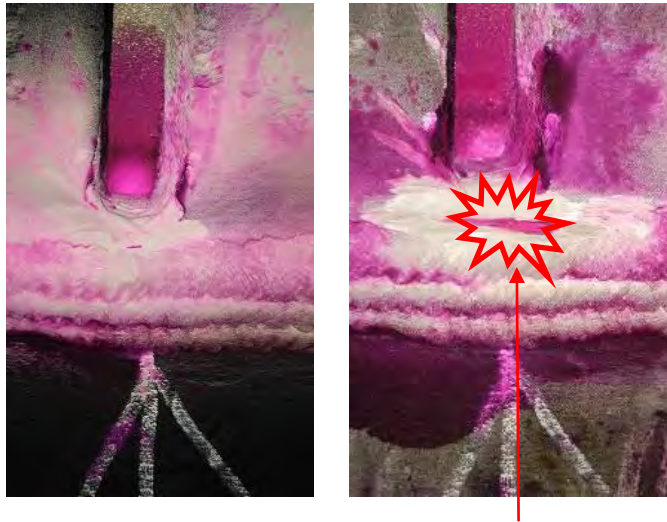
- After grinding on defect location, defect opening was gradually increased in size as seen in DP test photographs.

After grinding crack enlarged

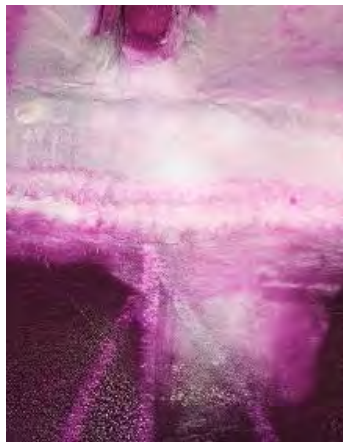
View of D.P. test after repair.

- Defect was repaired by welding & found satisfactory in D.P. test.

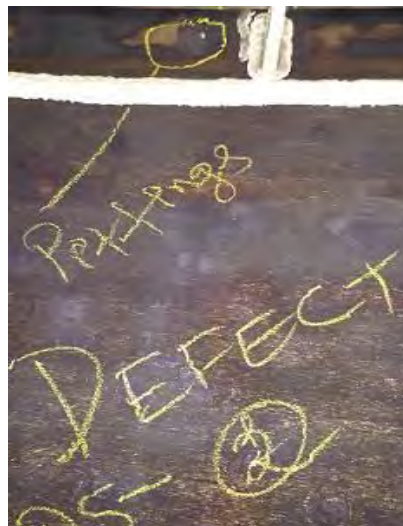
- Previously repaired defect locations was observed having pitting of 0.5 mm depth and 10.0 mm dia In South-West direction above "C" seam. Marked as defect D5-2 for repair.

- D5-2 and D5-3 were repaired by welding and found satisfactory in DP test.
- Condition of “C” Seam and “L” seam welding found satisfactory.

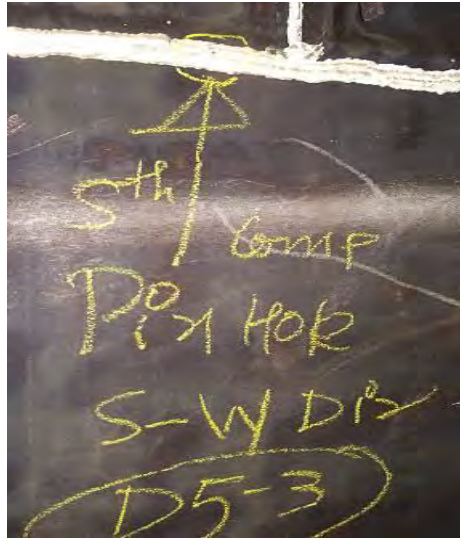
- Adjacent to defect D5-2 minor pinhole observed in “C” seam, marked as defect D5-3 for repair.

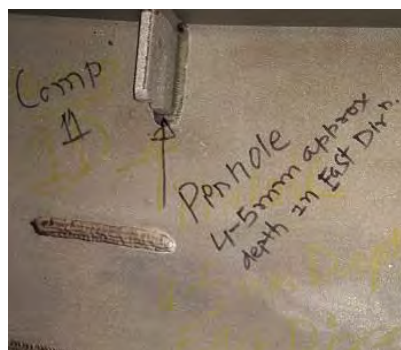
- A pinhole of approx. 4-5 mm depth was observed in bottom of the East side cleat weld. Marked as D11-1. Same was repaired by welding followed by DP test and found satisfactory.

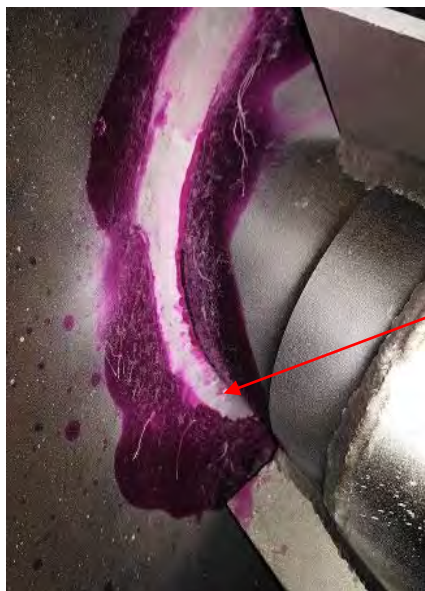
- All the Dish End to nozzle welding joints were D.P. tested at few locations indications observed which were shallow ground and found satisfactory in DP test. Carbamate inlet nozzle (C1-B) welding observed having sharp edges and crevice of approx. 2.0mm depth was observed in complete bottom half with nozzle. Same was repaired by welding followed by DP test and found satisfactory.

Crevice repaired by
welding in C1-B
Nozzle

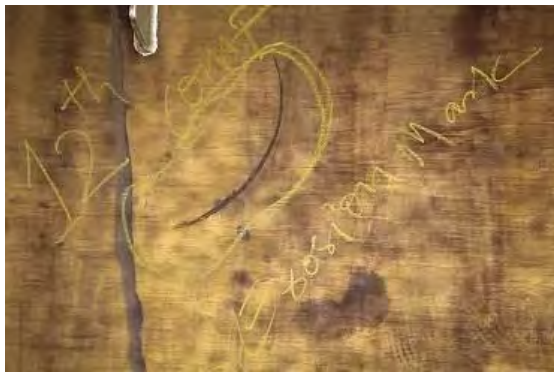
- Scratch mark of half round shape & approx. 0.5 mm depth and 200 mm length was observed on liner in South West direction.

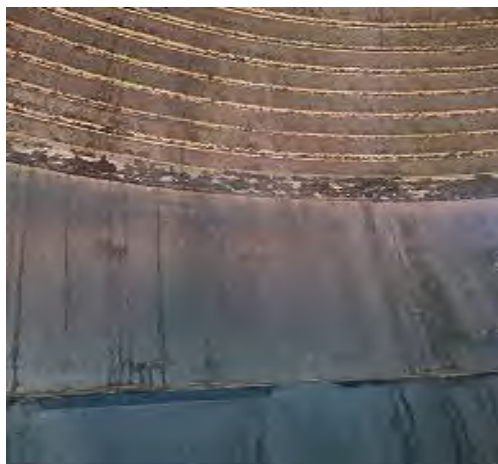
- The condition of sealing face was satisfactory.
- A thin blue grey oxide layer covered the overlay welding and liner in the gas phase (man way, dome and part of cylinder), except for the areas between the strip beads. The liner and liquid inlet box in the liquid phase were grey and slightly etched. No corrosion has been observed.

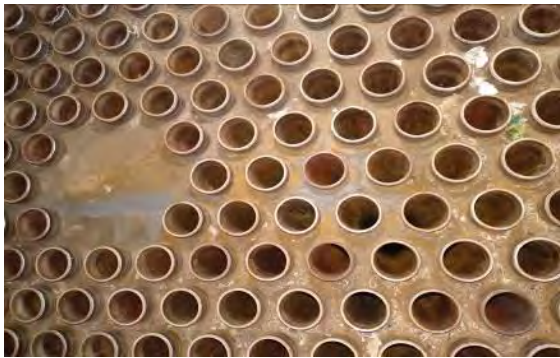
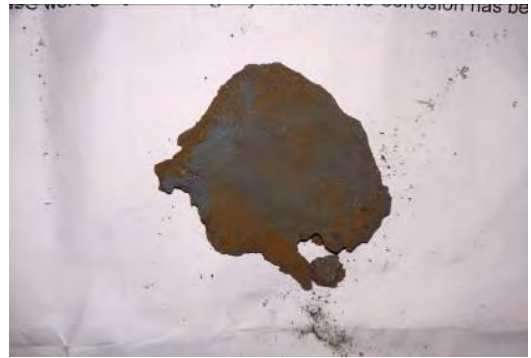
- The tube welds were bright and smooth. Thick & hard oxide deposition of 3 to 5mm thickness was observed, more prominent in centre & E-W direction of tube sheet.

Scales removed from tube-sheet.

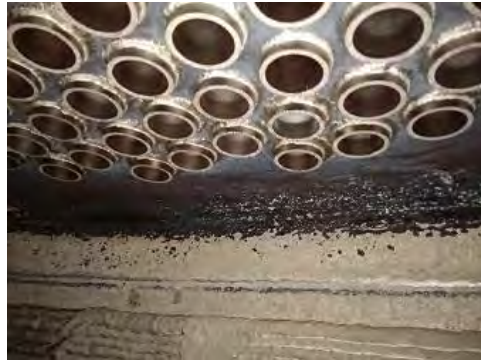
- The condition of sealing face was found satisfactory.
- The overlay welds in the man way observed silver and slightly etched.
- The overlay welds in the hemi-head were silver and etched. Many patches of approx. 2"x2" size on the hemi-head overlay welds were observed which were more etched than the surrounding areas in North and East direction, same was observed in previous inspection also.
- The tube sheet was covered with a thin grey oxide layer. This layer seems to be more hard & bonded on tube-sheet to shell weld joint.

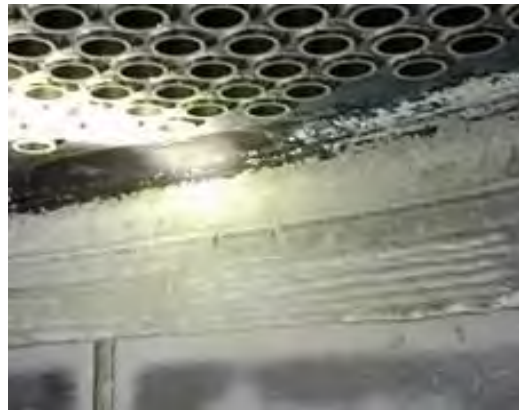
- Dark brown patches were observed at periphery of tube sheet at scattered locations, same was observed in previous inspection also.

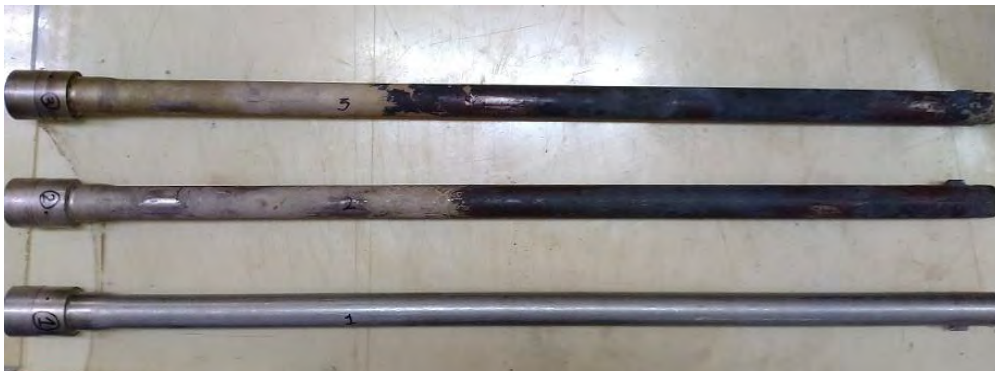
- One no. New Ferrule along with 02 nos. old/used ferrules of HP Stripper were offered for Inspection.
- New ferrule observed silver shiny in colour whereas on both old ferrules half of the length was observed having Silver coloration and the rest of the portion with dark grey hard scaling.

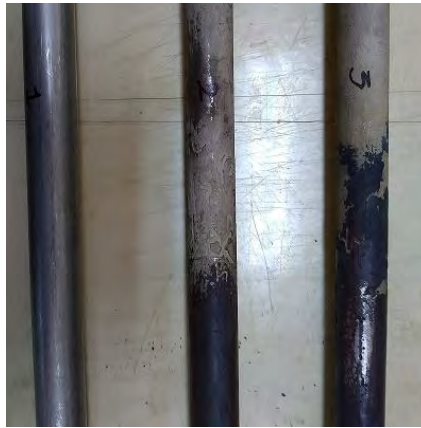
- Surface of new ferrule observed smooth whereas both the old ferrules observed having rough surface.

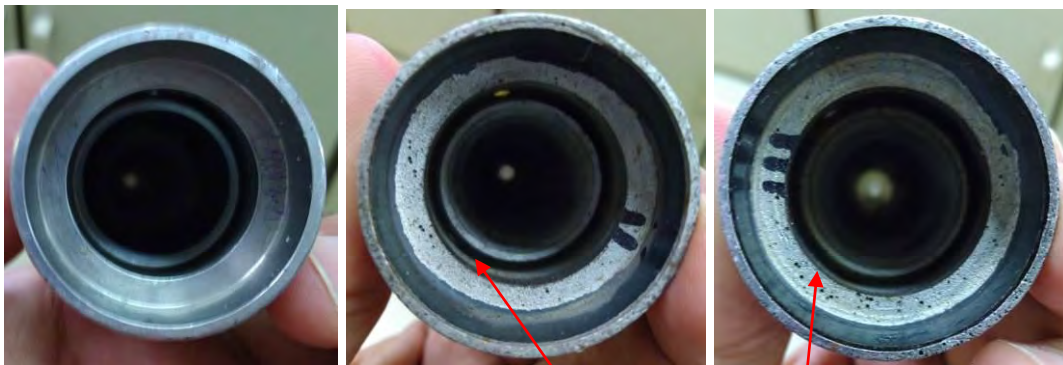
- Gradual thinning of tube ends of Old ferrules observed, viewed from I.D.
- (Images attached)

Sr No 01
New Ferrule.

Sr No 02 and 03 Used Ferrules.
Sharp tube ends observed.

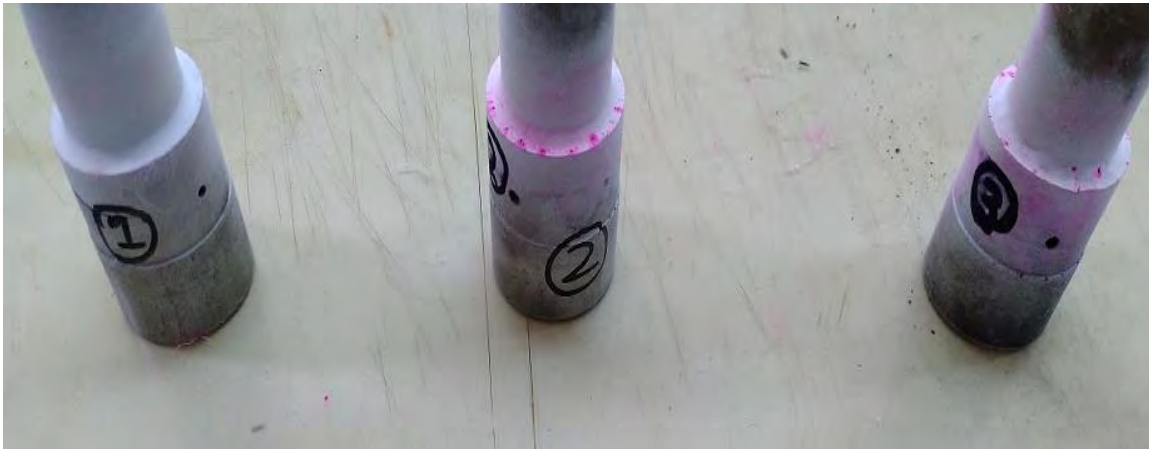
- Dye Penetrant test was carried out on seal weld and ferrule face.
- Welding of New ferrule (Sr No. 1) observed satisfactory.
- Old ferrule (Sr No. 2) face & weld observed rough and porous.
- Old ferrule (Sr No. 3) face and welding observed rough and pinholes observed on weld.

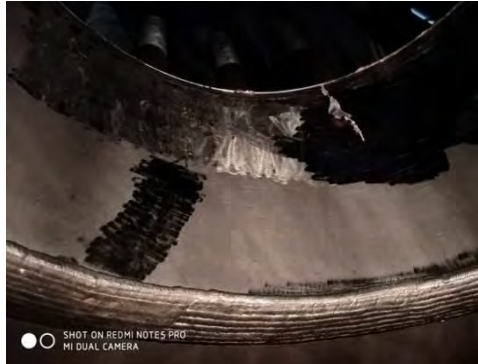
- The man-way liner was found silver-shiny in colour. Random grinding marks were observed on the liner in SW direction.

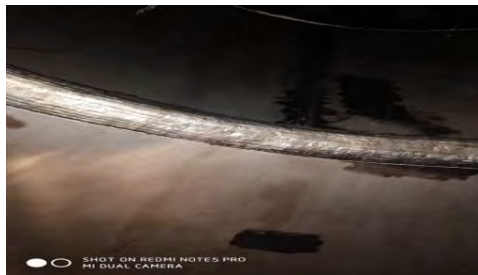
- Circumferential neck weld seam was found shiny & smooth.

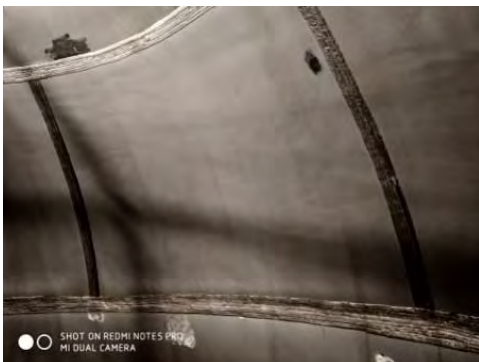
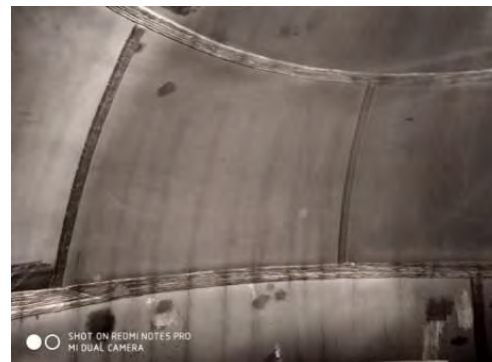
- Circular single segment liner just below neck, petal liners (08 segments) & cylindrical portion liners along with their welds were found silver-shiny and free from any crevices. However, random grinding marks were observed at scattered location in the Top head Liner segments.

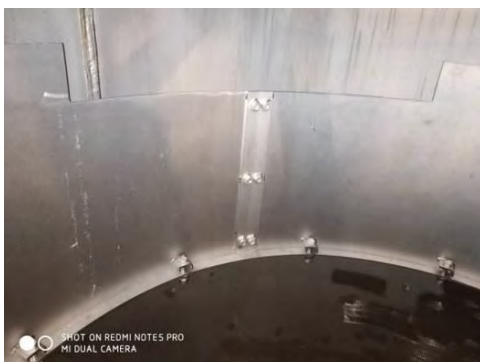
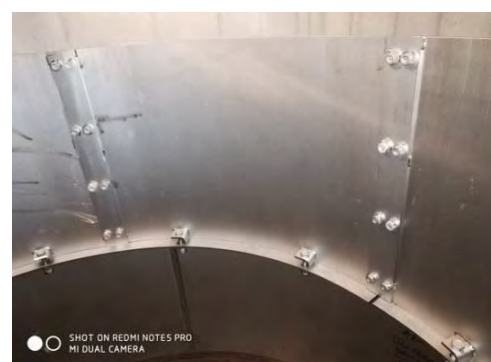
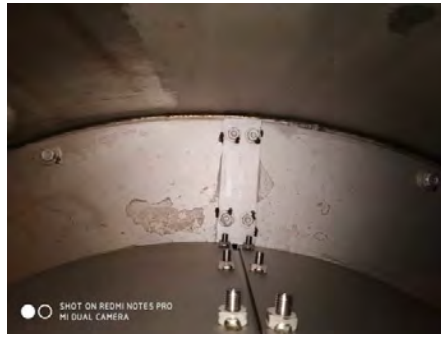
- Liquid collector, its weir segment and the fasteners were found intact.

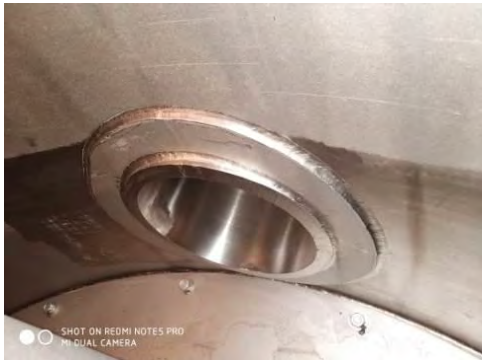
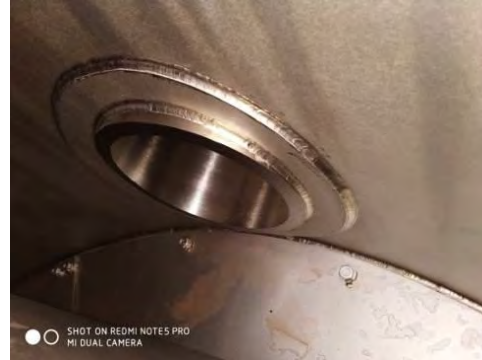
- Condition of both the liquid outlet Nozzles were found satisfactory.

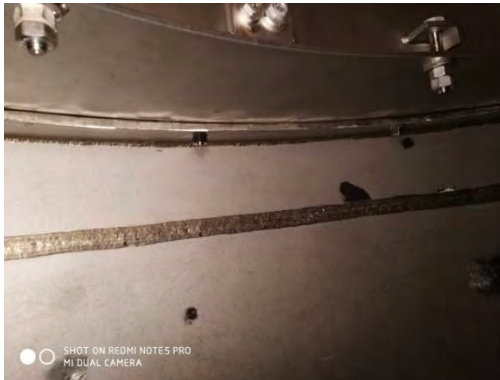
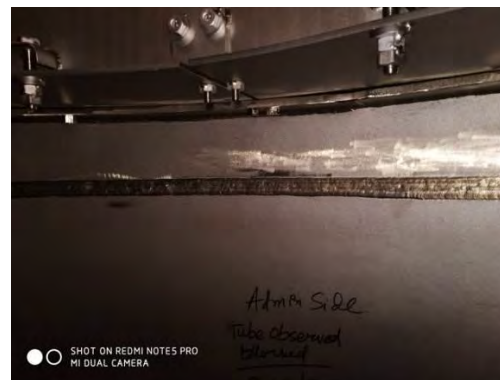
- Liquid collector support ring was found intact in its position.

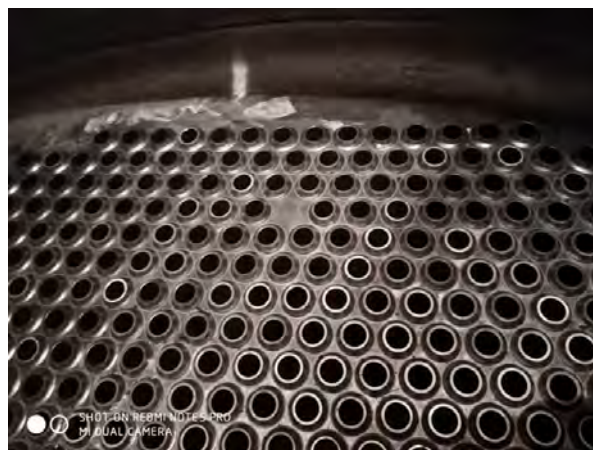
- Tubes to tube sheet orbital welds were bright, shiny and smooth. All the welds were found in satisfactory condition. No deposition or scaling observed in the tube I.D.

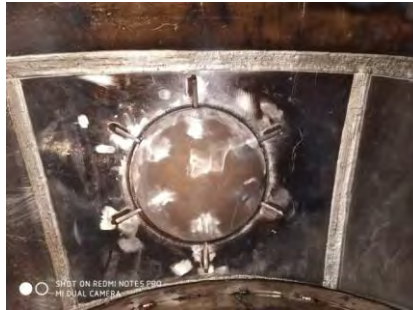
- The man-way liner was found silver-shiny in colour. Random grinding marks were observed on the liner.
- Circumferential neck weld seam was found shiny & smooth.
- Circular single segment liner just above the neck was found silver shiny in coloration.
- Petal liners (08 segments) & cylindrical portion liners along with their welds were found satisfactory. Coloration of the petal liner containing the Liquid Inlet nozzle observed blackish.

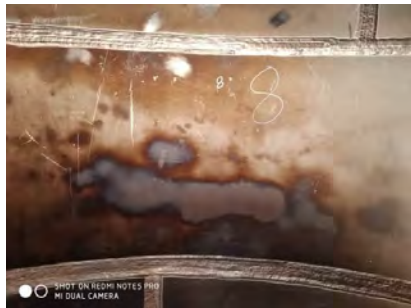
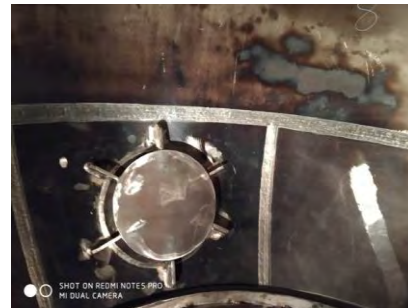
- Condition of the Impingement plate and its welds was observed satisfactory along with its holding cleats.
- The Cylindrical area liner just above the Liquid Inlet nozzle was observed having brownish colour patches.

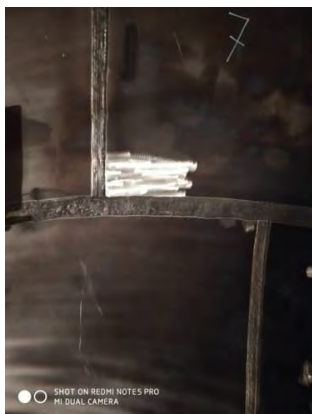
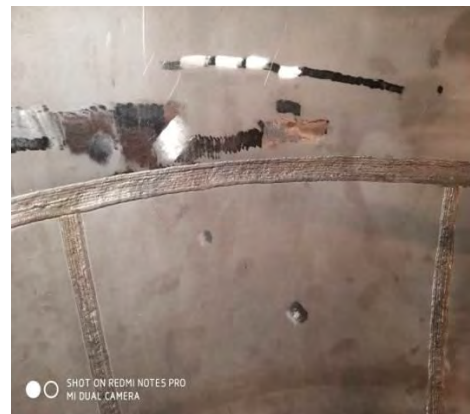
- Random grinding marks were observed at scattered location in the bottom head Liner segments.

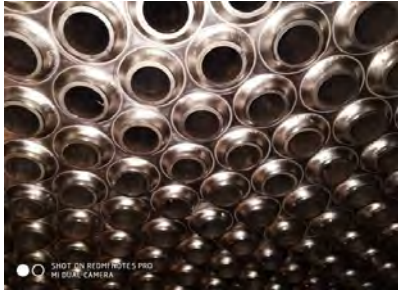
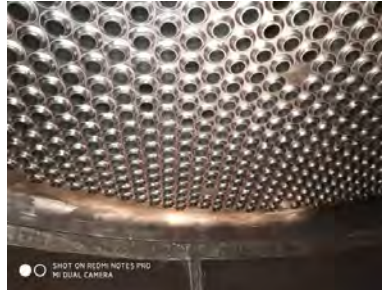
- Inlet distributor supports ring was found intact along with its fasteners.
- Tubes to tube sheet orbital welds were bright, shiny and smooth. All the welds were found in satisfactory condition. No deposition or scaling observed in the tube I.D.

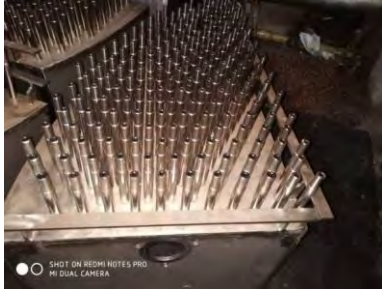
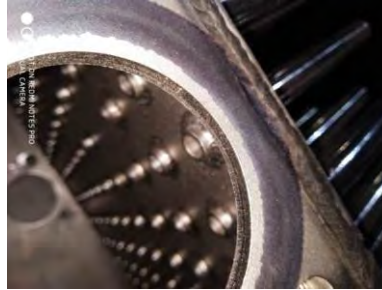
- The overlaid area of the tube sheet was observed shiny & smooth.
- Condition of 08 nos. of Inlet Gas Distributor modules was found satisfactory. All the Nozzles were observed shiny and smooth.

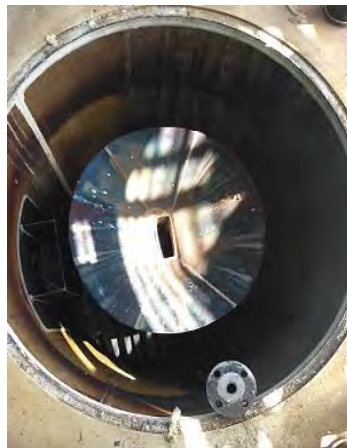
- Tube bundle was not removed from bottom compartment.

- Funnel and tubes were observed brownish black in colour.
- CO₂ inlet nozzle flange (3/4" NB) located at west side (Bottom comp.) found corroded, same was observed in previous inspection also.

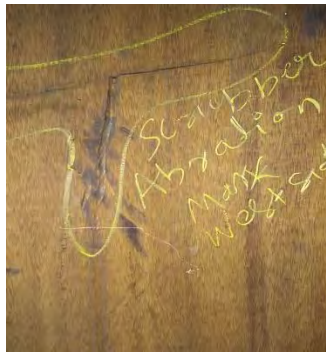
- Shell internal surface was found brownish in coloration and top hemi head observed silver shiny in colour.
- Condition of liquid inlet and gas outlet pipe found satisfactory.
- CO₂ Inlet line in South side was found intact.
- CO₂ inlet nozzle flange (3/4" NB) located at West side (Top Dome) found corroded same was observed in previous inspection also.
- Shell liner weld joint below the diaphragm plate found slightly rough and corroded.
- On Shell top course "T" shaped scratch/ abrasion mark of 0.5mm depth and 125mm x 125mm in length observed in West side.

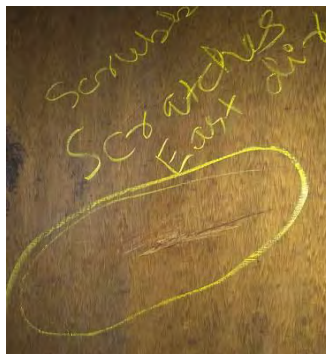
- Another scratch/ abrasion mark of 0.5mm depth and 100mm length observed on Shell top course in East side.

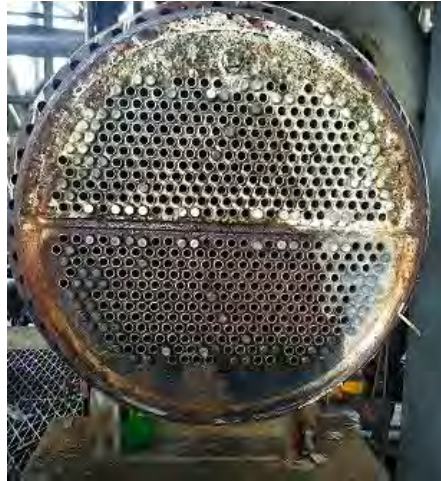
H-1207 (CIRCULATION SYSTEM -II COOLER)

- Pitting, Corrosion and whitish scaling was observed on the tube sheet area.
- Channel cover was found pitted / corroded from inside.
- Scaling was observed on the inside surface of tubes at many locations as per attached photograph.
- Few tubes are partially filled with water.
- Chemical cleaning carried out with help of external party of all the tubes.
- Epoxy primer may be applied inside channel cover.

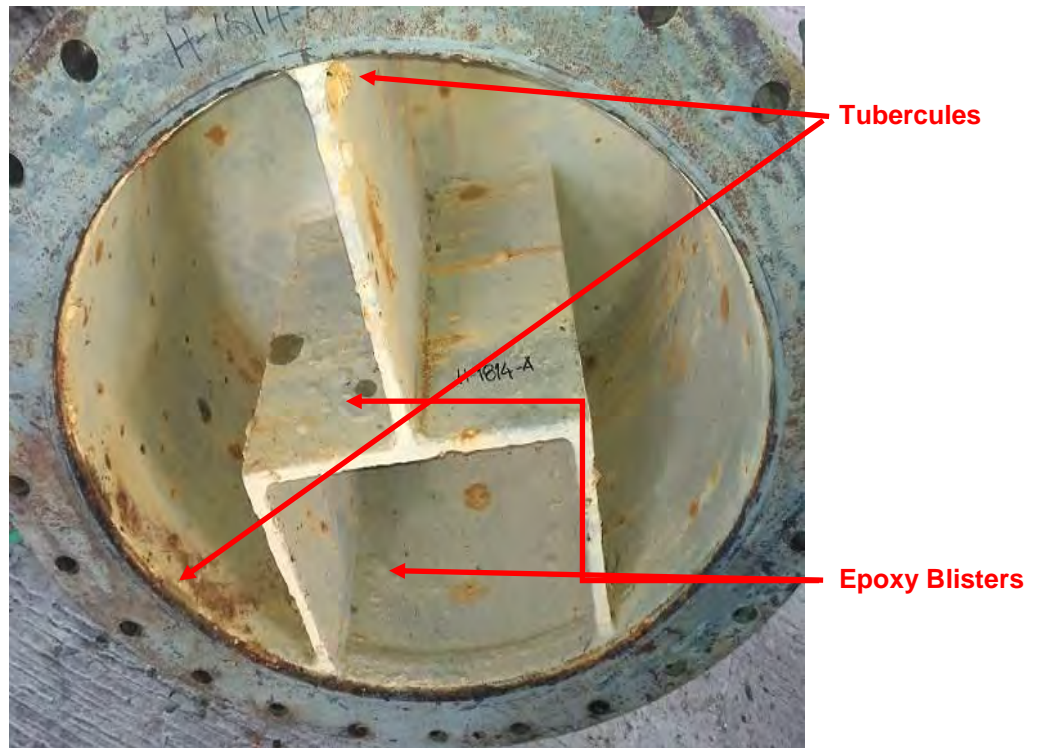
H-1814-A, L.O. COOLER OF HITACHI COMPRESSOR

- Condition of tubes and tube sheet was found satisfactory.
- Thin white scaling observed inside the tubes.
- Few tubes observed partially filled with water.
- Channel cover observed with epoxy paint blisters and tubercules, Repainting may be carried out.

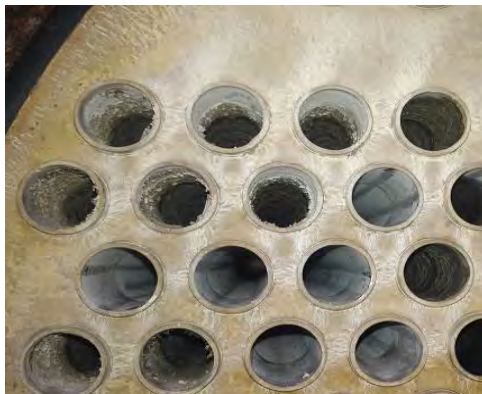
H-1814-B, L.O. COOLER OF HITACHI COMPRESSOR

- Condition of tubes and tube sheet was found satisfactory.
- White dry scaling was observed inside the tubes, found satisfactory after re-hydro jetting may be carried out on north side half from channel cover end.

- Few tubes observed partially filled with water.
- Epoxy layer was found peeled off at several locations on channel cover & partition plates.

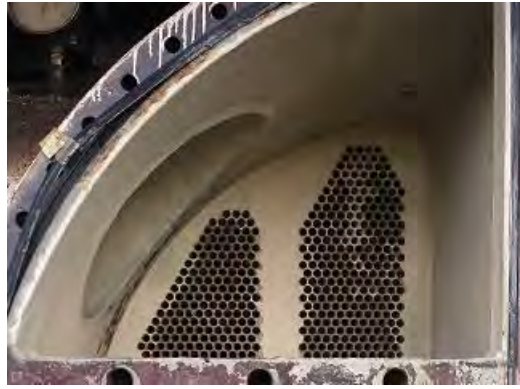
TOP HALF

- Tube sheet and tubes observed satisfactory condition.
- White thin layer observed on entire half.

- Thermowell observed covered with white colour scales.
- Few tubes observed partially filled with water.
- White dry scaling was observed inside the tubes, observed satisfactory after re-hydro jetting.

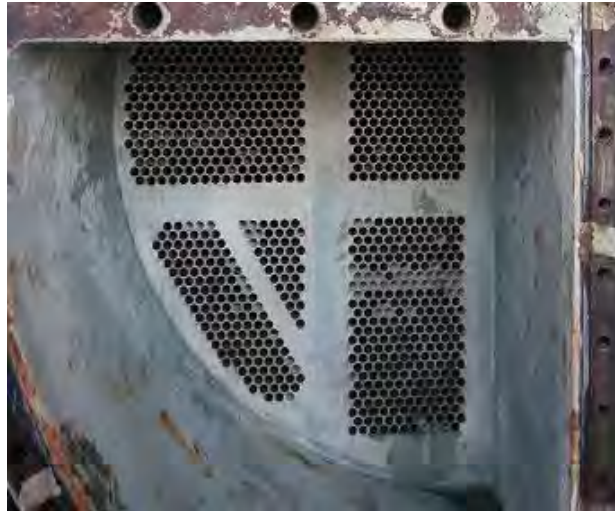
BOTTOM HALF

- Epoxy coating layer was found peeled off at several locations.

- Minor scaling / debris / rust flakes were observed at ID of few tubes.
- Few tubes observed partially filled with water.
- White dry scaling was observed inside the tubes. Found satisfactory after Re-hydro jetting.

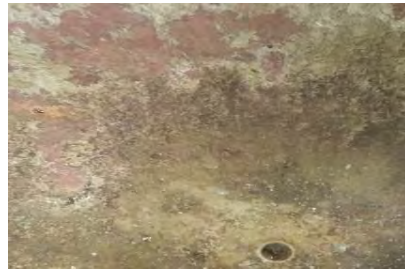
- Epoxy paint was found peeled off from few locations in bottom dish end and shell

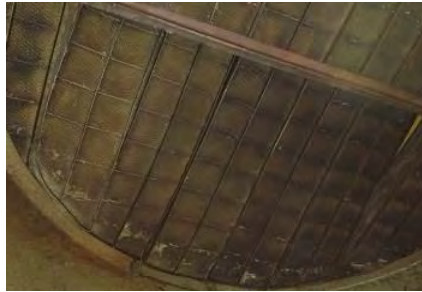
- Demister pads were found shifted from its position.

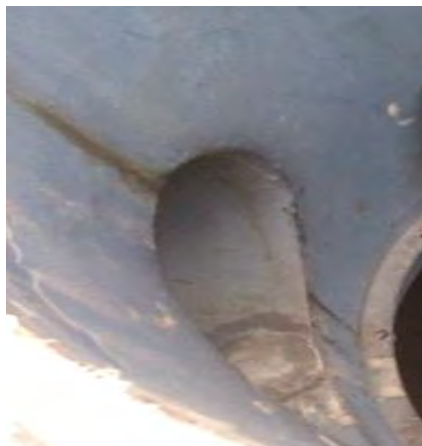
FROM TOP MANHOLE

- Grey hard scales were observed on entire shell portion.

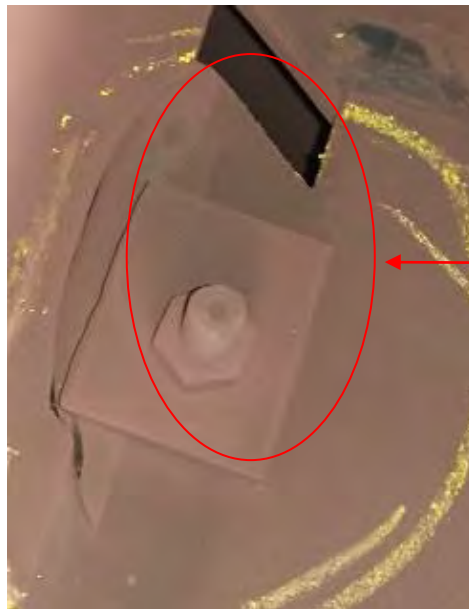
- Shell Internal surface found rusty / brownish in colour.
- Nozzle found satisfactory.
- Perforated tray was found in broken condition. (in North-West side)

Broken

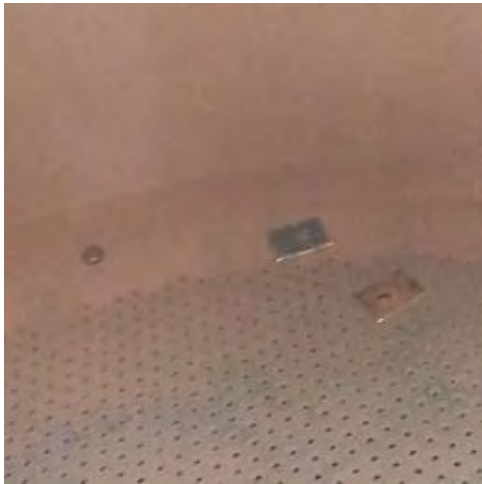
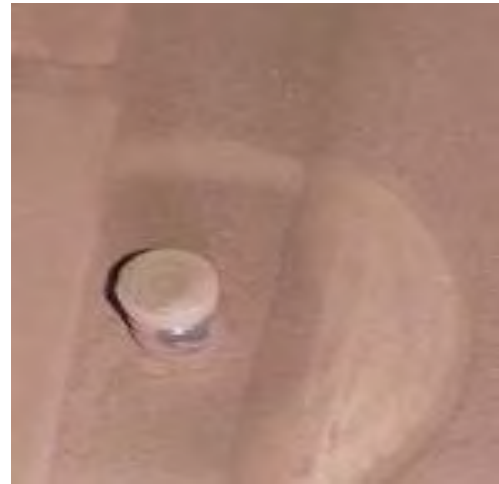
- Fasteners and clamp of trays observed in satisfactory condition, however one bolt observed missing and its washer and nut found lying on perforated tray.

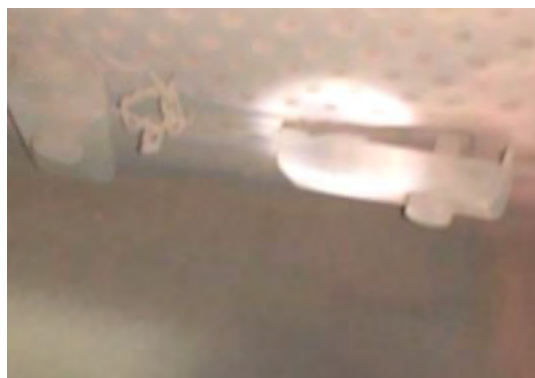
- Shell observed brownish in colour from inside.
- Nozzle condition was found satisfactory.
- Thermo well was found intact.
- 01 bolt was found in improper condition.

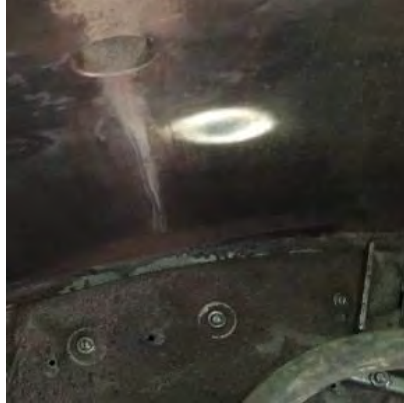
- Brownish coloration was observed on Top dish end and shell.
- Trays observed reddish in color.
- Fasteners of sieve tray were found intact in position.
- Accumulated sludge / debris observed in ½” nozzle, 3” nozzle and ¾” nozzle in East side.

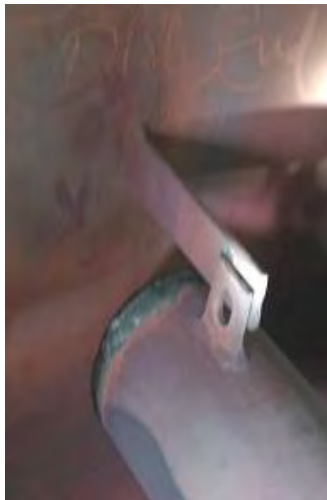
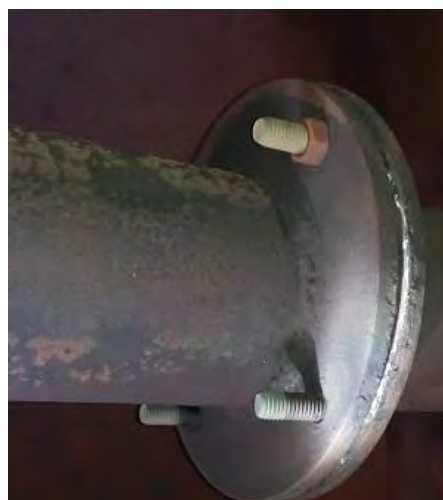
- Thermowell condition found satisfactory.
- Steam inlet line flange and clamping bolt found missing.
- On Shell , Reddish coloration was observed from inside.
- Few fasteners of Middle tray clamp found missing and rest of tray clamps found satisfactory.

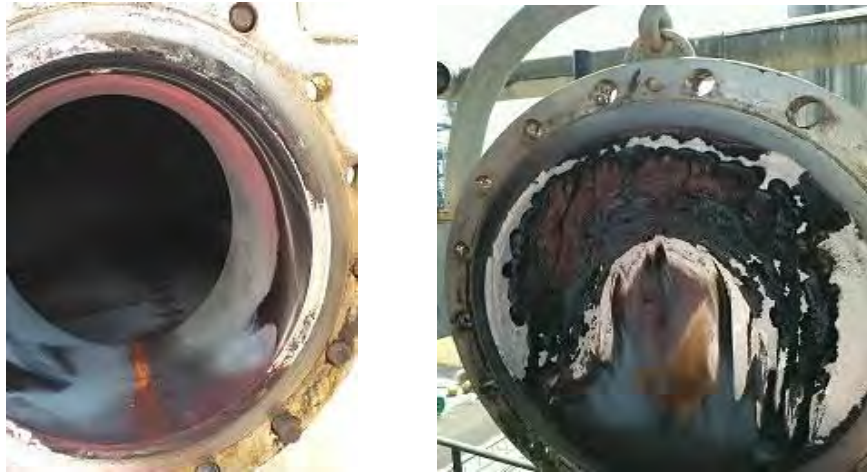
- Weld joint condition was found satisfactory.
- Manhole gasket seating face observed eroded / corroded at several locations.
- Thick blackish deposition observed on M/H cover and on M/H flange.

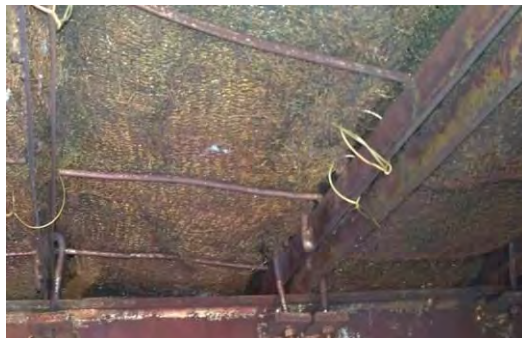
- Reddish Brown coloration was observed inside the vessel.
- Demister pads were found slightly damaged / loosened & lifted at several locations most prominent in South-East direction.

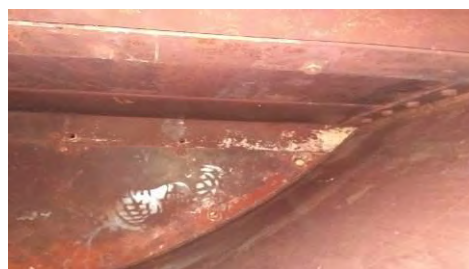
- 02 no of bolts of bottom plate found missing.

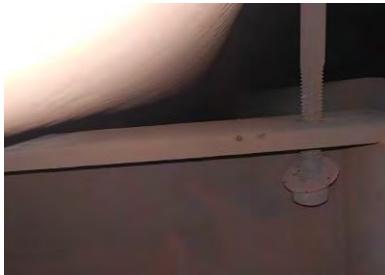
- Grayish black coloration was observed inside the vessel.
- U-clamp of the steam inlet header was found loose.

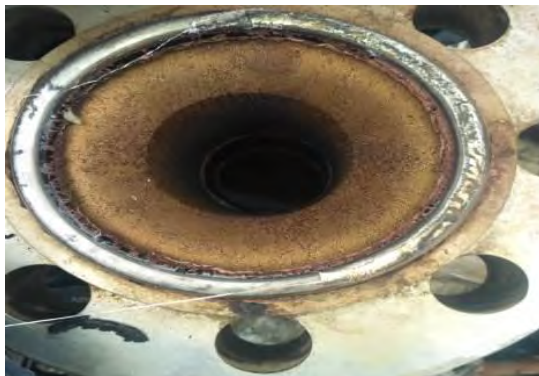
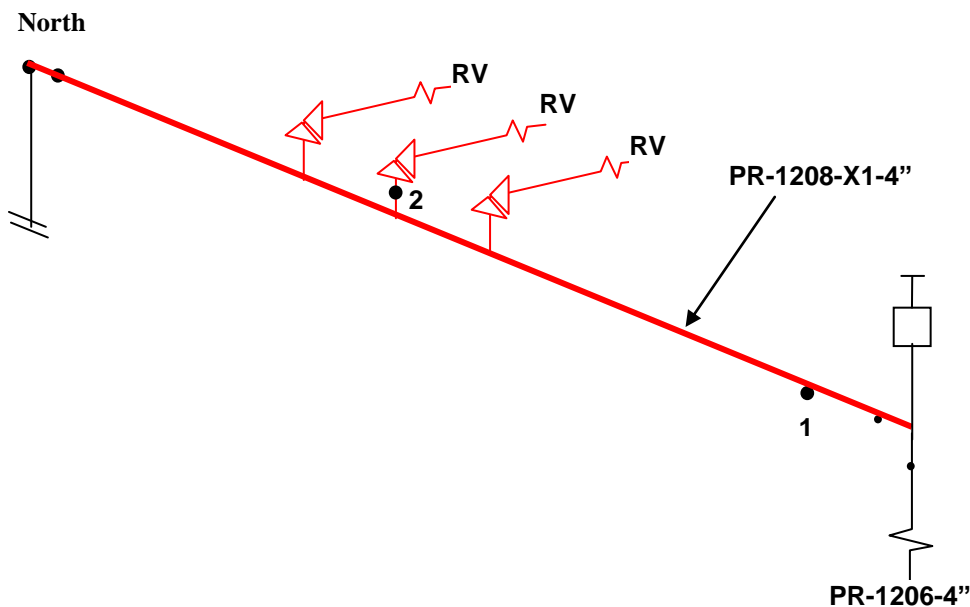
RV-1201 A, B, C NOZZLES

- Roughening of flange face and ID observed in all three RV Flanges.
- Brownish coloration observed inside RV Nozzles.
- Thickness measurement carried out as mentioned below. No abnormalities observed.

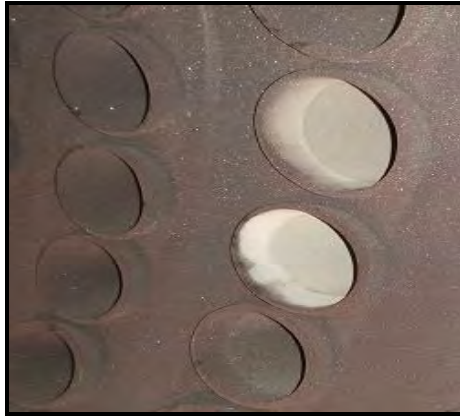
- The internal surface of the drum observed brownish black in colour.
- The condition of the weld joints found satisfactory.
- The tube stub ends were free from any defect.
- Whitish scaling was observed in ID of some of the tubes.

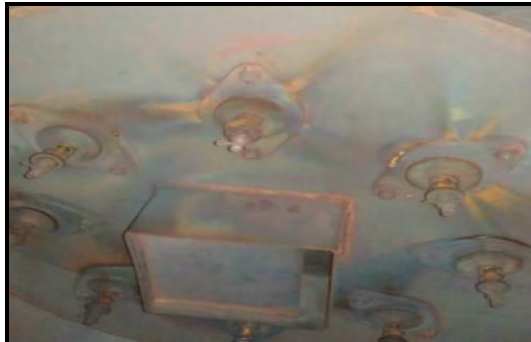
- Brownish coloration was observed inside the shell and dish end.
- All tray segments and angle supports were found intact in position.
- Unequal spring tension observed in spray nozzles.

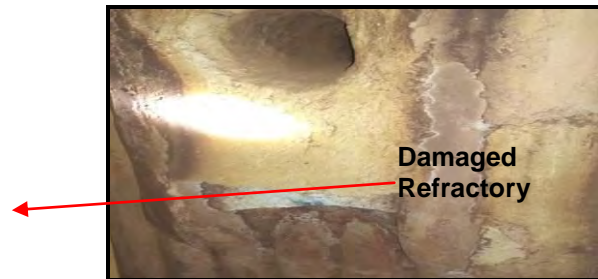
- Refractory near to the manhole (East side) found in damaged condition.

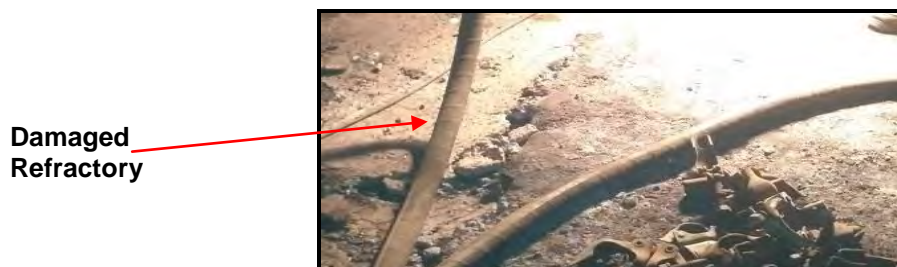
- Minor rust and scaling observed on South wall, Front panel, Rear panel, Cut corner and baffle wall tubes.
- Floor refractory was found damaged and lifted upwards, approx 6'' at centre of furnace.

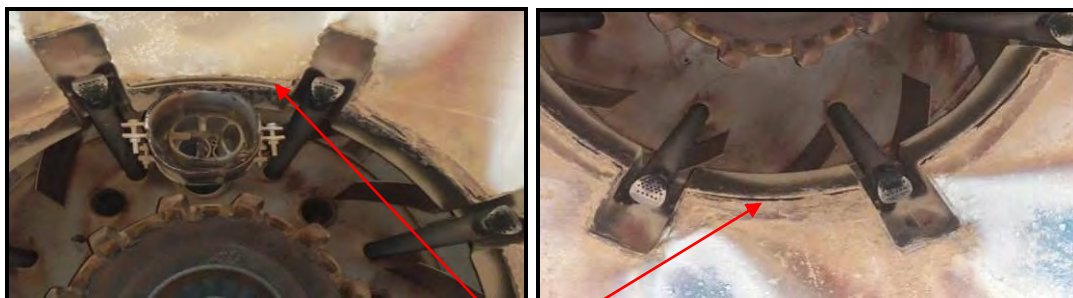
- Condition of thermo-wells in cut-corner wall found satisfactory.
- Refractory around the bottom burner was found damaged, also carbon deposition observed on all its nozzles.

Damaged Refractory

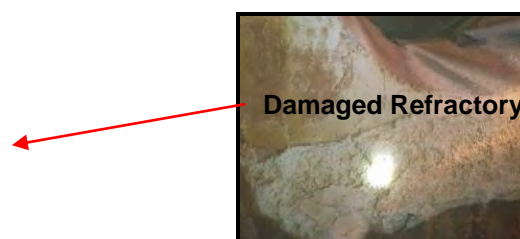
- Condition of refractory around the top burner was found satisfactory, however carbon deposition was observed on all its nozzles.
- Earlier repaired location of refractory near bottom burner was found damaged.

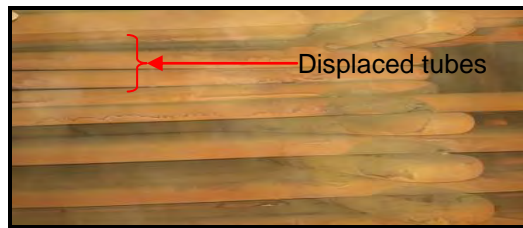
- Minor scaling was observed on Primary Super heater tubes.
- Some of the tubes of Primary super heater coil found displaced.

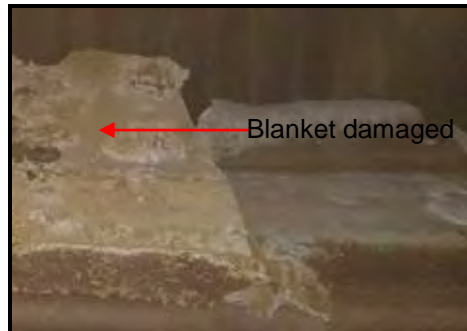
- Insulation fiber blankets placed on top of the Secondary superheater coil were found damaged as refractory from top roof fallen on it.

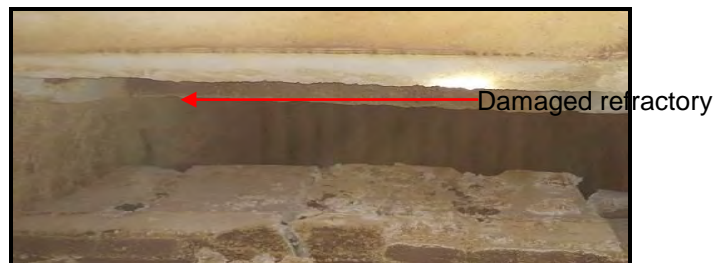
- Furnace roof refractory found damaged and loosened above secondary super heater coil.

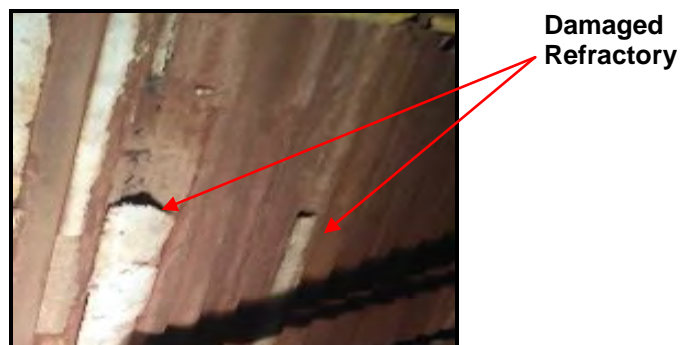
- Baffle wall refractory fell down at few locations.

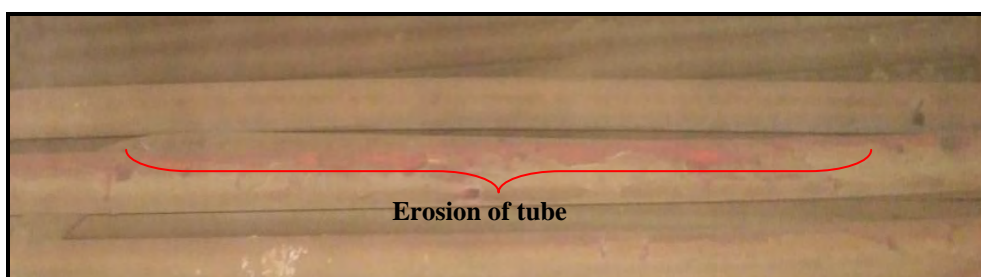
- Erosion observed on top tube of primary super heater coil.

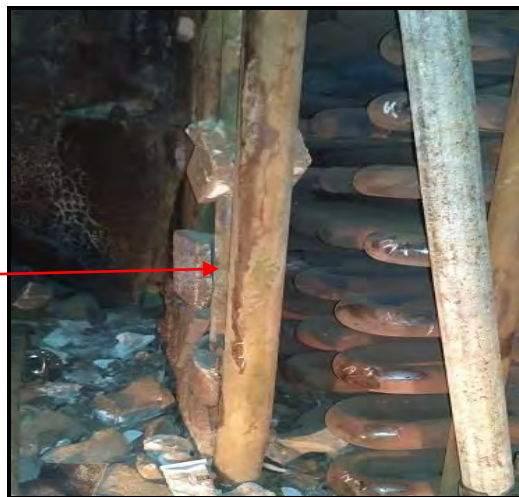
- DP Test and RT of Secondary SSH coil U bend root and final weld joints. (06 joints)
 - DP Test and RT of Bank tubes root and final joint (10 joints). These tubes were cut to facilitate welding/replacement of the Sec SH U bends.
- Bank tube refractory was found damaged / detached.

Damaged Bank wall
Refractory
