KALOL UNIT

PLANT TURNAROUND REPORT
(SEPTEMBER - OCTOBER – 2018)

Plant Turnaround for the year 2018 was taken from **17th Sep 2018** to **15th October 2018** for carrying out ESP Phase III (Energy Saving Project), Preventive maintenance jobs of Static & Rotary equipment.

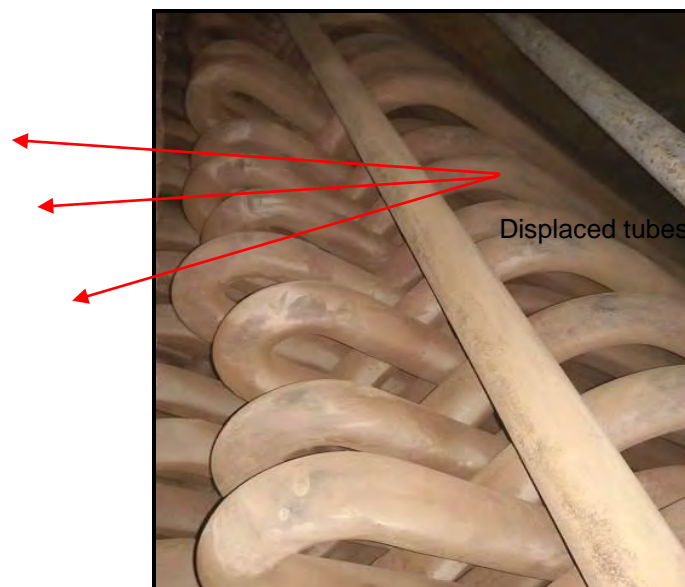
- Refractory found satisfactory on roof just above the access door.
- Minor rust and scaling was observed on boiler bank tubes.
- Some of the Secondary super heater coils found displaced.

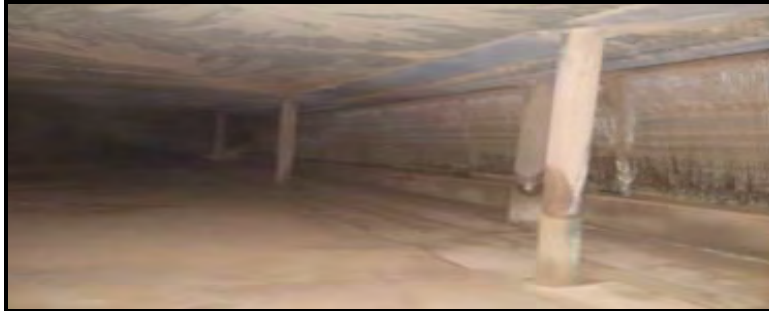
- Rust and scaling observed in middle compartment roof area & bottom surface.

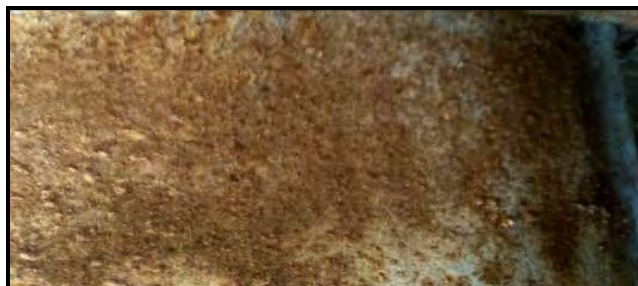
- Bottom plate found bulged upward at center portion and in North direction, however bulged downwards in west side portion. Same was also observed in past
- Paint/Epoxy found peeled off from the entire shell surface.
- Scaling/Rusting observed on shell.

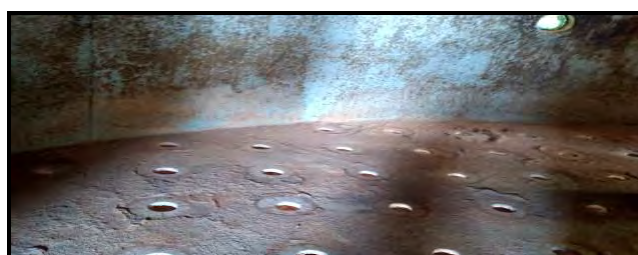
- Plate top surface found covered with debris/paint/oxide layers needs to be cleaned.

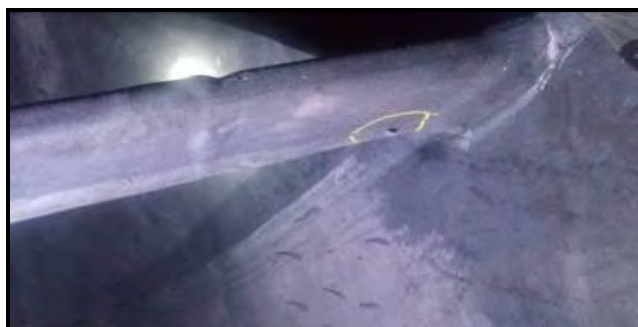
- Joint of rubber lining was found slightly opened at support of water inlet mesh holding plate. However, no leakage observed during spark test. (Marked with yellow chalk)

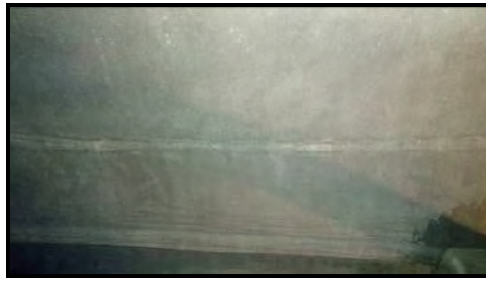
- In upper shell coarse, linear mark observed near long seam joint of rubber lining.

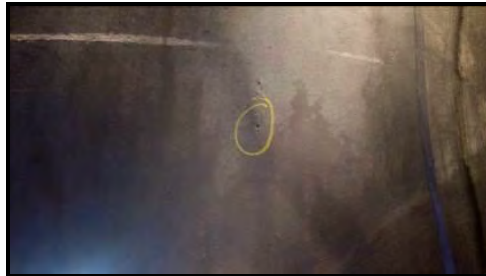
- 01 no. pinhole observed near manhole in bottom shell coarse. However, no leakage observed during spark test. (Marked with yellow chalk)

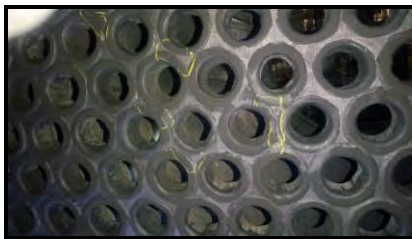
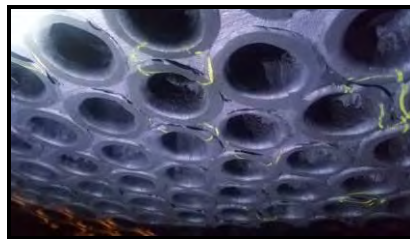
- Minor opening observed on sleeve joint of the nozzle bed rubber lining at few locations. (Marked with yellow chalk)

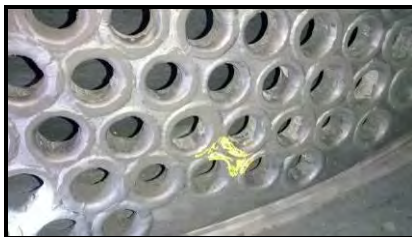
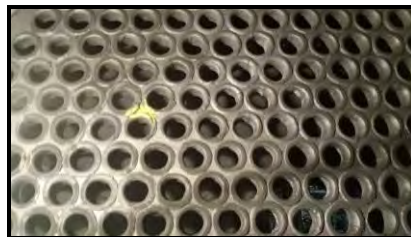
- Leakage observed at 02 nos. locations on sleeve joint of the nozzle bed rubber lining. (Marked with yellow chalk)

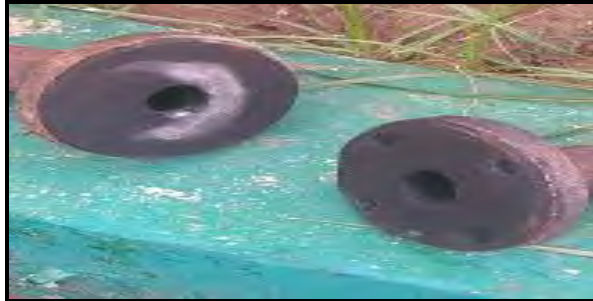
- On 05 locations spark leakage observed. (Marked with yellow chalk)
- Fastener holes were not pierced in Rubber lining of one flange.

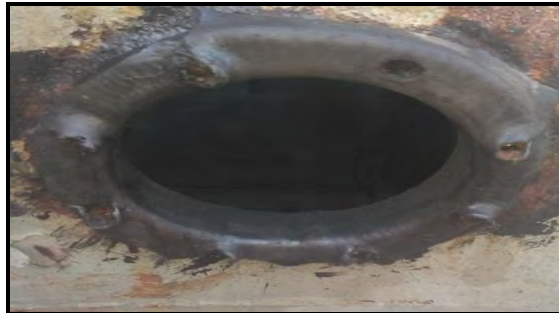
- Improper rubber lining and cutting observed in 4 nos. of flanges.

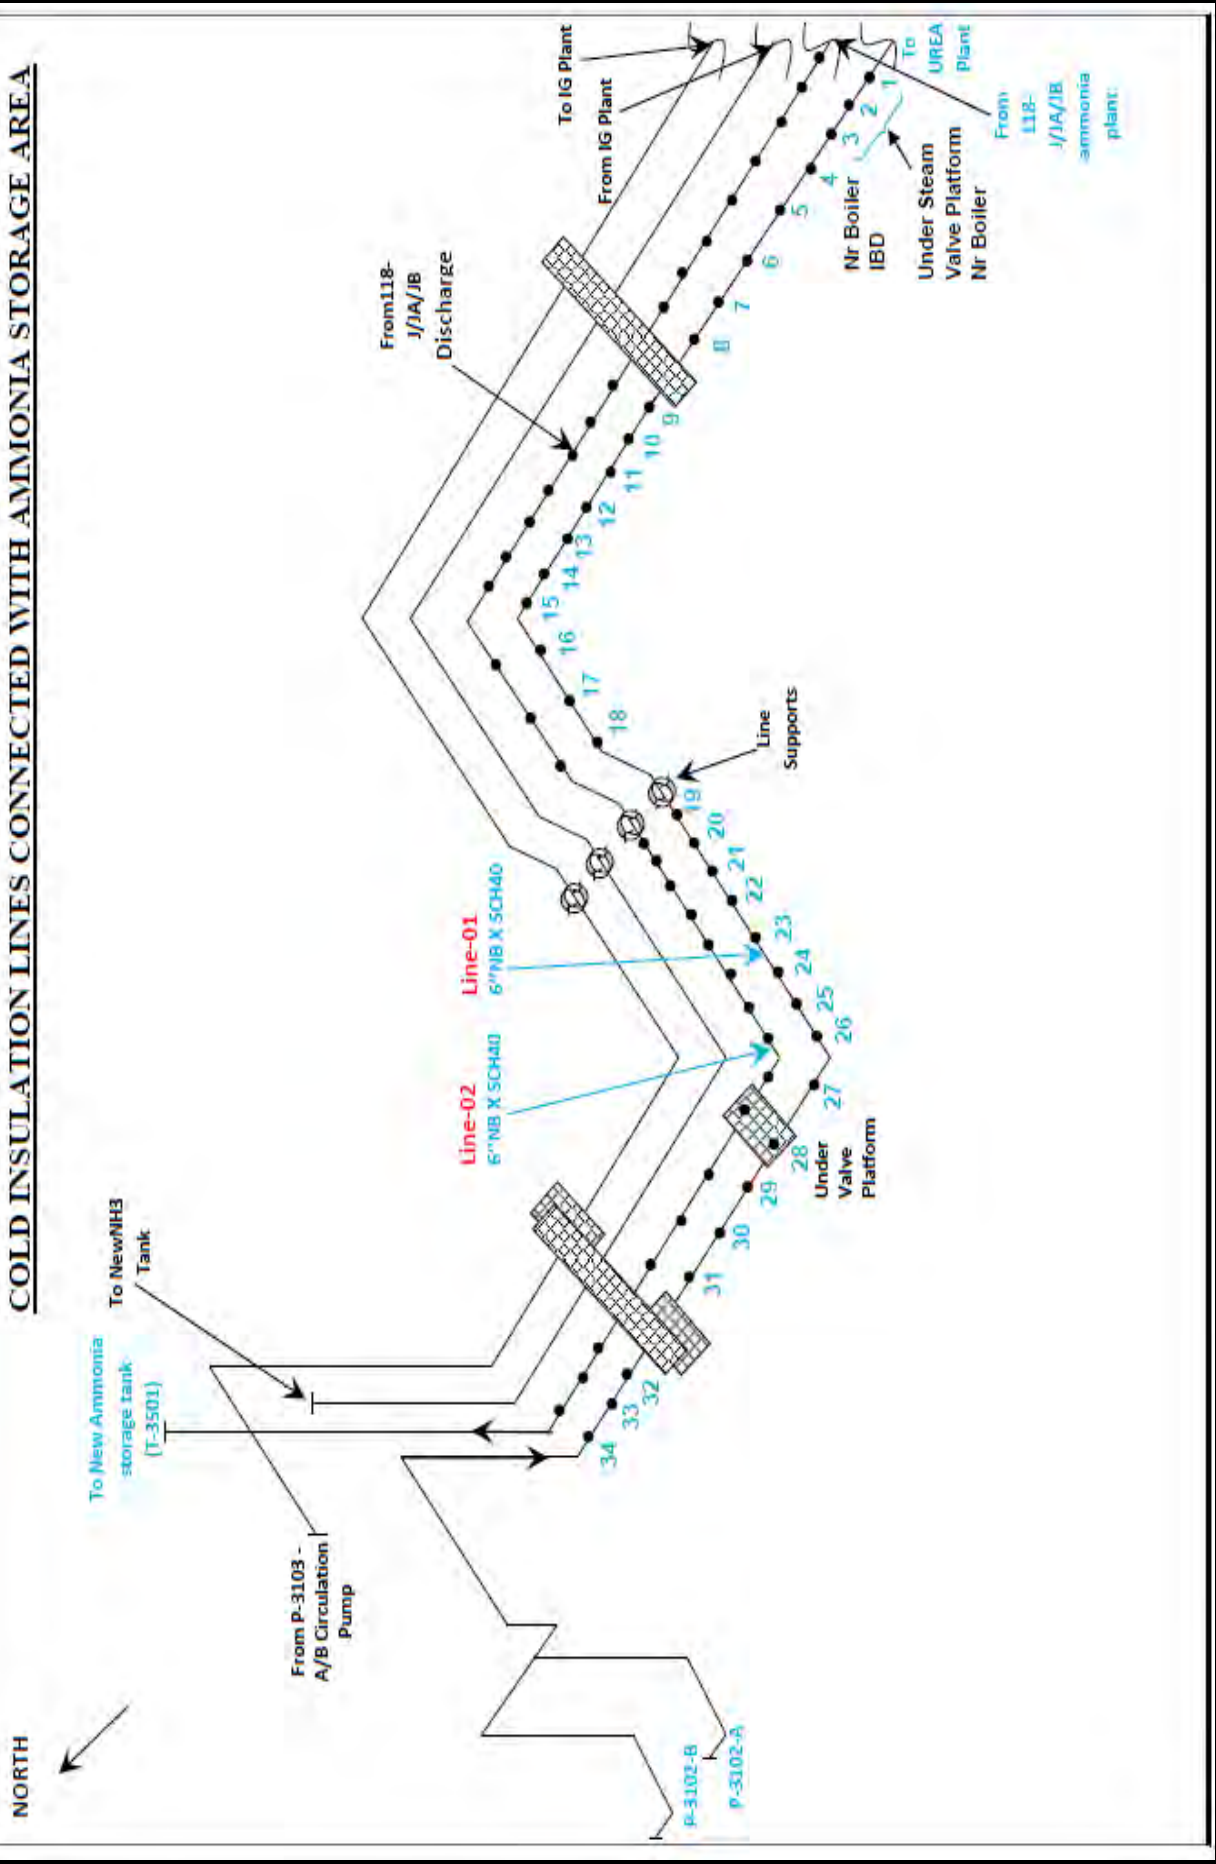
COLD INSULATION LINES CONNECTED WITH AMMONIA STORAGE AREA

No abnormalities observed in Visual Inspection. Support no. 1 to 20 in each line were replaced by pre-cast PUF blocks & rest of the supports were overhauled and replaced with existing wooden block supports. Isometric of Pipelines showing support location is shown below.

Line No.	Description	Size	Nominal Thick. (in mm)	Measured Min. Thick. (in mm)
1	From P-3102-A/B to Urea Plant	6"	7.11	6.48
2	From 118-J/JA/JB to New Ammonia Storage Tank	6"	7.11	6.04

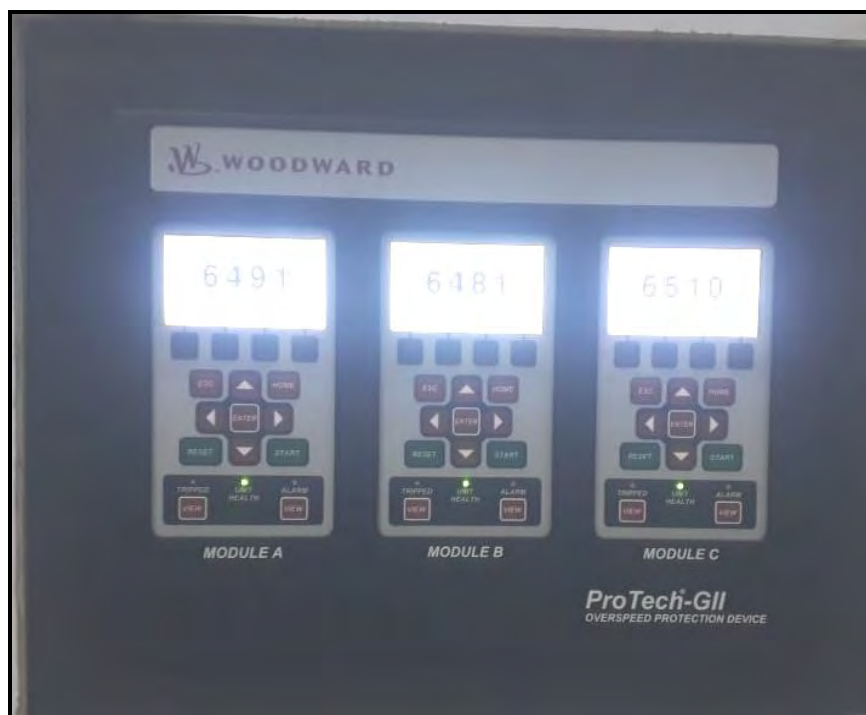
Protech GII was installed in ammonia control room & 110 V AC power supply was provided from different MCB of Power Distribution Board (PDB). Three numbers of Dedicated speed cables were laid from Protech GII to speed junction box installed in field.

Protech GII programming was done in presence of M/S Slcagen India limited, Mumbai & 110V AC power had been provided. OST was done by production person & found satisfactory response. Finally 2003 high speed Protech GII trip system was taken in line.

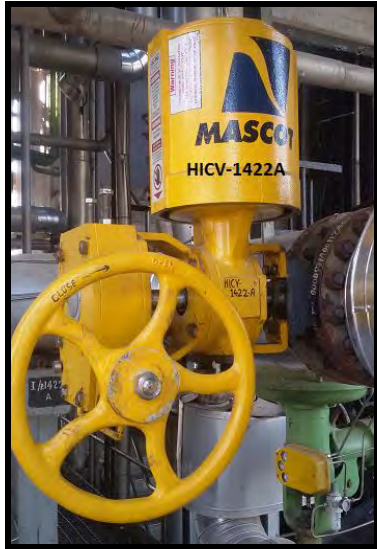
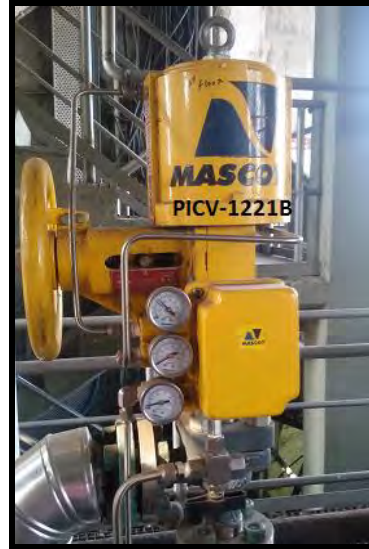
- Old and obsolete control valves were replaced with new control valve with technical specification as per updated process data

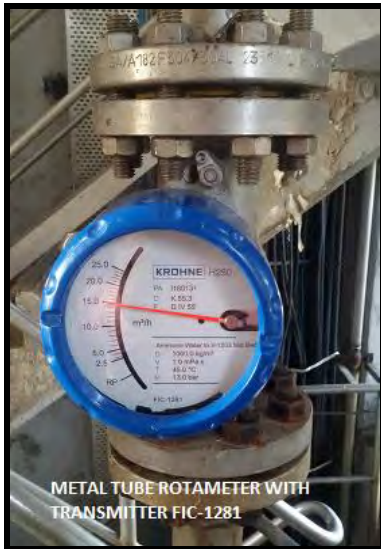
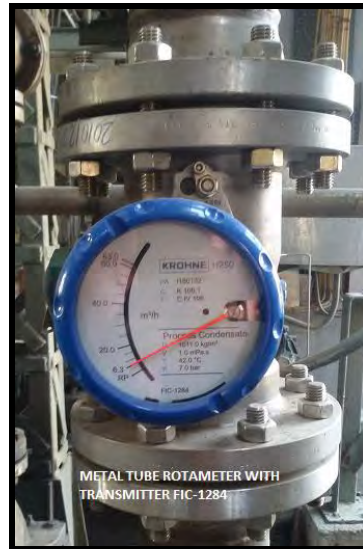
- Old and obsolete metal tube rotameter with transmitter were replaced with new rotameters with technical specification as per updated process data.

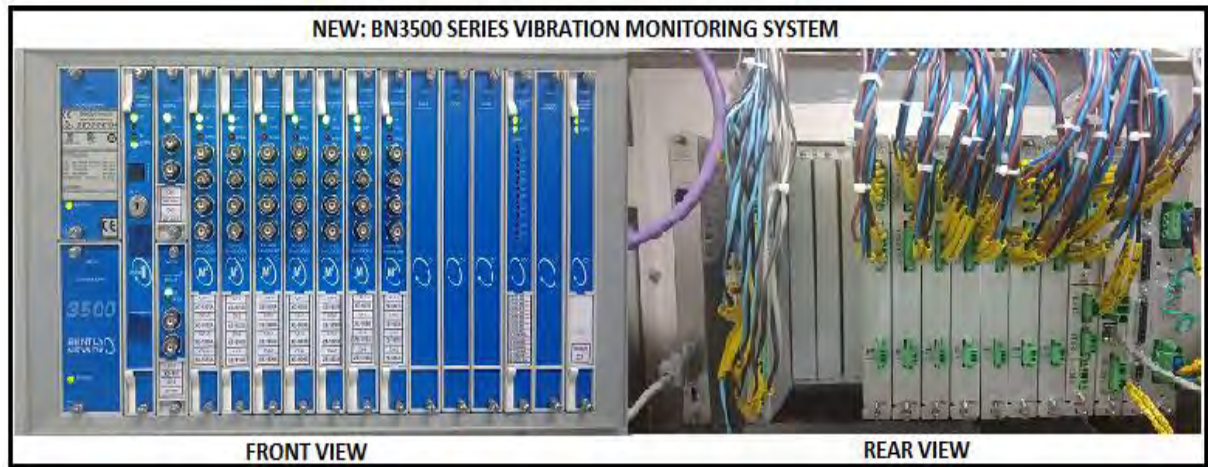
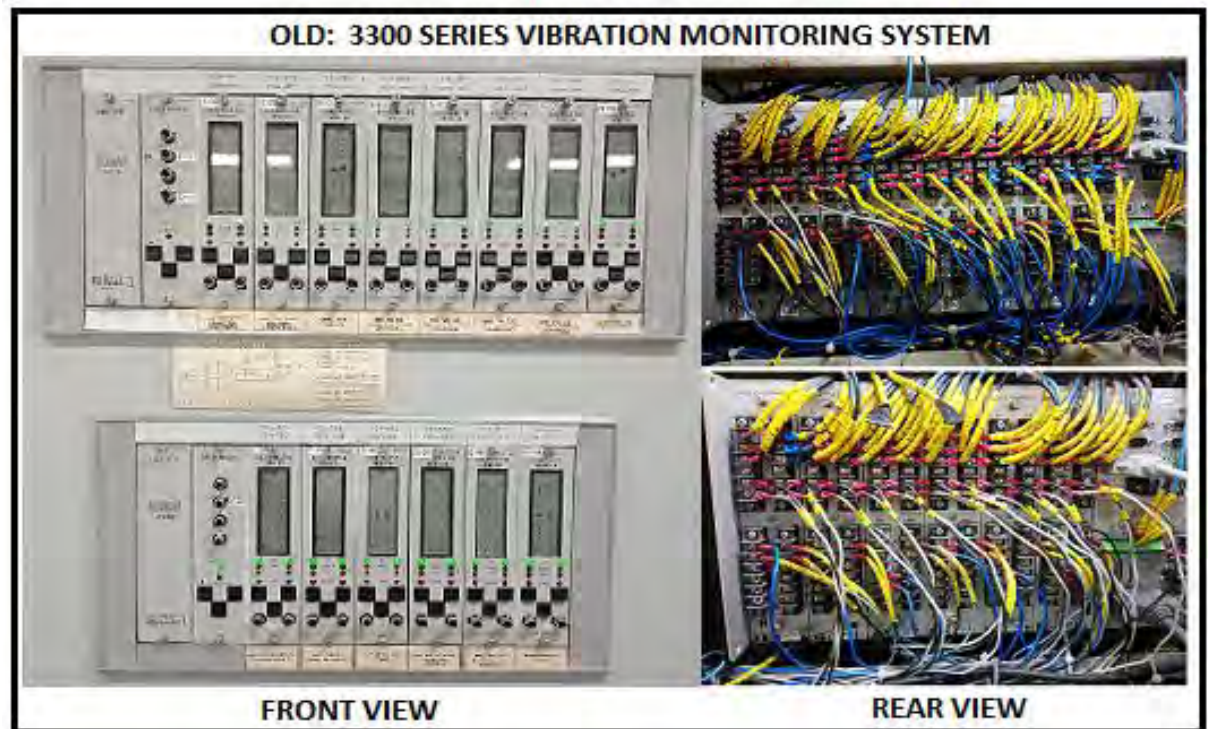
Existing Bently Nevada **3300 series** Vibration monitoring system, was upgraded to **BN3500 Series Vibration monitoring system**, for CO2 Compressor in Urea Plant.

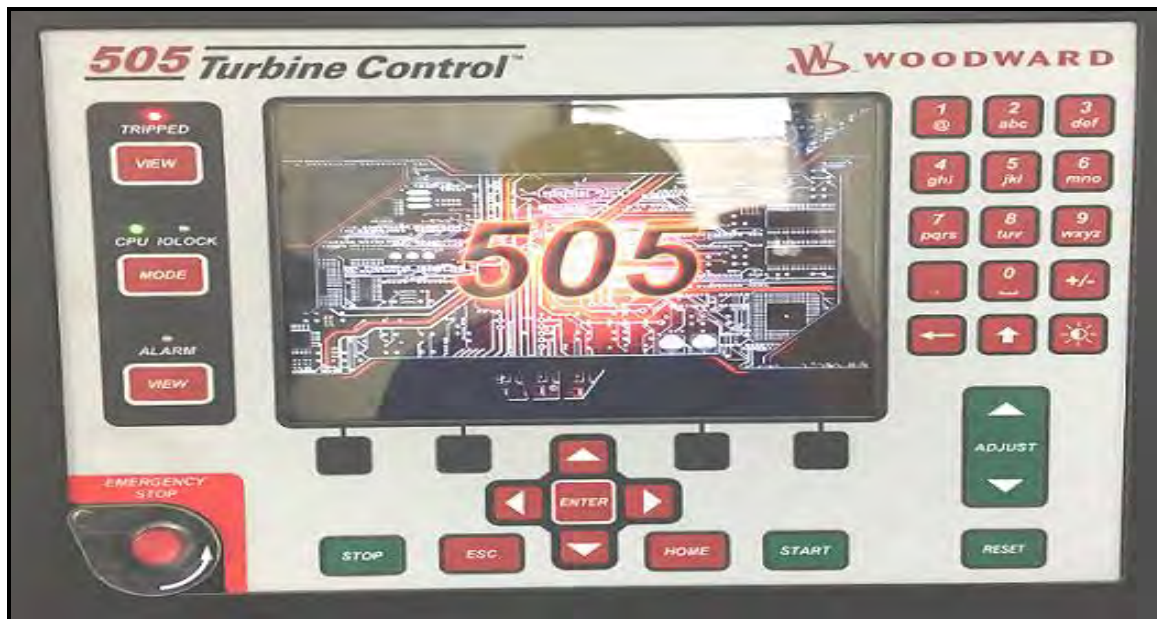
Woodward Governor panel to DCS marshalling cabinet power cable & signal cable were laid & power supply was provided. New RPM indicator was mounted in the field and old one was removed. Governor panel console, all push to fit TBs

were replaced to screw fit TBs to facilitate wiring. Cable trays were laid for field cables. Five Branch cables were laid for two MPUs, actuator output, feedback & speed output to RPM indicator. All cable terminations were done at both ends.

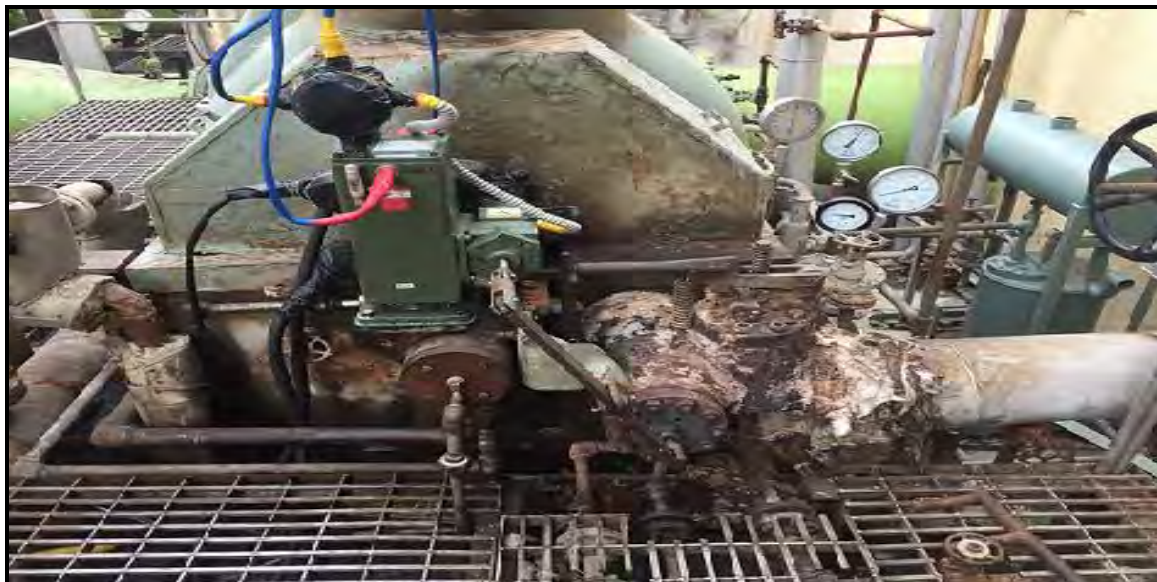
SI-4411 Turbine speed input: Old speed probe was removed and turbine speed is now sensed by new MPUs mounted on PGPL actuator. MPU output is connected to Woodward 505-D. Old speed converter in marshalling cabinet was removed and new 4-20 mA speed readout from Woodward 505-D was connected to DCS.

Governor was powered up & it's Operation at Idle speed, rated speed and Over-speed was checked after actuator mounting completion by mechanical maintenance.

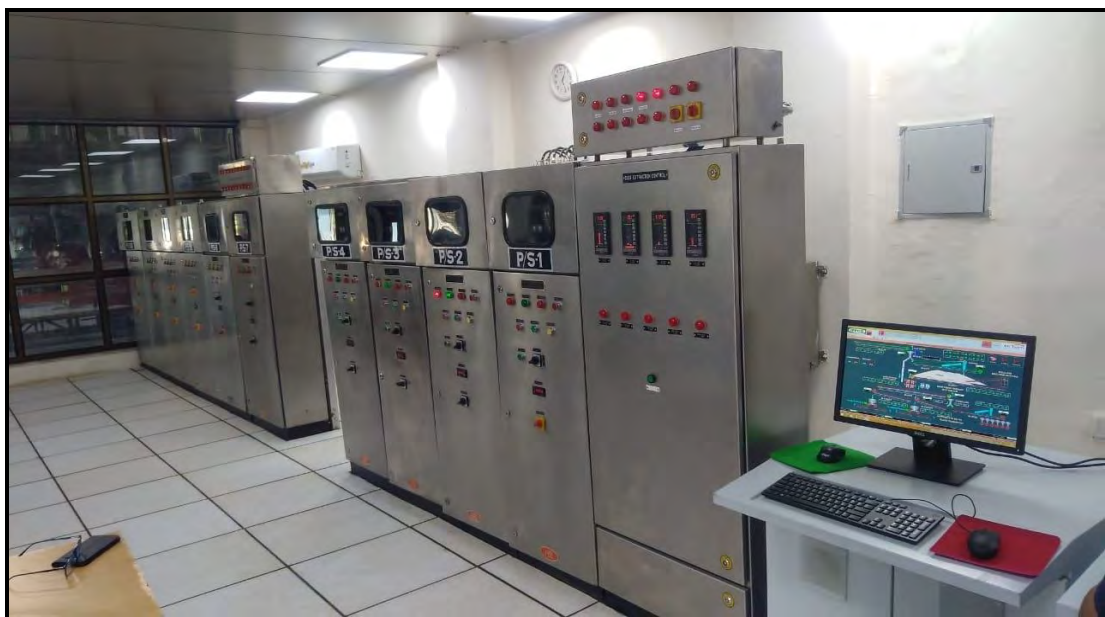
- In the place of new control room, there were several overhead cable trays passing for various purposes. These cable trays were rerouted from the outside of the control room so as to avoid any difficulty in the future.
- Control room: The new control room is designed so as to accommodate all the instrumentation panels as well as PLC-SCADA and its marshaling cabinet for conveyor belt control system, procured and maintained by Electrical section. In the earlier control room there was no false flooring. In the new control room false flooring is provided for the ease of cabling and cable replacement when needed.

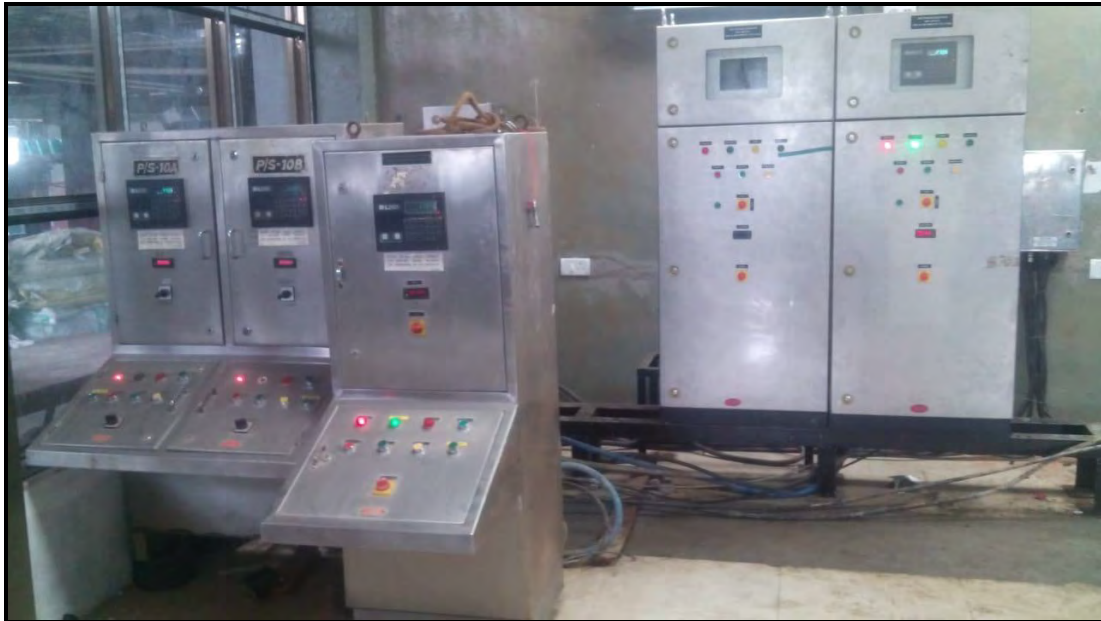
- Replacement of old Control panels with new panels: Main control panels of P/S-9A, 9B, 10A, 10B were different in construction and internal wiring than the rest of the machines. In the view to make the circuit uniform and easy to understand we replaced these panels with new panels having uniform construction and internal wiring. Out of these 4 panels 2 panels are with electrical components and without controller and interface whereas 2 panels are with electrical components, controller and interface

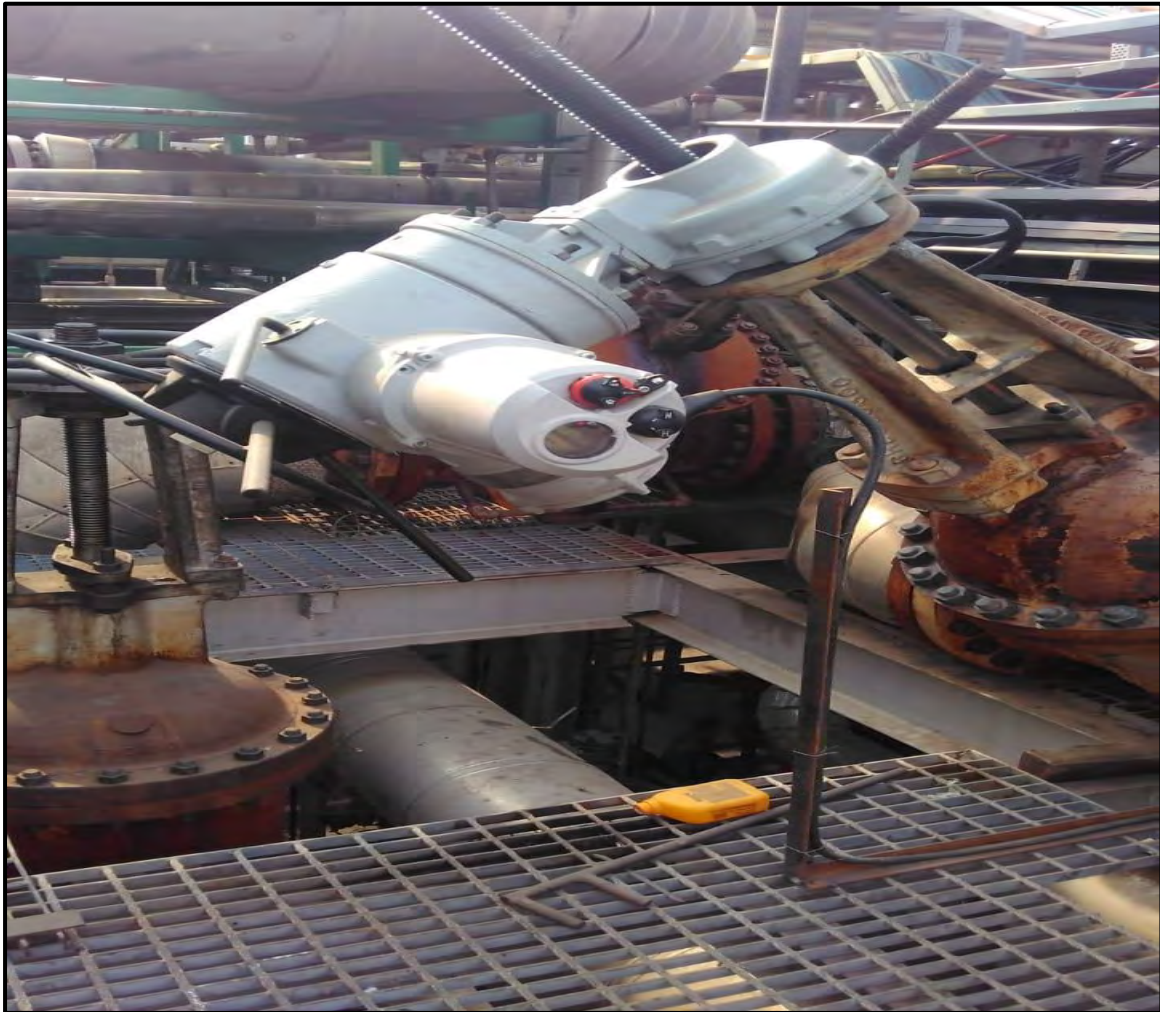
The existing manual operated valves are replaced with Rotork make IQ2 series latest motor operated actuators in LTS guard section in ammonia plant. The MOV was installed & commissioned successfully during ATA-18. The same was also tested for operation & indications from Local as per process requirement.

Actuator type- IQ40F25B4, Sr No: 5W480601 01, Enclosure- EXD IIB T6, WD-3010-100-09 Output RPM-96 Gear box model-IBB

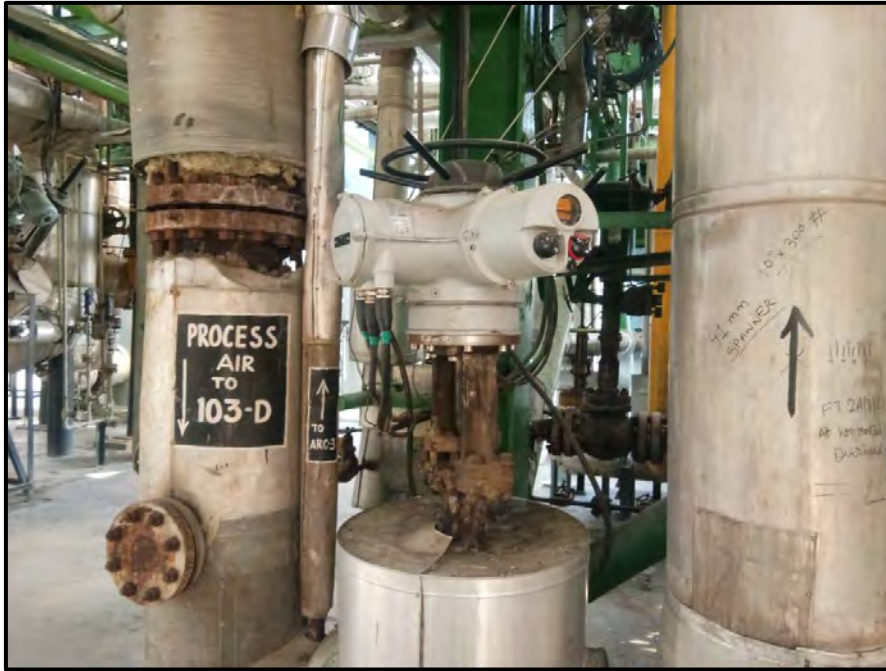
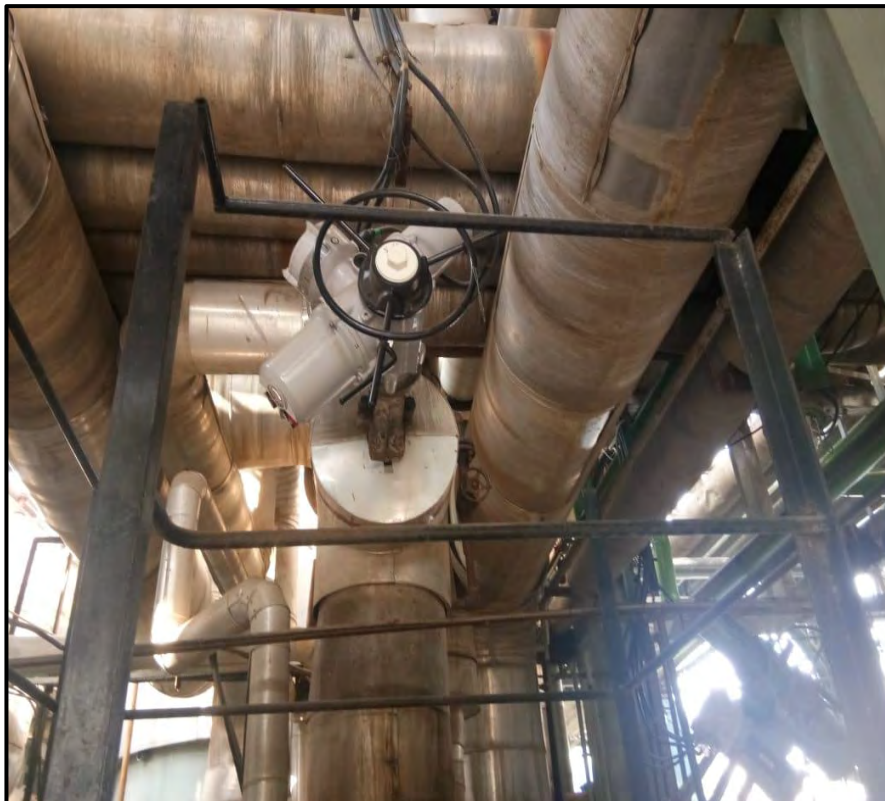
Also following motor operated valves are retrofitted with latest IQ series rotork make actuators .

SP-3	5W32161101	WD 3010-000	IQ70F25A	48
SP-4	5W32160601	WD 3010-000	IQ40F25A	144
SP-5	5W32160201	WD 3010-000	IQ35F16A	48
SP-156	5W32160101	WD 3010-000	IQ70F25B4	48

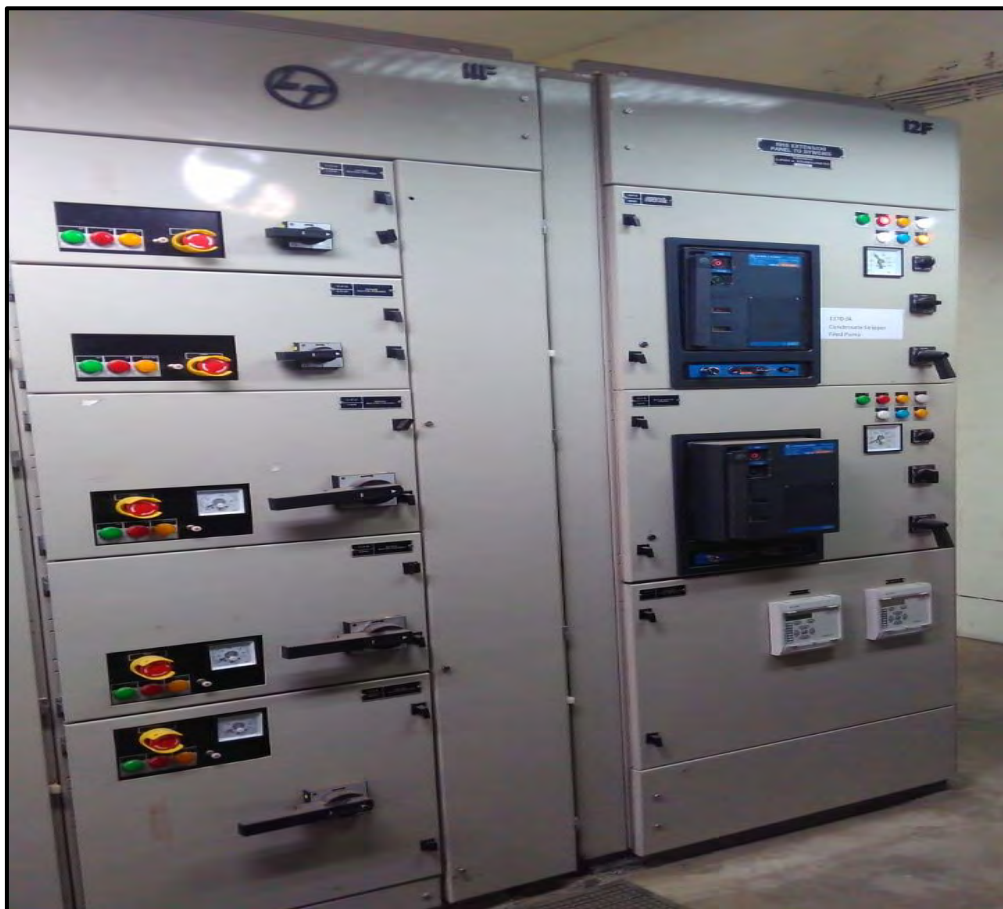
Installation, testing & commissioning of extension panel for MCC5

Extension panel is required to accommodate P-1170 JA (Condensate Stripper Feed Pump) 90 KW motor for emergency power supply source as per process requirement.

- Preparation of cable trench: As per drawing prepare cable trench.
- Preparation of base frame: As per drawing prepare base frame and grouted base frame with help of L&T crew.
- Installation and commissioning work done at RHS of existing panel SYWE805.
- Coupling of new extension panel SYWE 932 with existing MCC SYWE805 is done.
- After installation and commissioning work testing of new extension panel is done and found ok.
- After completion of job MCC panel charged and motor is tested OK.

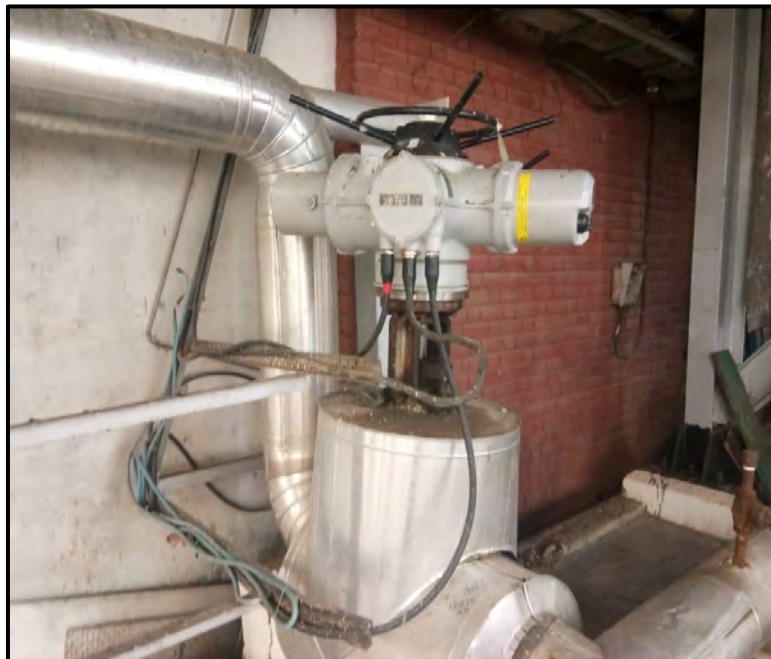
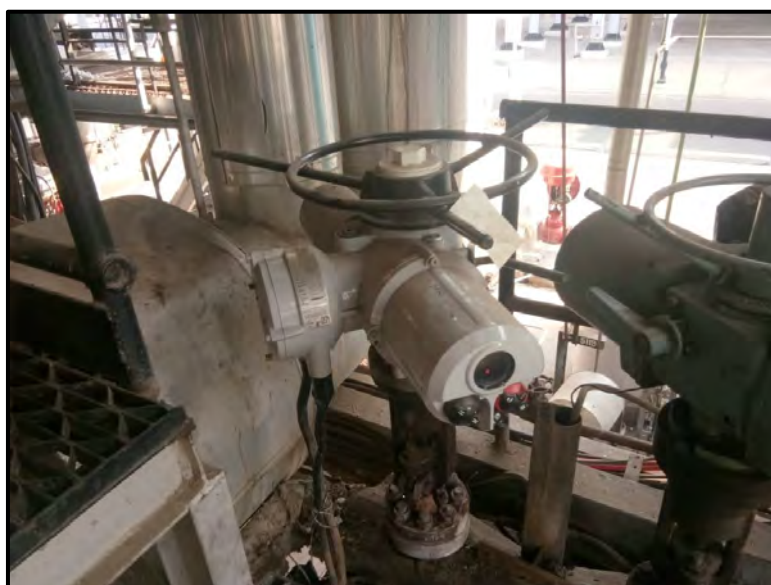
The existing manual operated valves are replaced with Rotork make IQ2 series latest motor operated actuators in MOV1801& MOV1501 train in Urea plant. The MOVs are installed & commissioned successfully during ATA-18. The same is also tested for operation & indications from Local as well as DCS as per process requirement.

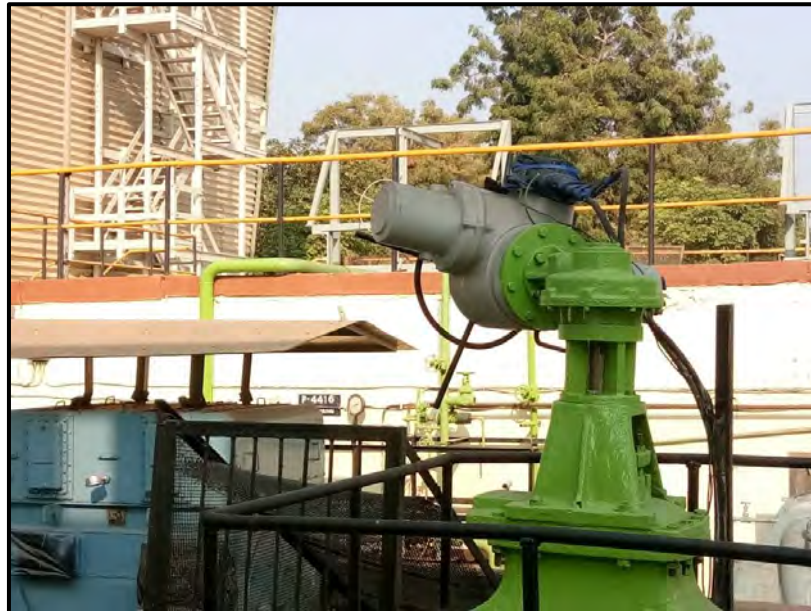
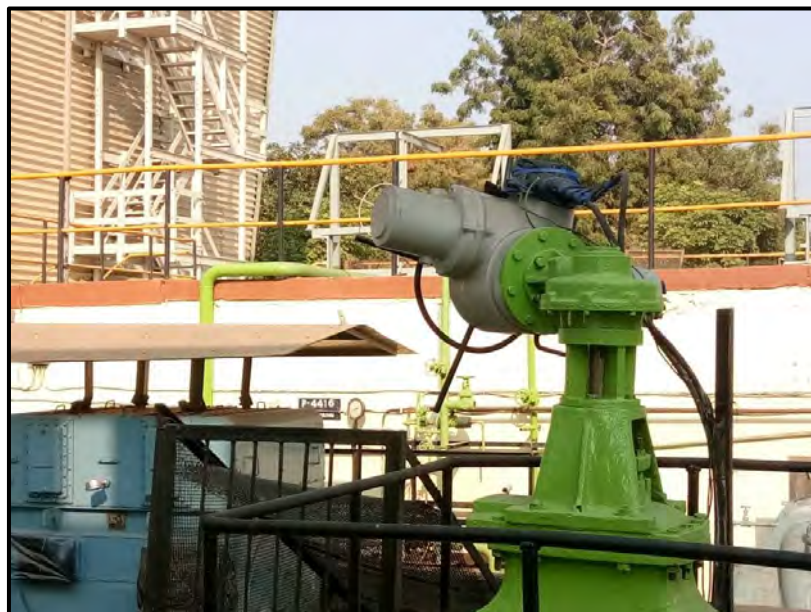
The existing manual operated valves are replaced with Rotork make IQ2 series latest motor operated actuators in MOV10, MOV11, MOV14, 4401/C & 4401/D train MOV in Utility plant. The MOVs are installed & commissioned successfully during ATA-18. The same is also tested for operation & indications from Local as well as DCS as per process requirement.

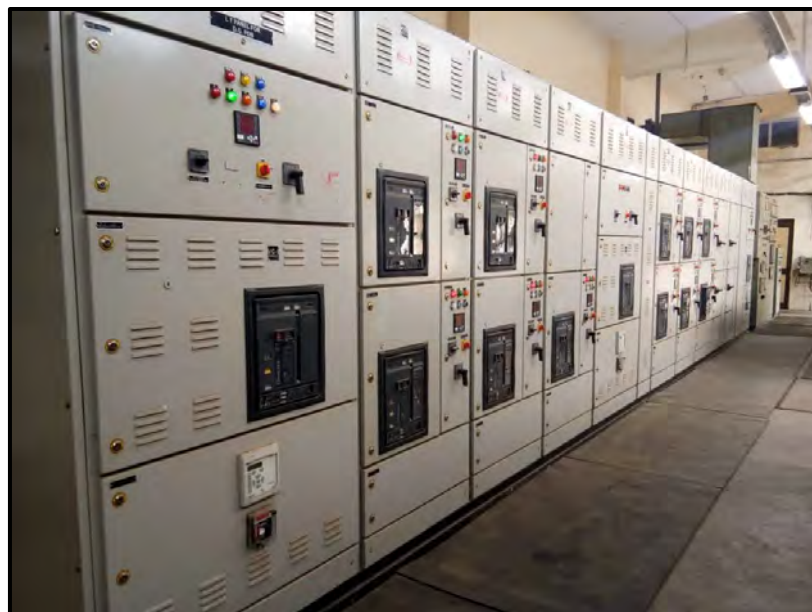
Replacement of LT distribution panel of D.G.Set power control centre(PCC)

Diesel generator set is required to cater emergency power to all critical loads for emergency power supply source as per process requirement. The breakers & its feeders are becoming obsolete and their spares are not readily available. So the whole PCC is planned to replace under capital budget with latest breaker feeders with additional feeders for reliable ,safe and uninterrupted emergency power provision at plant during total power fail.

- Preparation of cable trench: As per drawing prepare cable trench.
- Preparation of base frame: As per drawing prepare base frame and grouted base frame
- Removal of old PCC
- Installation and commissioning of new PCC
- Coupling of new panel busbar with the bus duct of DG set
- Testing of new panel is done and found ok.
- After completion of job MCC panel charged.

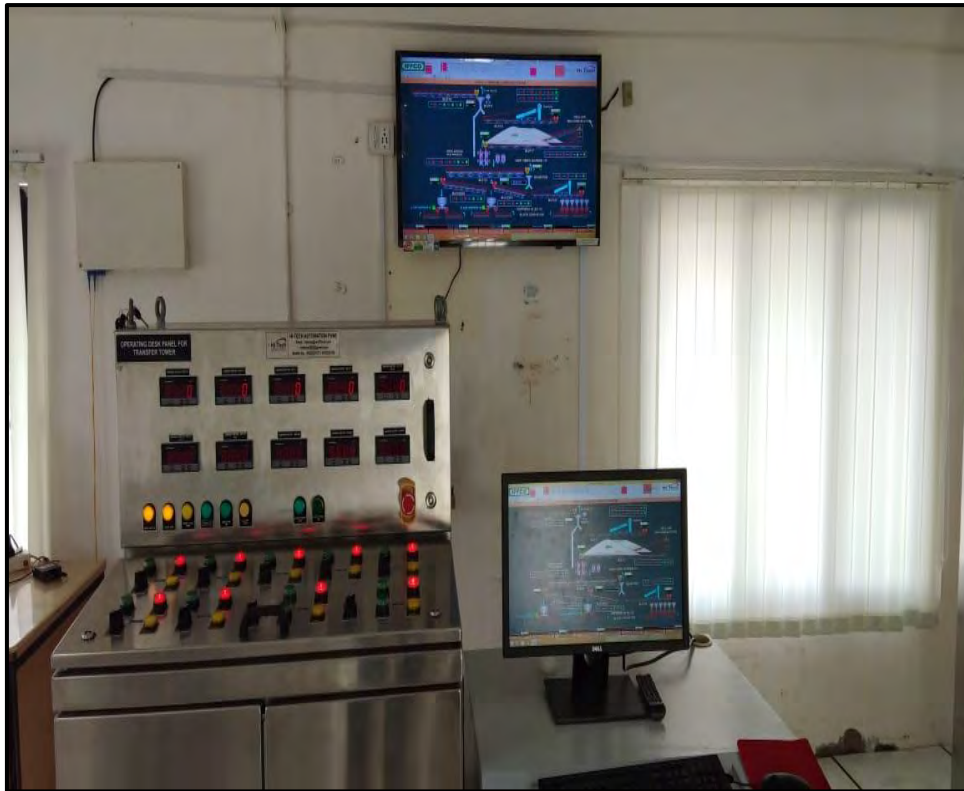
Initially the conveyors are operated through Mimic panel which was not reliable for operation as well as safety. So it was proposed to replace the same with latest PLC controlled panel for conveyors at both locations for reliable & safe operation with sequentially interlock logics, rope switch indication and monitoring & control of each equipment in PH plant for smooth & efficient operation of the plant.

New ABB make AC 800M series PLC based control panel with LED screen and OS has been installed at transfer tower. Pictures of OD (Operating Desk) panel, OS (Operating station) & LED Screen are shown below:

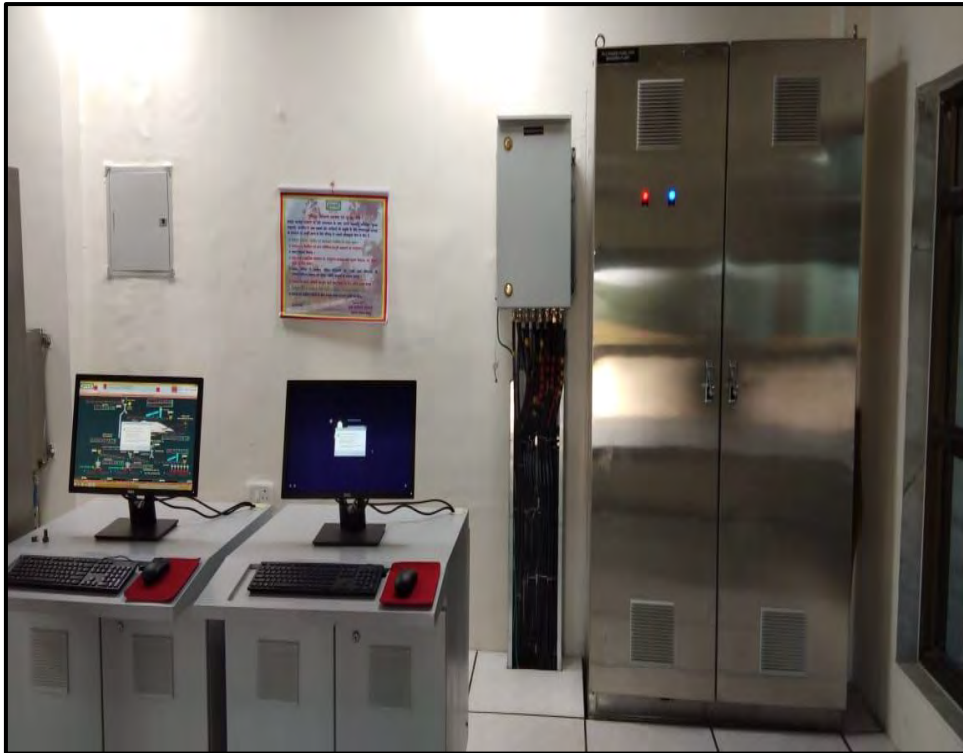
Installation of new PLC based control panel at Bagging Building:

A small PLC based was installed at Bagging building for monitoring of slat conveyor motors, P-2704/A, P-2704/B and controlling of blower K-2704/3. OS for bagging system and ES (engineering station) for complete integrated system has been installed at bagging control room. Picture are shown below:

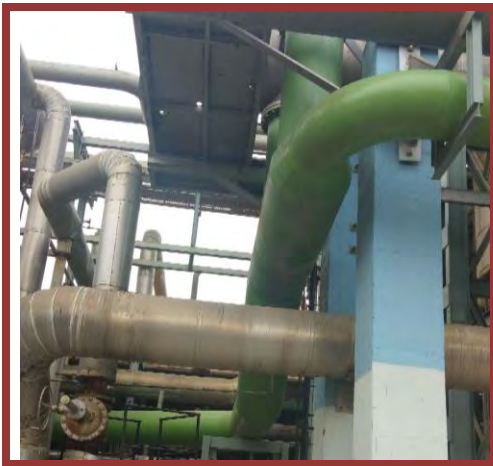
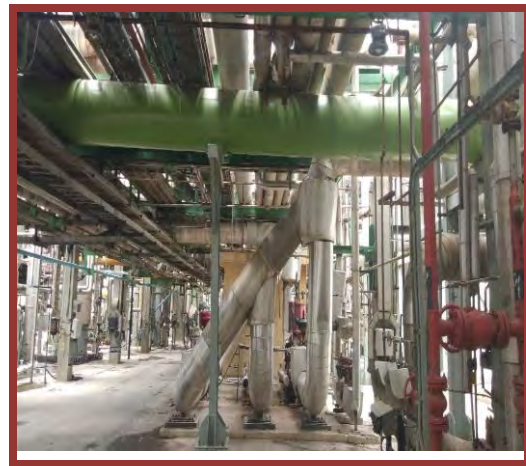
Installation of 101-JCA to 110-CA/CB 30" under ground CW header with above ground route.

Without interference to any line, line was taken over 4 newly erected column & modification in existing 4 supports. Job was completed in 11 days which otherwise could have required excavation and line laying in very intricate areas under the compressors and associated equipments.

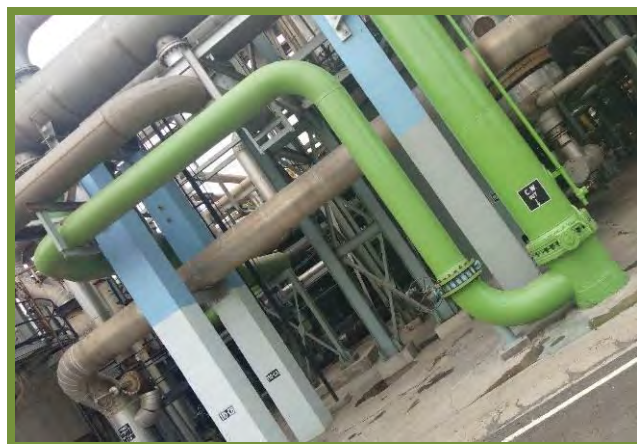
- 110 CA / CB bypass line size increased to 20" from 12".

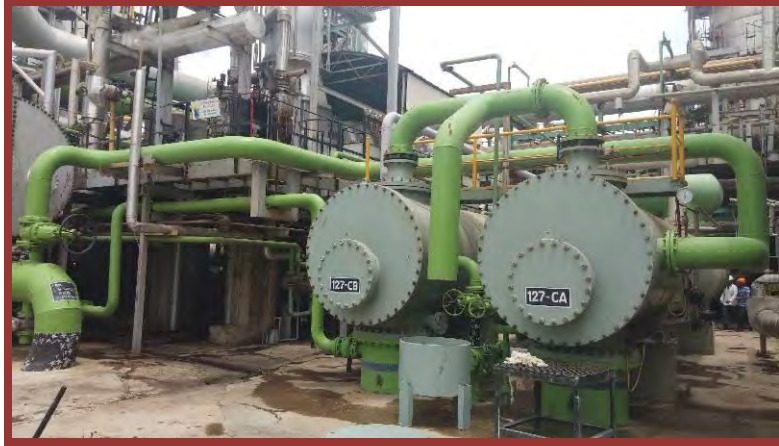
- CW old jump over removal & 24" Blinding at Root.
- Modification in 12" CW line interfering with 127CA/CB flushing system.

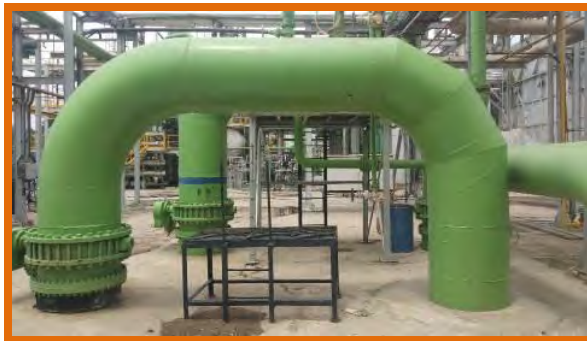
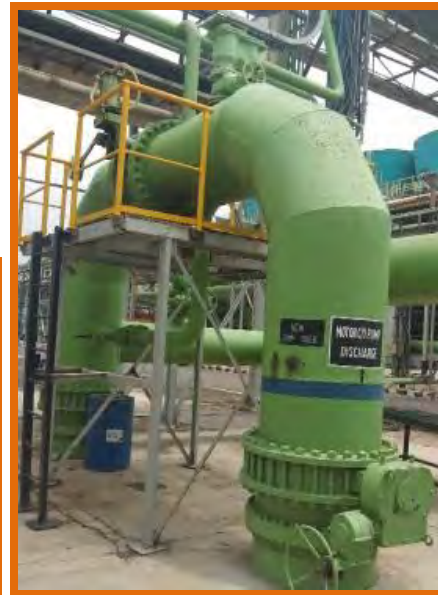
- Pump P-4401 C & D discharge line blinding at D/s of New Jump over.
- 24" Fresh Cooling Water Connection to 101 JCA with 6" u/s Drain.
- CW New Jumpover 36" Motorised Valve removal and Spool piece welding.

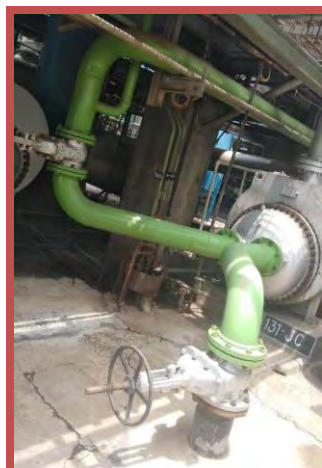
- CW Supply and Return of 131 JC (Air comp. 3rd stage cooler) to be routed in above Ground and size increased to 8".

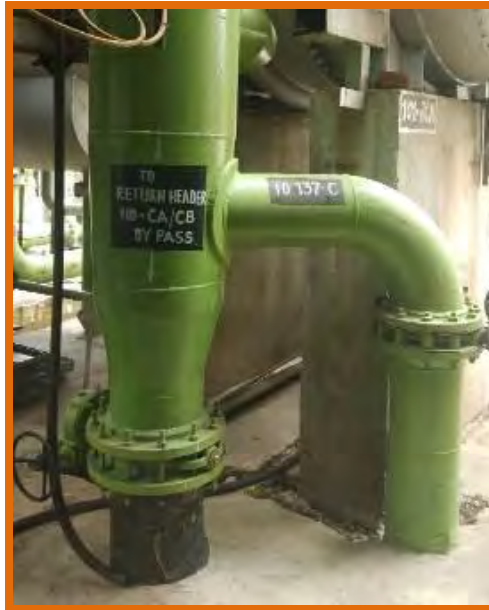
- 6" bypass line with I/V in New CW Jumpover .
- Modification in 137 C Supply line for its connection with CW outlet line of 101 JCA.

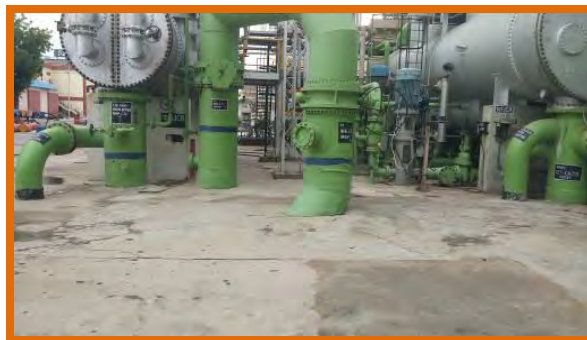
- Modification in 12" size 110 CA /CB Bypass line near 101 JCA.
- Obsolete 18" CW supply line of old NG Compressor to be blinded at root.
- Obsolete 18" CW Return line of NG Compressor area to be blinded at root near 101 JCB.
- Modification in 103J /JT H P Oil Cooler CW lines for ease of movement.
- 16" Interconnection piping between 101JCA and JCB in place of existing 12".
