KALOL UNIT

PLANT TURNAROUND REPORT
(SEPTEMBER - OCTOBER – 2018)

Plant Turnaround for the year 2018 was taken from **17th Sep 2018** to **15th October 2018** for carrying out ESP Phase III (Energy Saving Project), Preventive maintenance jobs of Static & Rotary equipment.

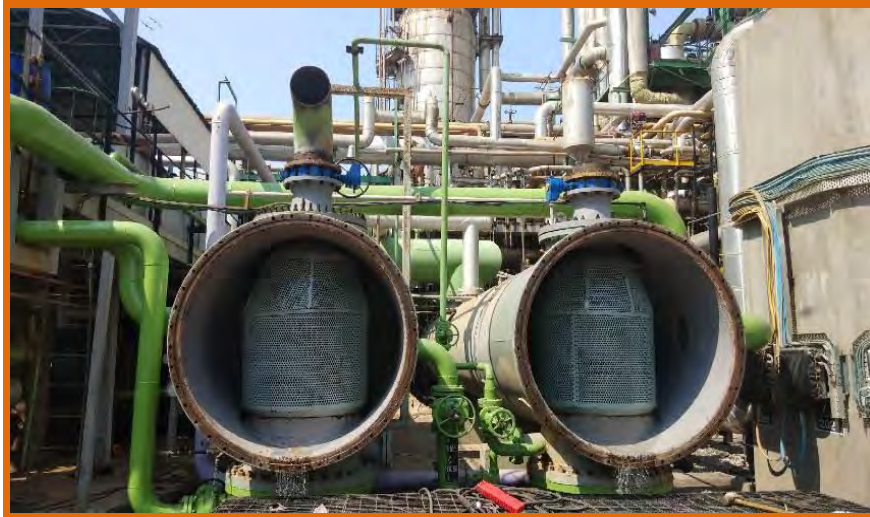
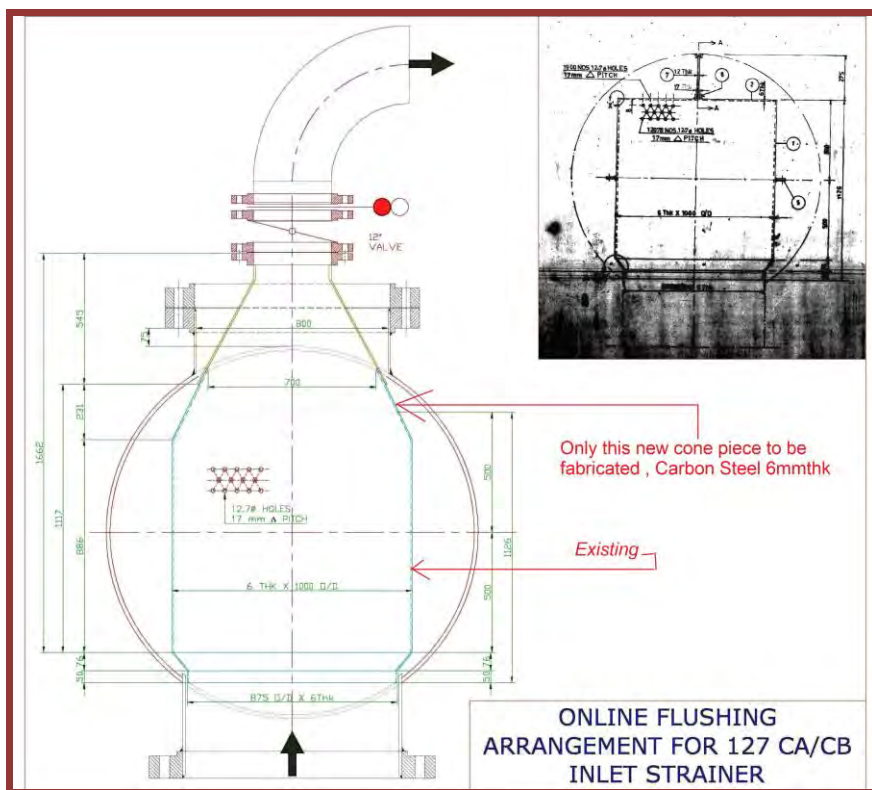
- 101-J area Condensate Point to Overflow Pot Outlet Line replacement.
- CW Return line, 2" Vent with Isolation valves at Top and line routed to Ground with Isolation Valve for 110-CA/CB CW Return line
- Provision of online flushing of 127-CA/CB (Refrigerant condensers) inlet strainers.
- This will provide online flushing feasibility of 127-CA/CB strainers.

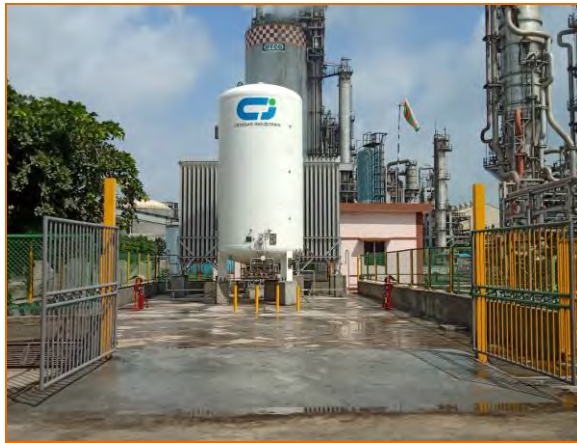
Installation of Liquid Nitrogen Tank (190-F)

Liquid nitrogen tank of 30000Liter capacity and 2nos of vaporisers of capacity 2000Nm³/Hr. have been installed to create nitrogen storage facility during shutdown.

Design pressure for inner shell is 18 Bar and design temperature is -196 Deg C to 37 Deg C

Interspaced insulation is perlite under vacuum. Overall dimensions of liquid nitrogen tank are 7641mm height and 3316mm outside diameter. Overall dimensions of vaporisers are 2.1mx2.1mx5.2 m height.

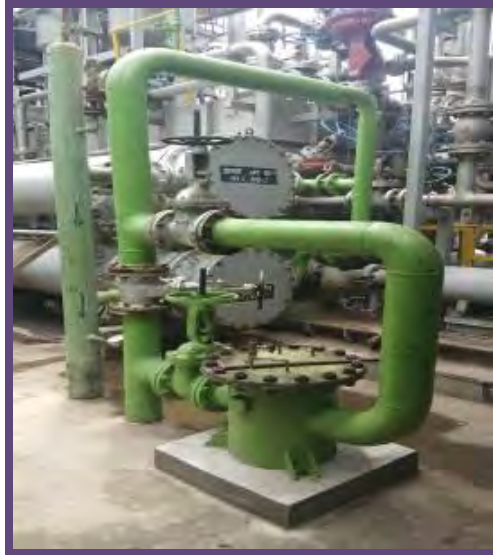
- EWR No. A416 : To provide Filter and Bypass Line with Isolation valves in CW line to 101-J/105-J Lube oil coolers.

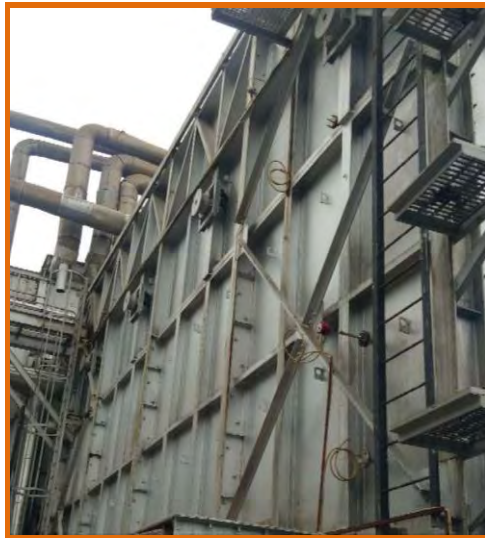
- Reformer Structure strengthening job :
- Approx. 40 Nos , 12 thk stiffner of size 100mm x225 mm have been provided on Beams for strengthening of reformer . Cover plates of 12 thk also provided on sides of Beam.
- The Job was carried out by M/s J&J before Erection of LT coil during shutdown.
- Platform for approach to 38 ata Steam Isolation valve near Aux Boiler.

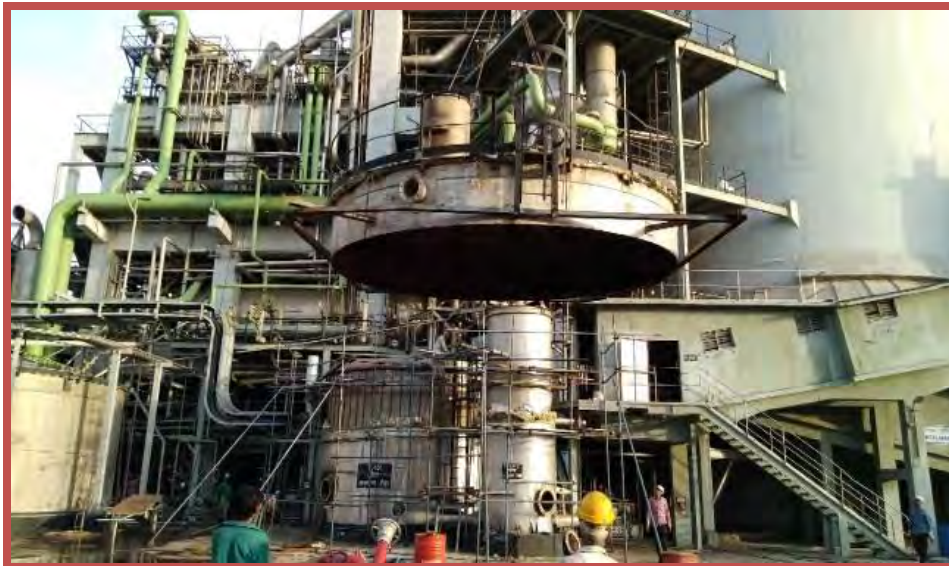
- To increase capacity of urea solution tank from 175m³ to 251m³ , one more course of 1.8 m height has been added.
- In existing additional urea solution tank ((T-1401A) , one course of 1.8 m height has been added to increase capacity from 15 m³ to 20 m³ .
- Total capacity of urea solution tanks has been increased from 190 m³ to 251m³ i.e. 33% increase in capacity.
- With implementation of the scheme, the hold up time of urea solution tanks will increase from 2.3 to 3.0 hours @ 1780 MTPD urea production and thereby improve the operational flexibility of Urea plant.

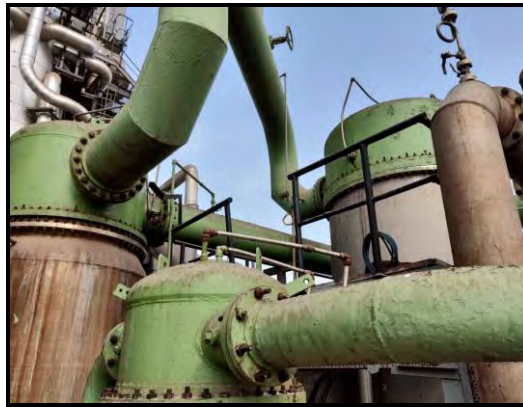
- Slope of Scrubber overflow (4") to Ejector to be increased.
- PT-1201 A/B/C to be taken from D/S of NRV of Ammonia line to V-1201 for 2 of 3 logic.
- Slope at joining point of combined drain header (2") below Autoclave to be increased.
- EWR No. U288 : In HPF line to H P Scrubber , one additional I/V with drain to avoid choking on HPF line.
- 4" Nippolet & Nozzles - (2 sets) welding for DPT 1212 near Stripper (H-1201)
- EWR No. U318 : Modification in cooling water outlet line in H1423 (1st stage evaporator condenser) & H1425 (2nd stage evap. 1st condenser)

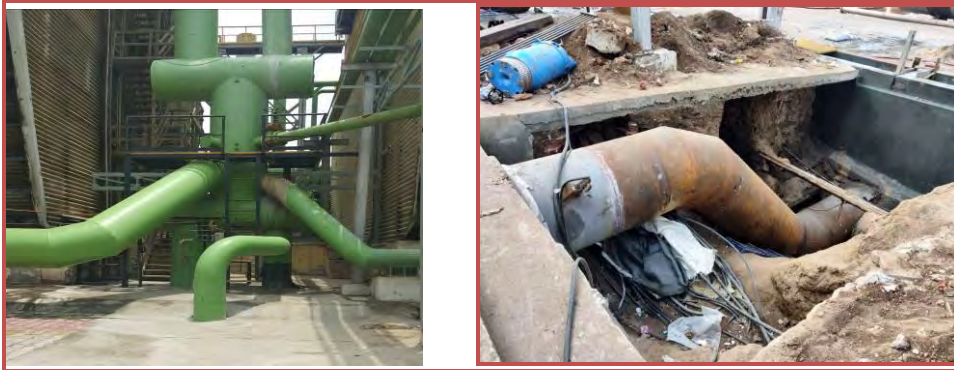
- Urea CT return header riser height increase by 700 mm.
- 6" & 4" dead end drains for horizontal headers of return risers in CT area
- 101 JCB to Old CT 30 " return Header (Part line- 22 mtrs) replacement in CT area.

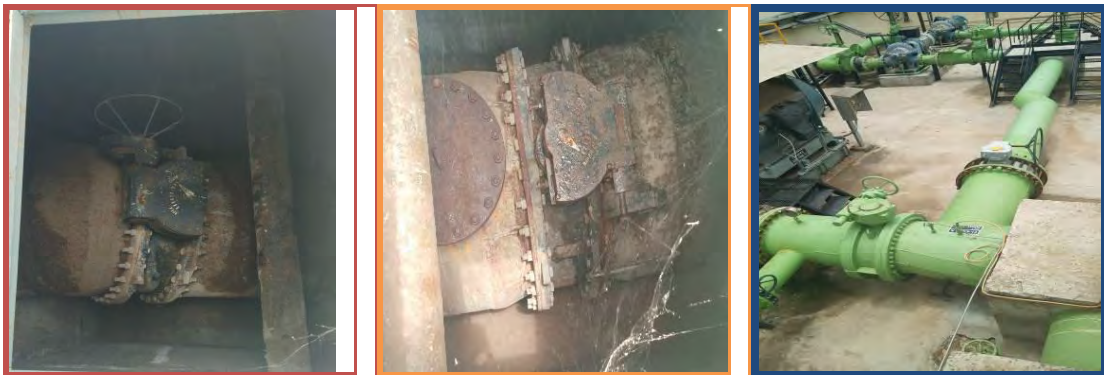
- Installation of 48" Butterfly valves in 52" UG CW header in pit near New CT & 20" Manhole at d/s of valve and 4" Size Bottom Drain.
- Installation of 48" Butterfly valves in 52" UG CW header in Pit near C/D pump Sump.
- Provision for Installation of 4401E Standby Pump Installation in Pump Discharge Line:
- 28" Line connection for future provision of stand by pump at New CT area have been done and 28" butterfly valve has been installed.

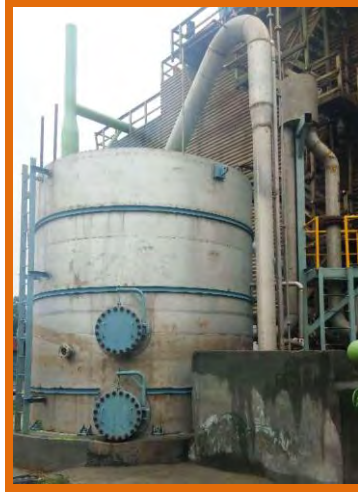
EWR No. CW-108 : Replacement of sand filter with VAG filter in Urea cooling Tower :-

In urea CT there was one sand filter and no VAG filter. The existing sand filter have been replaced by new VAG filter. Foundation was ready before shutdown

The total height of VAG tank is 4500mm and ID is 4212mm with shell and bottom plate made of SS304 material.

With new VAG filter backwashing is done automatically and problem of sand escaping to CT basins has been removed.

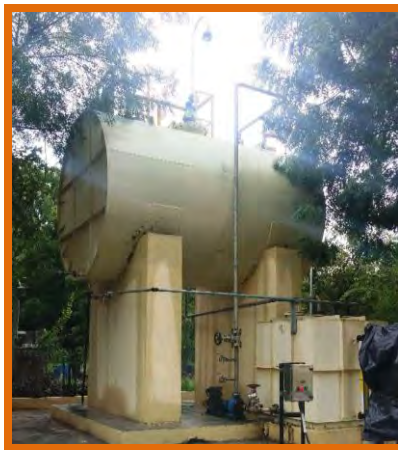
EWR No. CW-109 : Additional sulphuric acid system at new CT : -

As per above EWR additional sulphuric acid system (which include a buffer storage tank (T-4410), an unloading pump (P-4401), a bulk storage tank (T-4405) and a control valve (PIH-4405) for dosing have been installed for smooth control of cooling water PH.

Foundation were made ready before shutdown and job was continue after completion of shutdown being a running job.

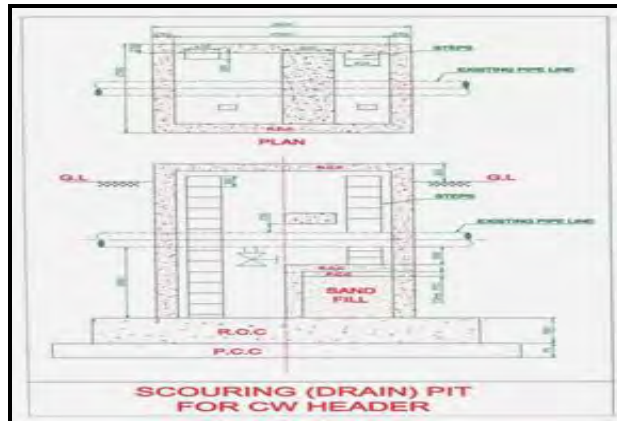
Scouring pit for following headers have been provided:

Pump 4402/4403 discharge to Urea

Urea return header
