IFFCO

ANNUAL TURNAROUND

DEC 5, 1976 - JAN 24 1977

GENERAL REPORT ON ANNUAL TURNAROUND

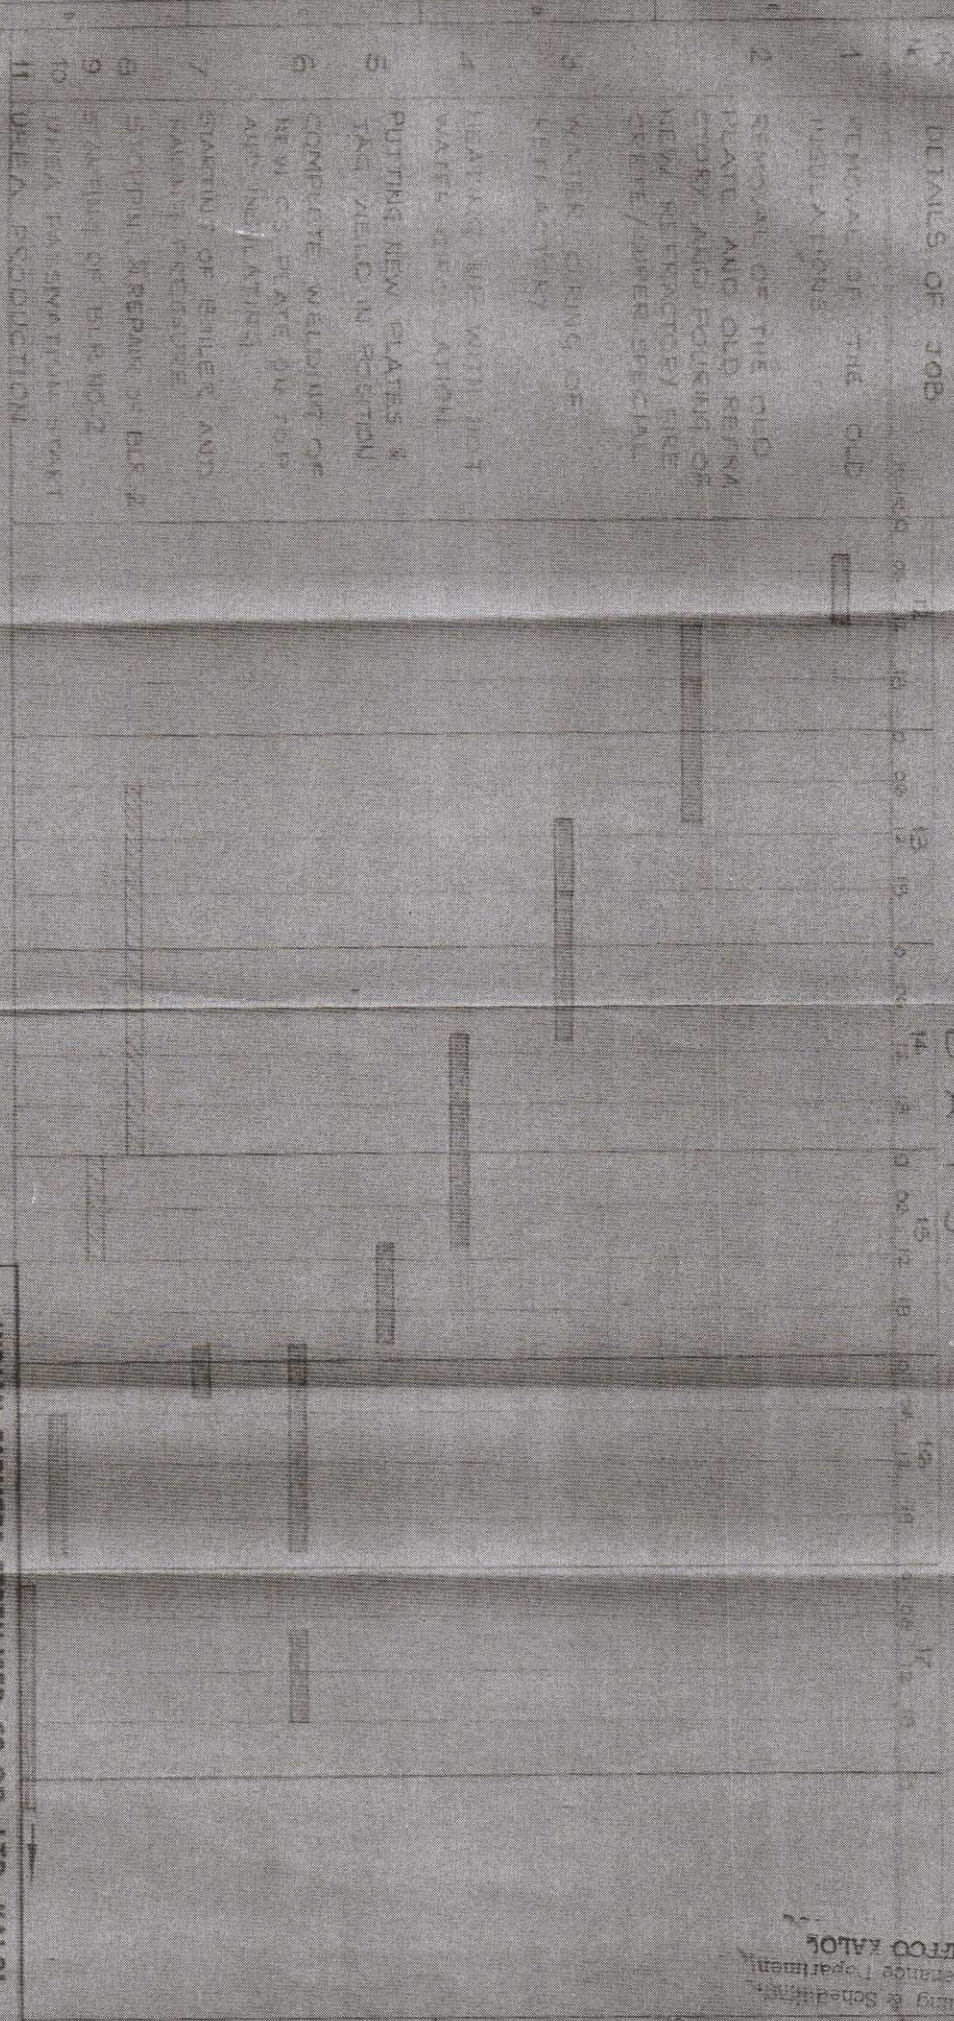
BAR CHART SHOWING THE REFRACTION  
REPAIR WORK ON ROLLER NO. 1.

ENTERED BY: [Name] AT: [Location] ON: [Date]  
 APPROVED BY: [Name] AT: [Location] ON: [Date]  
 1. DETAILS OF JOB  
 2. REMOVAL OF THE OLD WELD ALONGS  
 3. REMOVAL OF THE OLD PLATE AND OLD REFRACTION AND POSITION OF NEW REFRACTORY FIRE CLAYE / LAMER SPECIAL

4. WATER BORING OF AREA  
 5. HEATING OF THE WELDING WARE  
 6. PUTTING NEW PLATES & TAG WELD IN POSITION  
 7. COMPLETE WELDING OF NEW CO. PLATE ON TOP AND INSULATING
