MTC / REPORT / 01
REPORT NO. 30 / 2010

KALOL UNIT

PLANT TURNAROUND REPORT

INDIAN FARMERS FERTILISER CO - OPERATIVE LIMITED

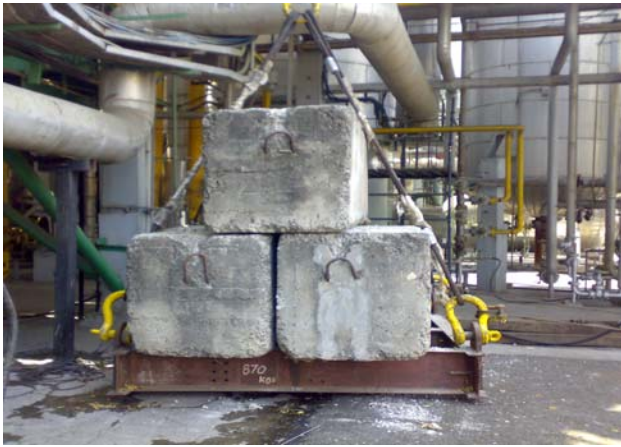
Chain block being tested

- a) The chain Block was tested with 23.5 Tons Dead weight and found o.k.
- b) The elbow bolts of 101-CB were opened and elbow was removed with RT-760 Crane.

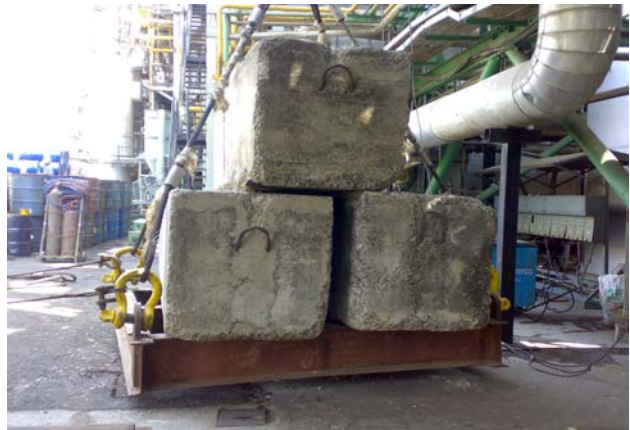
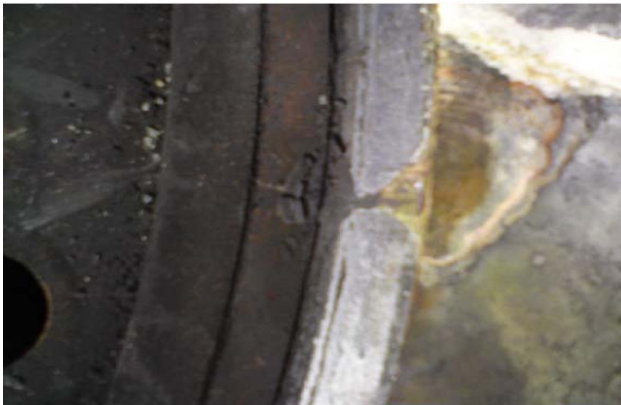
Gasket seating face

- f) The grafoil tape on the Gasket of F-2 joint was found washed out at one location.
- g) The bottom face of channel cover and Top face of Outer Tube flange attended with stone. The gasket groove and snub was found o.k. The flange was re-assembled with Soft Iron Gasket without any grafoil tape/ Teflon tape. However one of the soft iron gasket rejected due to depression observed on welded joint. The other soft gasket was found o.k. and used.

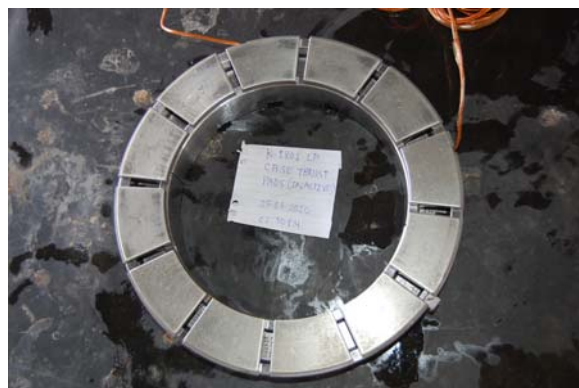
FIG 2, LP Case inactive side thrust pads

Bearing Description	Before O/H (mm)	Design value (mm)	After O/H (mm)
Journal bearing clearance on Turbine side	0.16	0.11 ~ 0.15	0.16
Journal bearing clearance on Gear Box side	0.16	0.11 ~ 0.15	0.16
Axial Thrust	0.34	0.28 ~ 0.38	0.34
Observations	Brownish deposits observed on active thrust pads.(Fig 1)

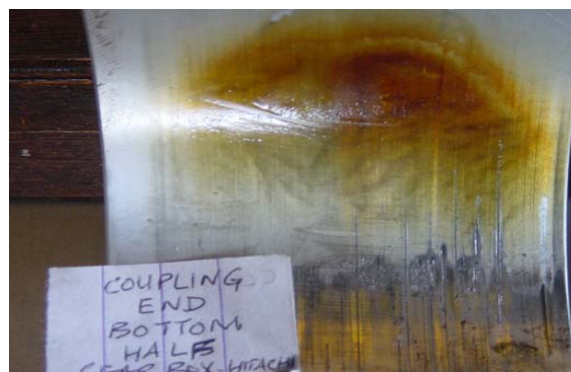
FIG 4, GB High speed shaft HP end bottom half

- HP case and Gear Box was coupled at the required tightening torque 9.7 kgf.m (95.06 Nm).
- High temperature rise of Thrust bearing of LP case was reported during June-2009. This has occurred earlier also for Gear box and HP case bearings. The photographs of damaged bearings are shown at Fig 3 and Fig 4 for reference. Hence it was decided to check the possibility of providing additional earthing brush on coupling spacer between Gear box and HP case. After opening the coupling guards, the dimensions were taken and observed that there is sufficient space for installation. Earthing brush is proposed to be installed after procuring the same during next Annual Shut down.

Description		Before O/H (mm)	Design Value (mm)	After O/H (mm)
Low speed shaft	Journal bearing clearance on LP side	0.17	0.125 to 0.185	0.17
	Journal bearing clearance on HP side	0.18	0.125 to 0.185	0.18
	Thrust bearing clearance	0.40	0.38 to 0.61	0.40
High speed shaft	Journal bearing clearance on LP side	0.24	0.15 to 0.21	0.24
	Journal bearing clearance on HP side	0.24	0.15 to 0.21	0.24
Gear backlash		0.48	0.383 to 0.608	0.48
Observations	Minor brownish deposition observed on bearings. (Ref Fig 3 & 4)

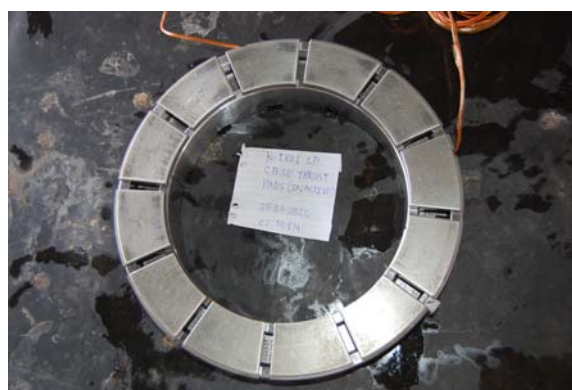
FIG 1, LP Case active side thrust pads

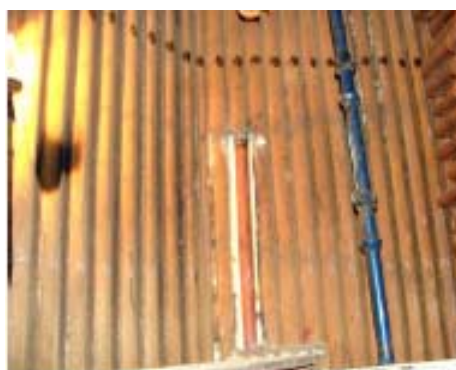
Location of tube sample in

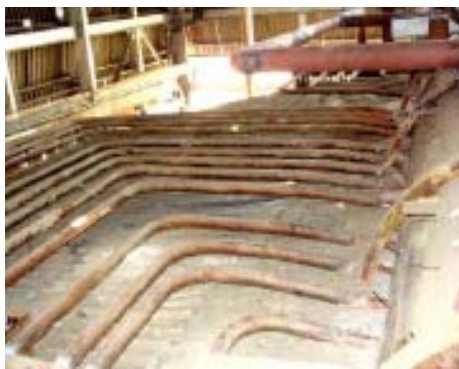
Riser Tubes

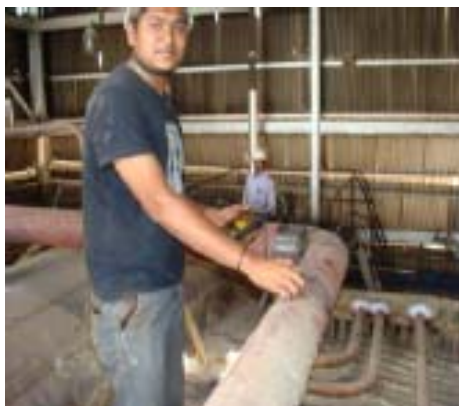
Thickness measurement in Saturated Steam line
