MTC / REPORT / 01
REPORT NO. 33 / 2013

IFFCO

KALOL UNIT

PLAN TURNAROUND REPORT

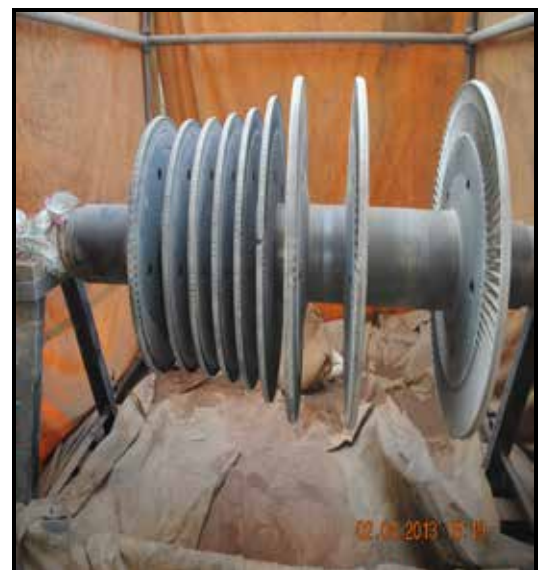
101-JT ROTOR BEFORE CLEANING

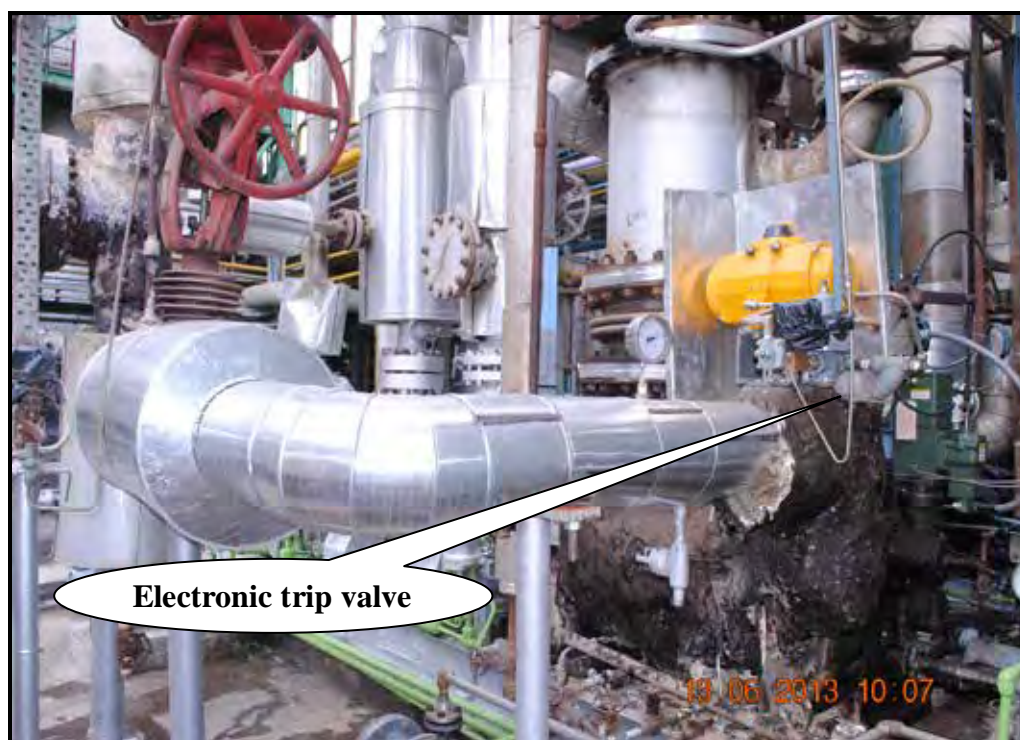
NEW SYSTEM

Installation of new Trip Mechanism: The new Trip mechanism procured against PO NO. 201004120551 was installed on the inlet flange of the turbine as shown in the sketch:

One No toothed wheel was installed behind the coupling hub and bracket for MPU were installed on the bearing housing. The new trip valve, MPUs were hooked up with the DCS and programmed for tripping of the turbine with low lube oil pressure, over speed, Remote Panel & Local trip.

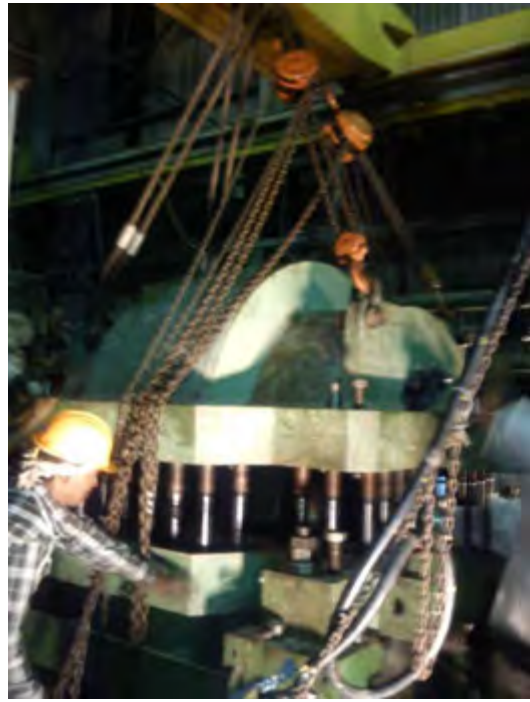
Lifting arrangement of top casing of LP case - 2

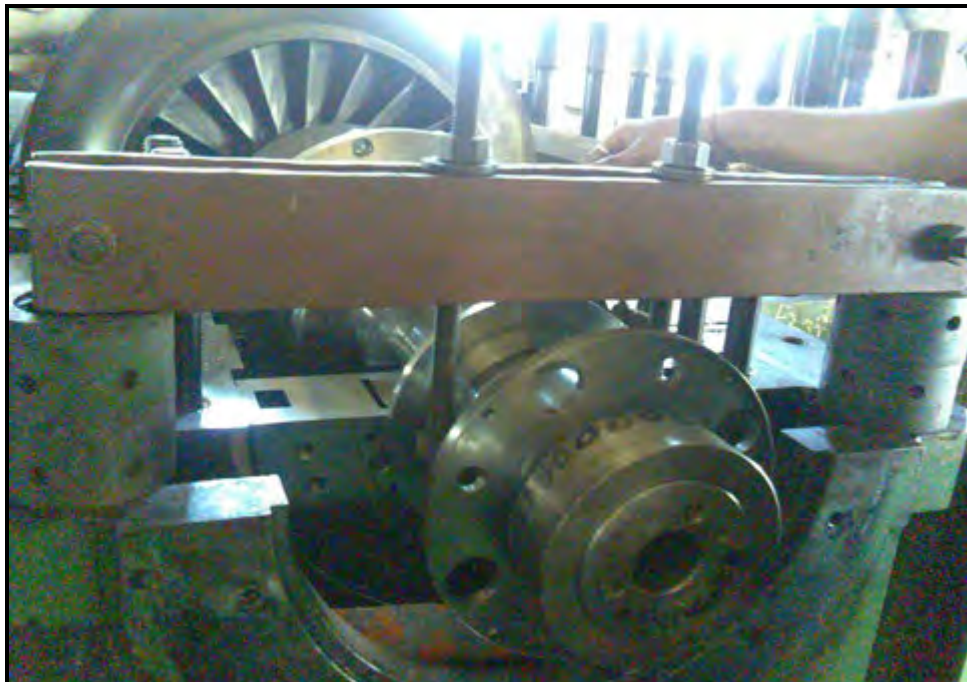
LP Case – Gear Box Side

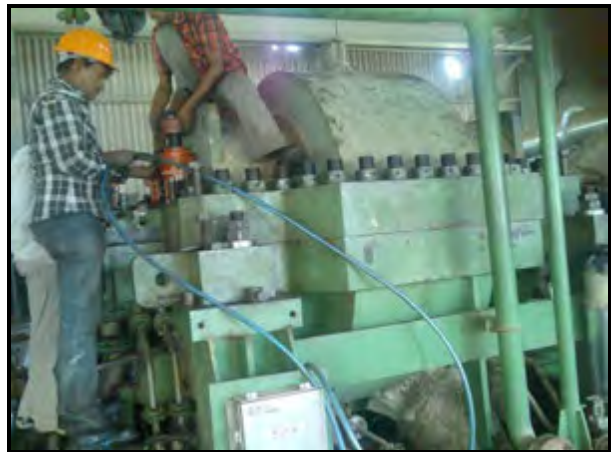
Tightening arrangement

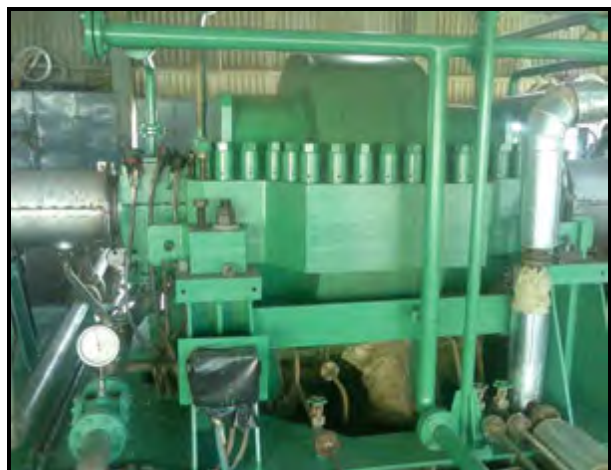
After overhauling of LP case

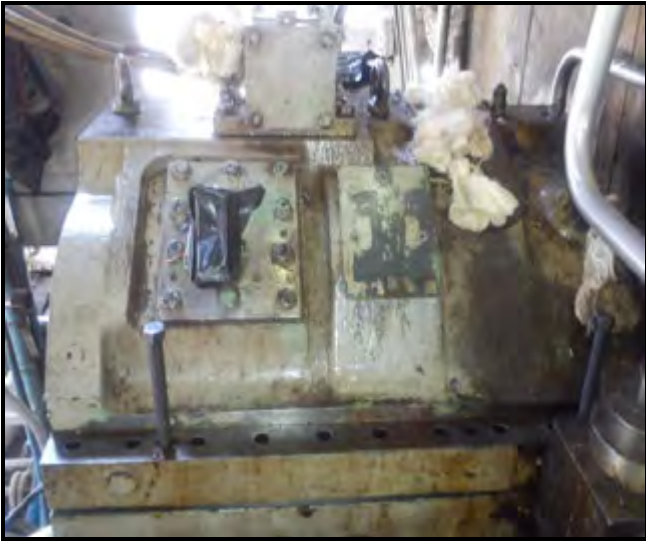
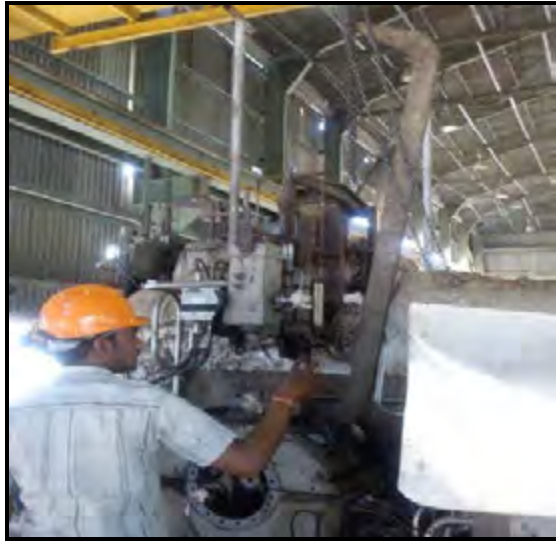
Earthing brush was found worn out completely & made a step at contact area on the rotor.

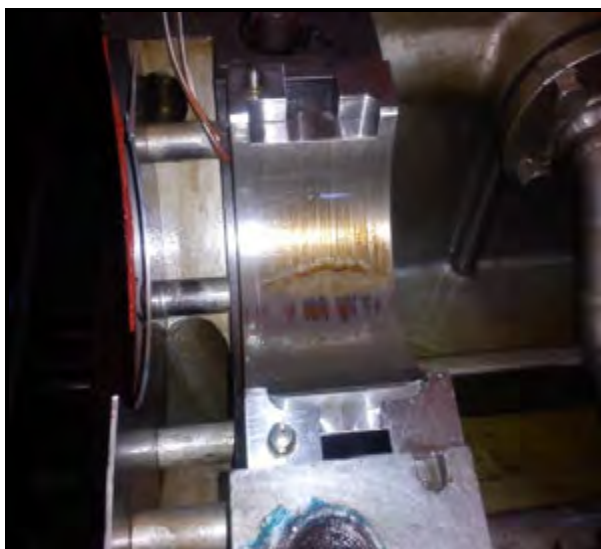
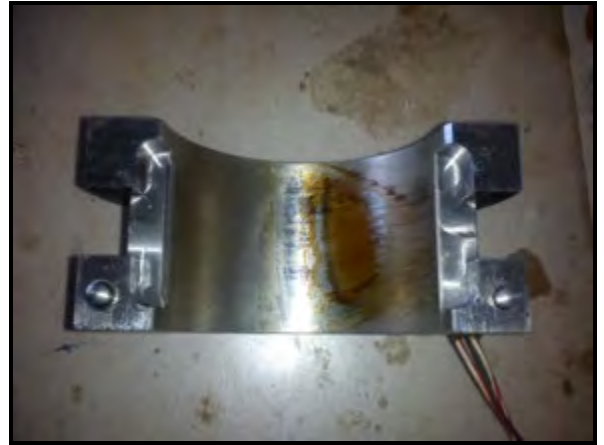
- Both LP & HP side couplings were decoupled.
- Gear Box top cover was opened.
- All the bearing top halves were removed and also high speed shaft & Low speed shaft were removed by lifting through chain block.
- Deposits were found in the lower half of both journal bearings of high speed shaft.

- All the Pinion & Gear wheel journal bearings were thoroughly cleaned and DP test was conducted found ok. Clearances were checked & assembled back the same.
- Gear wheel thrust bearings pads were thoroughly cleaned and DP test was conducted found ok. Clearances were checked & assembled back the same.
- Backlash between Pinion & Gear wheel was checked and found to ok.
- Alignment between Gear Box & HP Compressor was checked and corrected as per protocol values.

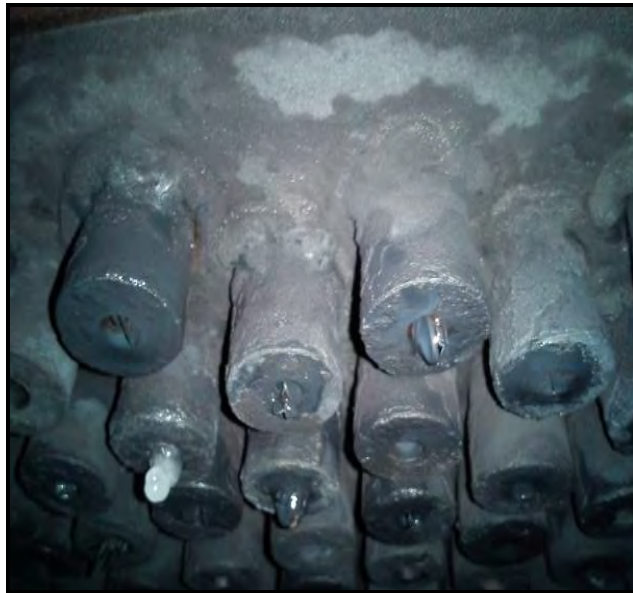
The 7.0 mm orifice plugs are provided at bottom of all tubes of recirculation heater to increase the rate of heat transfer. These orifice plugs are tack welded with tube and bottom tube sheet. Tubes were not getting cleaned completely by hydro jetting resulting into drop in efficiency. Therefore, it is proposed to remove all 1030 nos. of orifice plugs and to install SS plate with Teflon sheet at bottom tube sheet.

Orifice plugs in bottom tube sheet

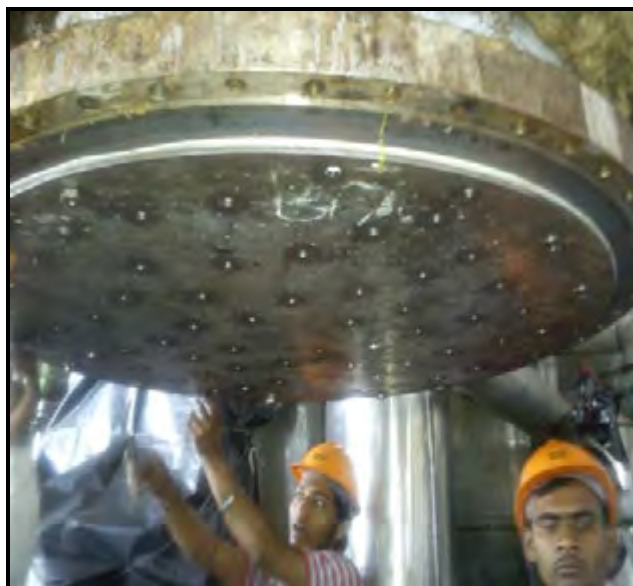
Assembly of perforated plate with Teflon sheet

- Hydrotest was carried out at 8.5 kg/cm²g in shell side to check the tube to tube sheet joint leakage. No leakage was found.
- Fitted perforated SS plate & Teflon sheet by SS fasteners.

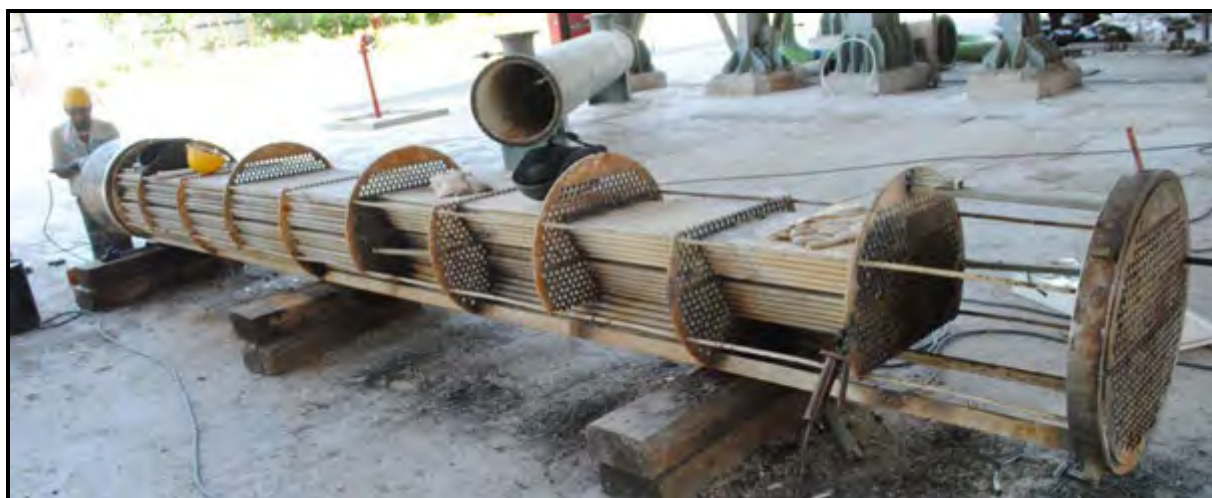
Retubing of 2nd inter stage cooler of Hitachi CO2 Compressor (H-1812) with duplex tubes (SAF2205)

To prevent frequent tube failure due to stress corrosion cracking in the presence of high CO2 gas temperature (tube side) and chloride presence in cooling water (shell side), it was decided to replace the tubes of SS 304L with the duplex tubes (SAF2205) in all inter stage coolers. Retubing of 1st & 3rd inter stage cooler of Hitachi CO2 Compressor (H-1812) with duplex tubes (SAF2205) had been carried out in annual SD-2012.

- Removed the equipment from its position with the help of Hitachi monorail after loosening all flanges.
- Tube bundle was pulled out from the shell.
- Tubes were cleaned by hydrojetting from the outside.
- Due to corrosion in outer surface, tubes were unable to pull out from the tube sheet.
- It was decided to cut the tubes with the help of cut rods.
- All tubes were cut with the help of cut rod. Both tube sheets were sent to central workshop to remove the expanded stub tubes from the tube sheet with the help of drilling.
- Replaced the existing CS tie rod with new SS tie rods.
- New tubes of duplex material were inserted in to the both tube sheet one by one.
- Tubes were expanded from 8% to 10% into the tube sheet. Measured Tube ID after expansion: 16.96 mm to 16.98mm.

- Inserted the tube sheet into the shell.
- Checked the leak from tube to tube sheet joint, Hydrotest was carried out at 12 kg/cm² g from the shell side. After hydrotest, minor leakage was observed through tube OD. Those tubes were expanded again. Confirmation hydrotest was done. No tube leakage was found.
- Heat exchanger was kept on the foundation & boxed up.

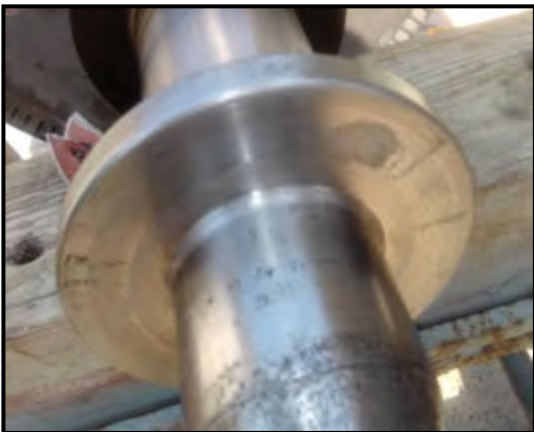
Scoring on Thrust Collar of Turbine
