MTC / REPORT / 01
REPORT NO. 40 / 2023

PLANT TURNAROUND REPORT
(APRIL – 2023)

INDIAN FARMERS FERTILISER CO.-OP. LIMITED

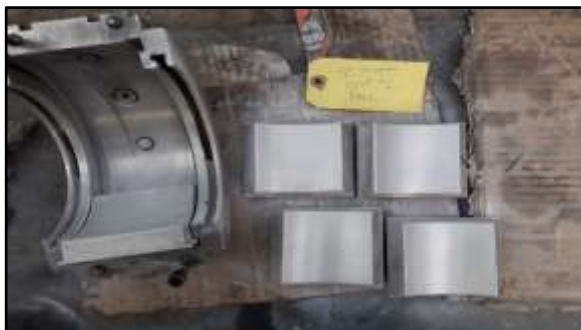
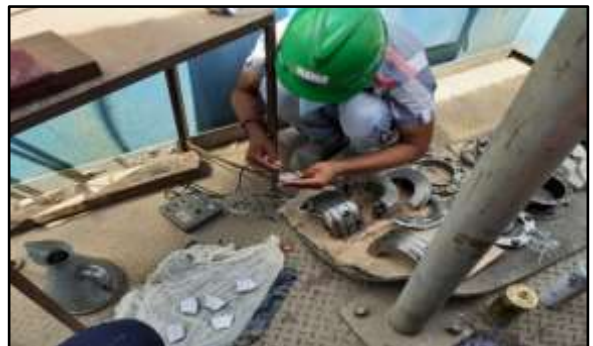
LP compressor front journal bearing pad DP test & gauss test

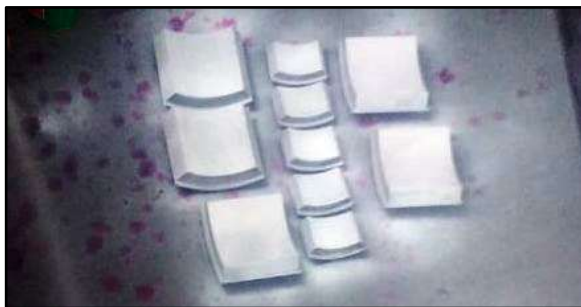
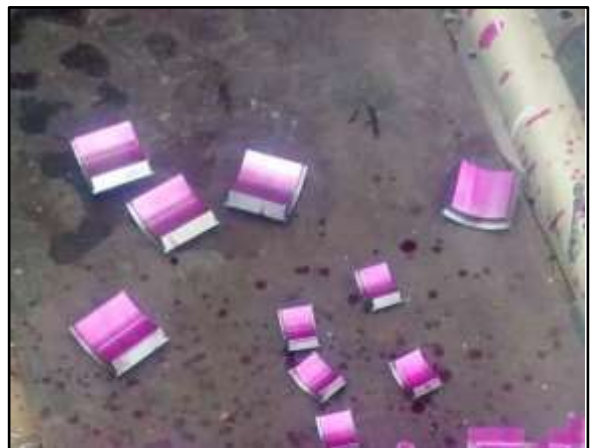
HP Compressor Front and Rear Journal Bearing pad DP test

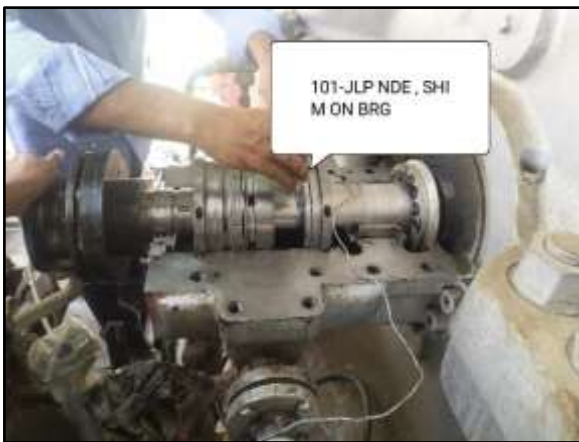
101-JLP NDE side bearing

Preventive Maintenance of 101-JLP was carried out. 101-JLP was decoupled from both ends. Journal bearings of DE side were removed for inspection, measured the clearances, found on higher side. So, replaced the bearing with new one. NDE side and Thrust bearings were visually inspected and Dye penetration test was carried out. Gauss reading of the bearing pads and base rings were measured and found within limits. Bearing clearances were taken and found within the design range. The DE side inboard oil guard found a crack and replaced it with new one.

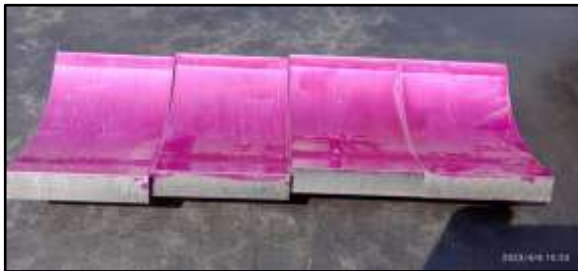
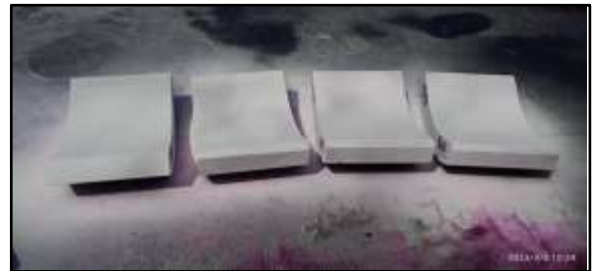
Turbine front journal bearing pads DP test conducted

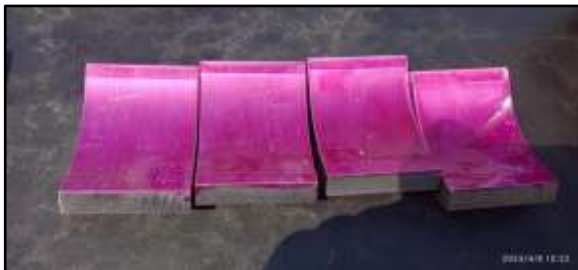
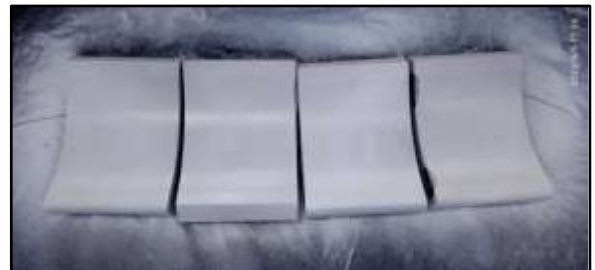
Turbine Rear Journal bearing Pads DP test conducted

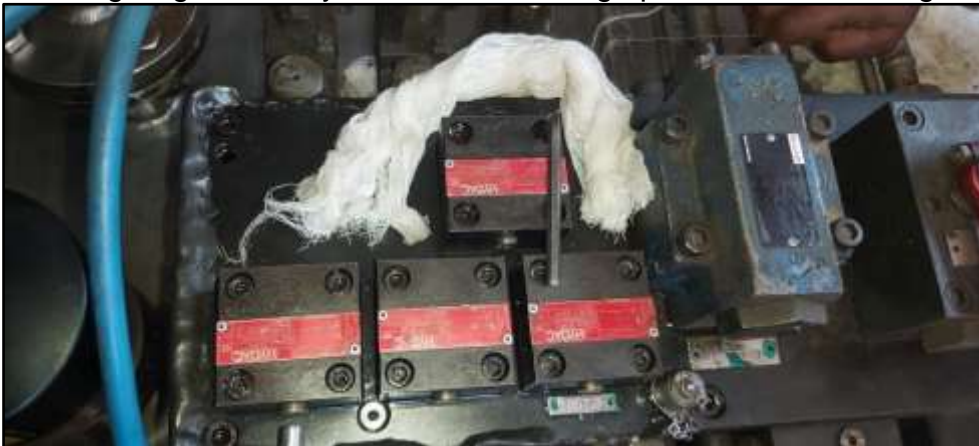
Logic Cartridge Assembly

- As per P & ID, checked all the Oil paths and opened the NRV 8511 of COP 8504 and found some particles got jammed between the seats. Removed the particle, re-assembled and installed it in position.

- Again, re-opened the logic cartridge covers of the safety block, checked the spring position, and boxed up the poppet valve.
- After energizing the safety block, the discharge pressure was 158 kg/cm².

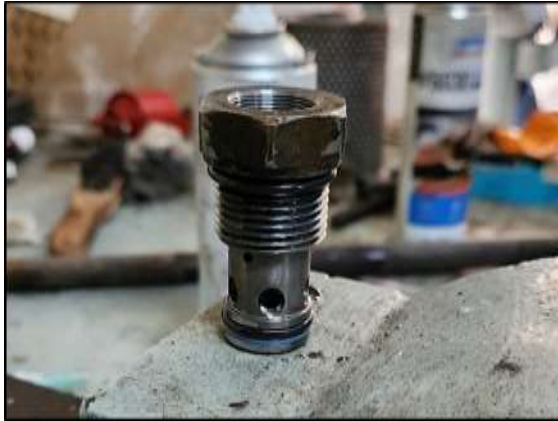
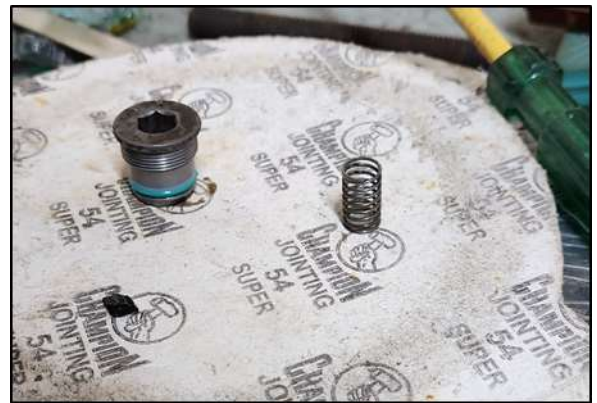
O-ring particle got stuck in NRV

Dismantled the NRV and removed the particle and assembled.

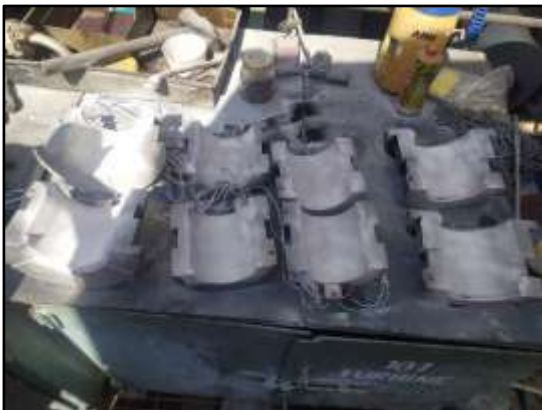
Gear wheel & pinion wheel bearing pad DP test

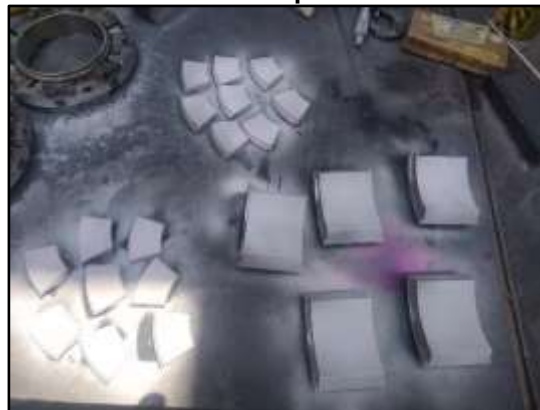
LP Bearing pad DP test

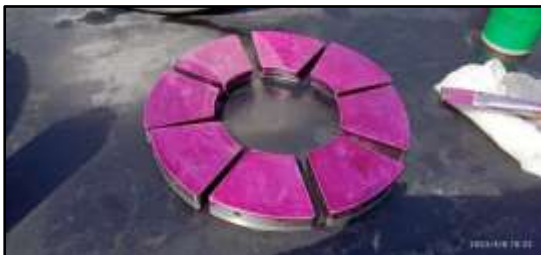
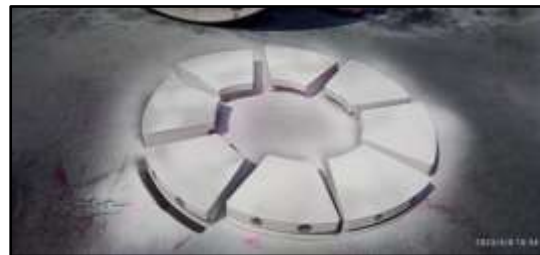
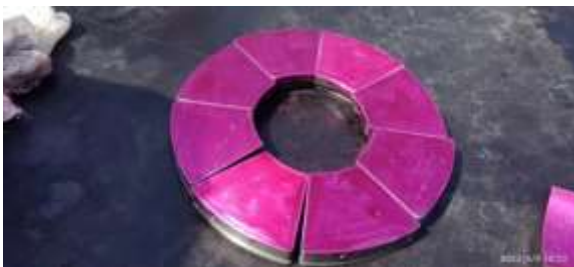
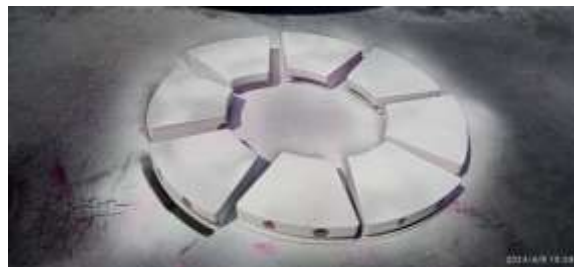
Turbine Active/Non-active thrust pads DP test conducted.

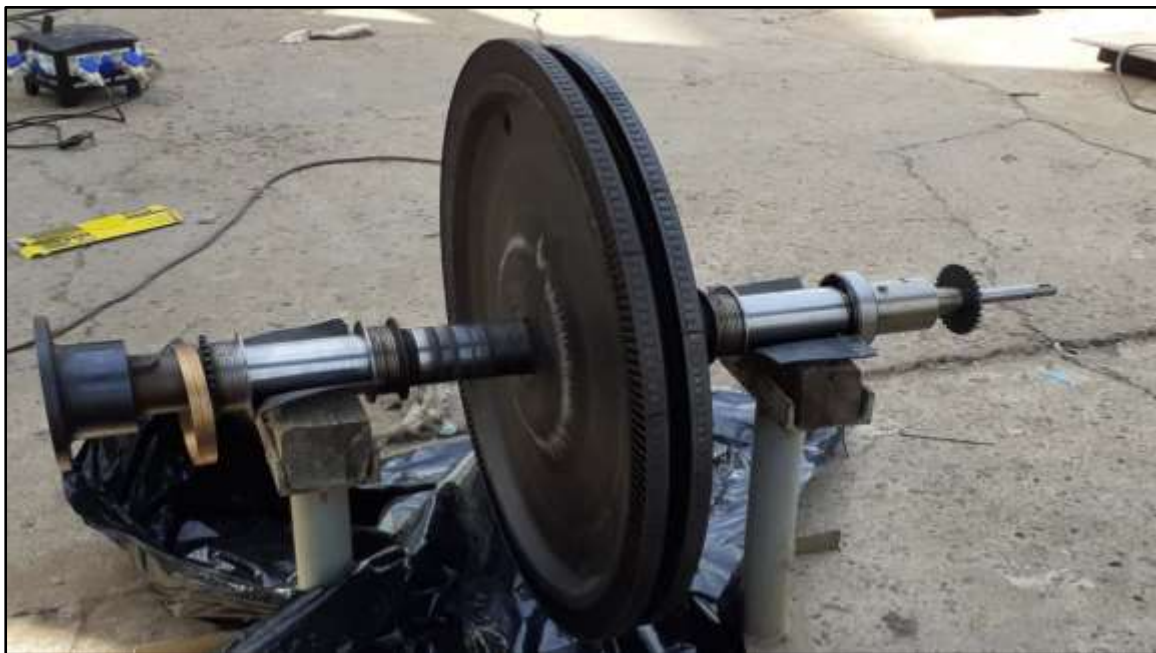
Turbine Rotor opened from its position.

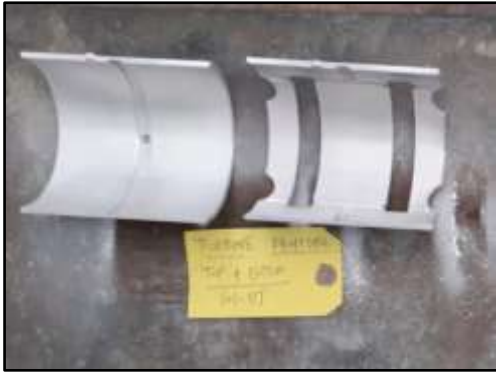
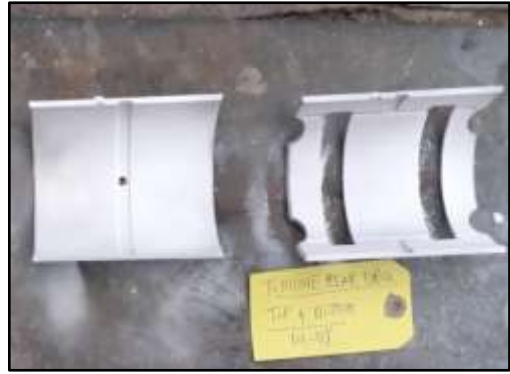
Turbine Front & Rear liner bearings DP test conducted

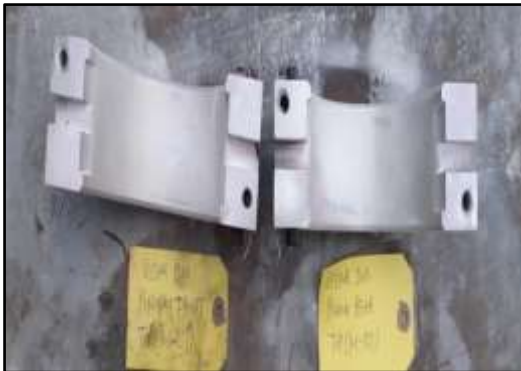
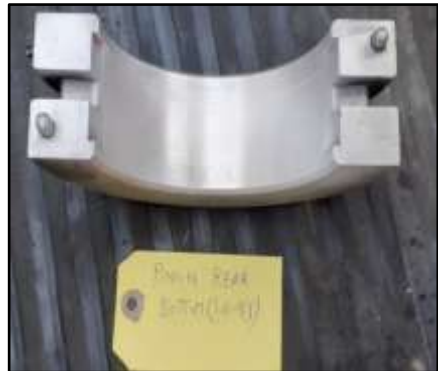
Pinion bearings DP test conducted

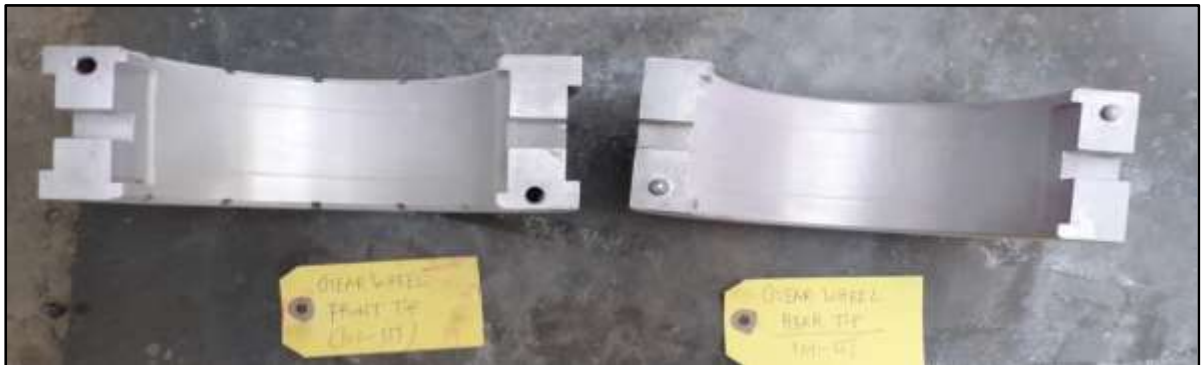
The top cover of the gear box was removed. The thrust bearings were inspected and found to have high clearance. So replaced the gear wheel thrust bearing with a new one. The remaining bearing dye penetration was inspected, and no defects were observed. A gauss measurement for the bearings was also carried out and found to be within the limit. Gear backlash and bearing clearance were measured and found to be within limits.

Gear wheel bearings DP test conducted

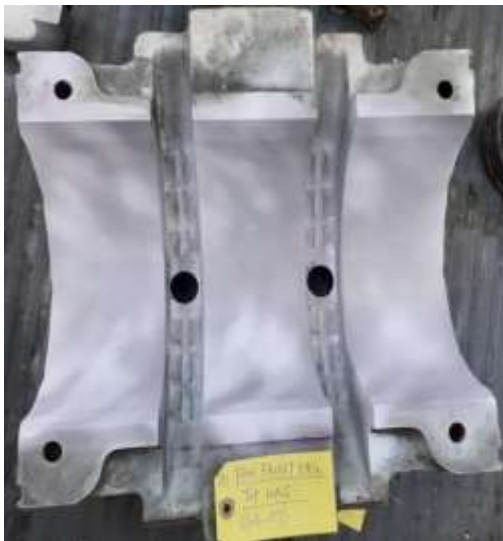
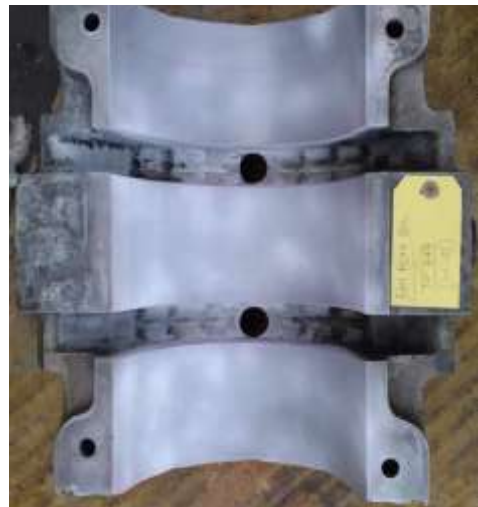
ID Fan Front & Rear bearings DP test conducted

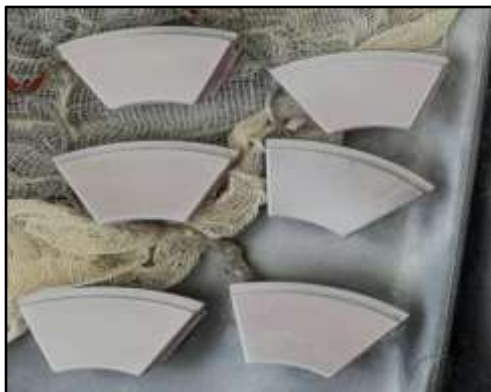
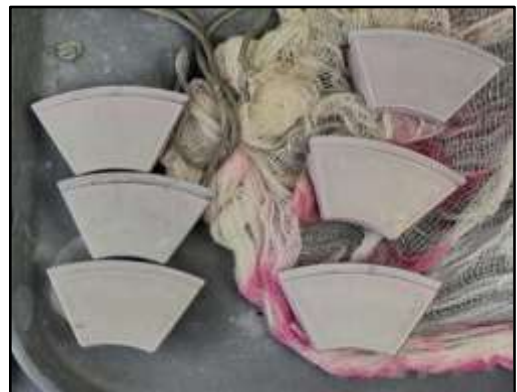
The hydraulic turbine was decoupled. The thrust bearing and both end radial bearings clearance were measured and found within limit. The bearing pads were visually inspected, and DP checked and found OK. The gauss measurement was taken and found within acceptable limit.

Turbine thrust pads Active/Non-active DP tests conducted

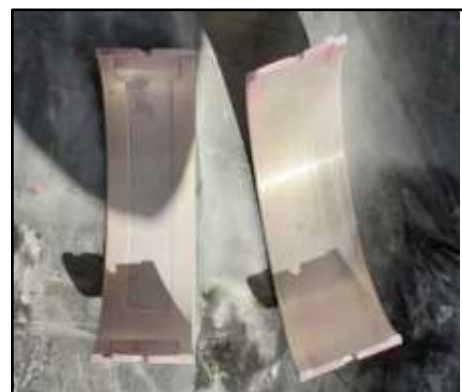
Turbine Front & Rear bearings DP test conducted

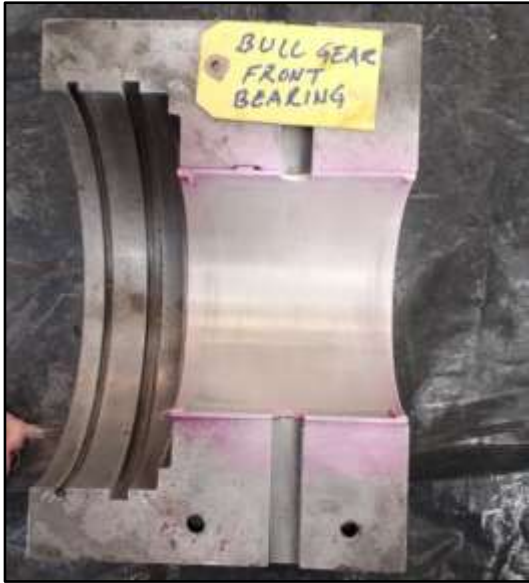
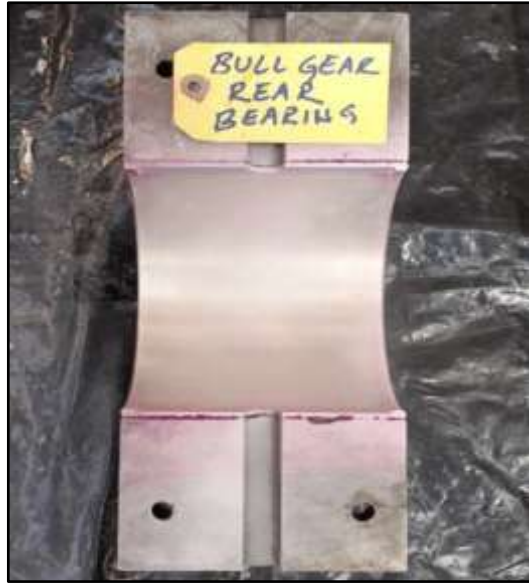
Gear Box was opened, and all the bearings were inspected and found O.K. Both the gear as well as Pinion were inspected and found O.K. Gauss measurement of gear shaft and bearings carried out and found within limit. Bearing clearances and backlash were measured and found within the design range. The main oil pump drive coupling was inspected and found in good condition. The oil piping's were cleaned with air.

Gear wheel bearings DP test conducted

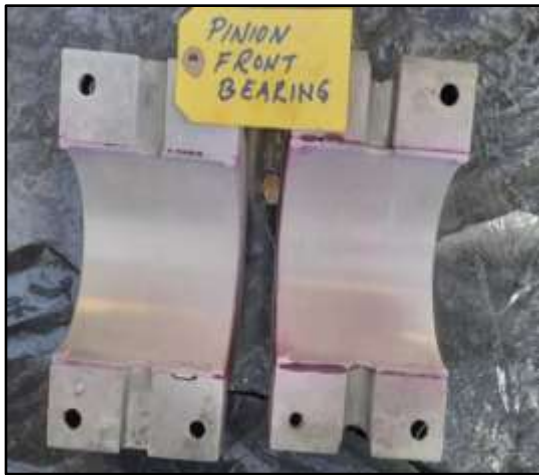
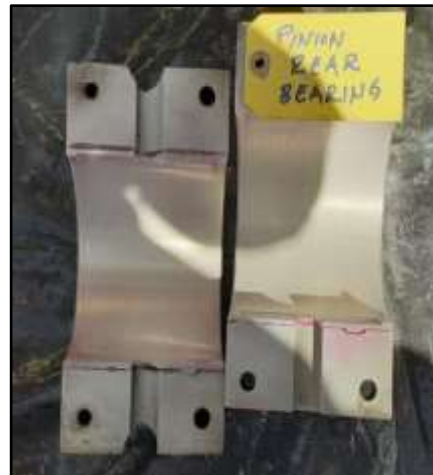
Pinion bearings DP test conducted.

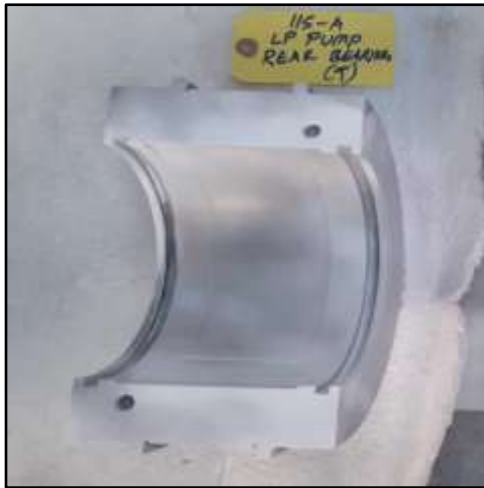
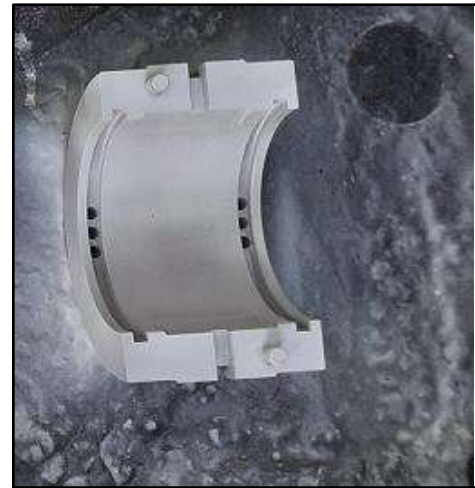
Pump Rear bearings DP test conducted

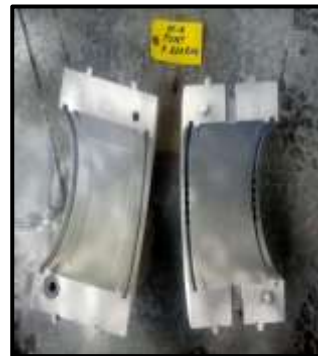
The pump was decoupled, and both ends of the bearing housing were opened. The thrust bearing and both end radial bearing clearances were measured and found to be within limits. The bearing pads were visually inspected, DP checked, and found to be OK. The gauss was checked and found to be within an acceptable limit. The suction strainer was cleaned.

LP-Pump Front & Rear bearings DP test conducted

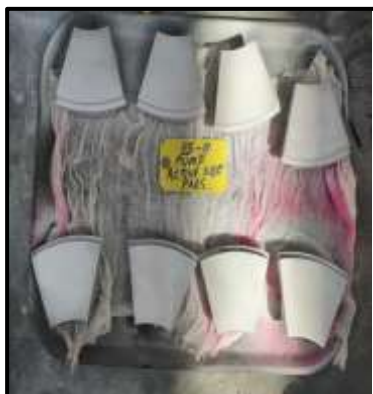
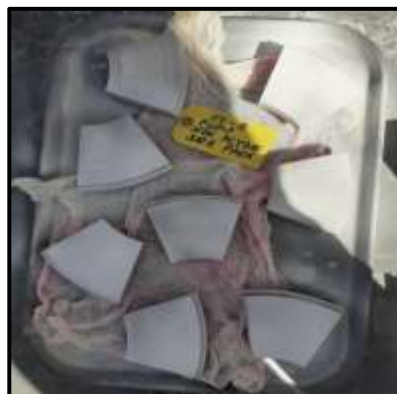
LP-Pump thrust pads Active/Non-active DP test done.

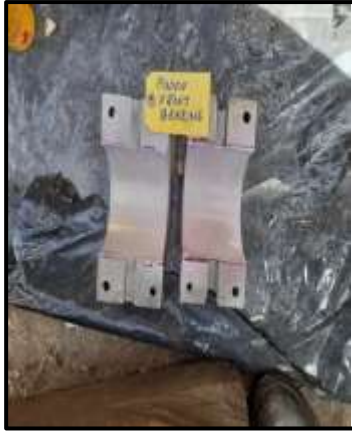
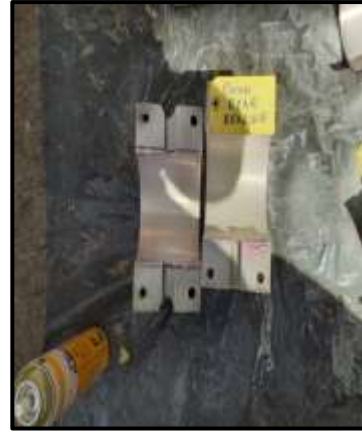
Pinion bearings DP test conducted

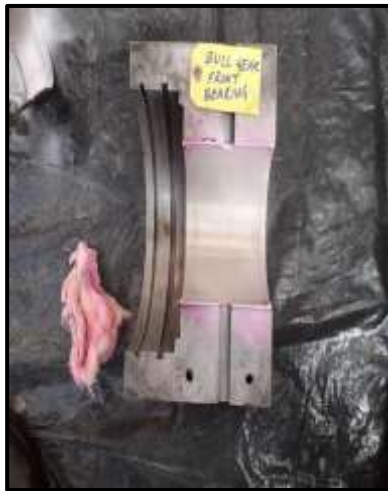
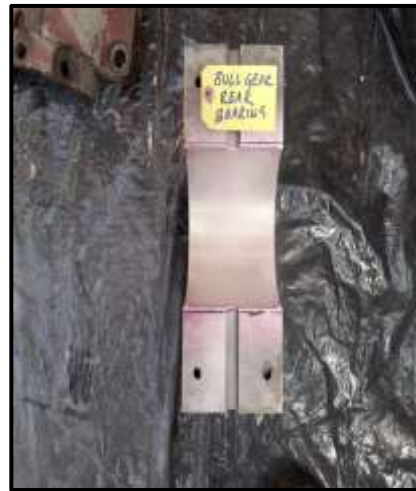
Gear wheel bearings DP test conducted

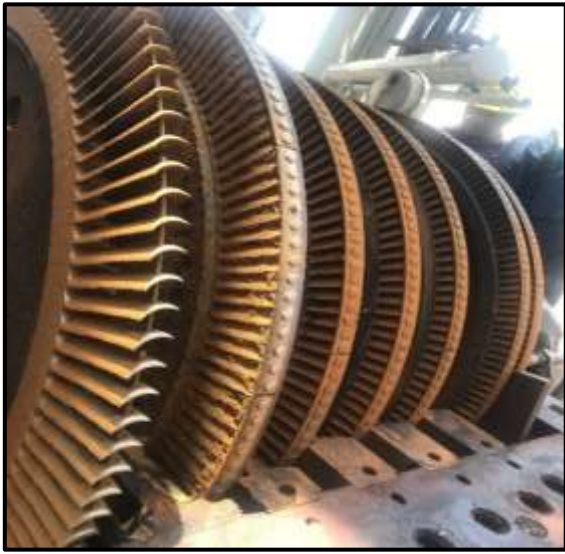
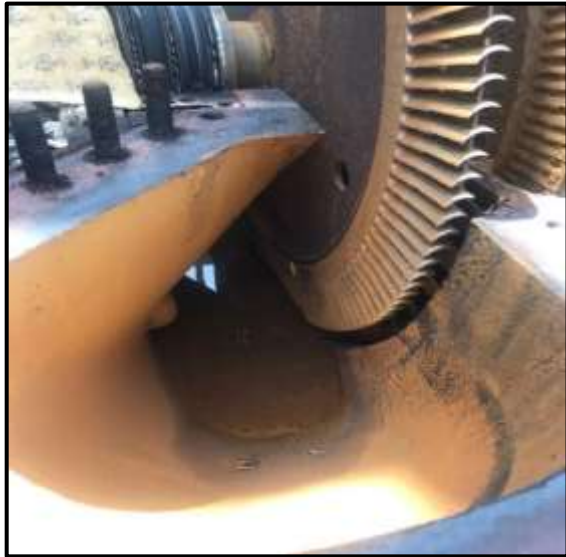
After opening the top casing

The turbine was decoupled, and the exhaust line was removed. The top casing was removed, and all axial as well as radial clearances were measured. The bearings were removed for inspection. The rotor assembly was taken out, and it was observed that the rotor blades of the last stage were eroded and filled with mud, cleaning done by shot blasting. The 2, 3, and 4 diaphragms were taken out for cleaning. The 6th diaphragm, which was jammed in both the top and bottom casings, was found to be eroded. Pittings were observed on the diaphragm, and DP checked and found to be okay. The bearing pads were visually inspected and DP check carried out, and both side bearings were replaced with new ones. Inter-stage labyrinths no. 2, 3, and 4 were also taken out, and new labyrinths were installed. While removing the inter-stage labyrinths, some of them were broken as they had been stuck in the diaphragm. The new rotor was installed, and all axial as well as radial clearances were measured. New carbon rings were installed. Bearing clearances were measured and found to be within limits. The steam inlet pipe, exhaust pipe, and all other related piping were boxed up.

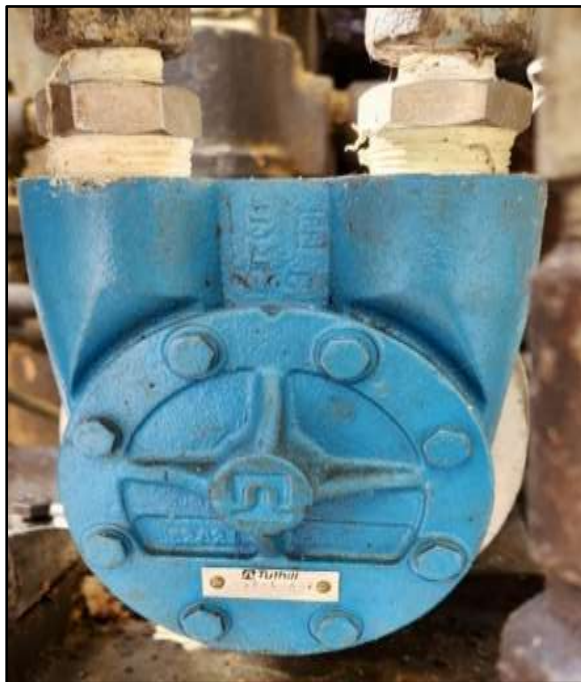
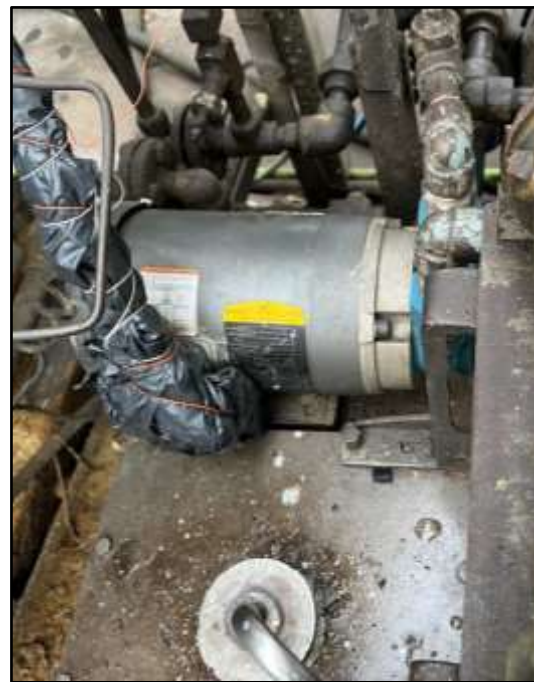
New AOP with motor of tuthill make was installed

New AOP with motor was installed on the lube oil tank with inlet and outlet lube line modification. Pump was procured from M/s. FABSMITH INDIA PRIVATE LIMITED, Chennai. against the order no 201004220318, Dtd : 02-Jun-2021.

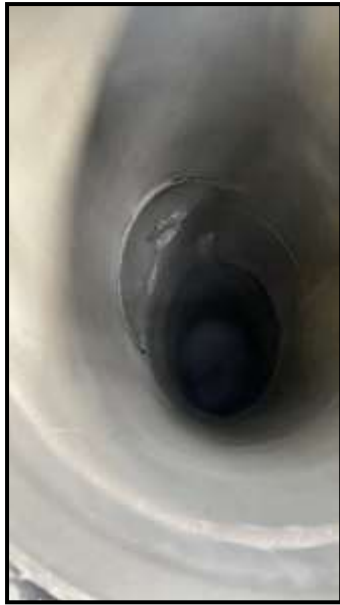
Damaged Liner

Repaired damaged Liner joint of 103-D top shell to transfer line. Damaged top flange refractory was repaired by civil section before box-up.

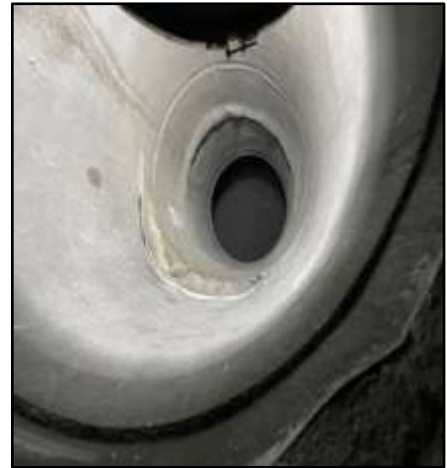
Extended portion grinded off

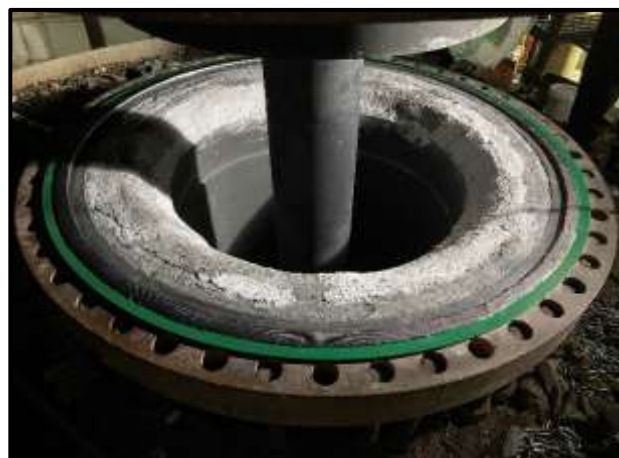
Box-up of Top cover with new gasket

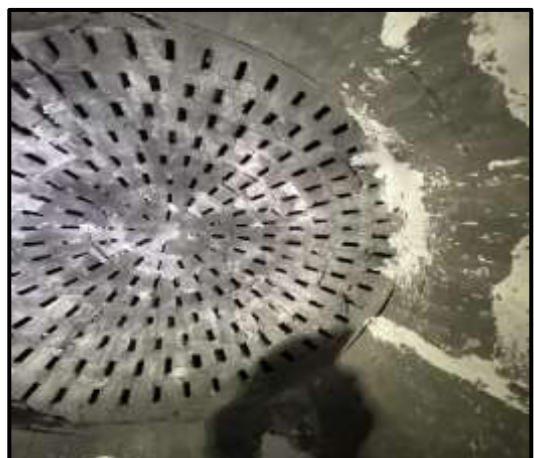
Damaged refractory in bottom portion was repaired by civil section as per the observation in inspection report.

Bottom Dome Refractory

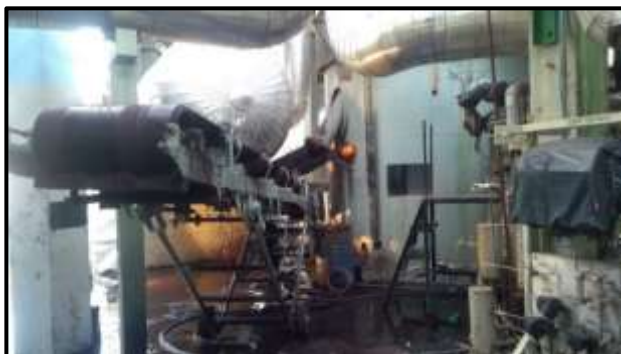
Unloading of Catalyst

- 104-D1, LT Shift Converter: Manholes were opened. Screens were removed for catalyst replacement. After removing all catalyst from the vessel, internal inspection of the vessel was carried out.
- Thermowell pipe found bent and its assembly found loose at end. It was repaired.
- After filling bottom Alumina balls, Bottom floating screen was provided.
- Then Catalyst loading was done.
- Then Raschig ring was provided above catalyst.
- Then top Floating screen and grating was provided
- Old bottom Floating ring mesh (Mesh size 3 X 3) and Top floating ring mesh (Mesh size 2 X 2 X 0.063" Ø & Mesh size 6 X 6 X 0.054" Ø) were reused.
- Manhole boxed up.
- LTS Catalyst was replaced after 5 years (earlier replaced on 2018)
- 2 nos. Portable boilers were hired for heating & reduction of catalyst by M/s. Aakash Exploration Services, Shertha. CPA No. 201004231962 dated 04/04/2023.

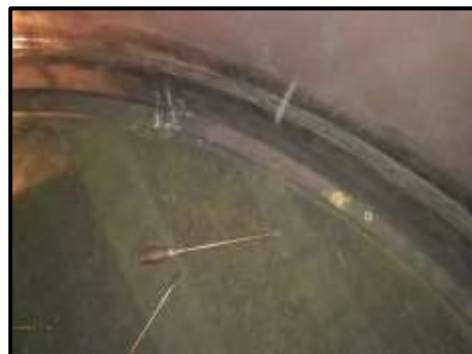
Bottom mesh

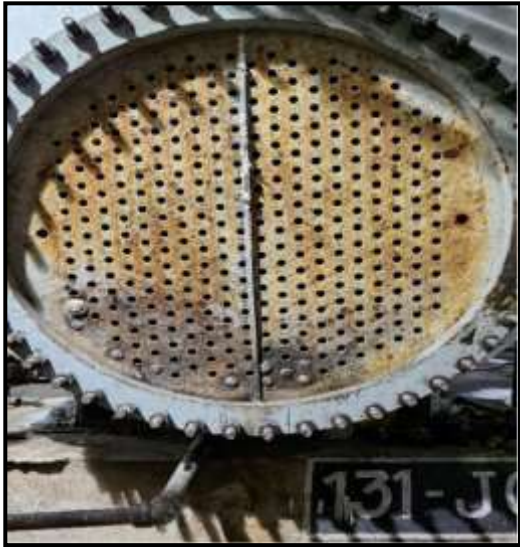
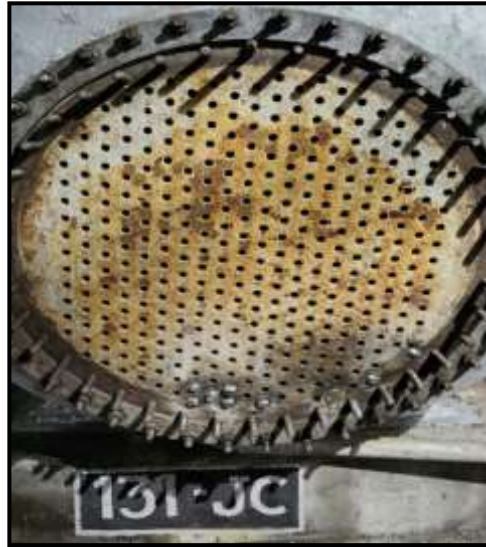
9 nos. tubes plugged (1 no. leaky & 8 nos. badly choked) in 131-JC

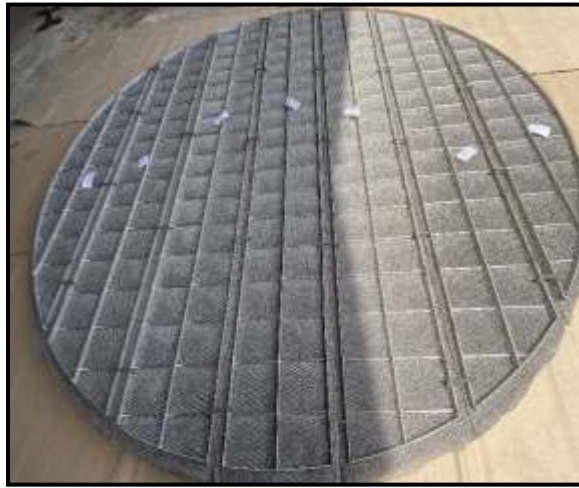
New Demister Pads

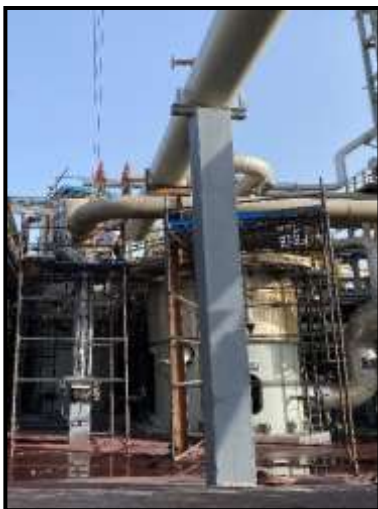
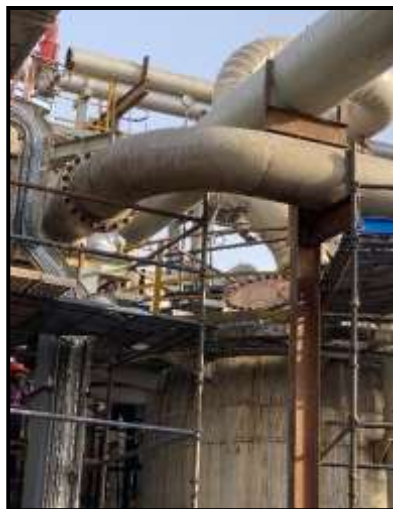
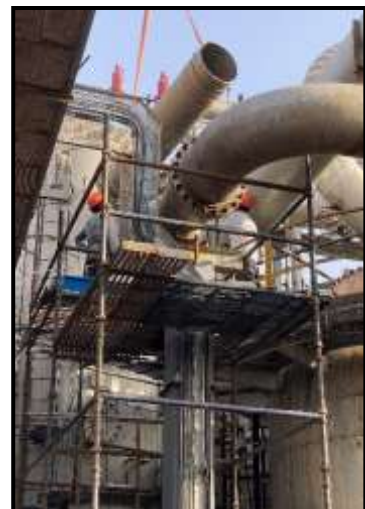
Pipe Supports erected & cut the lines

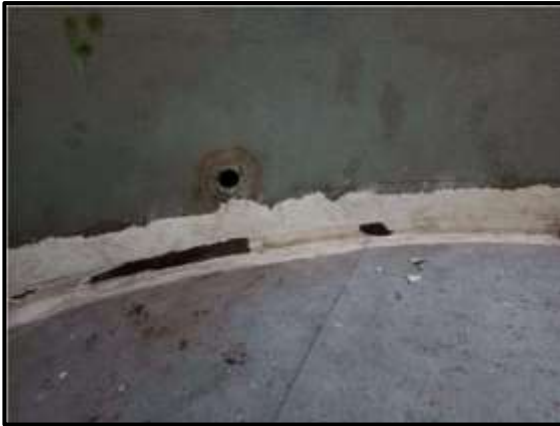
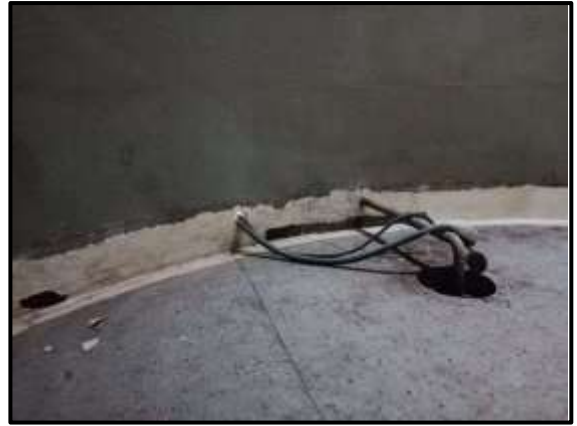
Coating peeled off at many location inside DM Water Tank

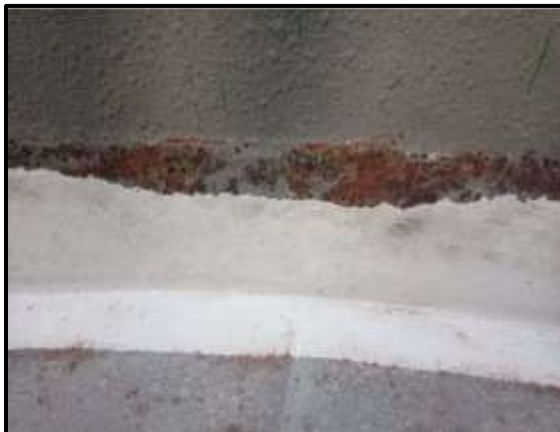
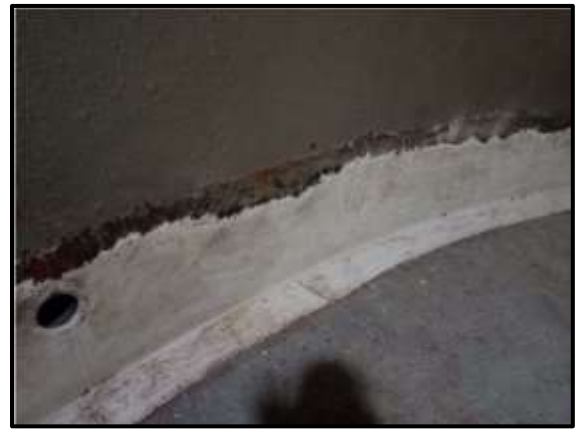
Surface prepared by grinding

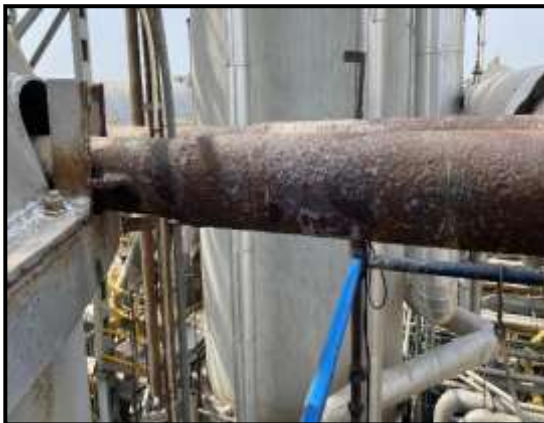
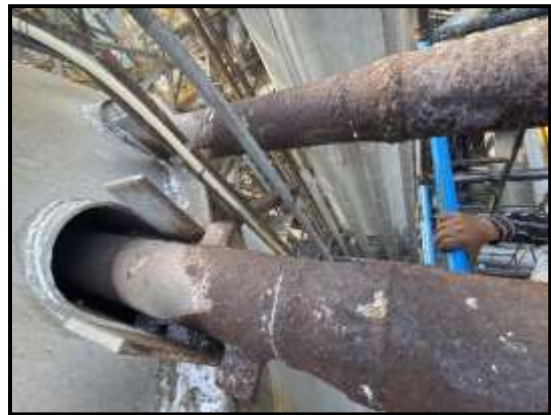
Corroded pipe pieces of start-up heater outlet line

- Replacement of reducers having corrosion of Startup Heater(102-B) outlet line. MOC: P22
 - Spool pieces – 2 nos. machined as per drawing from 4" Sch. XXS pipe of P-22 material and made ready before shutdown for replacement.

- Cut & removed existing piping (4" X Sch XXS) after marking. (Marked in red color in the isometry)
- Edges prepared; Fit-up & root welding of joints done.
- Root DP & radiography done.
- Final Welding carried out.
- PWHT of all joints carried out as per following: Loading Temp. : 200 °C, Heating Rate: 100 °C/Hr., Soaking Temp.& Time : 735 °C +/- 15 for 2 Hrs., Cooling Rate : 100 °C/Hr. After that cooling under insulation.
- Inspection: Butt joints - Root & final DP, 100% Radiography before & after PWHT

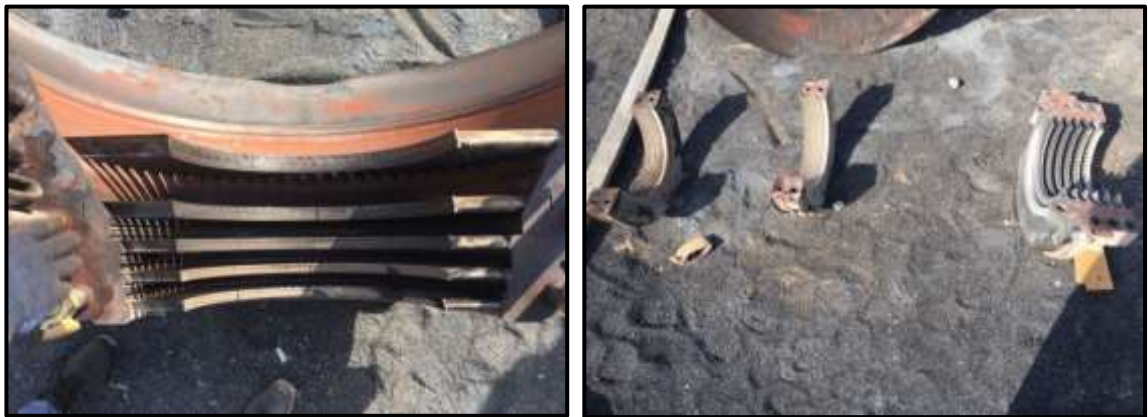
- Removed bottom halves of all three Guide blade carrier, steam chamber and inner gland one by one front side to rear side.
- Scaling was observed on fin area of rotor specially at area of 23 ata extraction steam.

Cleaning of rotor and diaphragm assembly.

- Rotor, guide blade carriers, steam chamber (Nozzle block) and inner gland were cleaned by grit blasting at Auto yard.

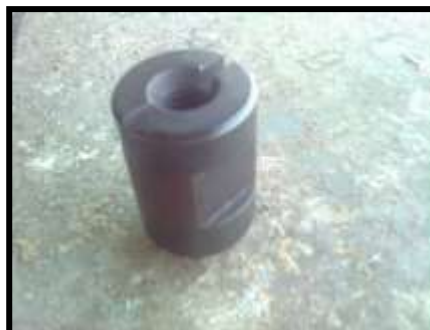
Guide Pin

- Following activities were carried out for centering of bottom of GBC-1 (Guide Blade Carrier-1) w.r.to rotor in a horizontal plane:
 - Labyrinth clearances were 0.30 mm at left side and 0.70 mm at right side.
 - Lifted the Guide Blade carrier and removed the guide pin. The guide pin are positioned in slots as shown in figure below

- For shifting the bottom of GBC towards left, tack welding was done at right side of guide pin. On the slot at left side, metal was removed by grinding by same amount.
- Pin was placed at slot and guide blade carrier no.1 was placed at position and clearance was found ok.

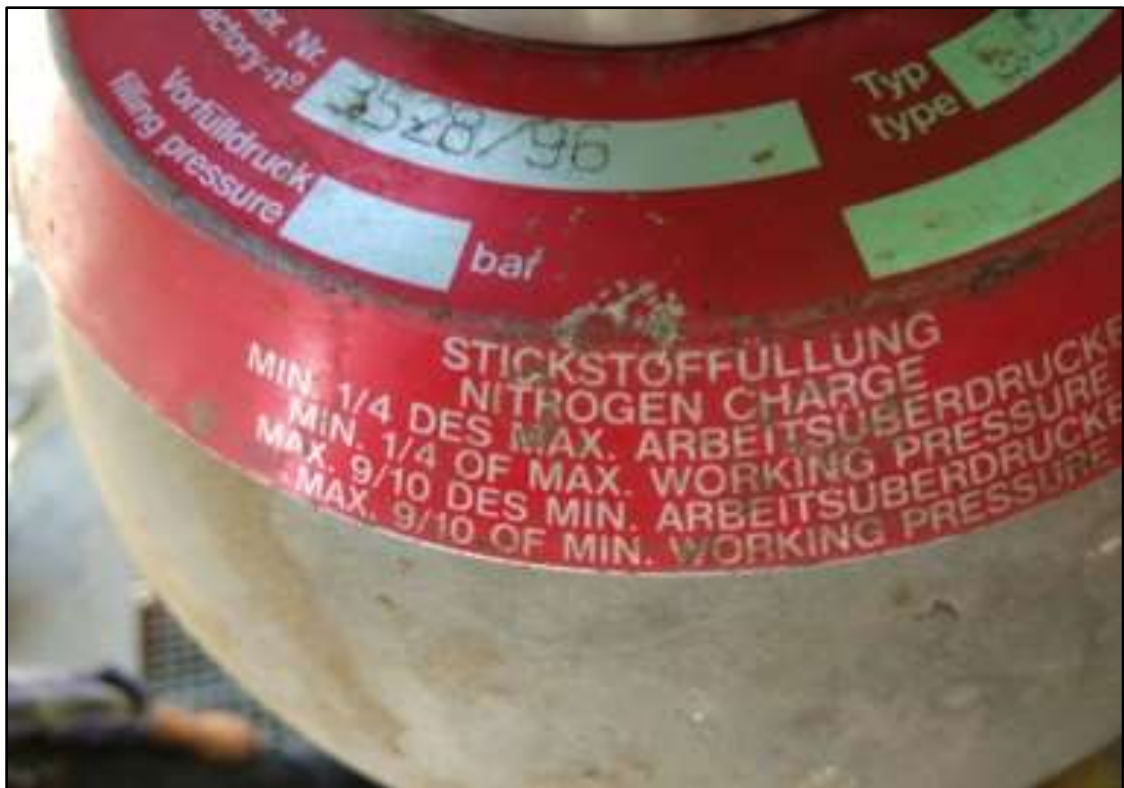
Accumulator Details

- The Balloon was checked and found approx 3.0 Kg pressure in Balloon.
- Gas filling Kit is available for filling of Nitrogen to oil accumulator.
- As per name plate details available on the body of Accumulator, nitrogen pressure may be kept between 6.0 kg to 9.0 kg. It was kept as 7.0 kg.

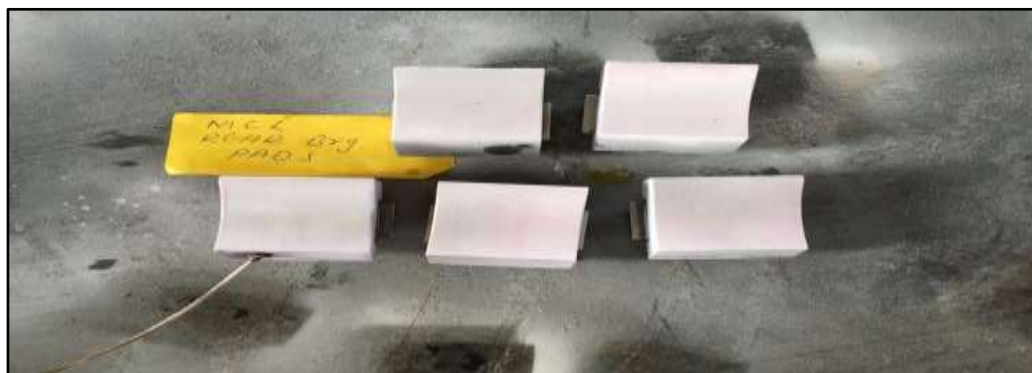
Tilting pad of Journal Bearing after DP test.

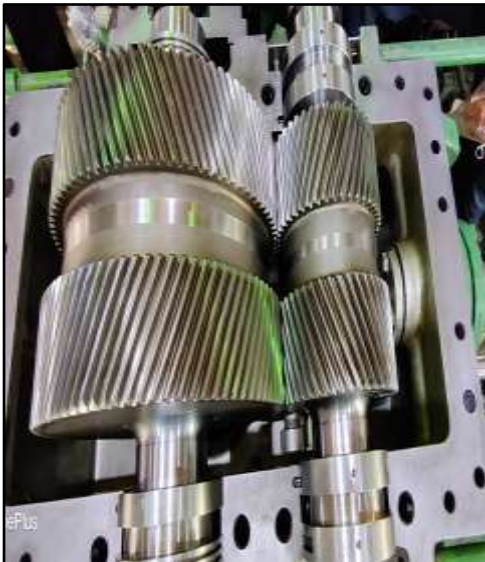
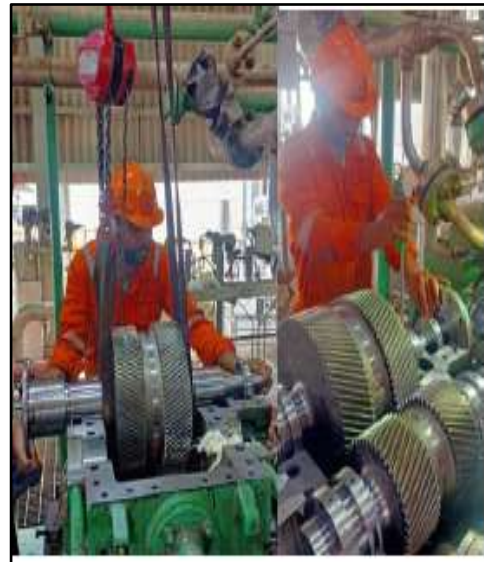
Complete Gearbox assembly before boxing up

- All the Pinion & Gear wheel journal bearings were thoroughly cleaned, and DP test was conducted found ok. Clearances were checked & the journal bearing of high-speed shaft were out of design range, so replaced.
- Gear wheel thrust bearings pads were thoroughly cleaned and DP test was conducted found ok. Clearances were checked & clearance was found out of design range, so the same were replaced.
- The backlash between Pinion & Gear wheel was checked and found to ok.
- Alignment between Gear Box & HP Compressor was checked and corrected as per protocol values.

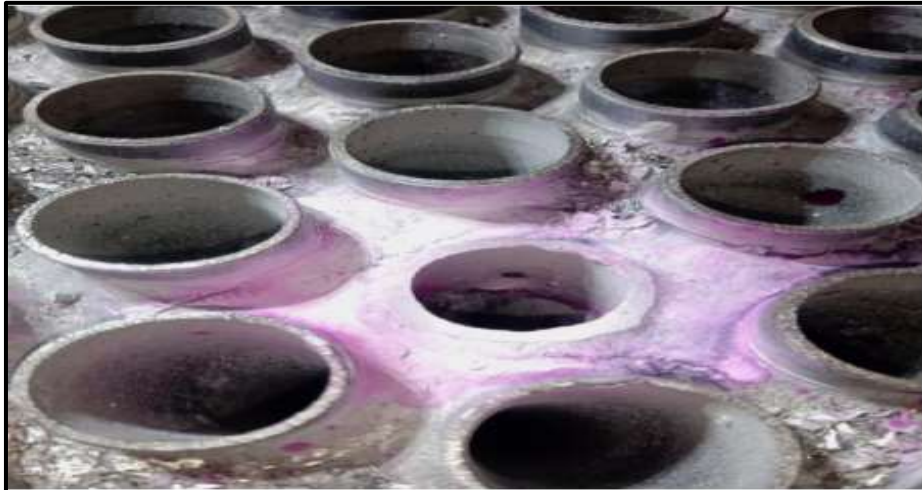
Eddy current testing was carried out by the Inspection Department. The thickness of a few ferrules was found to be below MRT value. After Eddy current testing 68 tubes were found to be below MRT value of 1.72mm. Hence these tubes were decided to be plugged. The procedure for the same was provided by Casale and the same was followed.

Protruded end of tube grinded

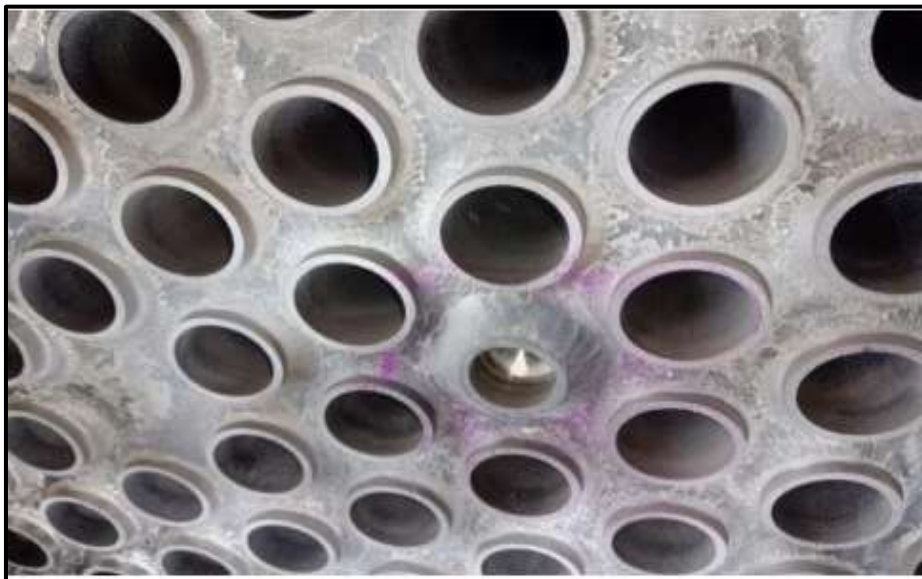
Bottom tube sheet side tube plug

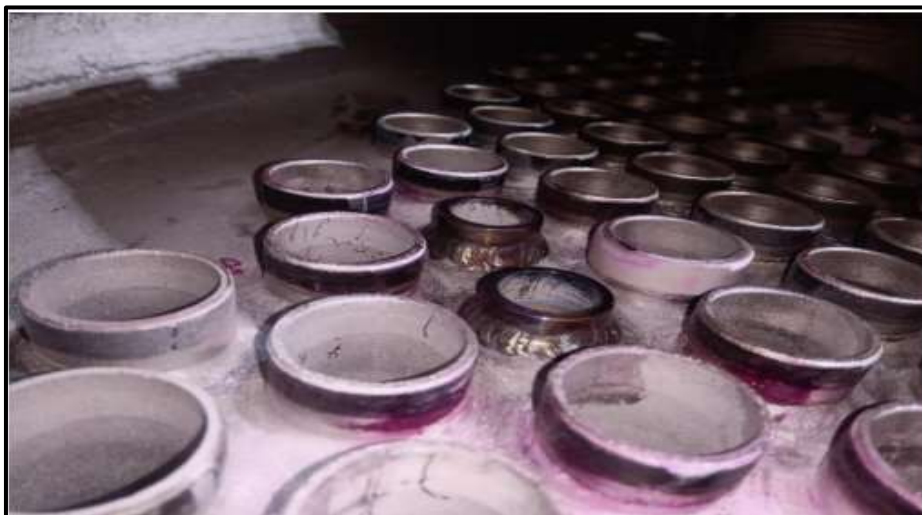
Top side tube sheet tube plug

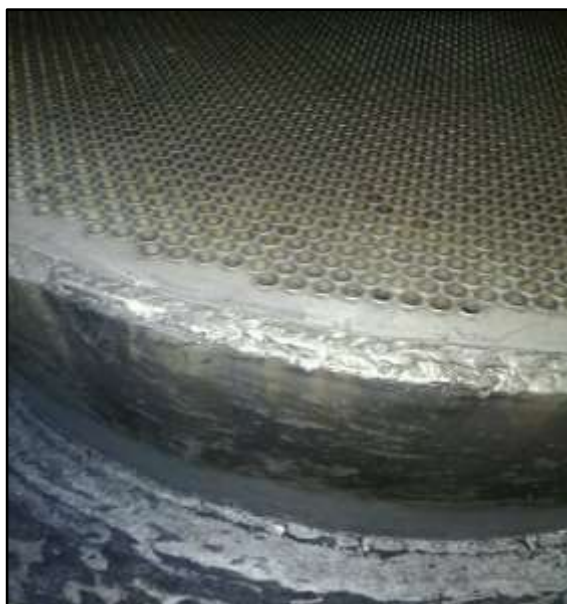
V-1424 DUMMY 2RE69 SKIRT

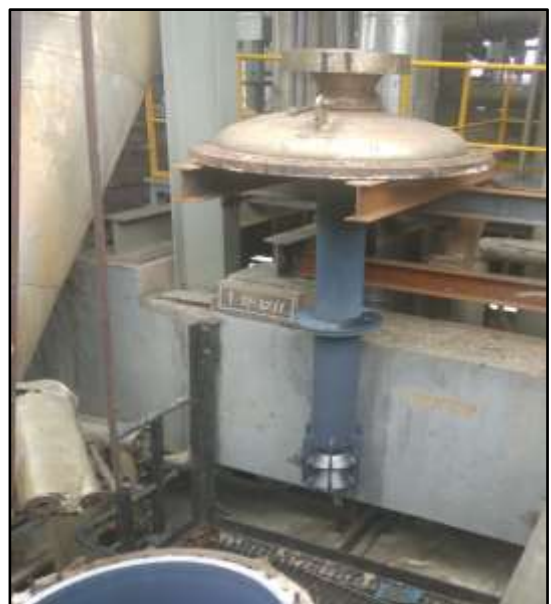
V-1202 NOZZLE ON STAND

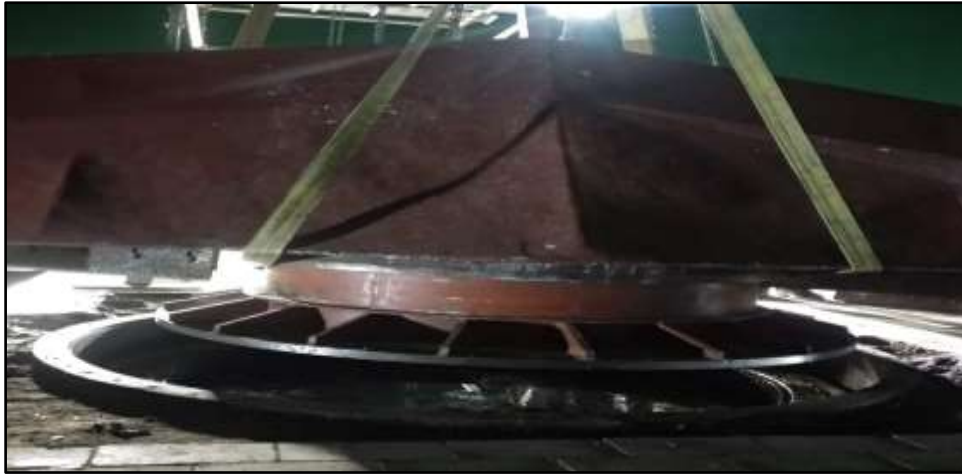
Scrapper arm lifted from position.
