MTC / REPORT / 01
REPORT NO. 40 / 2023

PLANT TURNAROUND REPORT
(APRIL – 2023)

INDIAN FARMERS FERTILISER CO.-OP. LIMITED

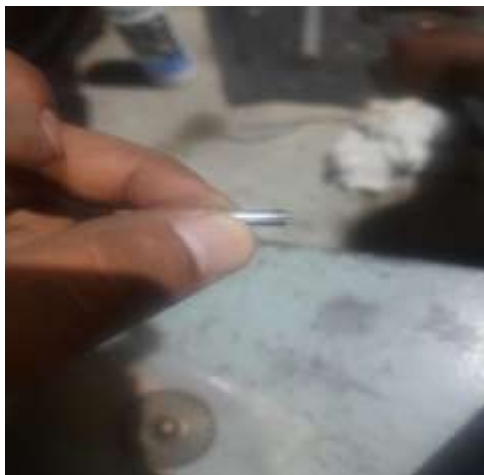
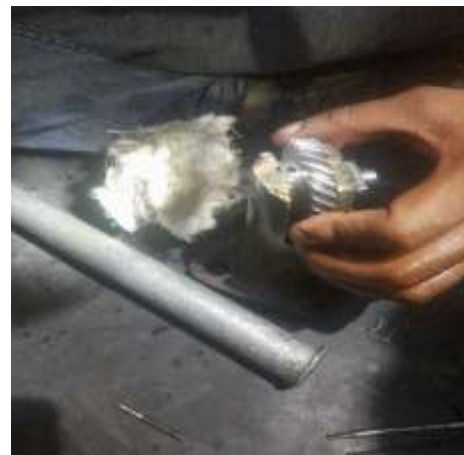
- Gear box opened to checked condition of governor coupling shaft. After inspection throughout the locking pin of governor was found damaged. Then locking pin was replaced.

Governor locking pin was damaged and replaced

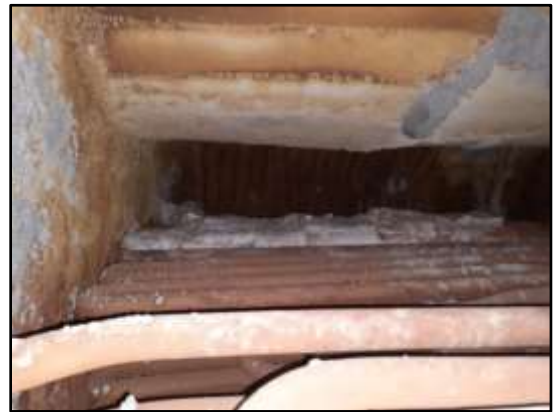
Ceramic insulation

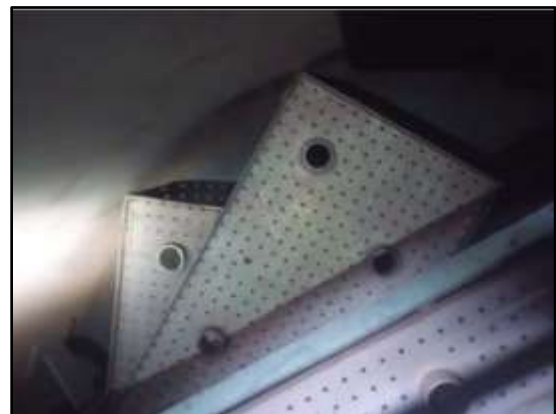
5th number Tray segment

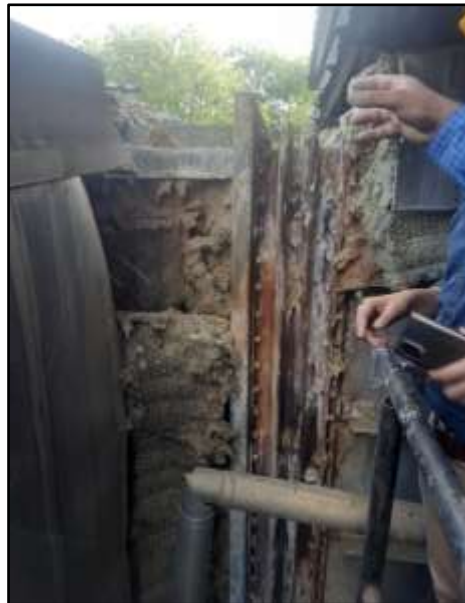
New Bellows for FD Fan Turbine duct

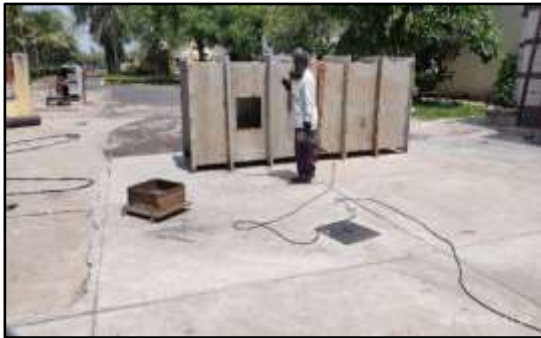
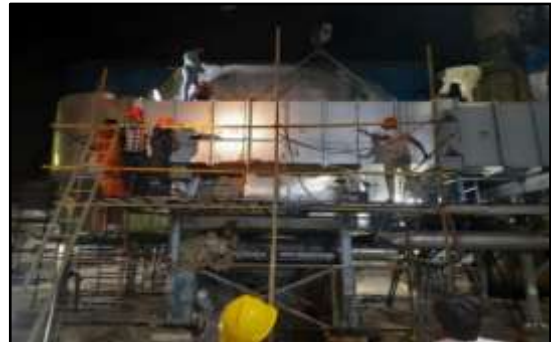
Replacement of damaged part of duct and Lube oil cooler of P-5111 is replaced

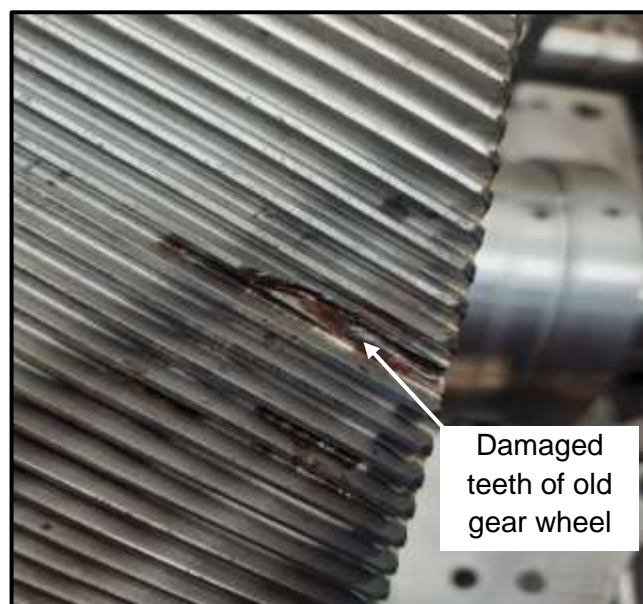
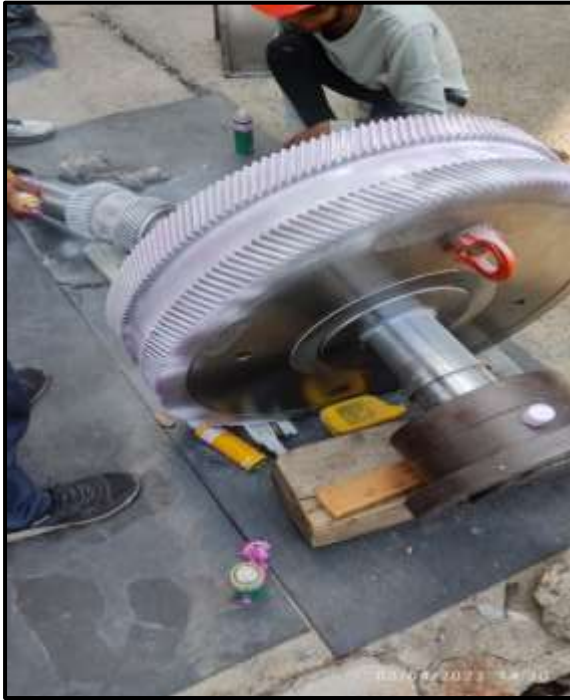
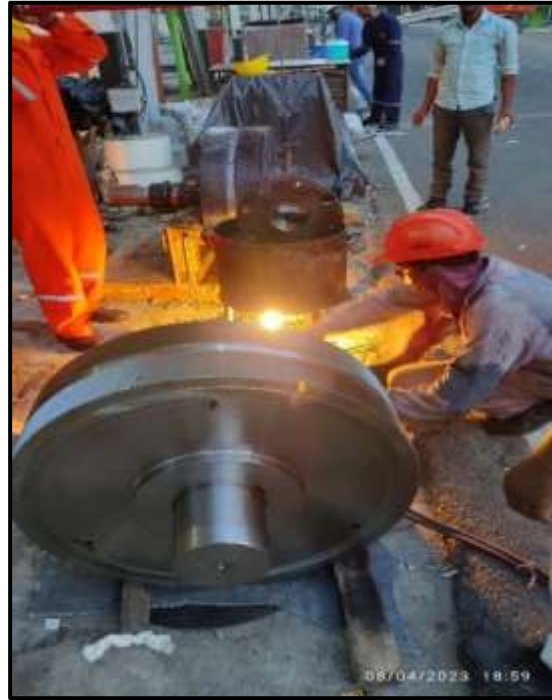
- Gear top cover was opened. GB internals were found damaged.
- Gear wheel and pinion was replaced with new one.
- DE and NDE Bearings of pinion found damaged, and replaced with spare.
- Checked and recorded DE and NDE bearing clearances and interference
- New gear wheel installed and recorded gear wheel DE and NDE bearing clearances.

New gear wheel for Q-4411

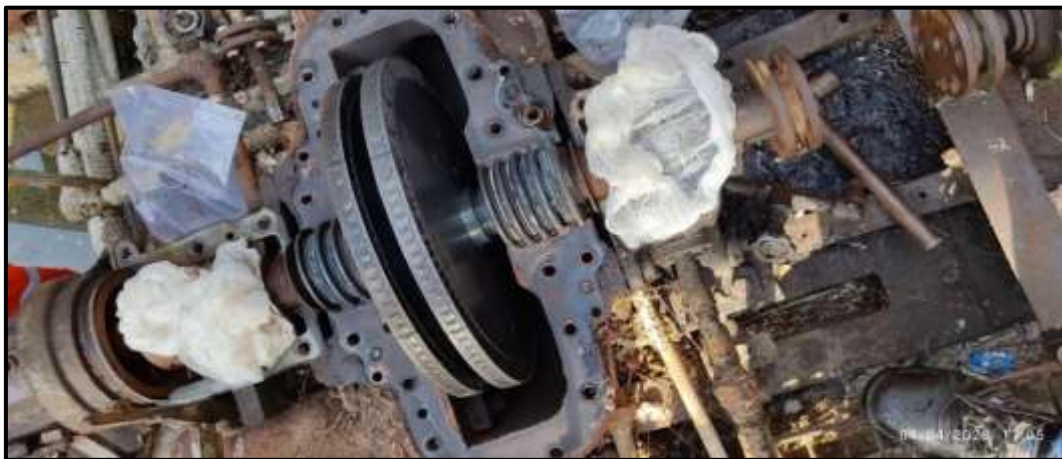
- Coupling between the Turbine and pump was decoupled.
- Governor was removed from the position.
- Removed all the bolts of the turbine casing and lifted the casing from the position.
- Top half of the bearing housings- both sides were also removed.
- Lifted the turbine rotor from the position.
- All carbon seals were removed. The carbon rings were found damaged and replaced.

Turbine Rotor

- Placed the rotor on support. DP test of rotor done and found ok.
- Top casing was positioned and tightened.
- Thrust of the Turbine was measured and recorded.
- Turbine oil seal clearance were also measured and recorded.
- Governor linkages were also made free.
- OST of turbine was done at 3430rpm.

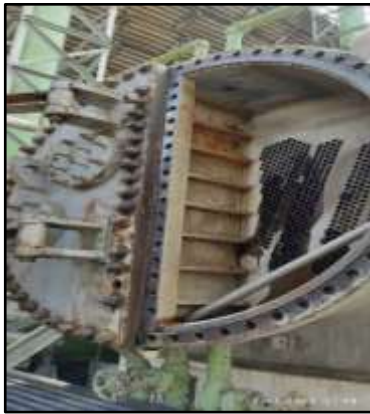
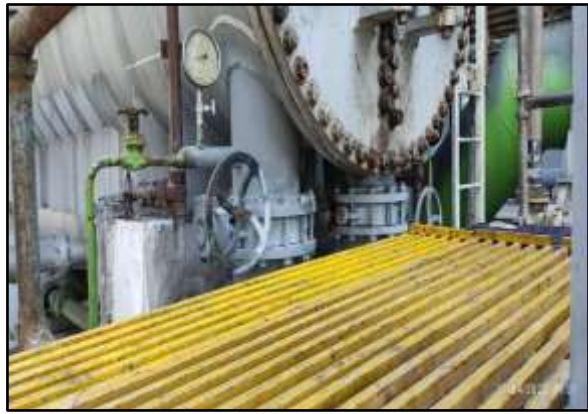
Hydrojet cleaning of surface condenser

- Hydro jet cleaning of surface condenser of Cooling water pump drive turbine Q-4411.
- Replacement of sacrificial Anode in Surface Condenser.

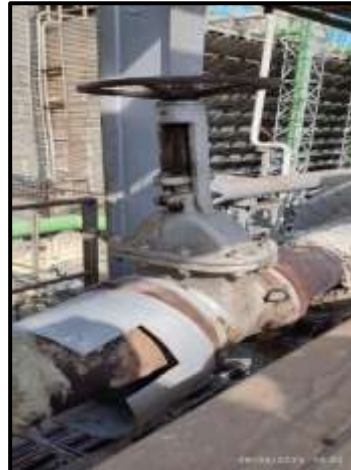
8" x 150# WCB gate valve

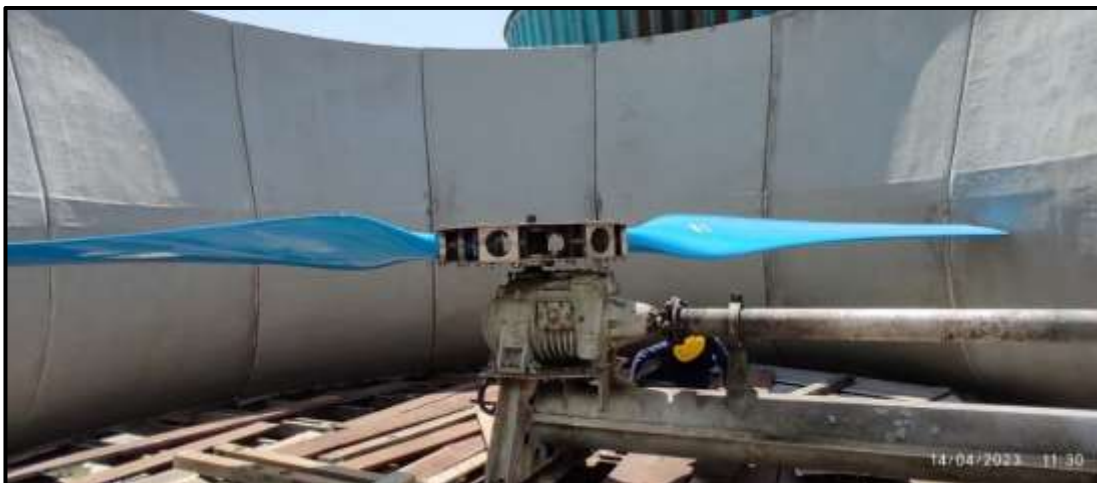
Cooling Tower Cylinder, Fan Blade and Hub assembly replacement

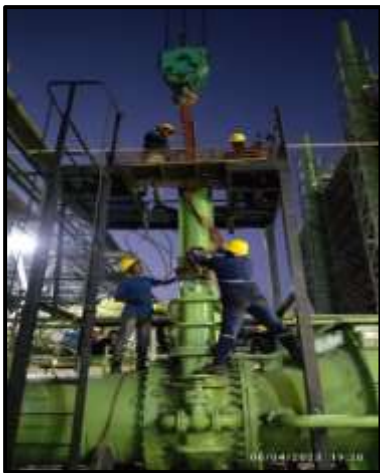
NRV and Gate valves repairing

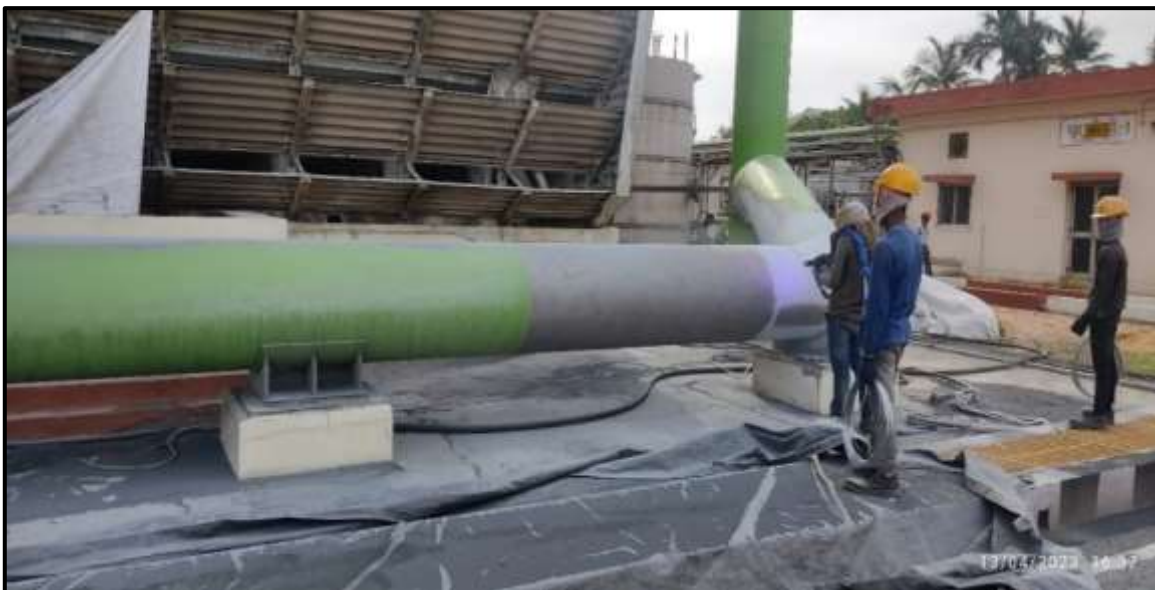
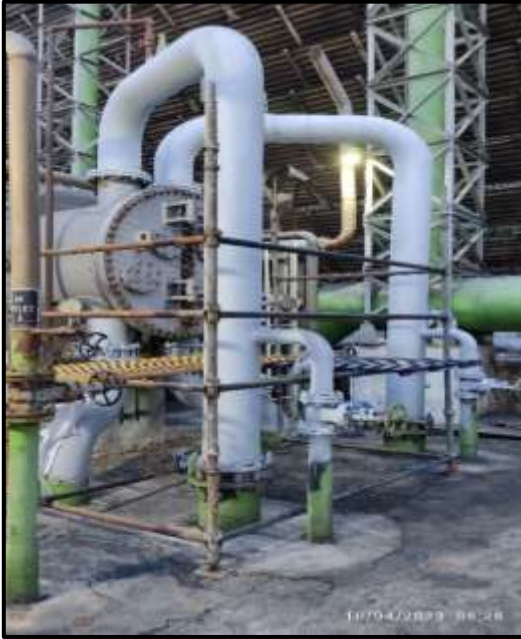
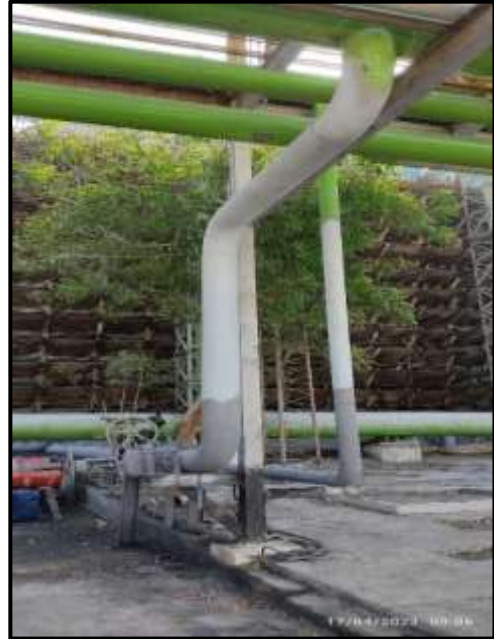
Zinc coating on cooling water pipelines

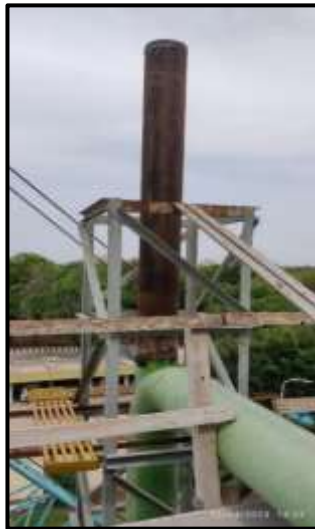
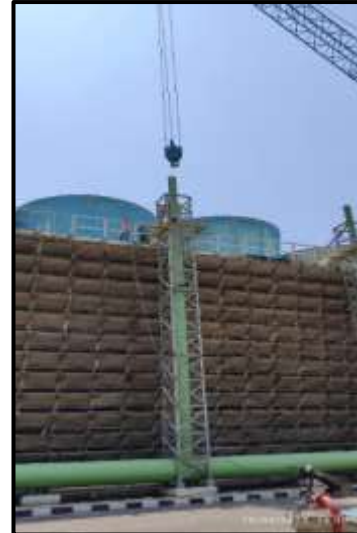
12" risers of cooling water (H-4401-5,6,7 and 8) east side were leaking. The same were replaced.

Replacement of risers

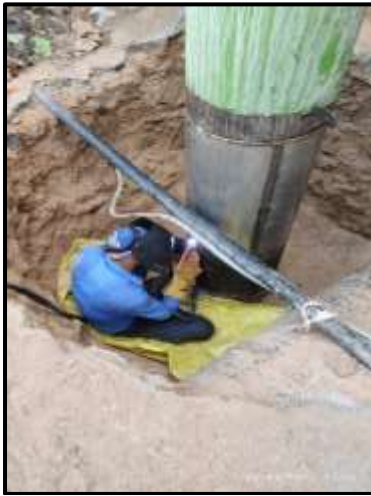
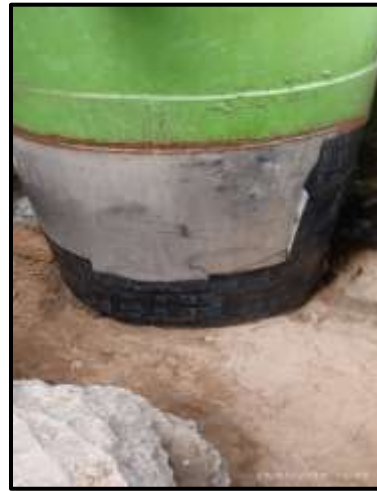
SS-304 plate cladding work with subsequent wrapping coating

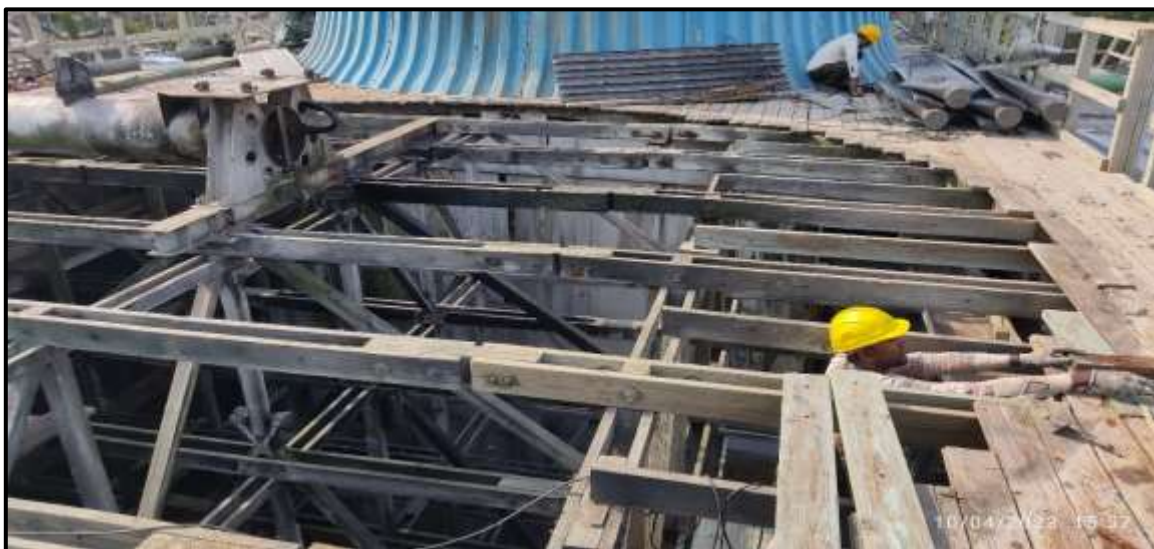
- M/s. Paharpur has done inspection of all cooling towers and found partition wall (Panels) in between Ammonia Cooling Tower cell 5 and 6 was dislocated. Also timber at some places in Ammonia CT between cell 4 and 6 found in bad conditions.
- Damaged timber is replaced with new timber as per inspection
- PVC partition panels were re-assembled between Ammonia CT cell 5 & 6.

Damaged timber replacement work

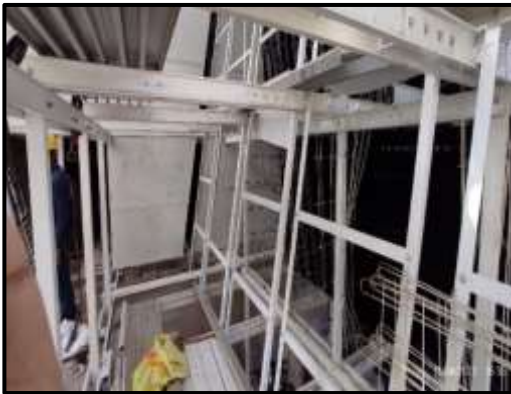
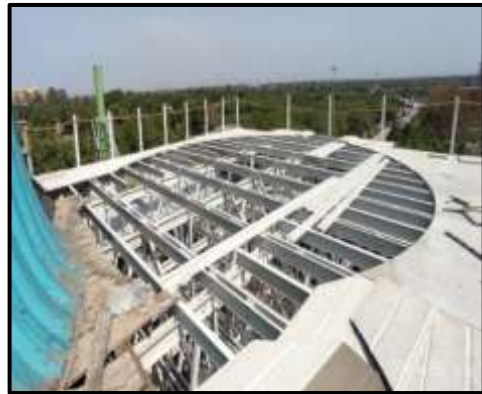
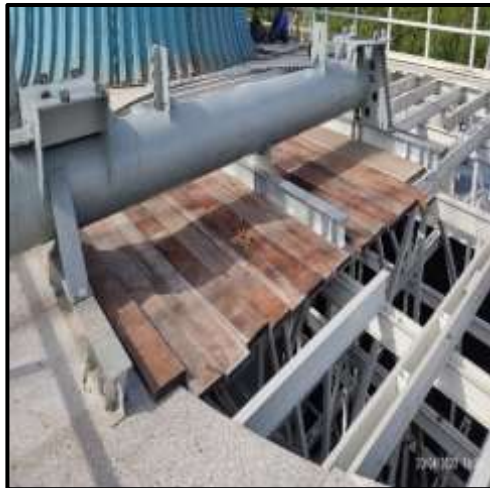
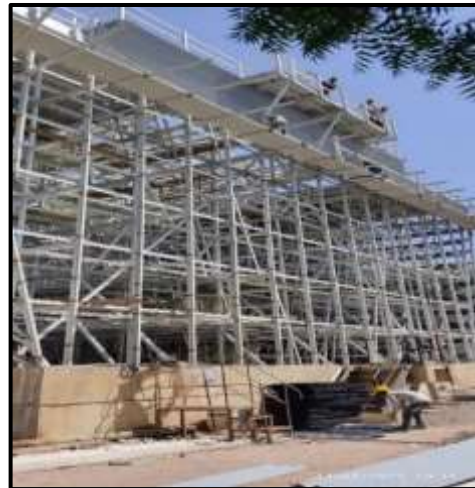
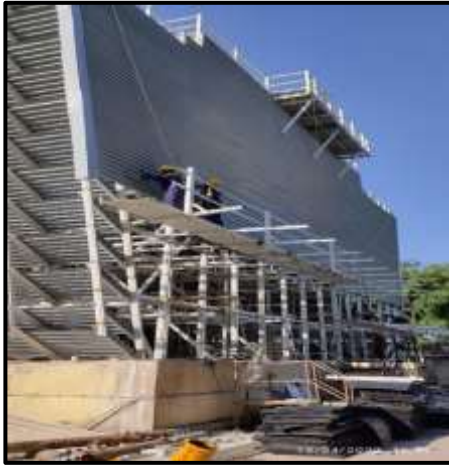
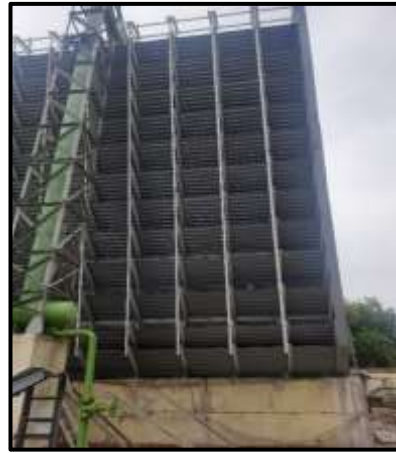
Erection and commissioning of cell No. 3 of NCT

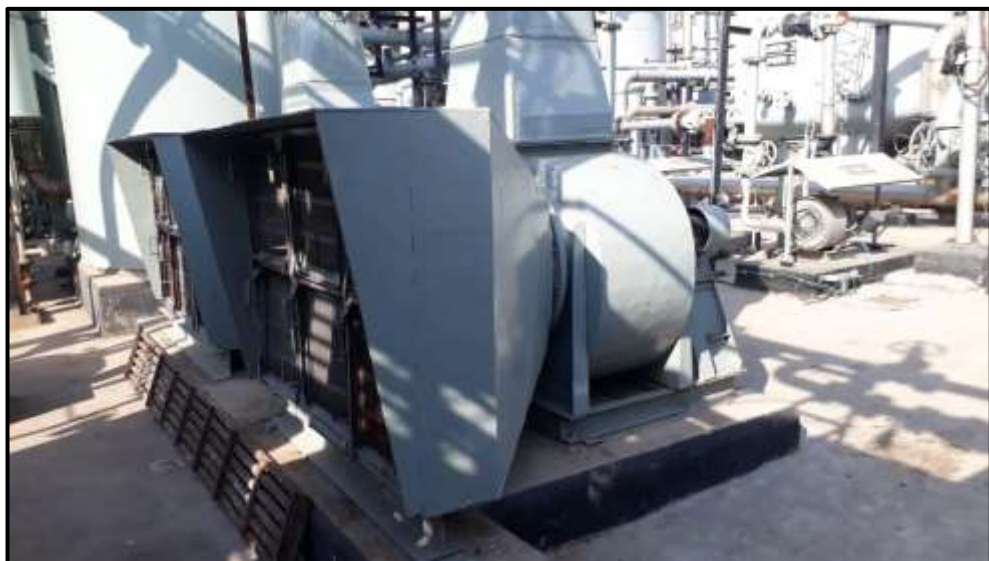
Due to ageing effect old blower was replaced with new upgraded M.O.C SS 304 blower.

Old Degasser blower

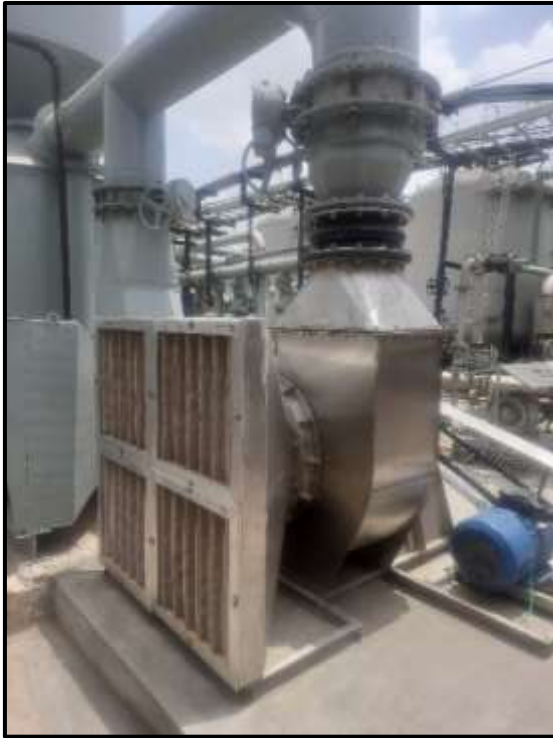
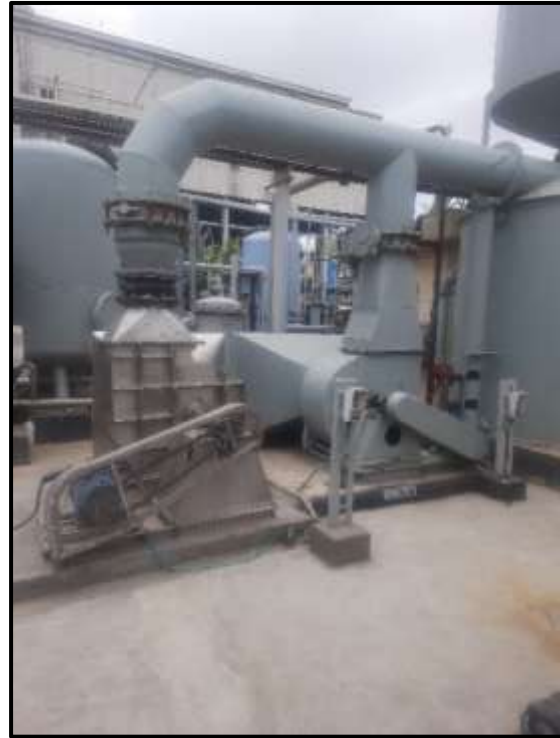
New Degasser blower

Two no. of degasser blower purchased from M/s. AEROTHERM PRODUCTS vide PO No. 201004221578. One blower K-4201/A is commissioned at site.

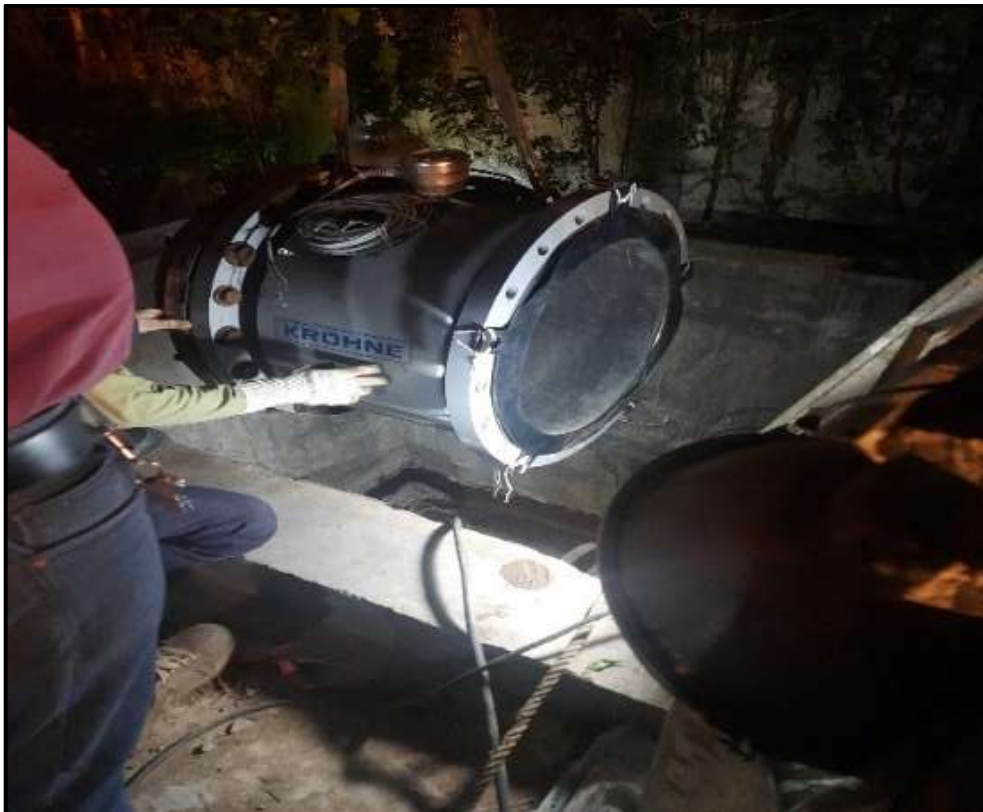
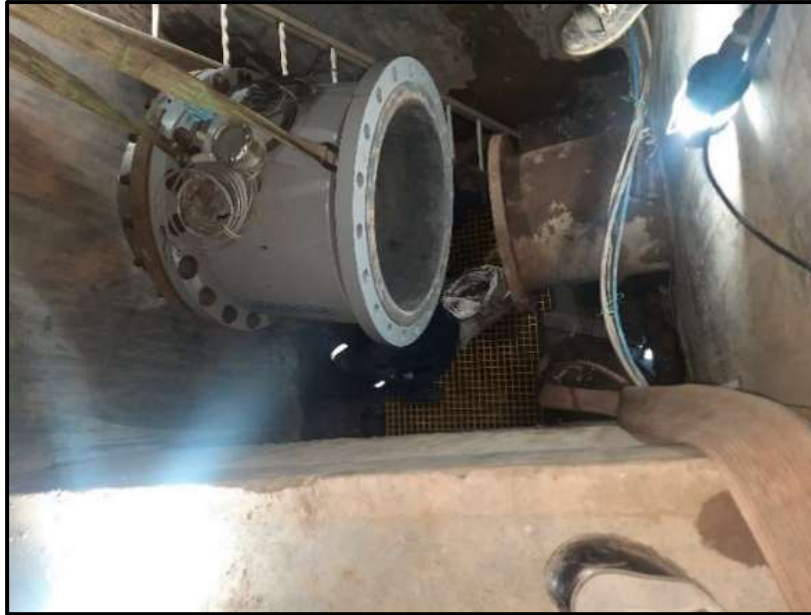
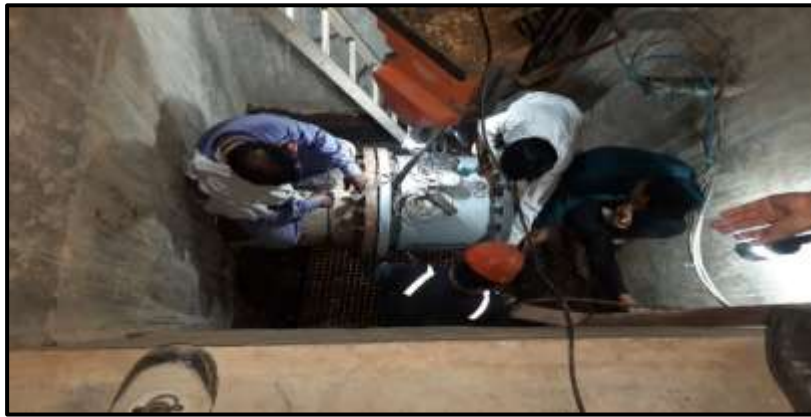
Flowmeter replacement

Replacement of 24" Faulty Flowmeter FI- 6200 in NARMADA WTP.

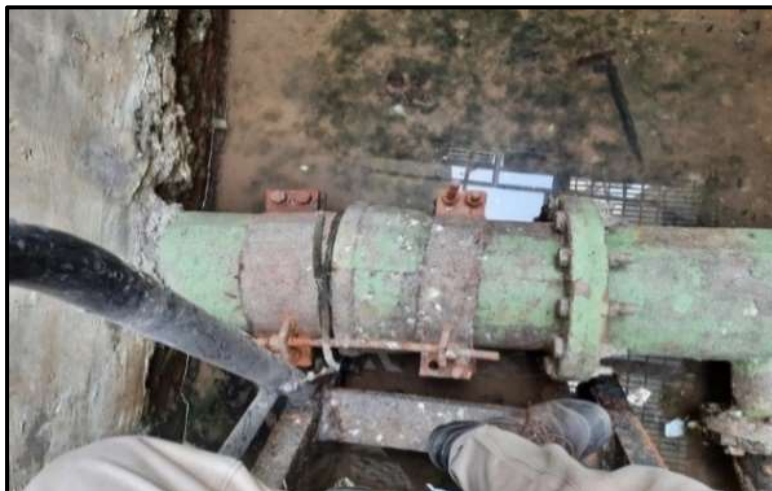
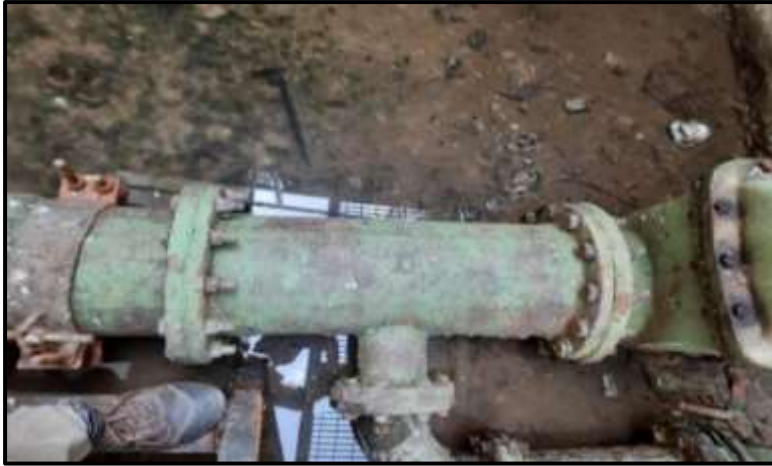
10" x 150# mud discharge Clariflocculator drain line spigot joint was leaking in Narmada plant. Leaking Spigot Joint is replaced with new CID joint.

Old CI/DI spigot joint

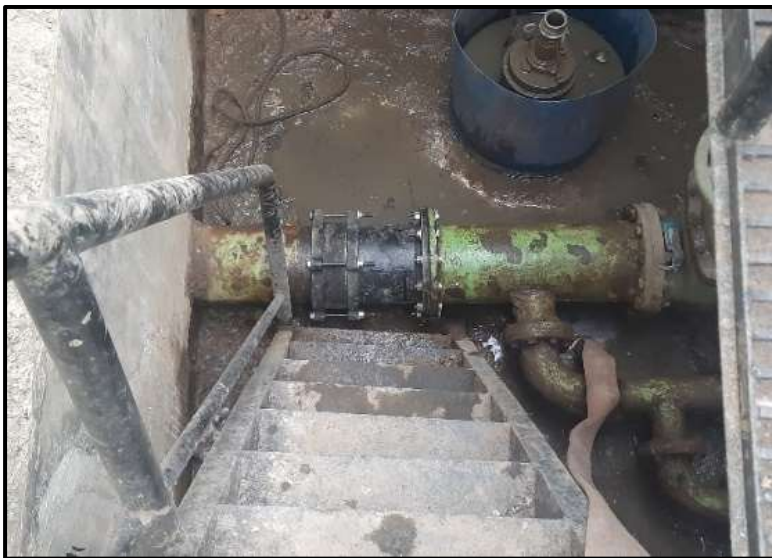
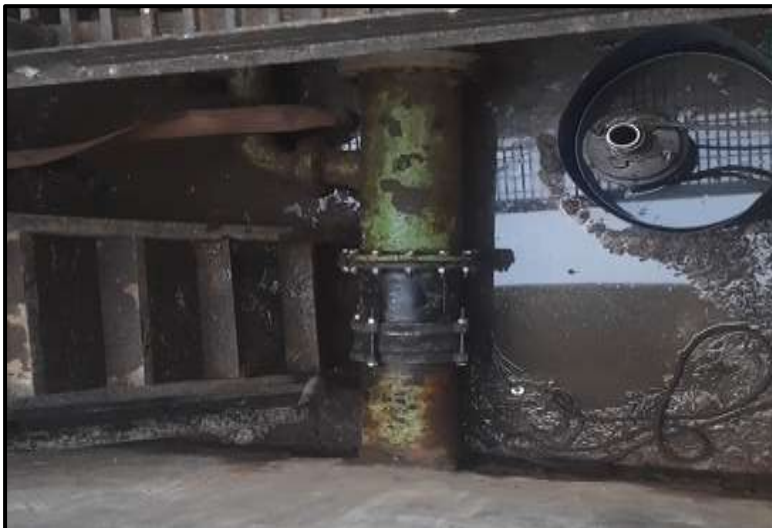
New CID spigot joint

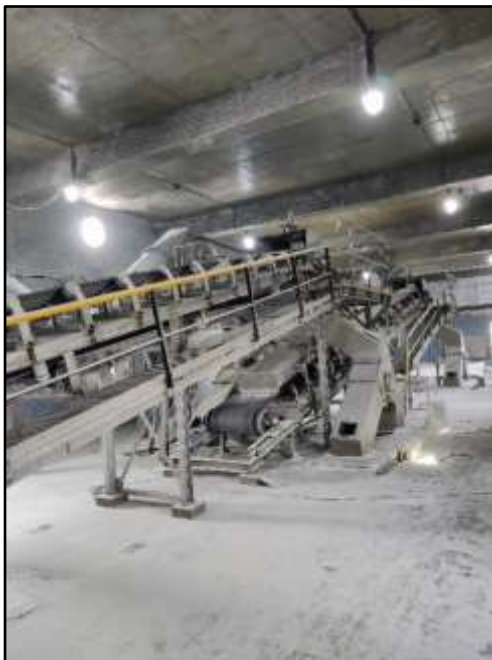
Replacement of M-2117 Conveyor belt, return roller, carrying rollers.

Replaced conveyor belt return roller, carrying rollers

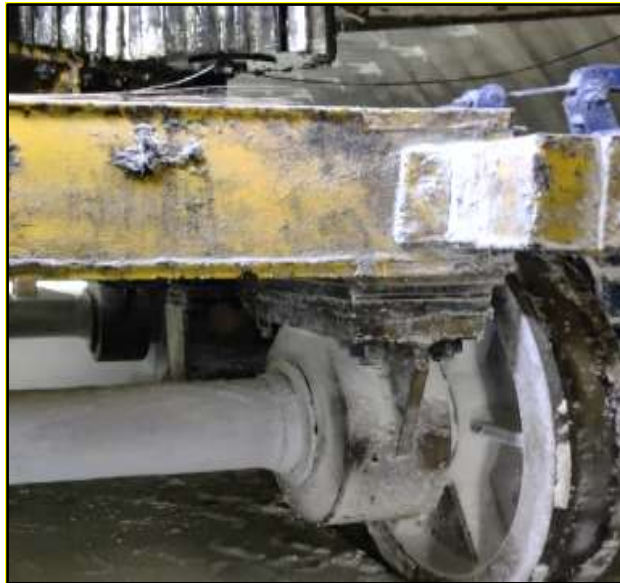
Scrapper boom lower limit was increased by adding shim to the lower carriage and lifting complete assembly by 18 mm.

- 4 no's bearing housing foundation bolts were loosen done Travel Bogie was raised by 4 no's of hydraulic jack 100-ton chain block were placed on travel bogie structure on each corner.

- 18 mm shim inserted between bearing housing foundation and travel bogie structure
- Released the 100-ton hydraulic jacks placed at each corner (4 corner)
- Scrapper boom lower limit was checked and adjusted by the limit switch.

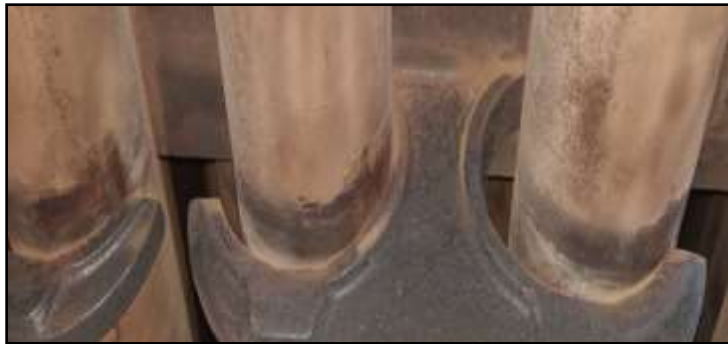
- Scaling was observed on all the tubes of Mixed Feed Coil.
- Bottom most part of Insulation covering plate was found burnt off at most of the locations. This was observed in previous inspection also.
- Rubbing on the coils observed near anchor supports. (Also observed in previous inspection)

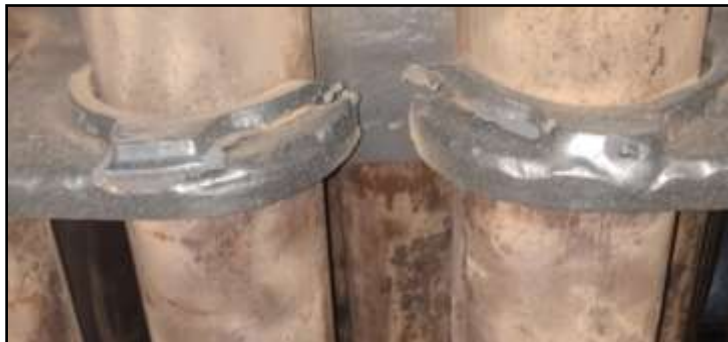
- Peeling off of top layer of casting was observed on first two rows of east side anchor supports of mixed feed coils. (Also observed in previous inspection)

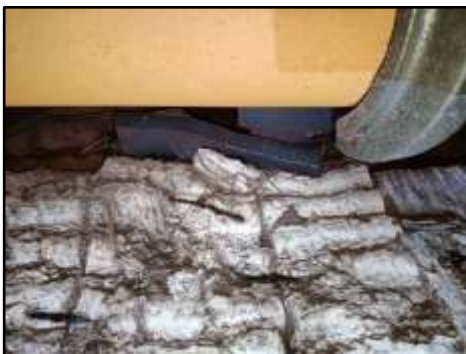
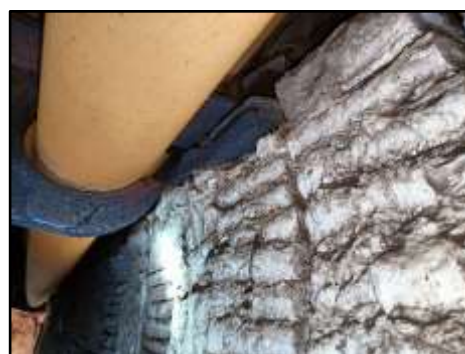
- Bottom floor refractory found loosens at some places and flooring found sagged at some location. Same was observed during previous inspection.
- 1st, 2nd and 3rd (counting from West) support resting plate found bent / twisted.

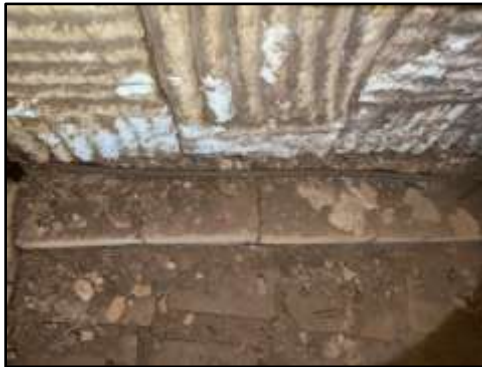
- Sealing refractory found fallen between tunnel slab wall and refractory near tunnel no. 2 & 4.
- Minor refractory found damaged at scattered locations.
- Insulation of East, West and South wall was found satisfactory.
- Mixed Feed coil found sagged in South-West segment compared to North-East Segment. (Same was observed in previous inspection)
- Some Brick wall segments were found bent.
- 01 no. Rod having approx. size of 15 mm dia. and 900 mm (3 ft) length found lying at bottom floor near West wall.

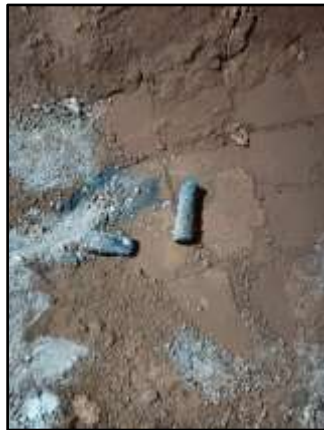
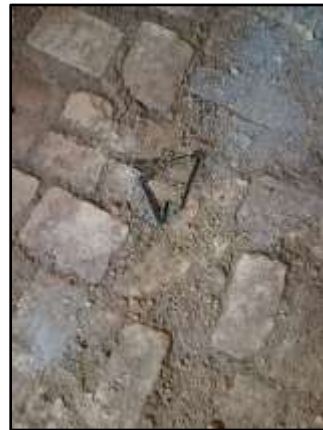
- Refractory of 1st center pillar found fallen.
- Few burnt metallic parts found lying on bottom floor.

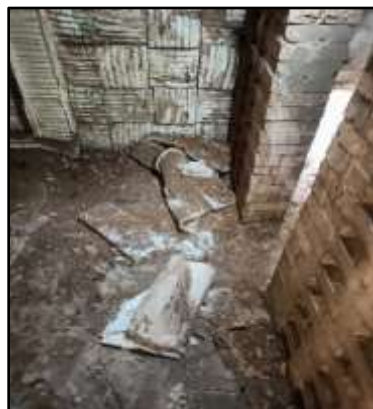
- Few refractory bricks & insulations found lying on bottom floor near East wall.

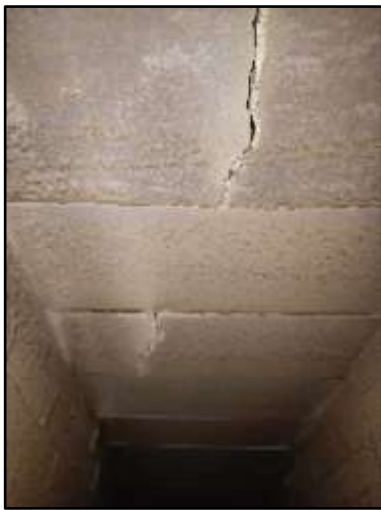
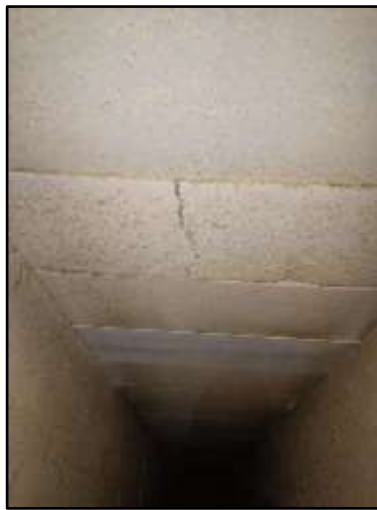
- Tunnel slab found cracked / damaged as follows.

Tunnel Row No.	No. of Slabs
1.	1
2.	1
3.	5
4.	1
5.	1
6.	5
7.	6
8.	2
9.	3

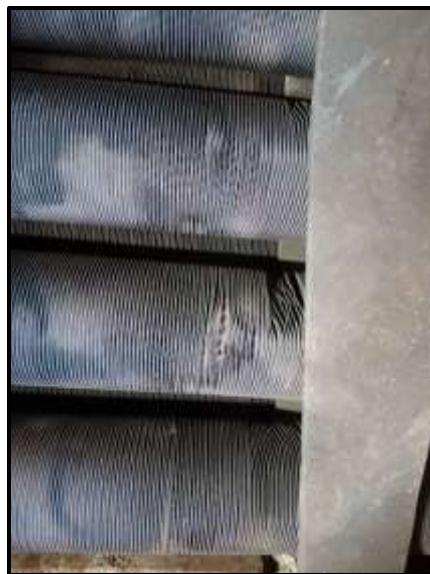
- Few fins of the LT Steam Super Heater Coil found bent.

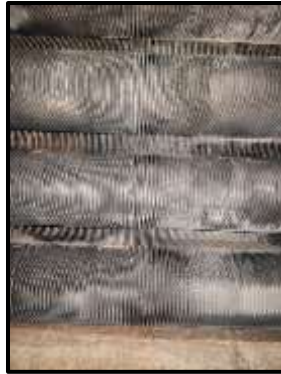
- Insulation covering sheet wire found laying on tube fins.

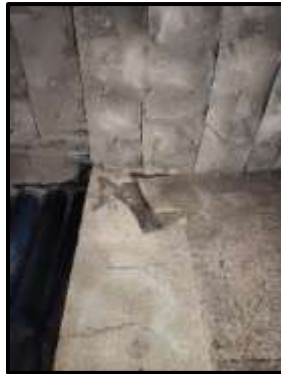
- Insulation covering sheet found laying near West side wall.

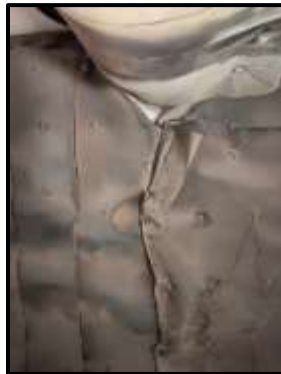
- Insulation covering sheet found loosed at East side wall.

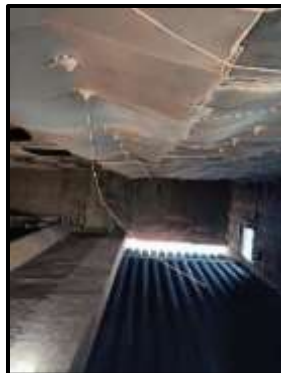
- Top roof insulation covering sheet found satisfactory, however its wire found loose at 05 locations.

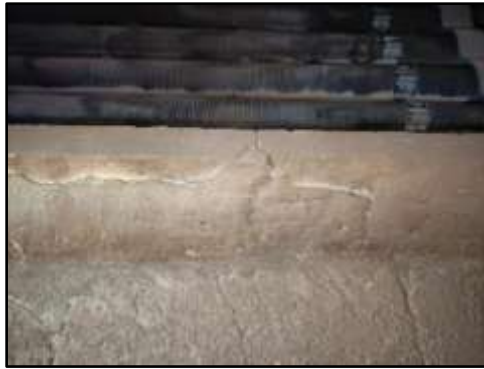
- Cracks was observed on partition wall between HT & LT section.

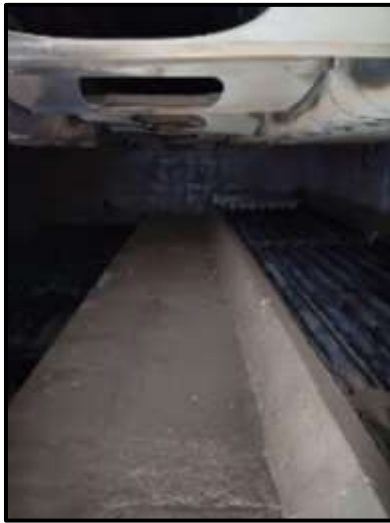
- 5th no. (Counting from West) hollow plate of flue gas path found sagged compared to other plates.

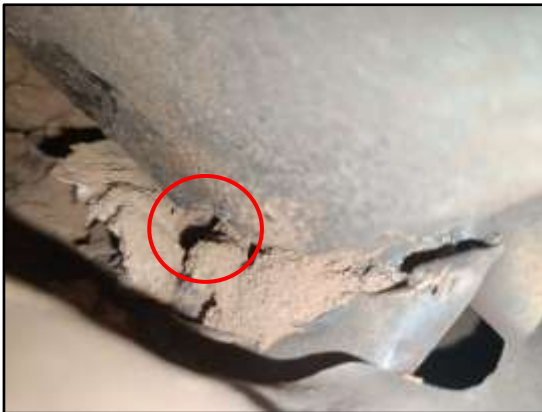
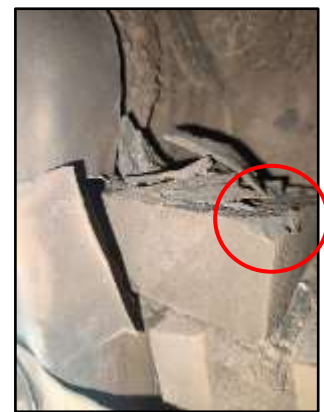
- Also Support and Support Resting plate found damaged at its corner.

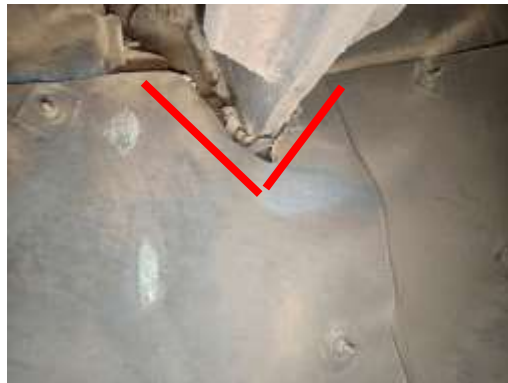
- Insulation covering sheet found sheared as a result of support shifting.

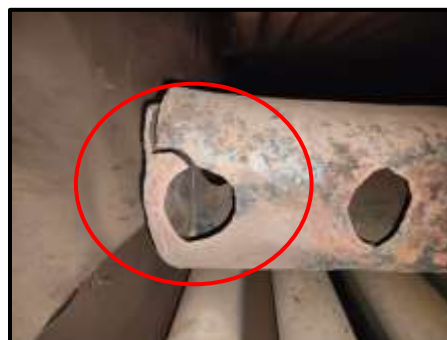
- 1st Super Heat Cap Hollow Pipe counting from East found cracked.

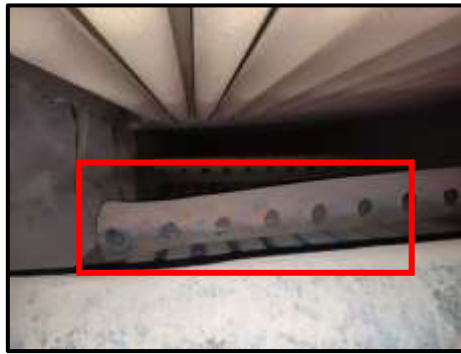
- 2nd Super Heat Cap Hollow Pipe counting from East found bent.

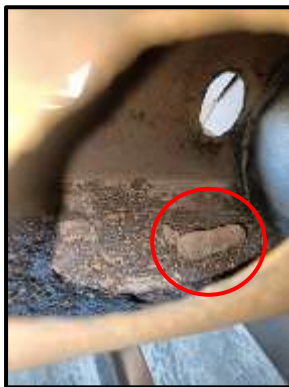
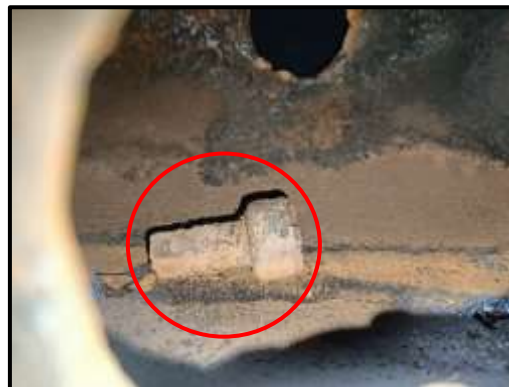
- Bolt, Stud and Debris found inside the Super Heat Cap Hollow Pipe.

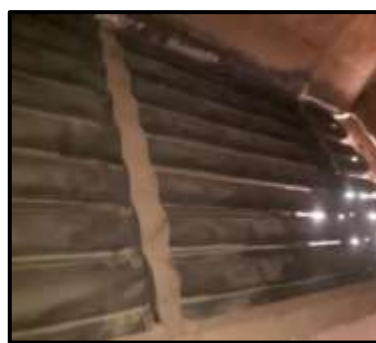
- HT Coil (finned tubes) were observed in good condition.

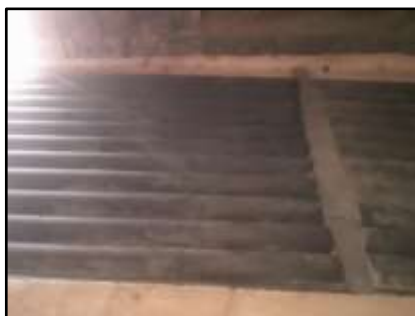
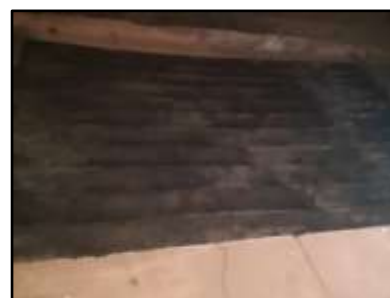
- LT coils found sagged (1 to 2") between 2nd and 3rd support.

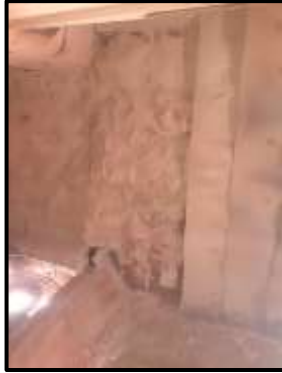
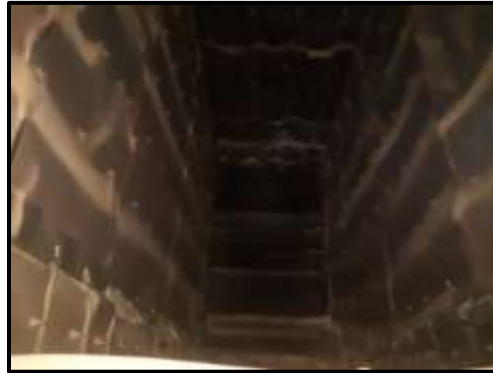
- Refractory found in good condition
- Thermowells were found intact.
- Tube supports were found in good condition.
- Minor refractory found damaged in East side. Insulation sheet was also found bent.
- Side wall and top roof Insulation covering sheet found satisfactory.

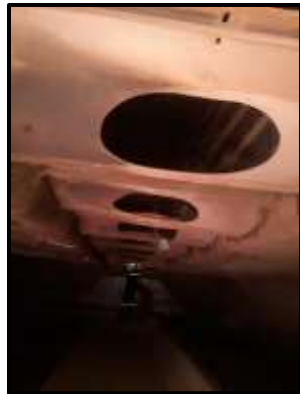
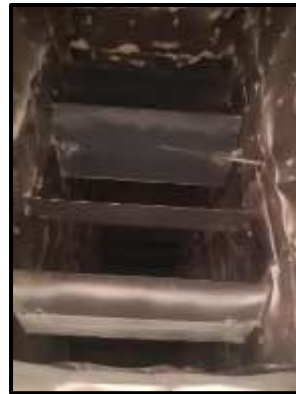
- Central distributor duct plate found in good condition.
- PRC-23 blades found open and in good condition.

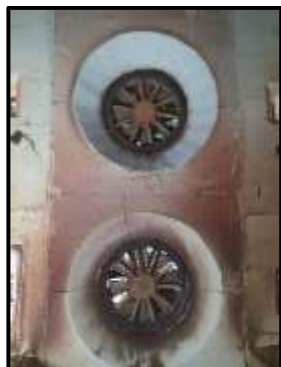
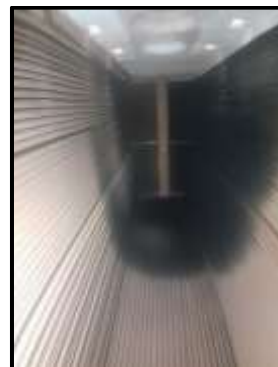
- Thin hard brownish scales were observed on the tubes.
- Metallic draft tubes were found burnt off inside the furnace.
- Refractory around 05 no. burners was found intact.

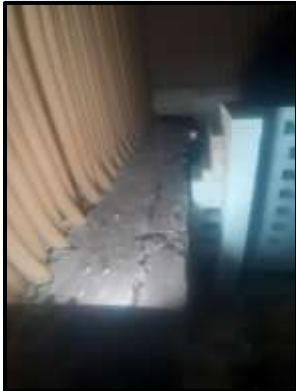
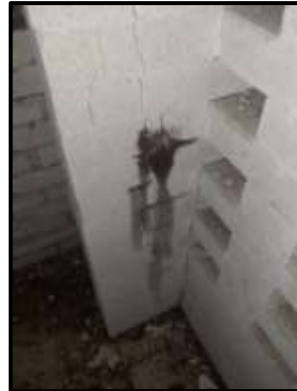
- Top header refractory was found having cracks at few locations.
- Top layer of bottom side wall refractory found loose in both East&West side.
- Center partition wall refractory found intact but burned at one location

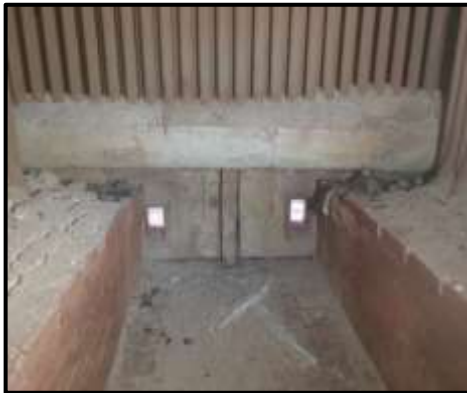
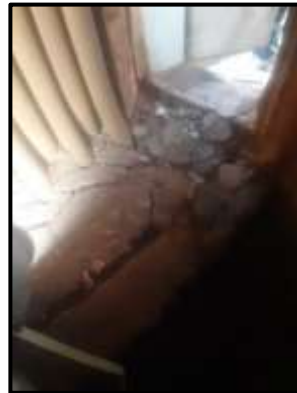
- North side bottom down comer header refractory found damaged in bottom most area towards East and West direction.
- Refractory just above the access door was found loosened.

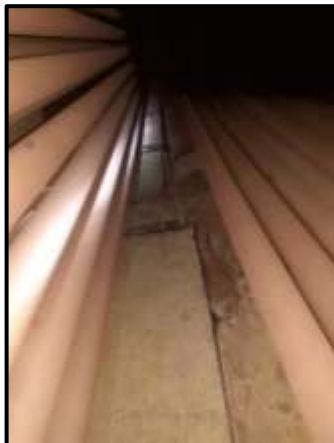
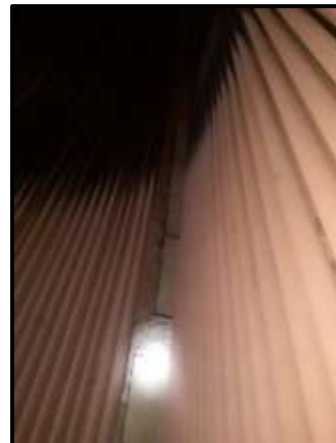
- Condition of the tubes was found satisfactory.
- Burner holes found satisfactory.
- Top header refractory was found having cracks at few locations.
- Side wall refractory found loose in East-West side.

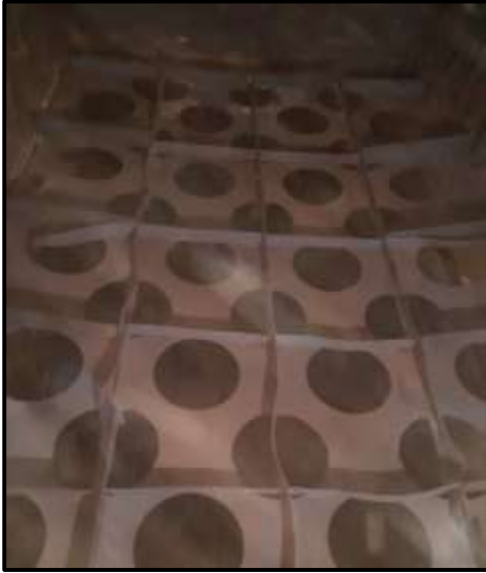
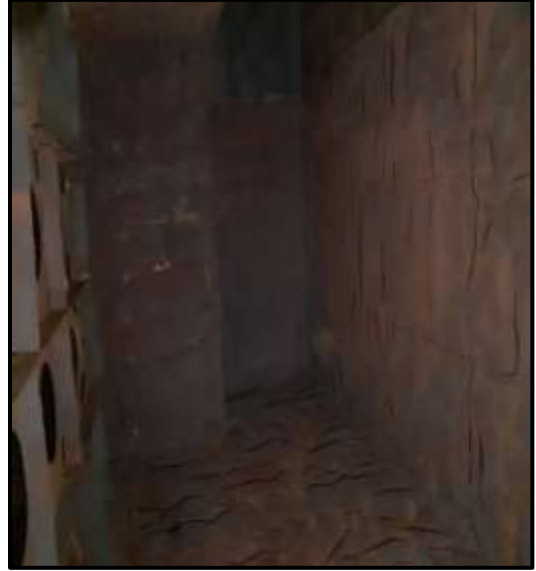
- Flue gas distribution shield found severely damaged need immediate repair work.

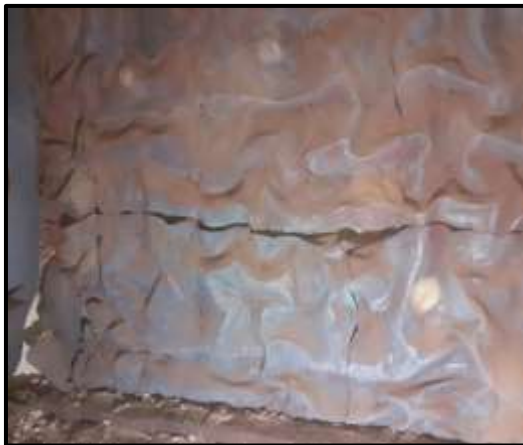
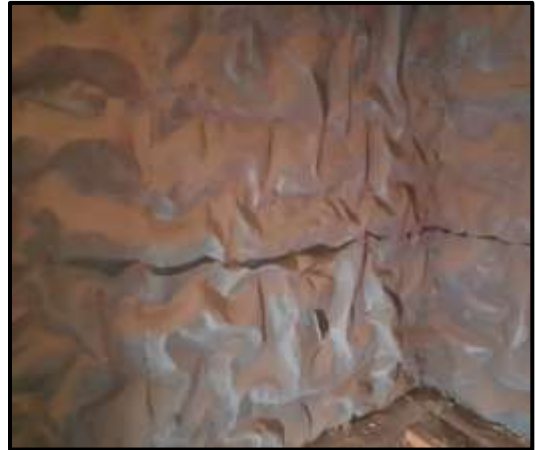
- Entire Furnace liner also found badly bulged and need to be repaired.
