MTC / REPORT / 01
REPORT NO. 40 / 2023

PLANT TURNAROUND REPORT
(APRIL – 2023)

INDIAN FARMERS FERTILISER CO.-OP. LIMITED

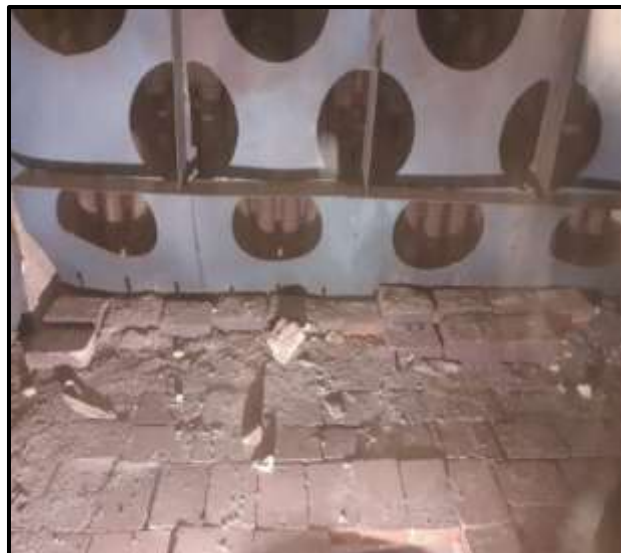
- Bottom floor refractory bricks were found slightly loose.

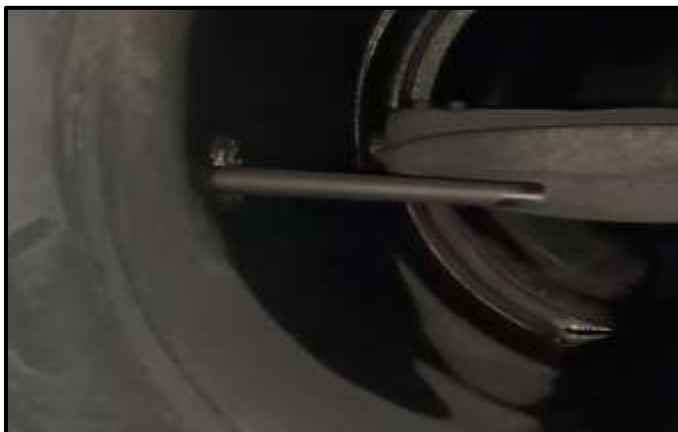
- Brownish Black coloration was observed.
- Thermowell was found intact in position at top nozzle.

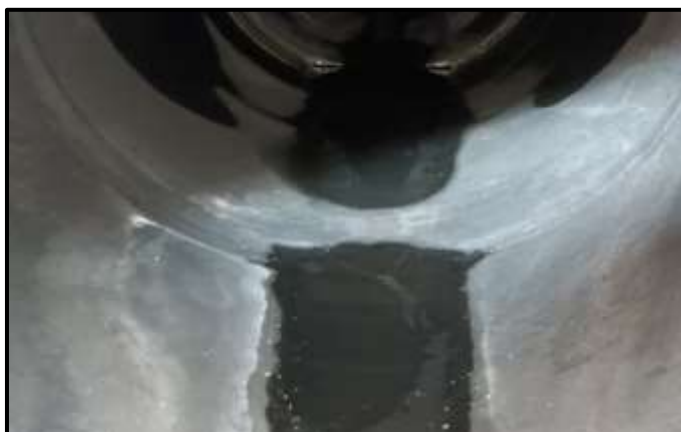
- The tubes were found brownish black in color.
- Tube to tube sheet welding found satisfactory.
- Water accumulated in top nozzle.

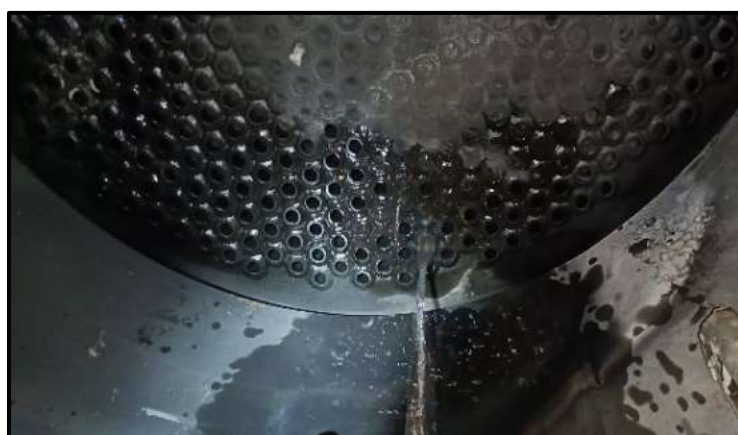
- Water fill test was carried out and 01 no. of tubes were found leaked.

Row no.	Tube no.
30	13

- Leaky tubes and surrounding 11 tubes (Total 12 tubes) were plugged.
- DP test of 12 nos. plugged tube was carried out and found satisfactory.

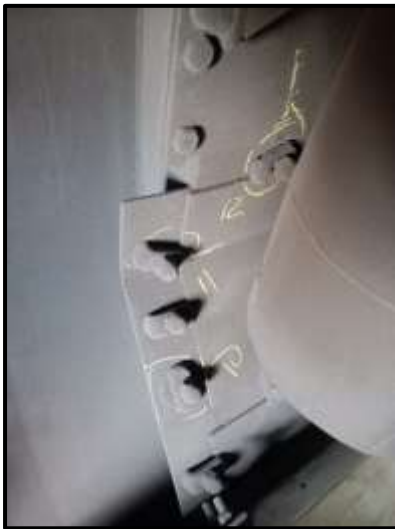
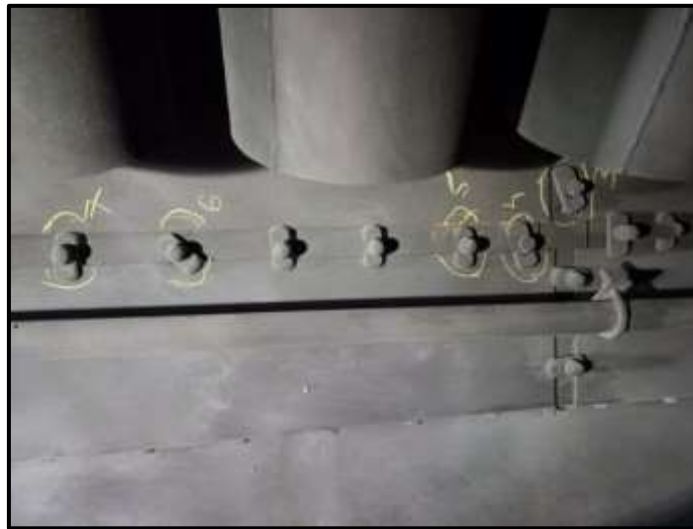
- Grayish black coloration was observed inside the drum.
- All Cyclone Separators were found intact in position.
- Demister pads were found intact in position.
- Minor pitting of approx. 0.5 to 1.0 mm depth was observed at scattered locations. (Same was observed at previous inspection).
- One of the holes at south end of phosphate dozing line (1" NB) was found enlarged.
- Grill covering the Down Comers were found bent at few locations. (Same was observed at previous inspection).
- Few bolts and clamps of Demister Pad holding cover plate were found loose. (Same were marked with yellow chalk & need to be attend)

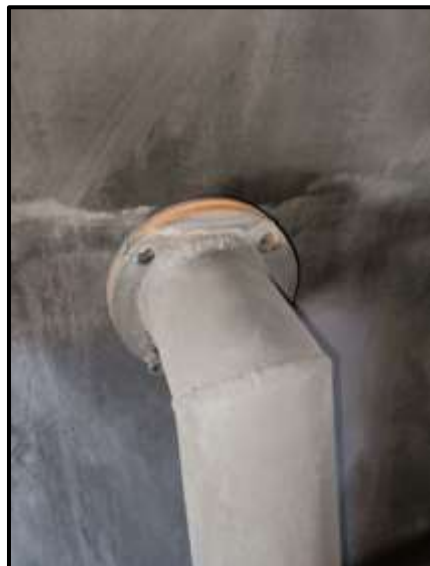
- 1" NB blow off line choked by mud at bottom of the shell. (Need to be clean)
- 02 nos. bolts found missing and 01 no. bolt found loose of 6" BFW header flange at East side. (Need to attend)

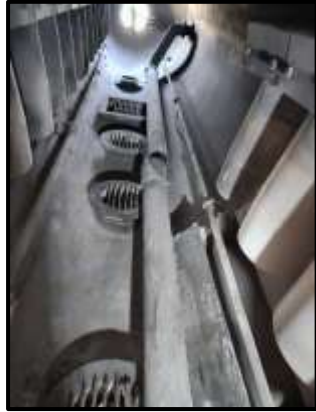
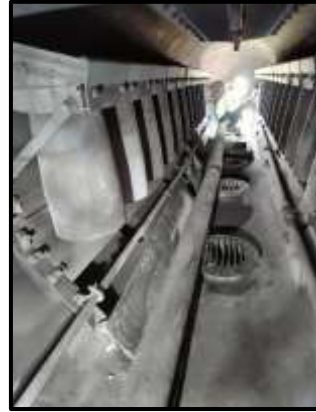
- 6" BFW header found removed from clamp at center and also found bent towards south side. (Need to attend)

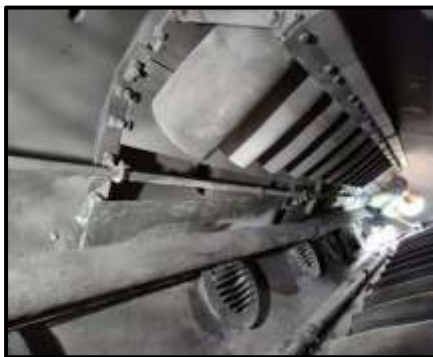
- 02 nos. Demister Pad holding plate bolts found sheared and 01 no. bolt found loose at the top. (Same was observed at previous inspection). (Need to attend)
- Bottom demister pad found removed from its position and laying at the bottom. (Need to attend)

Also, it's all cap nut found missing and few of that laying behind the removed demister pad.

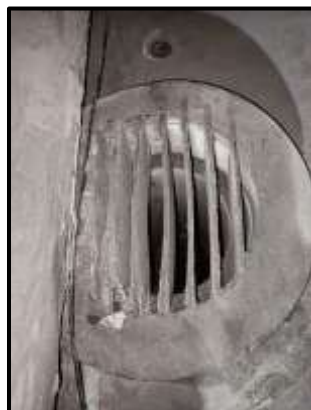
- All Stiffener plate of the 1st bottom demister pad from North found missing. (Need to attend)
- All Stiffener plate of the 2nd bottom demister pad from North found detached from weld. (Need to attend)
- Phosphate scale was observed at grill covering plate of downcomers and 6" BFW heater at few locations. (Need to be clean)

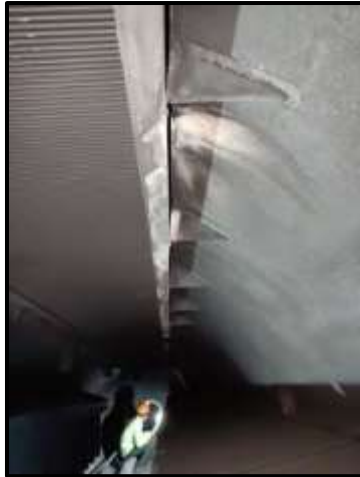
- Bottom surface of seal bar observed shiny at scattered locations.

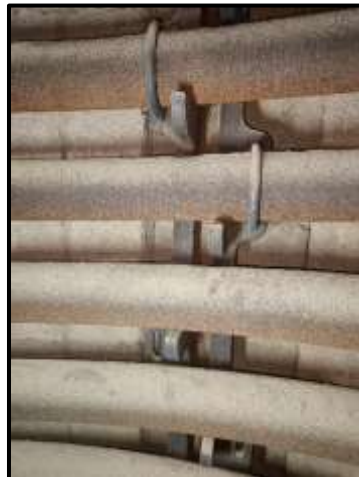
- Condition of weld joints was found satisfactory.
- Coils were observed with thin scaling/rusting on the surface.

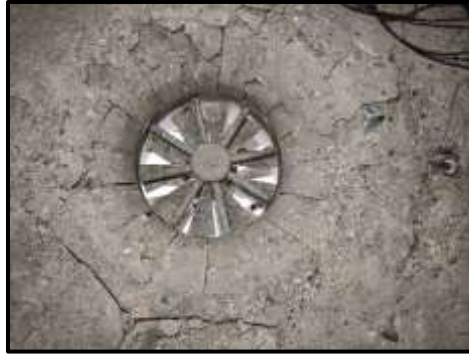
- Some of the burner block bricks were found damaged.
- Cracks were observed in wall refractory bricks at few locations.

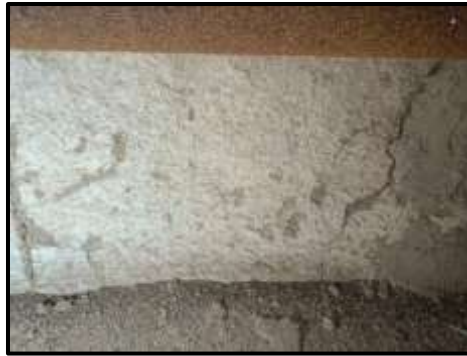
- Cracks were observed in cone area refractory at few locations and also found fallen from scattered locations.

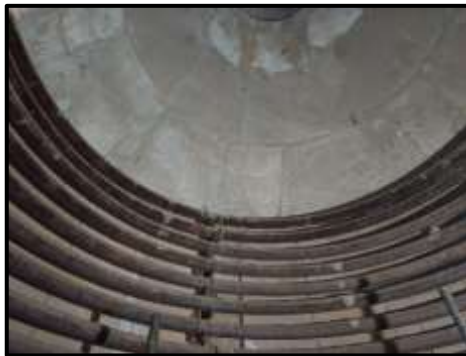
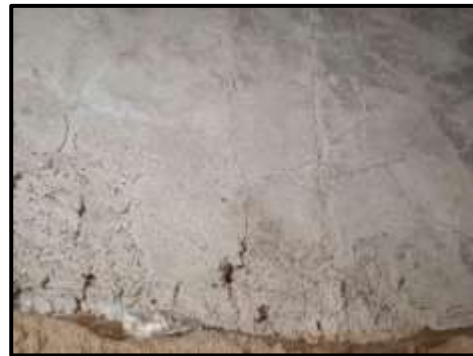
- Erosion of shell wall refractory was observed at few locations.

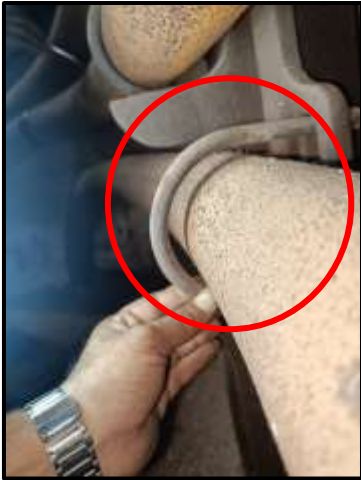
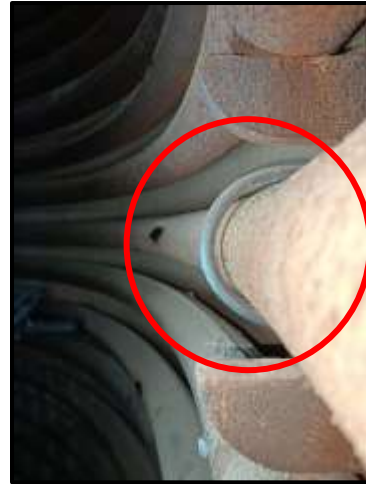
- Thermowell condition found satisfactory.
- Corner of 01 no. burner fan blade was found damaged, however burner fan condition found satisfactory.

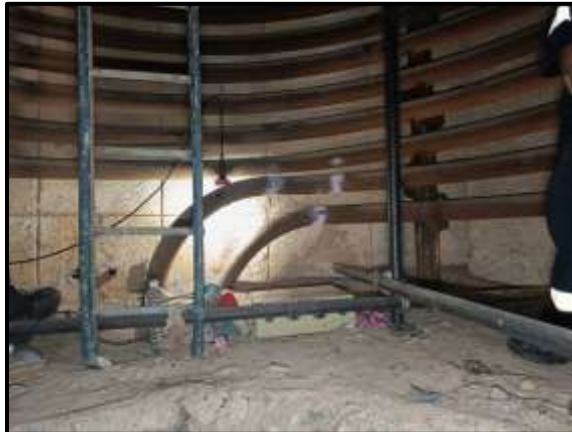
- Refractory found fell down and shell surface was exposed and corroded. (Need to be attend)

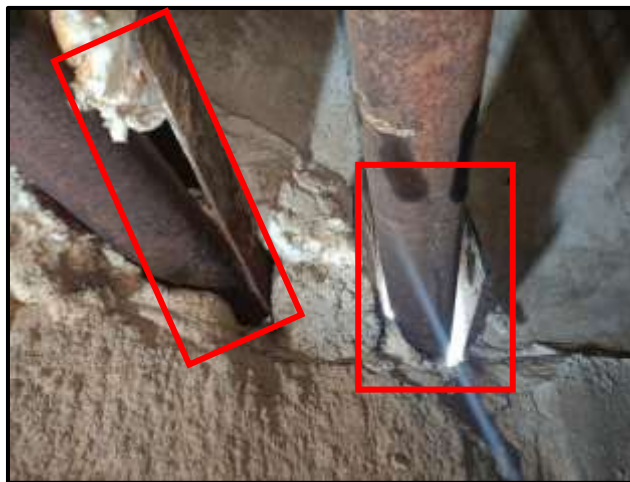
- Erosion / Corrosion was observed in covering cap of coil connected to SG-62 A Line. Also, one side of the covering cap found touched to coil surface. (Need to attend)

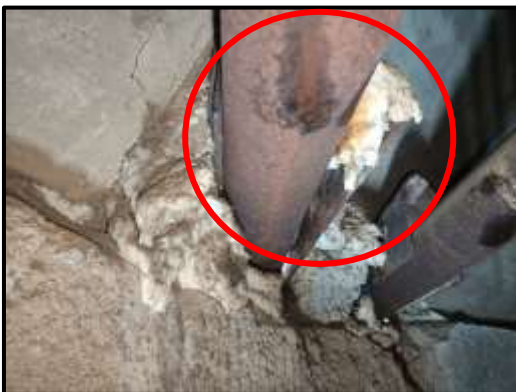
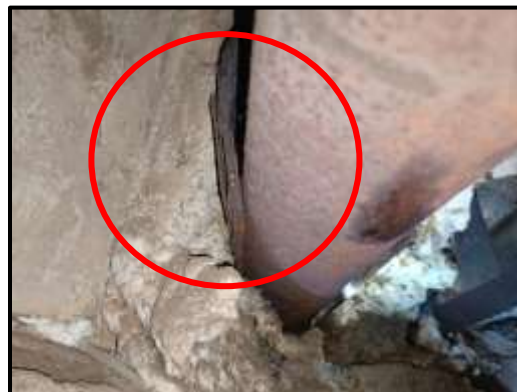
- Erosion of shell wall refractory at top side was observed at few locations.
- Refractory behind clamp at West side found fell down.

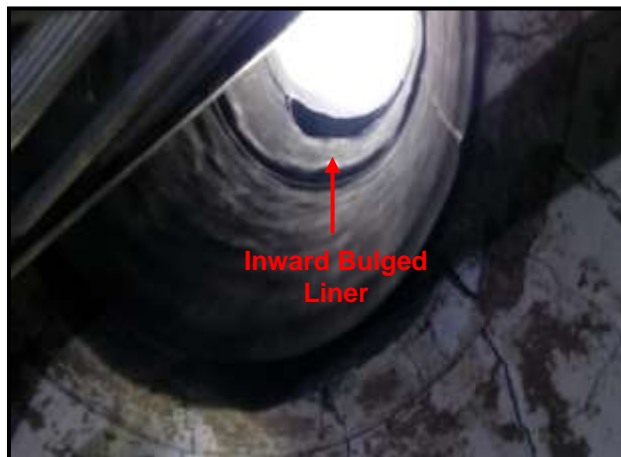
- Refractory found loose in cone portion of the shell at North and East side.

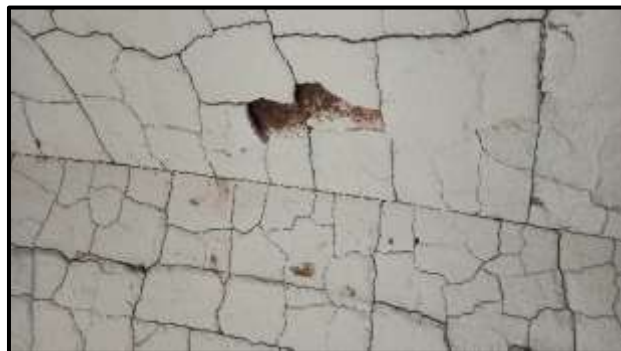
- Refractory found loose in straight portion of the shell at West side.

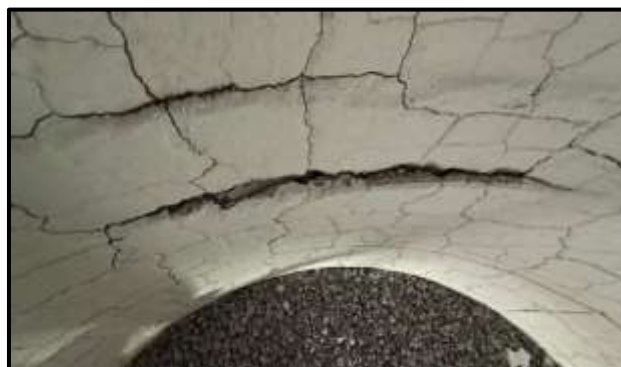
- Gap observed between cone refractory and bottom peripheral liner.

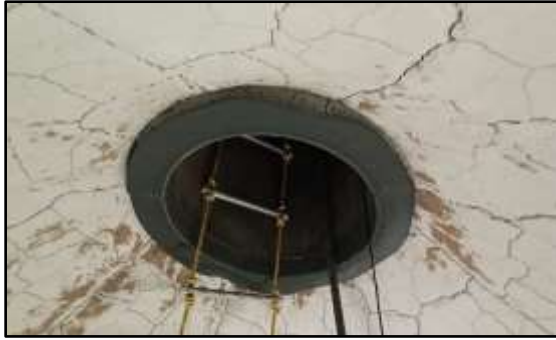
- Top flange refractory was damaged.

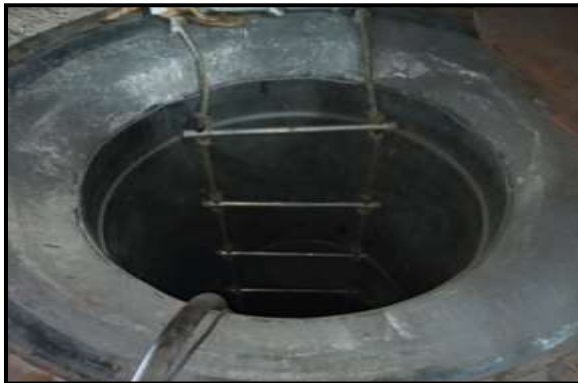
- Liner joint of top shell to transfer line was damaged.

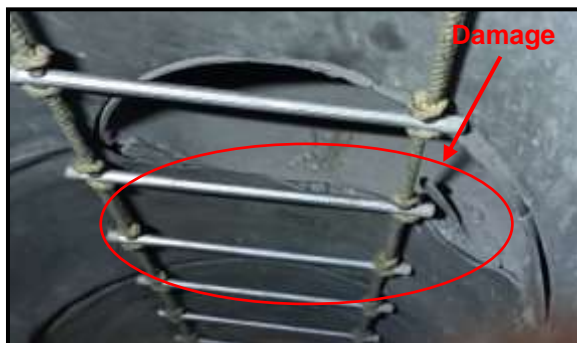
- Scattered cracks were observed in entire shell and cone refractory.

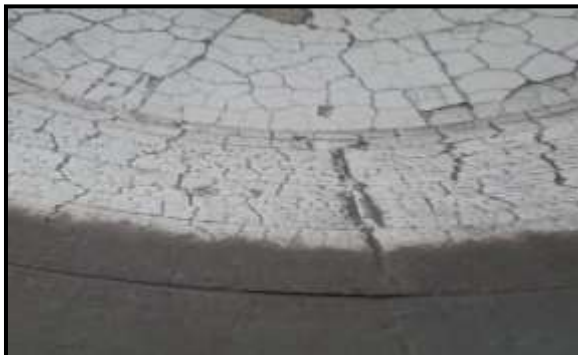
- Dent/Abrasion marks of alumina balls observed with white coloration in prominently in shell refractory and slightly in cone refractory.

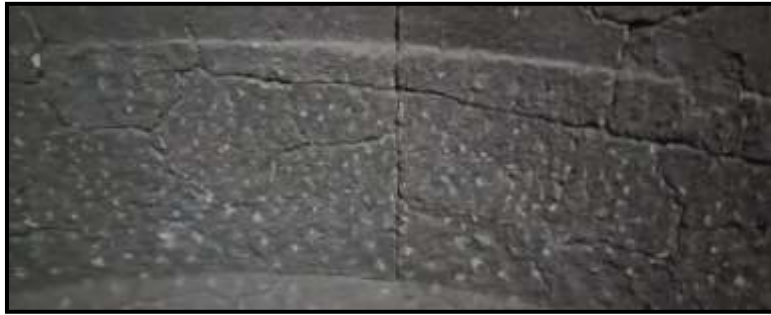
- Alumina balls found stuck up between gaps of dome refractory.

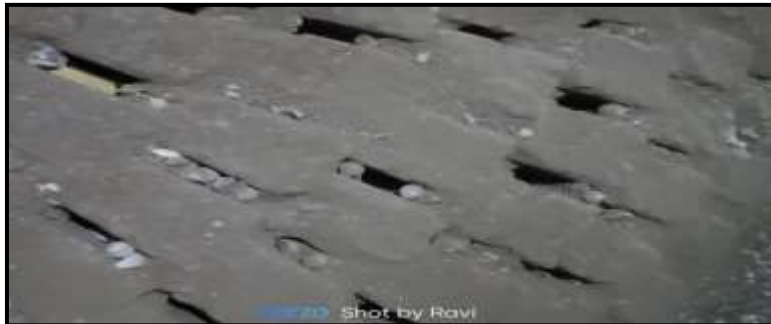
- Condition of Thermowells found satisfactory.
- 1st layer of the shell refractory found peeled off at few locations.

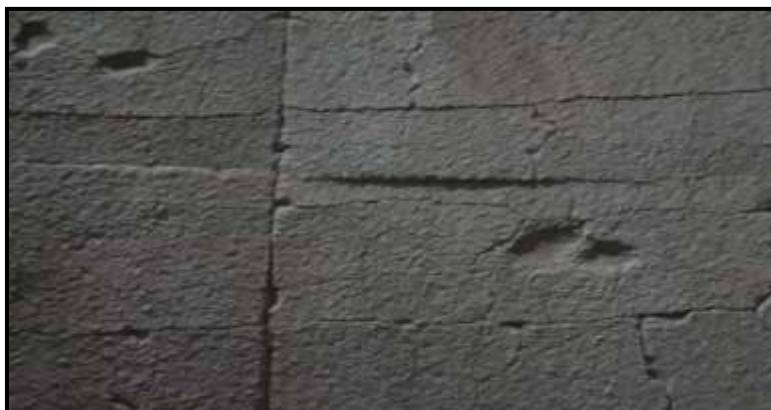
- The refractory around the 101-CA/CB gas inlet nozzles was found loosen and fell down and need to be repaired, liners of both nozzles found badly bulged.

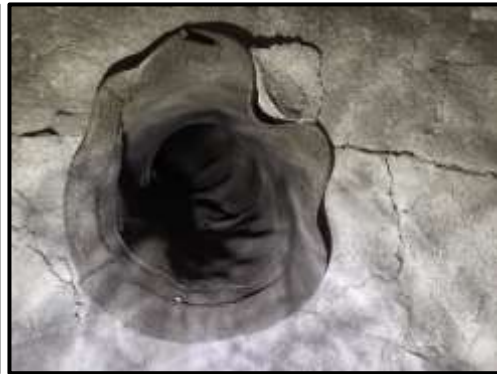
101 CB Nozzle View

- Gap was observed between the 101-CA/CB gas inlet nozzle liner and the shell refractory joint. Gap of approx 3" was observed towards the 101-CB nozzle.

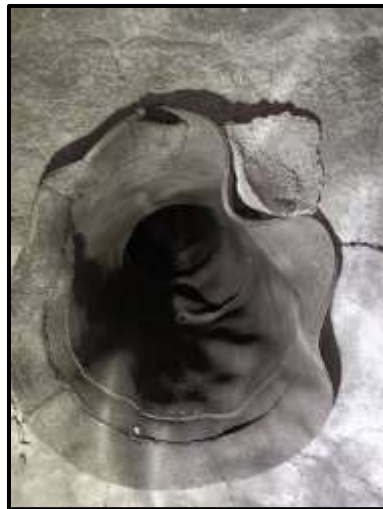
- 101-CA Gas Inlet Nozzle liner was badly buckled /distorted. Also welding of liner found eroded and cracked at $\frac{3}{4}$ portion of the welding at previously repaired location.

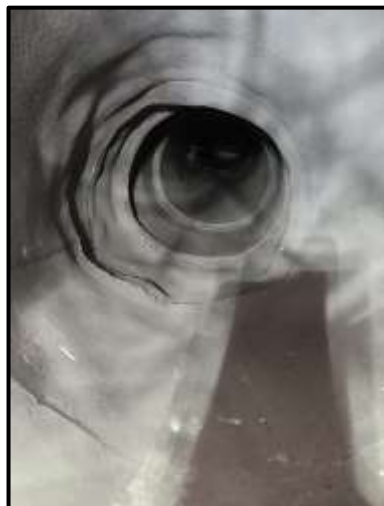
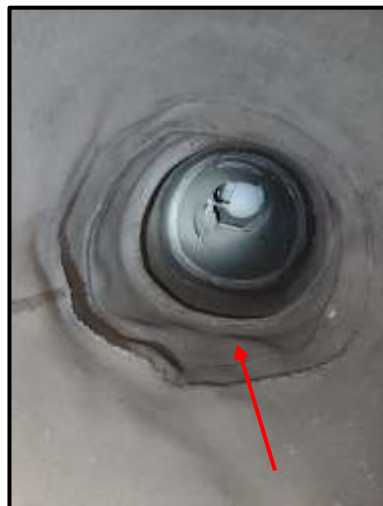
- Condition of the thermo well was found badly eroded in 101-CA Gas Inlet Nozzle.

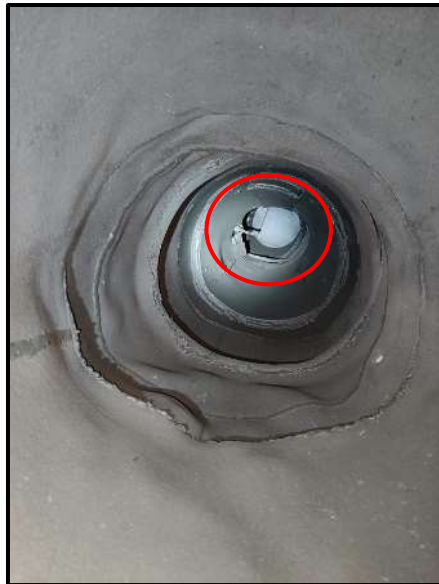
- 101-CB Gas Inlet Nozzle liner was badly buckled /distorted. Also welding of liner found cracked at mostly in bottom area.

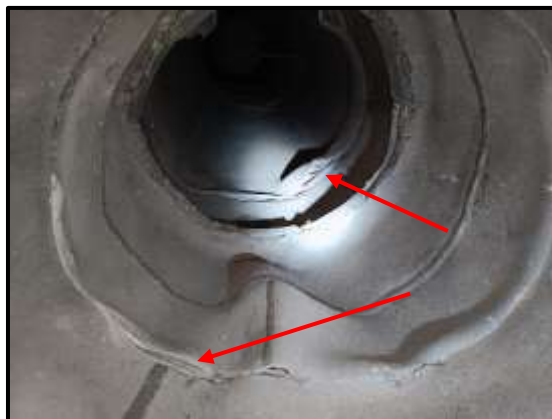
- Condition of the thermo well was found satisfactory in 101-CB Gas Inlet Nozzle.

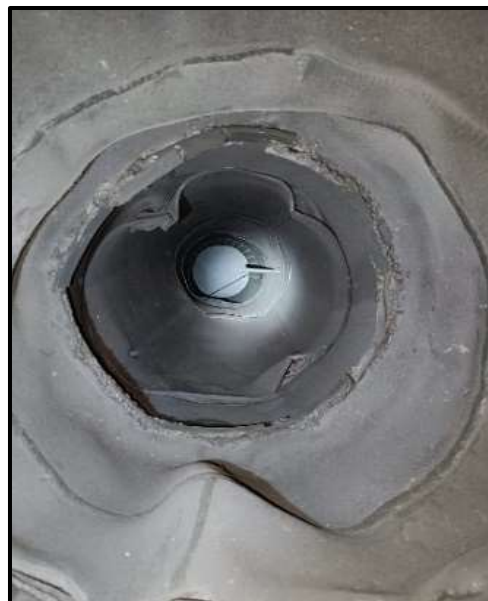
- Top Brick dome refractory found loose, broken and fallen down at few locations.

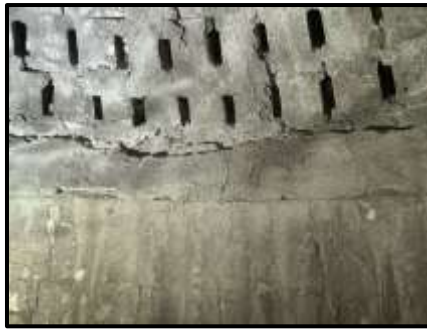
- Bottom conical refractory found cracked and loosen at many locations.

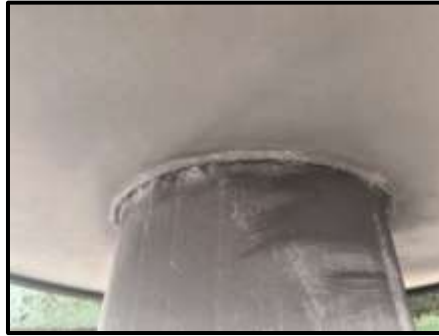
- Severe erosion was observed in circumferential weld of central pipe with top cover liner.

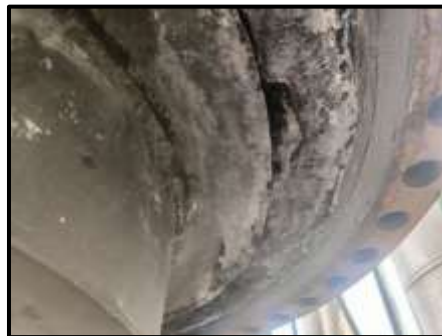
- Crevice observed at few locations on both sides of long seam of old pipe.
- Erosion was observed in top roof refractory.

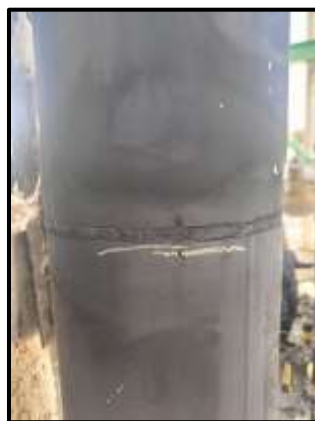
- Erosion was observed weld of old pipe. (Below perforated trays)

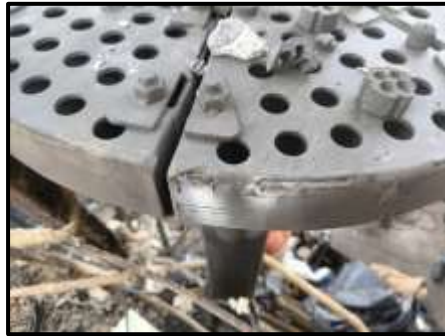
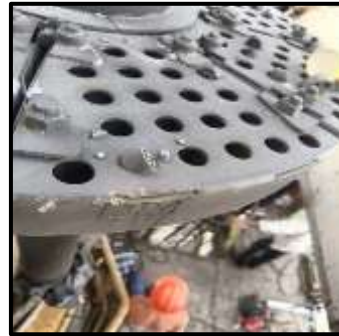
- Condition of the perforated plate found satisfactory. However, found slightly damaged at few locations during removing.

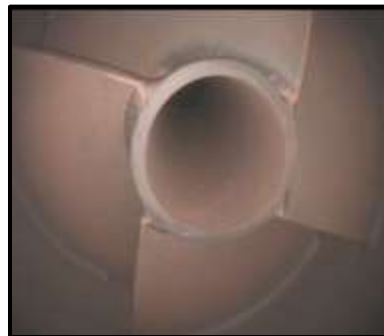
- Reddish Coloration was observed in ID of Nozzle.
- Blade assembly was found satisfactory.

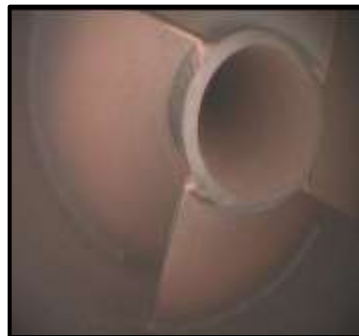
- Weld condition of blade found satisfactory.

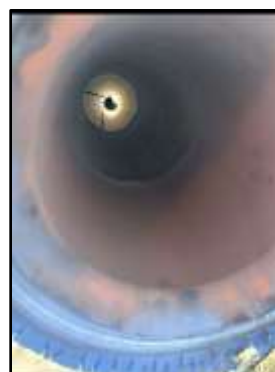
- Weld condition of air mixture pipe found satisfactory.

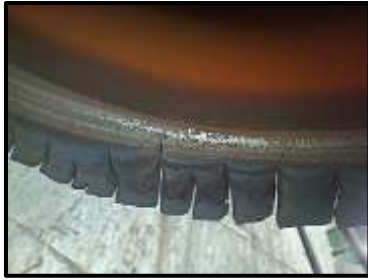
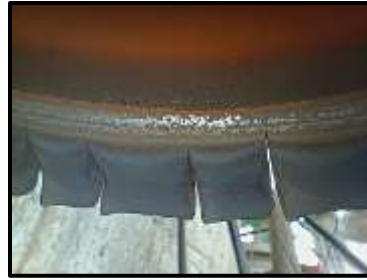
- Bottom funnel area found Burnt, Cracked and damaged.

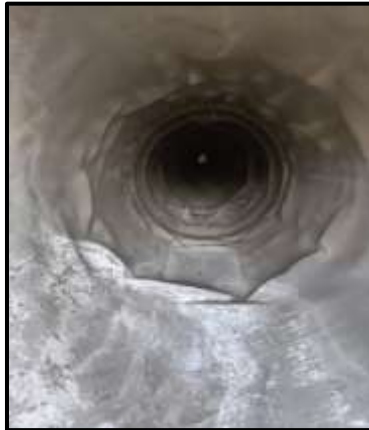
- Bulging was observed at several locations.

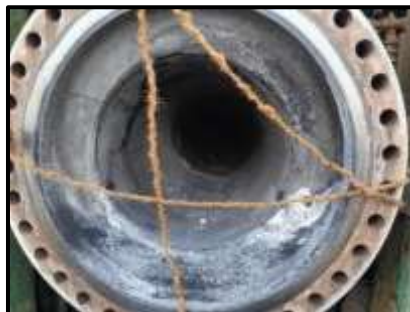
- Black scales were observed inside transfer line.
- Thermowell condition found satisfactory.
- Minor damage of the refractory was observed at flange (end plug side) of the transfer line. Also End plug seating area found eroded/damaged at Top and North side. (Same was observed in previous inspection)

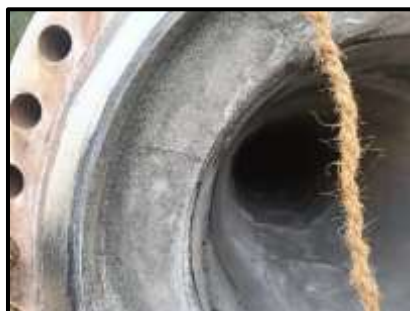
- Scattered cracks were observed on refractory.

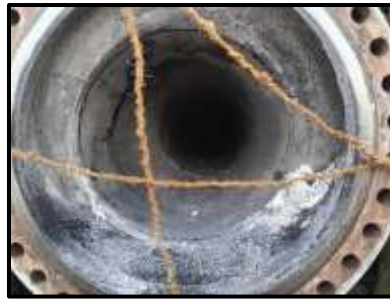
- Gap was observed between transfer line and End plug seat in entire periphery.

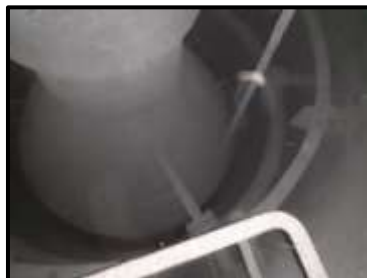
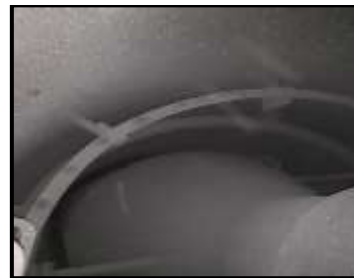
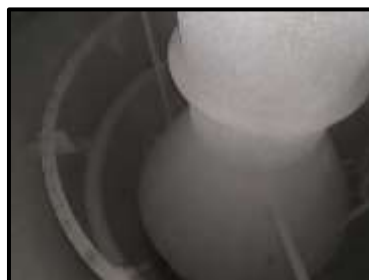
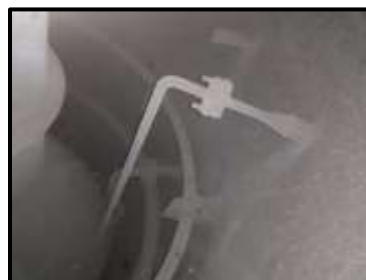
107-C (M.P. BOILER)

- Grayish black coloration was observed inside the boiler.
- All internals were found intact in position.
- Overall condition of the vessel was found satisfactory.

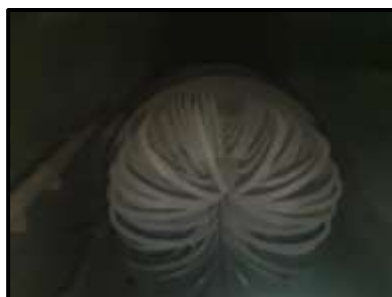
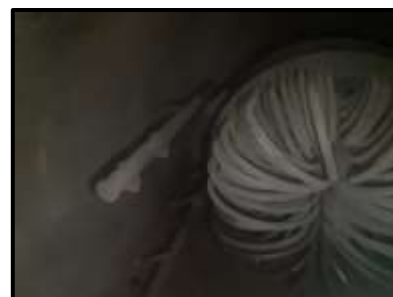
1123-C NEW SYN LOOP BOILER

- Condition of the weld joints were found satisfactory.
- Rust/ scaling observed on the weld & Dished End.
- Rust / scaling observed on the tube baffles and some of the tubes.

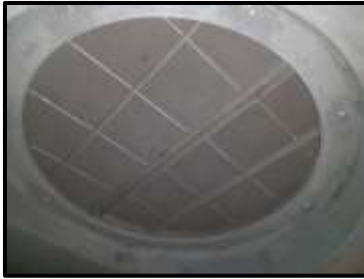
- Rust / scales observed lying on the shell bottom.
- South side top demister half was found upward lifted.
- Whitish scaling was observed on PO₄ inlet header.

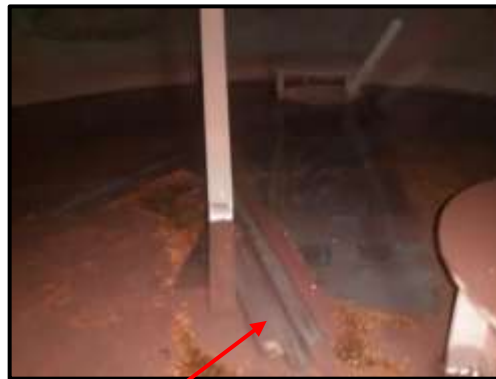
Tray Segment laying on bottom DE

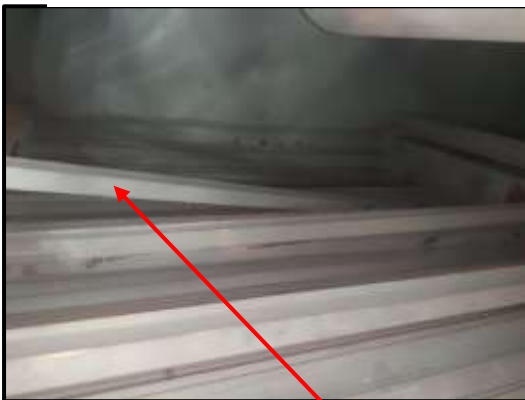
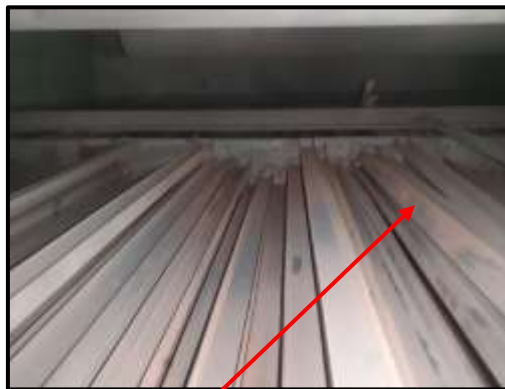
A metallic plate found lying on BDE.

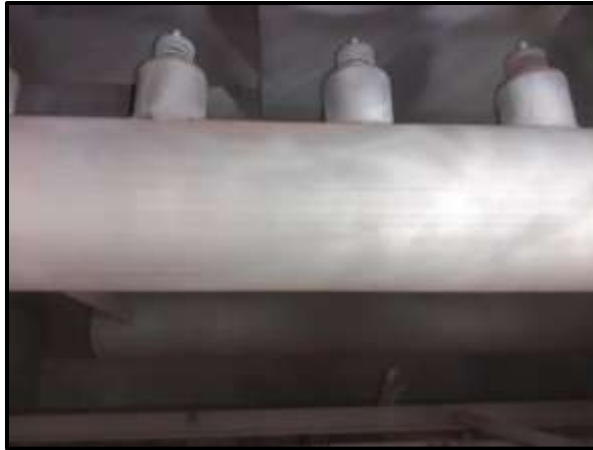
Tray Segments found dislocated from its position

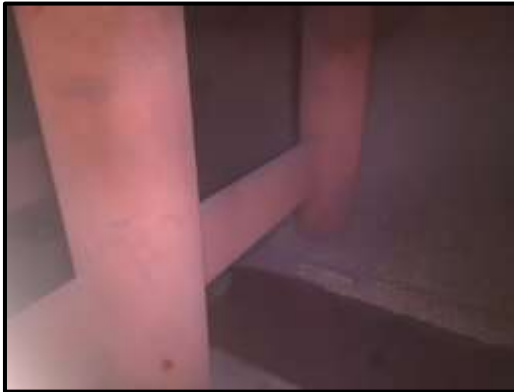
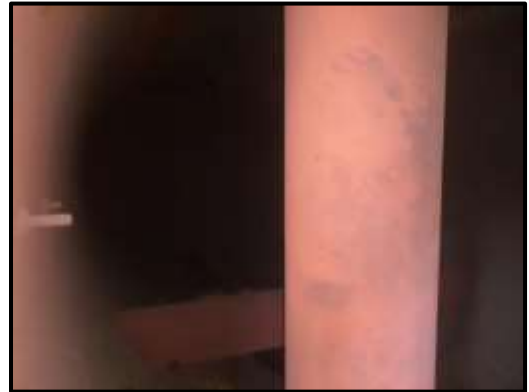
DEAERATOR STORAGE TANK

- Reddish coloration was observed inside the shell.
- All internals were found in good condition.
- Thermowell found intact.
- Overall condition of the storage tank found satisfactory.

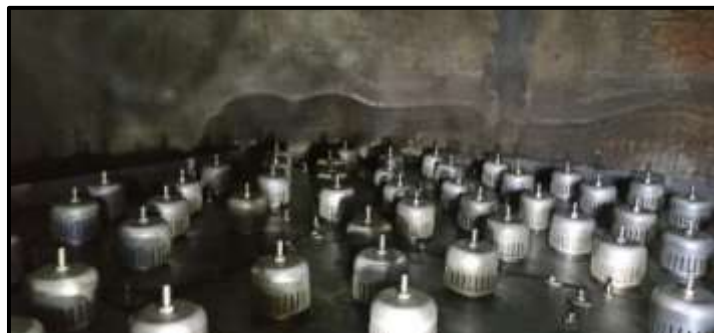
FROM MANHOLE- 1

- Brownish black coloration was observed on the shell.
- Bubble cap condition found satisfactory with all nuts intact.

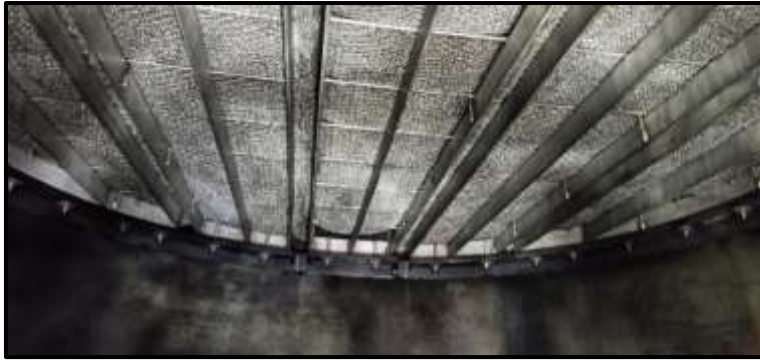
- Top demister pad condition found lifted on north side.

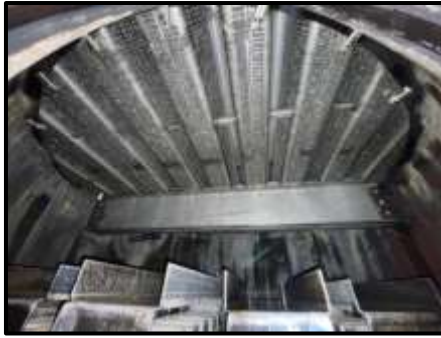
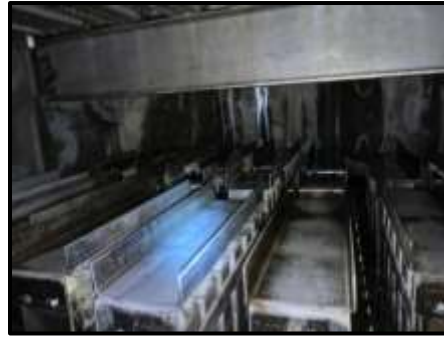
- Brownish grey coloration was observed on the shell as well as on all the gas risers.
- Sample collectors were found intact in its position.

- Condition of the gas risers was found satisfactory.

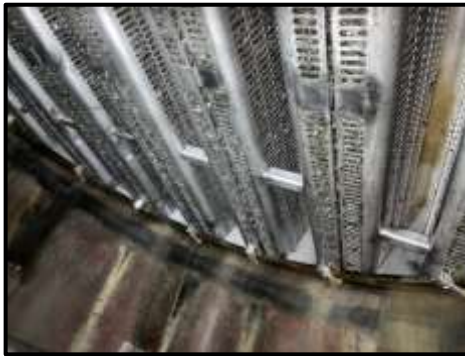
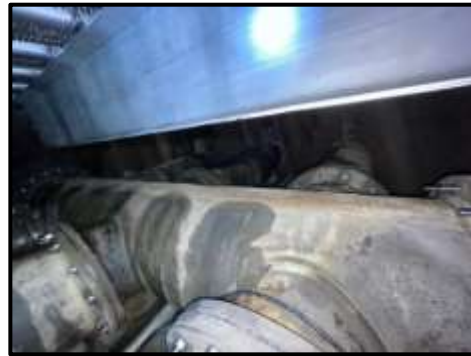
FROM MANHOLE- 4

- Corrosion cavities and holes were observed on South most liquid distributor collector plate, located just below the liquid distributor. (Visible just from M/H, (Same was observed in previous inspection))

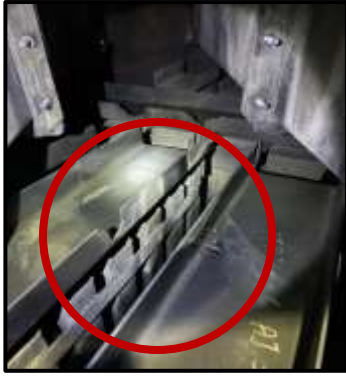
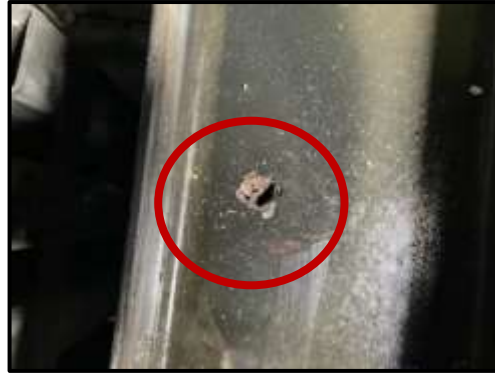
- Loose piece of debris found between gas rising holding plate towards North.

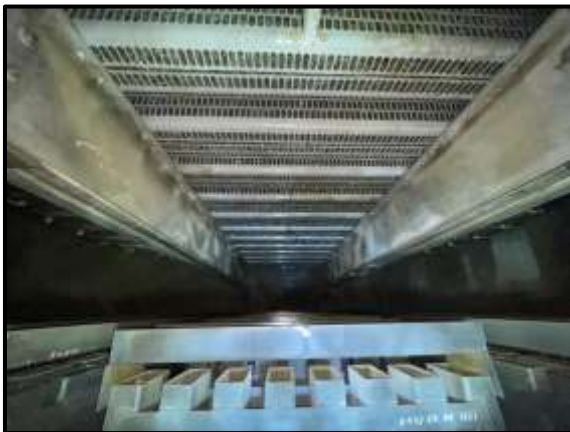
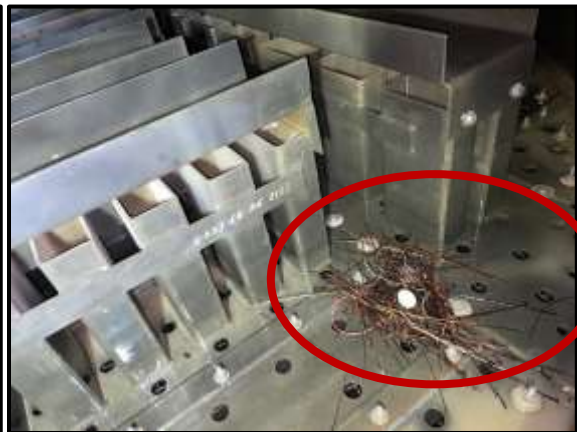
FROM MANHOLE- 5

- Excessive gap as compared to others was observed in several rasching ring holder. (Between two half of holder, (Same was observed in previous inspection).
- Grey coloration was observed on the shell.
- Bird nest and eggs found near M/H to be cleaned before box Up.

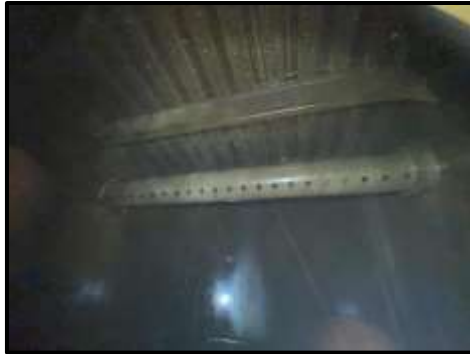
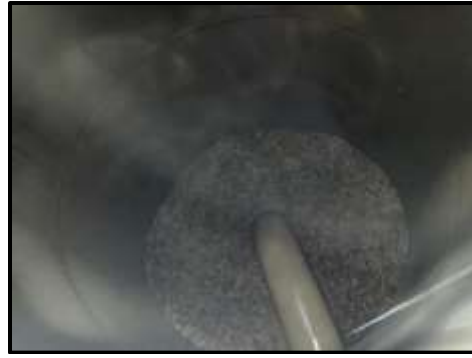
FROM MANHOLE- 6 (INSPECTED FROM OUTSIDE)

- Condition of gas distributor was found satisfactory.
- Grey coloration was observed on the shell.

- Paul ring inside. Outlet pipe found intact.

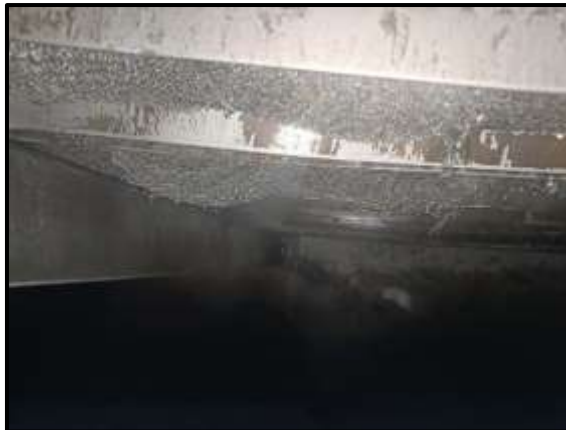
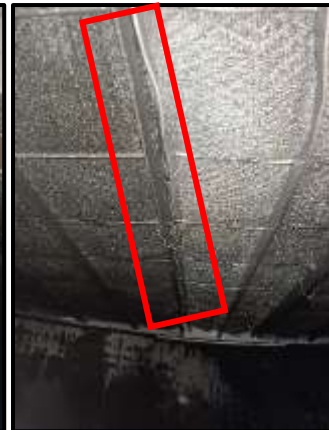
FROM TOP MANHOLE

- Demister pad supporting strips were observed slightly downward bent (mostly in center portion).
- Demister pad was found slightly removed and also gap was observed in center rib joint compare the other rib joints. (Need to attend)

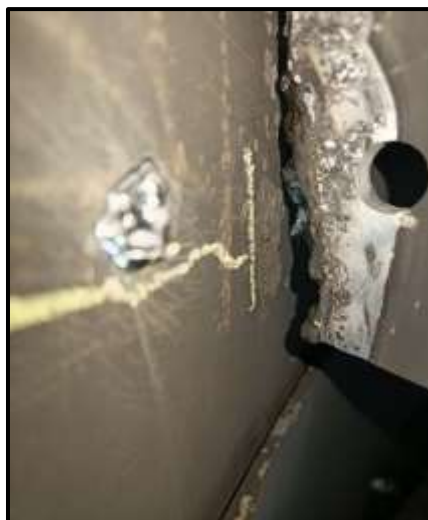
- All the bolts of liquid inlet nozzle flange were found in position & intact.
- Rubbing marks was observed behind the distributor header cap at S-W direction.

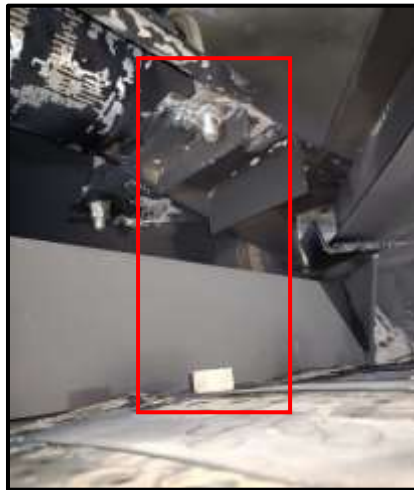
- Distributer header was observed to be shifted approx. 20mm towards south-west direction this has led perforated plate over header to foul with shell wall.
- Distributor header clamp found loose at North-West side. And its 01 no. nut found missing and same was found laying on the floor.

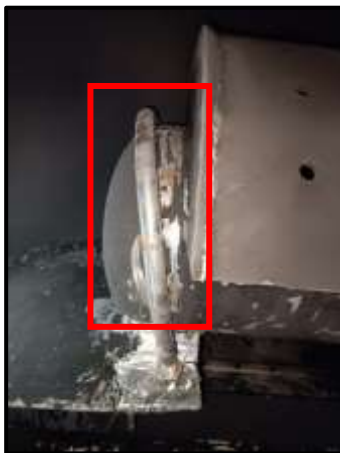
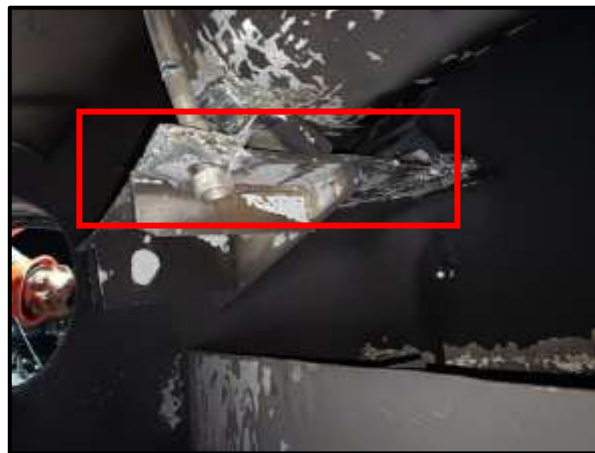
- Weld erosion observed in bottom stiffening plate of header support plate.
- Distributor header clamp found loose at North-East side. And its nut found missing.

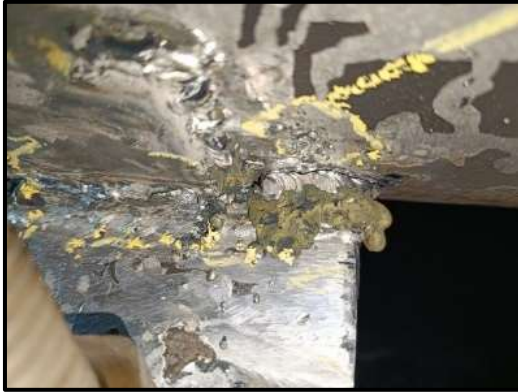
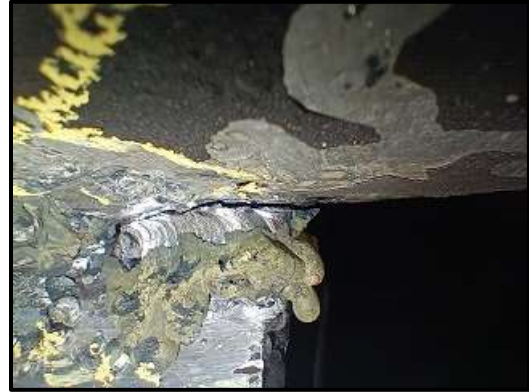
- Crack was observed in distributor header and support weld at North-West side. (Marked with yellow chalk)

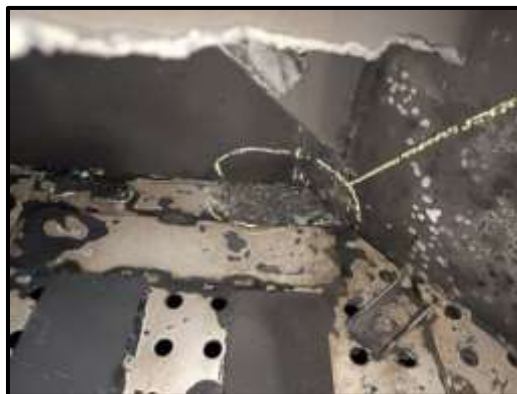
- Debris of weld spatters was observed at South-West corner on the floor.

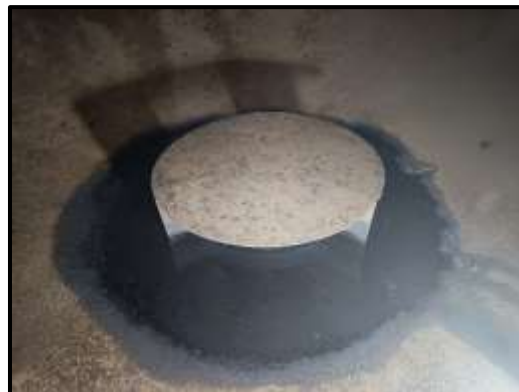
- Water was accumulated at bottom of the dish end.

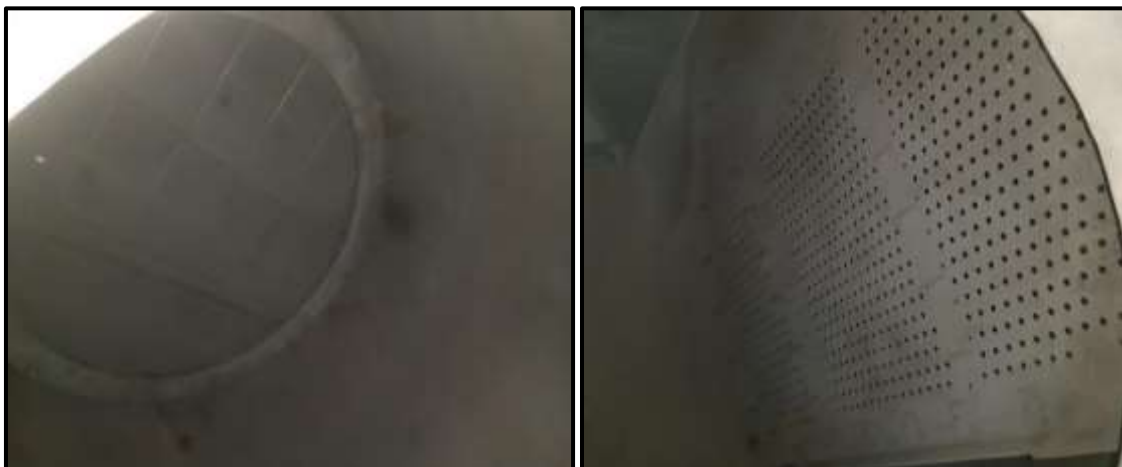
FROM TOP MANHOLE

- Grayish Coloration was observed on the shell & Man-way.
- Mist eliminator was found intact in its position.
- Brownish flow marks were observed coming from the supports of the Mist eliminator.
- Grayish dust was found adhered on the top plate and internals.

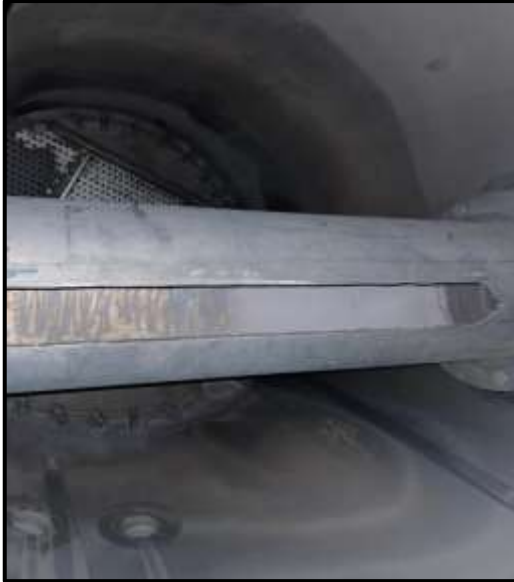
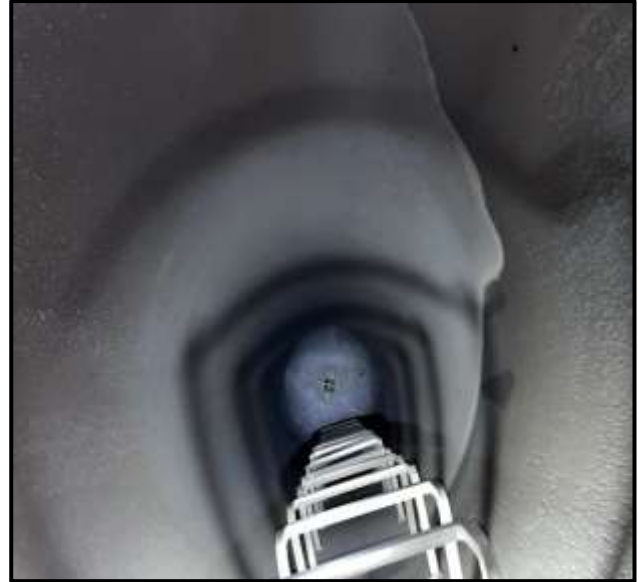
FROM BOTTOM MANHOLE

- Grayish Coloration was observed on the shell & Man-way.
- Bottom most tray was found intact in its position.
- 6" SS Internal Pipe (Steam Inlet) was found intact.
- Vortex breaker in the bottom was found in satisfactory condition. Flow marks observed on east side of shell.

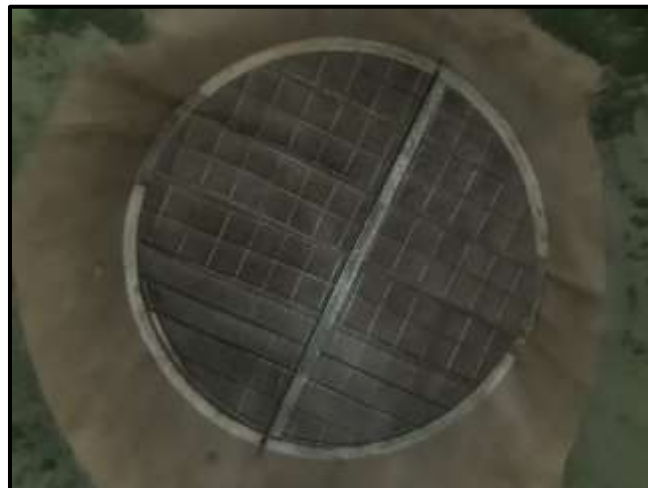
102-F RAW GAS SEPARATOR

- Epoxy paint condition was found satisfactory.
- Demister pads were found lifted from its position in East Side.

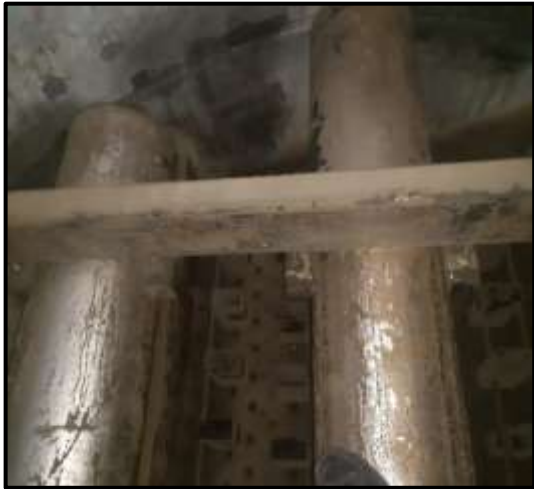
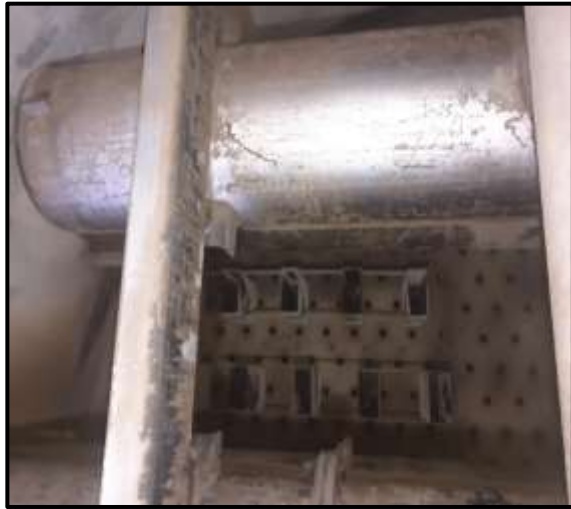
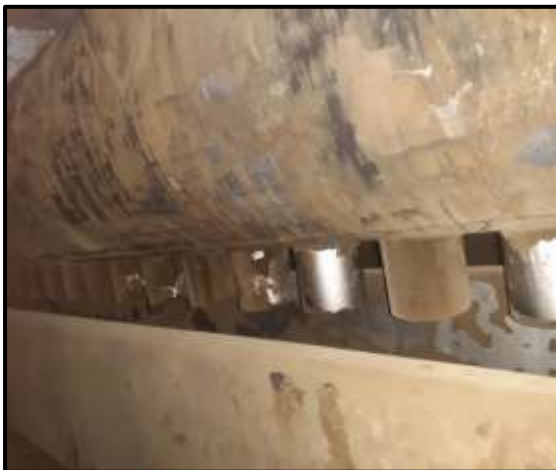
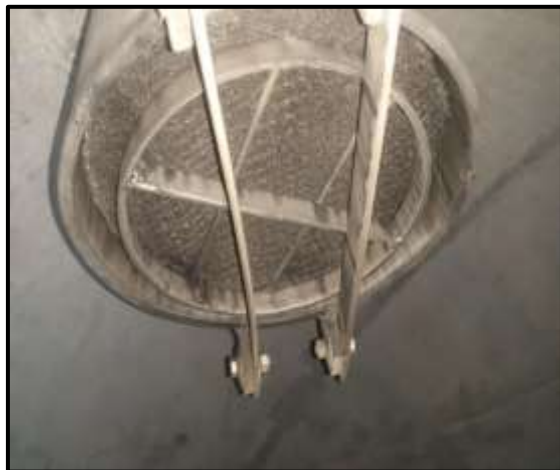
FROM TOP MANHOLE

- Silver gray coloration was observed at top dish end and shell coarse.
- Demister pipe found intact in position with pad.
- Liquid distributor header and its 03 nos. distributor pipes found intact in position, color of the same was observed silver gray with black patches at scattered location and liquid flow marks.
- Distributor pipe holding supports 02 nos. C-channel found intact in position. Distributor trays segment was found intact in its position.
- Hard scale and dust deposit was observed the outer surface of distributor header, pipes, gas riser and supports.
- Weld joints found in satisfactory condition without any sign of corrosion.

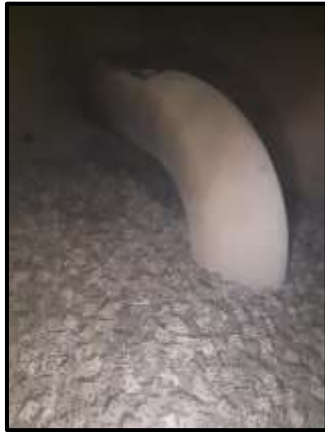
FROM BOTTOM MANHOLE:

- Paul rings inside the bottom dished.
- HP outlet header found intact and in good condition.
- Brownish color on Paul rings observed.

- Top bed demister found intact as seen from bottom manhole.
