MTC / REPORT / 01
REPORT NO. 40 / 2023

PLANT TURNAROUND REPORT
(APRIL – 2023)

INDIAN FARMERS FERTILISER CO.-OP. LIMITED

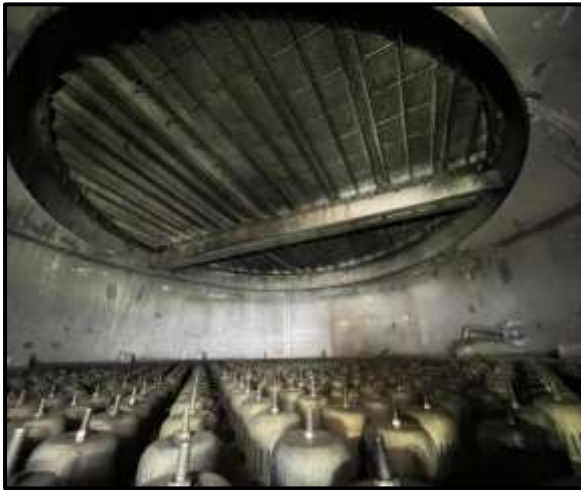
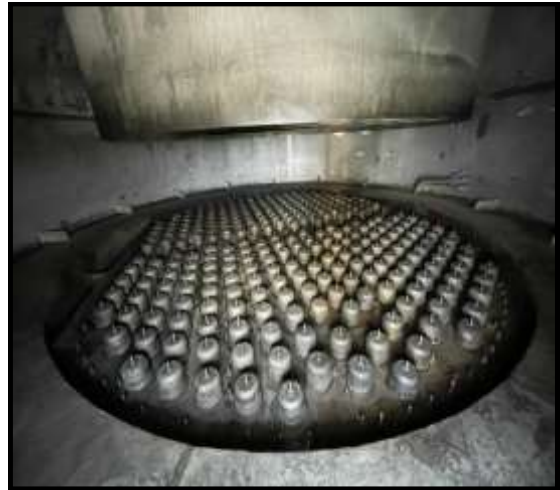
FROM TOP MANHOLE COMPARTMENT

- Demister pad was found intact in its position in satisfactory condition.
- Condition of bubble caps found satisfactory.
- Distributor collectors / drain pipes in West direction was found satisfactory.
- All weld joints found satisfactory.

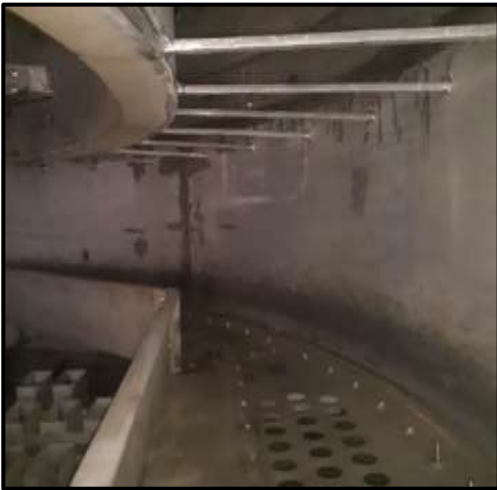
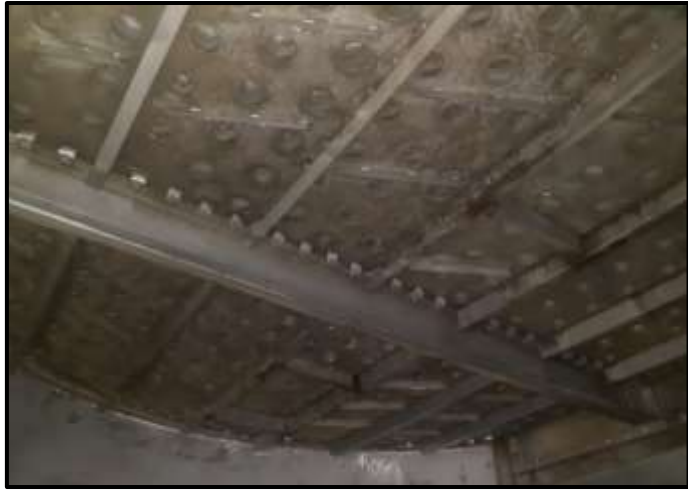
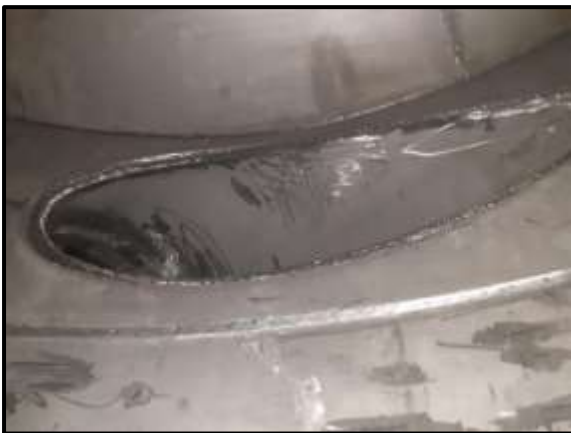
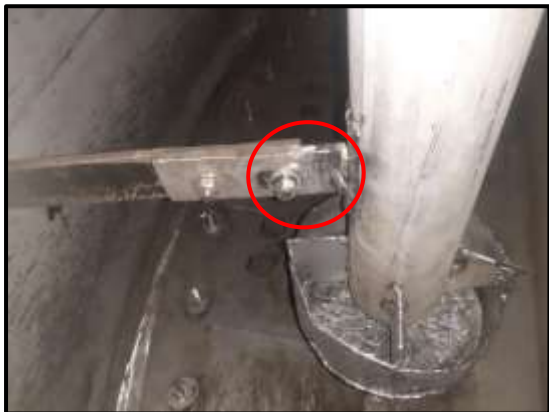
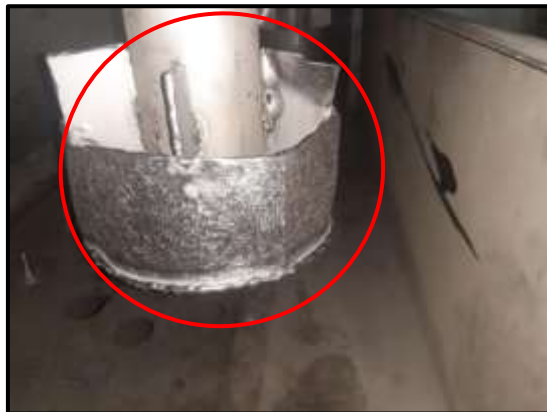
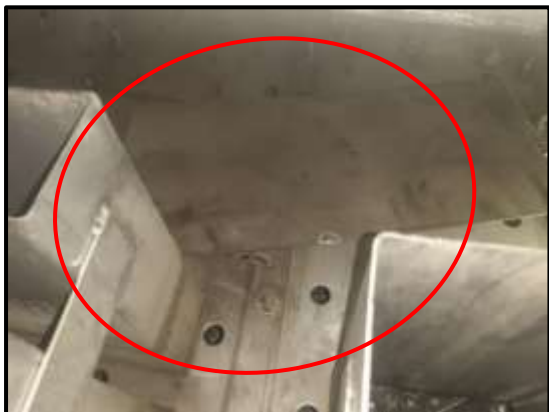
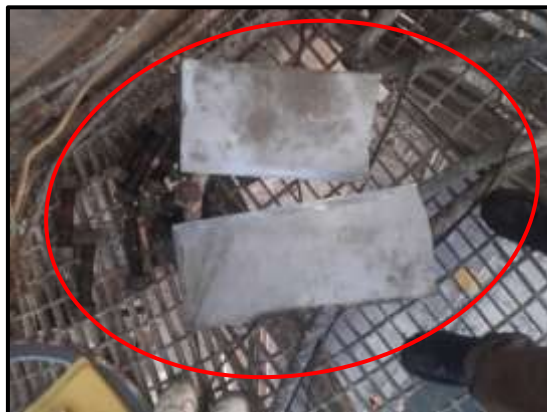
FROM SECOND MANHOLE COMPARTMENT

- Rectangular riser box and other fittings found intact in position.
- Holding bolts of flash feed gallery were bent at many locations.
- Silver coloration observed at scattered locations. Weld joints observed as if etching has occurred resulting in slightly differing colour in comparison to adjacent shell surface.
- Bubble cap tray found intact in position. 02 nos. drain line were found intact however 01 no. its clamp nut found loose. 01 no. drain pot found eroded.
- 02 nos. plates having approx. size of 10"x36" found lying on the rectangular riser box. Which were taken out.

- 02 nos. tangential inlet nozzle found in good condition.

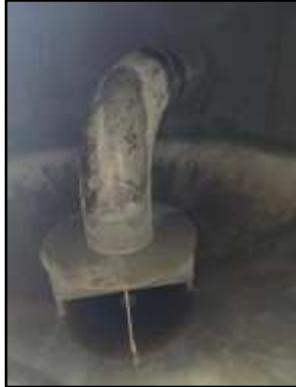
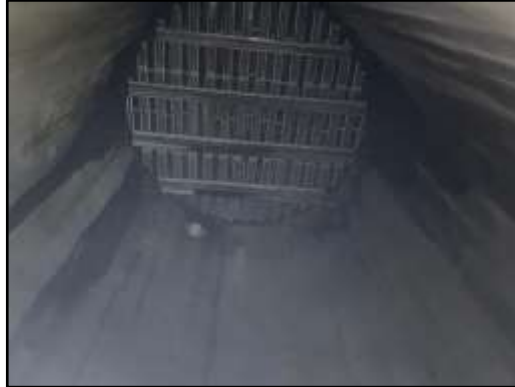
BOTTOM MANHOLE COMPARTMENT (FROM OUTSIDE)

- Vortex plate of the header found intact in position.
- Silver coloration observed at scattered locations.
- aMDEA liquid found accumulated on the bottom floor of the vessel.

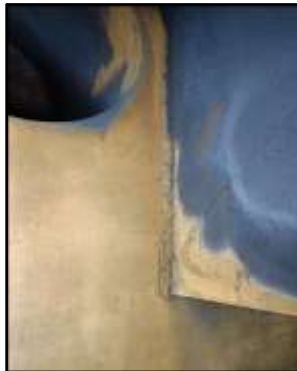
- Grayish black coloration was observed on bottom dome, whereas brownish Coloration was observed on shell.
- Blackish coloration was observed inside the inlet hood baffle.
- Thin scales were observed on bottom dish end.
- Weld discontinuity was observed in inlet hood baffle east side weld joint.

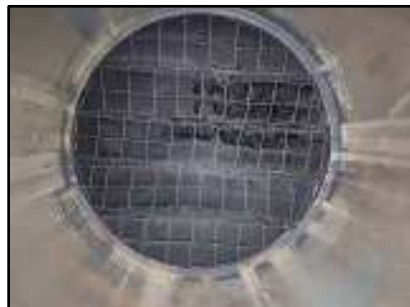
- Bottom vortex breaker was clear and its welds were found intact.
- Top demister pad found upward lifted from center and slightly shifted towards south side. Also center portion of the demister pad observed shiny.

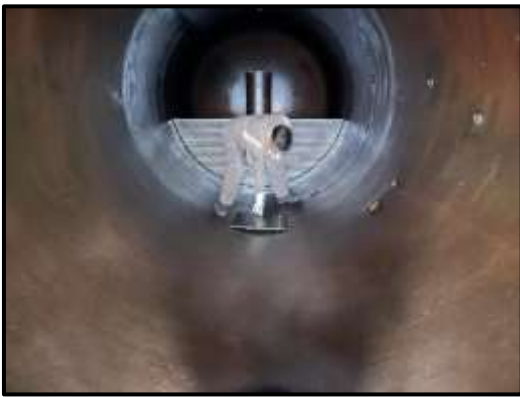
- Brownish black coloration observed inside the drum.
- Entire internal surface found oily.
- The demister pads were found intact.
- Scattered scales were observed on the surface of the dish ends and shell.
- Thermowell found intact.
- Top plate bolts of 117-C return standpipe found sheared and plate (approx. size of 400 mm x 400 mm) was detached and lying near manhole.
- Vortex breaker condition found satisfactory.
- Overall condition of the vessel was found to be satisfactory.

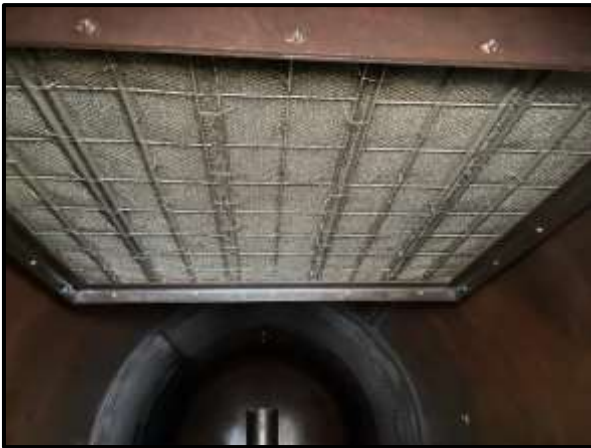
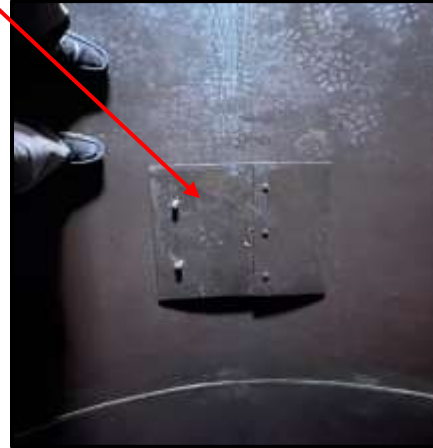
Standpipe cover plate detached from here and laying on bottom of the shell

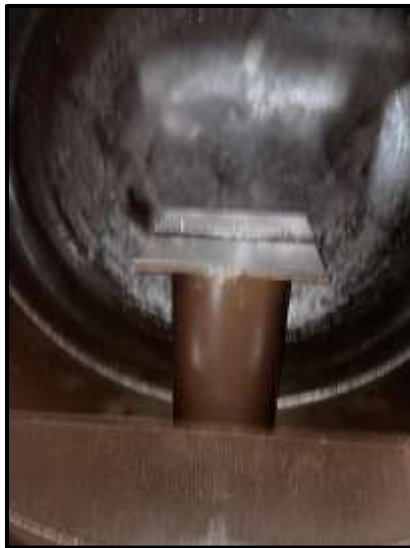
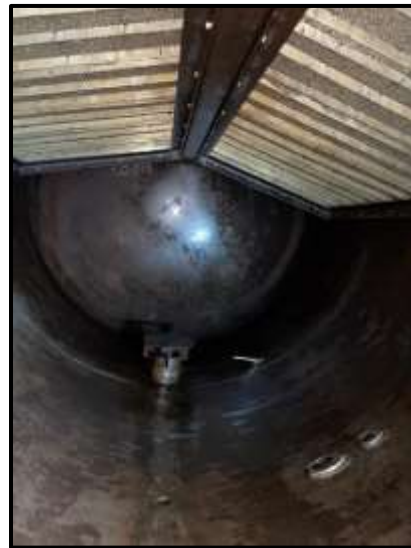
- Blackish gray coloration was observed inside the shell surface.
- Entire internal surface was found oily.
- The demister pads were found intact in position.
- Dish ends were found covered with scattered scales.
- Condition of all shell weld joints was found satisfactory.

- Thermo well found intact in position.
- Vortex plate condition found satisfactory.
- Oil found accumulated behind the make-up nozzle from 109F.

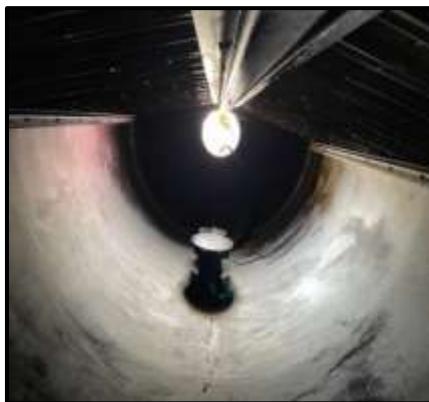
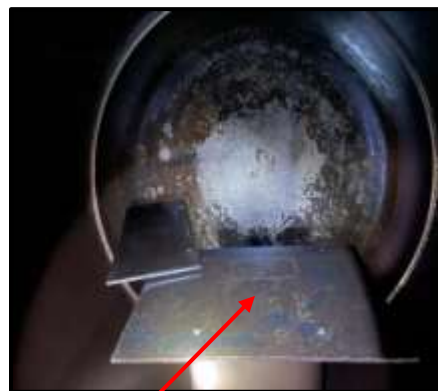
- The demister pads were found intact in position.
- The coloration of the inside surface of shell was brownish black.
- Surface of the entire vessel was found oily.
- Scattered hard scales were observed on the shell
- On East dish end thick scales with oily surface were observed.
- Condition of all the nozzles was found satisfactory.
- Condition of all the weld joints was found satisfactory.
- Overall condition of the vessel was found satisfactory.
- Thermowell condition found intact.
- Top plate bolts of 117-C return standpipe found sheared and plate is dislocated from its position.

Standpipe cover plate detached from here and dislocated.

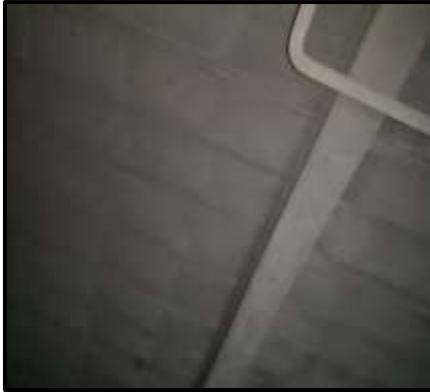
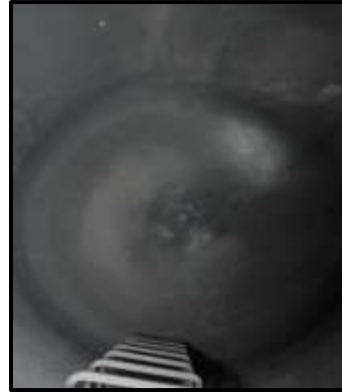
- Grayish Coloration was observed on the shell & Man-way.
- Demister was found intact in its position.
- Vortex breaker in the bottom was found in satisfactory condition.
- Overall condition of vessel was found satisfactory.

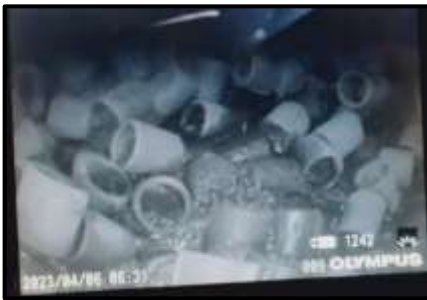
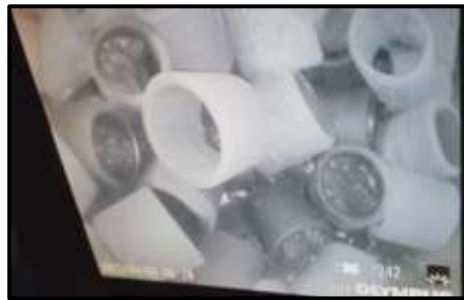
- Rasching rings were accumulated at bottom of the separator.

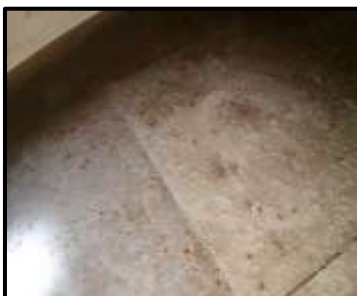
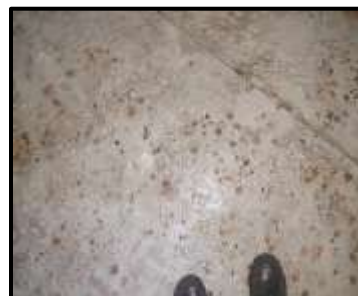
- Blisters were observed on whole bottom plate area. Rusting were observed on blister broken area on bottom plate.

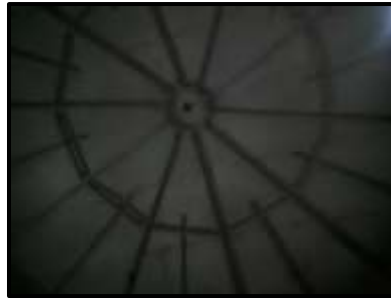
- Top roof angle supports with fasteners were found intact from inside.

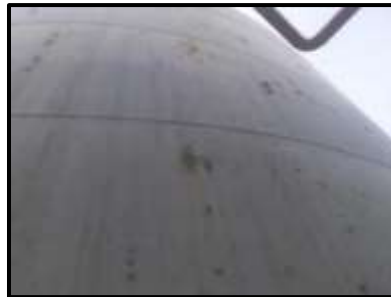
- Paint was also found damaged at few locations on shell wall from outside.

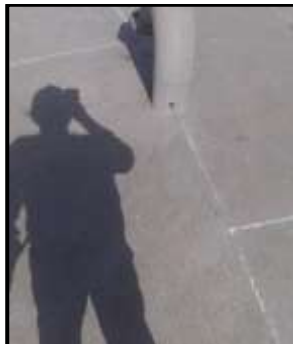
- Top roof from outside found O.K.

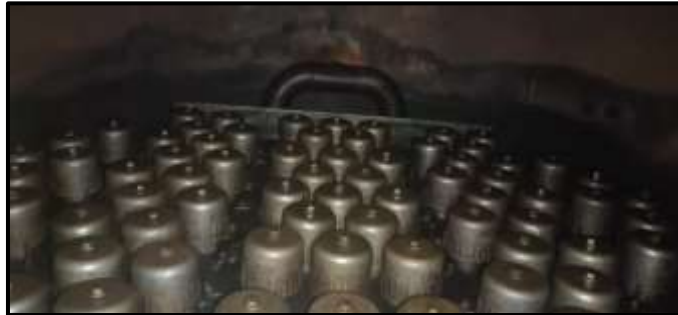
- Bubble cap holding plate found satisfactory. All bubble caps were found intact with its fasteners.

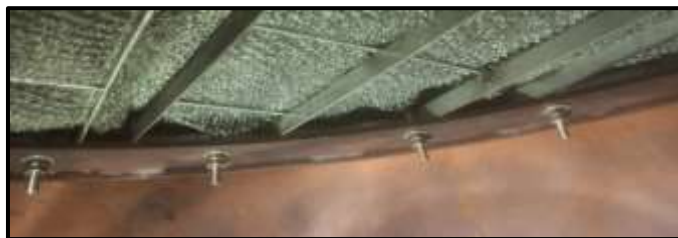
- Demister pads found intact in position, however at 03 location demister pad found upward lifted at North & West Side. Same was reported in previous shut down.

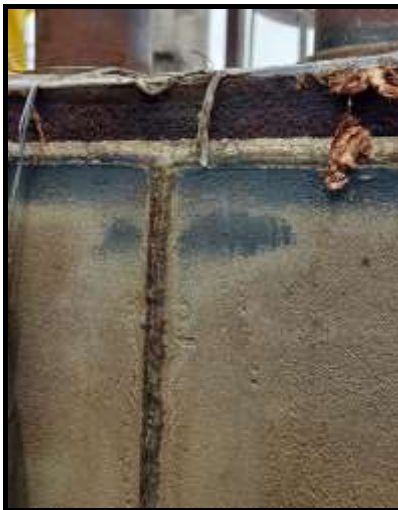
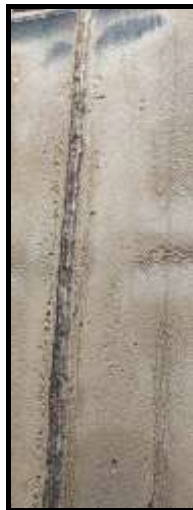
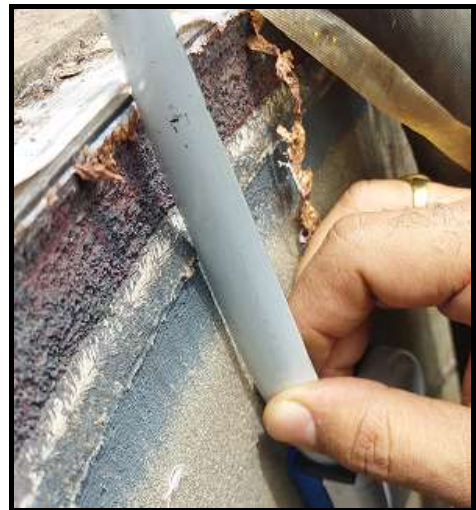
Compartment No.1 (Top Compartment)

- High roughening /corrosion of man way liner including its cladding, weld and on parent metal observed. Man way liner "L" seam weld observed more rough/porous with compare to its "C" Seam weld. Same was observed in past inspection also.

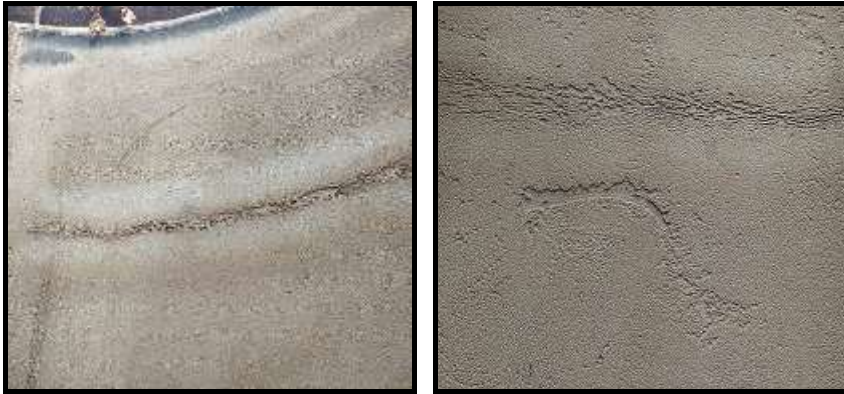
- Parent metal of man way liner observed rough / corroded / eroded at several scattered locations.

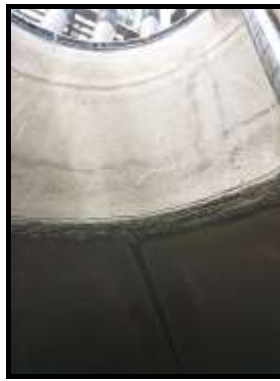
- Man way to dome liner weld observed rough.

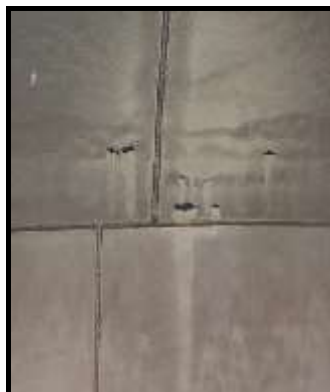
- Black paste like deposition observed on dome area in west direction.

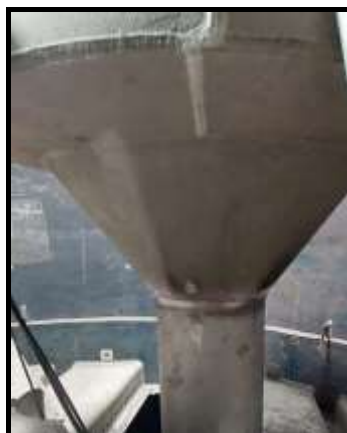
- Down-comer cone (Funnel) observed silver shiny in colour and rough in surface. Downcomer pipe was replaced with new pipe of 2Re69 MOC.

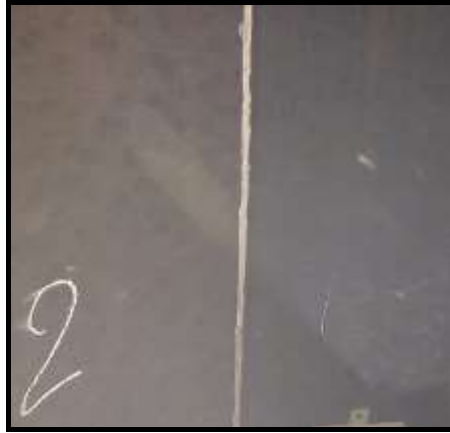
Compartment No.2

- All new cleats (Total-14 No's) and its welding observed satisfactory.
- Previously repaired defects found satisfactory.
- "C" Seam and "L" seam of liner welding found satisfactory.

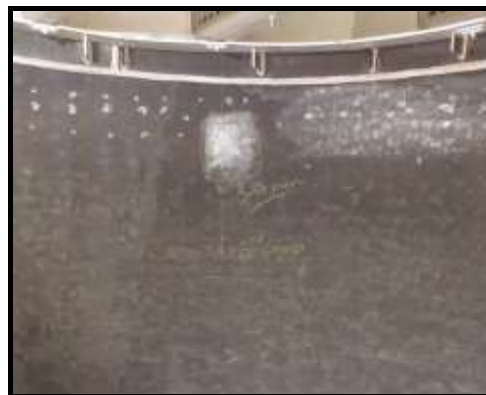
Compartment No.3

- Bulging of approx. 8mm depth and 2.5" width was observed in SW to South direction just above "C" seam near insert liner, same was observed during previous inspection.
- 03 nos. of tray holding clits were observed blackish in color and having severe corrosion attack including its welding, same observed in last inspection
- Circumferentially provided Insert liner (Size 3.5Ft long x 4 Inch width approx) observed silver shiny in color.
- Previously repaired defects found satisfactory.
- "C" Seam and "L" seam of liner welding found satisfactory.

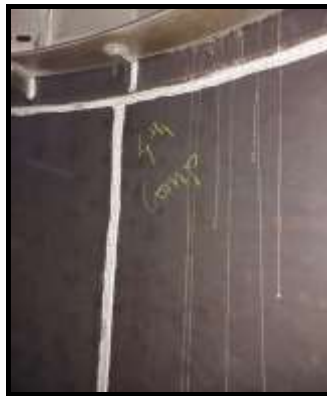
Compartment No.4

- Approx. 30 mm below circumferential weld depression of approx. 100 mm dia. and 3 mm depth was observed at west side liner. Same was observed during last inspection.

- Convex bulging of liner plate observed just above circumferential weld by approx. 4 mm height in complete circumference. Same was observed during last inspection.
- Concave depression of approx 2-5 mm depth observed at approx. 200mm below the C-weld seam in approx. 80% of the periphery. Same was observed during last inspection.
- 03 nos. of tray holding cleats (11 Old + 09 New=20) were found black and observed sever corrosion attack including its welding, same observed in last inspection.
- Circumferentially provided Insert liner (Size 3.0 Ft long x 4 Inch width approx) observed silver shiny in color.
- “C” Seam and “L” seam of liner welding found satisfactory.

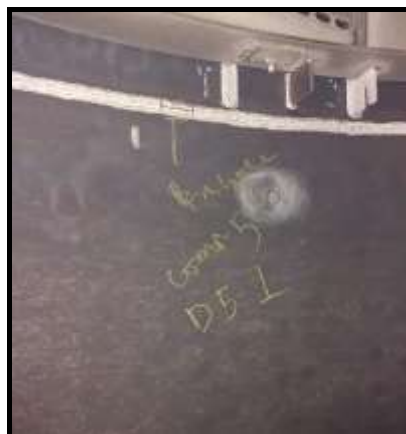
Compartment No.5

- Convex bulging of liner plate was observed just above the circumferential weld joint by approx. 3 to 9 mm height in almost all the periphery. The same was observed during last inspection.
- Concave depression of approx. 2-6 mm was observed at approx. 500 mm below the C-weld seam in full periphery. The same was observed during last inspection.
- “C” Seam and “L” seam welding found satisfactory.
- **On “C” seam weld Pinhole of approx. 0.3 to 0.5mm and 3 to 4 mm depth observed, Marked as D5-1 for repair.** Repair was carried out by welding and found satisfactory in DP test.

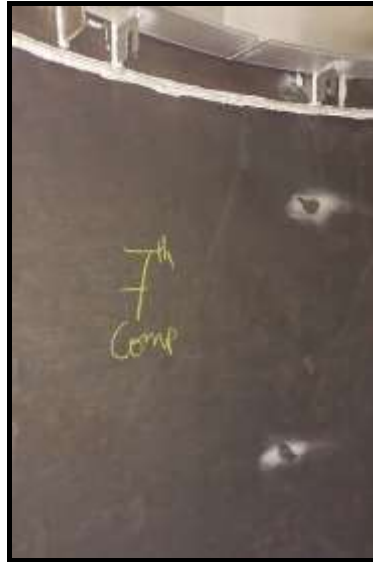
Compartment No.7

- Convex bulging of liner plate was observed above the circumferential weld joint by approx. 2-6 mm height at few locations. The same was observed during last inspection also.
- Concave bulging 1200mm below C seam and max. 5 mm. depth in approx. 60% periphery.
- 04 nos. of tray holding clits were found to be blackish in coloration and having severe corrosion attack including it's welding, same observed in last inspection.
- “C” Seam and “L” seam welding found satisfactory.
- Previously repaired defects were observed satisfactory.
- Tray orientation was in NW – SE direction.

- 11 old cleats having minor corrosion whereas 10 new cleats and its welding observed satisfactory.

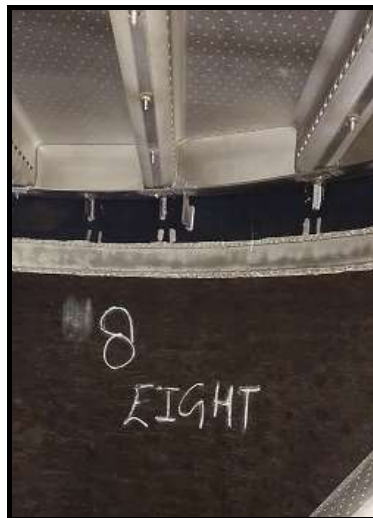
Compartment No.8

- Concave bulging at the elevation of approx. 300 mm above tray and 3 to 6mm. deep was observed in complete circumference. The same was observed during previous inspection also.
- 04 nos. of tray holding clits were found blackish in colour and having corrosion attack including its welding, same observed in last inspection.
- Insert liner found silver shiny in color and Shell liner observed brownish black in colour.

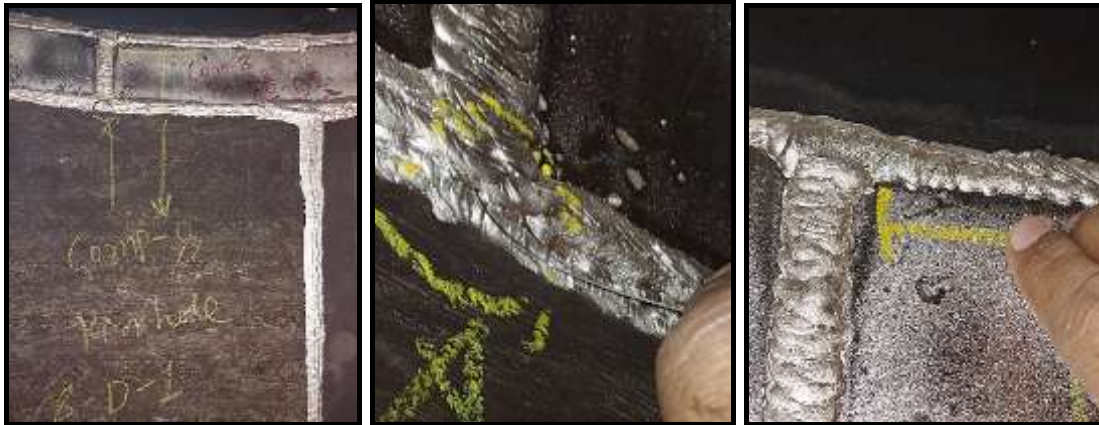
- “C” Seam and “L” seam welding found satisfactory.
- 04 old cleats (out of 10) having minor corrosion whereas 10 new cleats and its welding observed satisfactory.
- Tray orientation was in NE – SW direction.
- **On “C” seam weld of insert liner at two different locations Pinholes of approx. 0.3 to 0.5mm and 3 to 4 mm depth were observed, Marked as D8-1**

and D8-2 for repair. Repair was carried out by welding and found satisfactory in DP test.

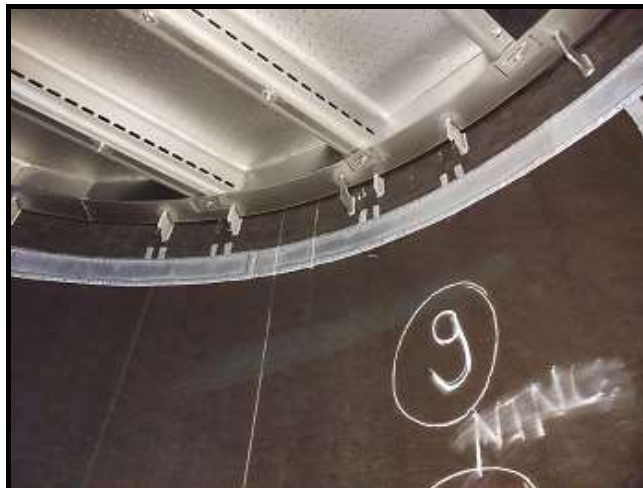
Compartment No.9

- 02 no. of tray holding cleats were found blackish in colour and having corrosion attack including its welding, same observed in last inspection.
- No noticeable bulging observed in liners.
- Insert liner found silver shiny, Shell liner observed brownish black in colour.
- “C” Seam and “L” seam of liner welding found satisfactory.
- 10 New and 11 Old cleats and its welding observed satisfactory.
- Trays orientation is in NW-SE direction.

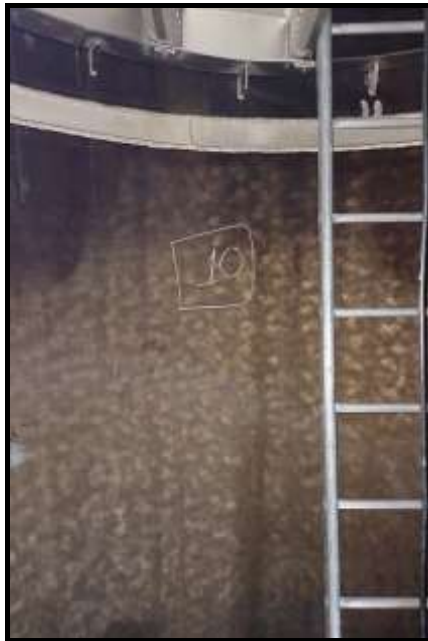
Compartment No.10

- Concave depression of approx 7mm depth at approx 70mm below the C-weld seam in south side of shell in approx. 100 mm dia was observed. Same as last Inspection.
- Concave depression of approx. 9 mm depth just above the C-weld seam towards the south side and adjacent to L-seam in approx. 100 mm dia. was observed. Same as last Inspection.

- Vertical bulging of approx. 2-3 mm height 25mm wide was observed from the C-weld seam to the bottom of the compartment in north side of the shell. The same was observed during last inspection also.
- Concave depression of about 5mm depth at approx 70mm below C seam in west side just adjacent to L seam was observed in 100 mm area. The same was observed during last inspection also.
- Insert liner found silver shiny.
- “C” Seam and “L” seam of liner welding found satisfactory.
- Shell liner observed brownish in colour
- Previously repaired defects were observed satisfactory.
- 10 New and 11 Old cleats and its welding observed satisfactory.
- Down comer was observed brown in colour with corrosion in its welding.

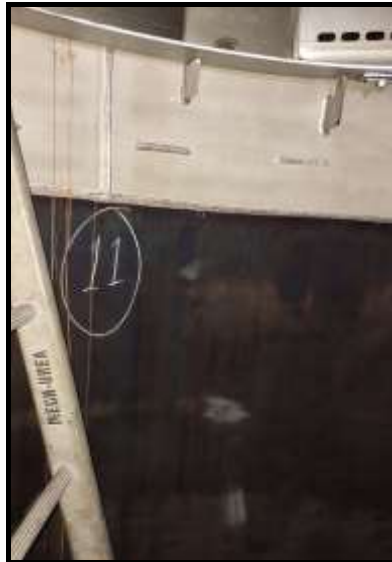
Compartment No.11

- Just below circumferential weld concave depression of approx. 10 to 12 mm depth in approx. 100mm dia. in North-West direction was observed. The same was observed during last inspection also.
- On insert liner segment convex bulging up to max. 5 to 8 mm height having width approx. 20-25 mm observed just above circumferential stitch welds (approx. 125 mm long). Same was observed during last Inspection also.
- Concave depression of about 5-6 mm was observed just above and below of C-weld seam in old and new liner. The same was observed during last inspection also.
- Insert liner and shell liner “L” and “C” seam welding observed satisfactory.
- Insert liner observed silver shiny and shell liner observed dark brow in colour.
- Shell liner observed brownish black in colour.

- 11 New and 11 Old cleats and its welding observed satisfactory.

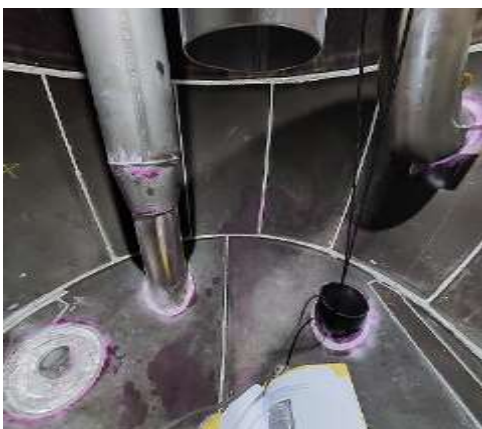
Compartment No.12 (Bottom Compartment.)

- Down comer nozzle with dish end liner found satisfactory
- Reducer of 10"x8" observed silver shiny in colour.
- Dark brown coloration on dish end observed.

- Concave depression of approx. 2-3 mm depth and approx. 5mm width were observed at approx. 200mm above the C-weld seam in 4"dia in east and west direction of the shell respectively. The same was observed during last inspection also.

- All old tray holding cleats (15 no's) were found blackish in color and having corrosion attack, however all new cleats (14 no's) and It's welding observed satisfactory.

- Tray orientation is in North –South direction.
- Two no's of long seams observed satisfactory. (North – South Direction)
- Petal welds condition observed satisfactory. (Total 12 Seams)

- All nozzles welding D.P test carried out and and few of them are observed with defects which were repaired by welding and found satisfactory in re dp test.

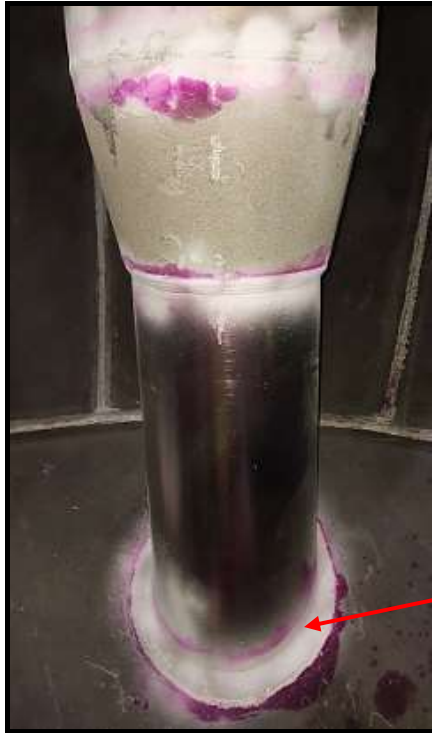
Two no's of indications observed in DP test. Repaired by grinding and welding.

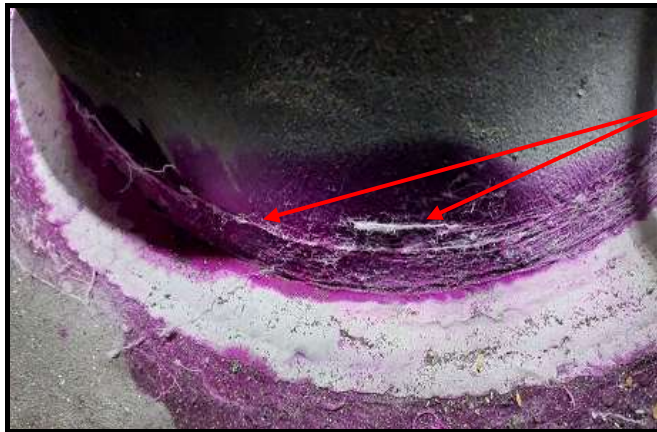
One no's of indication observed in DP test. Repaired by grinding and welding.

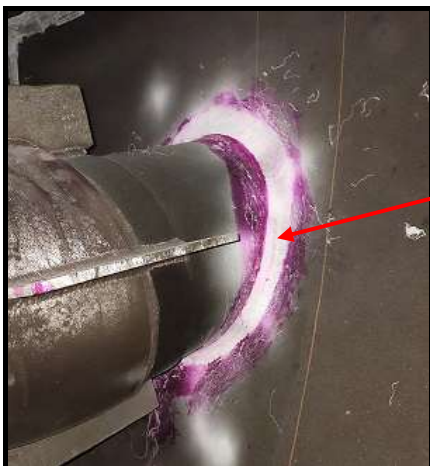
Weld opening /crevices observed at many locations hence complete circumferential weld run provided.

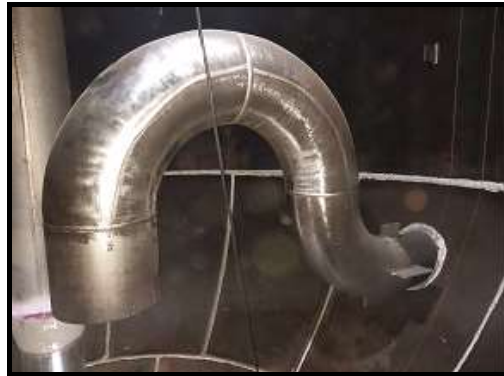
One no's of indication observed in DP test. Repaired by grinding and welding.

- C1B nozzle (8"NB Goose neck) found satisfactory in its position.

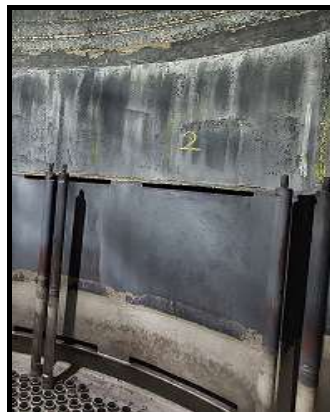
- The liner and liquid inlet box in the liquid phase were grey and slightly etched.

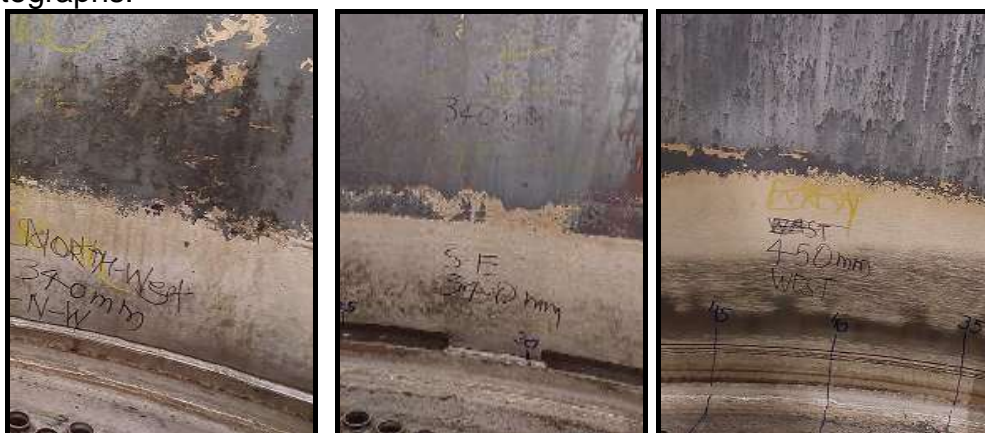
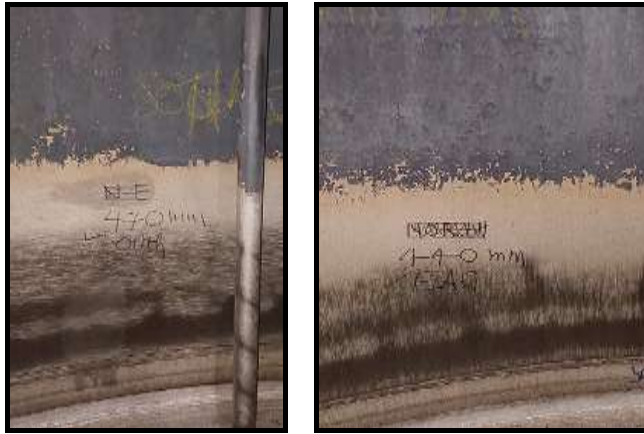
- Silver shiny surface observed at bottom portion of shell liner. Its height in mm from top tube sheet measured at different directions are as per under photographs.

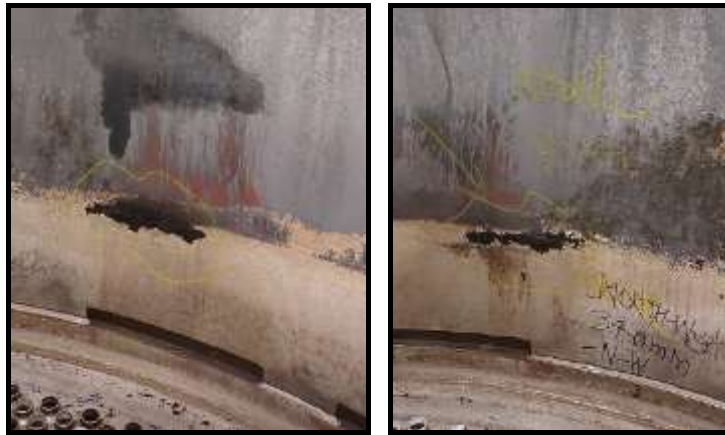
- Blackish deposition observed in North and North-West direction on the shell.

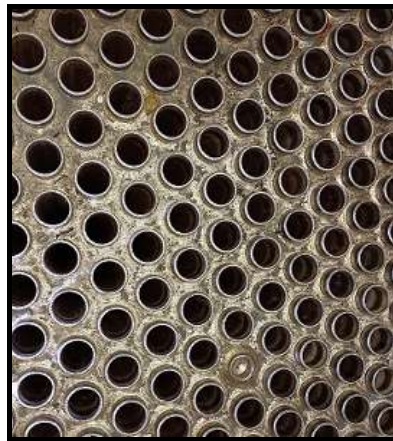
- The overlay welding on the tube sheet was grey and slightly etched.

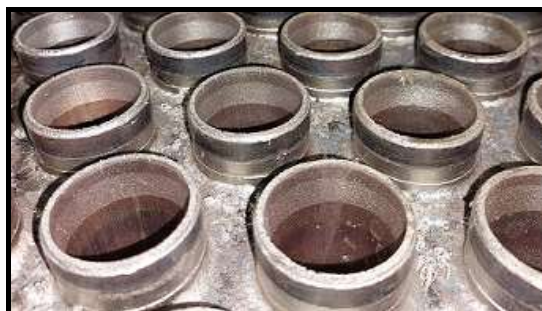
- The tube welds were bright and smooth and brownish in colour from inside. Tube stub ends observed etched / rough in many tubes.

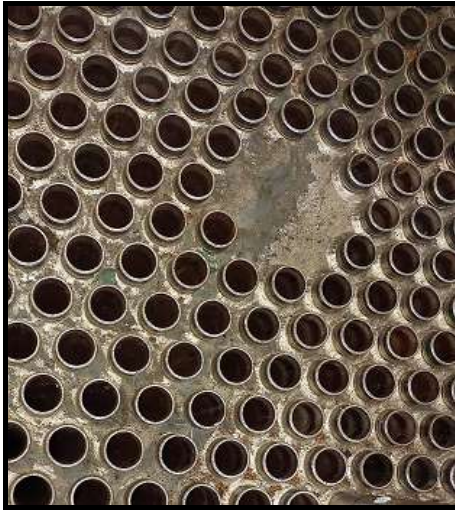
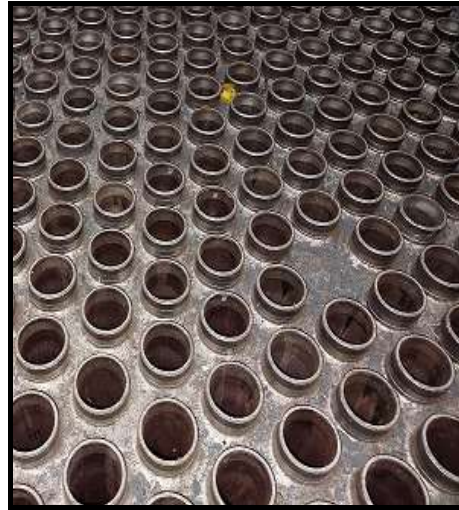
- Thick & hard oxide deposition of 3-5 mm thick approx. was observed, more prominent in center of tube sheet and East direction on tube sheet area.

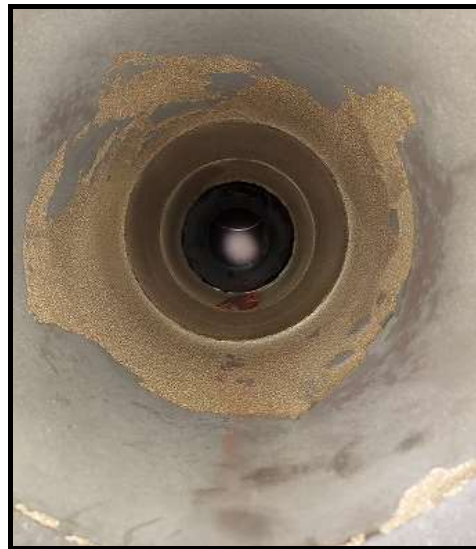
- Minor pittings were observed in ID of tubes 5 to 6mm from stub end edge in many tubes.
- Reddish coloration observed at one location in ID of gas outlet nozzle.

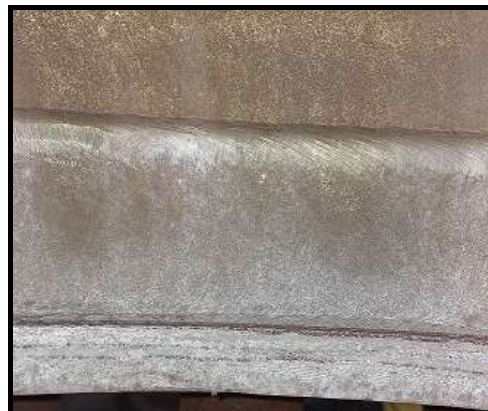
BOTTOM CHANNEL

- The condition of sealing face observed slightly etched.

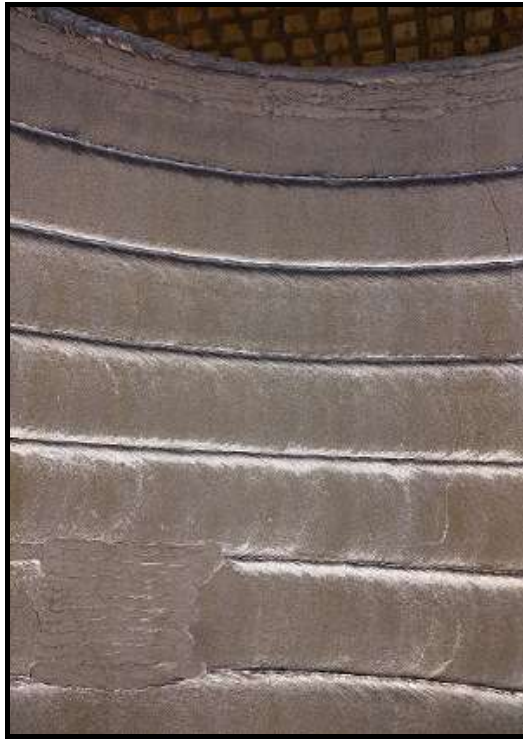
- The overlay welds in the man way observed silver and slightly etched.

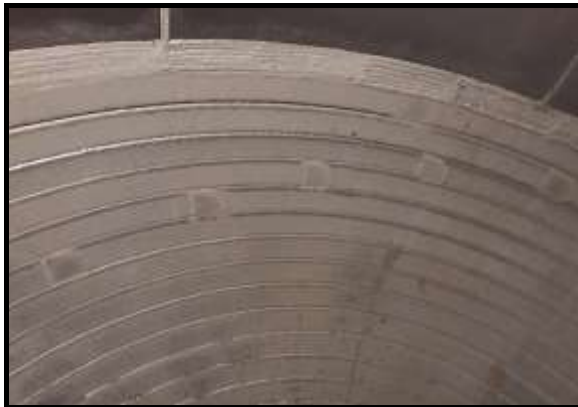
- The overlay welds in the hemi-head were silver and etched. Many patches of approx. 2"x2" size on the hemi-head overlay welds were observed which were more etched than the surrounding areas in North and East direction, same was observed in previous inspection also.

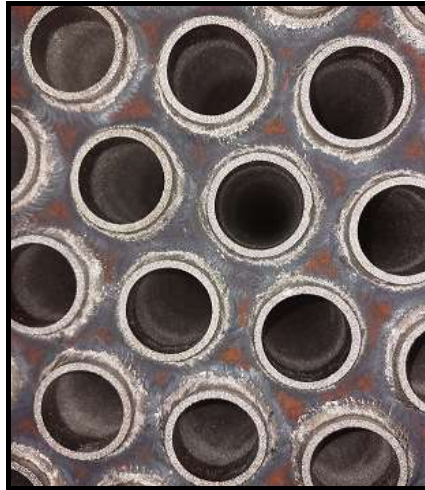
- The tube sheet was covered with a thin grey oxide layer. This layer seems to be more hard & bonded on tube-sheet to shell weld joint.

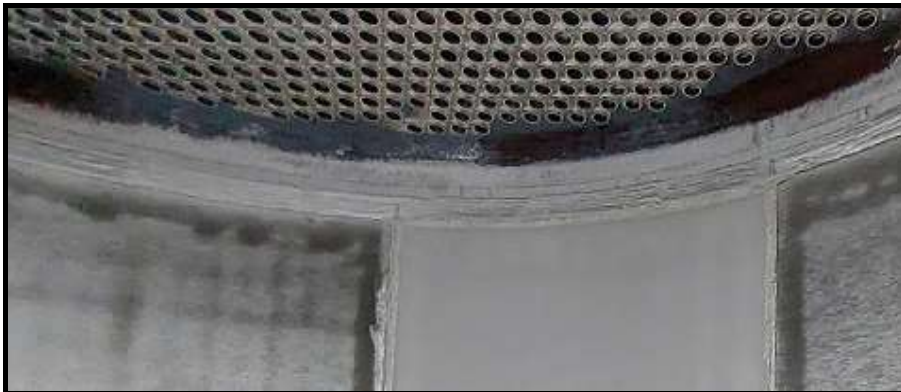
- Dark brown patches were observed at periphery of tube sheet same was observed in previous inspection also.

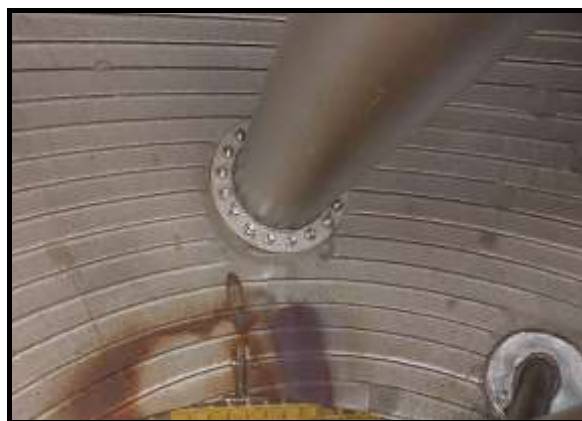
- The tubes from inside were smooth.
- Minor pittings were observed in ID of tubes 5 to 8 mm from stub end edge in many tubes.
- The liquid outlet pipe and the gas inlet pipe were observed bright and shiny. Its condition found satisfactory.
- Reddish coloration observed in dish end near radioactive source well.

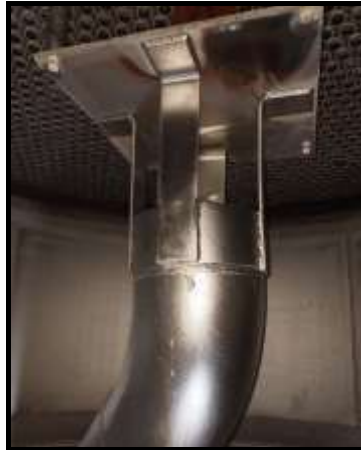
- Blackish coloration observed at one corner of CO2 gas inlet nozzle distribution plate.

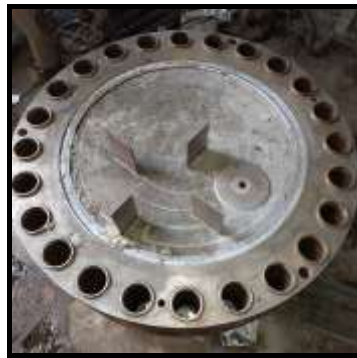
BOTTOM COVER

- The overlay welding was smooth and shows no defects.
- The vortex strips were silver shiny and good in condition.

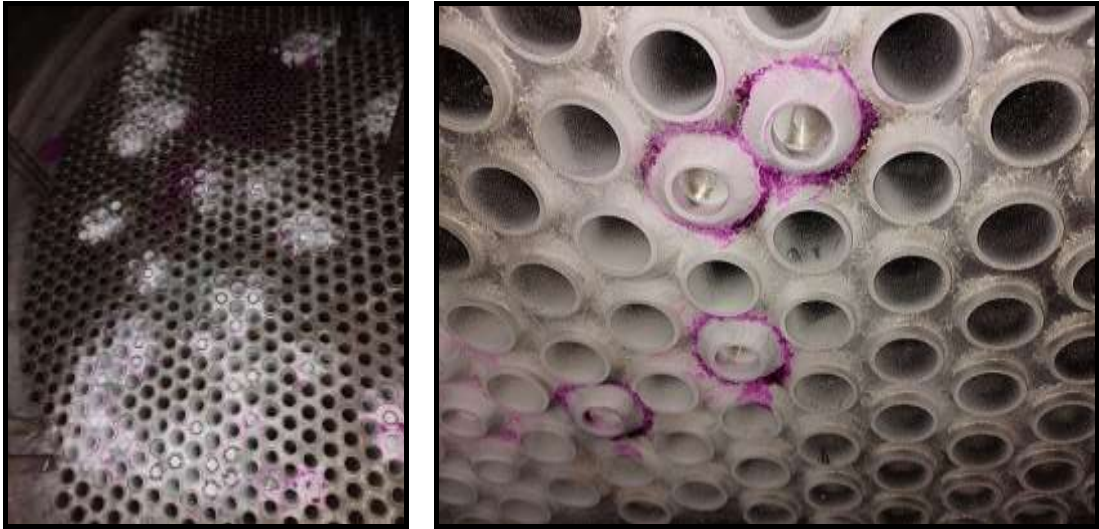
- Majority of the wall thinning was observed between 2nd to 5th baffle from top tube-sheet.
- 11 nos of tubes were observed having maximum wall loss of 1.80mm (Remaining Wall Thickness 1.50mm) (Cumulative since March-2002).
- 57 nos of tubes were observed having maximum wall loss of 1.70mm (Remaining Wall Thickness 1.60mm).

- Rest of the tubes were observed having maximum wall loss in the range of 1.10 mm to 1.60 mm (Remaining wall thickness range of 1.70 to 2.20 mm.)
- Total 68 tubes (57+11) were plugged having remaining thickness ranging from 1.50 to 1.60 mm. in SD-2023
- (Tube sheet layout attached at Annexure-6).
- All 68 tubes each from top and bottom tube sheet were plugged by welding. DP test carried out and found satisfactory.
- Total 87 tubes plugged till SD-2023.

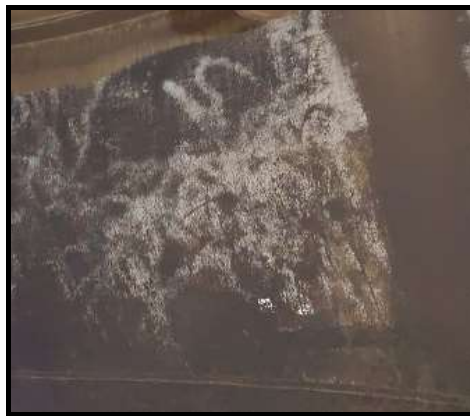
- The shell and Dish ends observed grayish black in color.

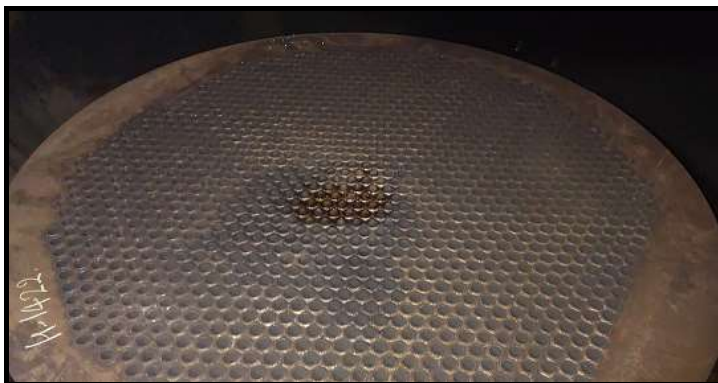
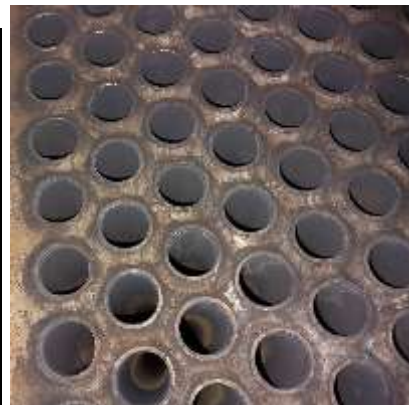
- Colour of tube sheet observed blackish.
- Tubes to tube sheet weld joints were found satisfactory. Brownish scaling observed inside many tubes.

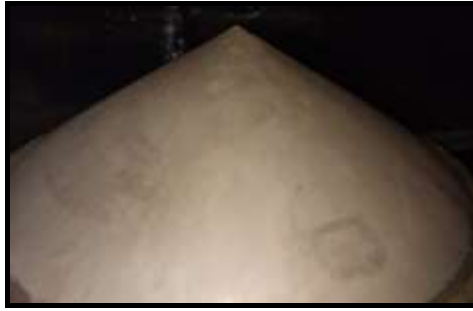
- Impingement cone to support bolts were observed bent, however they were tack welded and found satisfactory.

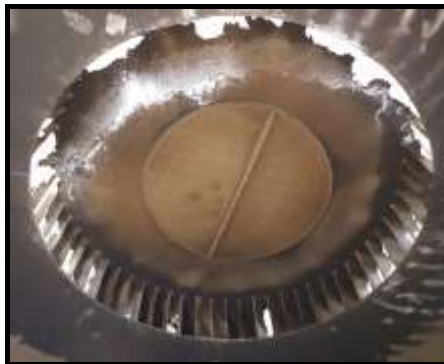
- Condensate flushing nozzles was found in satisfactory.
- Urea deposition observed in slots.

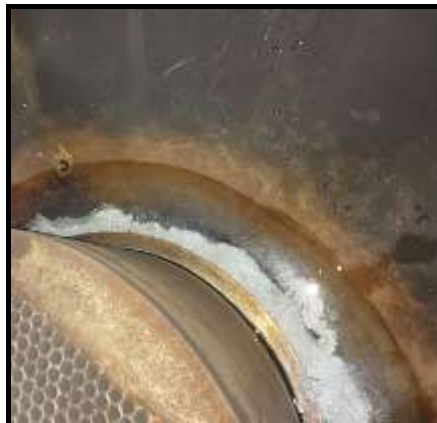
- At bottom dish end water and Urea accumulation observed.

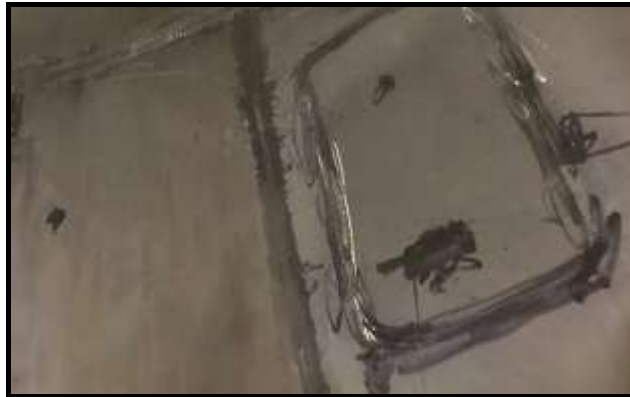
- Shiny silver surface observed inside the vessel.

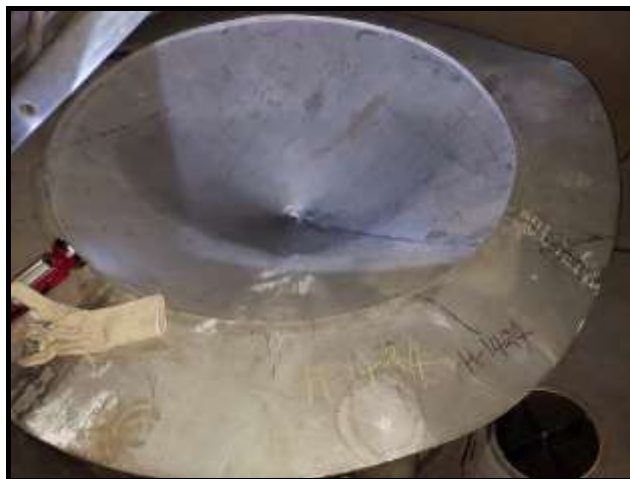
- Impingement cone corner was found bent in downward directions at few locations, this was also observed in earlier inspection.

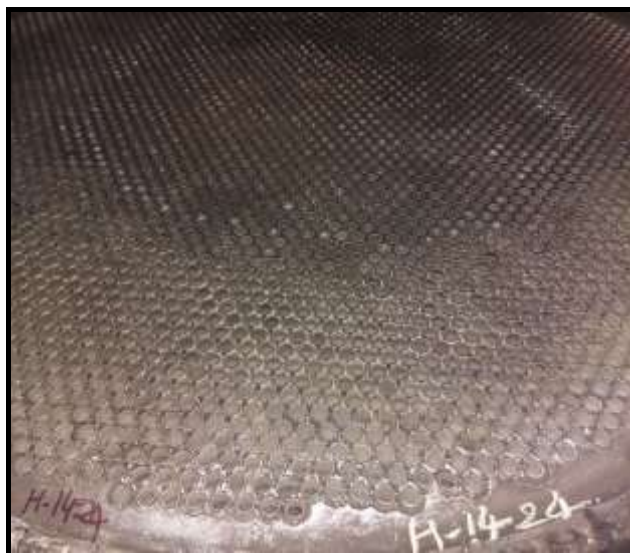
- Tube to tube sheet welding found satisfactory, urea solution layer observed on scattered locations on the tube sheet. Scaling observed from the I.D in many tubes.

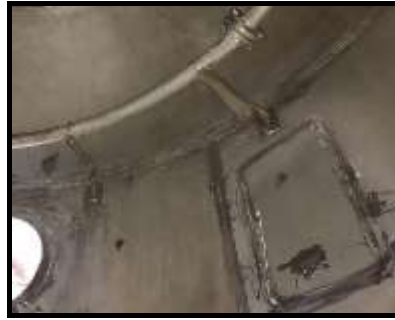
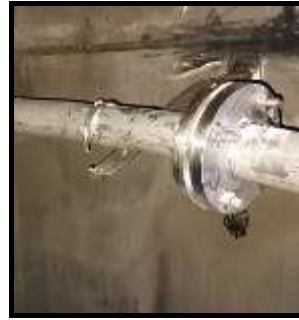
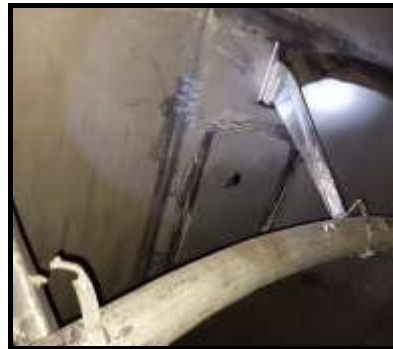
- Circumferential sparger and its supports found bent in downward direction at many locations. Sparger clamps observed broken at many locations.

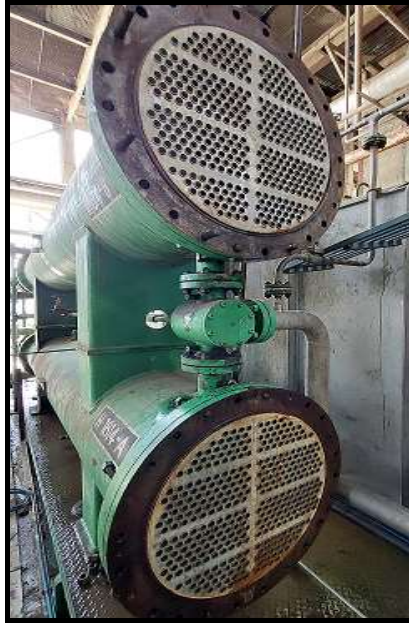
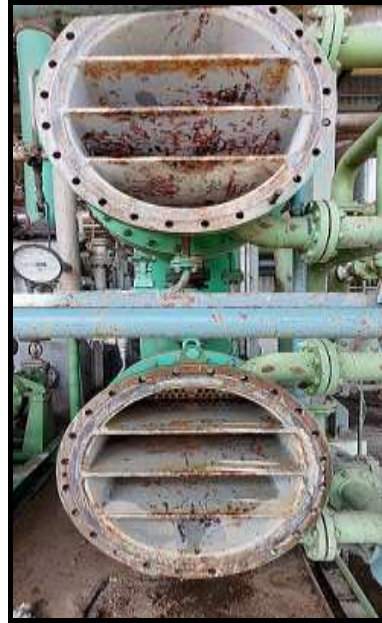
- Condition of tubes and tube sheet was found satisfactory.
- Thin white scaling observed inside the tubes.
- Few tubes observed partially filled with water.
- Epoxy layer was found peeled off at several locations on channel cover & partition plates, repainting may be carried out.
