MTC / REPORT / 01
REPORT NO. 40 / 2023

PLANT TURNAROUND REPORT
(APRIL – 2023)

INDIAN FARMERS FERTILISER CO.-OP. LIMITED

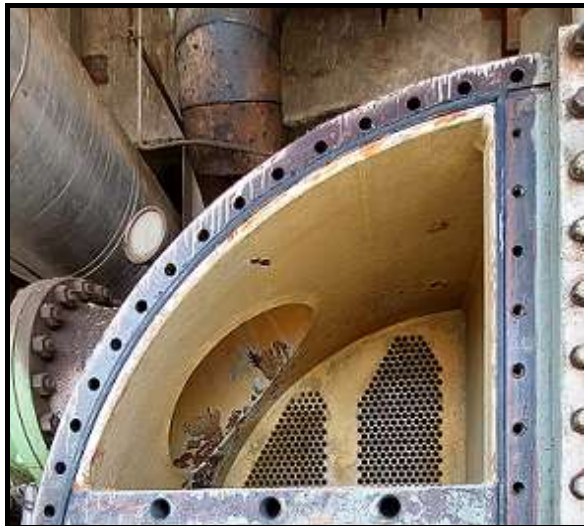
- Tube sheet and tubes observed satisfactory in condition.
- Scale layer observed on entire half.

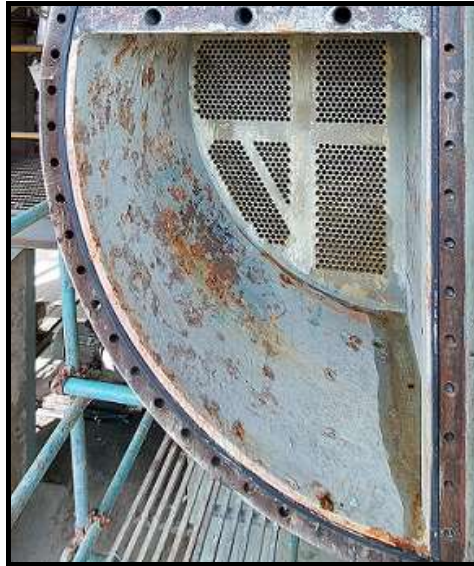
- Tube sheet and tubes observed satisfactory in condition.
- Epoxy coating layer was found peeled off at several locations.

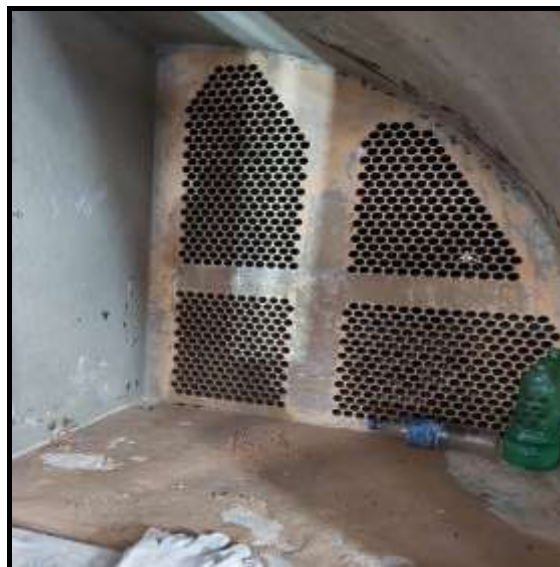
- Tube sheet and tubes observed satisfactory in condition.
- Scale layer observed on entire half.

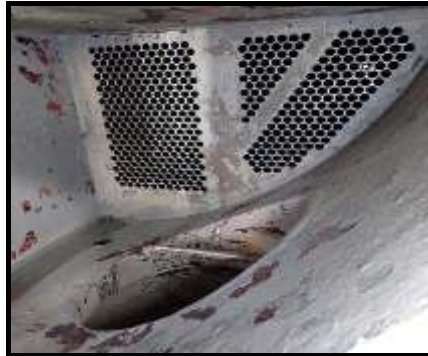
- Tube sheet and tubes observed satisfactory in condition.
- Epoxy coating layer was found peeled off at several locations.
- White dry scaling was observed inside the tubes, re-hydro jetting suggested and found satisfactory after that.

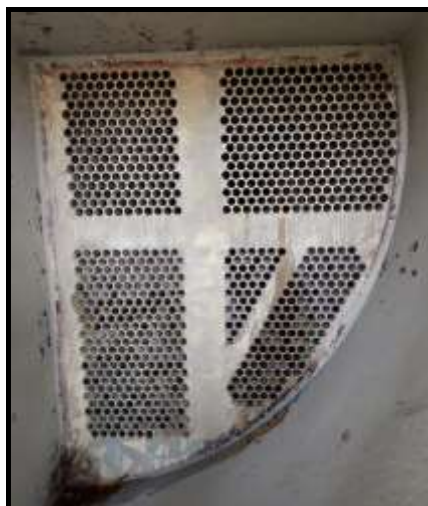
- Tube sheet was found in satisfactory condition.
- Epoxy coating was found peeled off at few locations.
- Minor scaling was observed inside few tubes.
- One tube found leaky in water fill test and same was plugged.

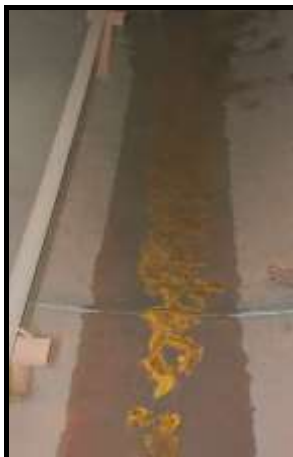
- Weld joints condition found satisfactory.
- Supports of 6"NB and 8"NB condensate inlet found satisfactory.
- 2"NB DM water makeup line sparger observed satisfactory.
- Water with resins observed accumulated at the floor.

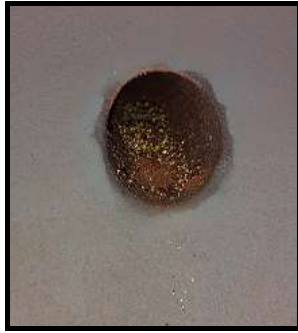
- Level indicator nozzle observed filled with resins.

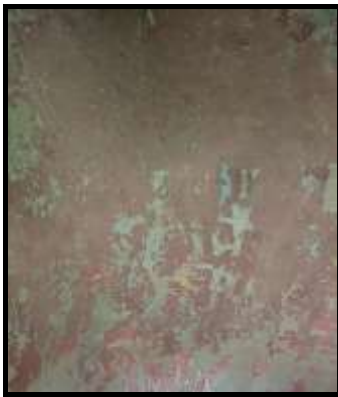
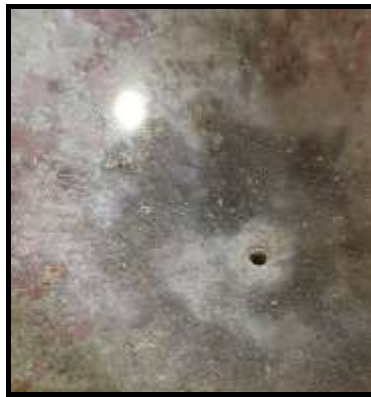
- Epoxy paint was found peeled off from many locations in bottom dish end and on shell.

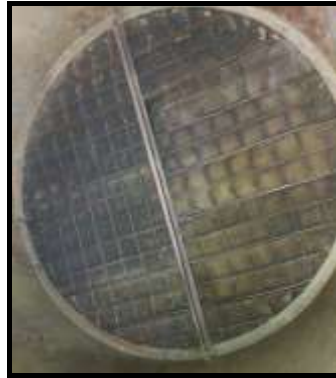
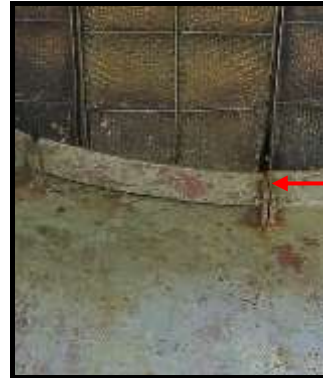
- Demister pads found intact in its position, however one bolt of its holding tray observed loose.

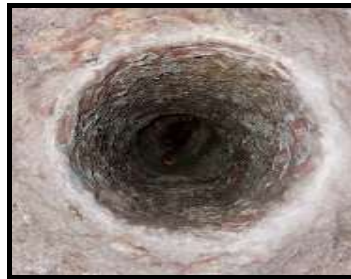
- Rusting / corrosion observed in bottom dish water outlet / drain line.

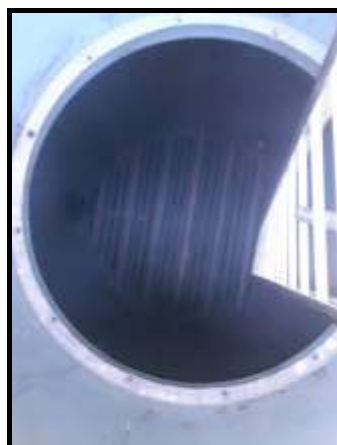
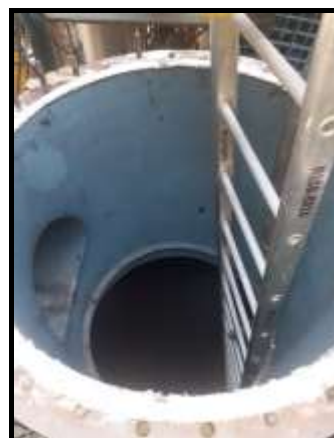
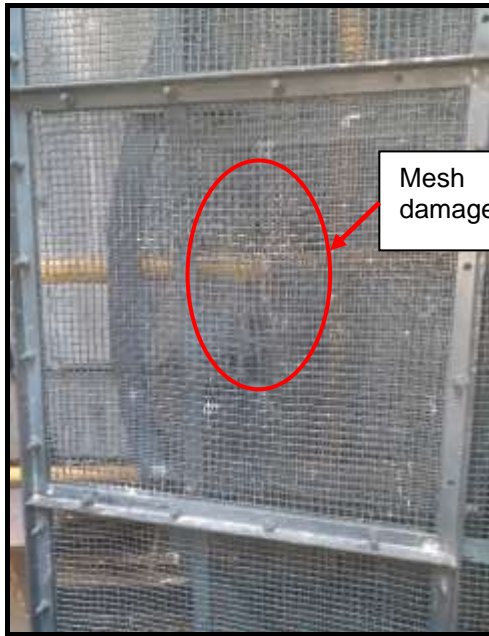
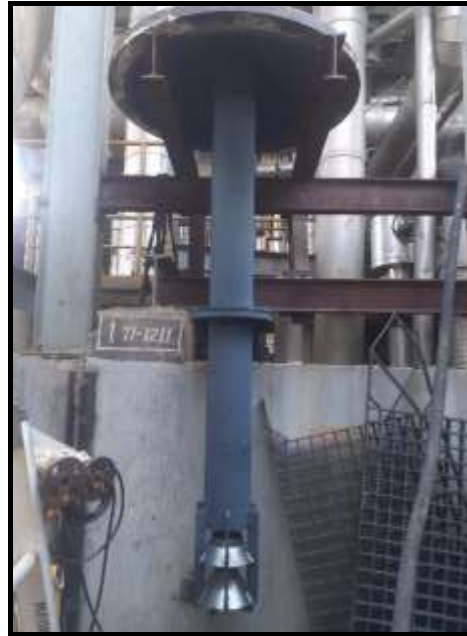
- Grey hard scales were observed on entire shell portion; however, it was peeled off at some locations.
- Tray holding cleats holes observed elongated.
- Mesh found damaged at 01 location.
- Tray support / Mesh Grid support strips found satisfactory and they were covered with grayish hard scales.

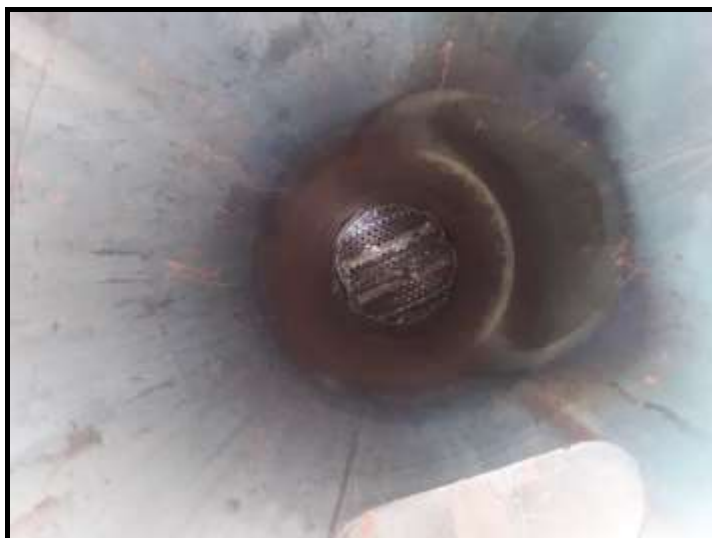
V-1203 (L.P. ABSORBER)

- Shell observed brownish in colour.
- Perforated support grid was found intact in position.
- All internals were taken outside.

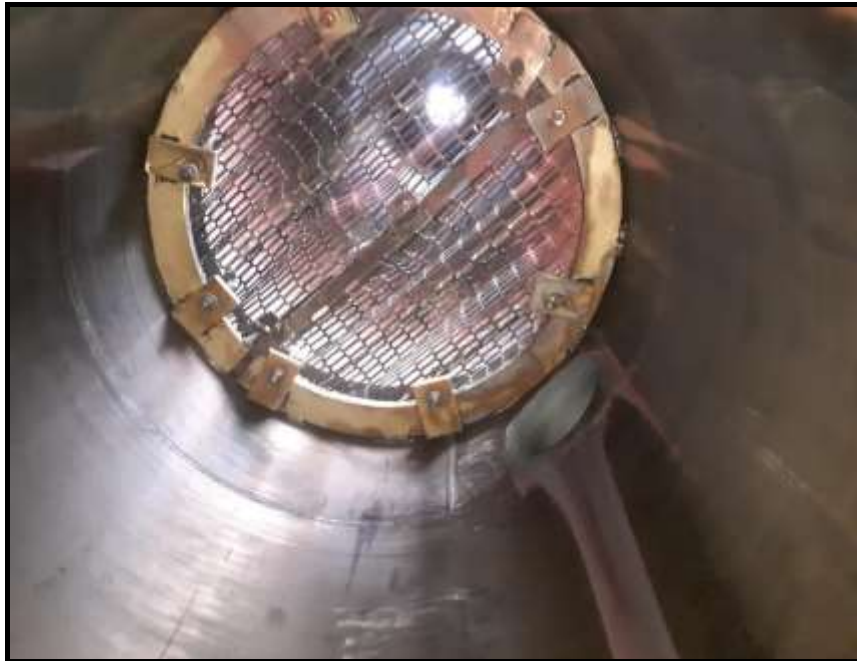
- Shell observed silver shiny in colour.
- Weld joints condition found satisfactory.
- Vortex Breaker was found intact.

- Perforated support grid was found distorted as viewed from top & bottom side.

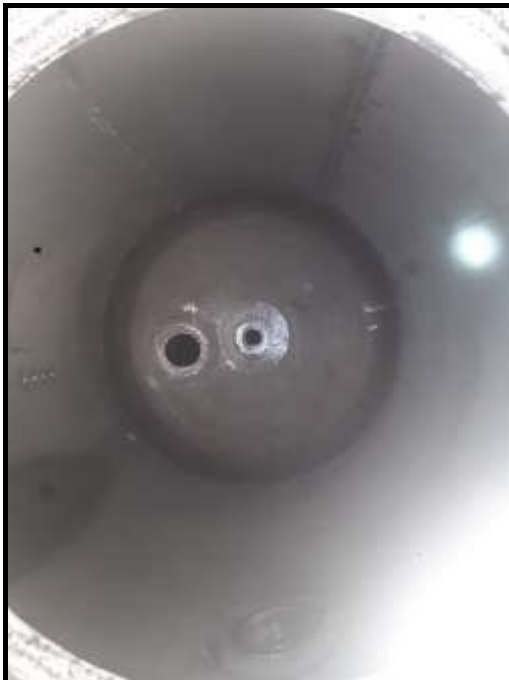
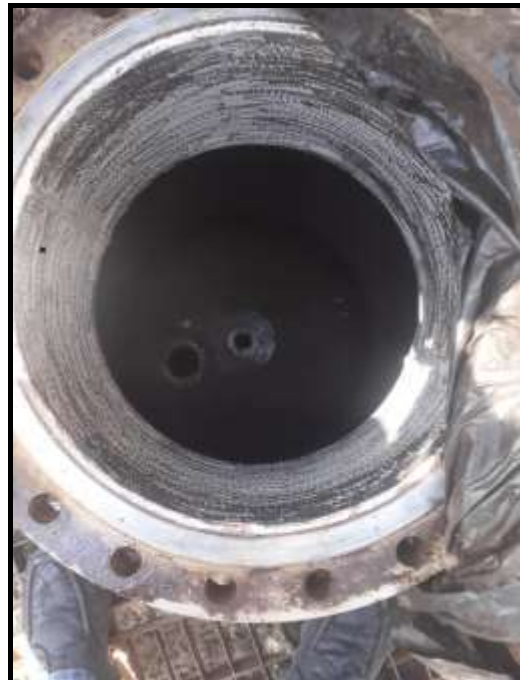
**V-1205 (L.P. CARBAMATE SEPARATOR)
FROM TOP MANHOLE**

- Brownish black coloration observed at top dish end and rest of the area observed silver gray coloration inside the vessel.
- Condition of all nozzles found satisfactory.
- Overall condition was found satisfactory.

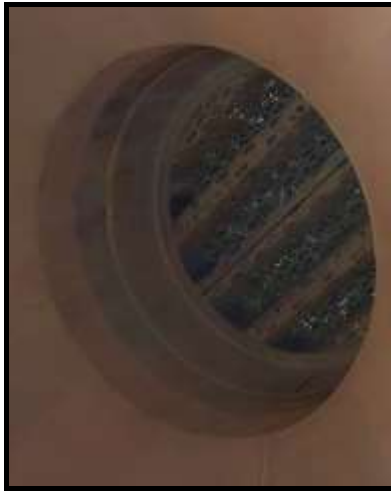
V-1206 (ATMOSPHERIC VENT SCRUBBER)

- Demister pads were found intact and satisfactory in position.

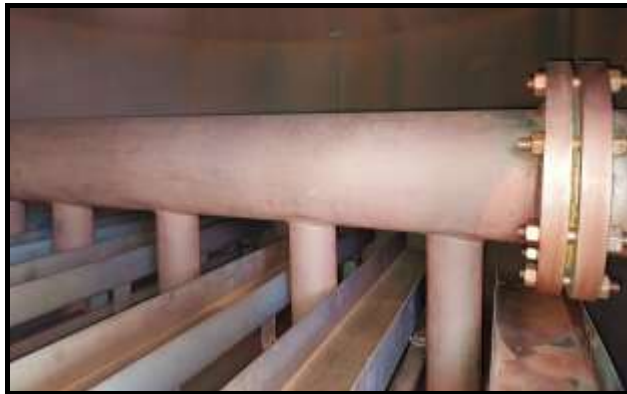
- Shell observed brownish red in color from inside.
- All bolts of liquid inlet flange found satisfactory.
- Liquid distributor condition found satisfactory.

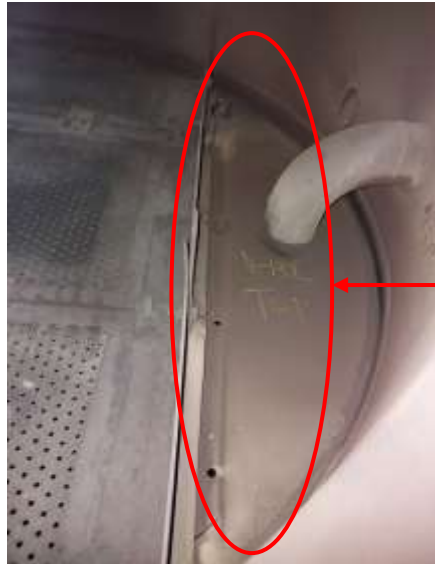
Bolts Missing

- Perforated tray might be observed shifted / bolts in missing condition.

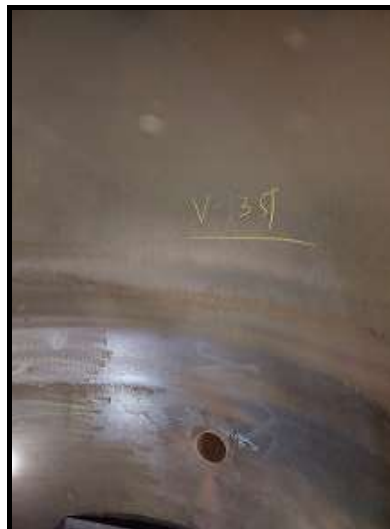
- Vessel was offered for visual inspection after dismantling middle segment of trays till 10th compartment.
- Brownish coloration was observed on Top dish end and shell.

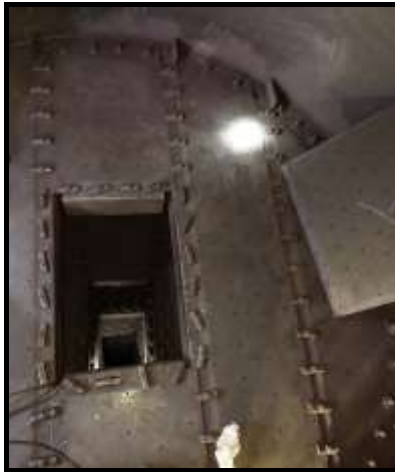
- Trays also observed reddish in color with minor oily sludge at periphery.

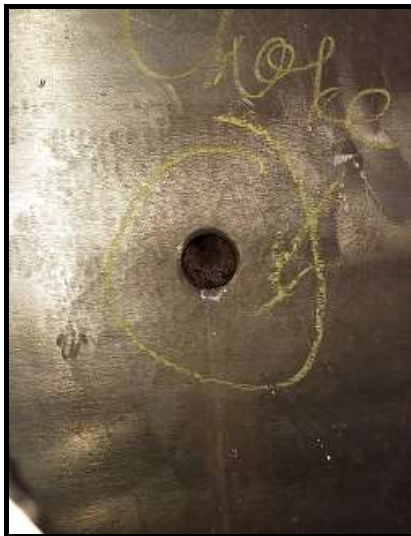
- Fasteners of sieve tray were found intact in position for other than dismantled segments.
- Accumulated sludge / debris observed in 3/4" nozzles near M/H (Top) in east side.

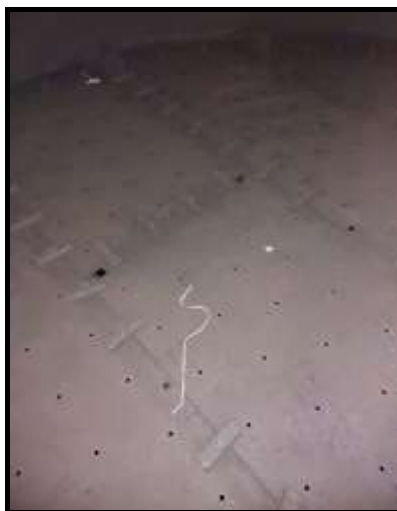
- Tray segments condition found satisfactory till 10th compartment.

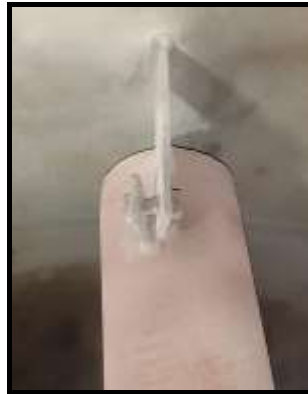
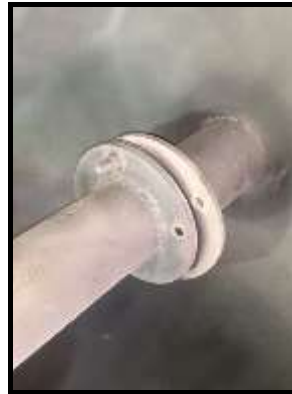
- Thermowell condition found satisfactory.
- Steam inlet line flange and clamping bolt missing / loose.

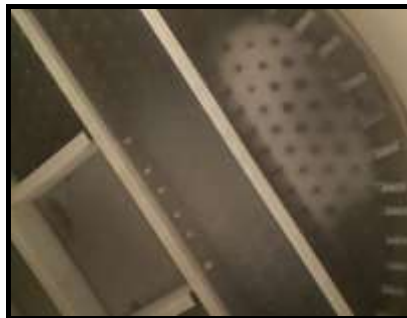
- Reddish coloration was observed from inside.
- Middle tray condition found satisfactory.

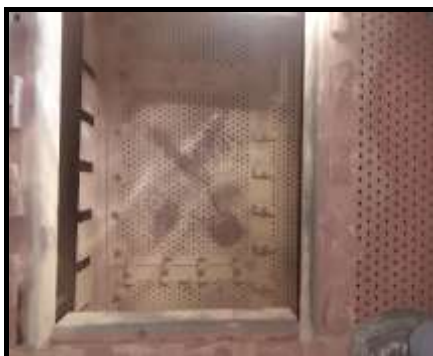
V-1352 (FIRST DESORBER)

- Brownish coloration was observed inside the vessel.
- All fasteners were found intact.
- Weld joint condition was found satisfactory.
- 1st tray middle tray segment was removed.
- 2nd tray middle segment was removed.
- Condition of 1st, 2nd and 3rd segment was found satisfactory.

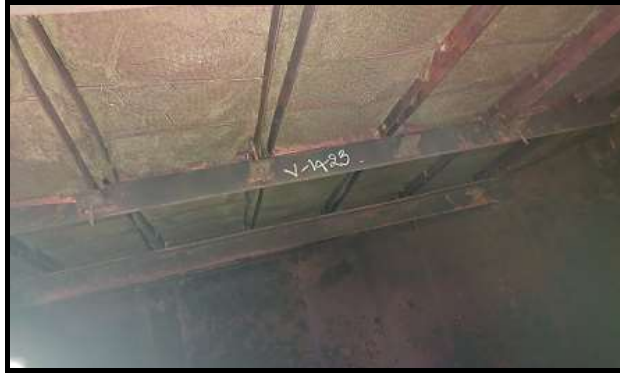
V-1423 (1st STAGE EVAPORATOR SCRUBBER)

- Reddish Brown coloration was observed inside the vessel.
- Demister pads condition observed satisfactory.

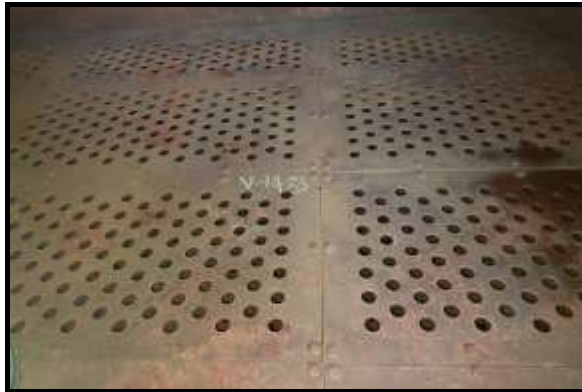
- Top perforated trays observed satisfactory.

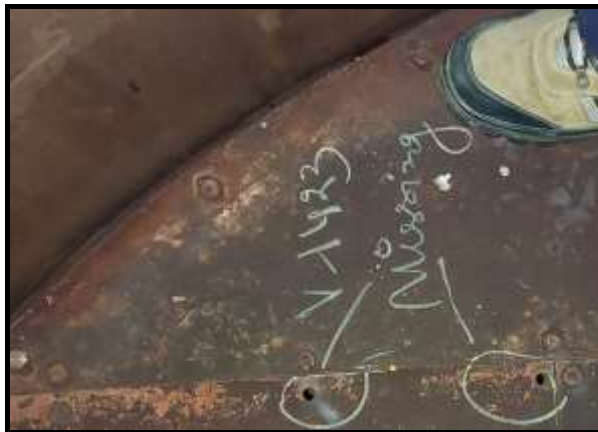
- 02 no of bolts found missing at bottom plate below M/H.

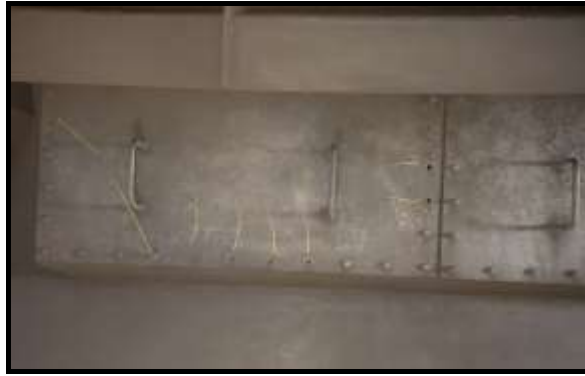
V-1501 (4 ATA STEAM DRUM)

- Grayish coloration observed on Shell.
- Hard grayish scaling observed on both dished ends.
- Distribution sparger was found intact in position.
- Demister pads were found intact in its position.
- Condition of all the weld joints found satisfactory.
- Water observed accumulated on shell floor.
- Few bolts of Steam inlet saturation box cover were found missing and few bolts observed loose in N-W side saturation box.

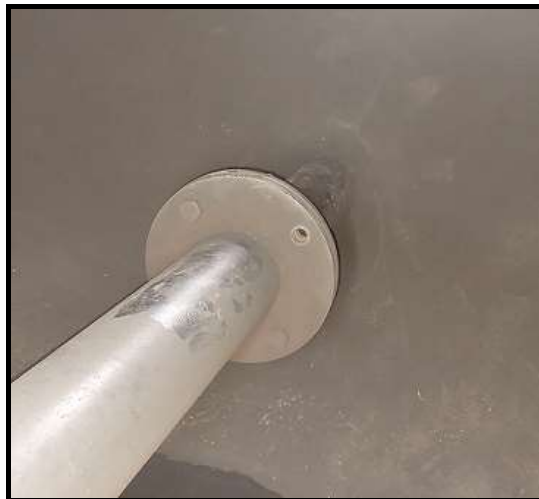
- One bolt found missing in Feed water inlet line flange (South side end).

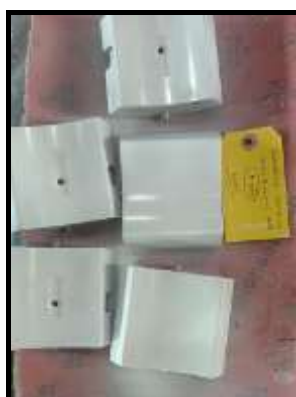
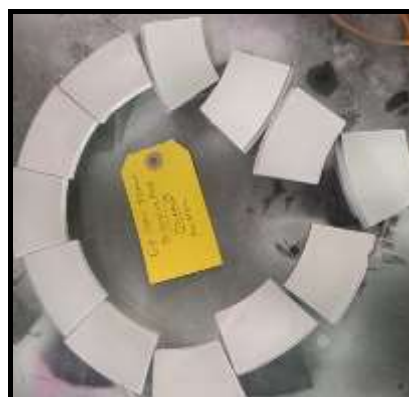
D.P. Test was carried out on all bearings to check condition of liner and its bonding of of Co₂ Compressor.

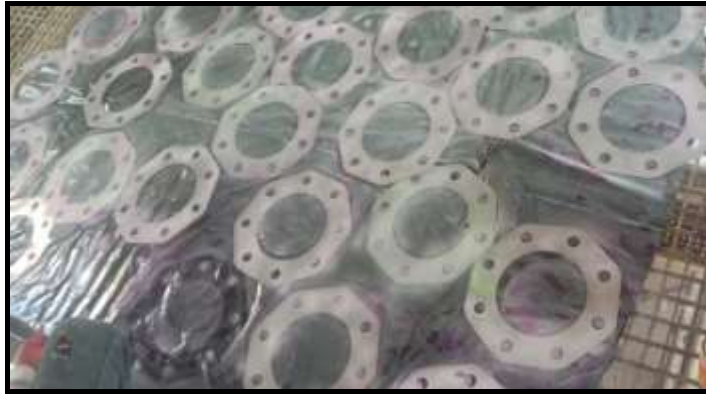
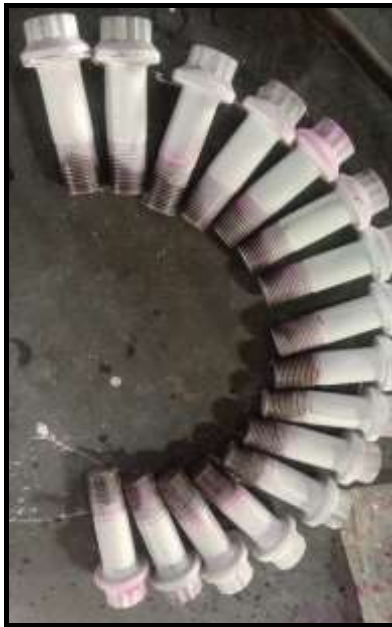
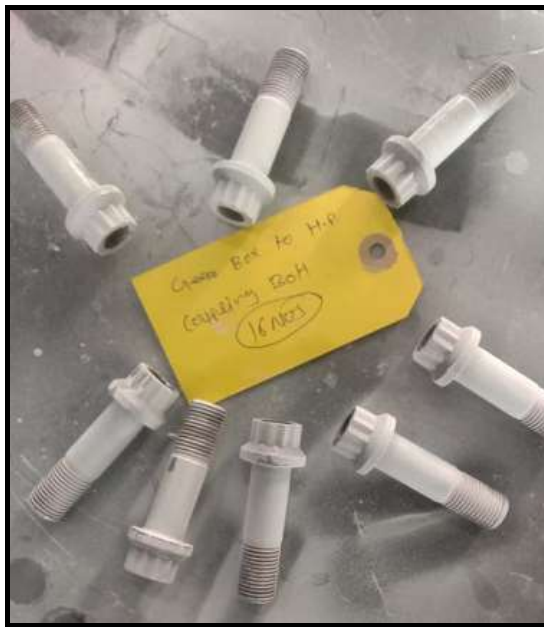
DP Test carried out on all coupling bolts and thick coupling shim discs of Co₂ Compressor.

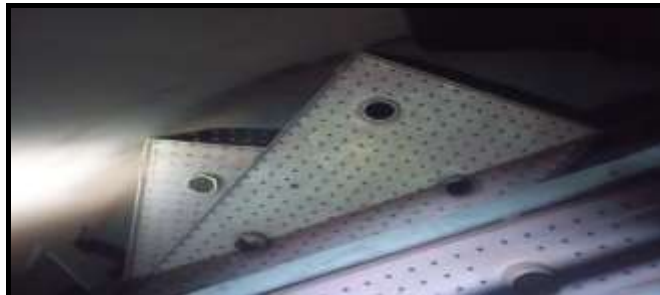
DEAERATOR TRAY SECTION

- Brownish coloration was observed inside the shell and dome area.
- 5th number Tray segment was found displaced from its original location as shown in below figure.

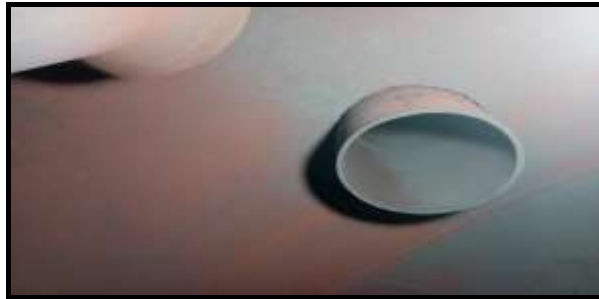
- Brownish coloration observed inside the vessel at shell and dish-end surface.
- Evaporator nozzle located at west side was found with incomplete weld from inside as shown in below figure.

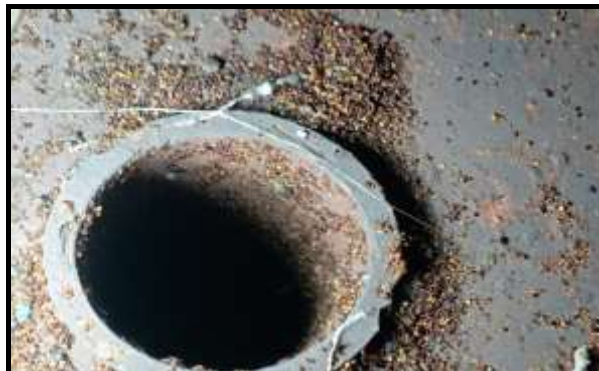
- Minor rusting observed at both dish ends.
- Resins were found near DM water line as shown in below figure.

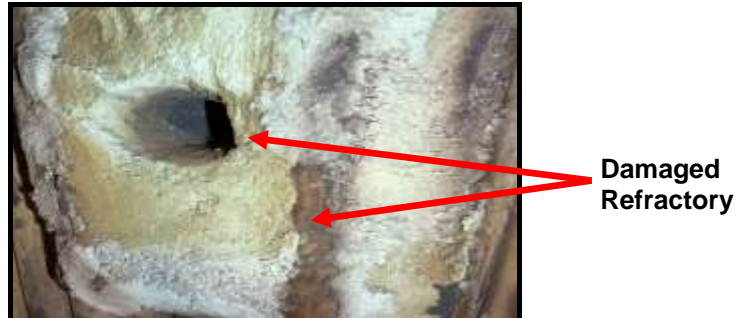
- Previously repaired east side refractory near to inspection glass refractory found in damage condition.

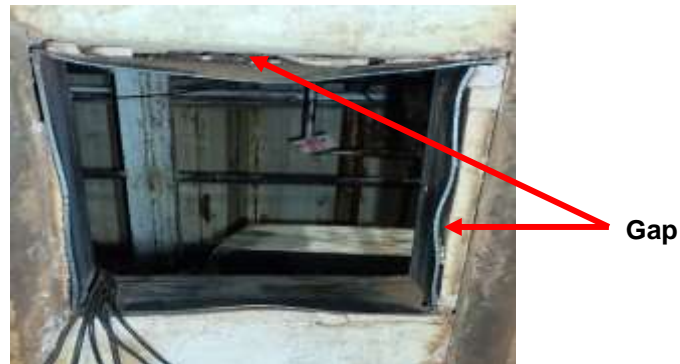
- Gap observed between manhole metal sheet and refractory.

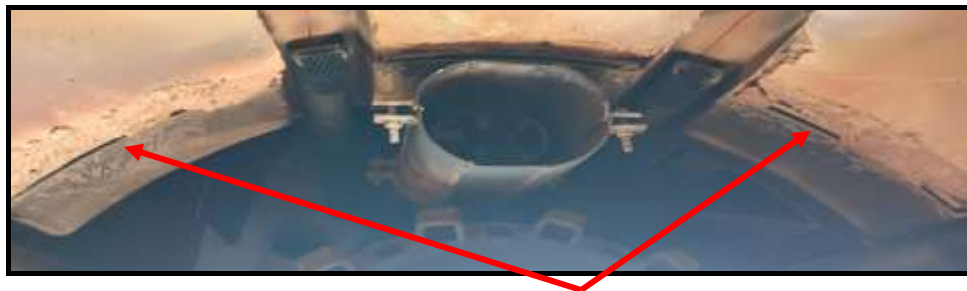
Damaged Refractory

- Minor rust and scaling observed on South wall, Front panel, Rear panel, Cut corner tubes and baffle wall tubes.
- Floor refractory was lifted upwards approx 6" at centre of furnace floor.
- Condition of thermo-wells in cut-corner wall found satisfactory
- Refractory around the bottom burner was found damaged also carbon deposition observed on all nozzles bottom burners.

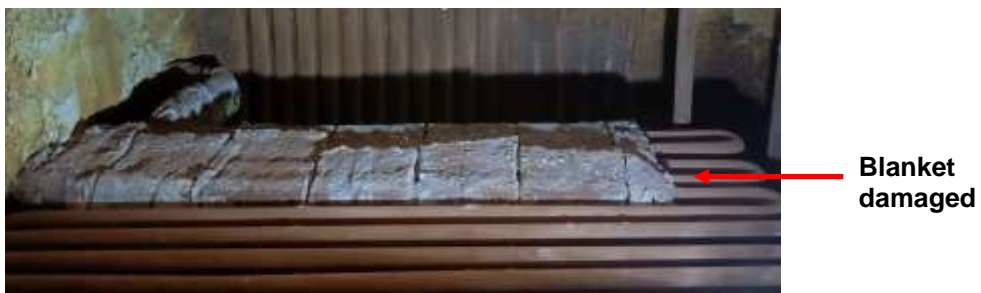
- Insulation fiber blankets placed on top of the Secondary superheater coil was found damage condition due to refractory fall down on it.

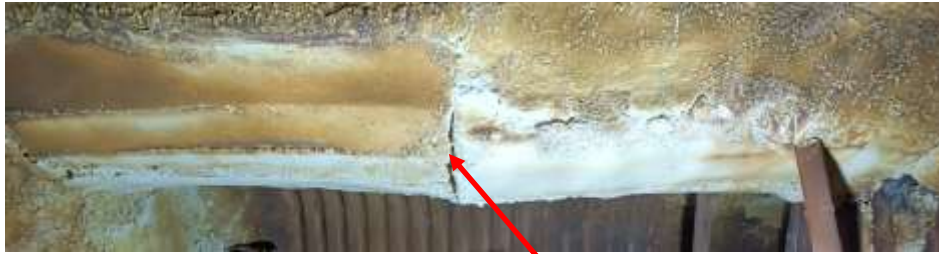
- Refractory found damaged and loosened above secondary super heater coil.

Damaged Refractory

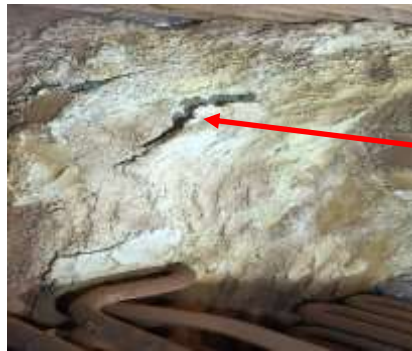
- Refractory found damaged and loosened near primary super heater coil west wall.

Damaged Refractory

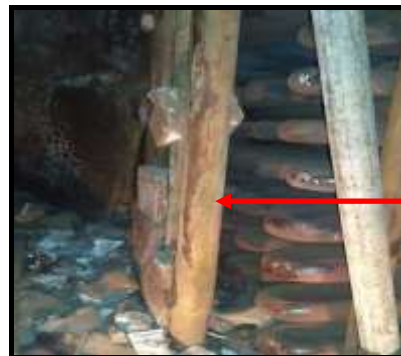
- Baffle wall tube refractory found damaged near secondary super heater.

Damaged Baffle wall

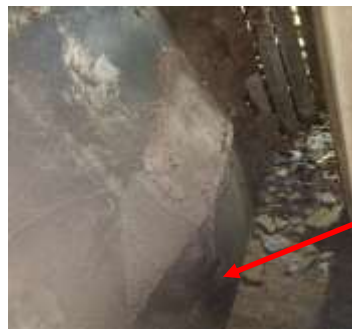
- Bulging was observed at baffle wall.

Bulging

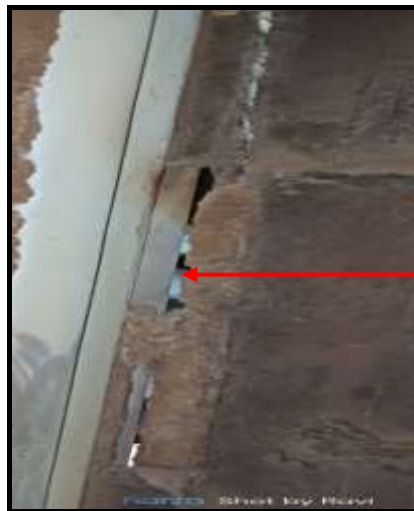
- Refractory was damaged condition at corner of wall.

Damaged

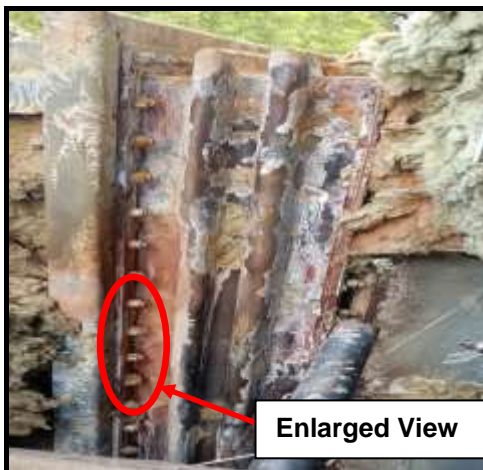
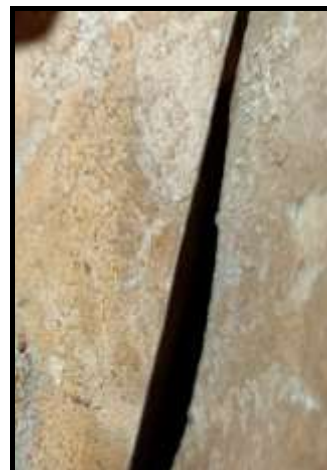
WEST SIDE

- Bellow found ruptured at location of appx.1.5 feet from top.

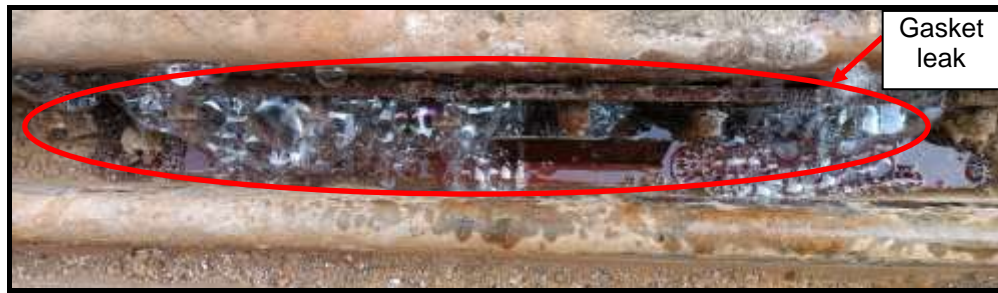
- Gasket was found leakage

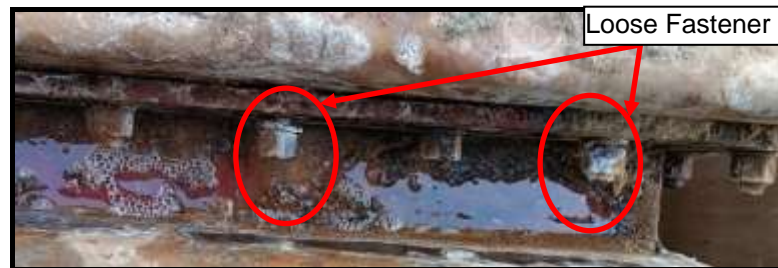
- Fasteners were found in loose condition.

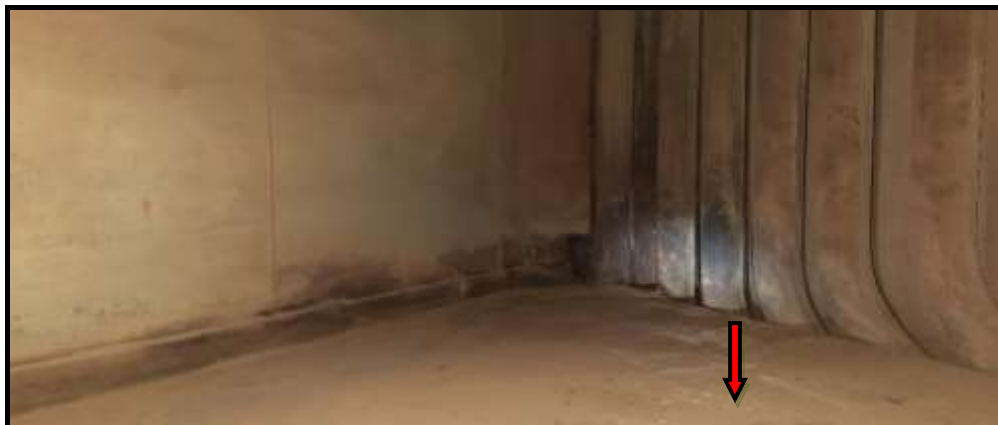
LOCATION : FLUE GAS DUCT AT THE BANK TUBE ZONE

- Erosion over the plate was observed inside the flue gas duct near bank tube zone as shown in below figure.

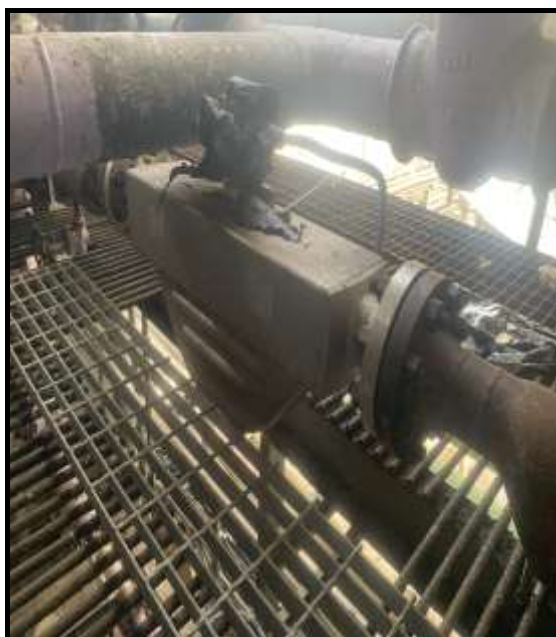
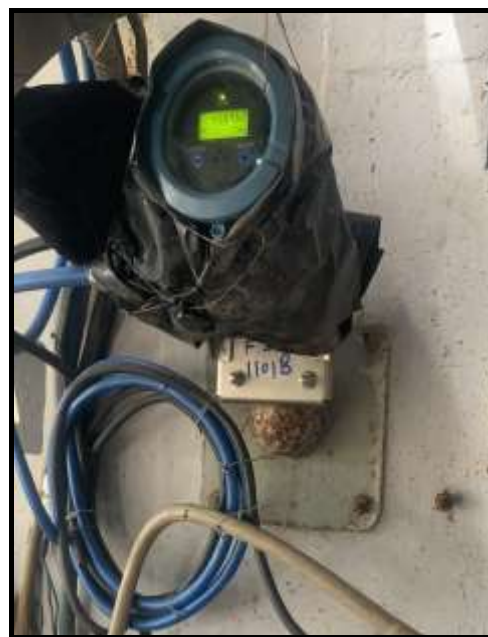
New Mass Flowmeter FS-1101B was installed parallel to existing mass flowmeter FS-1101A after mechanical line modification work. Transmitter mounting & cable laying work was completed & instrument was taken in line.

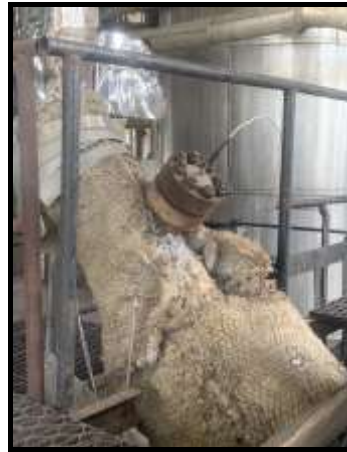
PDT-1212A: Extended diaphragm dual capillary type Differential Pressure sensor & Transmitter PDT-1212A of ABB make was replaced with new one from Yokogawa. Old seal & flanges was removed from LP & HP tapplings along with oil capillary & transmitter. New seal was inserted in tapping flange. Mounting flanges were tightened. Oil capillary were guided to transmitter mounting location. New transmitter was mounted & cable gland & termination work was completed.

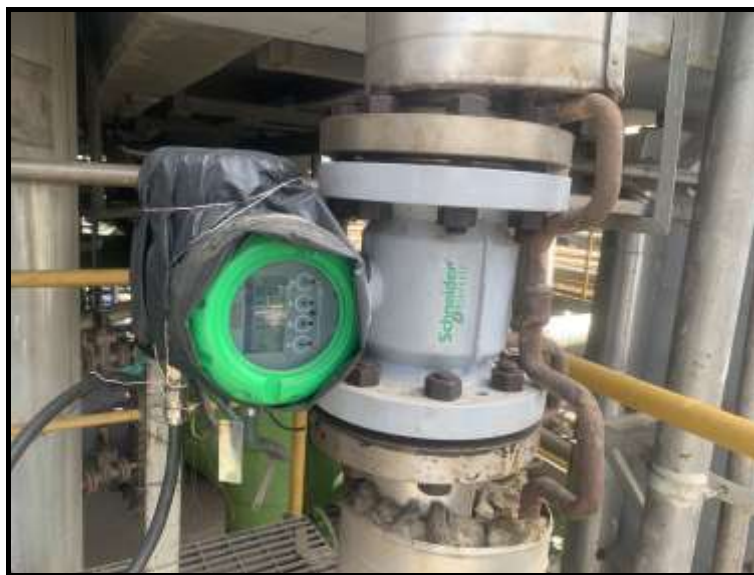
LICT-1501: 23-ata steam drum level: Old leveltrol was removed & GWR type level instrument was installed. Transmitter was mounted on platform & branch cable gland & termination work was done. Response of the radar was checked & instrument was taken in line.

FI-1204: Magnetic flowmeter: Old instrument was removed from line & new instrument was installed. Cable termination was done & transmitter was taken in line.

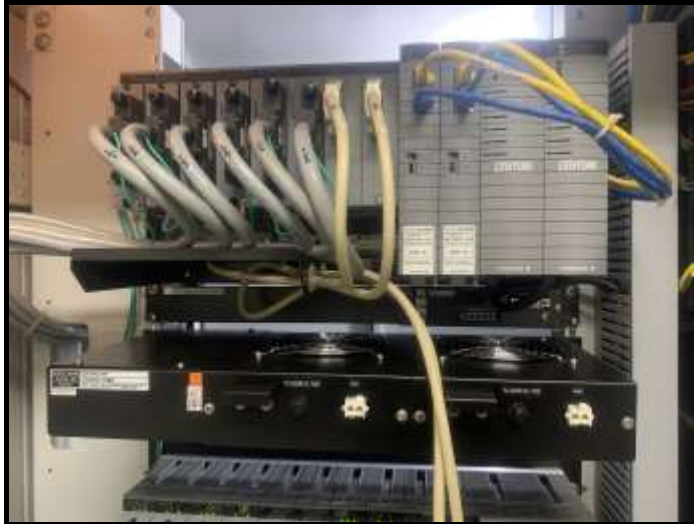
FCS0201 was upgraded from AFV10D to AFV30D. IO modules were removed from FCS node & Old FCS was removed. Then new FCS was installed & all IO modules were installed back. All LC64 & ST16 blocks were checked for proper operation.

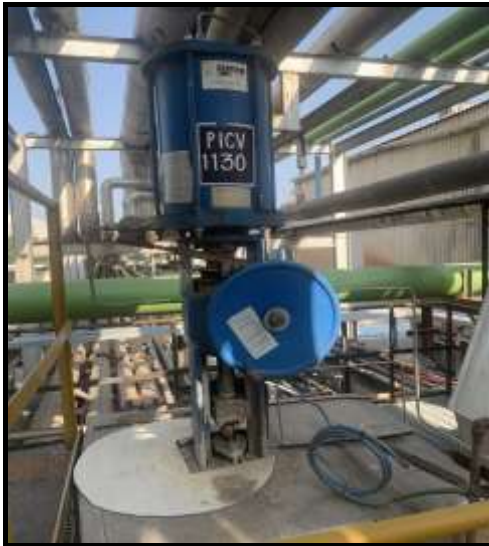
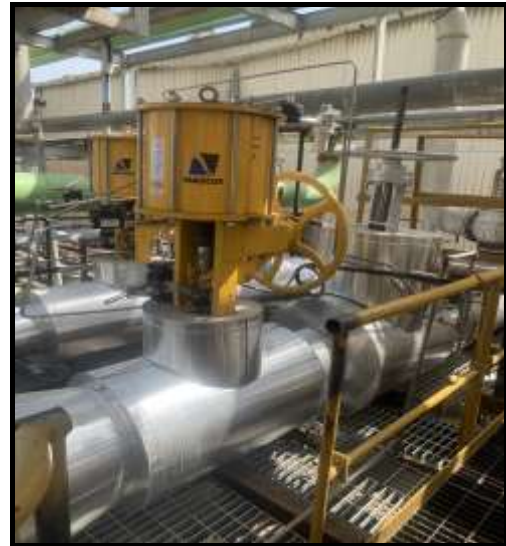
EWR U-365: To provide split pressure control valve for LS steam PICV-1130 A & B: Old Control valve PICV-1130 was dropped from line. After mechanical line modification, new Control valve PICV-1130A was lifted to the location & installation was carried out. All electrical & pneumatic connections were done. Control valve stroke checking was carried out & positioner calibration was done. Then it was taken in line. After mechanical line modification, New Control valve **PICV-1130B** was lifted to the location & installation was carried out. New branch cable was laid. All electrical & pneumatic connections were done. Control valve stroke checking was carried out & positioner calibration was done. Then it was taken in line.

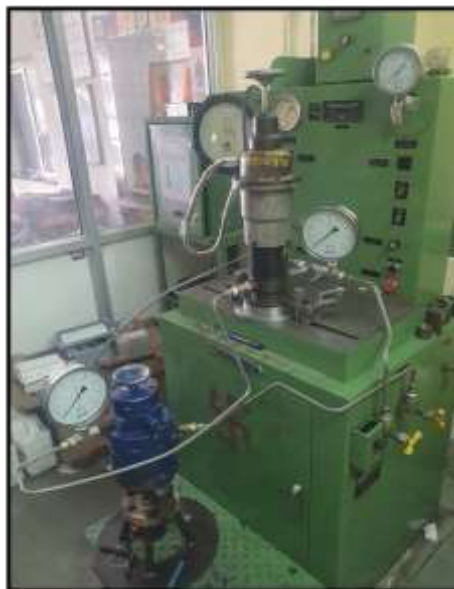
Fig – Governor/actuator Test Bench

- HIC-3- FD fan turbine speed control loop output to governor operation checked, I/P zero adjusted as per requirement.
- New Spare Yokogawa I/P configure for HIC-3 control loop.
- Operation checked for both Installed Turbine Trip SOV and Spare SOV (issued from store).
- Facilitate Mechanical Maintenance for testing Governor and oil Servo on test Bench by providing necessary tubing work, fabrication of BSP pipe fittings and other important activities.
- RPM meter of Governor Test Bench was not working same was attended.

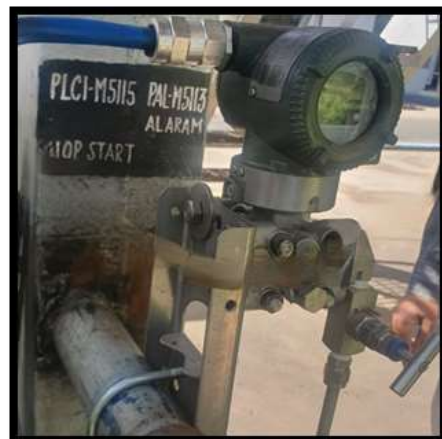
Pressure Transmitter

Old digital Pressure switch was out of calibration range. So, replaced with pressure transmitter with advantage that it will provide real time lube oil pressure value on DCS for better operation reliability.

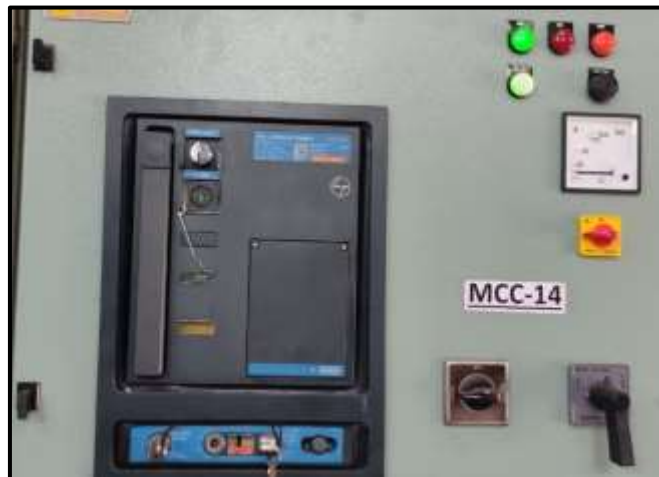
Feeder Modification in MCC-15 for second source arrangement for MCC-14

800 A ACB feeder has been upgraded to 1600 A feeder in MCC-15 to feed MCC-14 in case of outage/failure of Single transformer (TR-17) of MCC-14. Image are added below for reference:

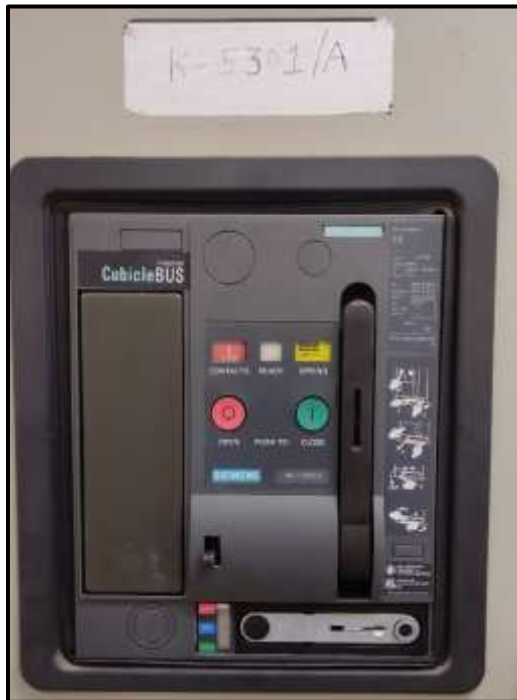
Upgradation of ACB feeder for K-5301A

Upgradation of ACB feeder from 800 A to 1250A has been carried out to cater the load of 250 KW screw compressor. Images are added for reference:

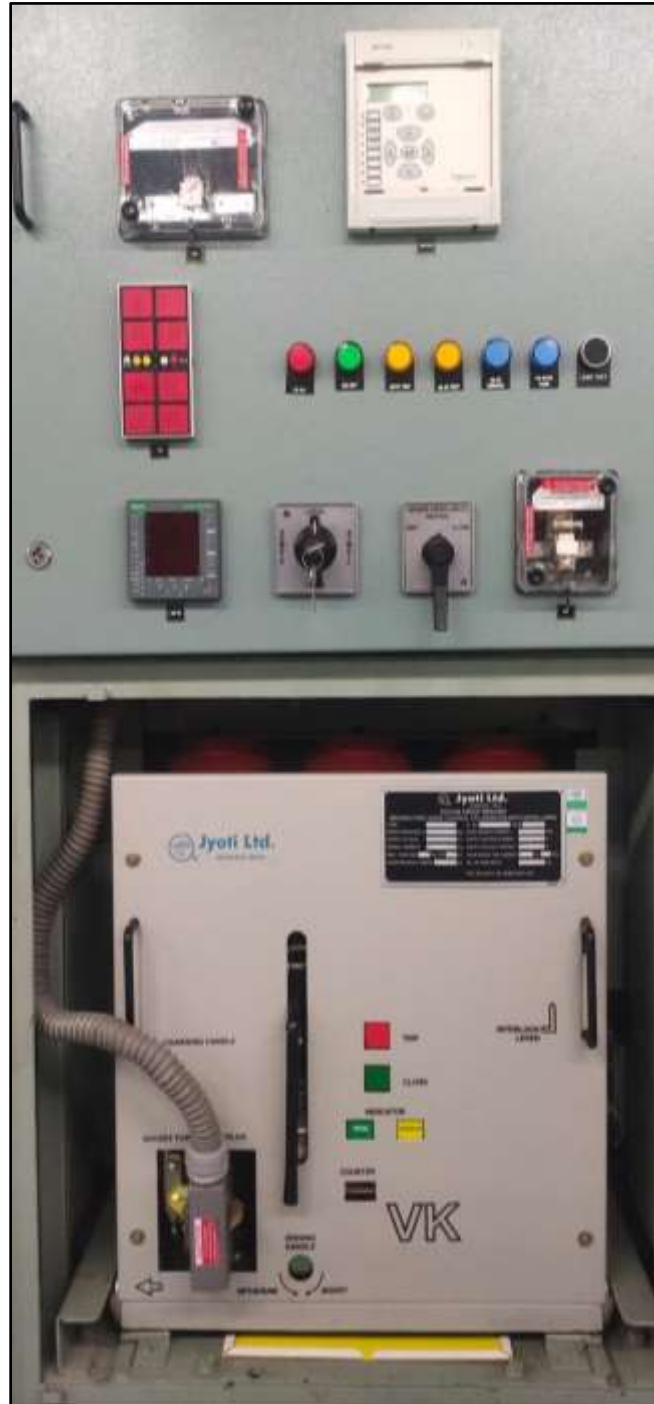
11 KV feeder modification job has been carried out to cater the load of new upcoming HP Ammonia pump P-1102D. The new VCB has been retrofitted and CT's have been replaced to take load of 2500 KVA 11/3.3 KV transformer. Images are added below for reference.

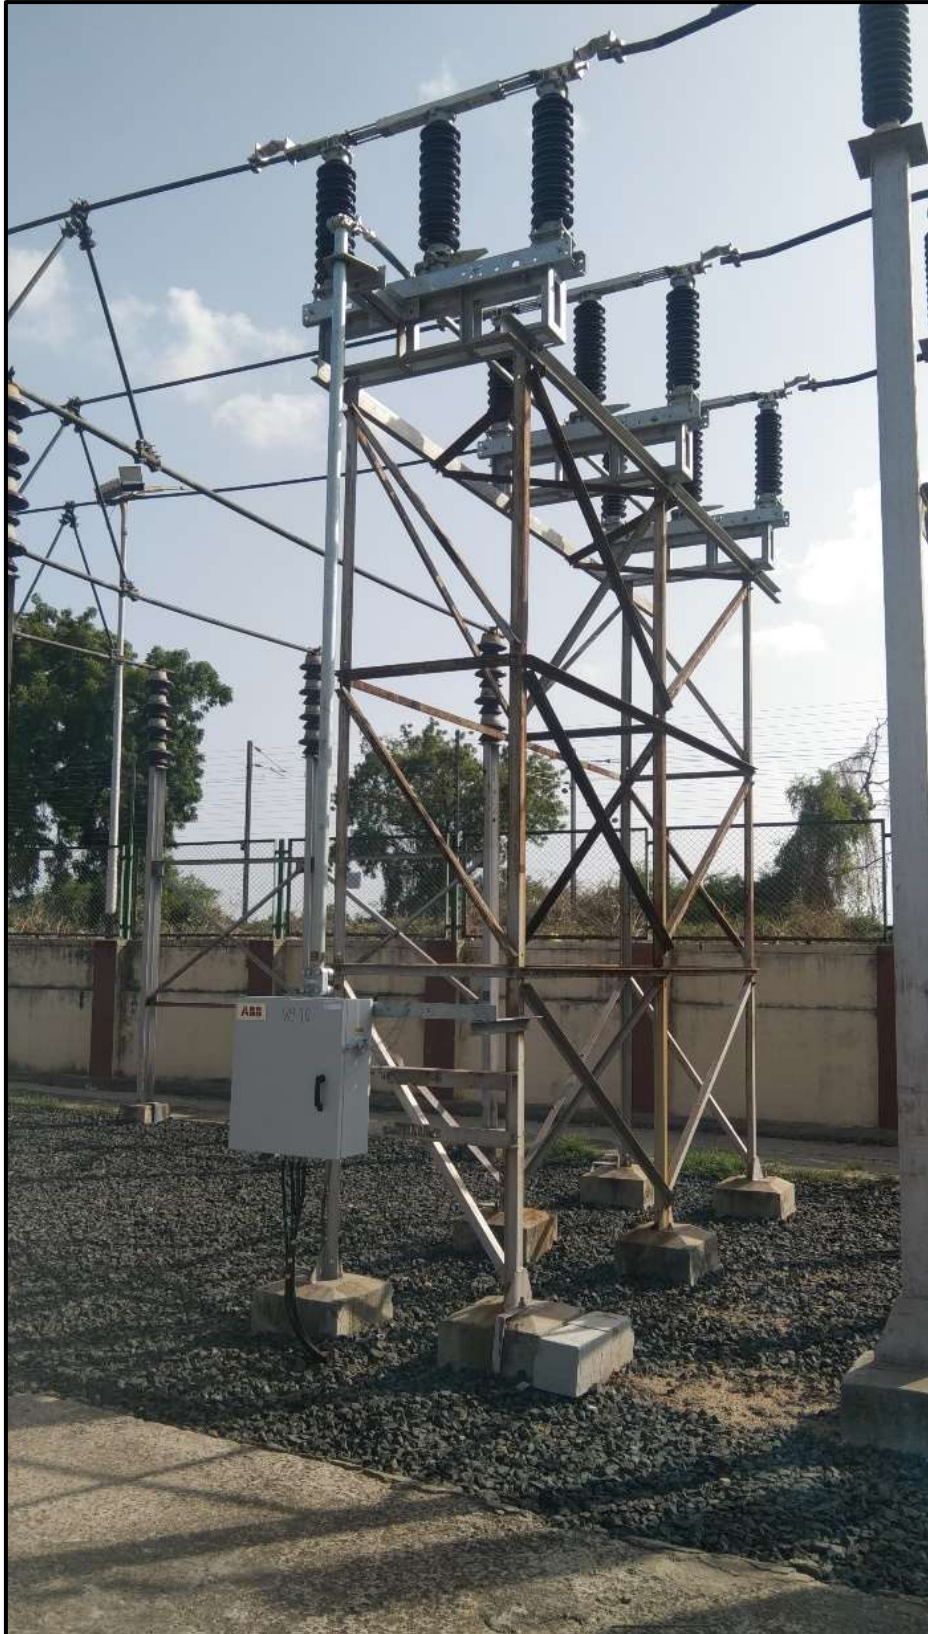
- All old and aged DC control cables replaced by new DC cables to avoid tripping of feeders.
- Three no. old isolators (89-7 ,89-9 and 89-10) have been replaced with 800 A ABB make motorized isolators at 66 KV yard. images are added below for reference:

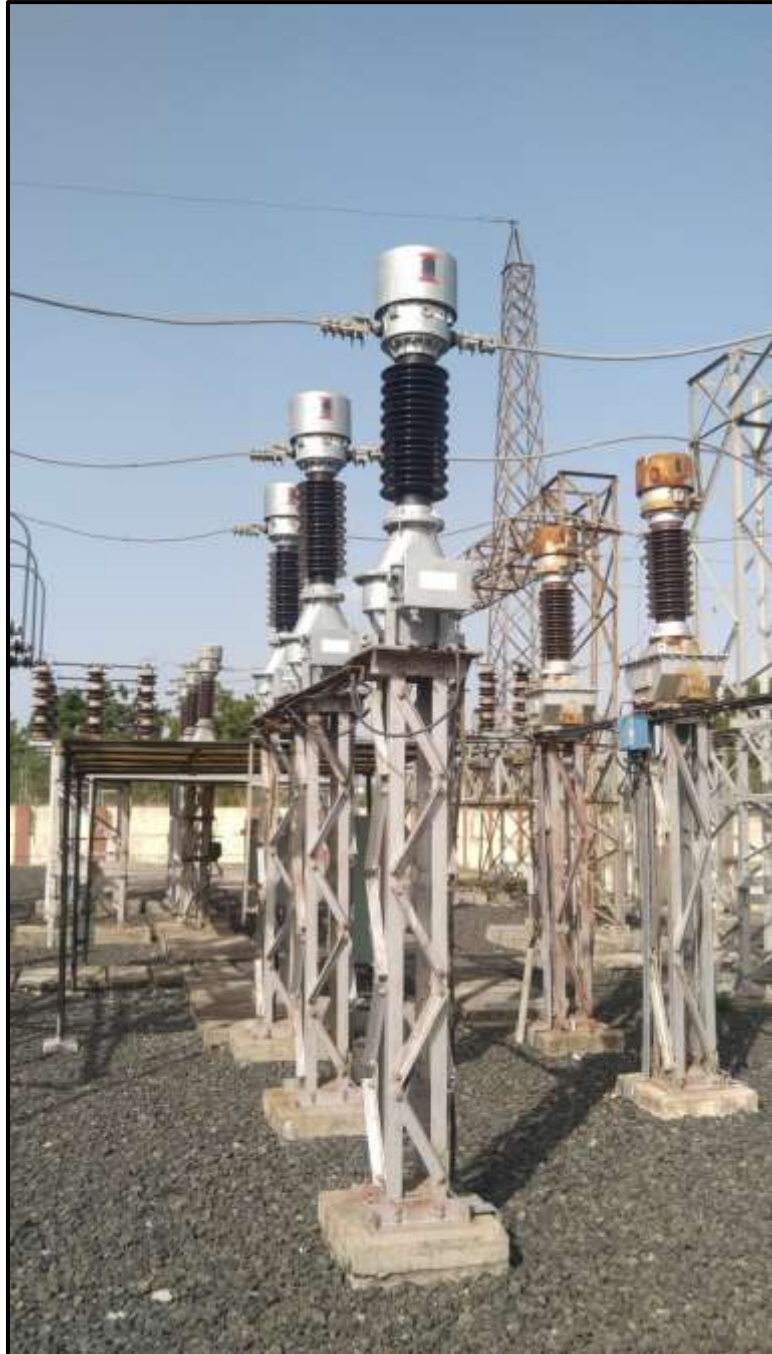
- Maintenance of CRP panel have been carried out at 66 KV yard.
- CT replacement have been carried out in Chhatral line from 100/1 to 150/1 to cater the enhance demand of 13.5 MVA. Total 3 CT's have been replaced under the supervision of GETCO/UGVCL. Images are added below for reference:

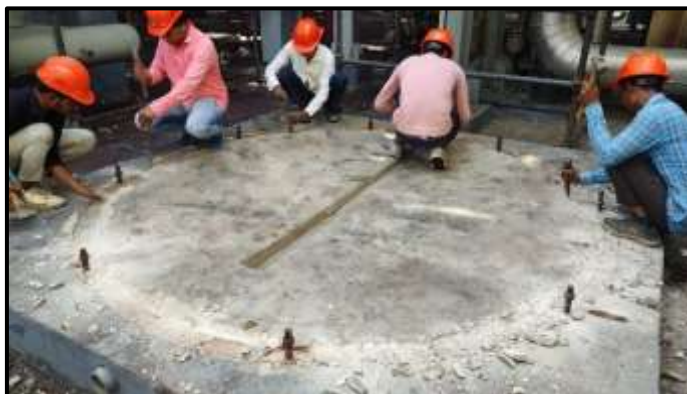
103-F (CO2 stripper reflux drum) Foundation modification

The foundation modification work to install the 103-F (CO2 stripper reflux drum) was carried out in Ammonia Plant.
