MTC / REPORT / 01
REPORT NO. 40 / 2023

PLANT TURNAROUND REPORT
(APRIL – 2023)

INDIAN FARMERS FERTILISER CO.-OP. LIMITED

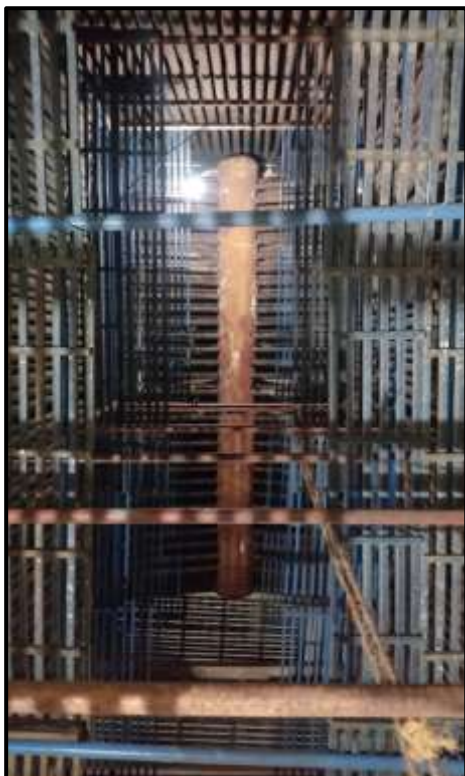
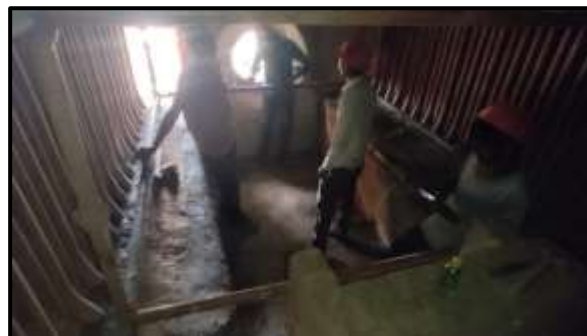
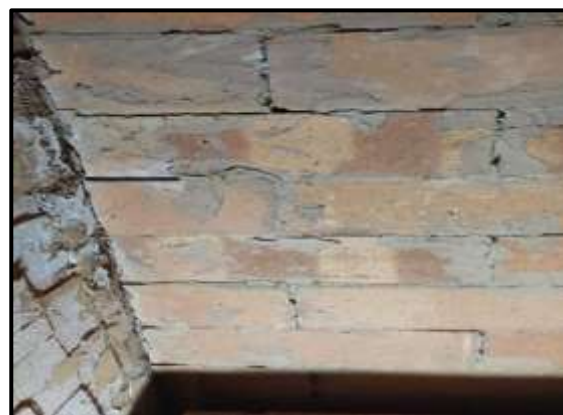
Refractory repairing jobs in primary reformer (HT & LT zone), Auxillary boiler and secondary reformer

The refractory repairing in primary reformer & auxiliary boiler was carried out. The 20 no. of tunnel blocks in primary reformer were replaced. The casting of auxiliary boiler side panels was carried out by civil section using the refractory material "Insulyte-11".

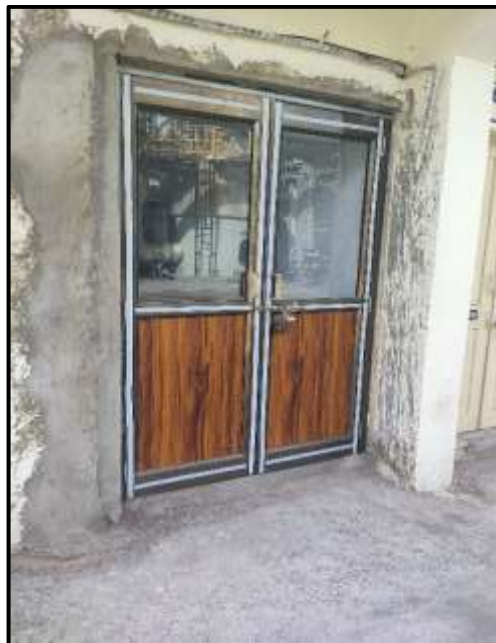
Re-Installation of UPSS Room Door:

Removed the Door to Change the Panel in the UPSS Room in the Ammonia Plant and After Changing the Panel, Installed a New Door.

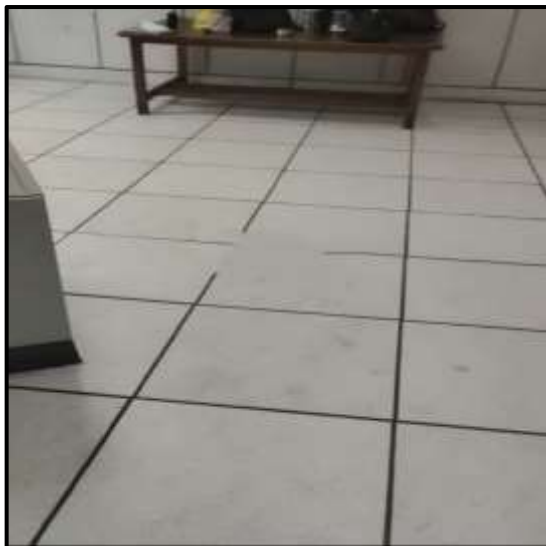
New False Flooring in Ammonia Control Room and UPSS Room:

The Damaged False Flooring was replaced in Ammonia Control Room and UPSS Room.

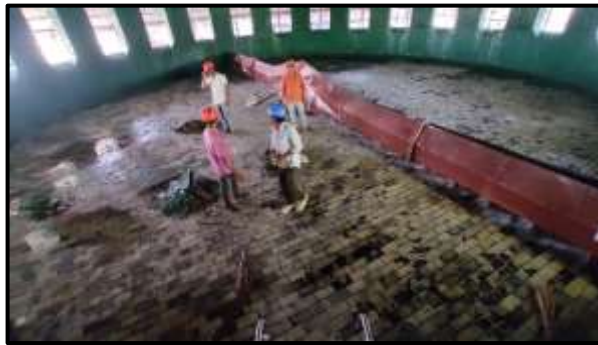
Anti-corrosive treatment of scrapper floor in prill tower

The inside surface of prilling tower was badly corroded, so epoxy painting was necessary for life of prill tower.

Anti-corrosive treatment of prill tower inside Scrapper Floor was done by M/S Gayatri Construction. The epoxy coating of scrapper floor and refixing of acid proof brick lining was also done.

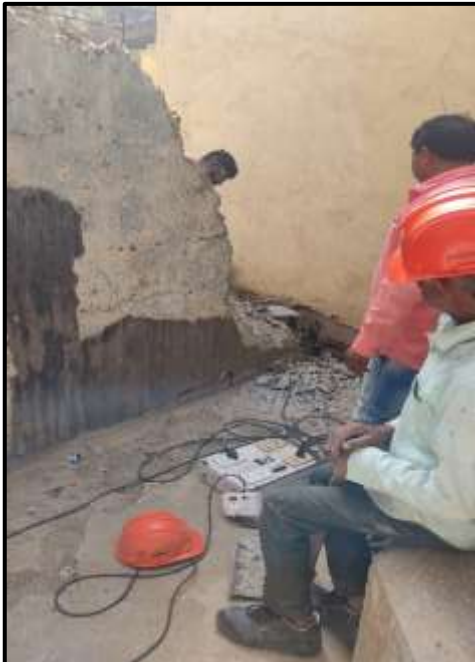
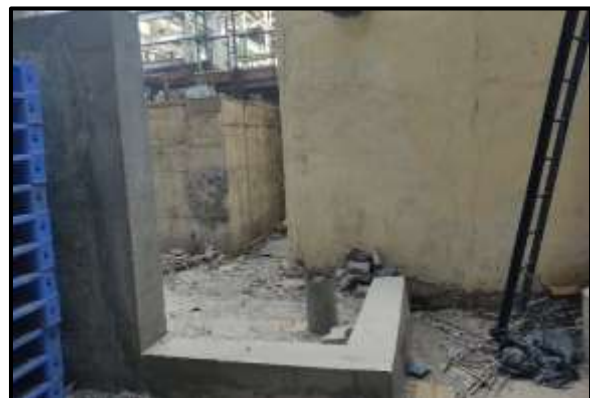
Dismantling of CO2 Sump in Urea Plant:

The CO2 sump was abundant, so dismantling of the same was done in urea plant.

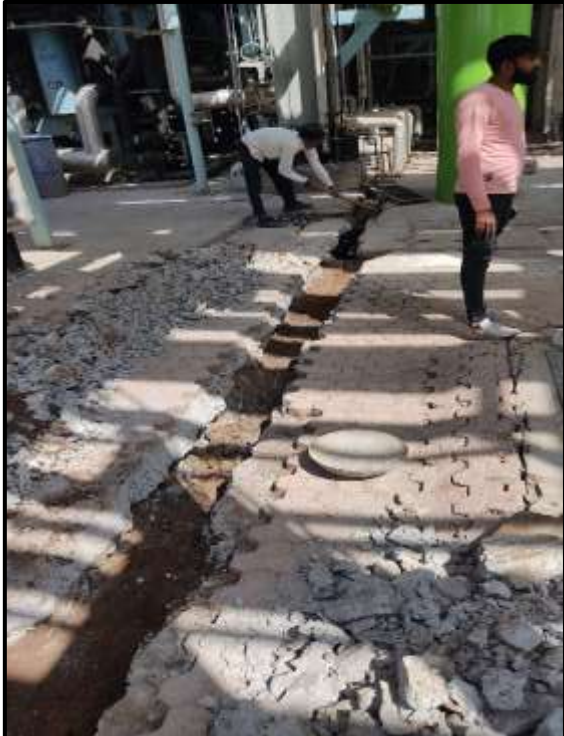
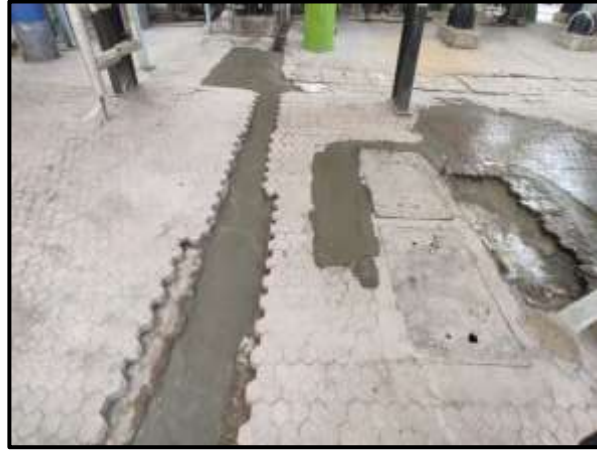
Drain Pipe Connection and Concreting Work:

There was a Drain Line leakage in the Urea Plant. Due to this waste water is seeping inside the nearby Cable channel. New line was provided to avoid the further seepage.

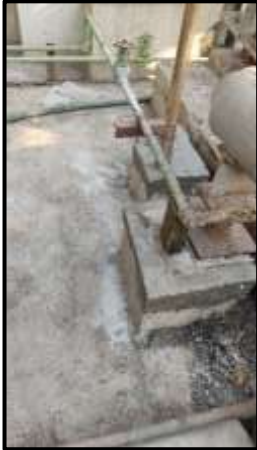
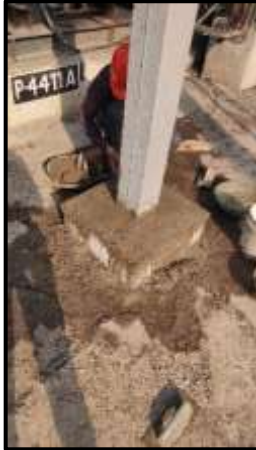
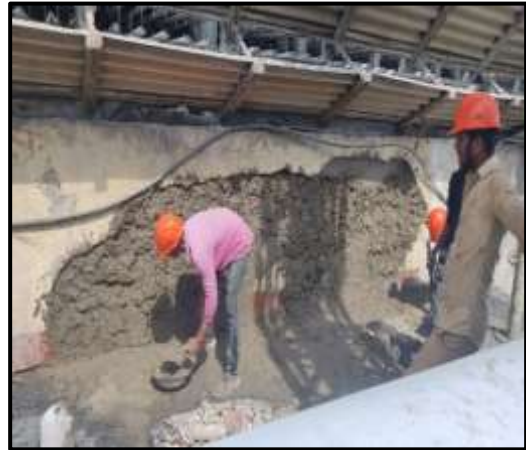
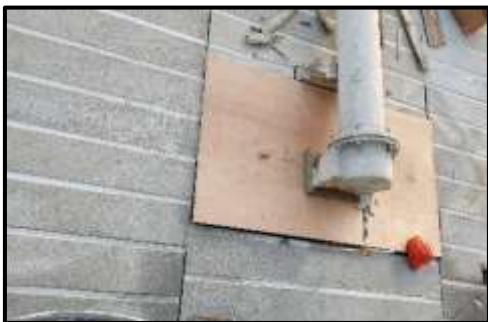
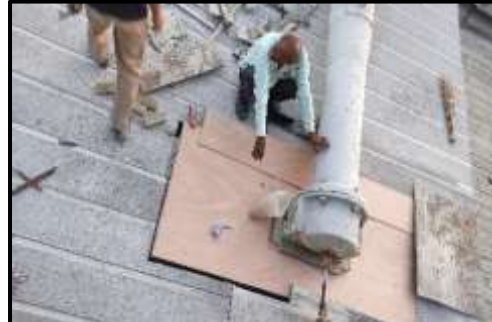
Plaster Work of Foundations & Columns

Removed Loose Plaster and re-plastering work of foundations, Columns and Cooling Tower Sump Walls.

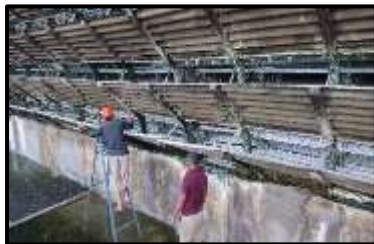
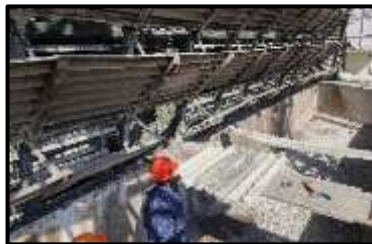
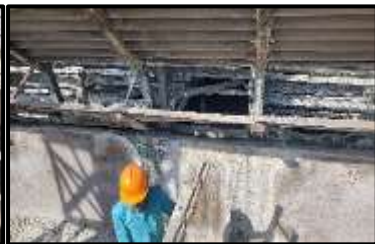
Repairing of Louvers in Cooling Tower

It was observed that various structural Supports were damaged above Cooling Tower. So, Repairing of Damaged Supports by using 19 mm water proof plywood.

The Louvers of Cooling Tower were Damaged which were repaired.

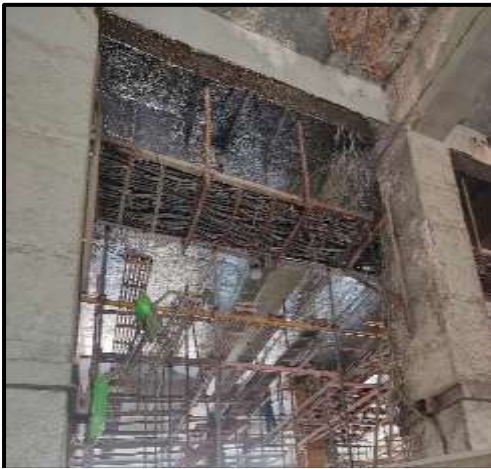
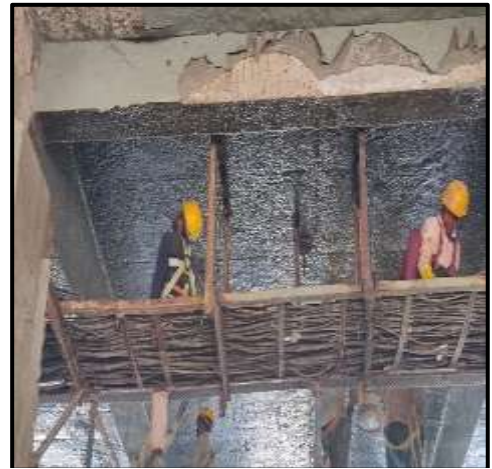
The condition of the concrete structure in conveyor gallery & Loading Floor is deteriorated. To rehabilitate the concrete condition, epoxy painting was carried out in B&MH plant. M/S. Gayatri Construction Co. did the epoxy painting job.

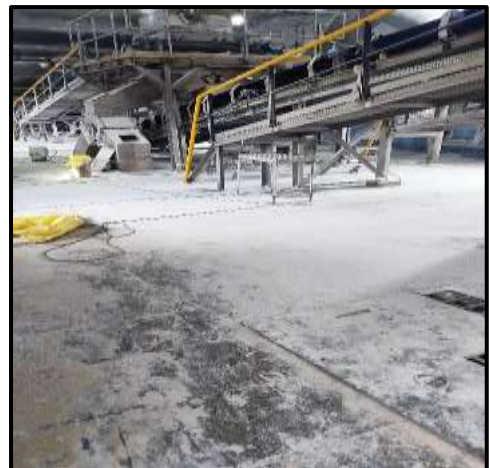
Construction of cutout and anchor fastening for splitting of conveyor belt 2122

Two cutouts were made and anchor fastening was done for splitting of conveyor 2122 in B&Mh plant.

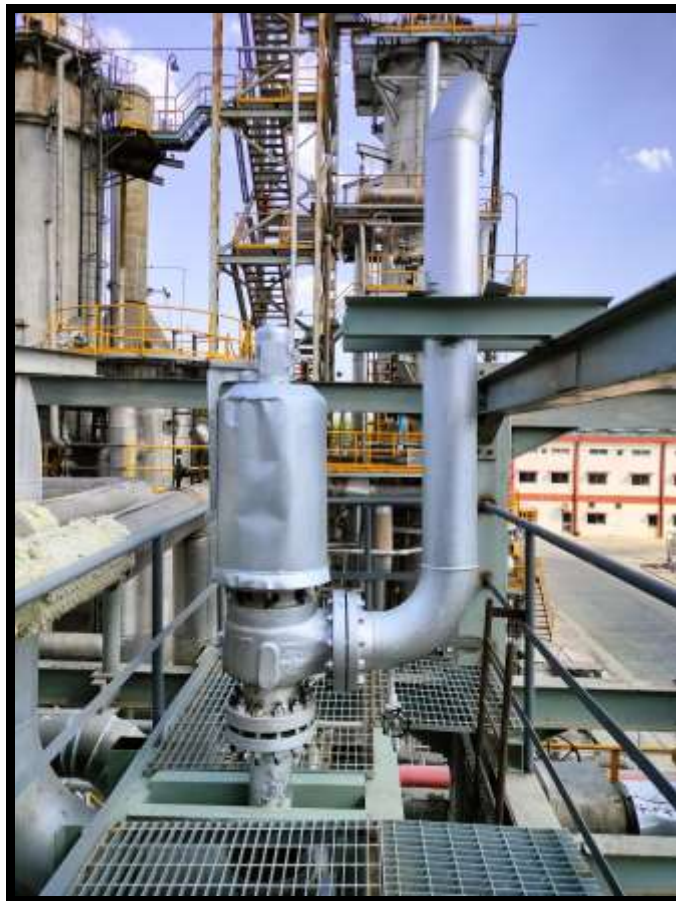
New PSV

Previously, only one relief valve (RV-MS-9) with isolation valve was installed on MP steam header (MS-1-8"). It was observed that MP steam header safety was at risk, when this relief valve is isolated for maintenance purpose. Therefore, to ensure the safety of MP steam header, additional PSV is installed towards the back end of Ammonia Plant by undertaking required line modifications with IBR approval.

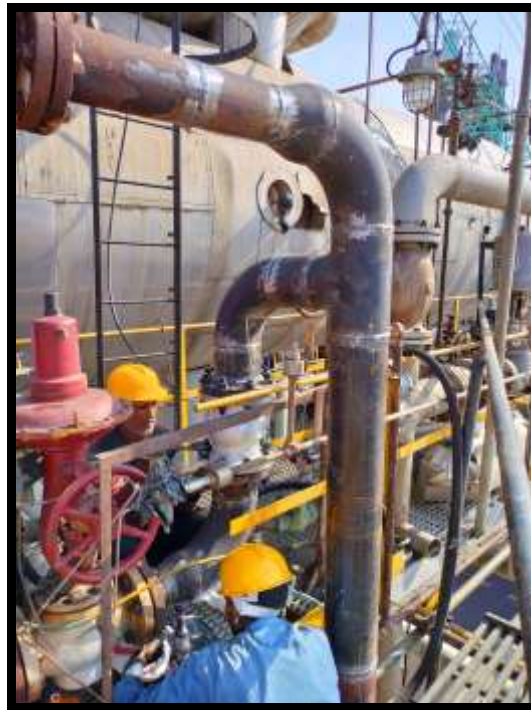
PICV 16

Therefore, isolation valves are provided at upstream & downstream of PICV-16, by undertaking required line modifications with IBR approval.

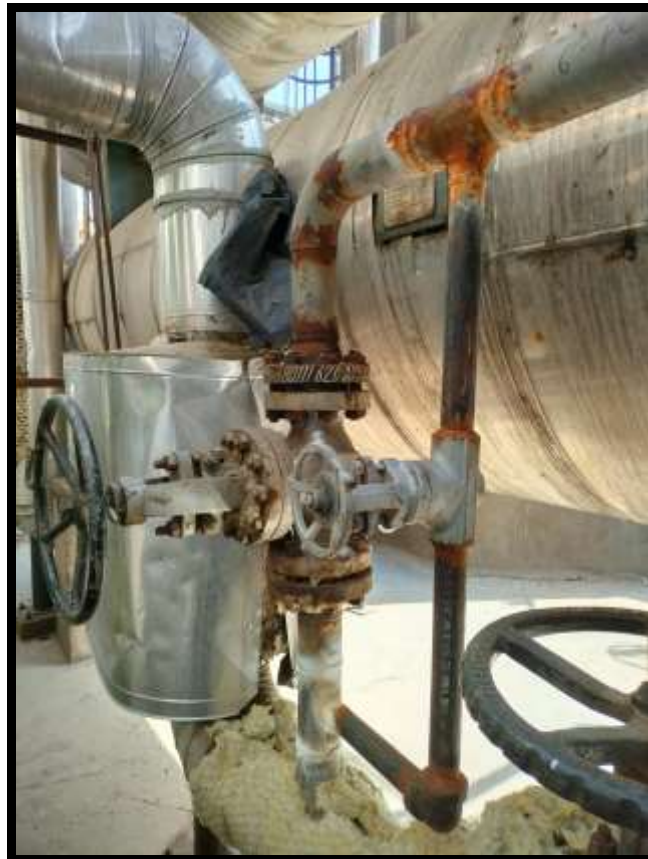
1.5" bypass line

Provision of 1.5" Bypass line with isolation valve (Globe) at the level control valve of 1104-E (LIC-3018) was made to address the problem of high vibration in 3" LIC-3018 Bypass line.

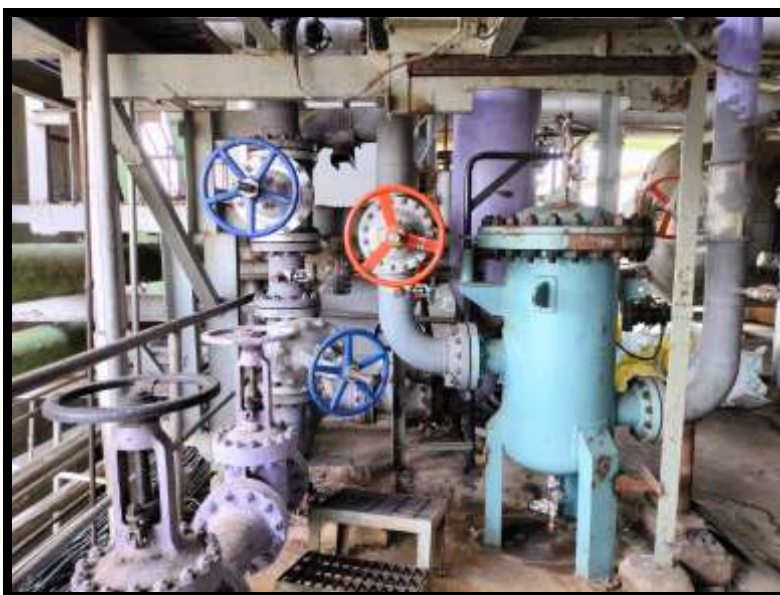
New oil filter

Liquid ammonia from Ammonia Plant or from ammonia storage tanks, after preheating is filtered for suspended impurities in ammonia filter (V-1102). It was observed that liquid ammonia, used as feed stock contains about 3-5 ppm oil, coming from oil seals of upstream compressors, which caused operational bottle necks in HP section.

In view of the above, suitable piping modifications were carried out to provide new oil removal filter with double isolation valves, in parallel to existing filter in liquid ammonia stream, to avoid any operational bottlenecks in HP section.
