KALOL UNIT

PLANT TURNAROUND REPORT
(MARCH – APRIL – 2017)

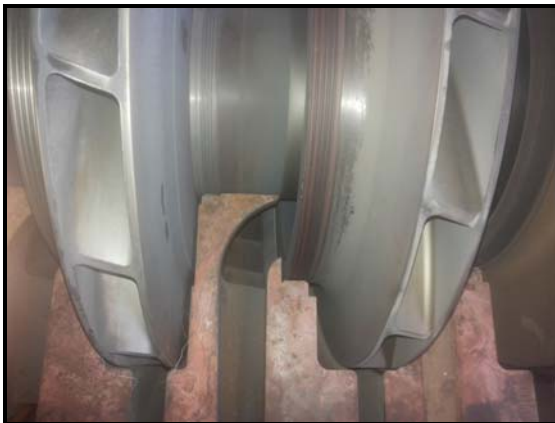
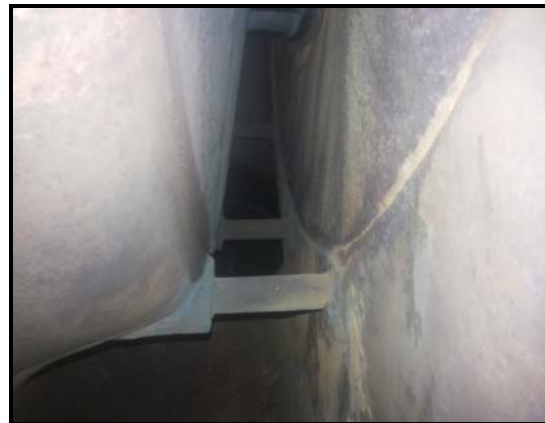
101-JLP was decoupled from both ends. Casing bolts were opened & compressor casing top half lifted by using crane. After opening, it was observed that the condition of rotor, diaphragm and flow path is good and there was no major dust/corrosion in these areas.

View of internals after removal of top casing

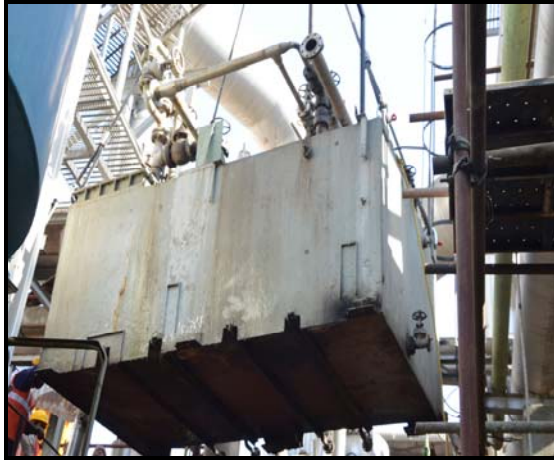
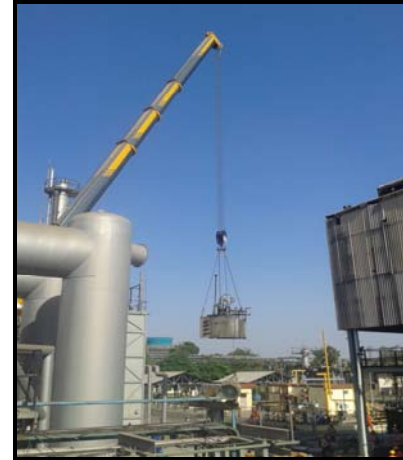
Dismantling & Removal of existing 101-J / 105-J LO console

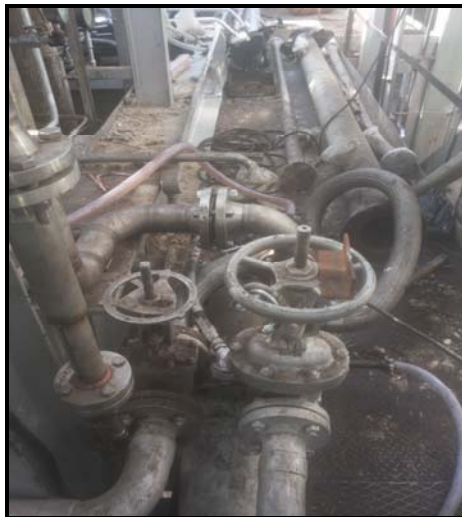
105-J GO and LO lines bypassed

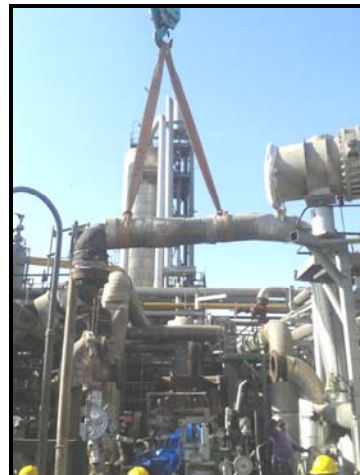
Removal of Steam Inlet & Extraction Piping

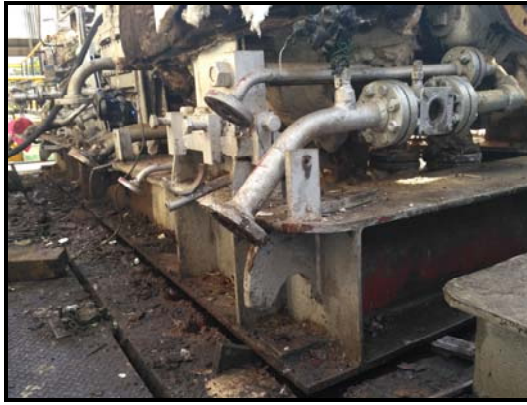
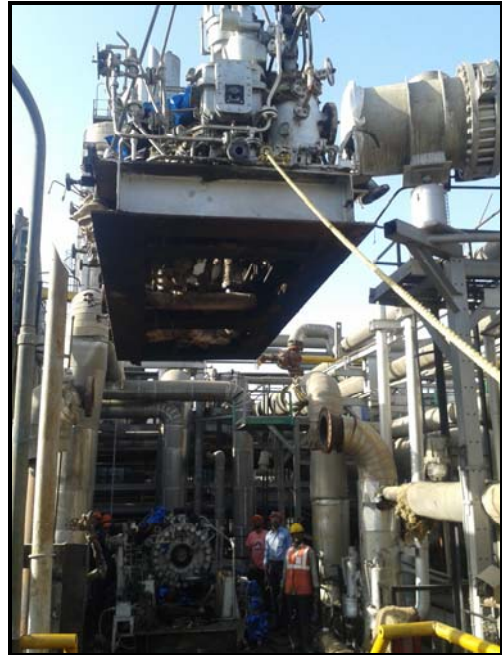
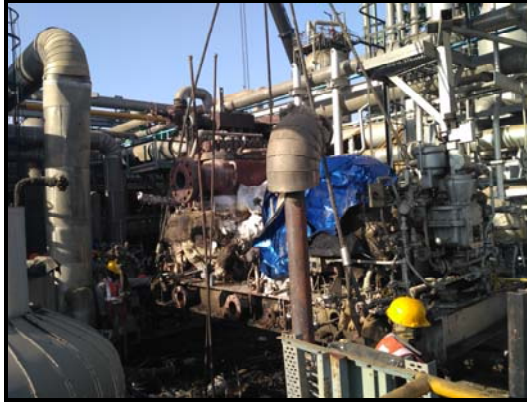
Removal of 103-JAT & 103-JBT alongwith baseframe

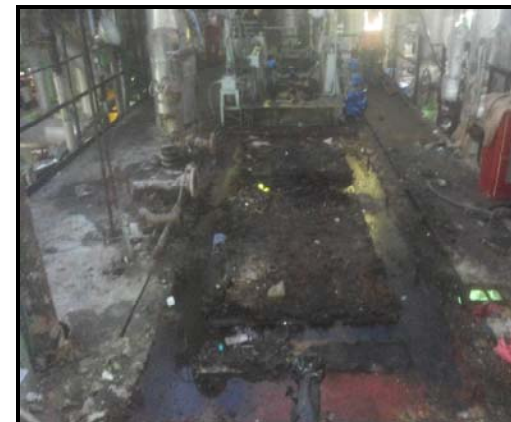
Foundation of 103-JAT and JBT after removal

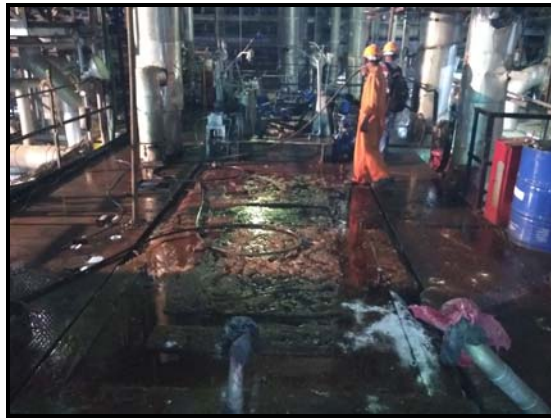
Turbine Floor Cleaning

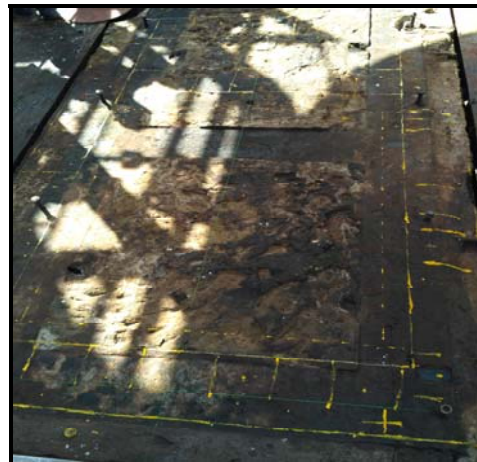
Marking of New Turbine Base frame layout on floor

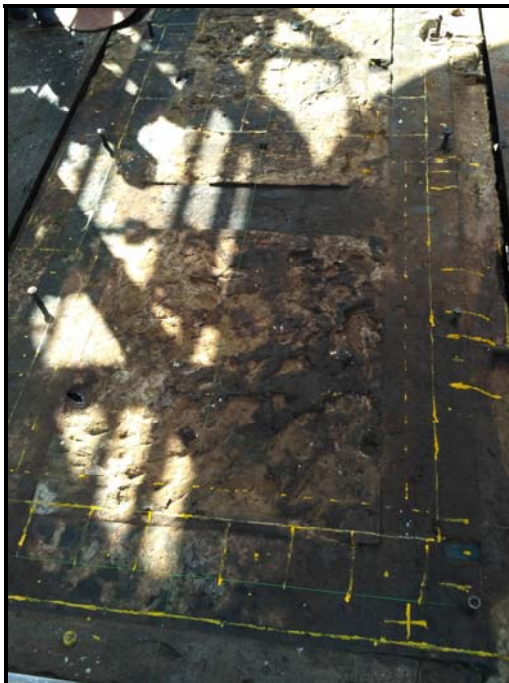
Packer Plate positions marked on floor

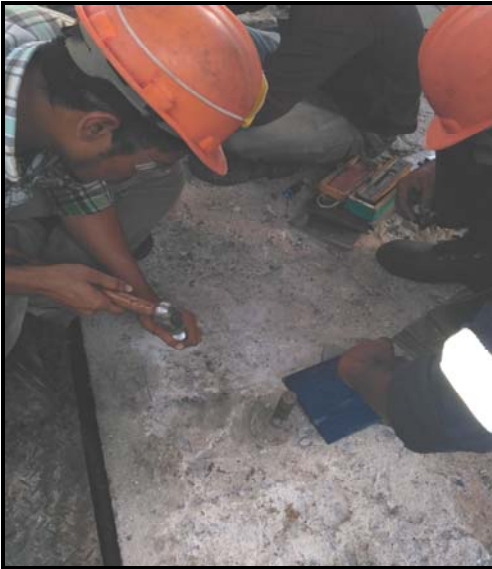
Micro chipping

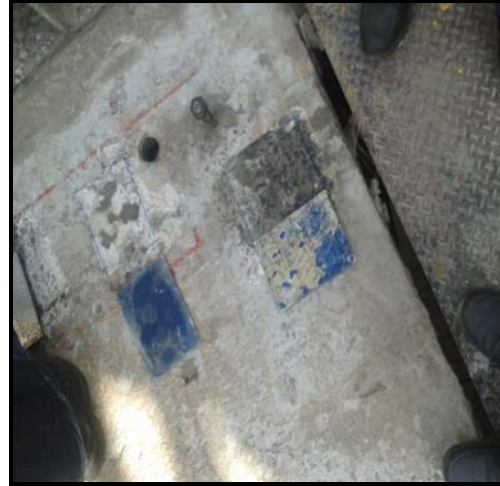
Blue check of Packer Plates

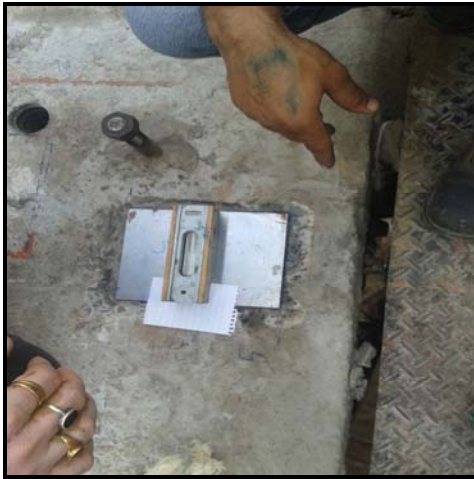
Packer Plate Level checking by Master Level

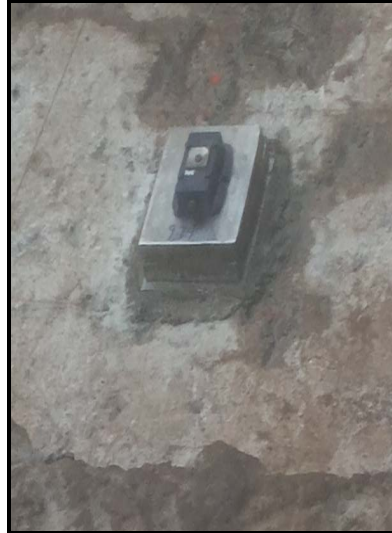
Shim plates and fixator

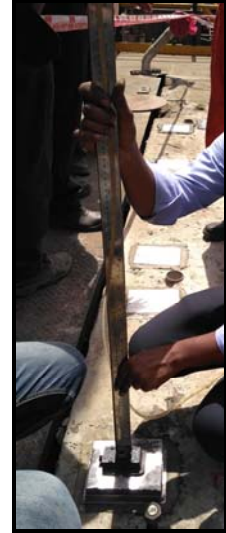
Level checking

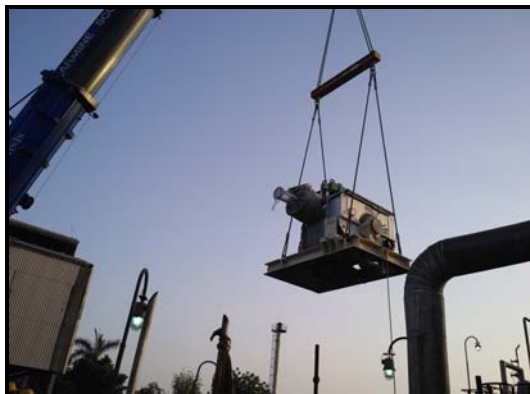
Turbine being lifted

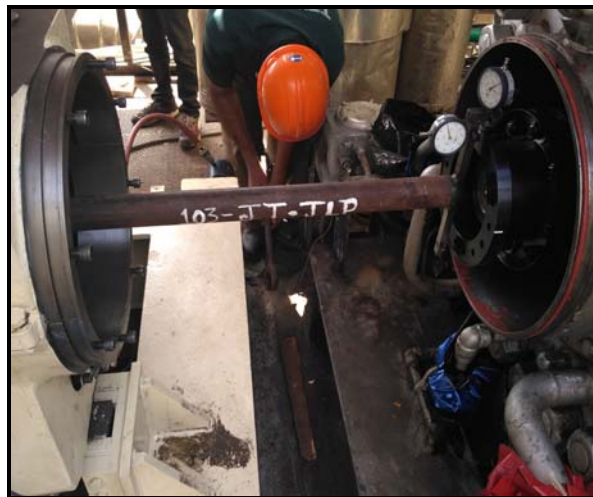
Alignment Fixture fixed

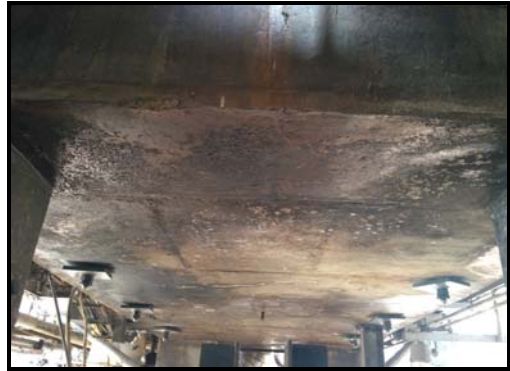
Lock Plate fixed from bottom

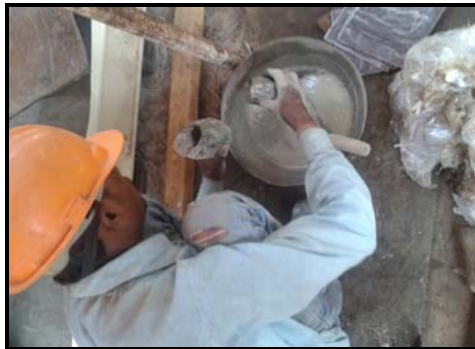
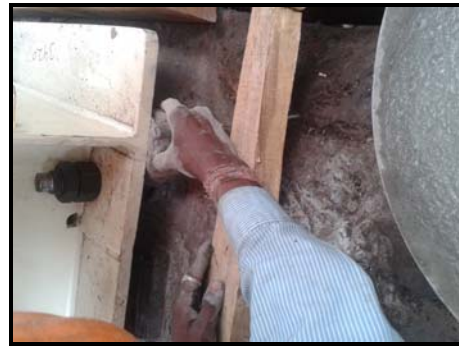
Shrinkkomp filling in the pockets of foundation holes

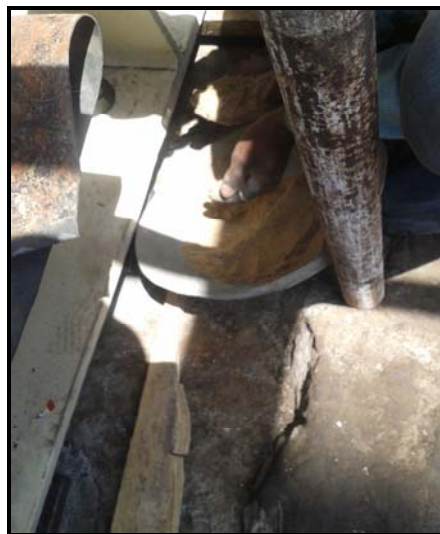
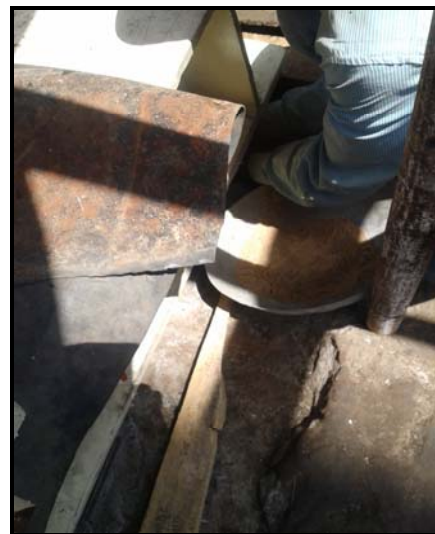
Sand filling in the pockets of foundation holes

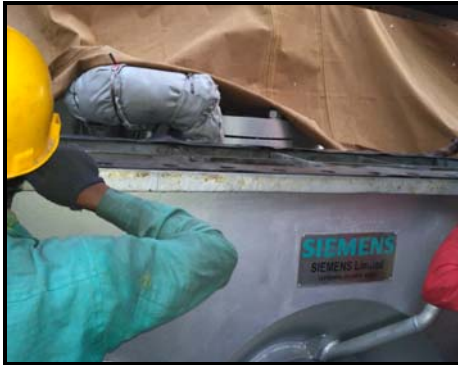
Installation of Transition Piece

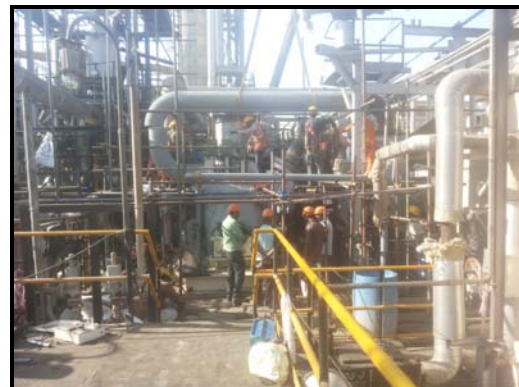
Extraction line fabrication u/p

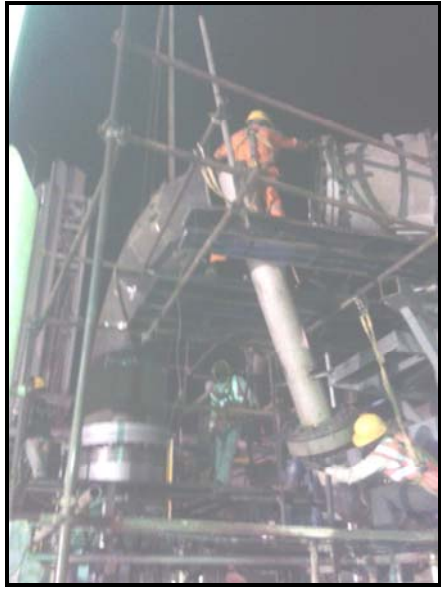
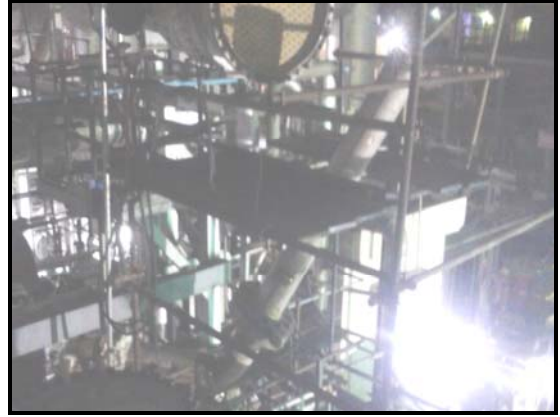
Blowing arrangement of Steam inlet line

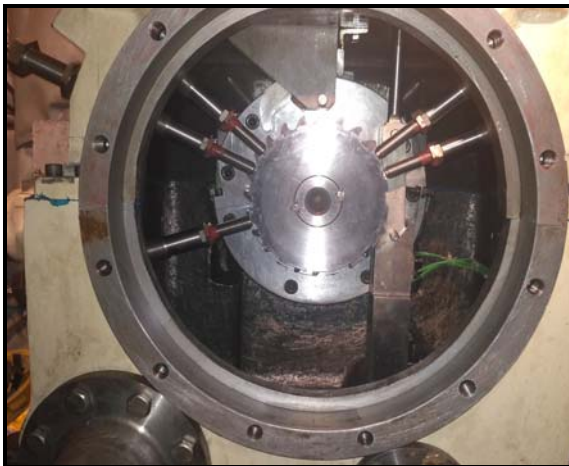
Front end bearing housing view

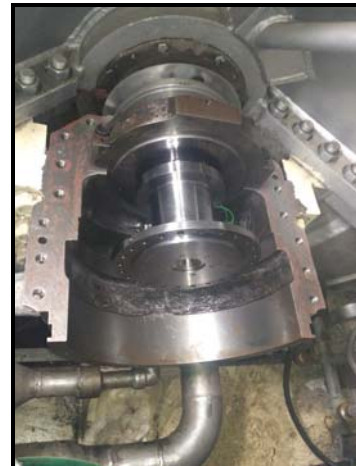
Rear end bearing housing view

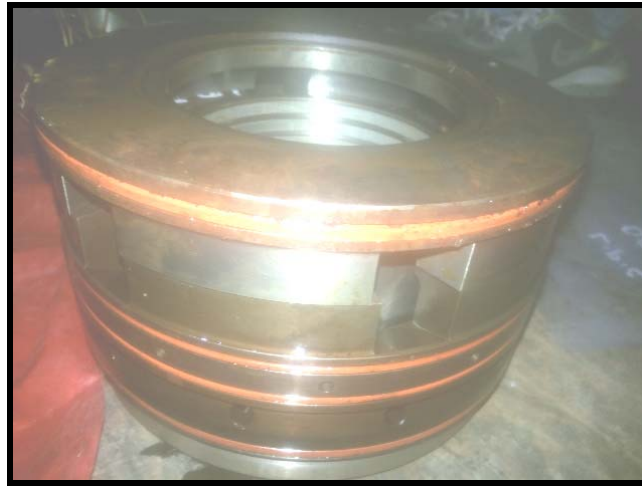
- The intake & discharge end seal assemblies were taken out with the help of tool supplied by DR applying the procedure given in the manual, page no. M.3 (1). Rev.01 (SPECIAL TOOL 2). After the removal of seal from one end, shaft was locked for arresting the axial movement, to facilitate the removal of second seal on other shaft end. Greyish deposits were observed in the oil seal. The O-rings were also damaged. After cleaning, the clearances of oil seal were measured.

Oil Seal discharge end

- Removed bundle key after removing the locking screw.
- Then bundle was dismantled
- After cleaning the barrel, head covers and studs, DPT was carried out and found no defects.
- Rotor was cleaned and DPT was done
- Gauss was checked on all parts and found OK.
- Major items replaced:
 - Impeller labyrinths (Stage 6) was found damaged and hence replaced
 - Both ends complete oil seal assembly

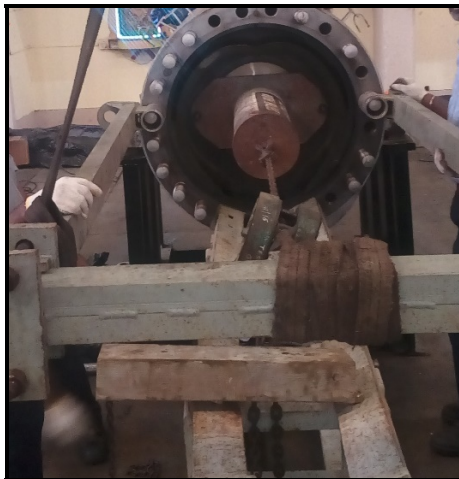
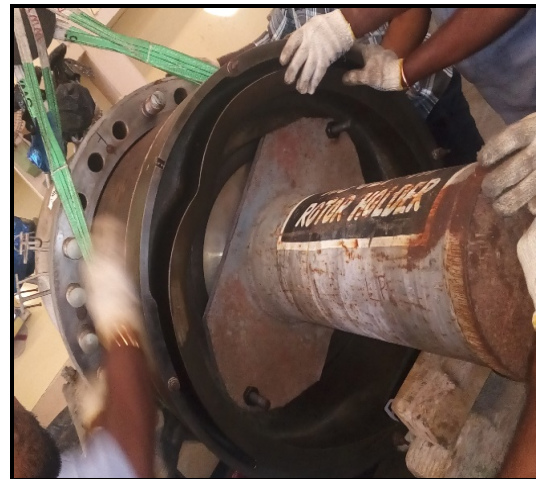
Bundle being pulled out from barrel

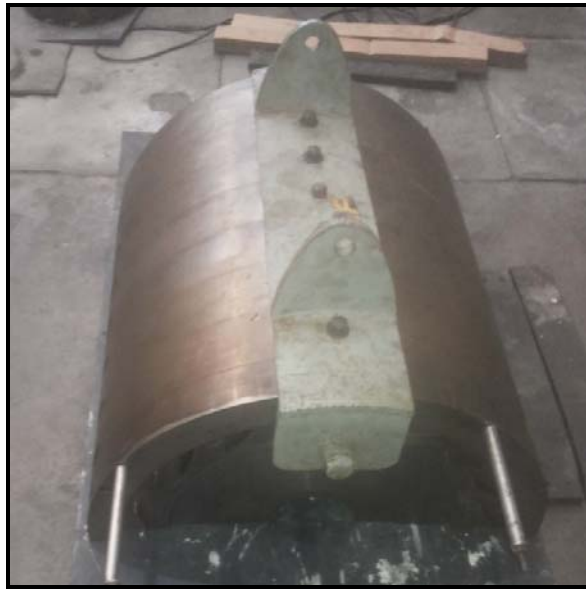
Top half with lifting tool

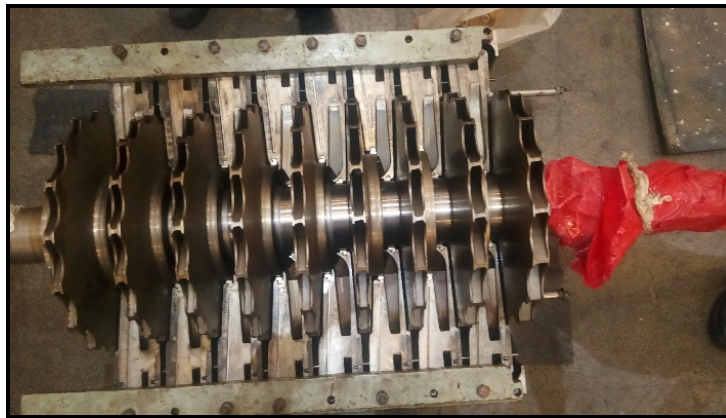
Clamps provided on parting plane

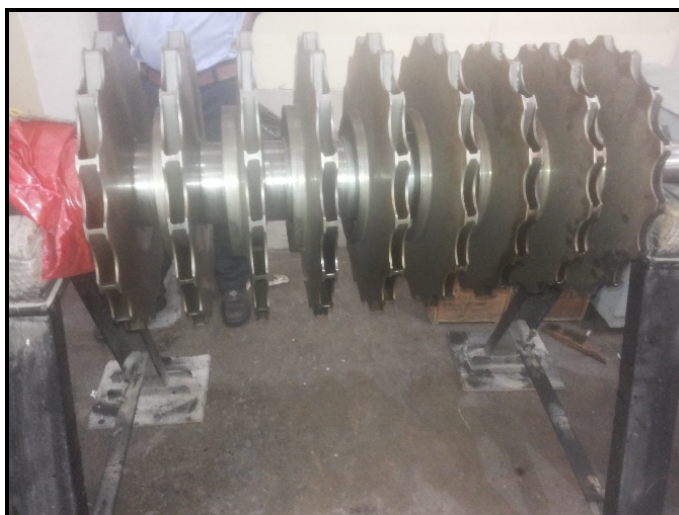
LP Rotor

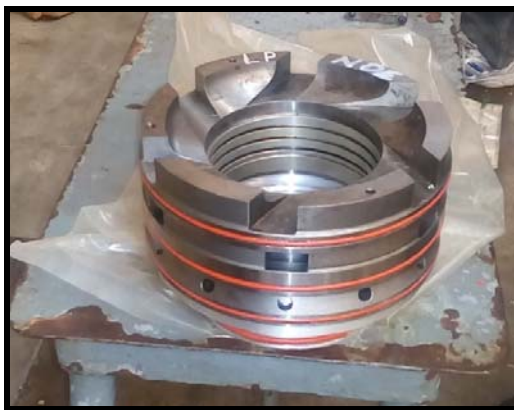
Intake side seal

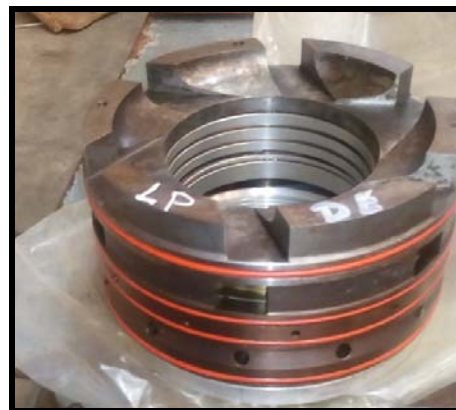
Discharge side seal

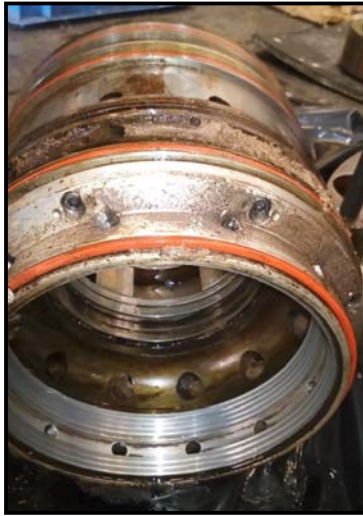
Sludge deposit was observed in both intake and discharge end seals. Discharge end seal (at compressor end) was having deep scoring marks. The O-rings were also damaged.

Oil Seal Intake end

- Removed bundle key after removing the locking screw.
- Then bundle was dismantled
- After cleaning the barrel, head covers and studs, DPT was carried out and found no defects.
- Rotor was cleaned and DPT was done
- Gauss was checked on all parts and found OK.
- Major items replaced:
 - Both ends complete oil seal assembly
 - All Impeller and shaft labyrinths were replaced

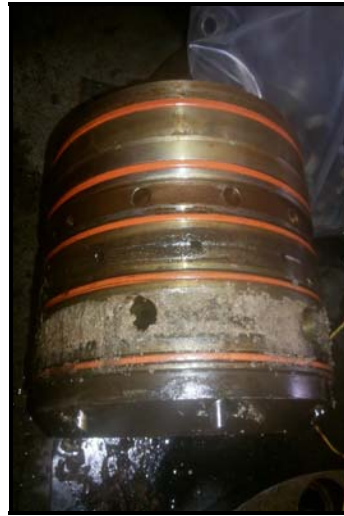
Oil seal Discharge end

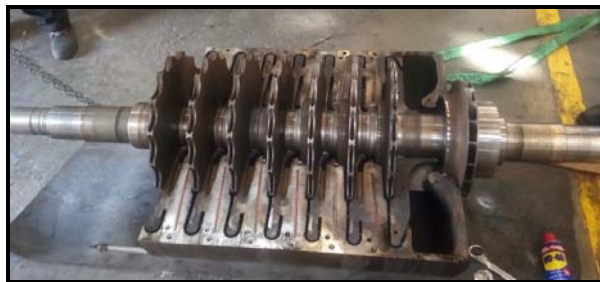
Bottom half of inner bundle

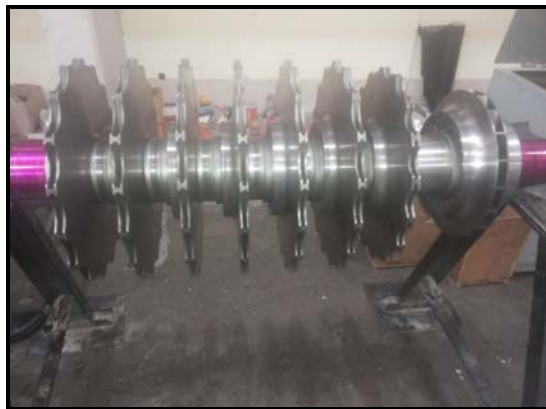
JHP rotor

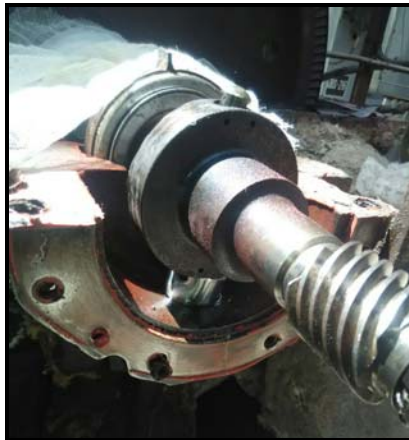
Trip pin & Plunger of 104-JT

- Found “U” lock staple of trip pin assembly broken & trip pin was sticking up with Plunger assembly. “U” lock staple was replaced & Plunger assembly was removed. The open space was filled with putty.

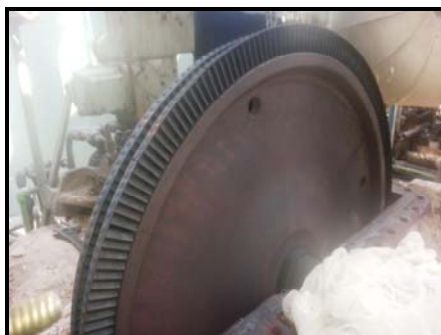
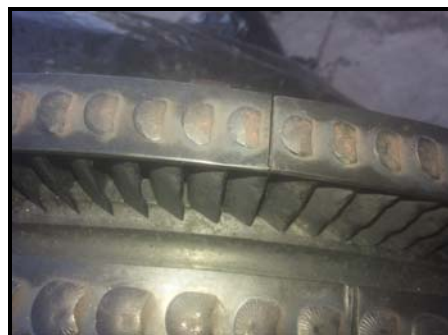
Rotor of 104-JT

Some blades were found bend slightly

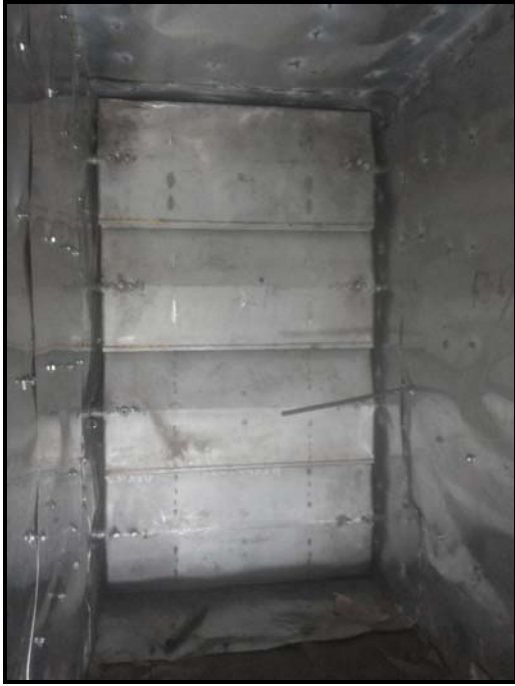
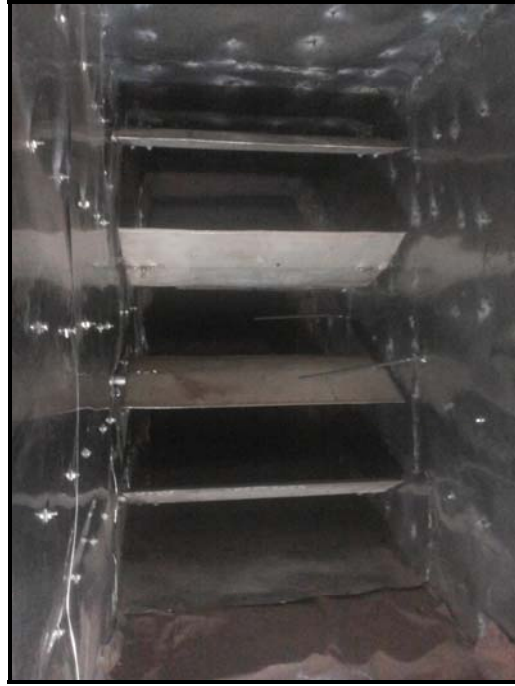
PRC-23 dampener area after replacement of dampener and CF insulation

- PRC-23 Damper blades and shafts were pre-fabricated as per M W Kellogg drawing NO 214 D 16. The blades were fabricated so that there is an overlap with adjacent blades. The length of shaft was kept more for adjustment of length.
- The damper blade material was Incoloy 800 H and shaft was SS 304
- PRC 23 was dismantled after removing the linkages and measurement was done.
- Shaft length was cut and kept as the required length

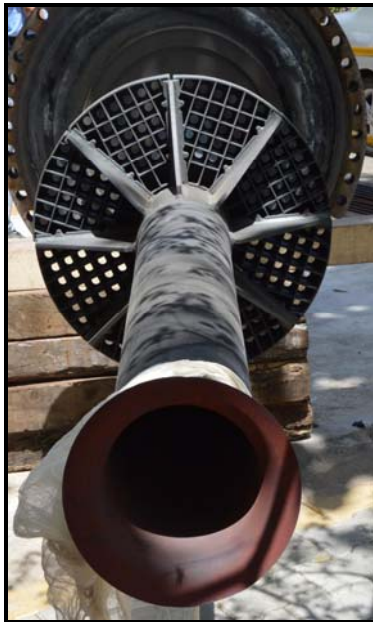
The Air line from Steam Air coil upto 103-D was replaced with SS 321 H line by Technical. For replacement job, 103-D top cover was removed. Reddish deposits were observed at the tip of burner and inside. The Burner was inspected- DPT of all weld joints, burner tip and distributor welds at random was done and found OK.

103-D Burner

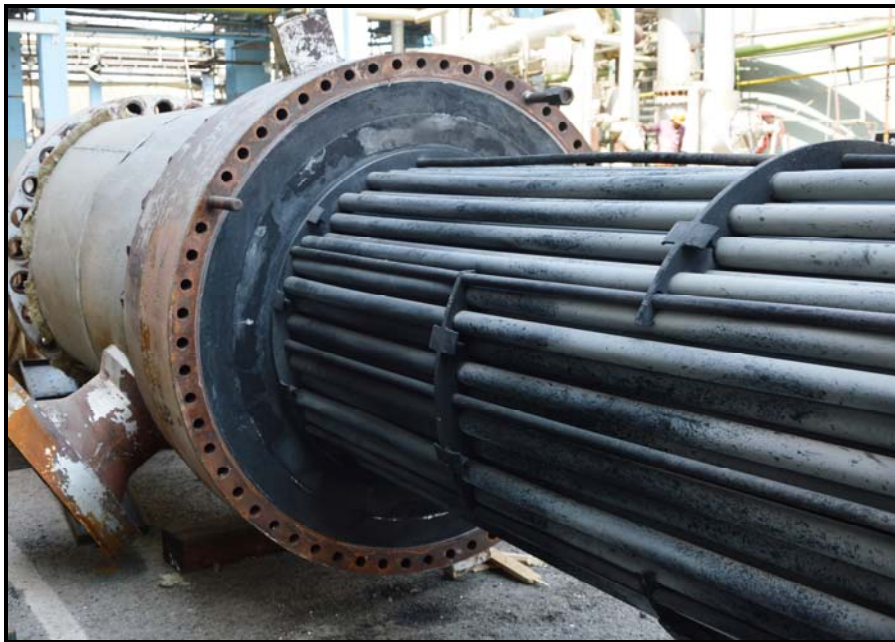
Black deposits were observed on shell liners and tubes. The deposit was more at the top portion. Shell inspection of both 101-CA & 101-CB was carried out and it was decided not to replace the inside liners of nozzles S1 & S2.

Old 101 CB tube bundle

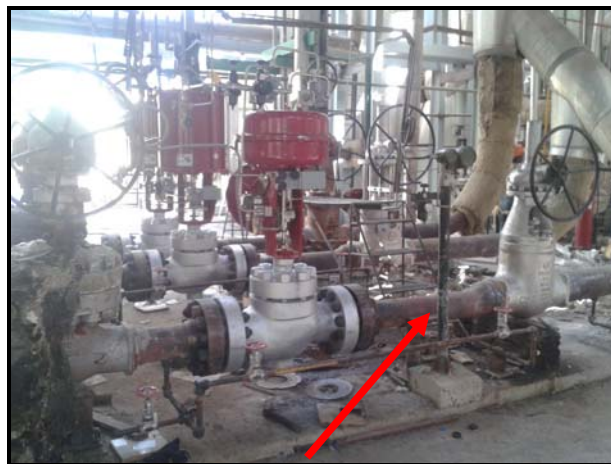
Replaced Bypass line of PIC-13A & B and MIC-22 with P22 material from HP side upto above indicated I/V including I/V

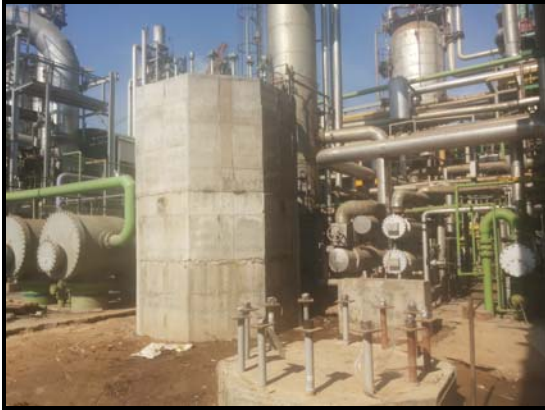
Foundation of 1104-E

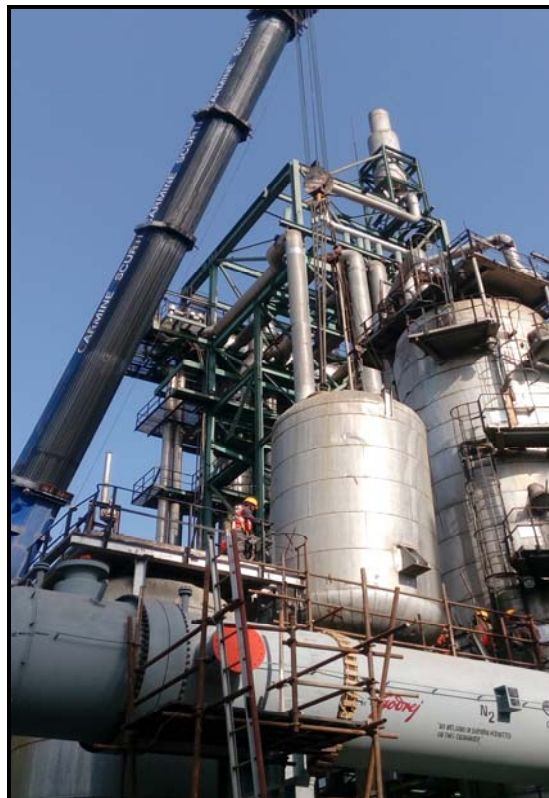
101-D Removal

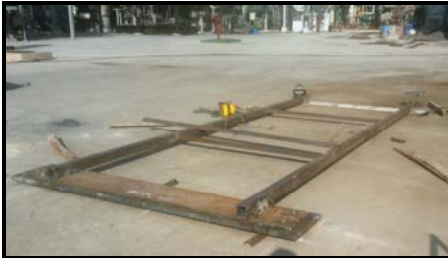
Template made for 1123-C

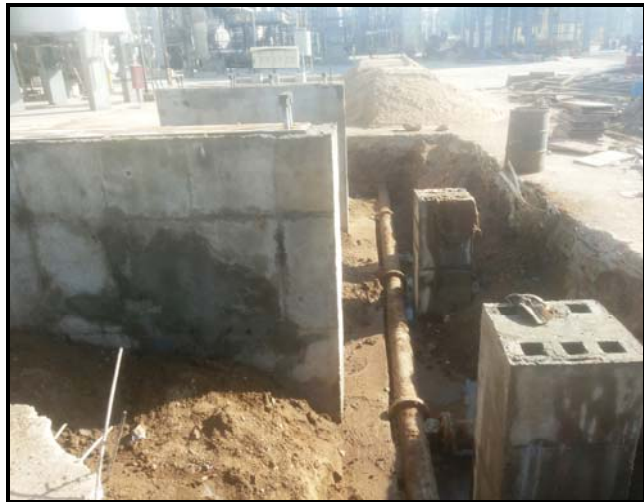
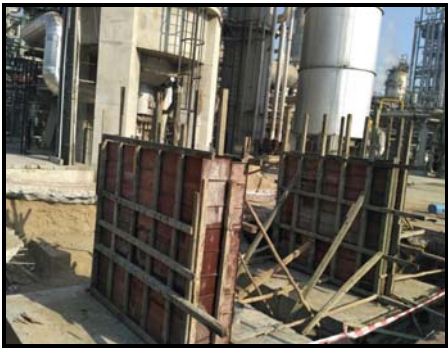
Foundation of 1123-C

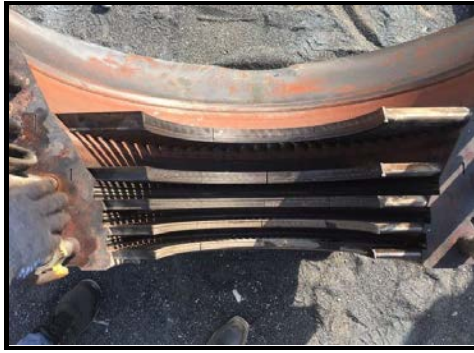
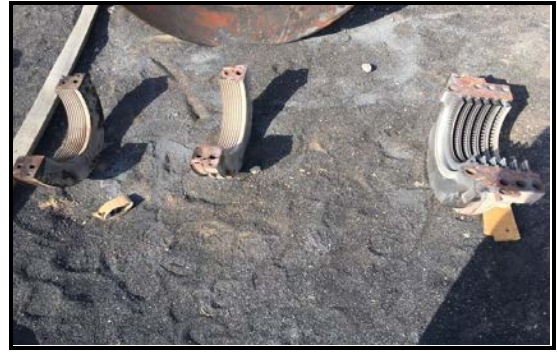
- Removed bottom halves of all three Guide blade carrier, steam chamber and inner gland one by one front side to rear side.
- Scaling was observed on fin area of rotor specially at area of 23 ata extraction steam.

- DP test of rotor, all guide blade carriers, steam chamber and inner gland were done which were found ok.

- Rotor, guide blade carriers, steam chamber (Nozzle block) and inner gland were cleaned by grit blasting at yard near Onshore Yard.

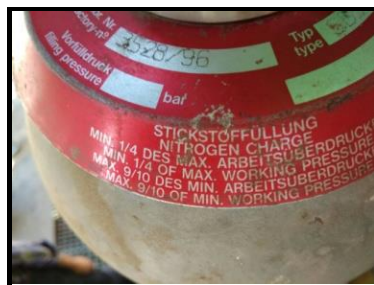
Re-Nitrogen Filling in Oil Accumlator.

- The Balloon was checked and found approx 3.0 Kg pressure in Balloon.
- Gas filling Kit is available for filling of Nitrogen to oil accumulator.
- As per name plate details available on the body of Accumulator, nitrogen pressure may be kept between 6.0 kg to 9.0 kg. It was kept as 7.0 kg.

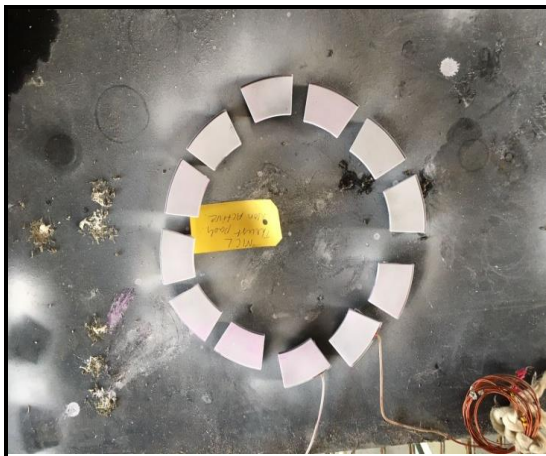
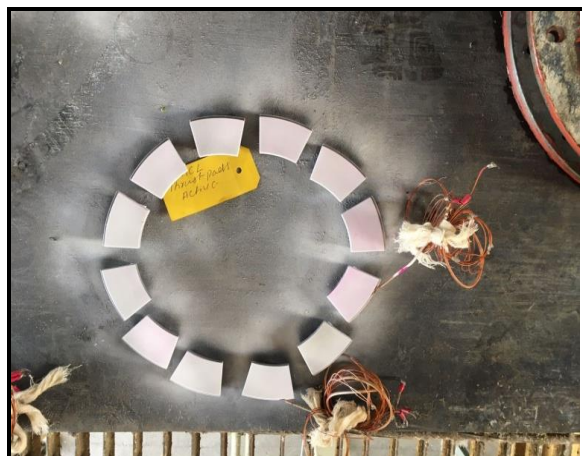
- Decoupled the LP case from Gear box.
- Alignment of LP case and gear box was checked and noted.
- Journal bearing pads on GB side were opened for inspection.
- Journal bearing pads on Turbine side were opened for inspection.
- Thrust bearing was opened for inspection. Clearances value found within acceptable limits.
- Gauss measurement of pads, Thrust collar, journal shaft & bearing housing were carried out by Inspection section and found within acceptable limit.
- DP testing of thrust pads, thrust collar and shaft journal was done and the same found acceptable.

- Alignment between LP Case & Gear box was corrected as per OEM reference values.
- LP case and Gear box was coupled at required tightening torque 20 kgf.m (196 Nm). Finally spacers between LP case & gearbox were assembled after alignment correction.

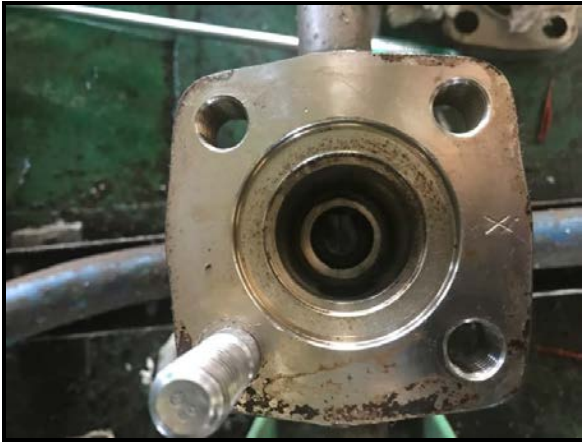
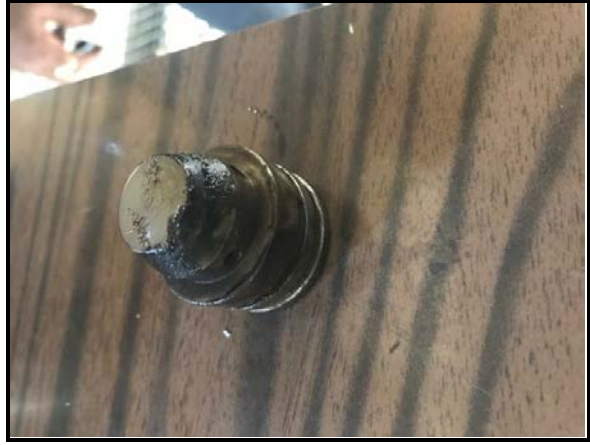
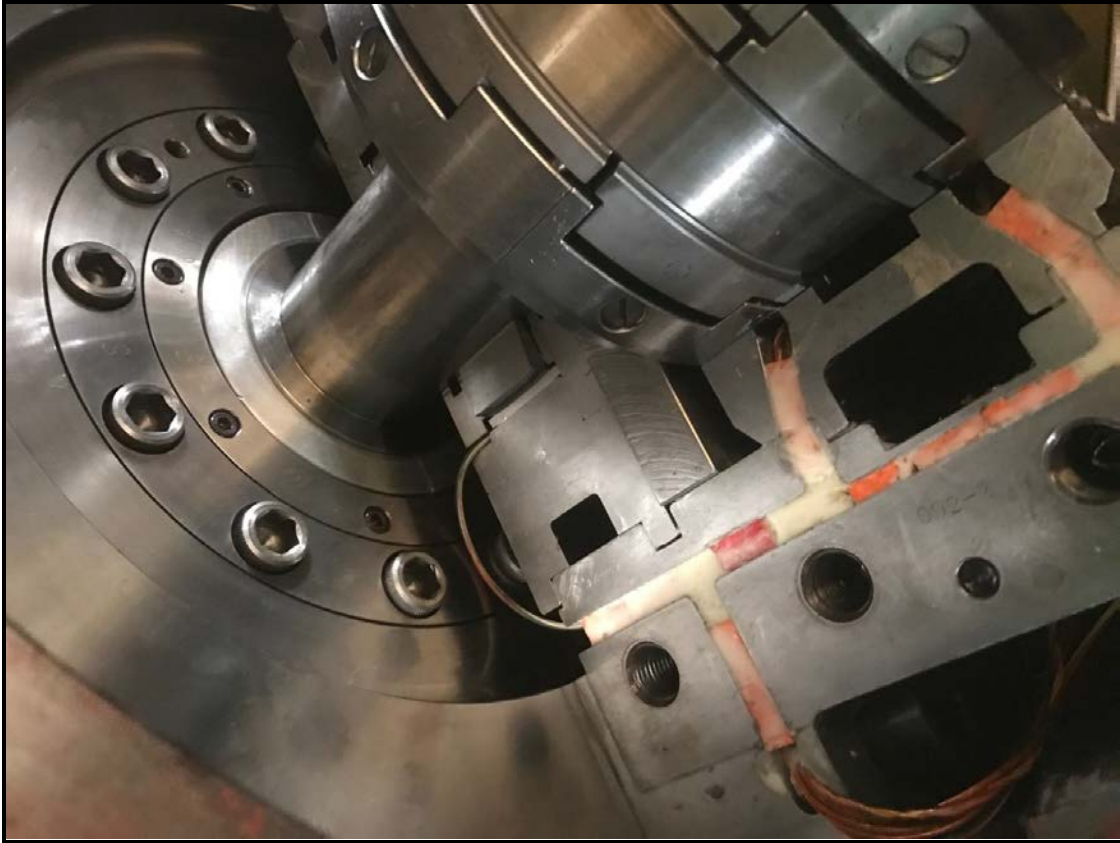
Problem Observed.

After taking Turbine compressor train in to Lub oil Circulation, it was observed that there is oil leak from HP Compressor Body drain flange and also huge oil was found in Instrument Air Line.

All the Oil supply system was checked. There is Gravity Drop type NRV in Lub Oil system and it was found OK. Then Bearing Housing covers were opened and found that Leak was coming from cable path of RTD, wherein, Sealant needs to be applied.

- It was observed that after stopping of lube oil pump, oil was leaked from CO₂ drain line.
- It was decided to open the free end bearing cover.
- It was found that after opening of cover that instrument probe wire was not fixed at position as adhesive compound was not filled in gap by instrument deptt.
- It was fixed by rubber compound by instrument and cover boxed up.
- After that, no leakage was observed.

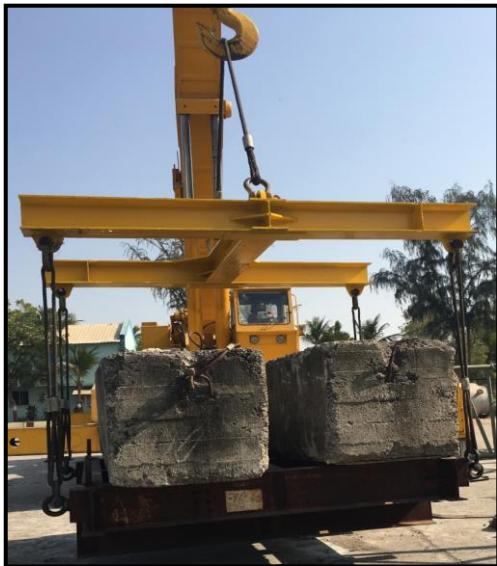
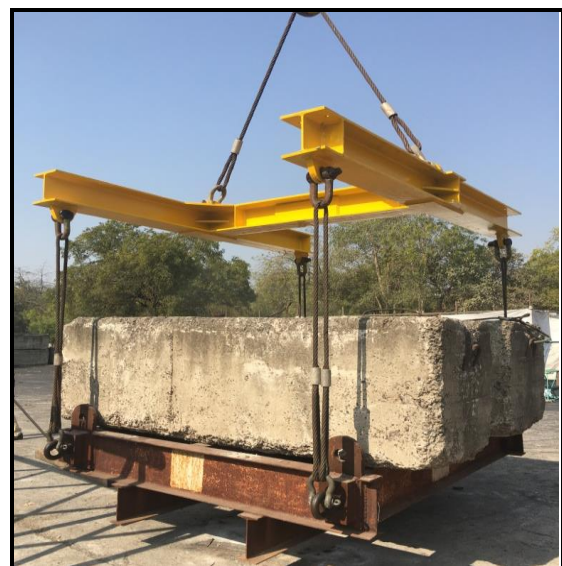
For load testing of 4 nos. of eye bolts in horizontal loading condition as shown in attached figure.

Lifting of load in eye bolt testing arrangement

Loading test of all 4 nos. of eye bolts were done at weight 18 ton for 15 mins.

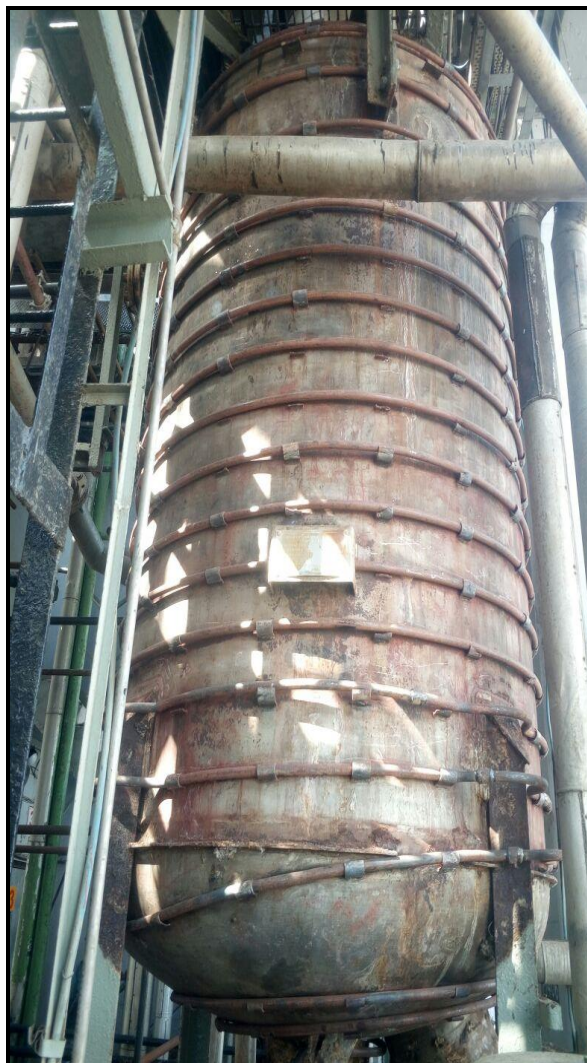
Replacement of existing corroded CS steam tracing lines of V-1406

All Steam coils were replaced by new one as old one had many holes leak in it.

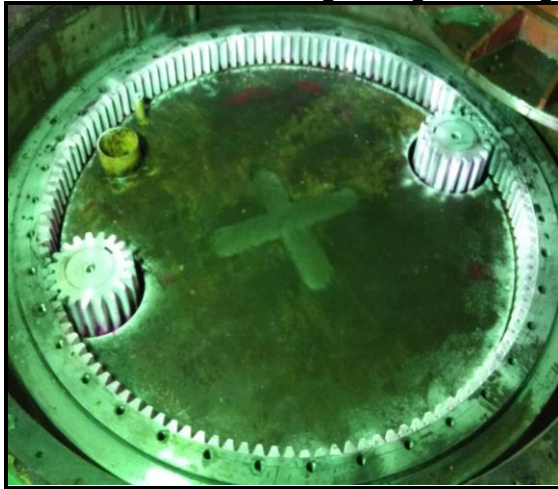
Skew bearing mesh with gear

- Measured and noted down clearance between gear wheel and bottom plate.
- Skew bearing and pinion teeth were checked by DP Test and found ok.
- Checked and noted down backlash between gear and gear wheel.

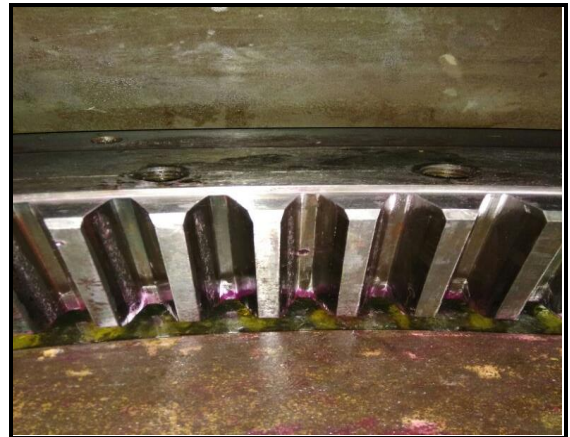
Skew bearing teeth

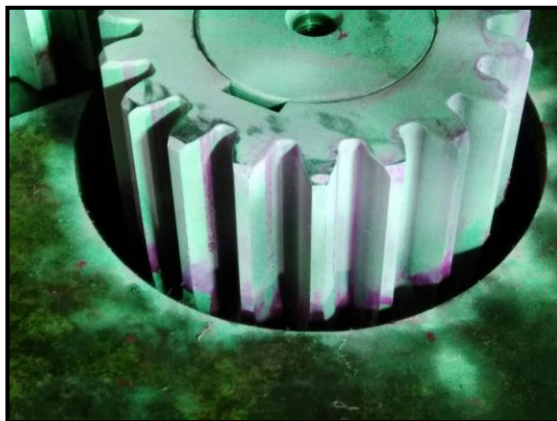
Dye penetration test of gear teeth

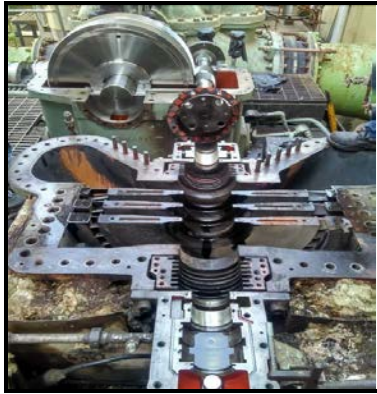
Bottom casing

- Top casing was positioned and tightened.
- Axial float of rotor was measured & found higher than design value. Scoring & abrasion marks were observed on active side pads. Hence the active side pads were replaced with new ones. Final axial float was measured & recorded.

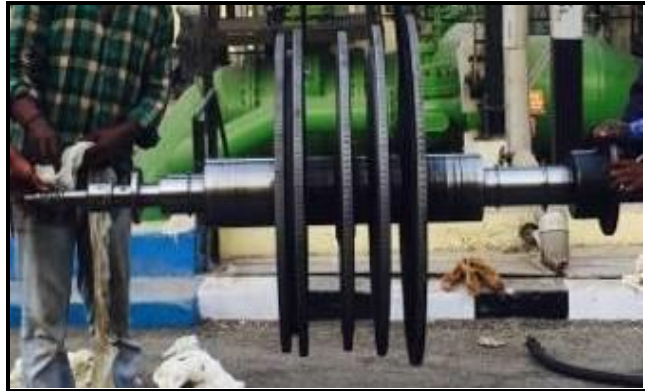
Rotor assembly

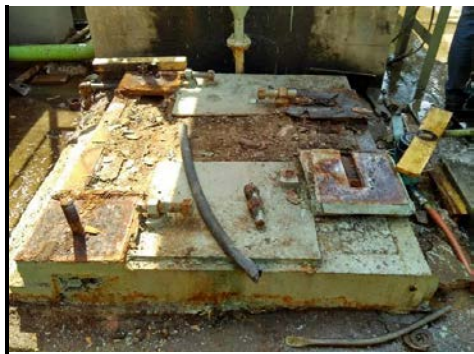
Old CS base frame

- Coupling between the pump and GB was decoupled.
- Both the journal bearings were opened, checked & found ok.
- Bearing clearances were measured and recorded.
- Suction & discharge bellow of pump were removed.
- Pump foundation bolts were loosened.
- Pump was lifted & shifted to safe location with the help of Kobelco crane and placed on new fabricated SS base frame for marking.
- Old CS base frame was removed after marking reference points at site.
- 4 nos. of 6" dia drilled (425mm length) holes were done at RCC foundation by civil section.
- New SS base frame was placement on its position & fixed it with matching reference points.

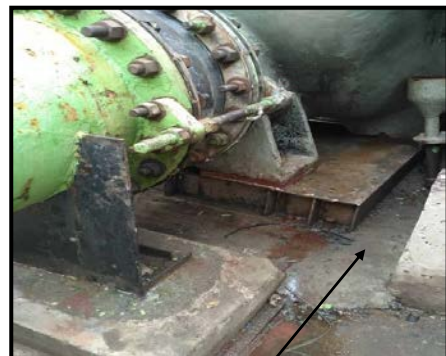
New SS base frame

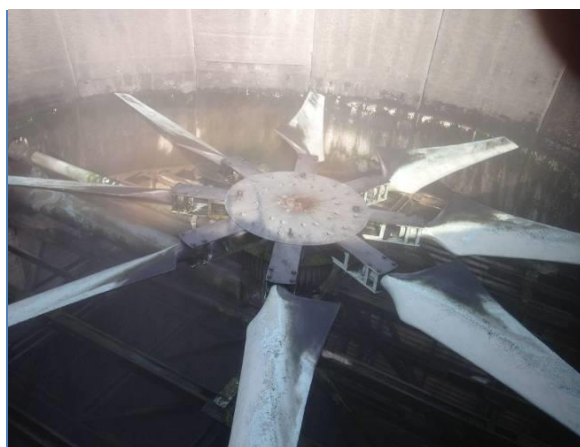
Old Fan Blade assembly

Purchase order 2010041711138 dated 07/11/2016 was placed on M/s Coolflo, Mumbai to supply the new efficient aerofoil designed hollow FRP fan blades assembly. To provide the more traverse area for fan blade within cylinder, hub diameter was reduced from 2600mm to 1800m. Recirculation of considerable amount of air at the extreme inboard sections of the fan blade subtracts the net airflow. To improve performance, a FRP seal disk was mounted on hub.

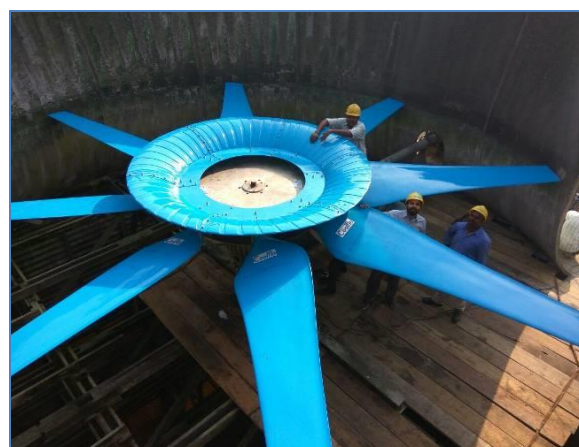
New Fan blade assembly with seal disk

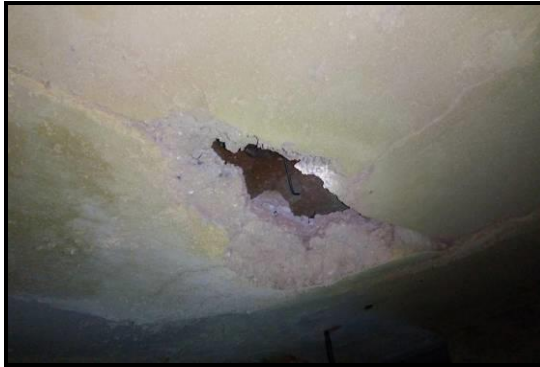
- Scaling was observed on all the tubes of Mixed Feed Coil.
- Bottom most part of Insulation covering plate was found burnt off at most of the locations. This was observed in previous inspection also.
- Refractory at the ceiling in front of 1st& 2nd row tunnel counting from East side (Nr. Man hole) was found fallen hence exposing the holding anchors.

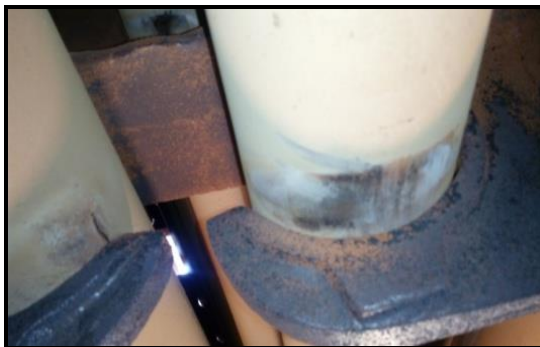
- Rubbing on the coils observed near anchor supports, however no reduction in thickness was noticed. (Also observed in previous inspection)

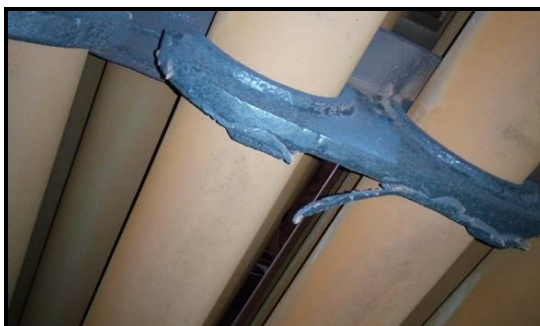
- Peeling off of top layer of casting was observed on first two rows of east side anchor supports of mixed feed coils. (Also observed in previous inspection)

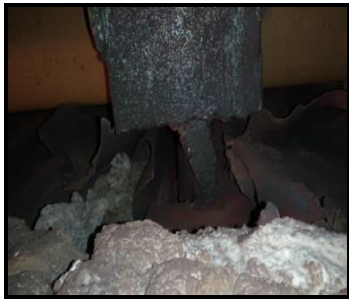
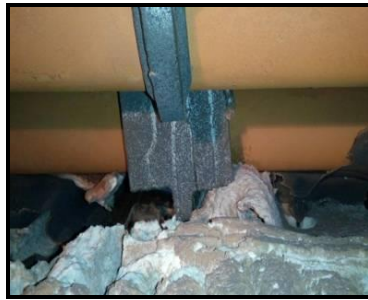
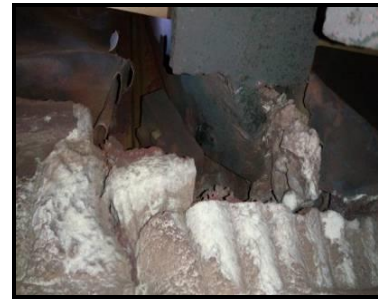
- Support piece found lying at the bottom floor.
- All Mixed feed coil supports found cracked / damaged at south end. The same was repaired and new supports were provided where ever required.

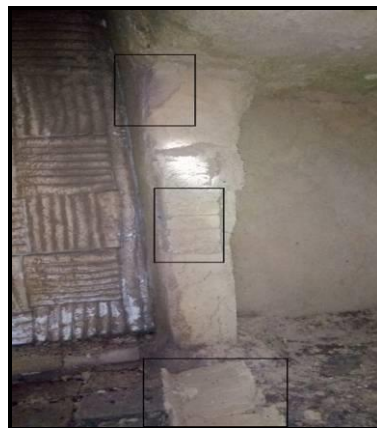
- Tunnel thermo well pipes were found slightly bent, scaled and eroded. Same was observed during previous inspection.
- Bottom floor refractories found loosen at some places and flooring found sagged at some location. Same was observed during previous inspection.
- Top layer refractory was found peeled off and fallen near west wall.
