KALOL UNIT

PLANT TURNAROUND REPORT
(MARCH – APRIL – 2017)

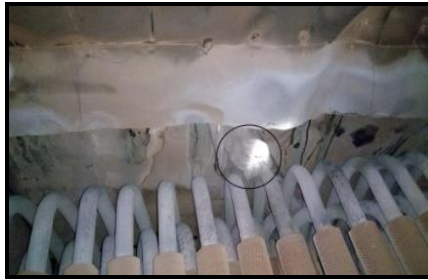
- Damper condition was satisfactory however liner was found bent and distorted near the damper.
- Thermo well near damper was found slightly bent.
- LT Side, Fiber blanket found fallen near top coil at east side.

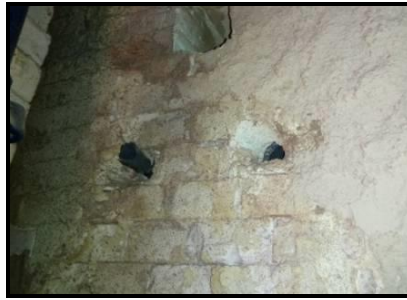
- Thin hard brownish scales were observed on the tubes.
- Metallic draft tubes were found burnt off / thinned inside the furnace.

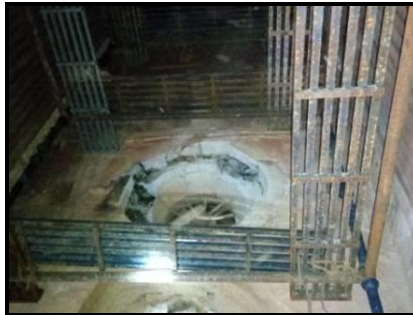
- Refractory around burner no-5 (topmost) was found severely damaged. Refractory around other burners have minor damages.

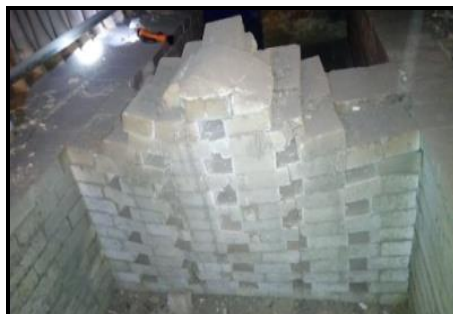
- Top header refractory was found having cracks at few locations.
- Top layer of bottom side wall refractory found loose in both East & West side.
- Center partition wall refractory found sagged and some of the refractory bricks found cracked/damaged.

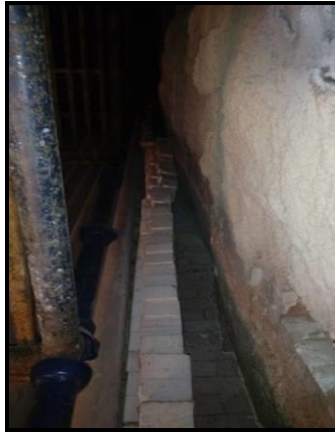
- Tube supported refractory found loose and damaged adjacent to burner no. 4 (counted from bottom) in East wall.

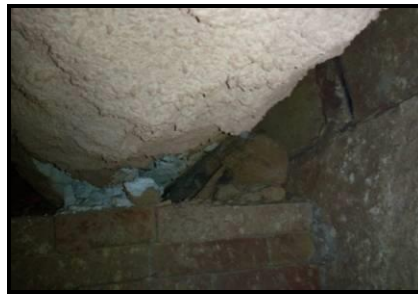
- North side bottom down comer header refractory found damaged in bottom most area towards West direction. Observed in past Inspection also.

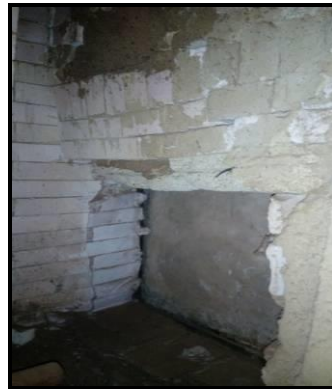
- Refractory just above the access door was found loosened.

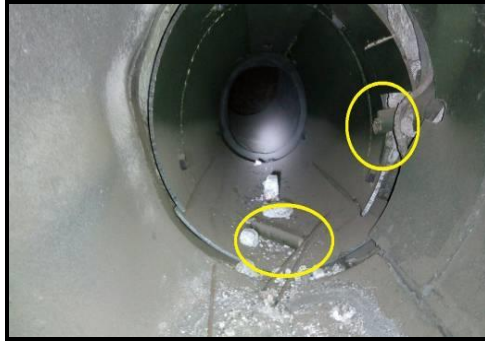
- Thermowell found damaged and detached from its position.

- Thickness measurement of the shell was carried out and found satisfactory.
- Liners and gas distributor were replaced. DP test was carried out during fabrication work and found satisfactory.

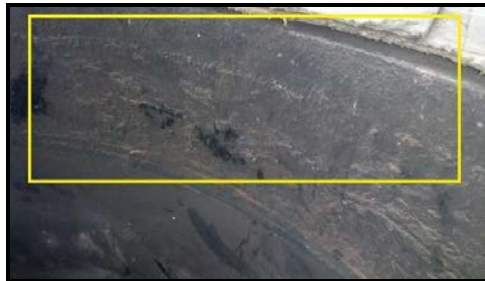
- Erosion observed in entire circumference up to 6" length from top of the shell.

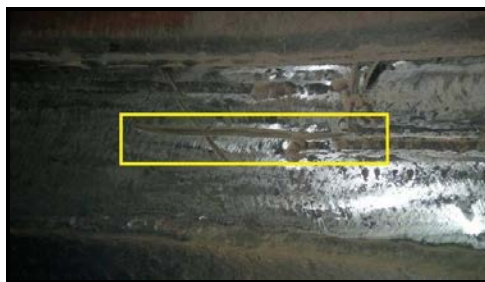
- All Circumferential and Longitudinal weld seam of the shell found satisfactory.
- Deep grinding marks observed on the all backing strips of the shell.

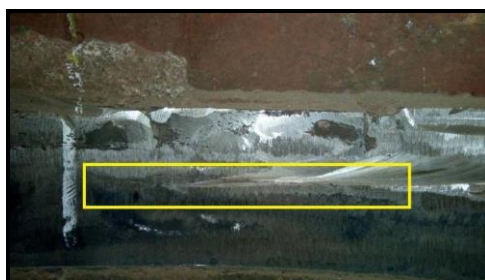
- Welding tack observed above 1st backing strip (Counting from top) at north side. (Need to be remove)
- Superficial cracks were observed on surface of the top backing strip.

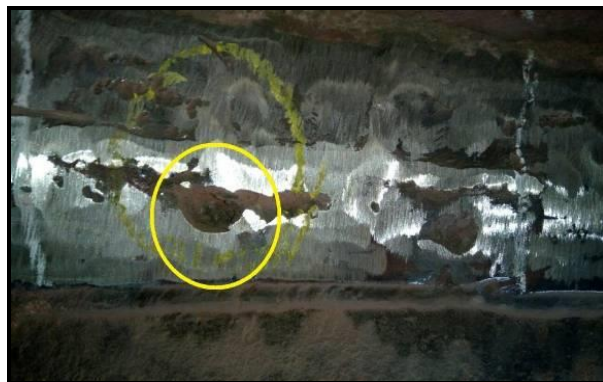
- Dent was observed having approx. size of 10 mm x 15 mm with depth of 4-5 mm at East side. (Need to be repaired)

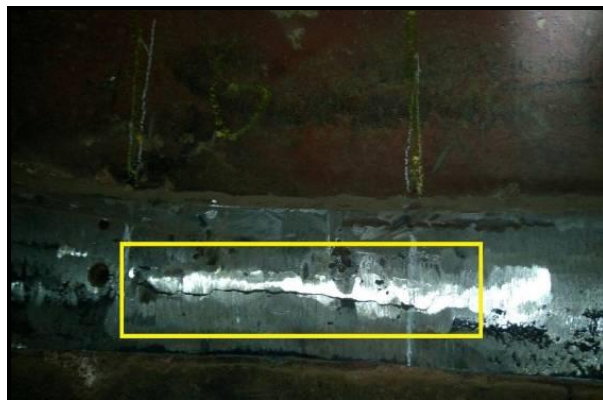
- Cracks were observed at seven location of bottom last backing strip. (With approx. length of 150 mm to 200 mm each)

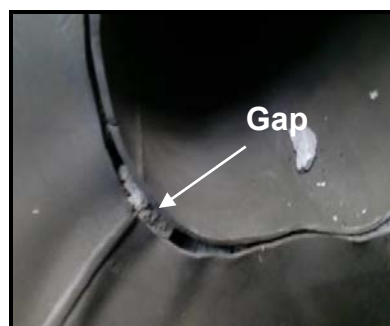
- At scattered locations cracks observed on refractory lining of the shell and cone.
- Thermowell was found intact.
- Approx 1" Gap was observed between shift liners of top shell to transfer line.

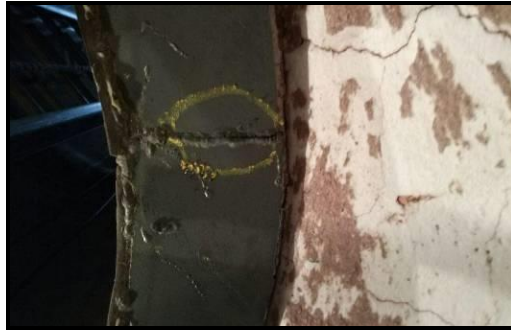
- Crack observed in the man way bottom peripheral liner having approx. length of 50 mm.

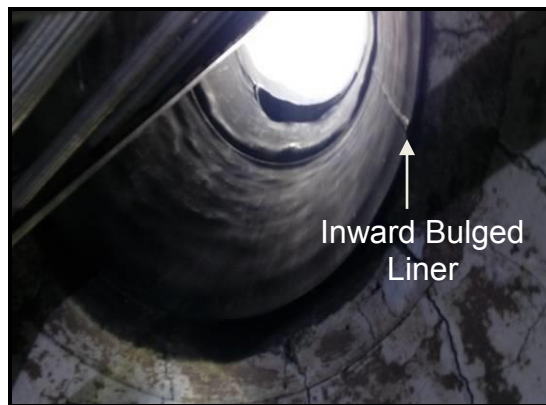
- Inward bulging of approx 1" observed in top shell liner all around the circumference. The ID measured at this location & was found to be approx. 700mm. The location of this bulged location is approx 1990mm from vessel top flange face.

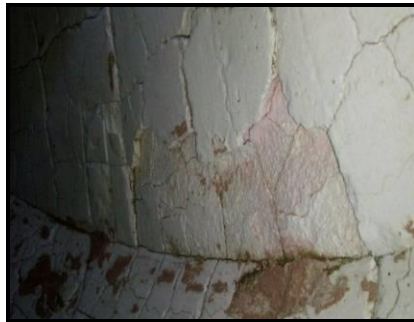
- Refractory found loose in cone portion of the shell at North and East side.

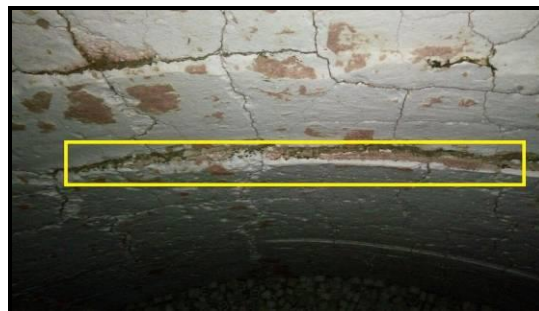
- Refractory found loose in straight portion of the shell at East and West side.

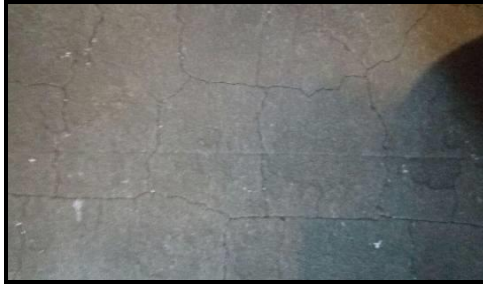
- Scattered cracks were observed in entire shell and cone refractory.

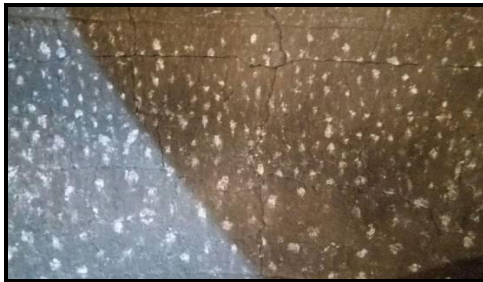
- Dent/Abrasion marks of alumina balls observed with white coloration in prominently in shell refractory and slightly in cone refractory.

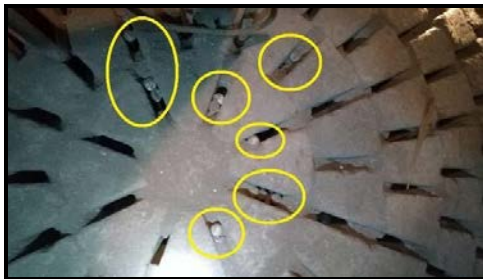
- Alumina balls found stuck up between gaps of dome refractory.

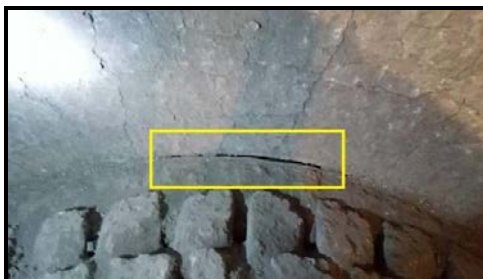
- Condition of Thermowells found satisfactory.
- Gap observed having approx. 450 mm x 10 mm area between cone and dome refractory at west side.

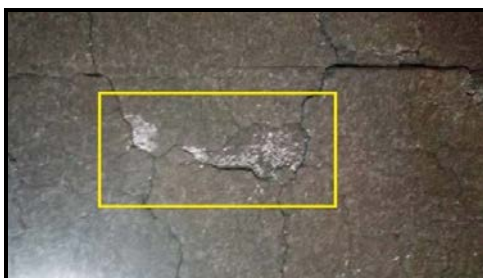
- 1st layer of the shell refractory found peeled off at 4 locations.

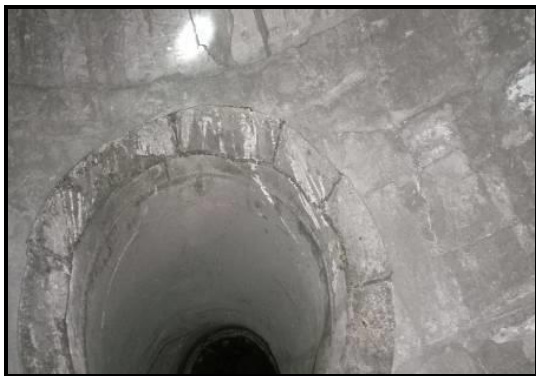
101 CA Nozzle View

- The refractory around the 101-CA/CB gas inlet nozzles (approx half of the top circumference) was found eroded and loosened. Same was observed during previous inspection also.

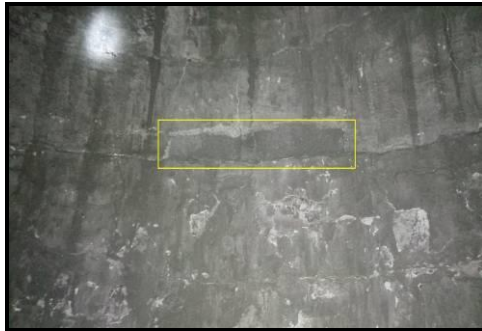
- Top Brick dome refractory condition found satisfactory.
- Bottom conical refractory condition found satisfactory.
- In straight circumferential joint, refractory found fallen down in approx. 450mm x 50 mm area towards north direction.

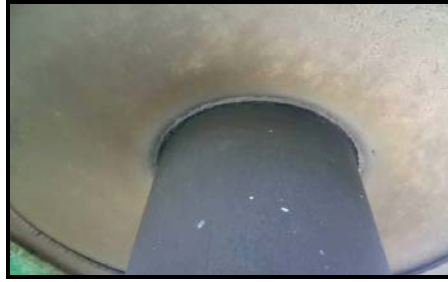
- Circumferential weld of central pipe with top cover liner found eroded.

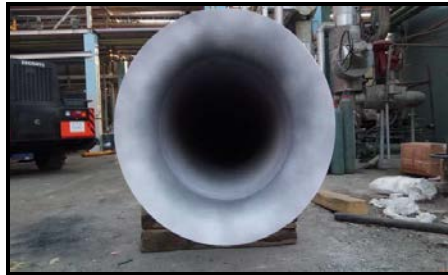
- Crevice observed on both sides of long seam of old pipe.
- Condition of the perforated plate found satisfactory.
- All stitch weld condition found satisfactory.
- DP test carried out of all weld joints of new air mixture nozzle including bell mouth and found satisfactory.

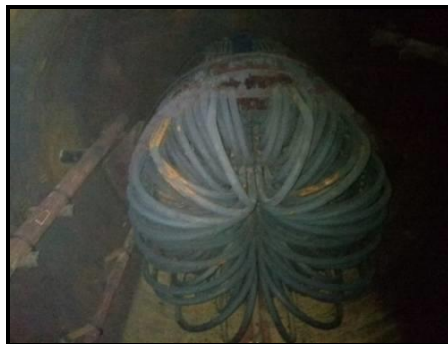
- Condition of the weld joints were found satisfactory.
- Rust/ scaling observed on the weld & Dished End.
- Rust / scaling observed on the tube baffles and some of the tubes.

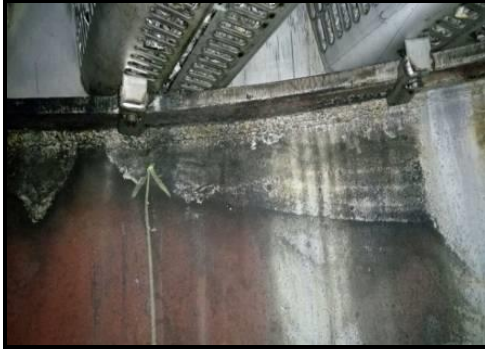
- 01 no. Rasching ring holding clamp was found loose at south side.

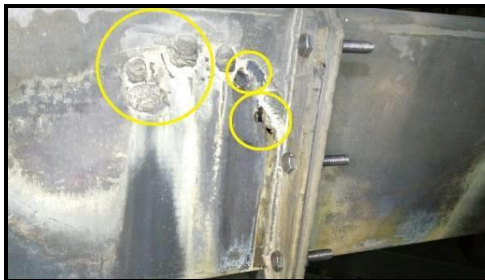
- Condition of liquid distributor was found satisfactory.
- Brownish grey coloration was observed on the shell as well as on all the fittings.
- Corrosion cavities and holes were observed on South most liquid distributor collector plate, located just below the liquid distributor. (Visible just from M/H)

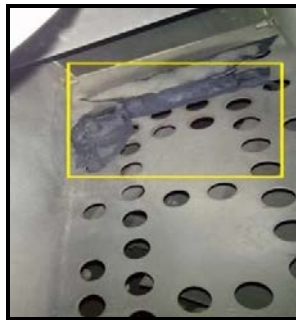
- Rubber piece was found lying on the gas riser holding plate at west side.

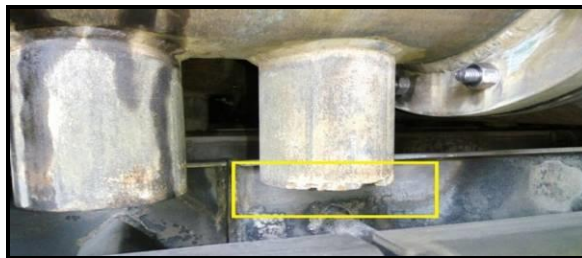
- Liquid distributor bottom nozzle found eroded at bottom edge. (Visible just from M/H)

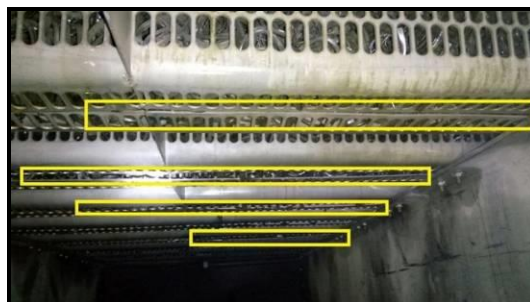
- Excessive gap as compared to others was observed in several rasching ring holder. (Between two half of holder).

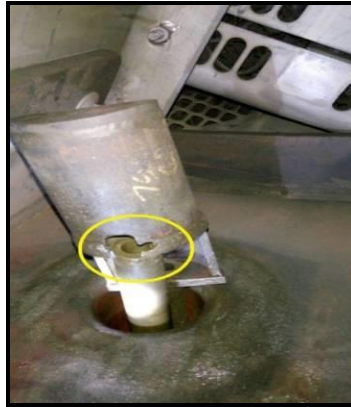
- Grey coloration was observed on the shell.
- Sample collector was found detached from its welding.

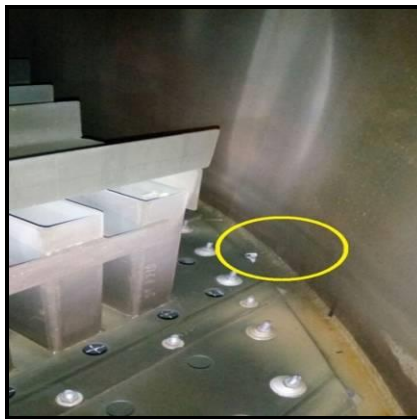
- Piece of rasching ring was found stuck up between shell and riser plate.

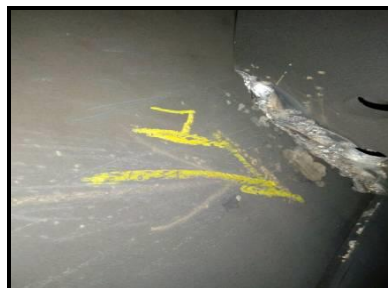
- Demister pad supporting strips were observed slightly downward bent (mostly in centre portion) and supporting rods were found satisfactory.
- All the bolts of liquid inlet nozzle flange were found in position & intact.
- West side distributor header was found rubbing with the shell plate in S-W direction causing dent in the shell plate. Same was also observed in previous inspections. (Image no.01)

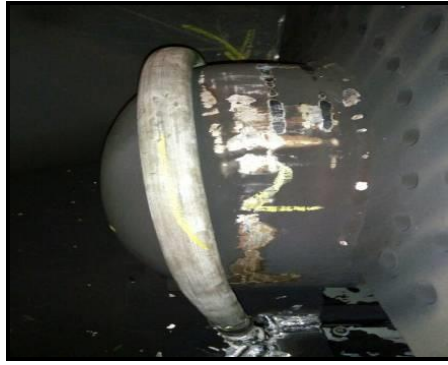
- U-Clamps of North- East and South- West side distribution header were found loose. Need to be tightened. (Image no.02)

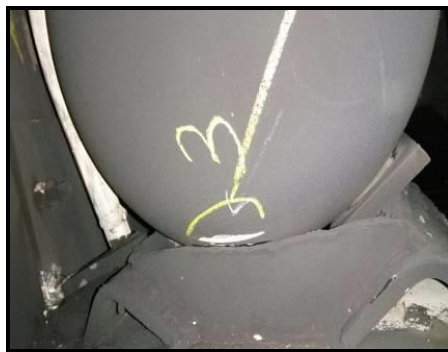
- West-South side distributor header found rubbing with U-clamp support causing abrasion in approx. 60 mm X 8 mm area at bottom in cap of header. (same were marked with yellow chalk) (Image no.03)

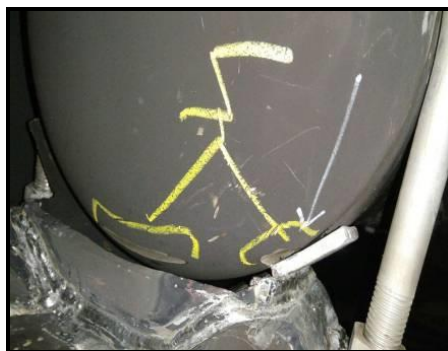
- East-North side distributor header found rubbing with U-clamp support plate causing dent/slot of 100 mmX20 mm and 50 mmX10 mm area in cap of header at bottom and west side respectively. (same were marked with yellow chalk) (Image no.04)

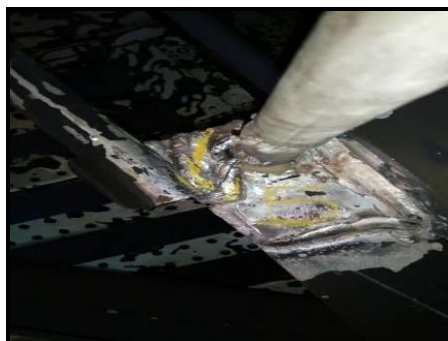
- Header support pipe at North-West side found cracked/detached. (Image no.05)(Need to be repaired)

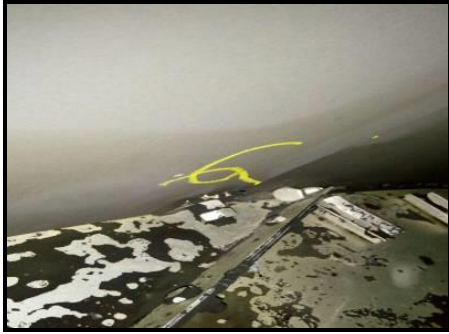
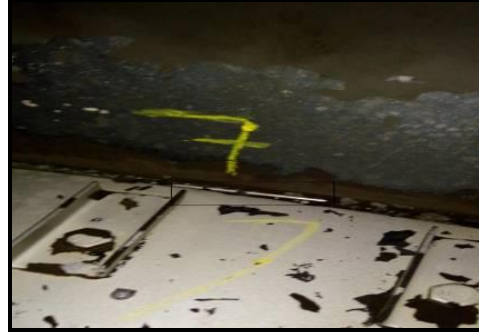
- 01 no. bolt and filler wire (approx size of 90 mm in length) were found stuck up between shell liner and trays below distribution header towards South-East corner and East side respectively. (Image no.06 & 07)

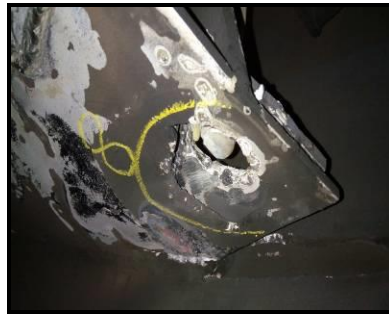
- North-East side U-clamp hole found enlarged in bottom plate (need to be repaired) Further with U-clamp nut found missing and same was lying in the bottom channel floor. (Image no.08) (Need to be repaired)

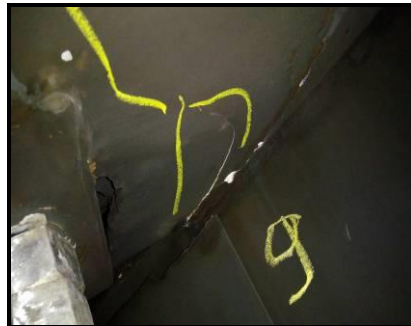
- A crack was observed having approx length of 75 mm in the bottom of the U-clamp support plate at North-West side. (Image no.09) (Need to be repaired)

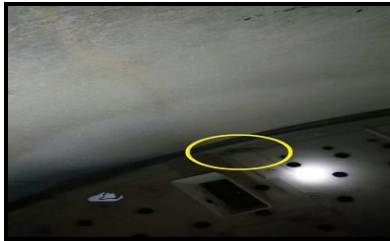
- Liquid found accumulated in HPFV RV header line.
- Piece of Black polyethylene was found stuck up between shell and liquid collector plate at N-W direction.

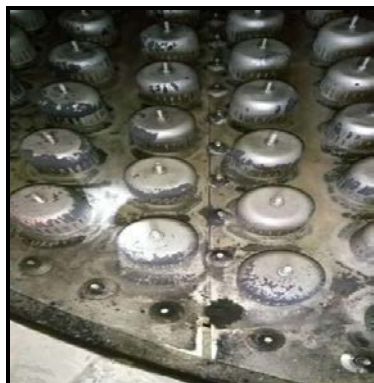
- Debris found adhered on the bubble cap resting plate stud.

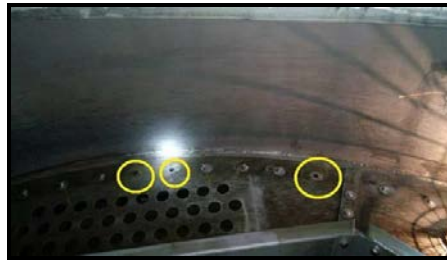
- Rectangular riser box and other fittings found intact in position.
- Holding bolts of bottom tray found loose and bent at many locations. 03 nos. bolts are missing from at north side.

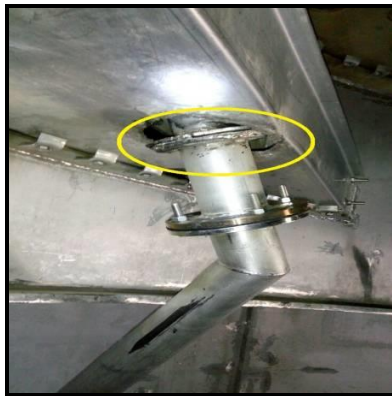
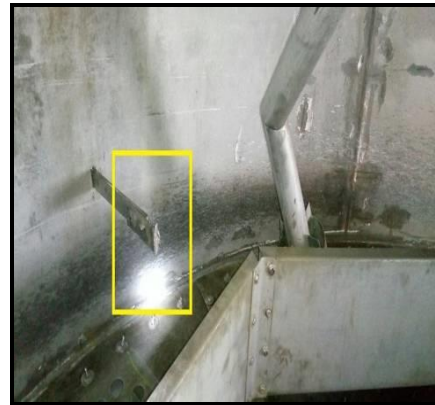
- Silver coloration observed at scattered locations. Weld joints observed as if etching has occurred resulting in slightly differing colour in comparison to adjacent shell surface.
- Bubble cap tray drain line was detached from its welding of top plate and support plate.

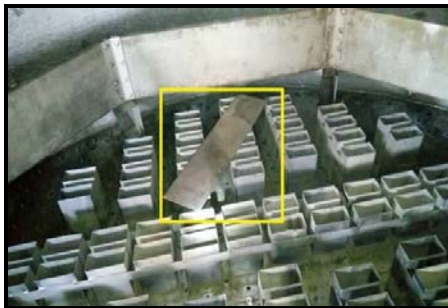
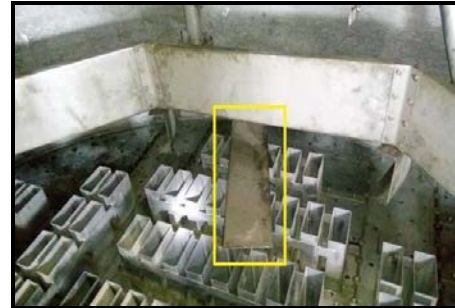
- 02 nos. plates having approx. size of 10"x36" found lying on the rectangular riser box.

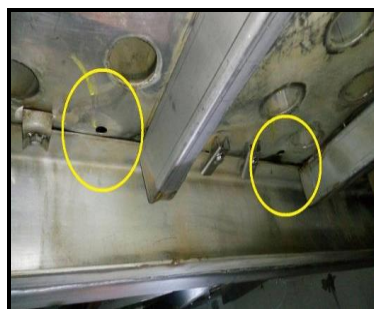
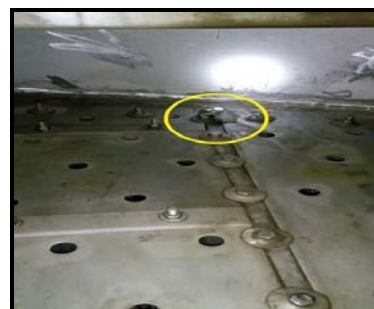
- 03 nos. holding clamp of top bubble tray found missing and 02 nos. clamp of the same found laying near the rectangular riser box.

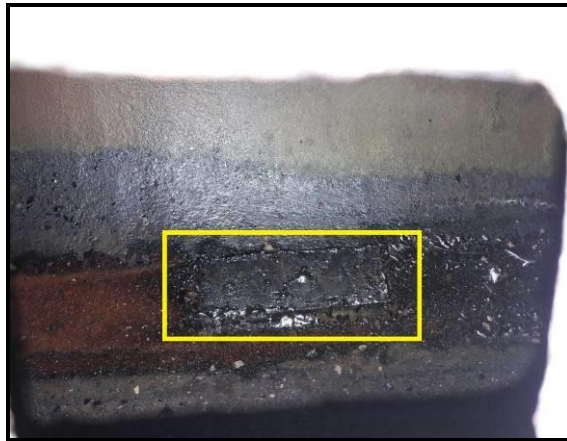
- Bubble cap holding plate found satisfactory.
- Bubble cap surface found oily.
- Distribution header flange bolt found intact.
- Plate piece was observed inside the Gas inlet distribution header having approx. size of 100 mm X 30 mm. Same was removed.

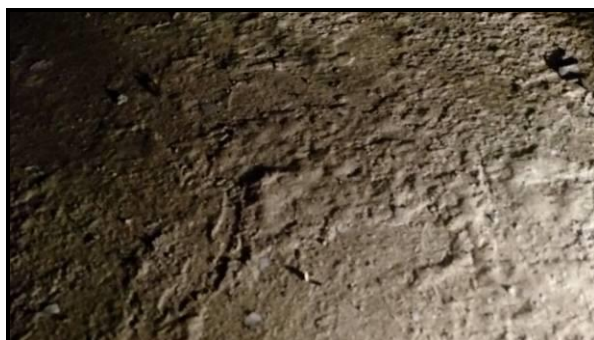
103-F, REFLUX DRUM

- Demister pads were found intact in its position.
- Top layer of Epoxy paint/primer was found peeled off at scattered locations in bottom half of the vessel.
- Nozzle condition was found satisfactory.
- Soft Blisters filled with liquid matter were observed in complete dish end.

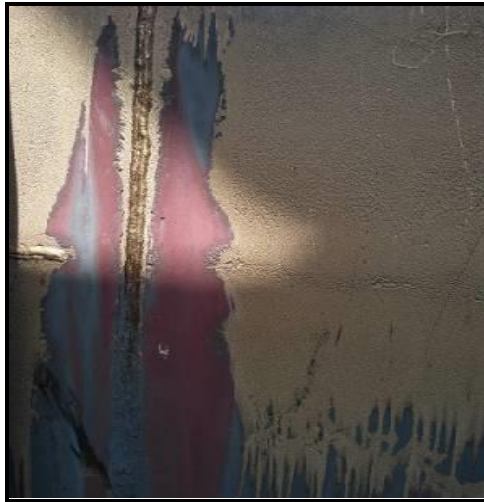
Compartment No.1 (Top Compartment)

- Roughening /corrosion of dome liner were observed and grayish oxide layer was observed on dome and man way surface.

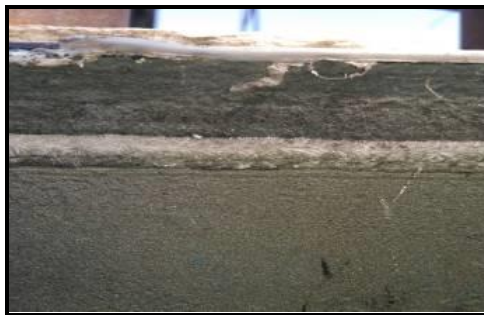
- Just above man way liner's top circumferential seam having high corrosion attack in all circumferences, it was observed in previous inspection also.

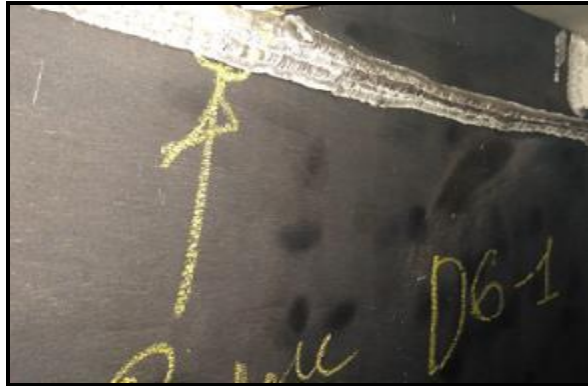
- In south - east direction minor pinhole like indication observed in "C" seam, marked as defect D6-1

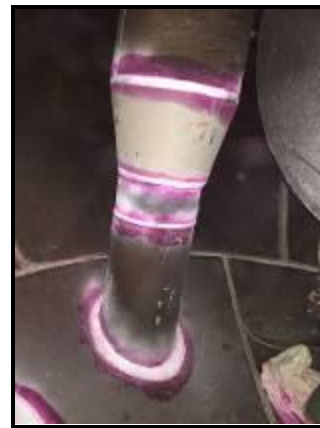
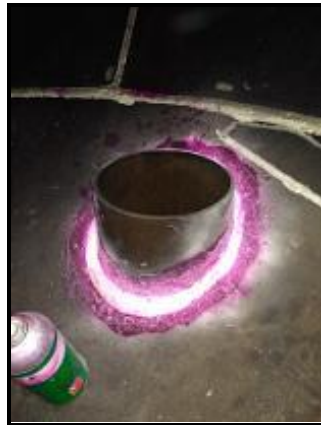
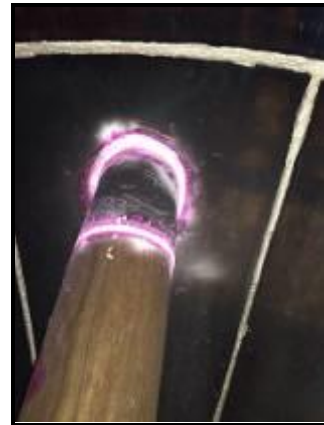
- Concave depression of approx. 2-3 mm depth and approx. 5mm depth were observed at approx. 200mm above the C-weld seam in 4"dia in east and west direction of the shell respectively. The same was observed during last inspection also.
- All old tray holding cleats (15 no's) were found blackish in color and having corrosion attack, however all new cleats (14 no's), its welding observed satisfactory.
- Tray orientation is in North –South direction.
- Two no's of Long seams observed satisfactory.(North – South Direction)
- Petal welds condition observed satisfactory.(Total 12 Seams)
- New tray cleats and its welding found satisfactory.(14 no's)
- All nozzles welding D.P test carried out and at few locations indications observed which were repaired and found satisfactory in DP test.

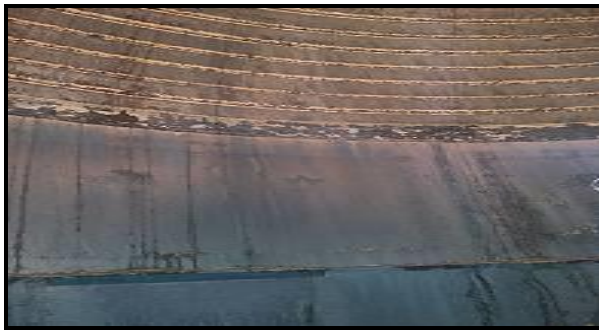
TOP CHANNEL

- The condition of sealing face was satisfactory.
- A thin blue grey oxide layer covered the overlay welding and liner in the gas phase (man way, dome and part of cylinder), except for the areas between the strip beads. The liner and liquid inlet box in the liquid phase were grey and slightly etched. No corrosion has been observed.

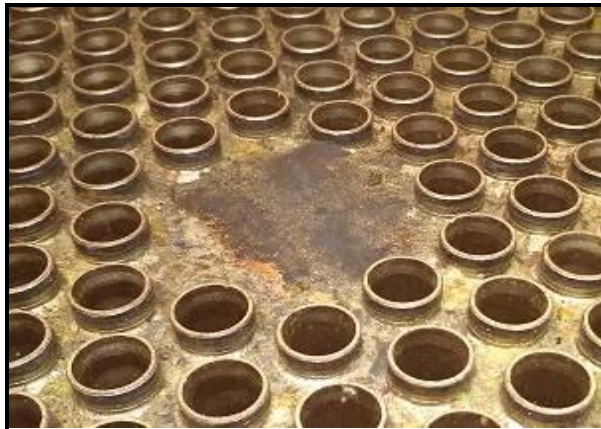
- The overlay welding on the tube sheet was grey and slightly etched.
- The tube welds were bright and smooth. Thick & hard oxide deposition was observed, more prominent in center of tube sheet East - West direction on tube sheet area. Needs Cleaning.

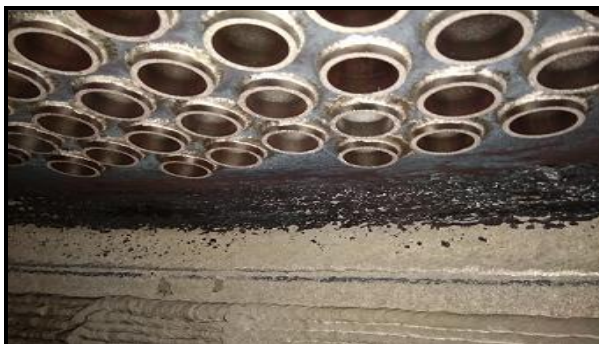
BOTTOM CHANNEL

- The condition of sealing face was found satisfactory.
- The overlay welds in the man way observed silver and slightly etched.
- The overlay welds in the hemi-head were silver and etched. Many patches of approx. 2"x2" size on the hemi-head overlay welds were observed which were more etched than the surrounding areas in North and East direction; same was observed in previous inspection also.
- The tube sheet was covered with a thin grey oxide layer. This layer observed more hard & bonded on tube-sheet to shell weld joint.

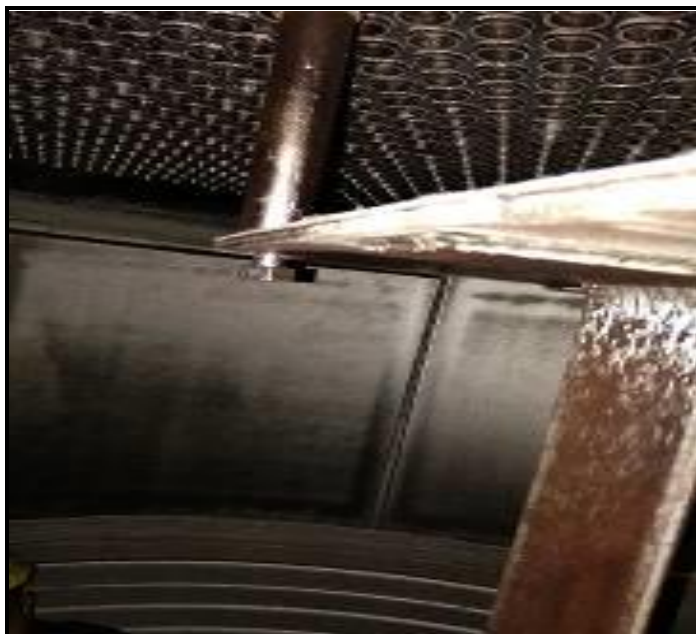
- 01 no. Impingement plate bolt found loose of CO2 Inlet line.

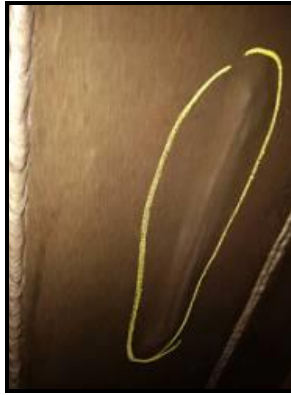
TOP SHELL

- Shell internal surface was found brownish in coloration and top hemi head observed silver shiny in colour.
- CO₂ inlet nozzle flange (3/4"NB) located at west side found corroded same was observed in previous inspection also.
- Condition of liquid inlet and gas outlet pipe found satisfactory.
- CO₂ Inlet line in south side was found intact.
- Shell liner weld joint below the diaphragm plate found satisfactory.
- Bulging of approx. 3.0 to 4.0mm height and size of 25mm x 250mm observed in top course just 1200mm approx. above 1st "C" seam in East direction.

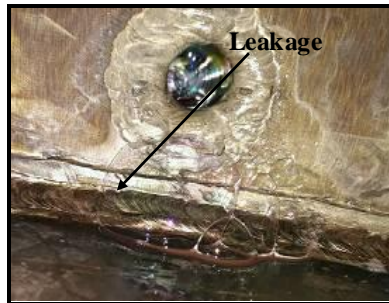
- Pneumatic testing of all liner welds and nozzle welds were carried out at 0.2 Kg/Cm² and leak observed in ¾"NB Nozzle (blind) in seal welding. (North-East Direction.)

- This leak point was repaired and finally found satisfactory in DP Test.
- Also Pneumatic test carried out after repair and found satisfactory.

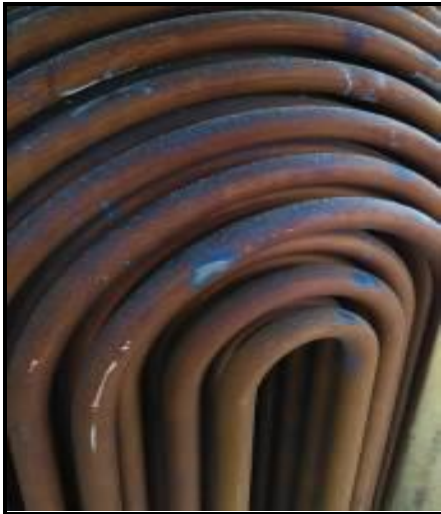
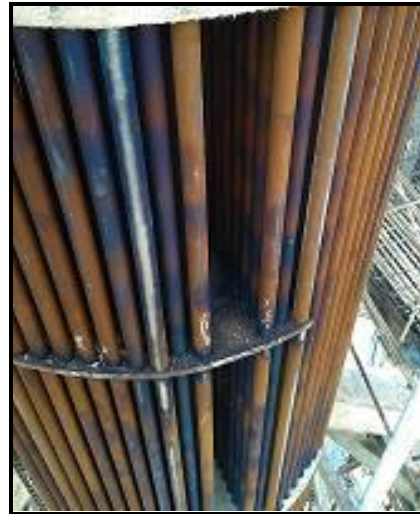
- Coloration of tubes external surface assumed to be brownish black above 1st baffle from top and light golden at the rest of area. Peacock Blue Colour marks were observed at scattered locations on the tube surface, predominant at top half of the tube bundle.

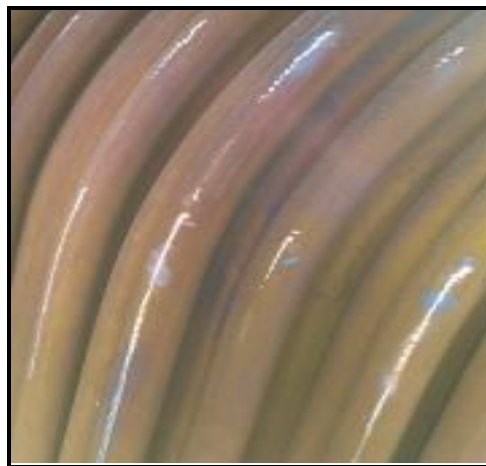
- Tie rods and lock nut tack weld found satisfactory.
- Mechanical abrasion/impact mark seen on the four tubes just above the topmost baffle plate at East side. Abrasion mark size on one tube is approx. 150 to 300 mm x 6 to 7mm x (0.1-0.2 mm depth).

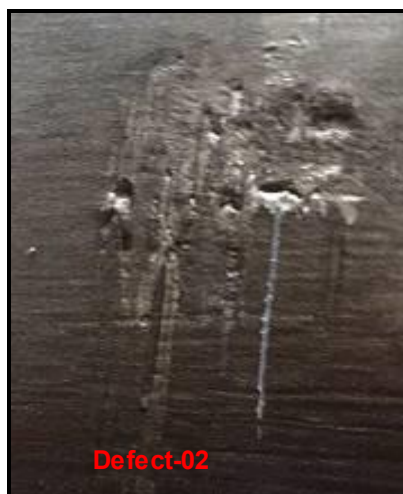
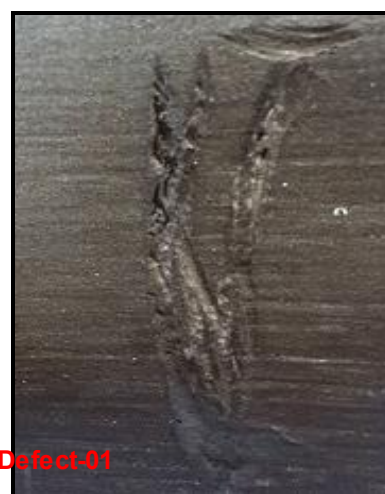
- Abrasion marks due to the lowering of tube bundle were observed at scattered locations on the liner including those caused in the past.
- Top two courses found to have brownish gold coloration whereas bottom course was silver grey in colour.
- Liquid over flow basket weld & Carbamate inlet line nozzle weld found satisfactory.
- (3/4" NB CO₂ inlet line holding clit weld was found in to have minor crevice, in south bottom corner as observed in previous inspection also, however welding of its holding pad was found satisfactory.
- Circumferential weld joints (04 nos.) and longitudinal weld joints (03) observations are as under.
- 125 mm above 1st "C" seam in south direction crack /opening of 0.25mm depth x 30mm length observed in shell liner. Marked as defect 1 and defect 2

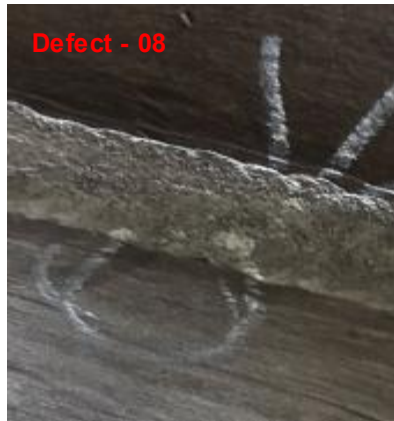
- In 1st “C” Seam welding observed flushed out and crevice, pin holes observed. Marked as defect 8.

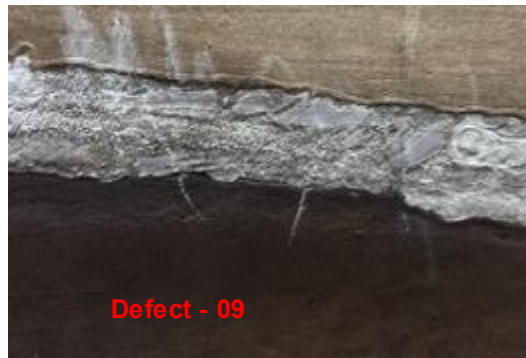
- 2nd “C” seam in East direction weld crevices / weld roughening observed. Marked as defect 09.

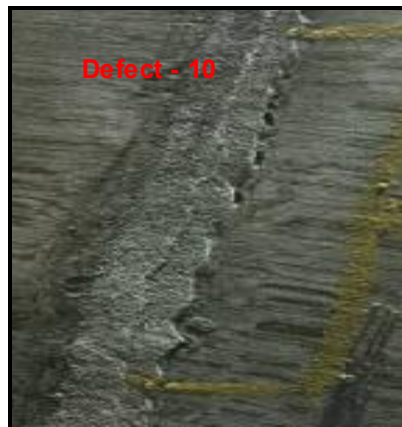
- In 3rd course “L”seam, weld crevices and under flushed welding observed in series. Marked as defect 10.

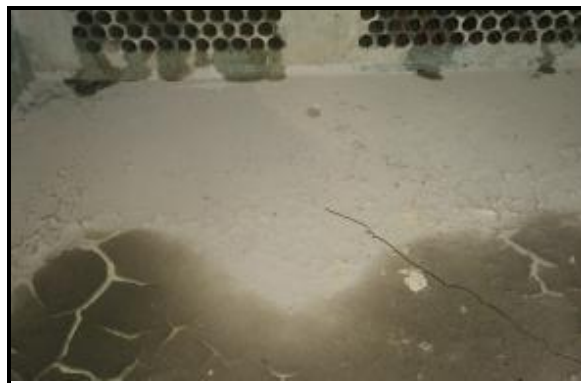
TOP HALF

- Tube sheet was found in satisfactory condition.
- Epoxy coating layer was found peeled off and cracked at several locations.

- Thermo well was found intact.
- Minor scaling / debris / rust flakes were observed at ID of few tubes.

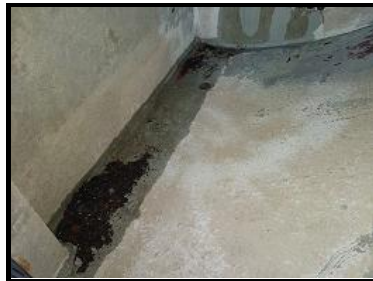
BOTTOM HALF

- Tube sheet was found in satisfactory condition.
- Thermo well was found intact.
- Debris found accumulated at bottom corner.

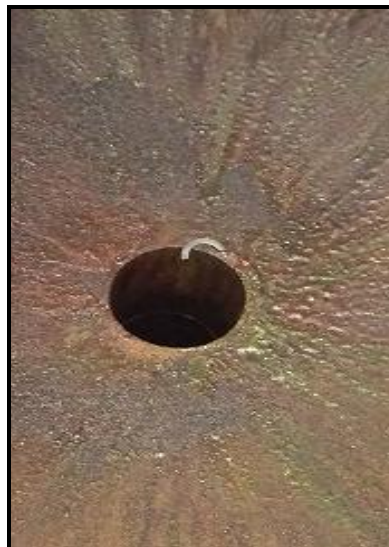
V-1103 (NH3 SUCTION VESSEL)

- Vessel from inside observed brownish.
- The condition of longitudinal and circumferential weld joints observed satisfactory.
- Oily layer was found on the bottom dish end, shell and man way.
- Level troll nozzles found satisfactory.
- Foreign element (half cut metallic ring) observed near NH3 liquid outlet line.

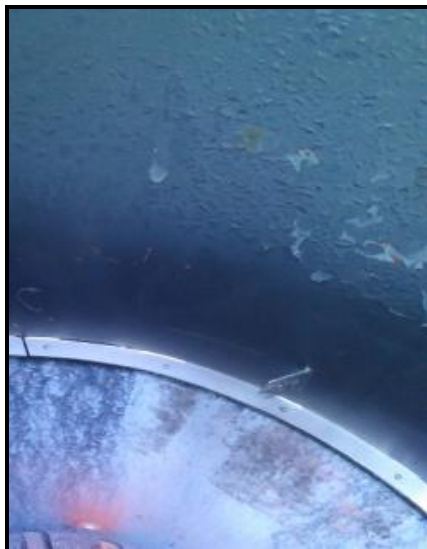
V-1202 (RECTIFYING COLUMN)

- Grey hard scales were observed on entire shell portion.

- Tray holding cleats holes observed elongated.
- Tray support / Mesh Grid support strips found satisfactory and they were covered with grayish hard scales.

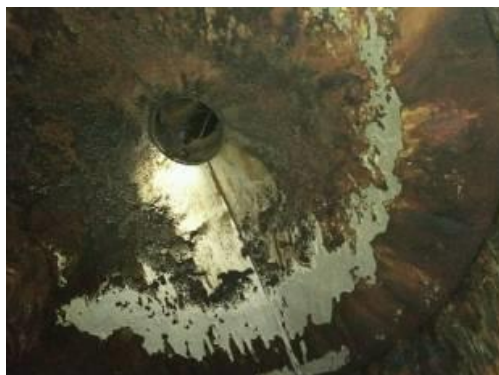
FROM BOTTOM MANHOLE

- Coloration of top cone was brownish with white solution like layer observed.

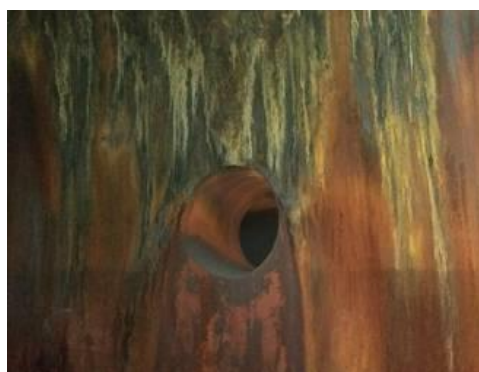
- Shell observed reddish in colour.
- Deposition of dust / scale observed on solution inlet nozzle from H-1204.

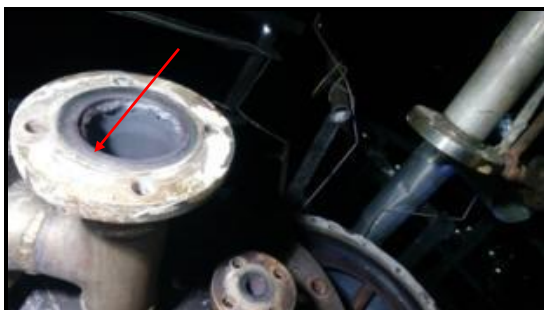
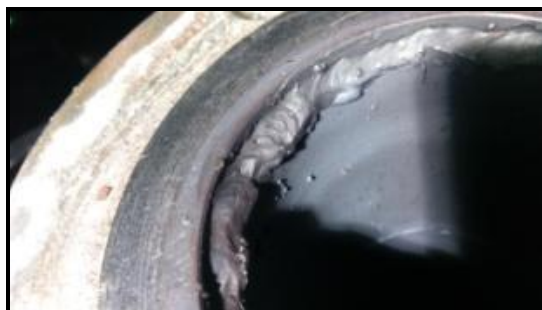
FROM TOP END

- Shell observed brownish in colour.
- Perforated support grid & its stool were found intact in position. However, it is not free in the shell.
- Through Pinholes observed in the flange weld as shown in the figure, as deposition observed on the outer side of flange weld.

- This pin hole was repaired by welding.

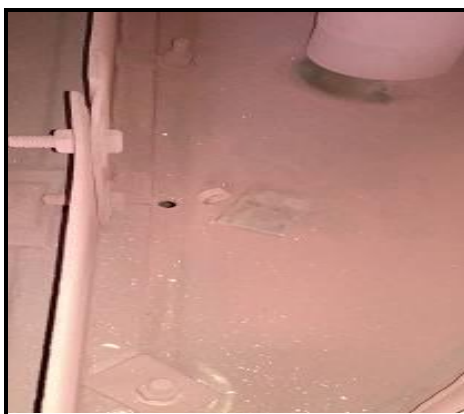
V-1301 (2ND DESORBER):

- Shell Internal surface found rusty / brownish in colour.
- Nozzle found satisfactory.
- Fasteners and clamp of trays observed in satisfactory condition, However one bolt observed missing and its washer and nut found lying on perforated tray.

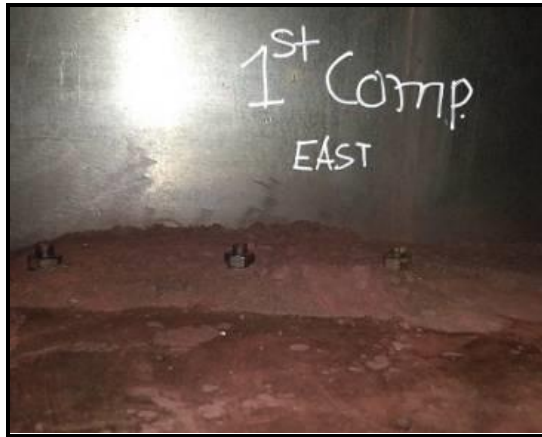
1st COMPARTMENT (Counting from Top)

- Brownish coloration was observed on Top dish end and shell.
- Trays also observed reddish in color and lots of accumulated debris / sludge observed most prominent in east corner.

- In Top 5 compartment amount of accumulated sludge/debris observed more, cleaning suggested.
- From 7th to 20th compartment scattered minor sludge/debris observed on trays in periphery.
- In general all compartments having similar observations as below, however any other specific observations were described compartment wise in this report.
 - Trays and its supporting ring observed satisfactory in condition.
 - Brownish coloration was observed inside of shell.
 - Fasteners of sieve tray were found intact in position, however in few Compartment lock nuts, bolts were observed lying on trays.
- Overall condition of vessel found satisfactory.

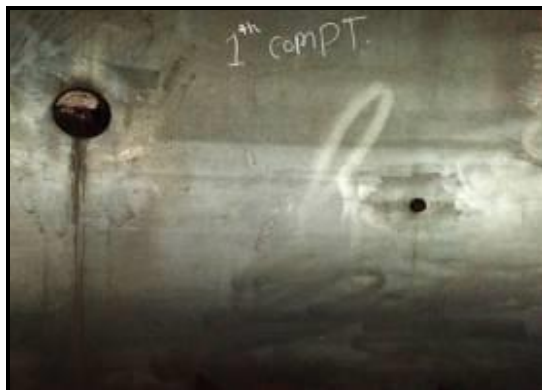
- Fasteners of sieve tray were found intact in position.
- Trays and its supporting ring observed satisfactory in condition.
- Accumulated sludge / debris observed in sampling and level indicator nozzles.

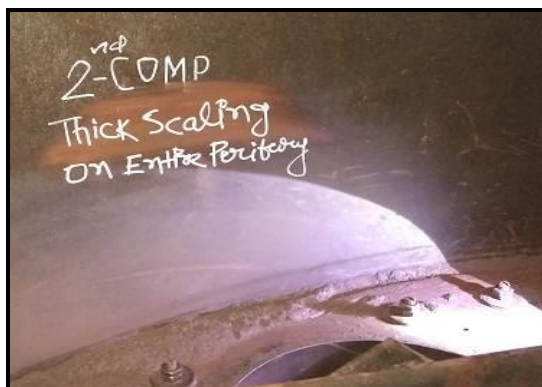
2nd COMPARTMENT

- Thick layer of sludge/debris observed on entire periphery.

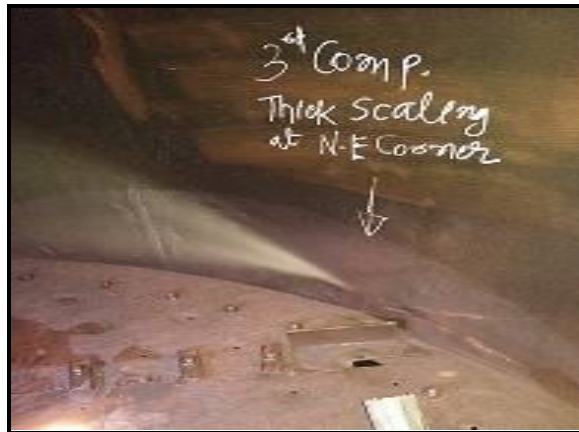
3rd COMPARTMENT

- Thick layer of sludge/debris observed on North –East corner.

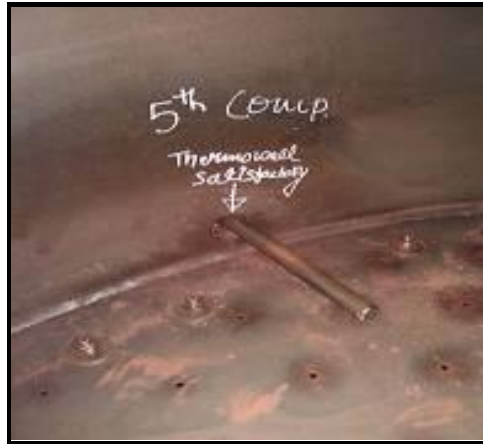
5th COMPARTMENT

- Thermowell condition found satisfactory.

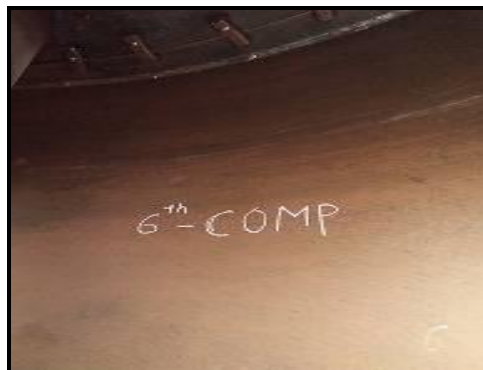
6th COMPARTMENT

- "C" Seam condition found satisfactory.

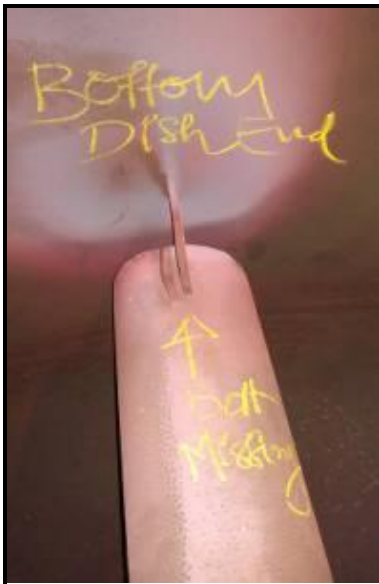
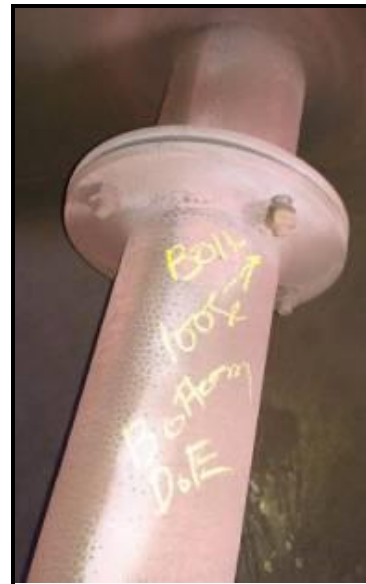
- Steam inlet line clamping bolt missing and its flange bolts found loose.

- Reddish coloration was observed from inside.
- Tray clamps & steam inlet pipe found satisfactory
- End cap of the steam Inlet pipe was found detached and lying on the dished end which was repaired by welding and found satisfactory.
- Clamping bolts provided and flange bolts were tightened.

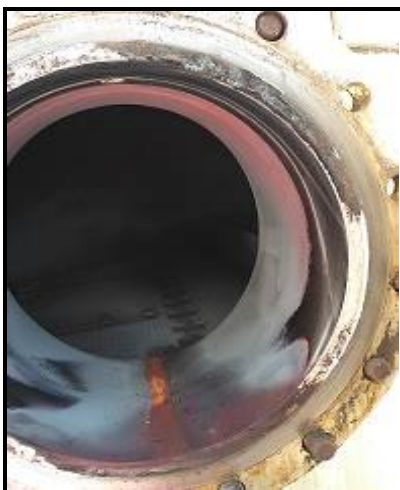
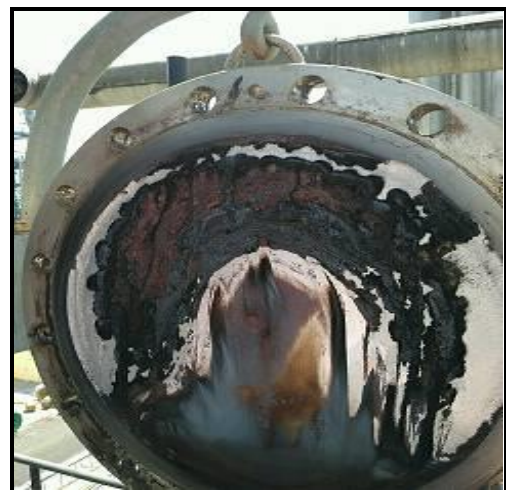
FROM TOP MANHOLE

- Vessel inside surface observed blackish in colour.
- Fasteners were found satisfactory in its position.
- Weld joint condition was found satisfactory.
- Manhole gasket seating face observed eroded / corroded at several locations.
- Thick blackish deposition observed on M/H cover and on M/H flange.

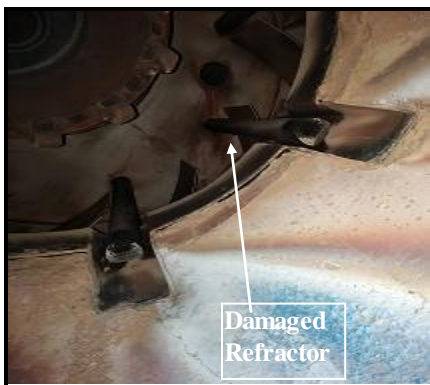
From South Wall Access Door

- Previously repaired refractory found Satisfactory just above the access door.
- Minor rust and scaling was observed on South wall, Front panel, Rear panel, Cut corner tubes and baffle wall tubes.
- Floor refractory was found damaged and lifted upwards at centre of furnace floor. Previously repaired floor refractory found damaged.
- Condition of thermo-wells in cut-corner wall found satisfactory.
- Condition of refractory around the bottom burner was found damaged at 5 locations which were marked with yellow chalk and carbon deposition observed on all 8 nozzles of top and bottom burners.

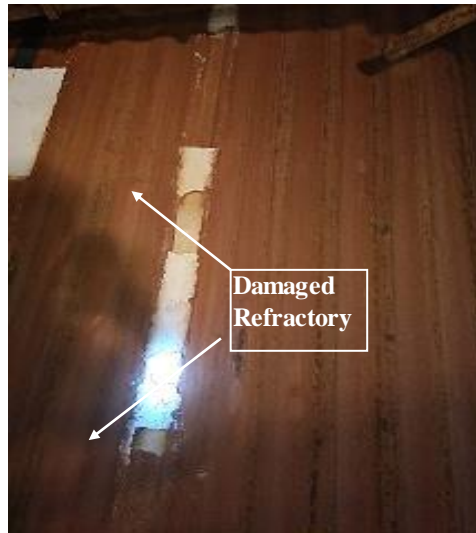
- Baffle wall refractory fell down at few locations.

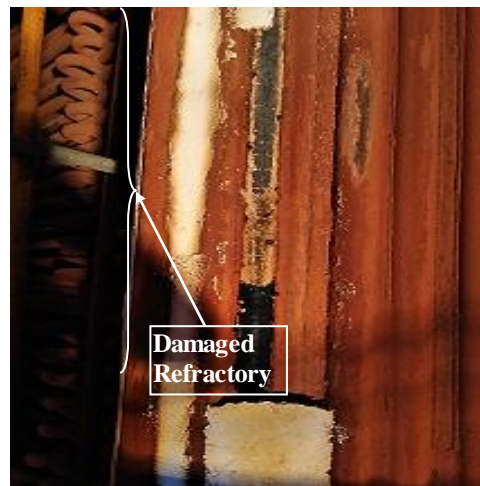
- Refractory on west wall above primary super heater tubes found loosened.

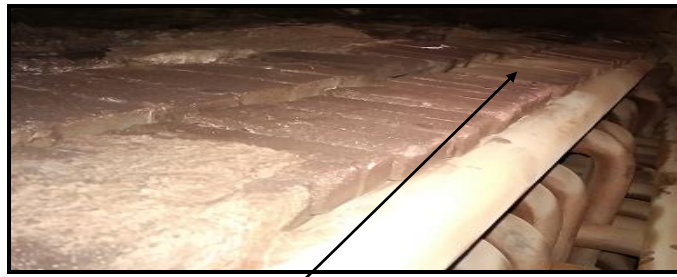
From North Wall Access Door

- Refractory found satisfactory on roof just above the access door.
- Minor rust and scaling was observed on boiler bank tubes.
- Condition of Secondary super heater coils was found satisfactory.
- Refractory bricks were observed slightly detached from baffle wall at top portion.

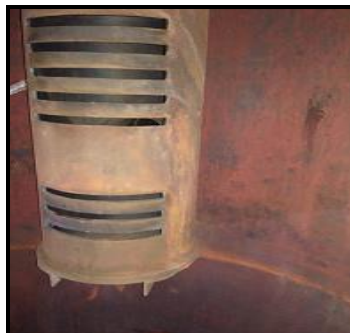
CONTINUOUS BLOW DOWN DRUM

- Shell and Dish end observed brownish in colour.
- Steam expander condition observed satisfactory.

- Dish end welding and long seam welding observed satisfactory.
- Thickness measurement carried out. Minimum thickness observed on shell 13.91 mm and dished end 13.01 mm.
- Overall condition of vessel observed satisfactory.

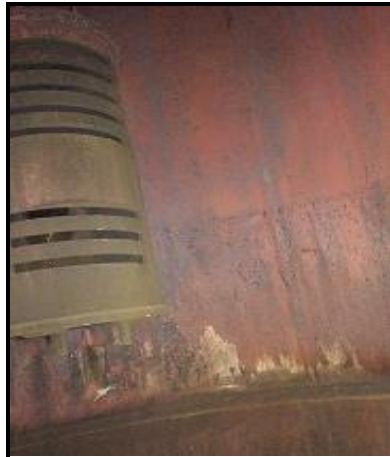
INTERMEDIATE BLOW DOWN DRUM

- Shell and Dish end observed brownish in colour.
- Steam expander condition observed satisfactory.

- Dish end welding and long seam welding observed satisfactory.
- Thickness measurement carried out. Minimum thickness observed on shell 14.21 mm and dished end 12.17 mm.
- Overall condition of vessel observed satisfactory.

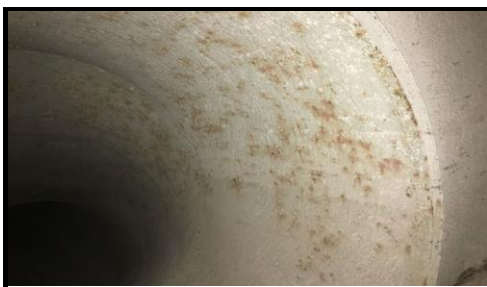
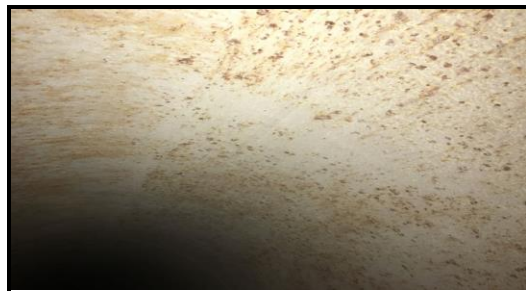
52" NB CW INTERCONNECTION LINE

- Condition of Epoxy paint was found satisfactory in general however rusting marks were observed at scattered locations.
- All circumferential and long seam welds found satisfactory.
- Rusting and blistering of paint was observed at scattered locations on suction pipe of P-2205 A/B, repainting is suggested after cleaning.
