KALOL UNIT

PLANT TURNAROUND REPORT
(MARCH – APRIL – 2017)

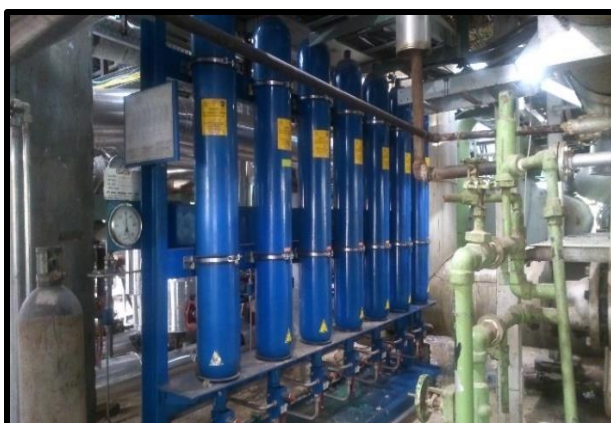
HP Oil Tank System Accumulator System

HP oil tank had inbuilt instruments along with junction box. Multi-Pair cables were laid from junction box to DCS Marshalling cabinet. Wiring termination work was carried out in junction box & cabinet end with proper ferrule at both side. Loop checking of all instruments were carried out & found ok.

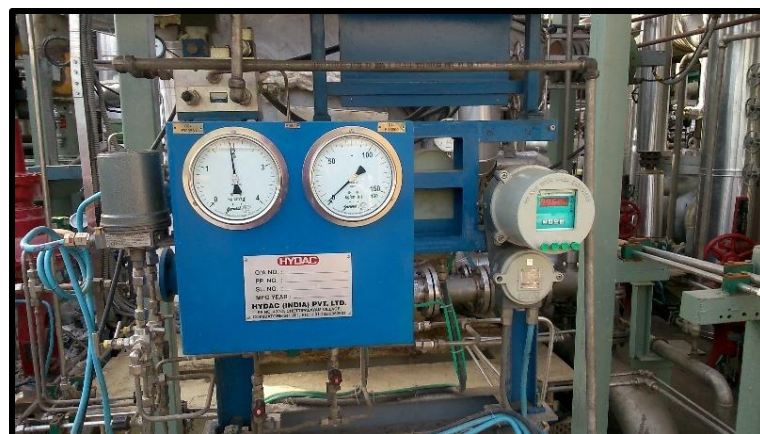
Turning Gear System

M/S Hydac make Turbine Turning gear system was installed for barring purpose. Related instruments were installed & wiring work was done. Logic for turning gear was made in DCS system, checked & found working satisfactory.

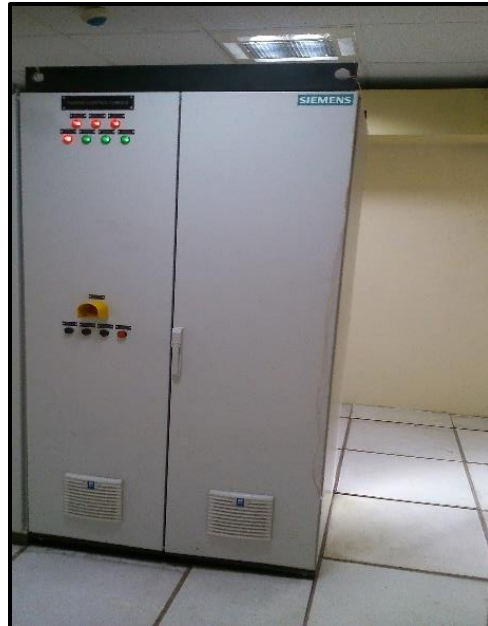
Turbine Control Cubic (TCC) panel was installed in new marshalling room. Power of 110Vac provided from UPSS power distribution board. All wiring related work between TCC Panel to ESD & DCS Cabinet was done. Five dedicated cables from MPU's of turbine to TCC cabinet were laid & terminated in its location.

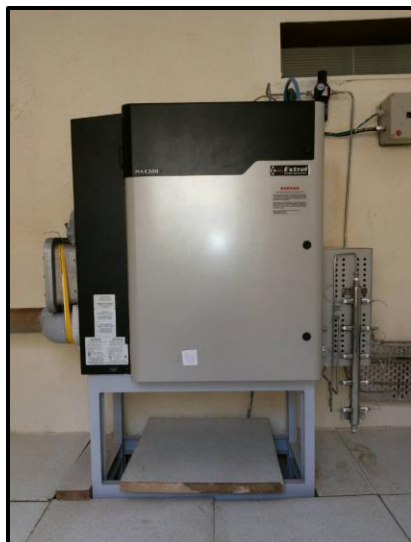
HIS0153

New HIS was installed in shift-in charge room. 110V ac power supply was provided from power distribution board (C-121). V-net IP bus & Ethernet cable were laid from L2 switch & Ethernet Hub to HIS. Related Software were loaded in HIS by M/S YIL engineer. Finally HIS was taken in line & found ok.

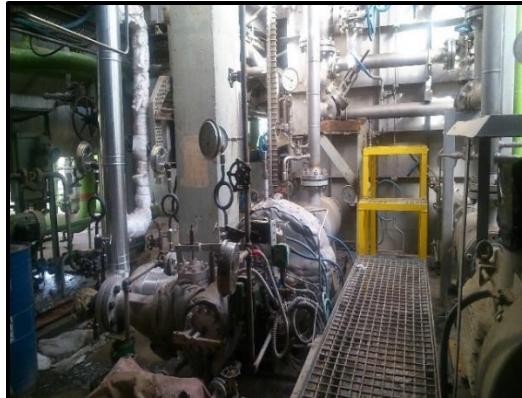
FRC-485

Old control valve was replaced with new one. Line modification work was done by mechanical maintenance. Air supply tubing & signal cable work were carried out. Finally control valve stroke was checked and found ok.

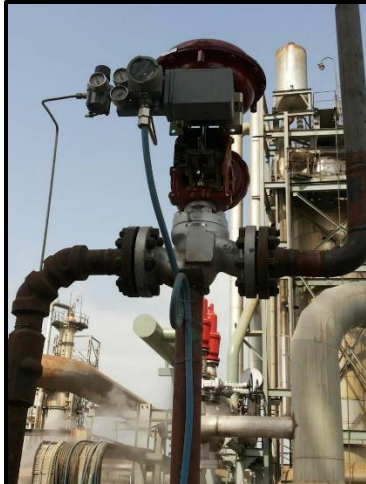
New Vent Valve at Methanator inlet line

As per EWR A-317 new vent valve was installed at inlet line of Methanator. Related tubing & wiring related work were carried out. Finally Valve stroke was checked & found ok.

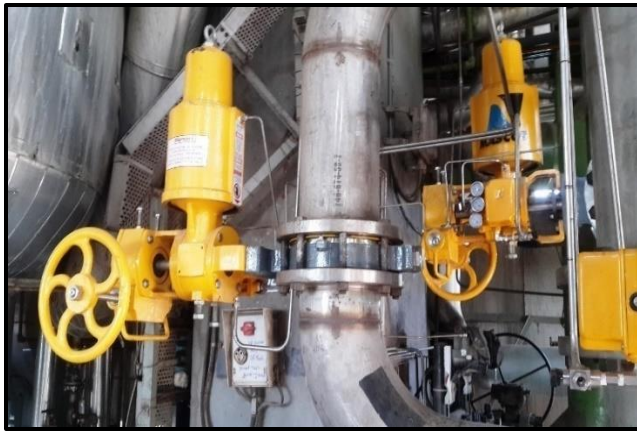
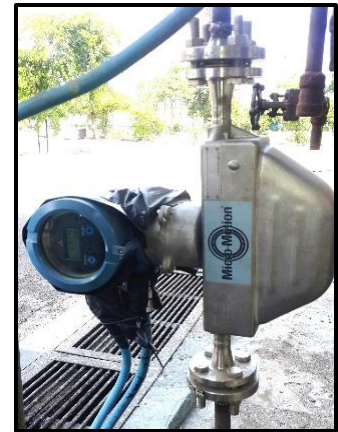
- Existing very old Serck make butterfly type control valve HICV-1222A, HICV-1222B & TRCV-1202 of CCS-I were replaced with MASCOT make butterfly type control valves procured with technical specification as per updated process data.
- Existing very old Serck make control valve LICV-1504B and LICV-1204 were replaced with MASCOT make new control valves procured with new technical specifications and with updated process data.

Control valves TRCV-1202 & HICV-1222B Neem oil Mass Flow meter

- For neem oil flow measurement, existing rotameter was replaced with Micro motion, Emerson make Mass Flow meter FI-1901 with accurate measurement and remote indication in DCS.

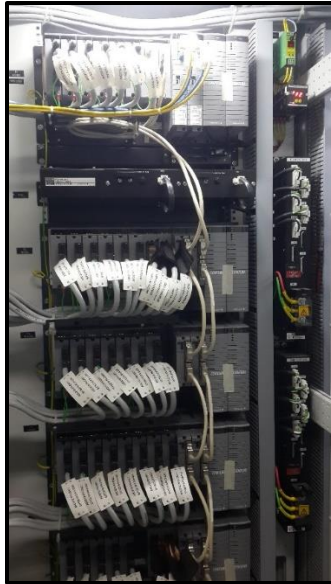
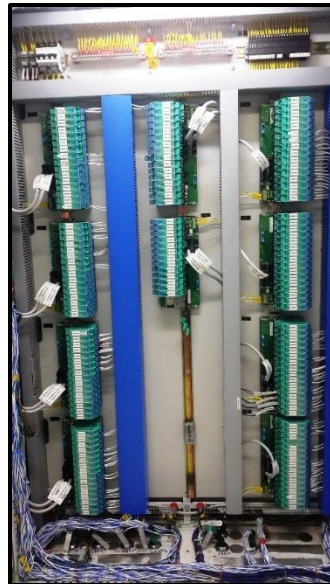
- Existing DCS System Domain 05 Centum CS related cabinet (FCS0501 with Bus Converter), two analog marshalling cabinets (C101 & C102), four Digital Marshalling cabinets (C111, C112, C113, & C114), and Power Distribution cabinet (PDB121 & ACDB) were removed after removing all earthing wires, power cables, communication cable and instrument signal cables.

- Installed two new Centum VP System cabinets (FCS0202 & FCS0203), two Analog Marshalling cabinets (AIC-221 & AIC-222), two Digital marshalling cabinets (DIC-211 with interposing discrete relay for MCC and MOV related digital IOs and DIC-221 for Field digital IOs) and one Power distribution cabinet PDB (PDB230). All Prefab signal cables were connected to IO cards in new system cabinets. New redundant Cat5e cables laid from FCS0202, FCS0203, HIS0259 and STN0258 to old existing FCS0201 for control bus communication via Ethernet hubs. Also connected all old & new field cables in appropriate Marshalling cabinet for all old instruments and new instruments related to ESP.

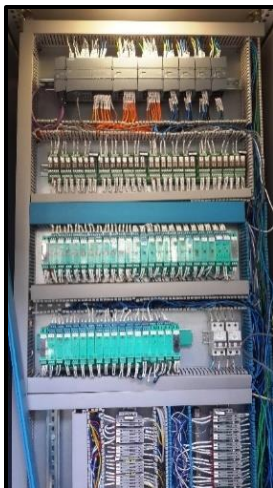
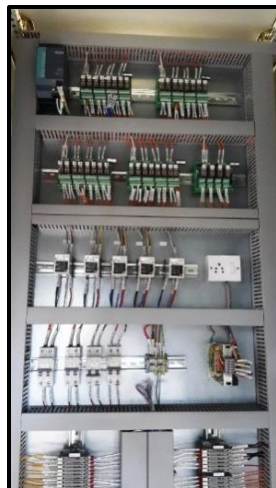
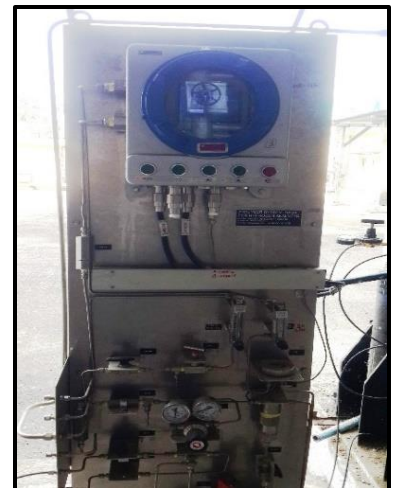
- 110V ac UPS power was provided to VAM PLC panel from PDB and Instrument air header provision were done at VAM area.
- Necessary power cable, single pair and 12 pair instrument signal cable laying were done from DCS marshalling room and MCC15 to VAM Panel. Also installed necessary Junction box in VAM area for VAM package Instrument.
- VAM PLC panel, package field instrument and control valve installation done by vendor M/s Thermax Ltd., were checked. Also done loop, interlock and functional checking of all instrument items up to local HMI on PLC panel.
- VAM PLC was connected to DCS through MOSBUS cable and necessary MODBUS Tag data mapping and monitoring graphic configuration were done in DCS. Also done instrument loop checking & interlock checking from DCS.

VAM PLC Panel front VAM PLC Panel Rear Hydrogen Analyzer

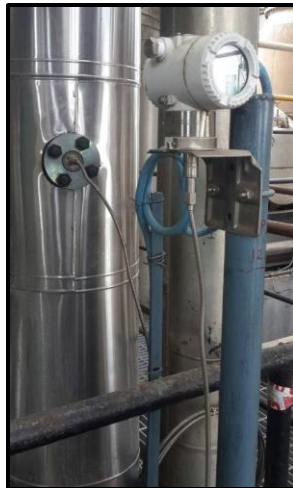
PT-1213 HP Thermowell

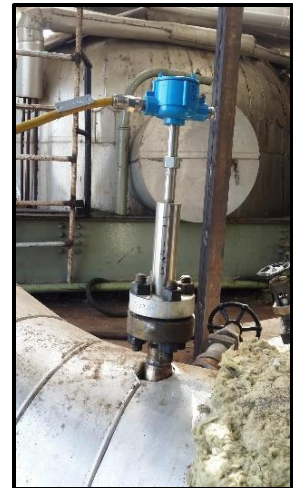
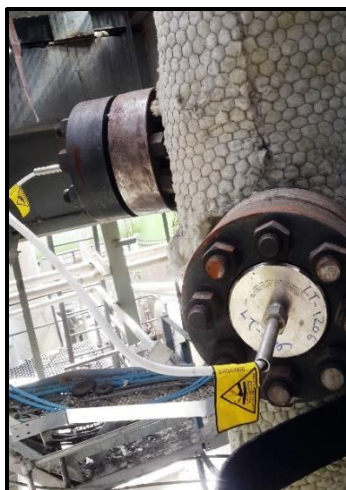
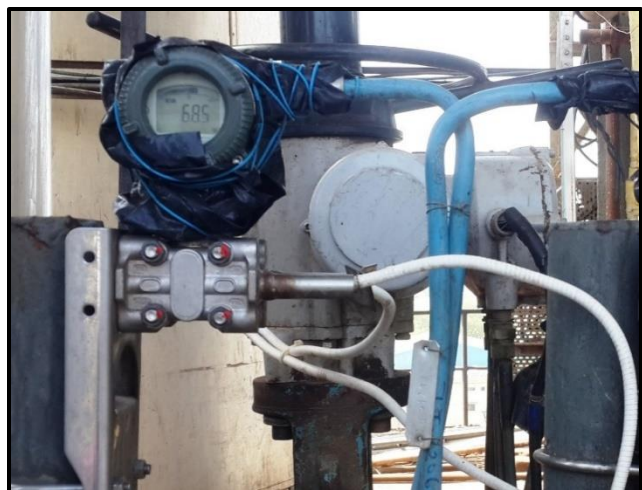
LT-1206 Extended diaphragm remote seal (4" 2500# type DPT with capillary

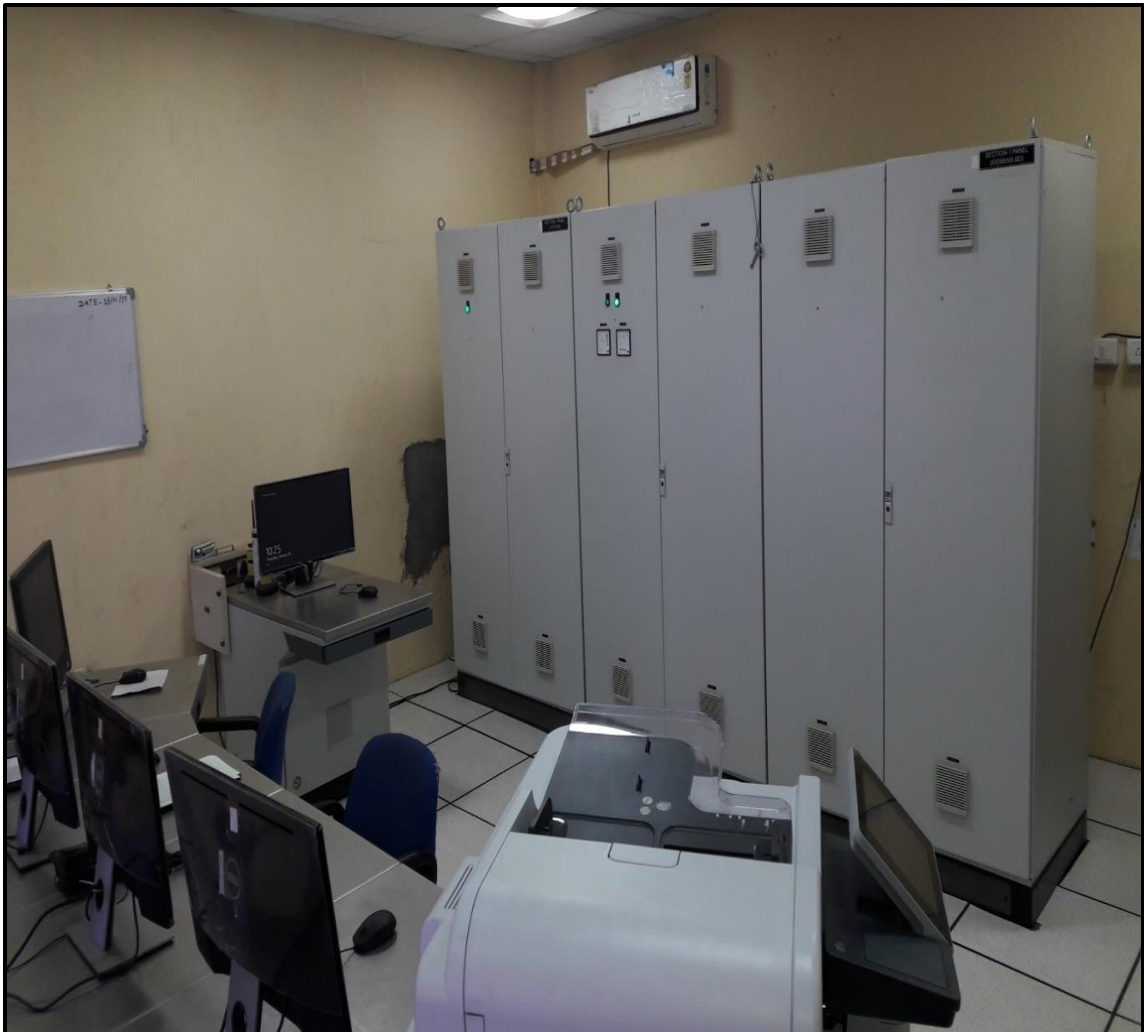
The new load management system was installed in electrical substation for control & monitoring of electrical network for safe & reliable operation of plant. The picture of installed SCADA and its control room is given below-
